# RECOVERY COOPERATION FOR PADANG EARTHQUAKE DAMAGE BY SEISMIC ISOLATION BUILDINGS DESIGN

EWBJ (Engineers without Boarder, Japan)  
Takayuki Teramoto Toshio Okoshi

## Abstract

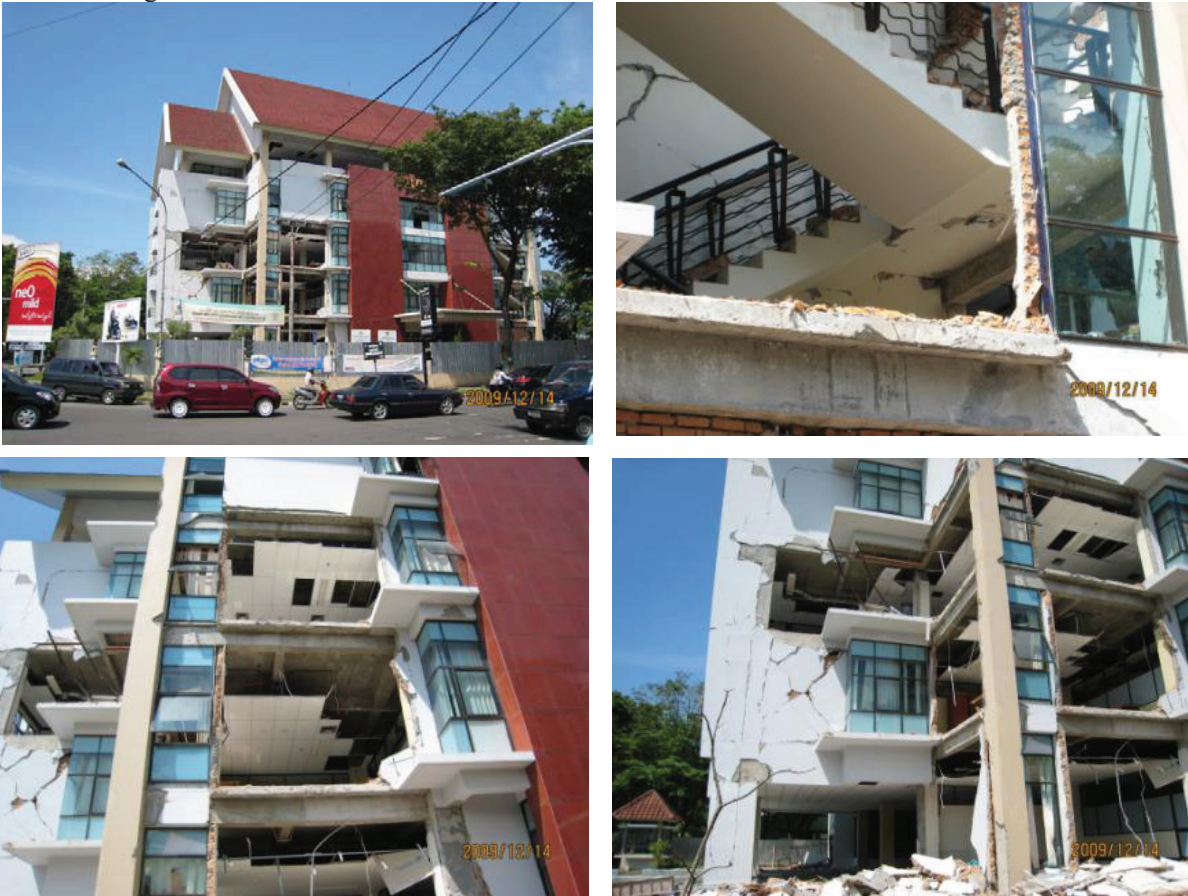
Figure 6. Photograph of BPKP

#### 3.1 Building damage 1/ Board of audit (BPKP)

Reinforced concrete rigid frame structure of 6-story with brick wall  
Damage of exterior brick wall and curtain wall

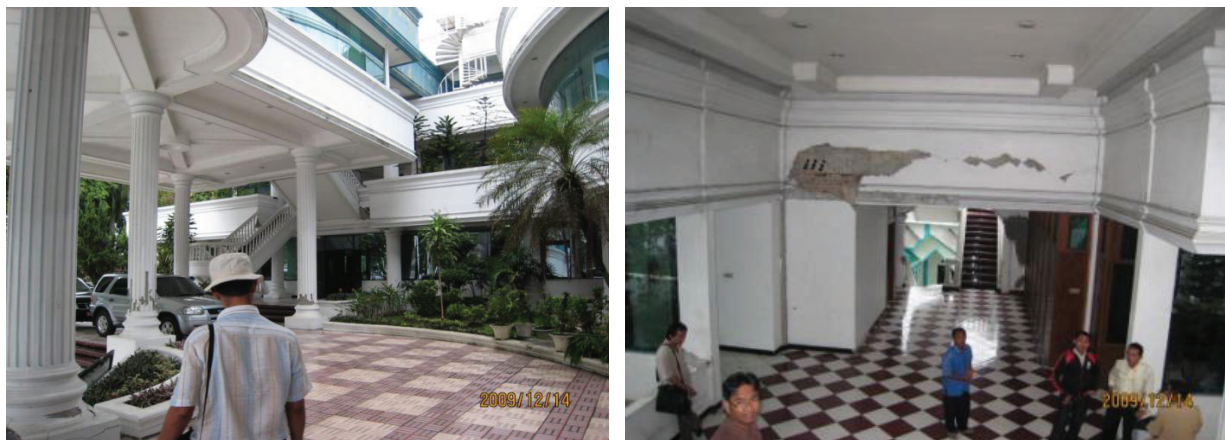
Figure 7. Photograph of Public works office (1)

#### 3.2 Building damage 3/ Public works office

Reinforced concrete rigid frame of 4-story with brick wall  
Shear-crack of reinforced concrete beams connected to the outer columns

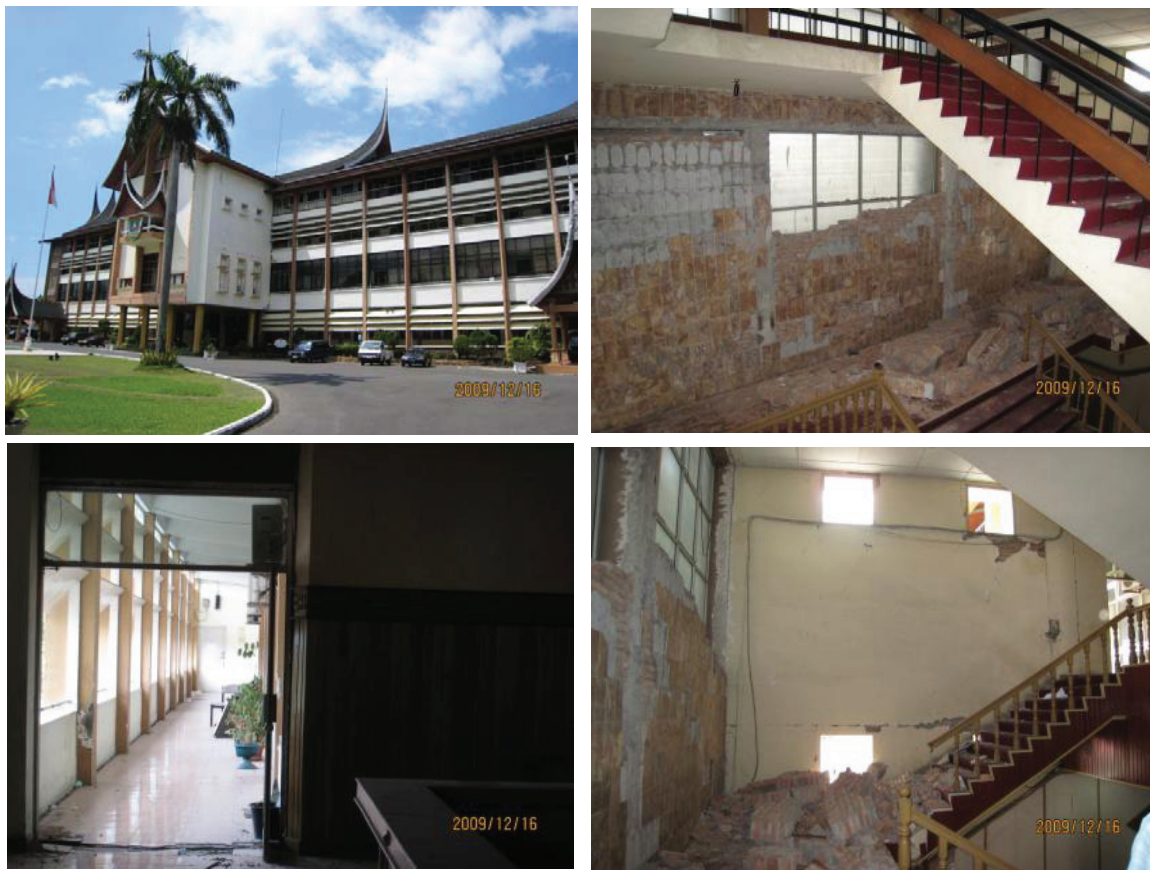
Figure 9. Photograph of State government office

**3.3 Building damage 10/ State government office**

Historical reinforced concrete rigid frame with brick wall  
 Brick wall with curtain wall and hitting of expansion joint

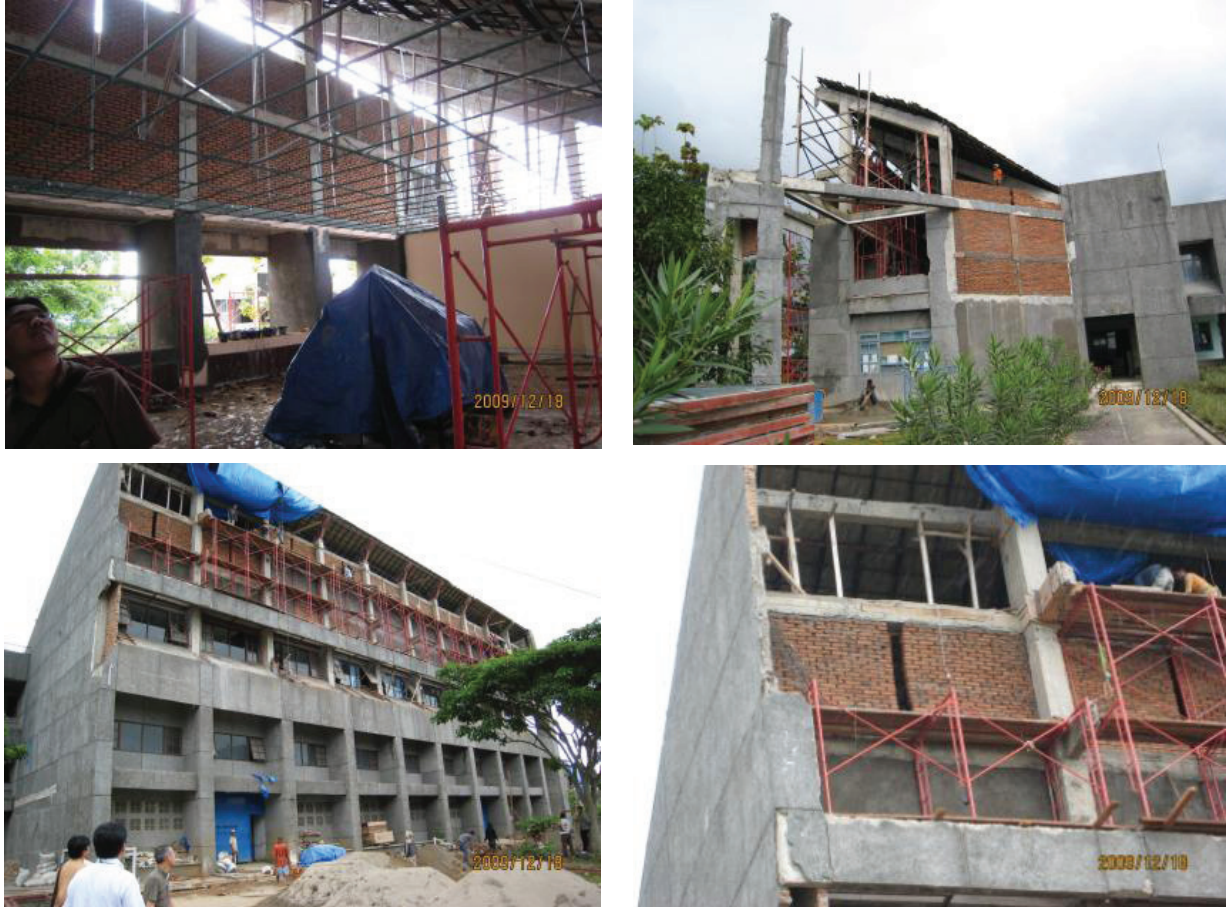
Figure 10. Photograph of Andalas university

### 3.4 Building damage/ Andalas university

Falling-down of brick exterior walls, they started to repair using the same method.

Structural engineers may have no right to change this construction method to seismic one.
