14th US-Japan Workshop

Performance of Base-Isolated Buildings Under the 2011 East Japan Earthquake

Categorization of Damage to Buildings Caused by the 3.11 Tsunami

Damage to RC Buildings and Steel Buildings is discussed in order to develop structural design methods for Tsunami Evacuation Buildings

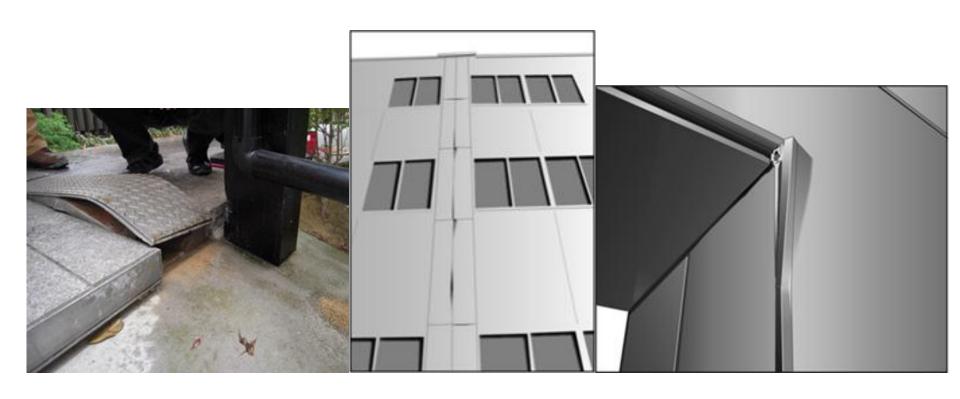
Damages of finishing material to the Expansion Joints

- Insufficient consideration of dynamic and cyclic behavior.
- 2. Unintended contact with other elements.
- 3. Lack of strength and deformation capacity.
- 4. Neglecting unique considerations required for joints during construction.
- 5. Misunderstandings the required deformation capacity to one direction only.

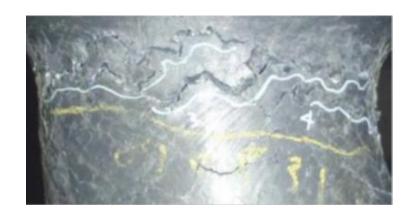
Crack of Lead Dampers

(cracked depth) 30mm

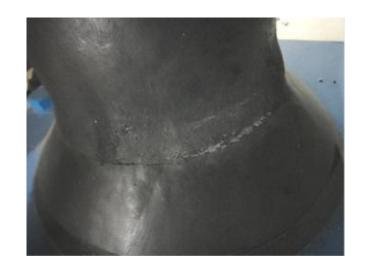
(cracked depth) 7mm.

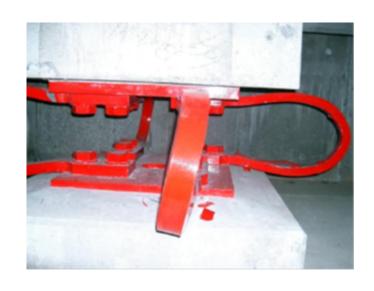
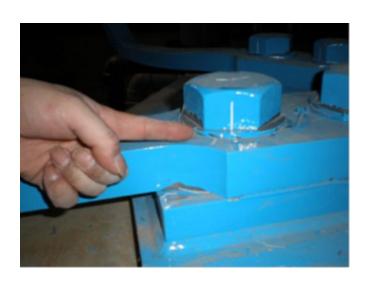
Damages of Bolt Fasteners of Steel Dampers

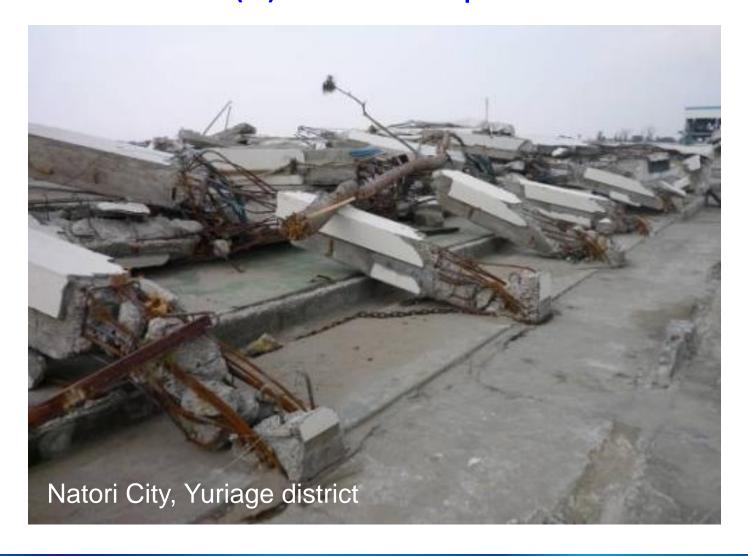
Damage to RC buildings (1) Total collapse

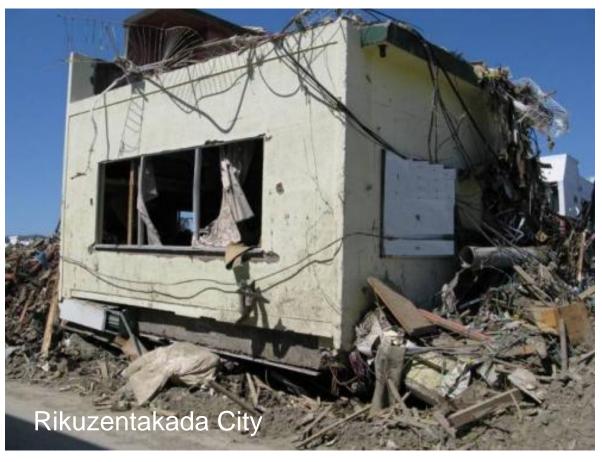
Damage to RC buildings (2) Collapse of 1st story

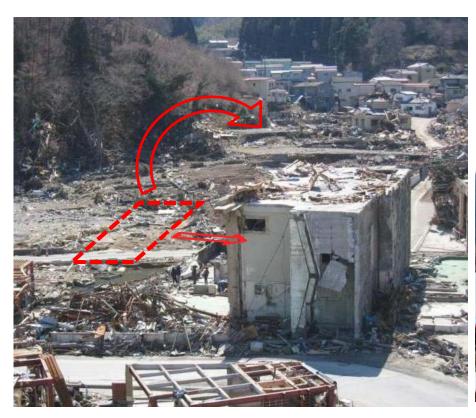
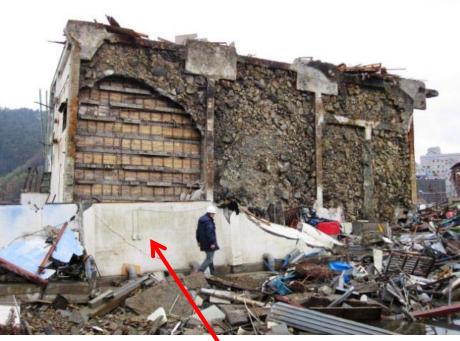
Damage to RC buildings (3) Overturning

Refrigerated warehouse got over the fence

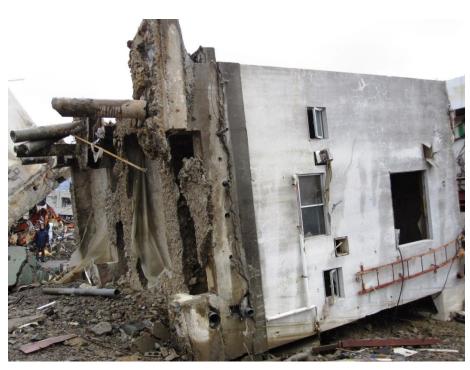
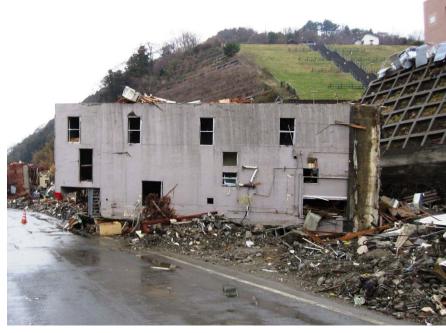
Damage to RC buildings (3) Overturning

Trapped air below floor slab caused buoyant force

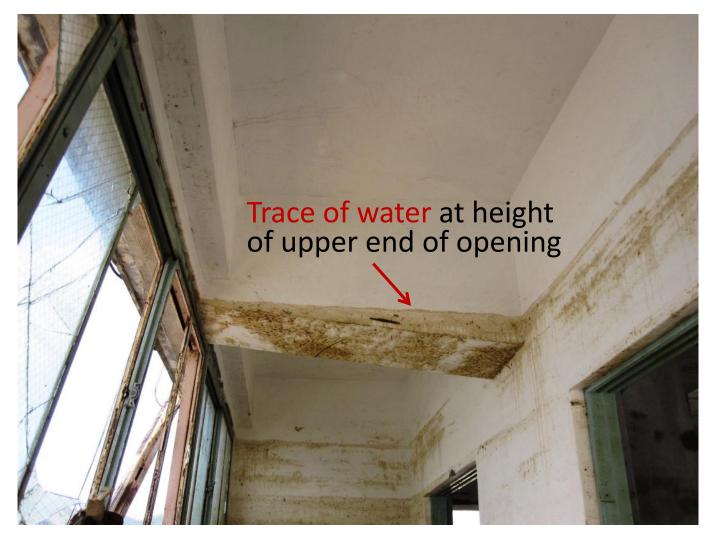
The building was submerged completely

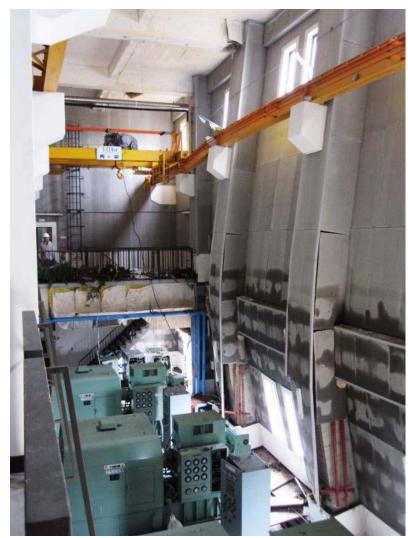
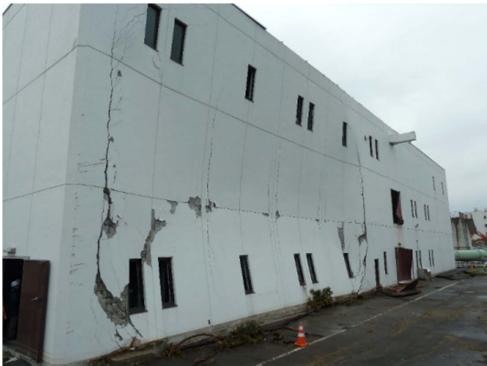
A filtration plant

Damage to RC buildings (4) Failure of walls

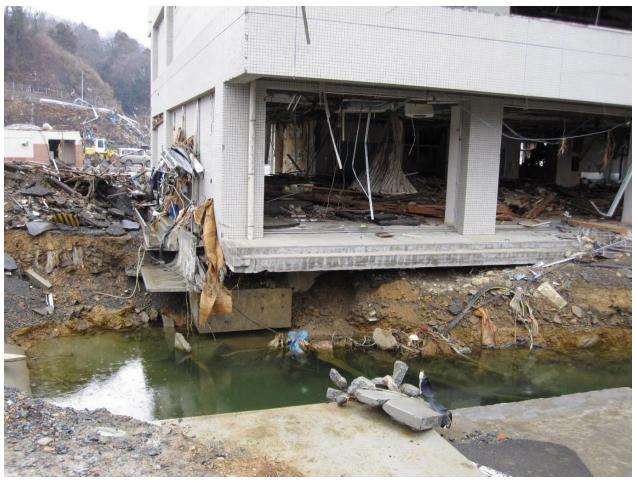
Damage to RC buildings (5) Scour

Very strong stream was generated around the corner of the building, resulted in large holes on the ground

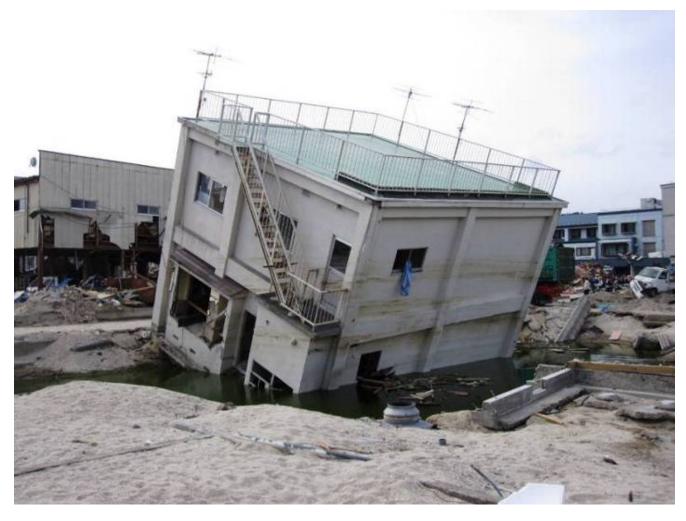
Damage to RC buildings (5) Scour & Tilting

In case of mat foundation

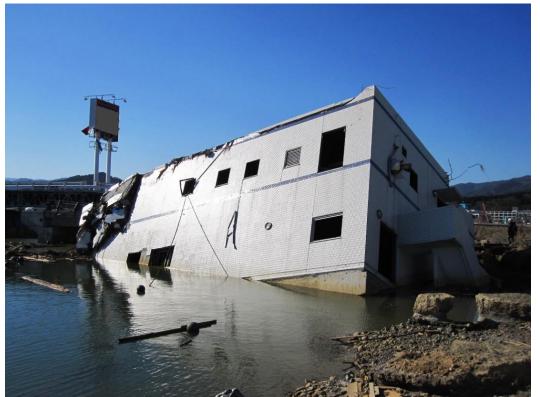
Damage to RC buildings (6) Sliding

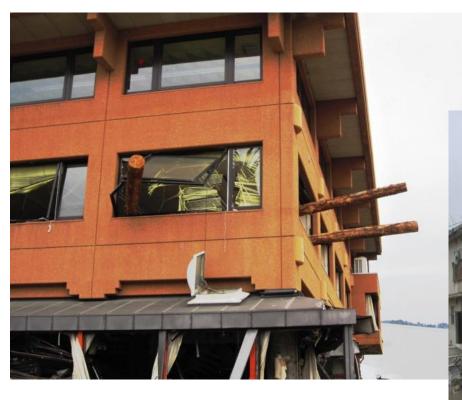
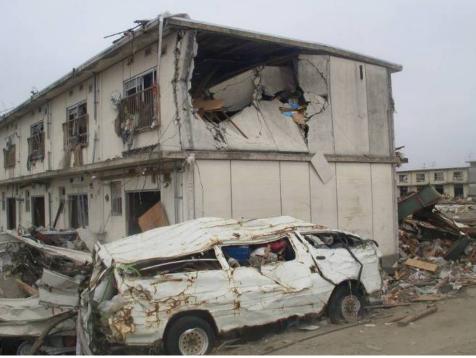
Damage to RC buildings (7) Debris impact

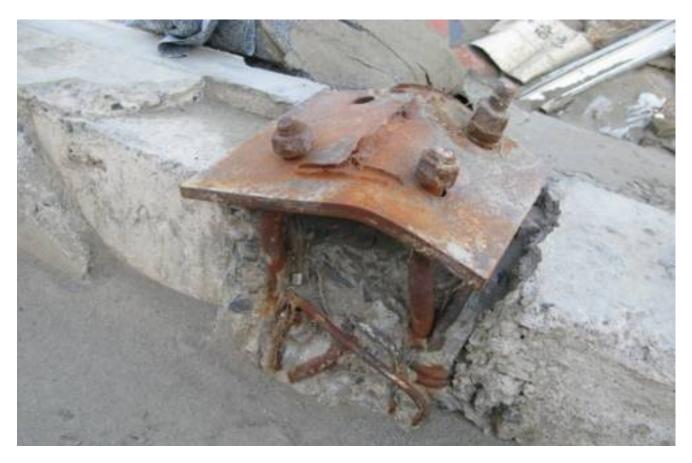
Damage to Steel buildings (1) Failure of exposed column

Rupture of anchor bolt, base-plate or welding part between column and base-plate

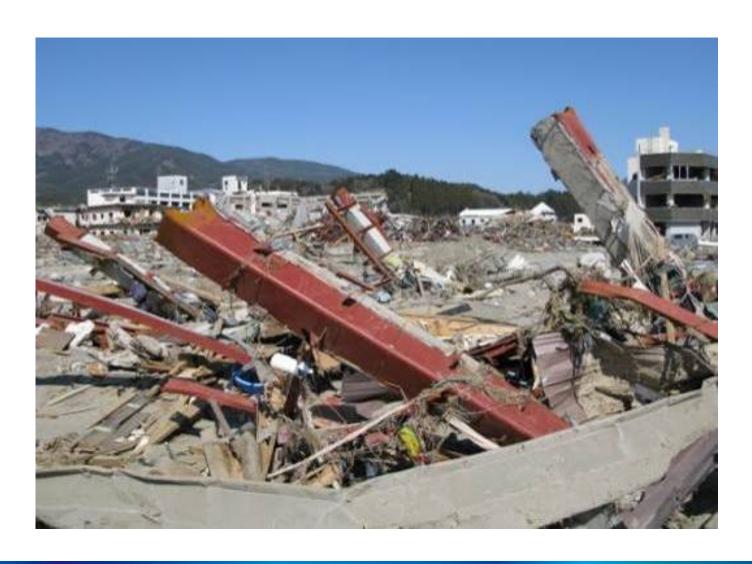
Damage to Steel buildings (2) Failure of column top connection

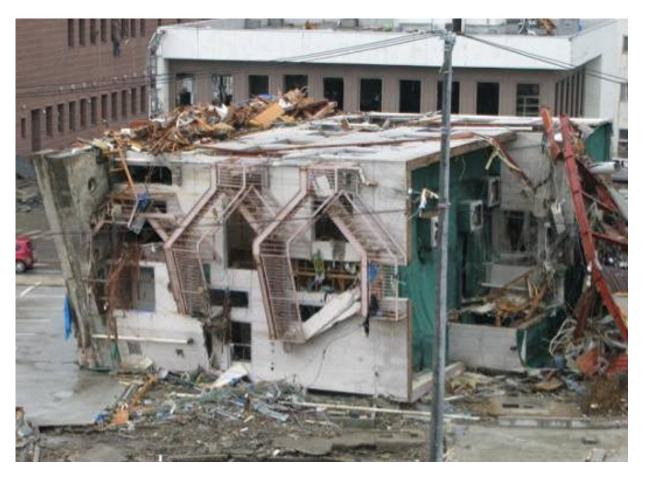
Damage to Steel buildings (3) Overturning

Exterior finishing was survived
Then large tsunami load and buoyancy happened

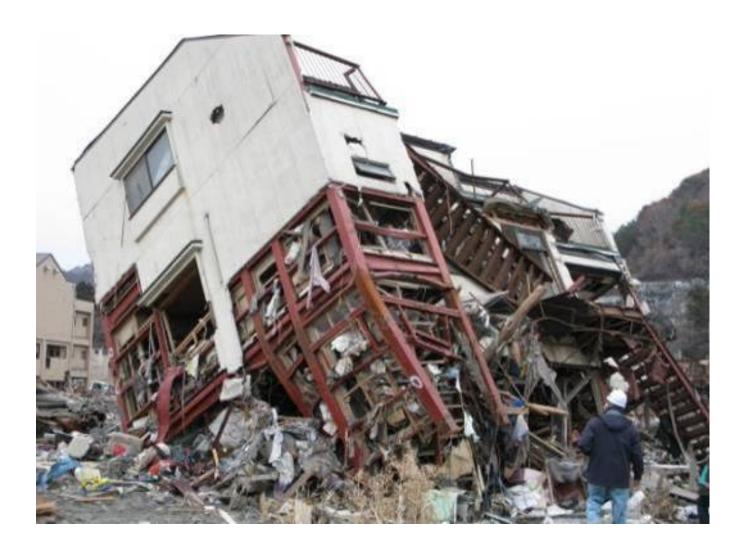
Overturning due to rupture of anchor bolt and buckling of 1st story columns

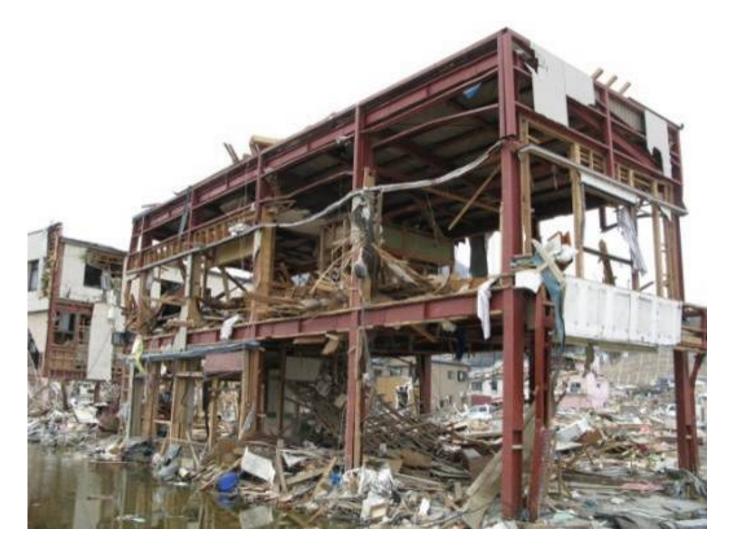
Damage to Steel buildings (4) Washed away of finishing

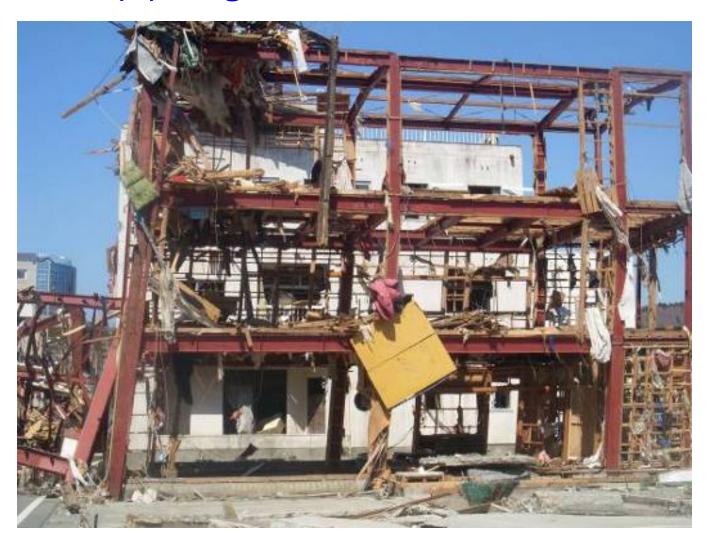
Damage to Steel buildings (5) Large residual deflection

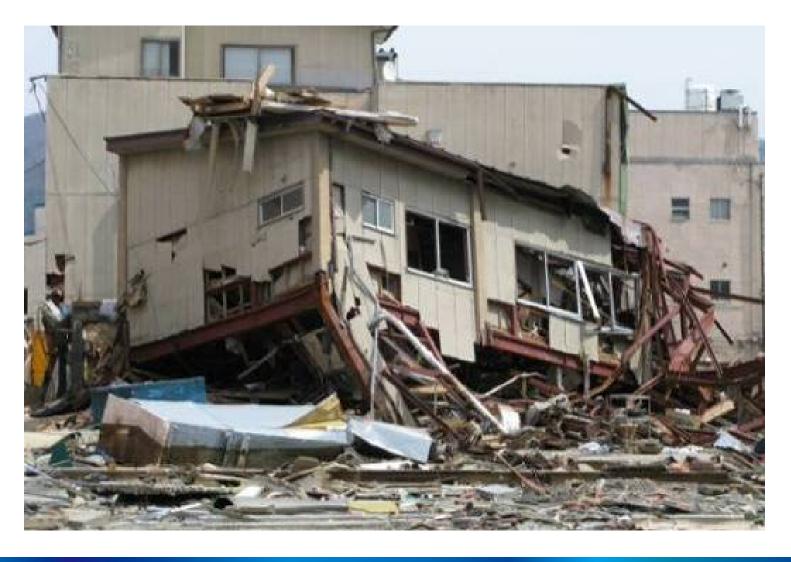
Damage to Steel buildings (6) Collapse of 1st story

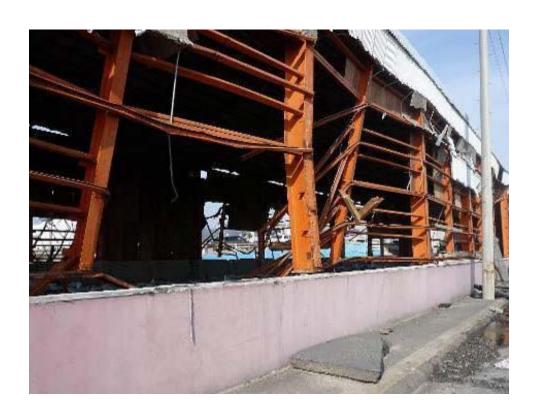
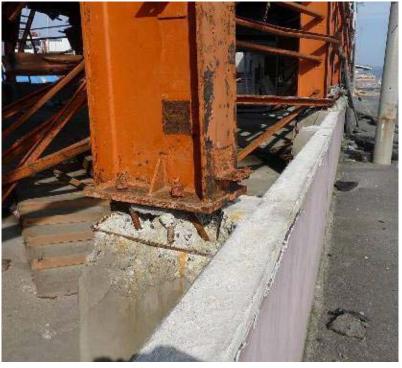
Damage to Steel buildings (7) Deformation of columns due to tsunami pressure and/or debris impact

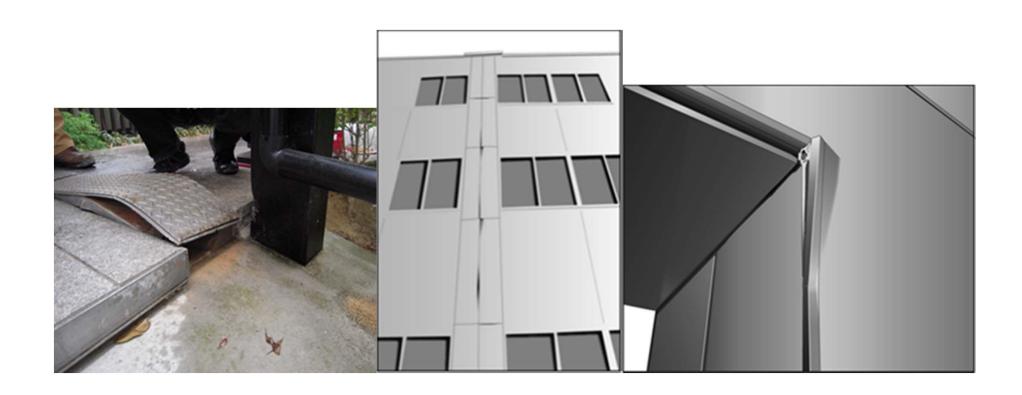
Damages of finishing material to the Expansion Joints

- Insufficient consideration of dynamic and cyclic behavior.
- 2. Unintended contact with other elements.
- 3. Lack of strength and deformation capacity.
- 4. Neglecting unique considerations required for joints during construction.
- 5. Misunderstandings the required deformation capacity to one direction only.

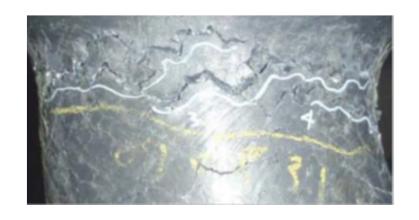
Crack of Lead Dampers

(cracked depth) 30mm

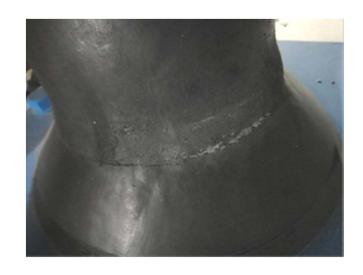
(cracked depth) 7mm.

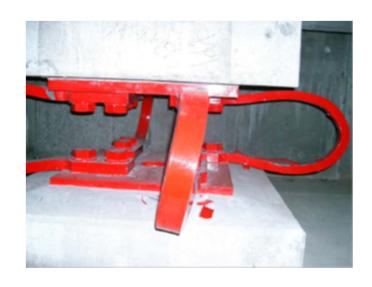
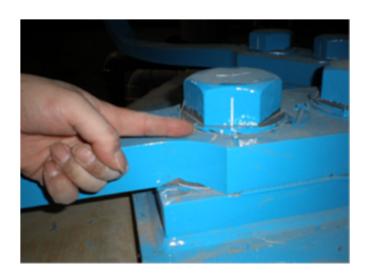
Damages of Bolt Fasteners of Steel Dampers
