An Example of Improving Earthquake Safety Project in South-east Asia

Dr. Takayuki Teramoto
Tokyo University of Science

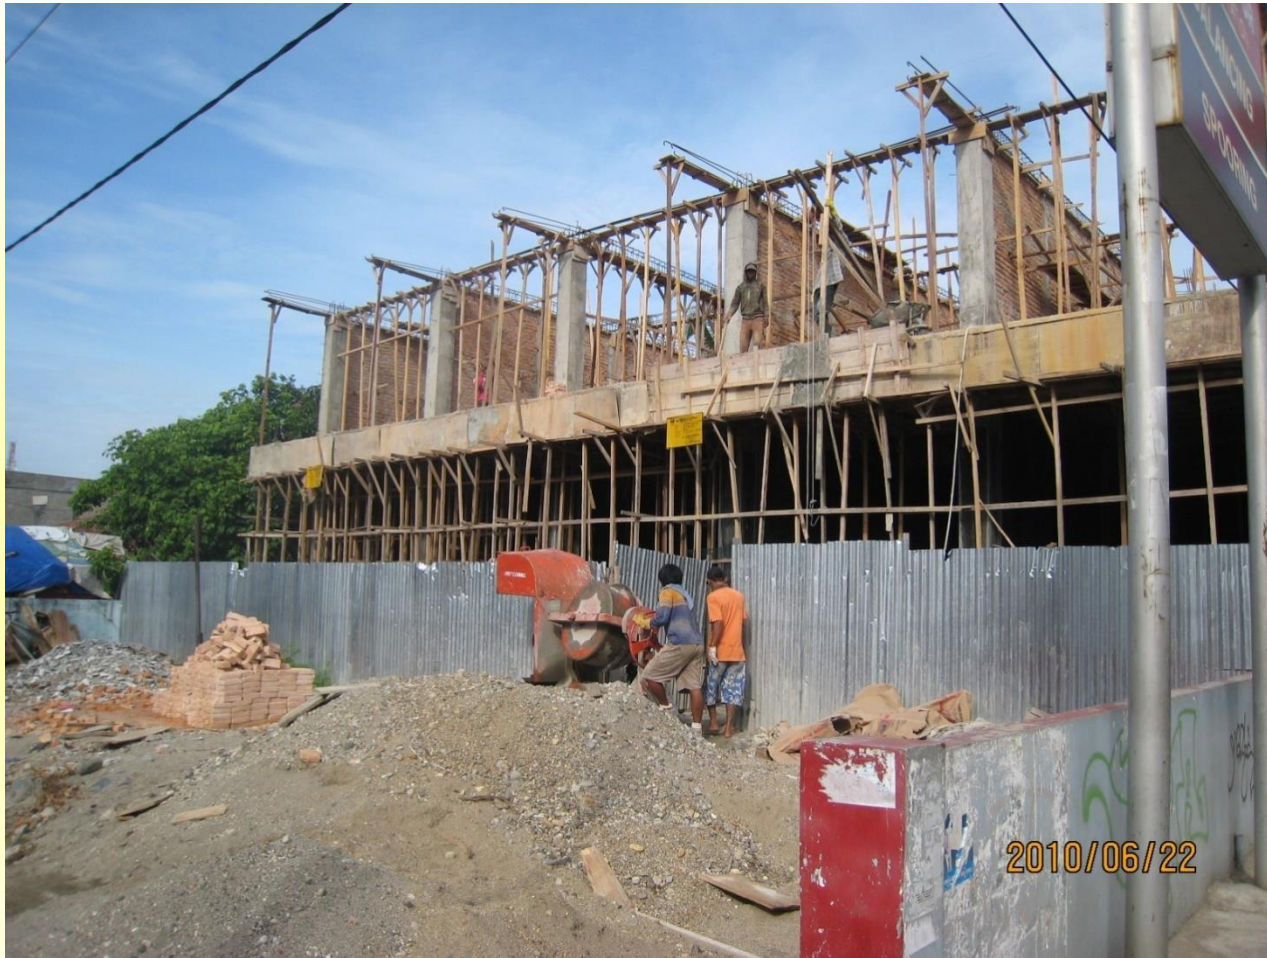
Site concrete mixing by a local constructor

Aggregate materials are not good and the sand includes fine mud like silt. Concrete mixing cars are used only in the governmental buildings or big buildings.

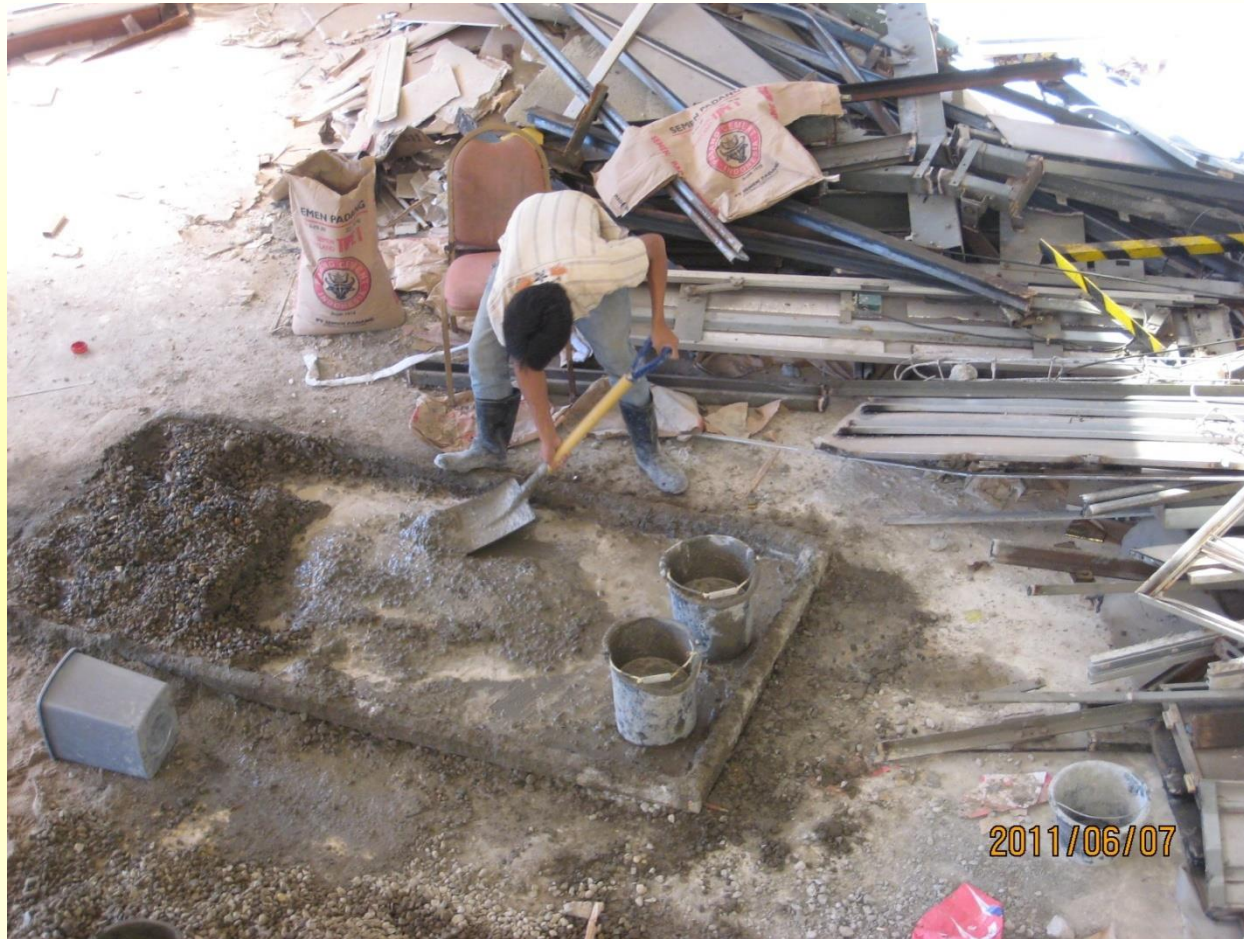
Site concrete mixing by hands

This construction site is the repair one of damaged hotel building. The hand mixing may be chosen because of small casting concrete amount.

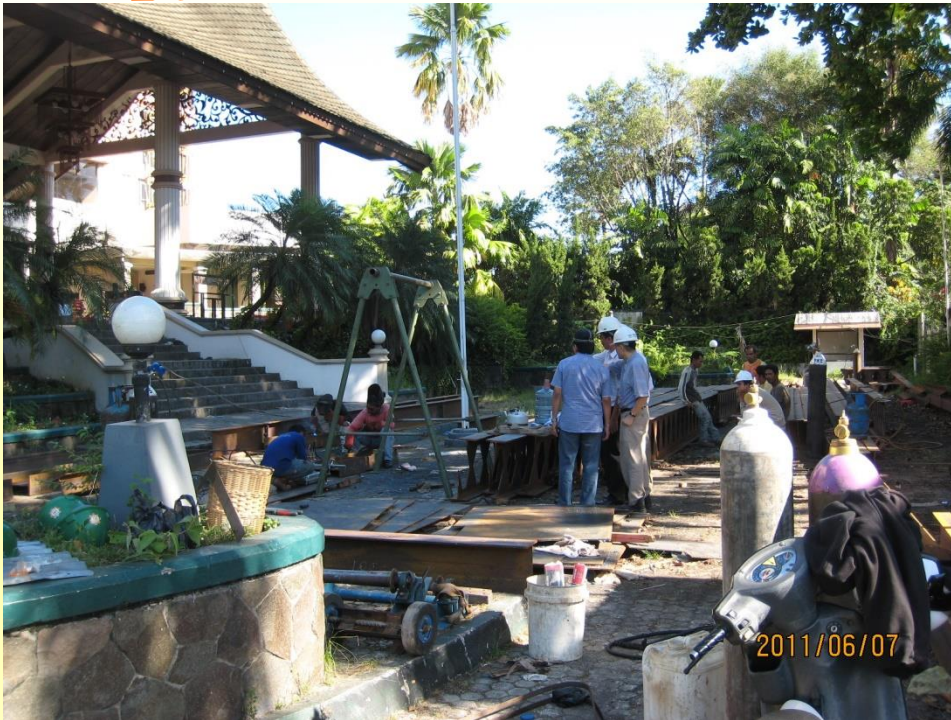
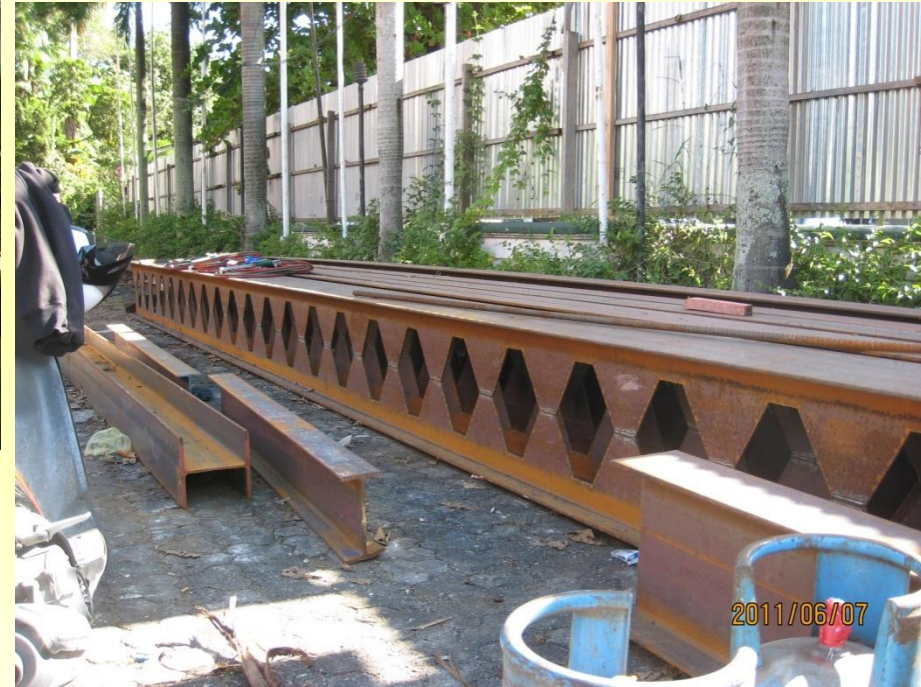
Site fabrication of steel members

This steel member fabrication was carried out at the construction site without roofs. It rains occasionally in Indonesia. The welding is not good in wet condition.

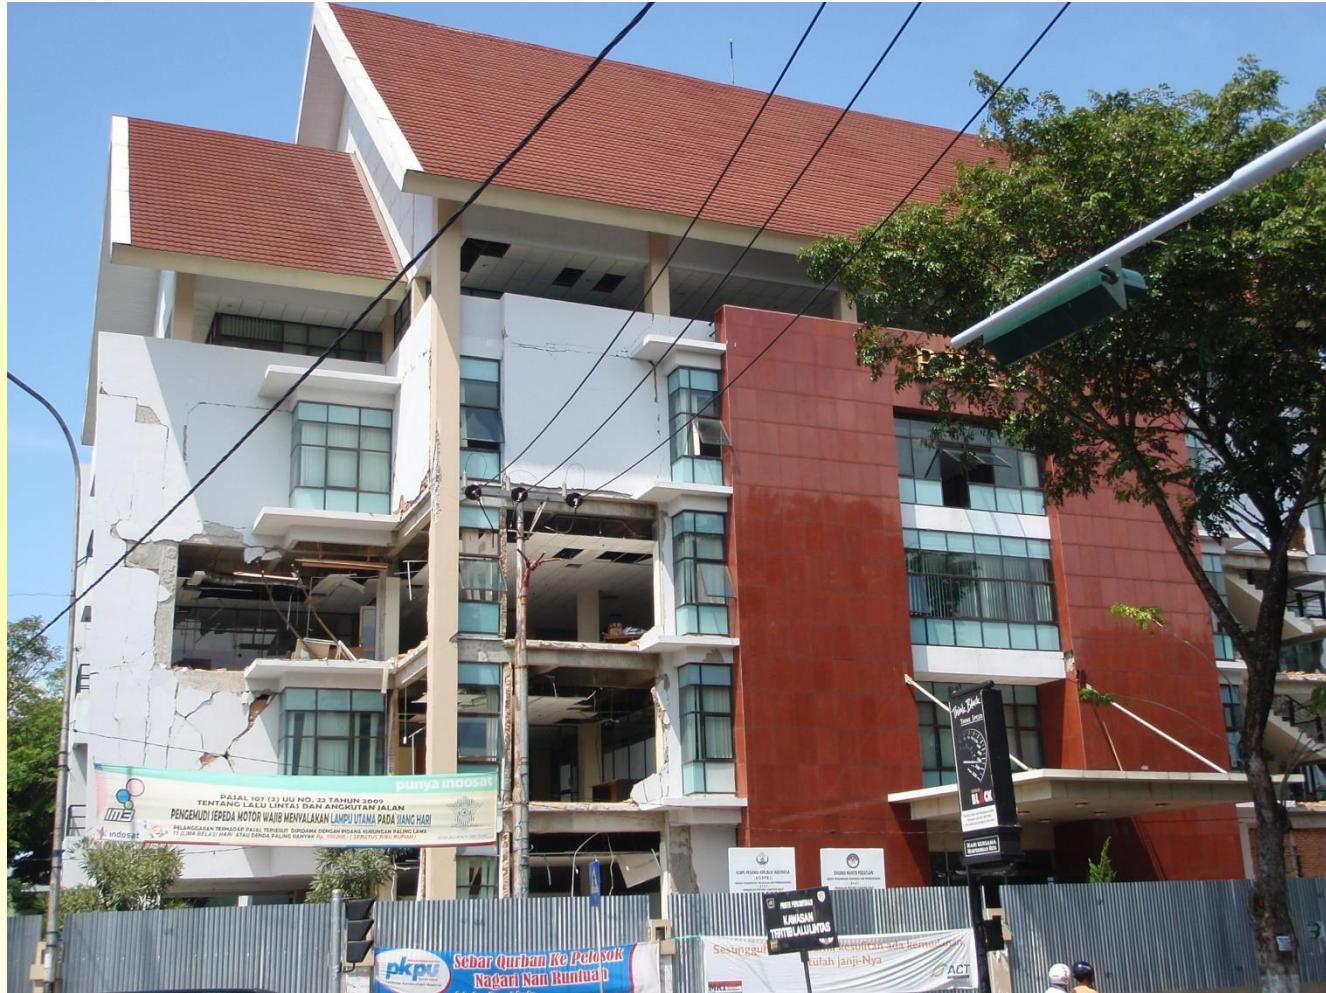
Typical brick wall damage by flexible frame

Main damages are falling-out and cracking of brick walls and reinforced concrete members are slightly damaged.

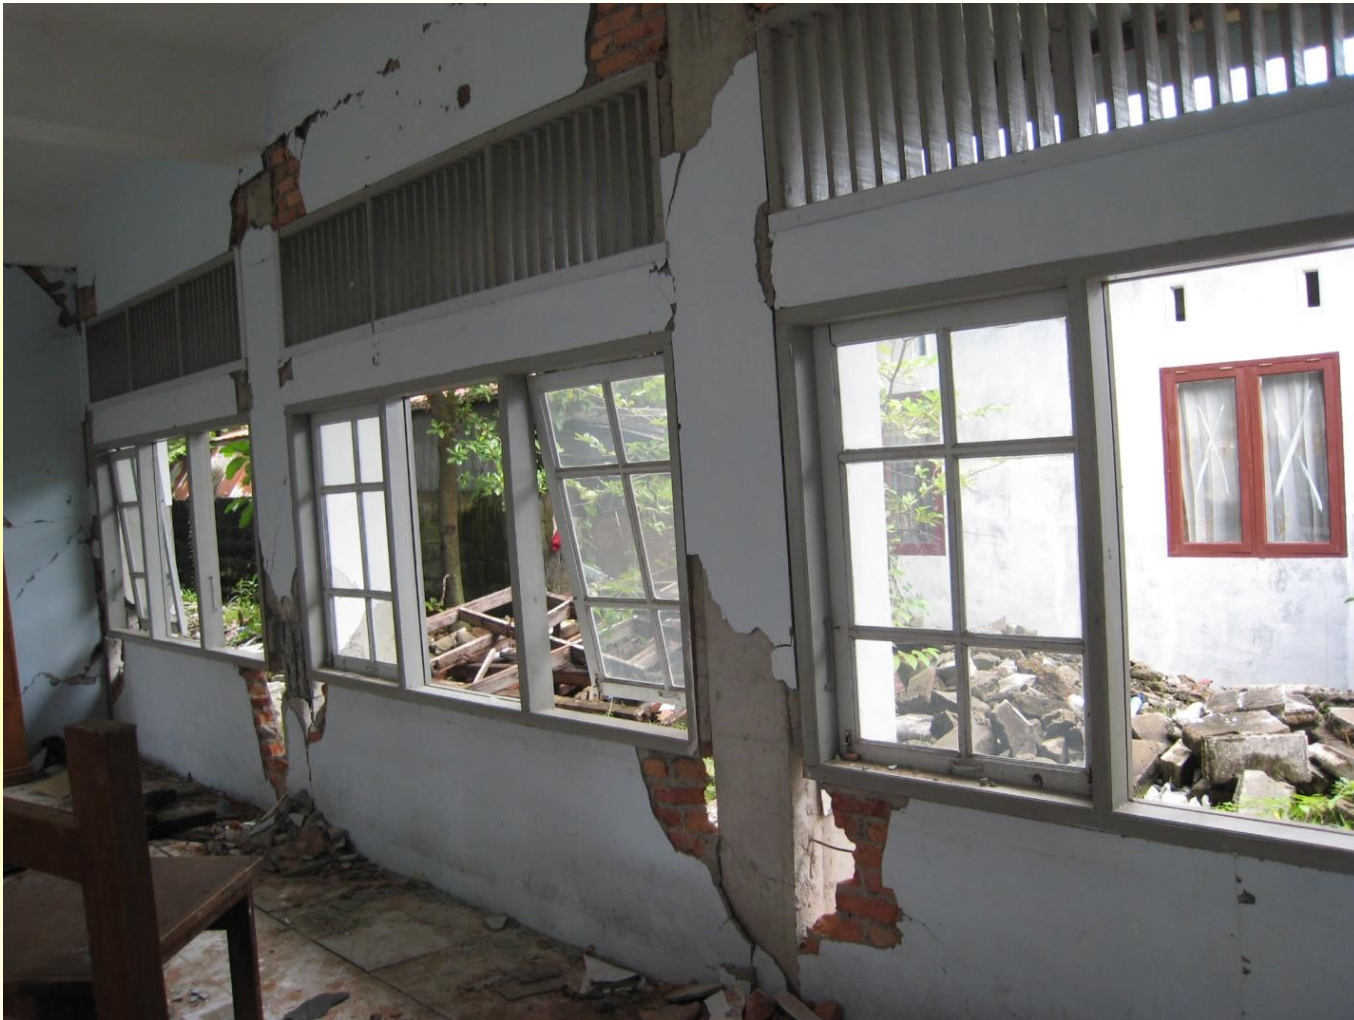
Seismic damage of columns and brick walls

Mainly brick walls are damaged, but reinforced concrete columns are cracked by shear force in case.

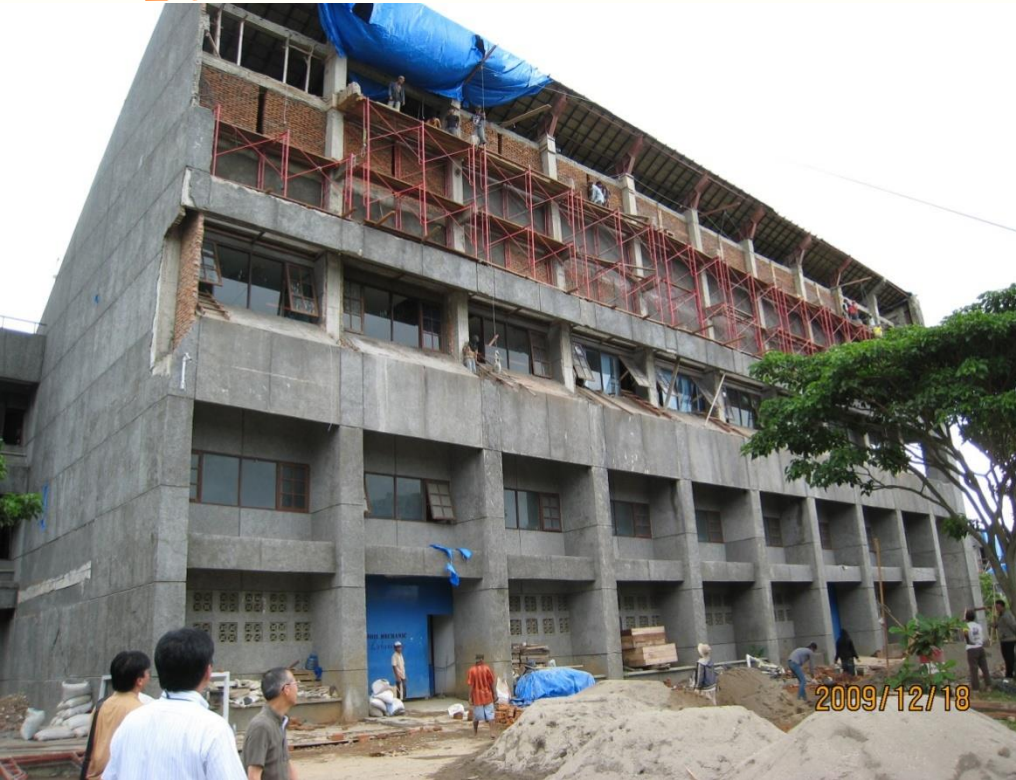
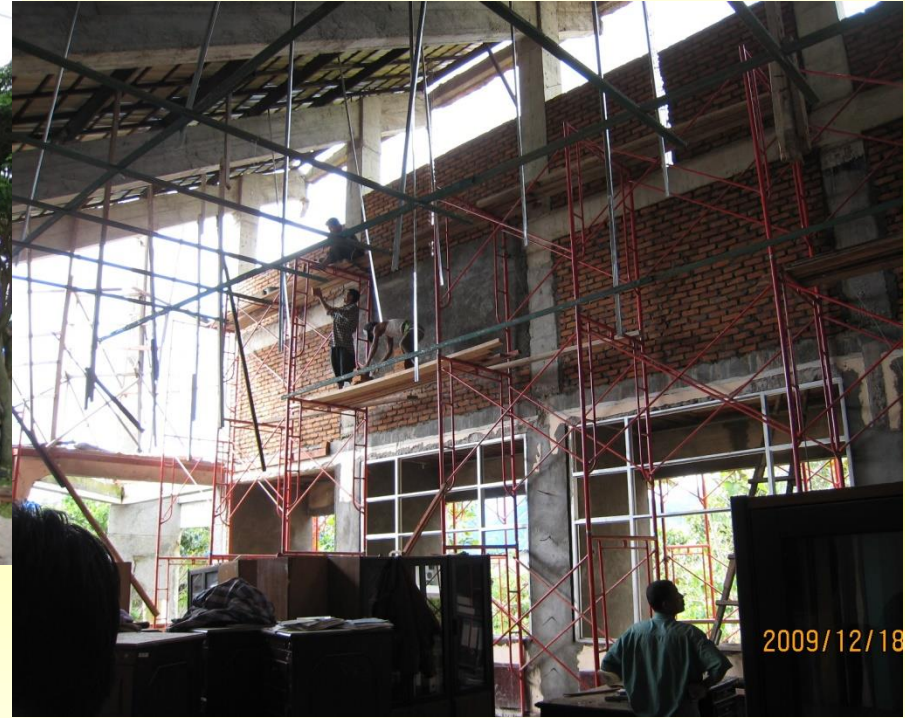
Repair of damaged brick walls

Damaged brick walls were repairing after the earthquake as the same construction method. Maybe the architect decided this repair and the structural engineer did nothing for this.

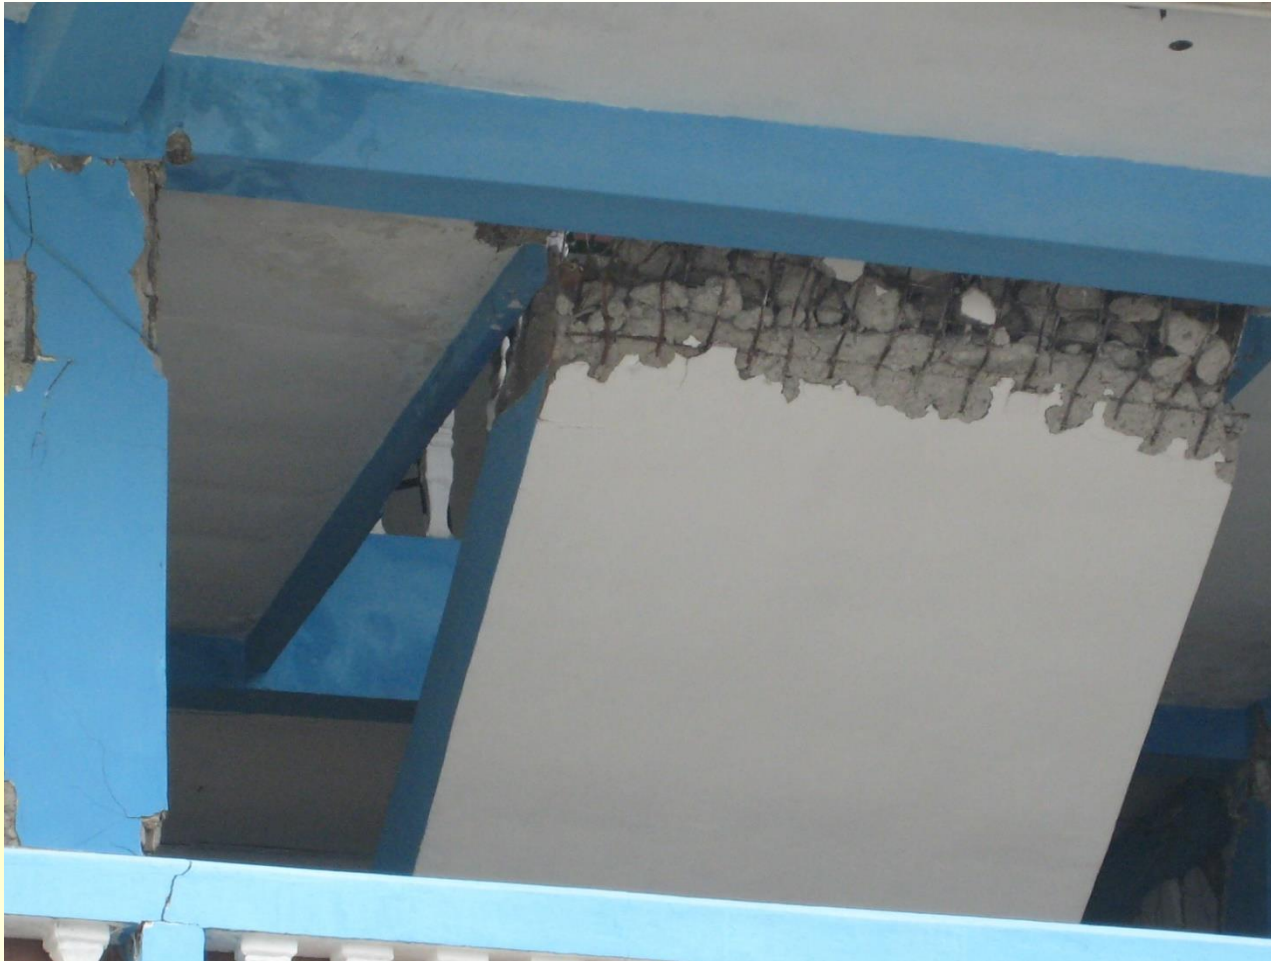
Damage of stair slope-slab

Building story drifts were so large because of flexible frame. Stair slope-slabs worked such as structural braces and were damaged by the tensile and compressive force.

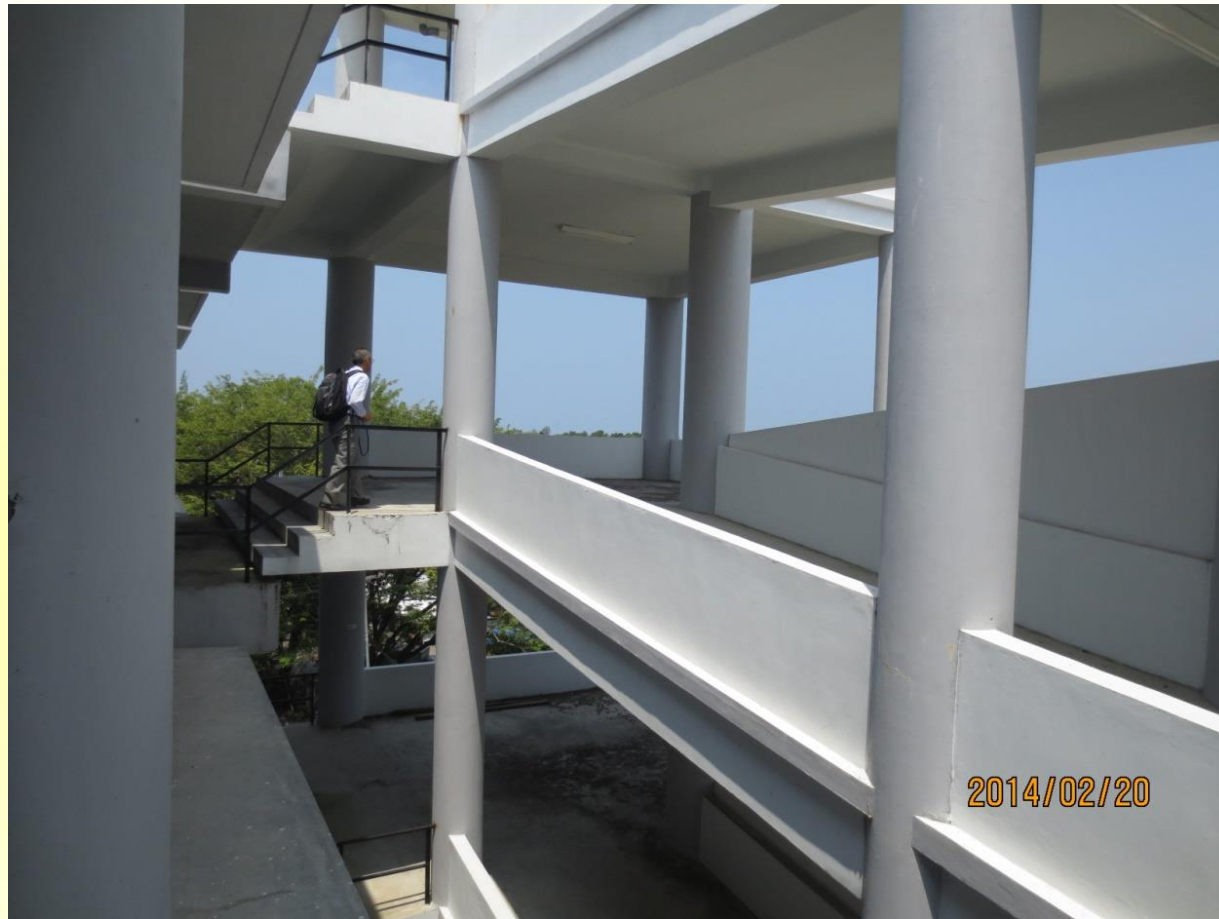
Building just before completion (2)

This is “Slope building” for running up to refuge, and was designed as a usual seismic structure with expansion joint. Hand rails between two buildings were connected tightly.
