**16th US-Japan-NZ Workshop on the Improvement of
Structural Engineering and Resiliency
Nara, Japan, 27-29 June 2016**

2015 Gorkha (Nepal) Earthquake: An Overview

Professor Rajesh Dhakal, PhD, FIPENZ
Professor of Structural and Earthquake Engineering
Department of Civil and Natural Resources Engineering
University of Canterbury
Christchurch, New Zealand

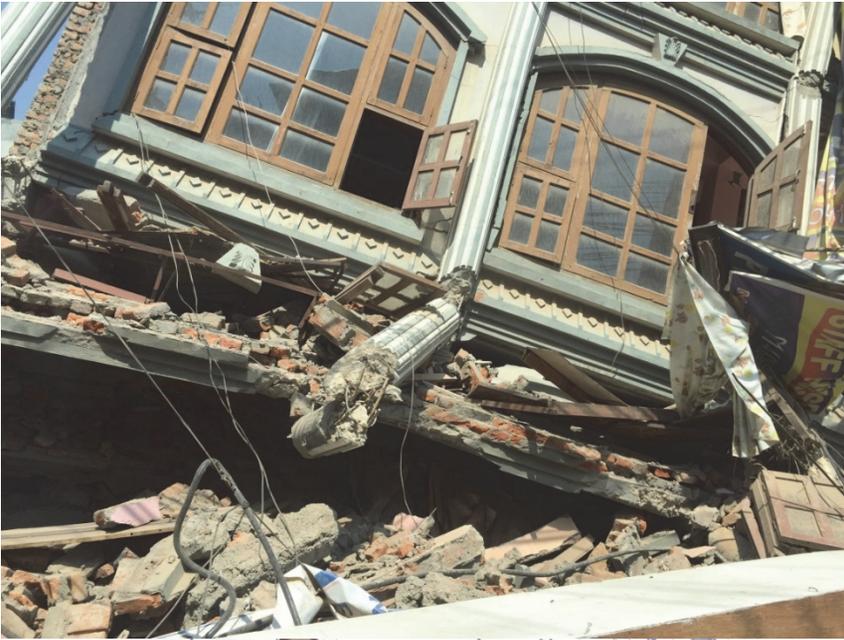
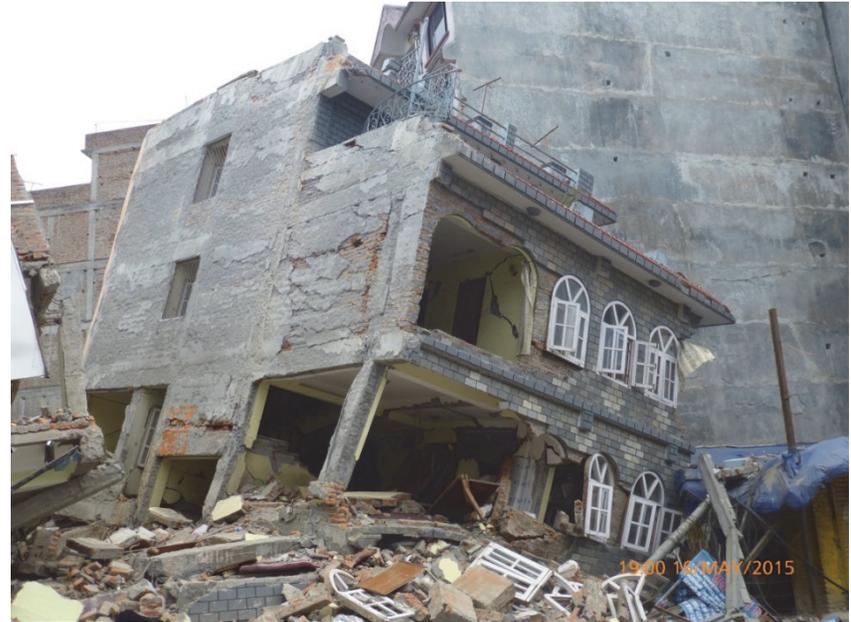
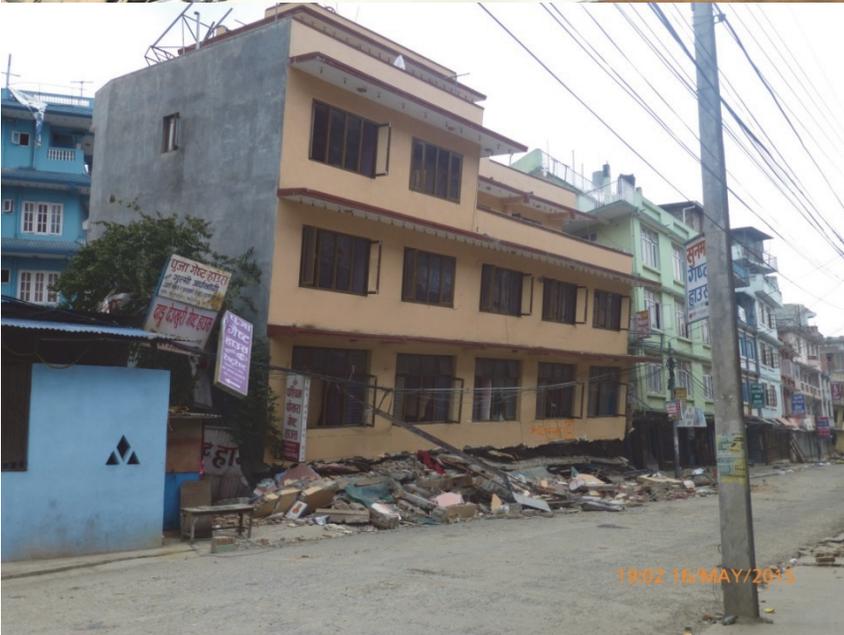
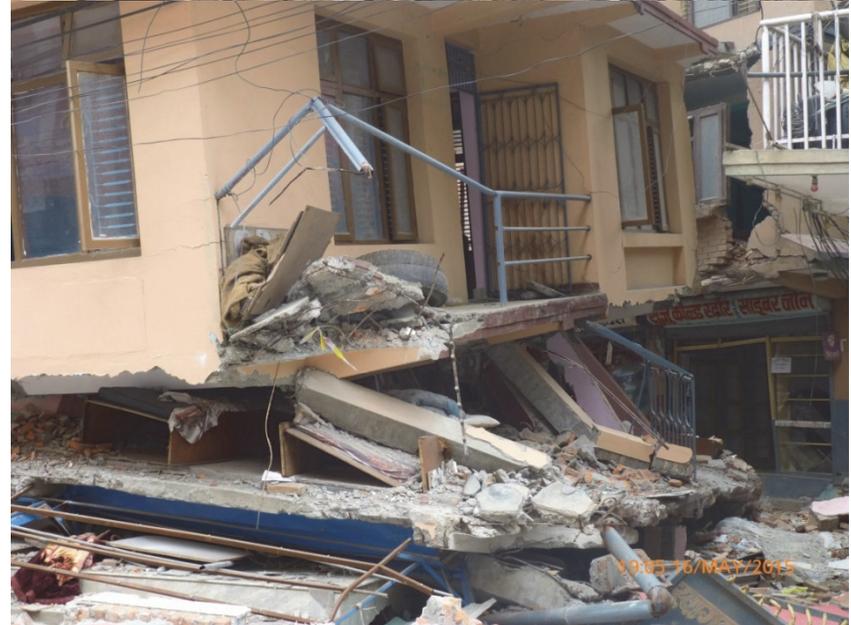
Most Non-Engineered Houses Collapsed

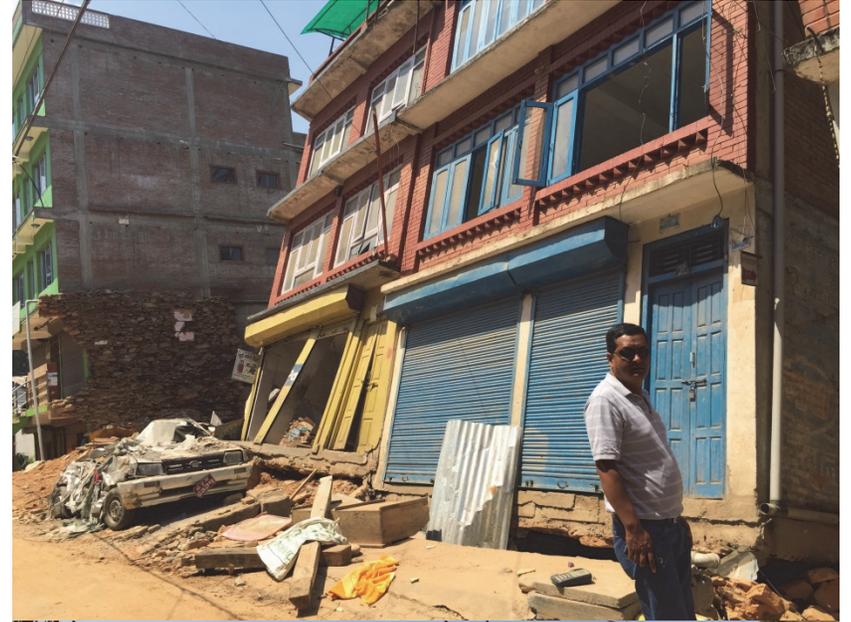
Hilly settlements were hit harder: Ridge effect

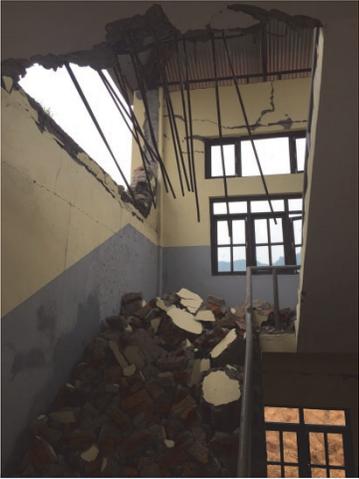
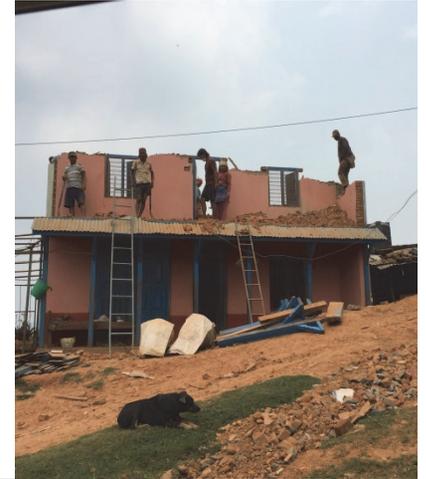
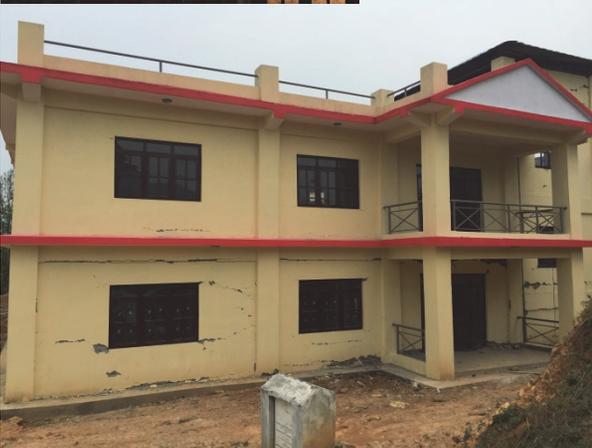
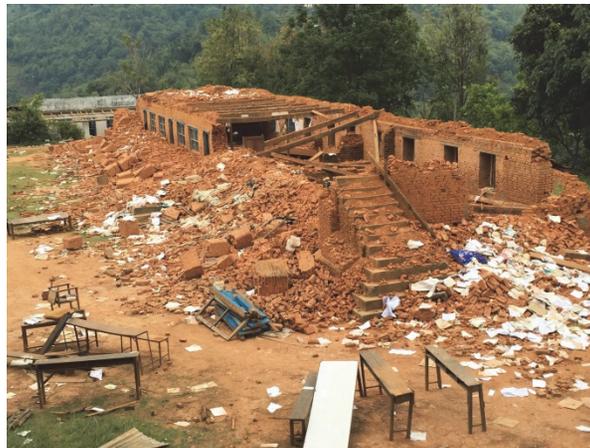
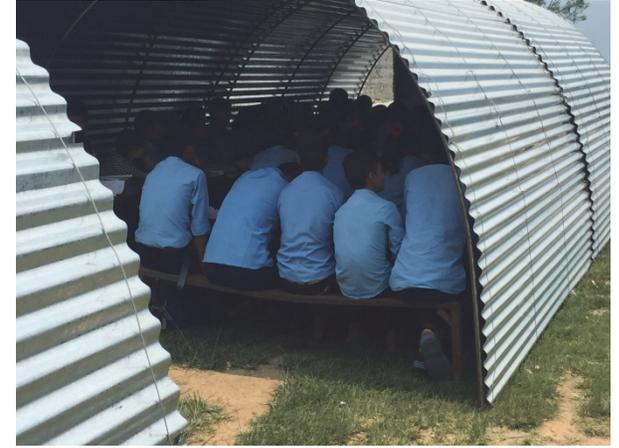
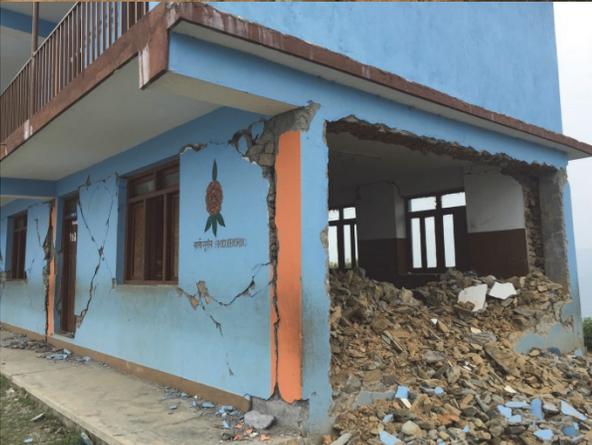
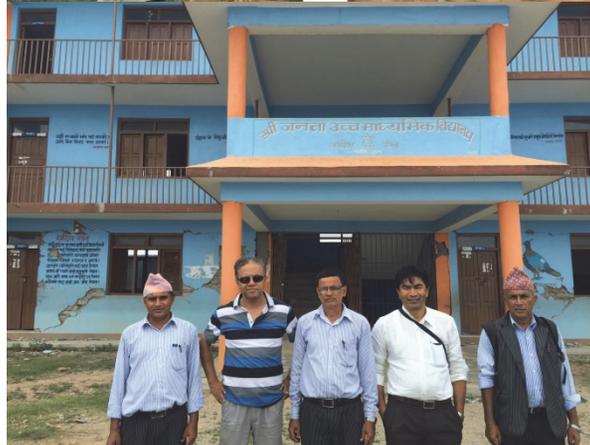
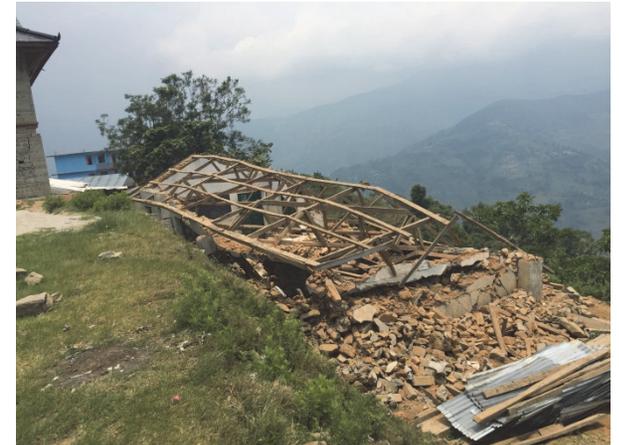
Severe Impact on Educational Facilities

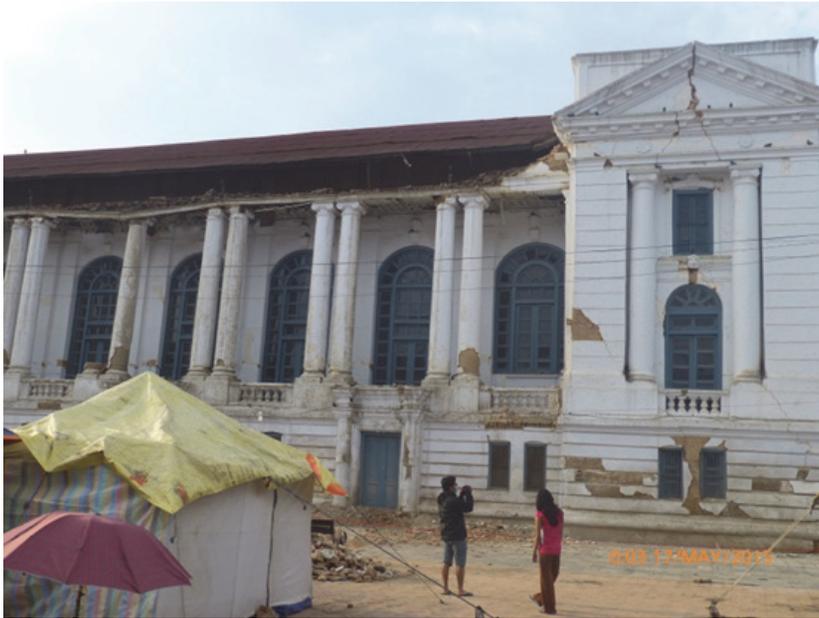
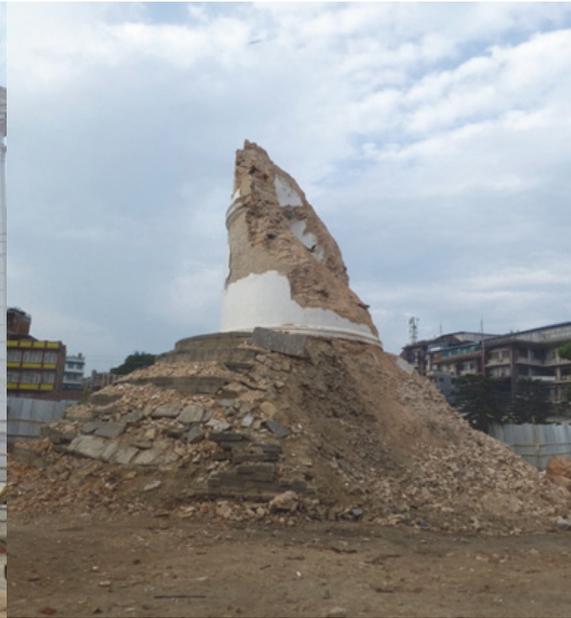
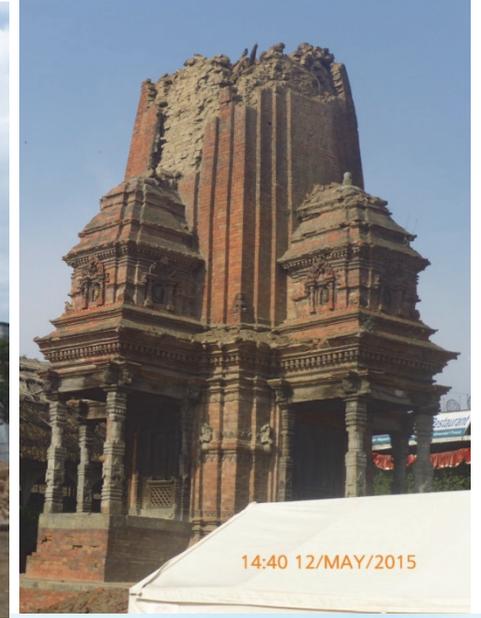
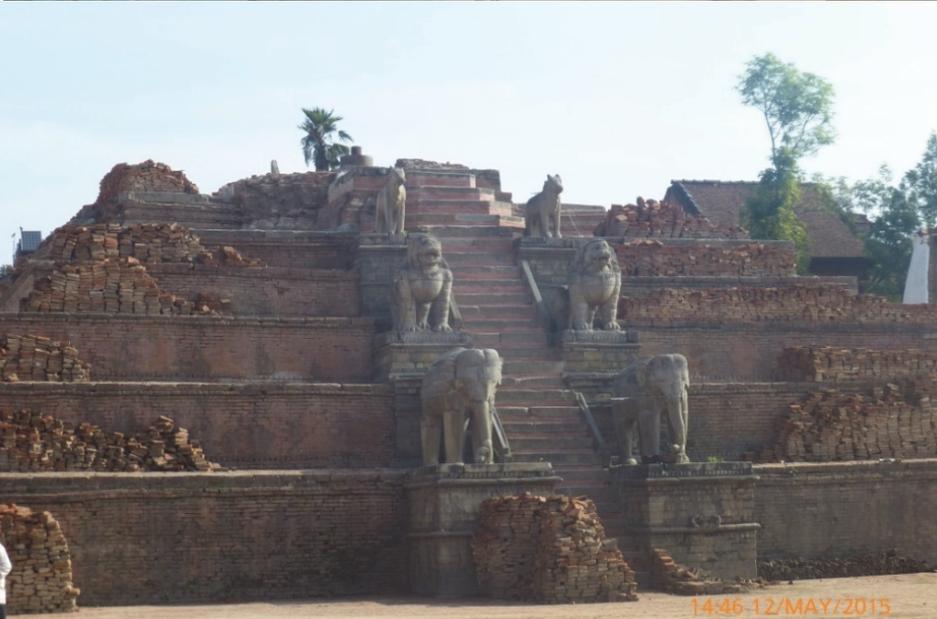
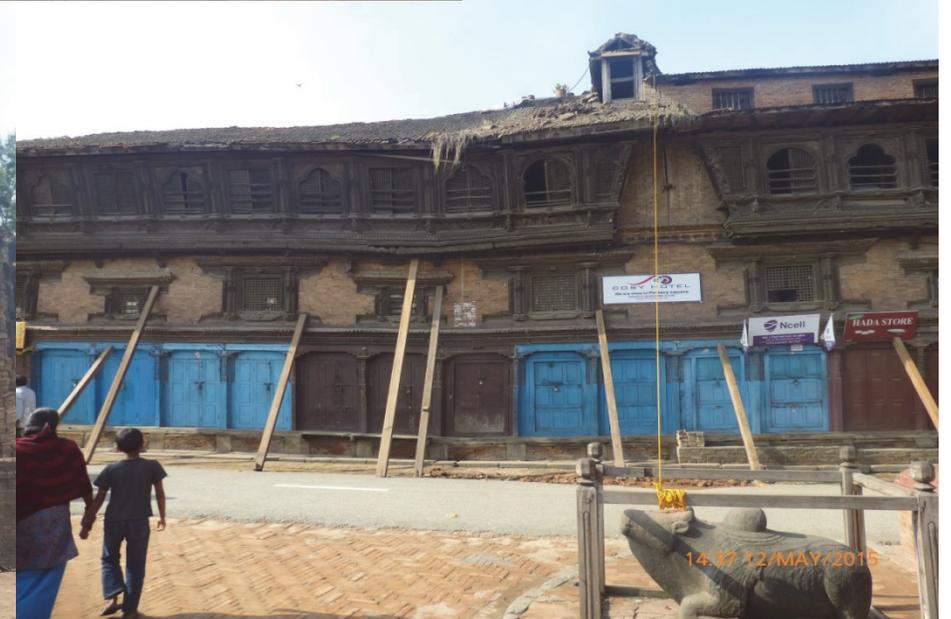
Severe Damage to Heritage Sites

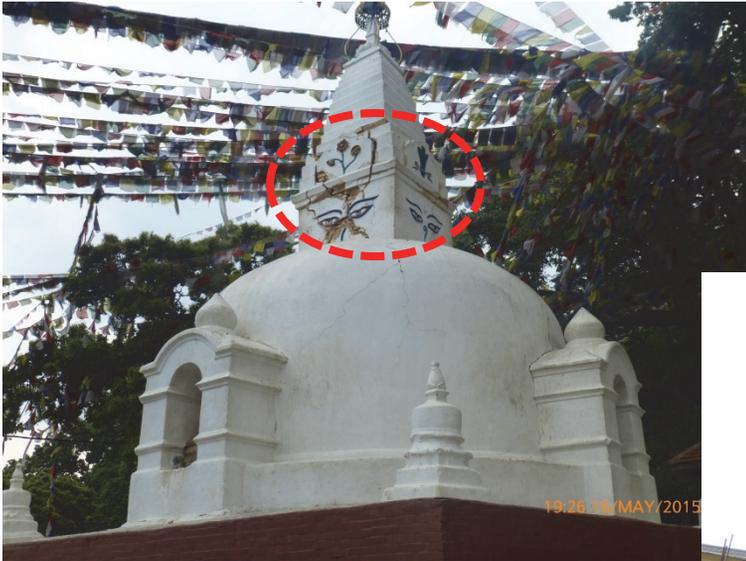
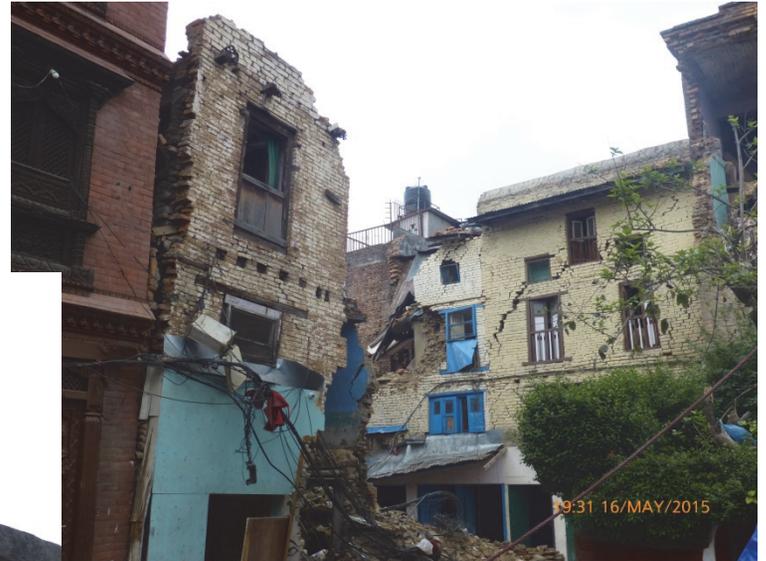
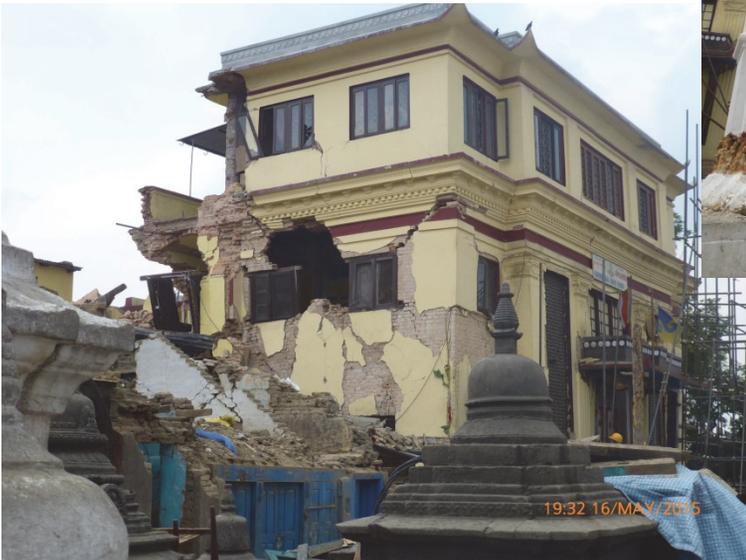
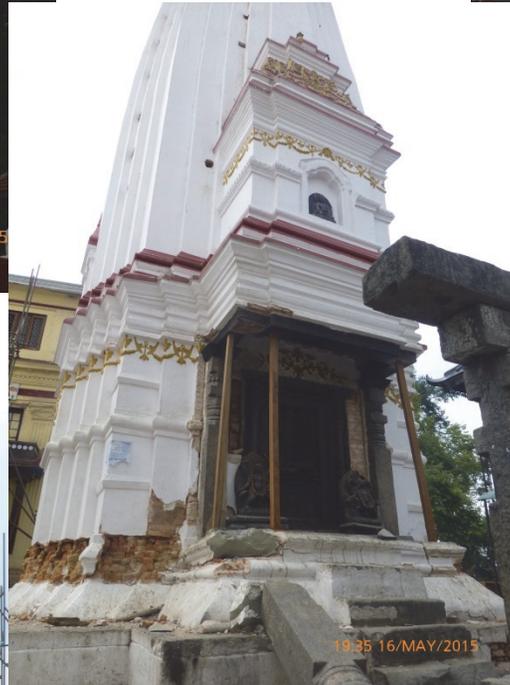
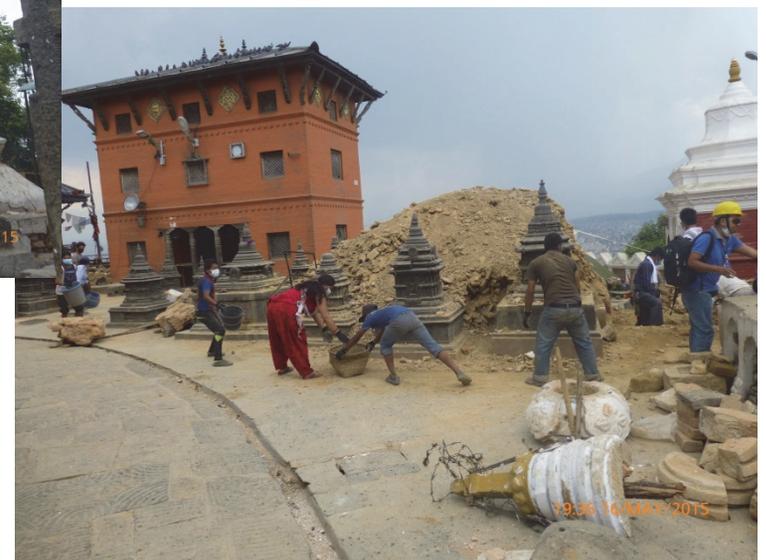
Religious Precincts also Suffered

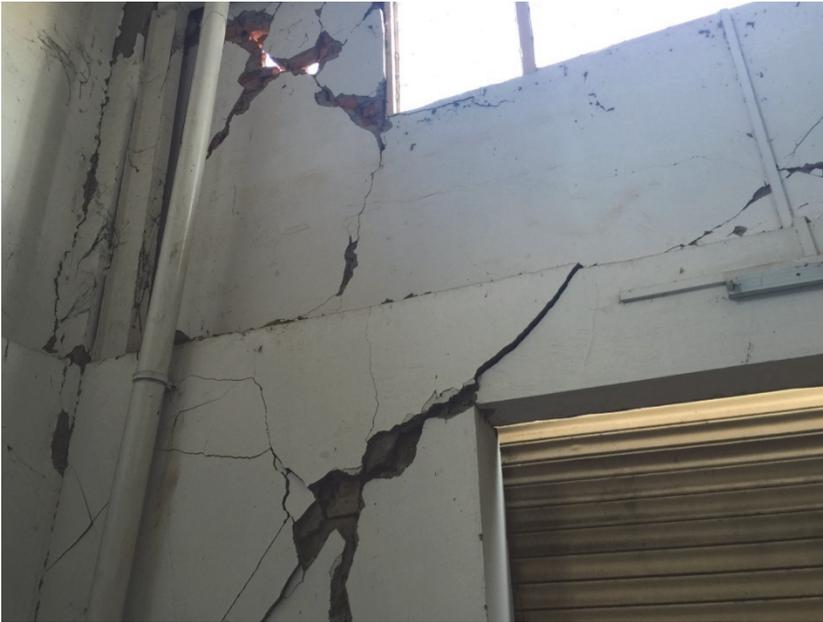
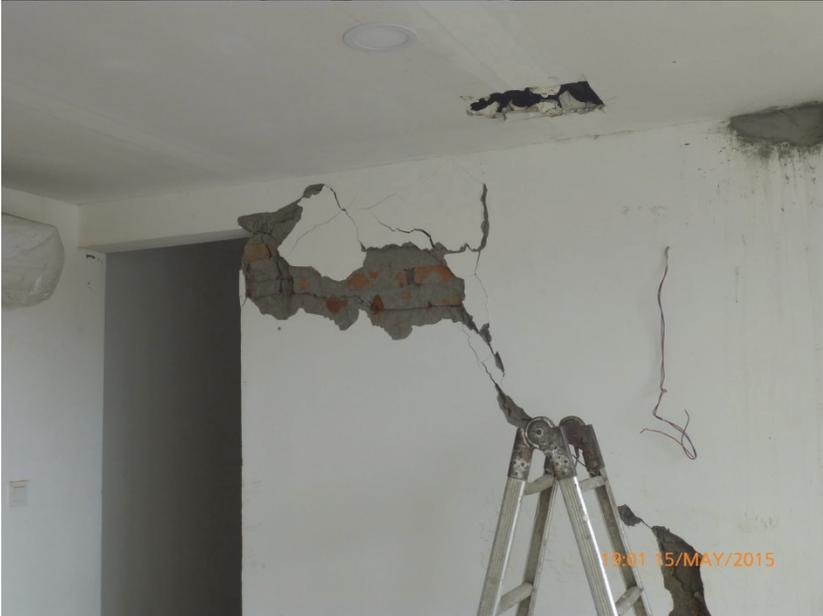
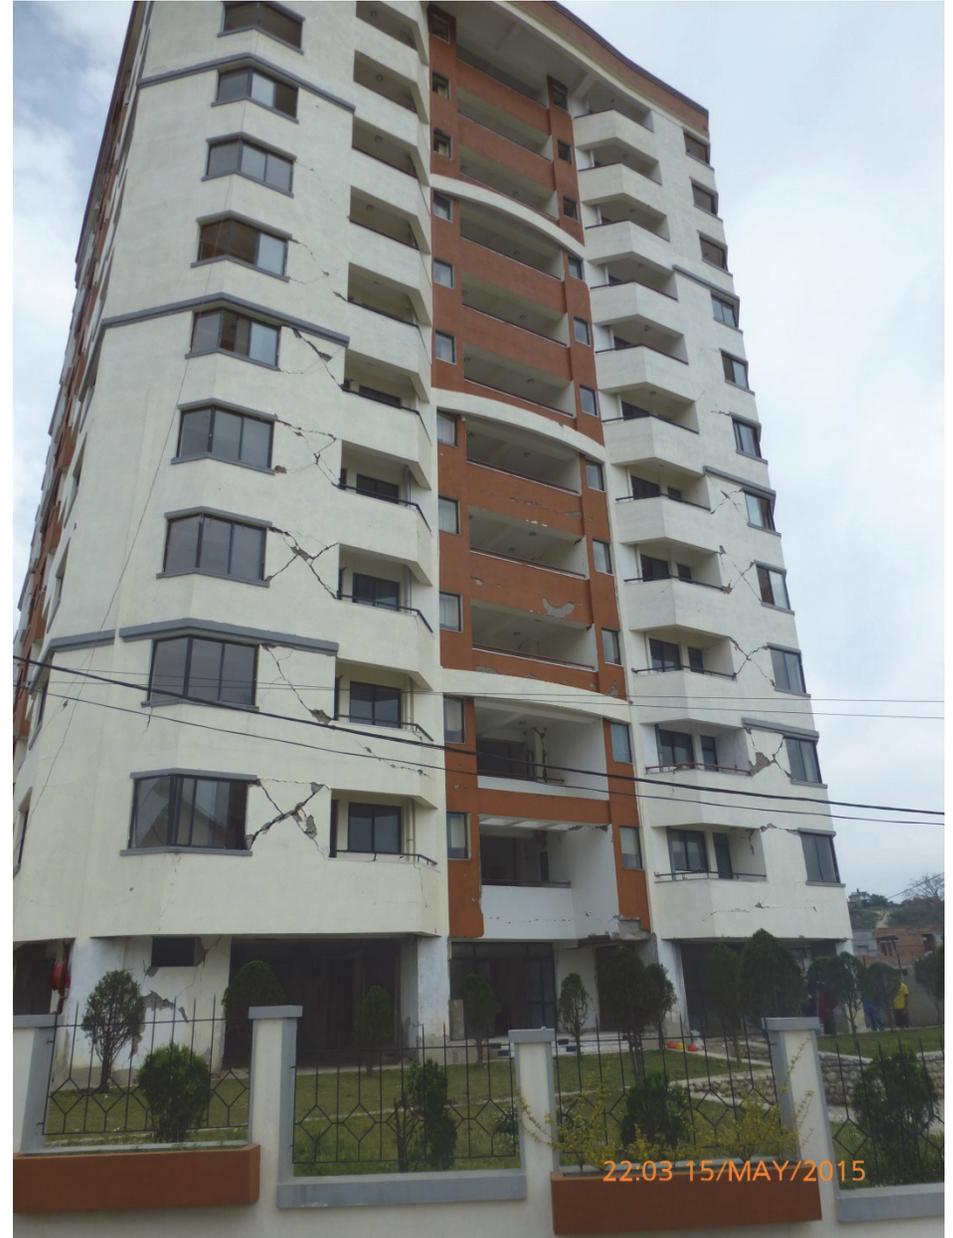
Damage to Walls: A Common Sight in Tall Buildings

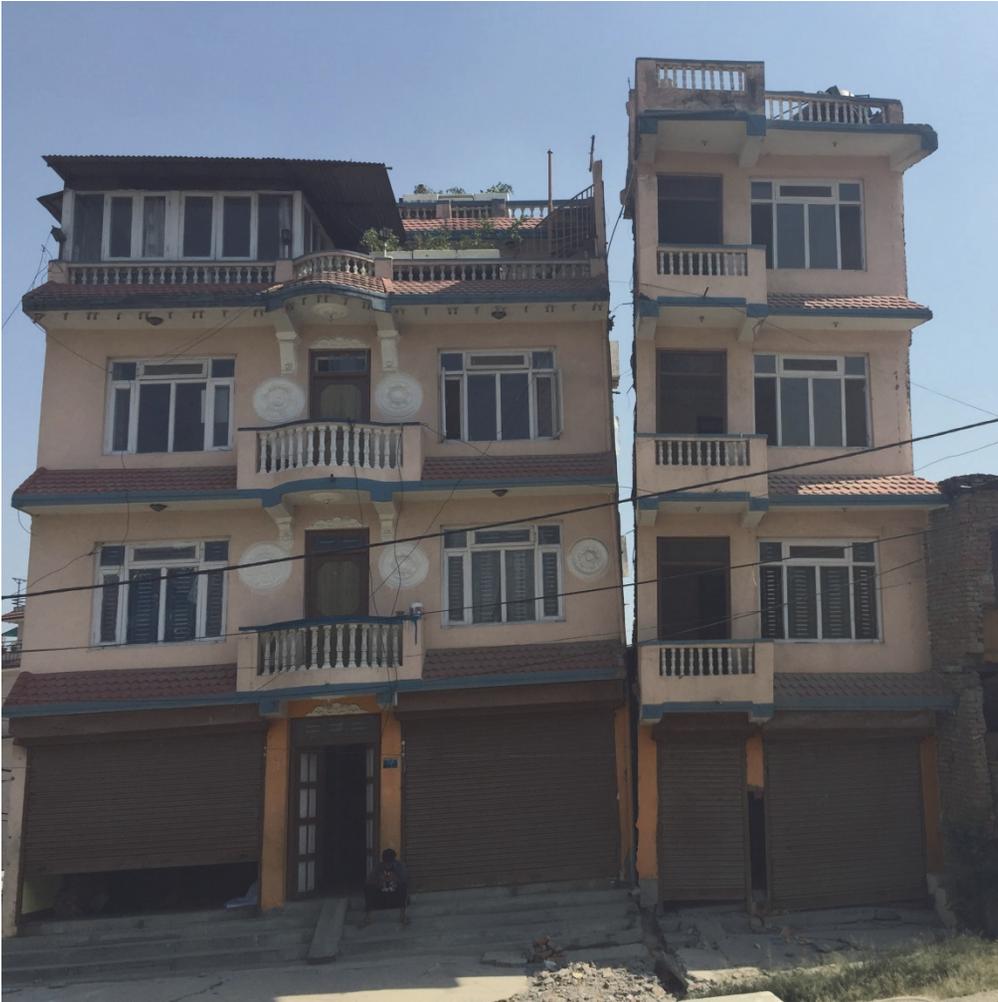
Lokanthali (Bhaktapur)

Buildings were affected also by poor performance of soil and foundation

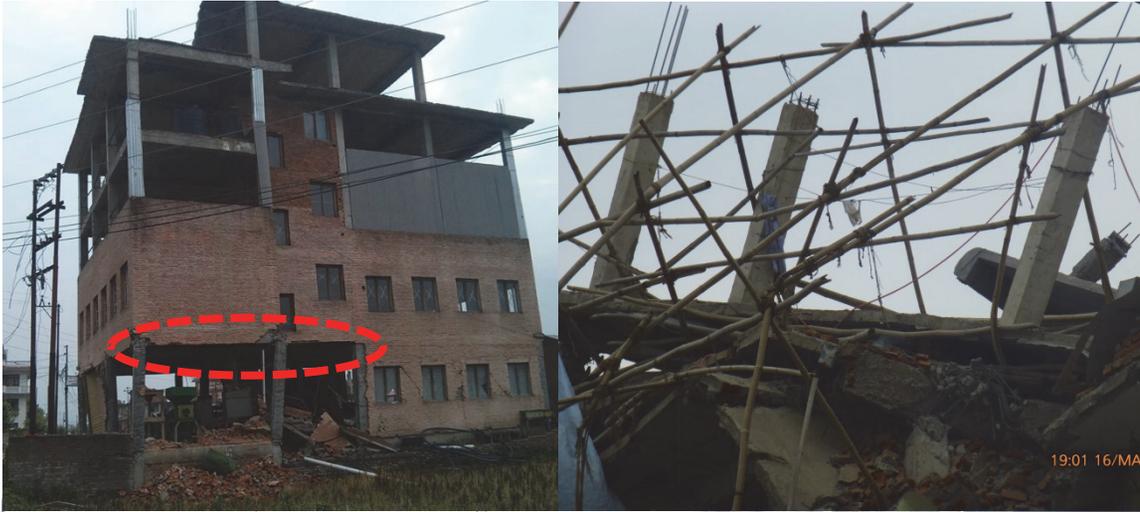
Gongabu

Buildings under construction: Bad Examples

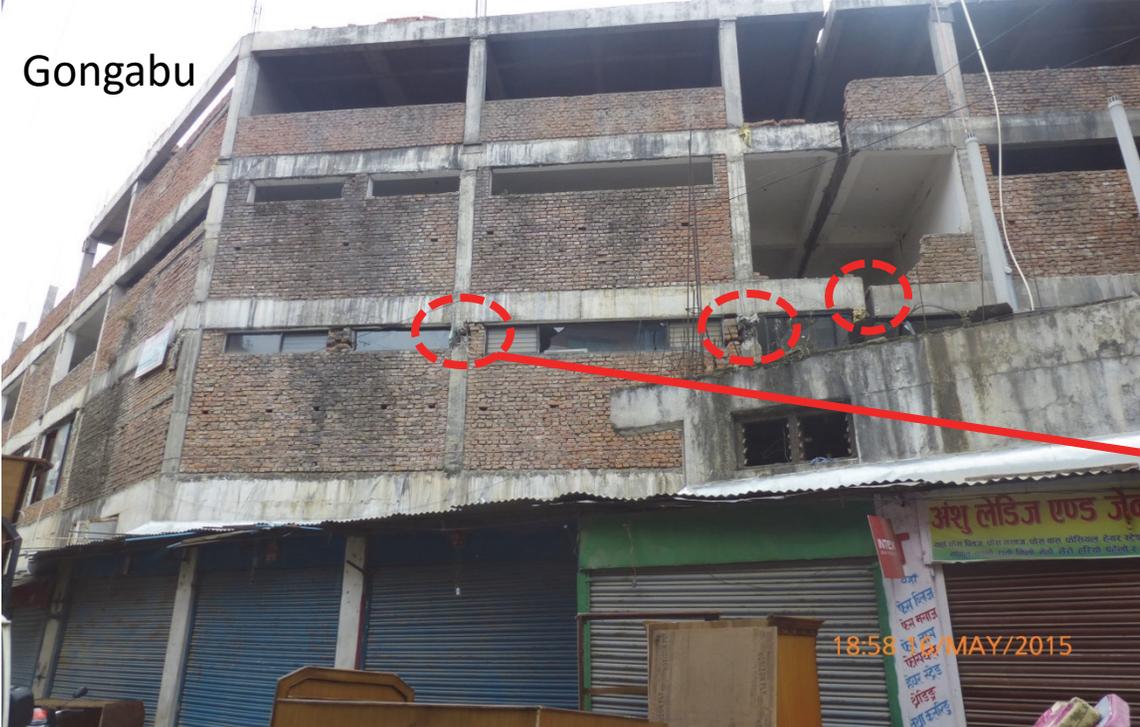
Incorrect strength hierarchy

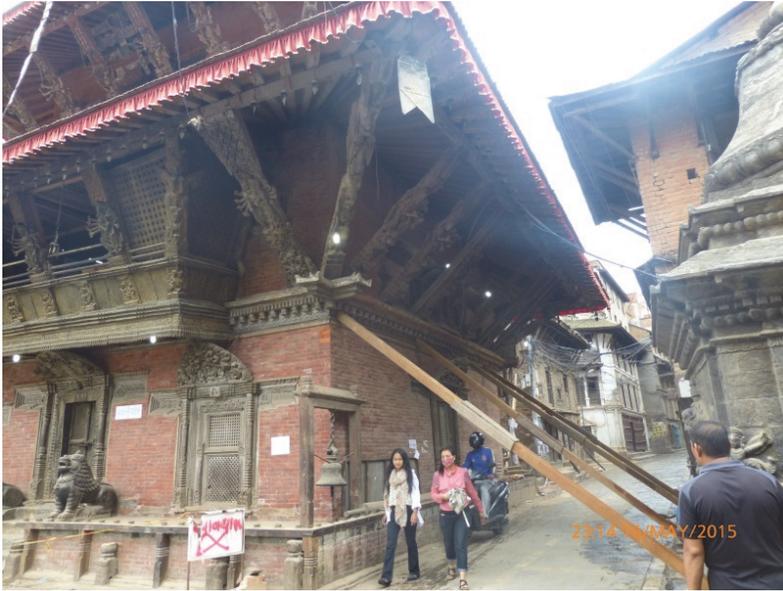
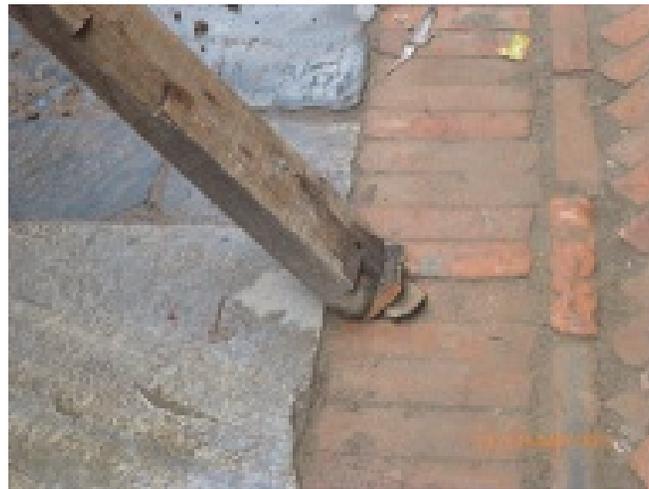
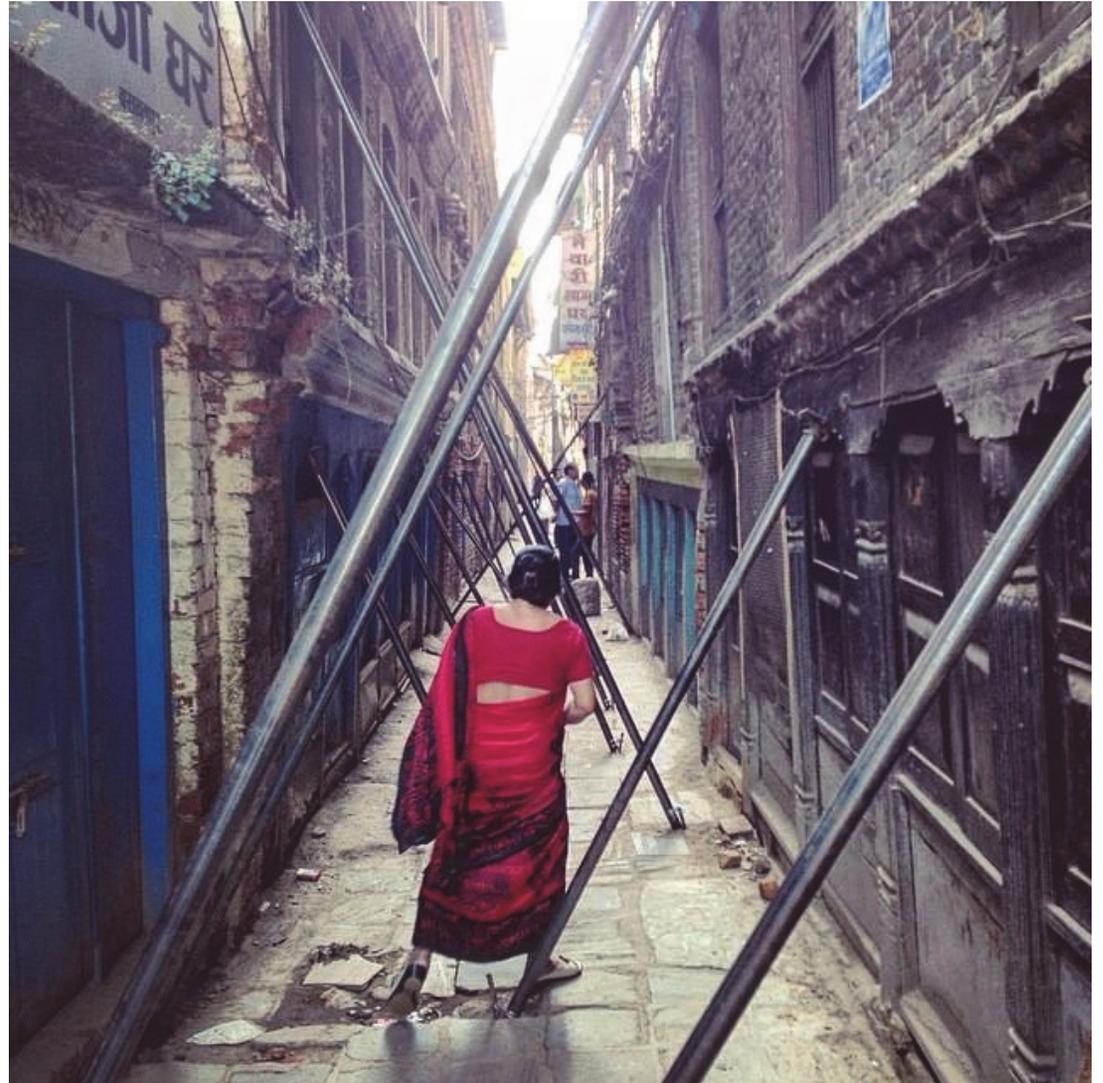
Shoring/Protection of Damaged Structures
