OBSERVED RESPONSE OF SEISMICALLY ISOLATED BUILDINGS DURING THE 2016 KUMAMOTO EARTHQUAKE

Mineo Takayama, Keiko Morita
Faculty of Engineering, Fukuoka University
Fukuoka, Japan

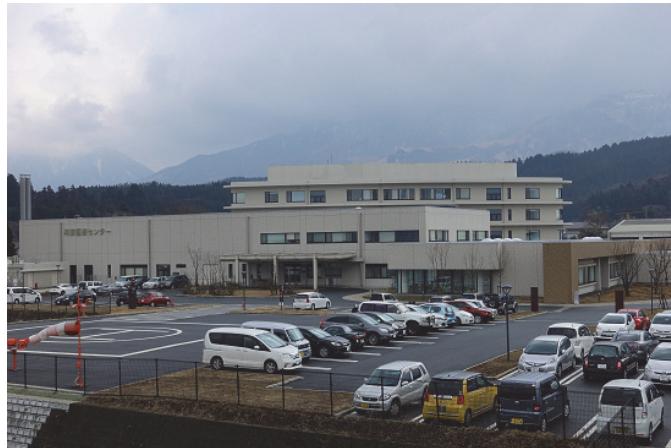
Figure 3. Photo of Medical Facility M.

Table 3 shows maximum amplitudes of recorded on the scratch plates. A maximum double amplitude of 90 cm and a maximum single amplitude of 46 cm were recorded at Medical Facility M in Aso City as shown in Figure 3. Figure 5 show the orbit recorded by mainshock of the earthquake. The amount of deformation recorded at Medical Facility M is the largest for a seismically isolated building so far. There was almost no residual deformation in any of the buildings, and no defects were identified in the seismic isolation devices.

In an interview with the building manager, it was confirmed that the seismically isolated buildings were undamaged, and normal business continued without even any furniture or medical equipment falling over. Patients were not evacuated from the Medical Facility **M**. And this hospital accepted a total number of around 70,000 patients from 13 damaged hospitals with seismic-resistant structure.

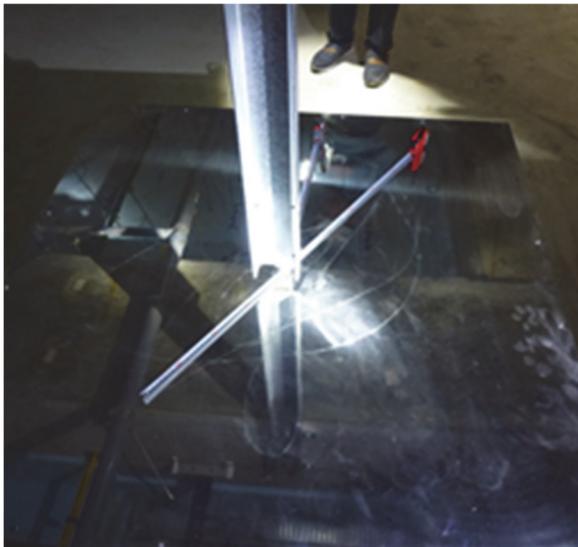
Figure 4. Photo of scratch plate.

During the earthquakes of seismic intensity 7 that occurred in succession in Kumamoto, the seismically isolated buildings demonstrated their capabilities by functioning extremely well. A scratch plate, like a Figure 4, which allow the movements of a building to be recorded by marking scratches on a metal plate, had been installed in 8 of the buildings, and this made it possible to confirm the movements of these buildings during the earthquakes.

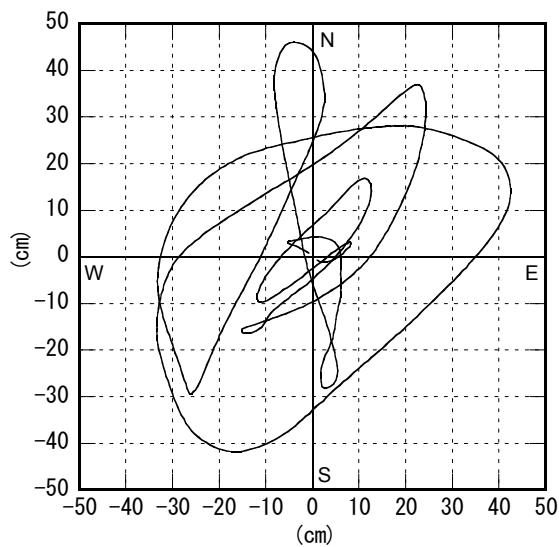
Figure 5. Orbit recorded at Medical Facility M.

The seismograph station K-NET Ichinomiya, located close to Medical Facility M in Aso City, measured a seismic intensity of 6-lower during the main shock. The record on the scratch plate in the isolation level of Medical Facility M immediately after the foreshock showed a locus smaller than 5 mm in diameter. A single amplitude of 46 cm was recorded during the main shock, which indicates its severity. Also, the dominant period of the seismic motion measured at K-NET Ichinomiya was 3 seconds as shown in Figure 6, and the amount of deformation of the isolation level estimated from the displacement response
