STATISTICAL ANALYSIS OF BUILDING DAMAGE IN JAPAN BASED ON THE 2016 KUMAMOTO EARTHQUAKE

Fumio Yamazaki¹, Takuya Suto¹, Masashi Matsuoka², Kei Horie³, Munenari Inoguchi⁴, Wen Liu¹
Chiba University¹; Tokyo Institute of Technology²;
MS&AD InterRisk Research & Consulting, Inc.³; Toyama University⁴
Chiba¹; Yokohama²; Tokyo³; Toyama⁴, Japan

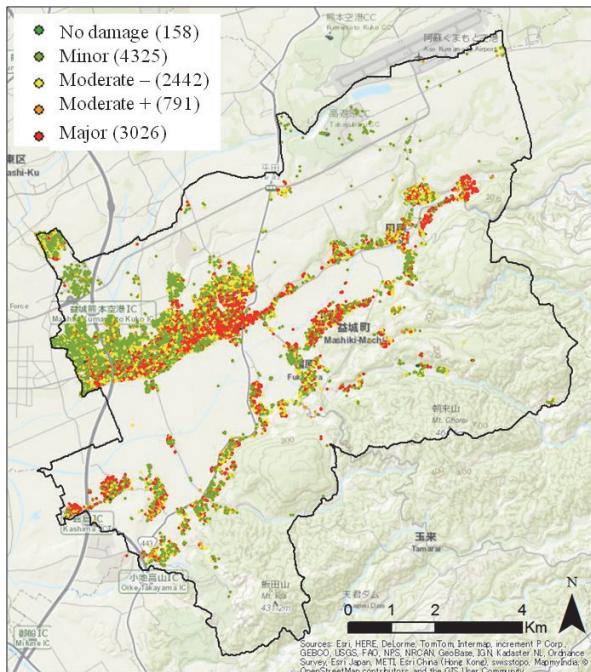
The final result of the property loss evaluation is shown in Figure 2 (Mashiki Town 2017). It is observed from the figure that the major damage buildings are distributed widely, especially along the Futagawa fault line. The overall damage grade gets smaller in the northern and eastern areas. In the central part of Mashiki Town, major damaged buildings exist more around the Town office building than around the KiK-net station, which is consistent with field observations.

Figure 2. Result of damage (loss) assessment by Mashiki Town government (2017)

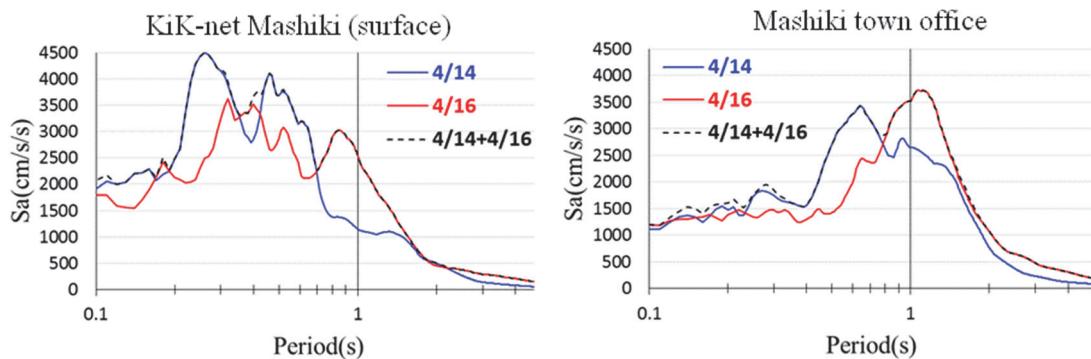
Figure 3 compares the acceleration response spectra (the resultant of the two horizontal components, 5% damping ratio) for the recorded motions at the two seismic stations for the foreshock (April 14) and the main-shock (April 16). In the figure, the result for the connected time histories (April 14 and April 16 in 5-s interval) is also plotted. It is seen for the KiK-net station that in a short period range less than 0.7 s (0.8 s for the Town office station), the April-14 event exhibits higher response values than those of the April 16 event. But in the longer period range, the April 16 event shows higher response values. It is also noticeable, especially for the April 16 event, that the Mashiki town office record shows much higher values than those of the KiK-net station in the period longer than 0.7 s, which is considered to be responsible for the structural damage of wooden buildings in Japan.

Figure 3. Acceleration response spectra (the resultant of the two horizontal components, 5% damping ratio) for the records at KiK-net Mashiki station and Mashiki Town office.

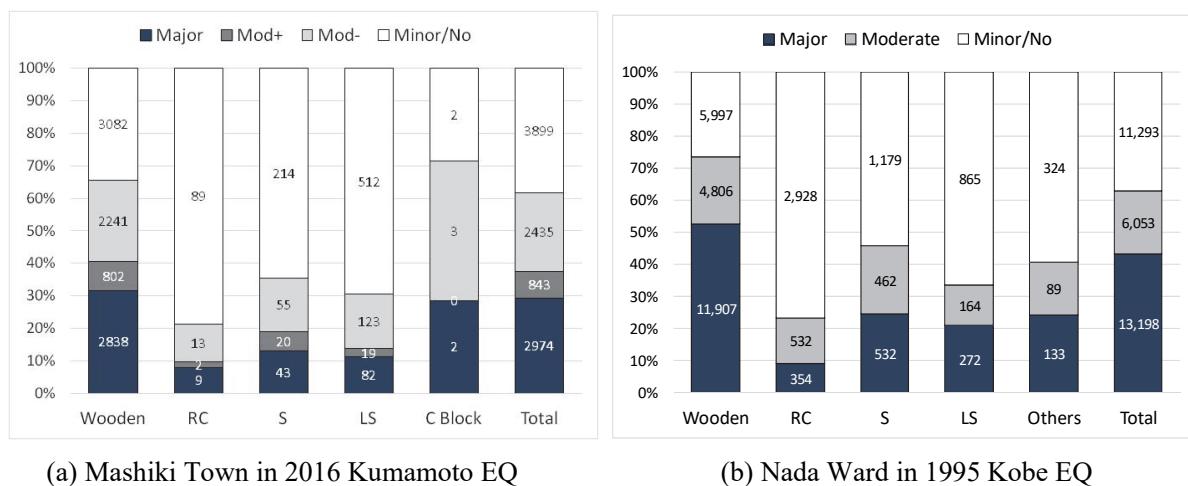
The building damage data shown in Figure 2 were analyzed based on the structural material and construction period. From all the loss assessment data, non-residential or non office-use buildings, such as a storage barn, were excluded. Figure 4 shows the damage classifications for a total of 10,151 buildings in Mashiki Town due the 2016 Kumamoto earthquake and that for 30,544 buildings in Nada Ward due the 1995 Kobe earthquake (Yamazaki & Murao 2000). The ratio of major damage for each structural material is in the order of "wooden", "Steel (S)", "Light-gauge Steel (LS)", and "Reinforced Concrete (RC)" buildings for the both datasets. Although there is a 21-year time difference, the vulnerability of buildings with respect to the structural type is quite similar. Note that at the time of the Kobe earthquake, the damage class "Moderate" corresponds to the monetary loss ratio of $20\% \leq r < 50\%$, which is the summation of "Moderate+" and "Moderate-" in the Mashiki data.

Figure 4. Damage classification of buildings by local governments with respect to the structural type.

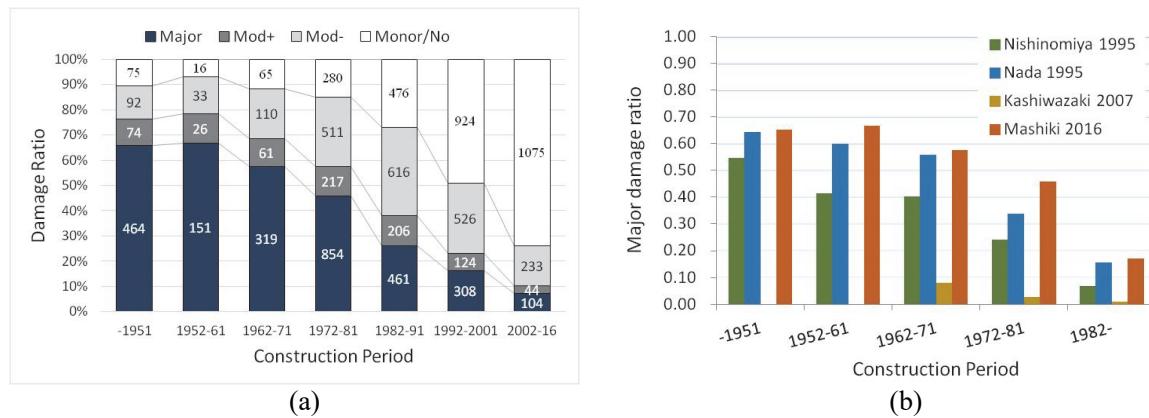
The effect of construction period, which corresponds to the change of seismic code in Japan, was then investigated only for wooden buildings since the number of buildings for other structural types was not large enough. Figure 5(a) shows the damage ratio of wooden buildings in Mashiki Town with respect to the construction period and damage (loss) category. It is clearly observed that within the construction period of 1982-2016, that corresponds to the new seismic code in Japan, the damage ratio becomes smaller for newer wooden buildings. Note that the seismic provision for wooden buildings was upgraded in 2000.

In the damage category, "Major", which represents the monetary loss over 50%, is most important since the demolition of the building is a normal situation for this class. Figure 5(b) compares the ratio of major damage class for wooden buildings with respect to the construction period for Nada Ward in Kobe City (Yamazaki & Murao 2000) and Nishinomiya City (Yamaguchi & Yamazaki 2000) due to the 1995 Kobe earthquake, and Kashiwazaki City (Nagao et al. 2011) due to the 2007 Niigata-Chuetsu-Oki earthquake, and the Mashiki Town data in this study. For the same construction period, the major damage ratio of the Mashiki Town is almost the same level as that of Nada Ward. The damage ratio of Nishinomiya City is slightly small than that of Nada Ward since the city includes the area of lower seismic motion in the northern part.

Figure 5. Damage classification of wooden buildings with respect to construction period in Mashiki Town (a) and comparison of the major damage ratio class for wooden buildings for four different datasets in Japan.
