Observed Response of Seismically Isolated Buildings during the 2016 Kumamoto Earthquake

Mineo Takayama
Fukuoka University

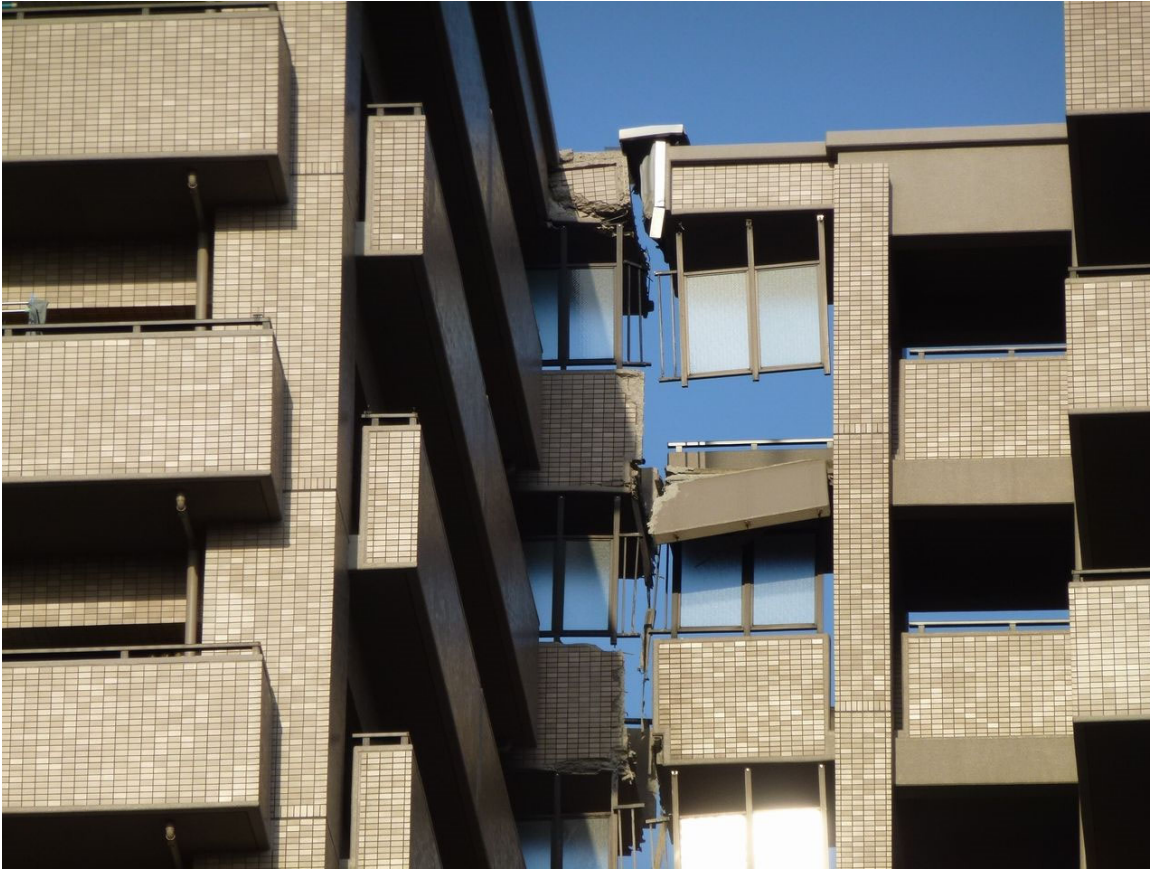
Damage of Expansion Joints

Many damages occurred even in relatively new reinforced concrete apartments.

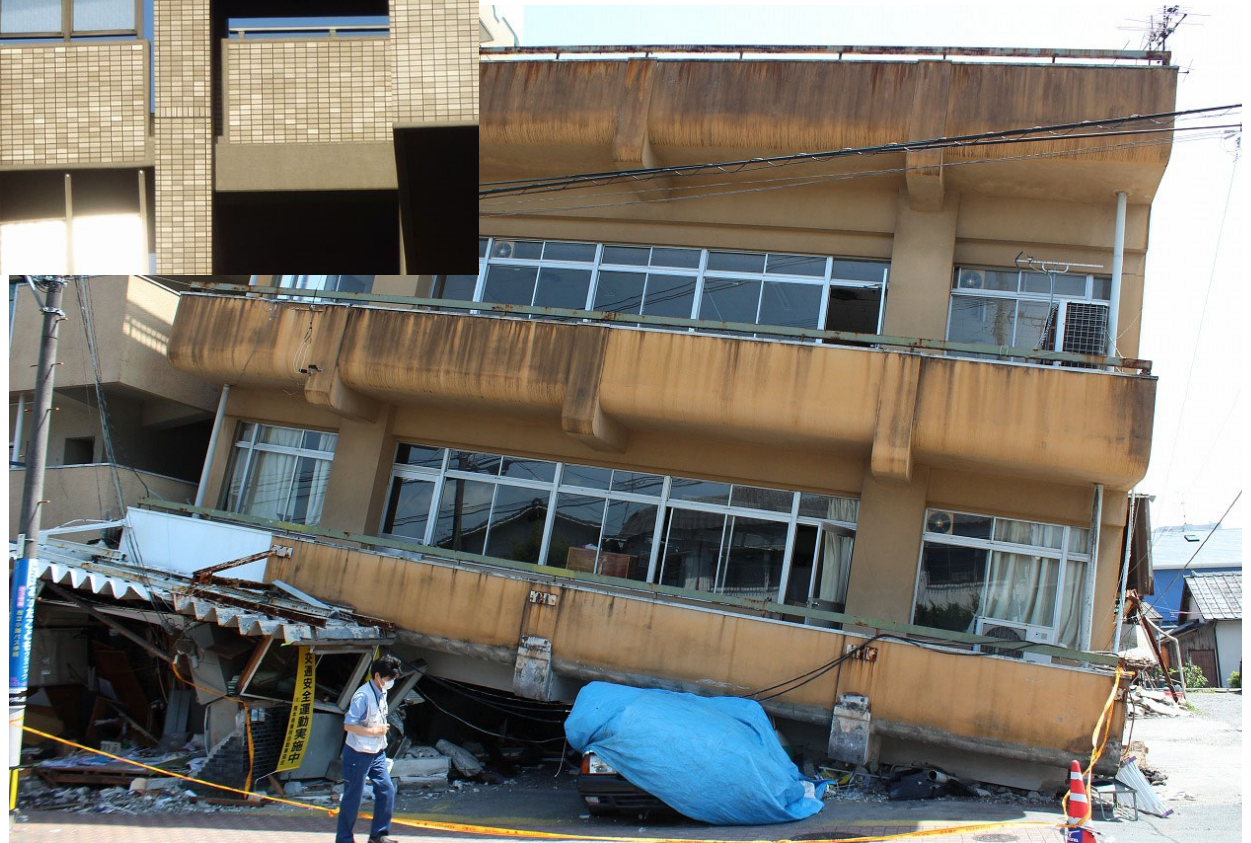
Collapse of old reinforced concrete building

Seismic reinforcement of old buildings is urgent.

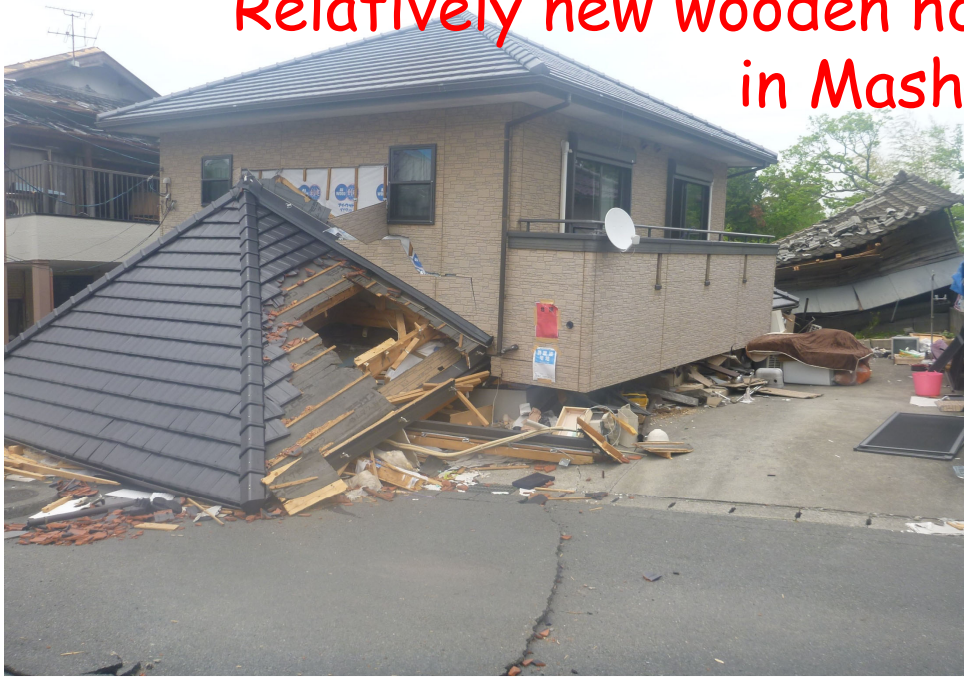
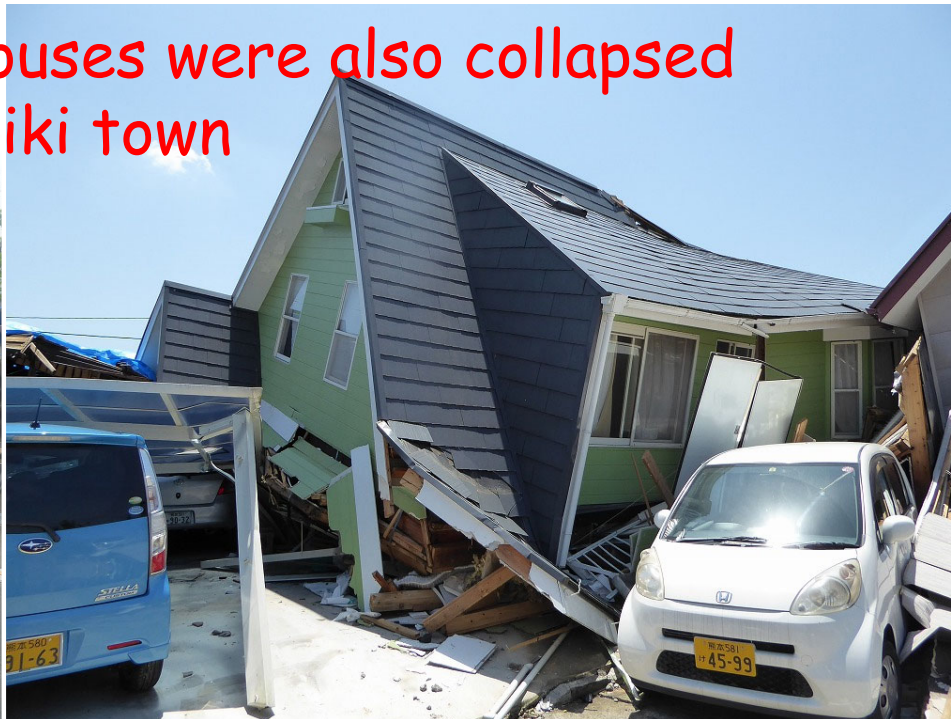
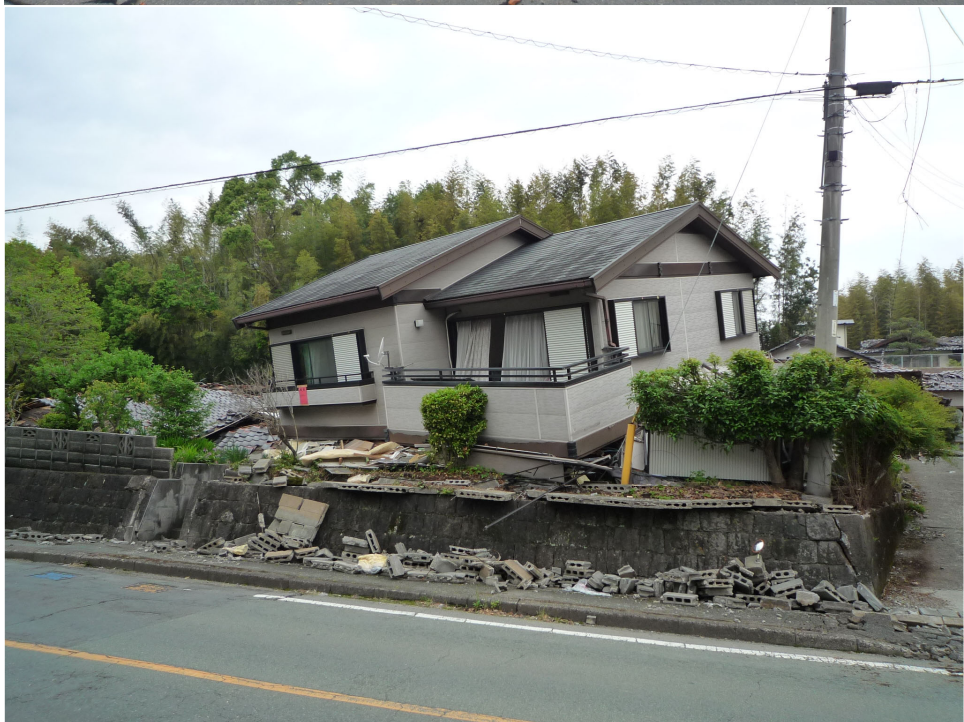
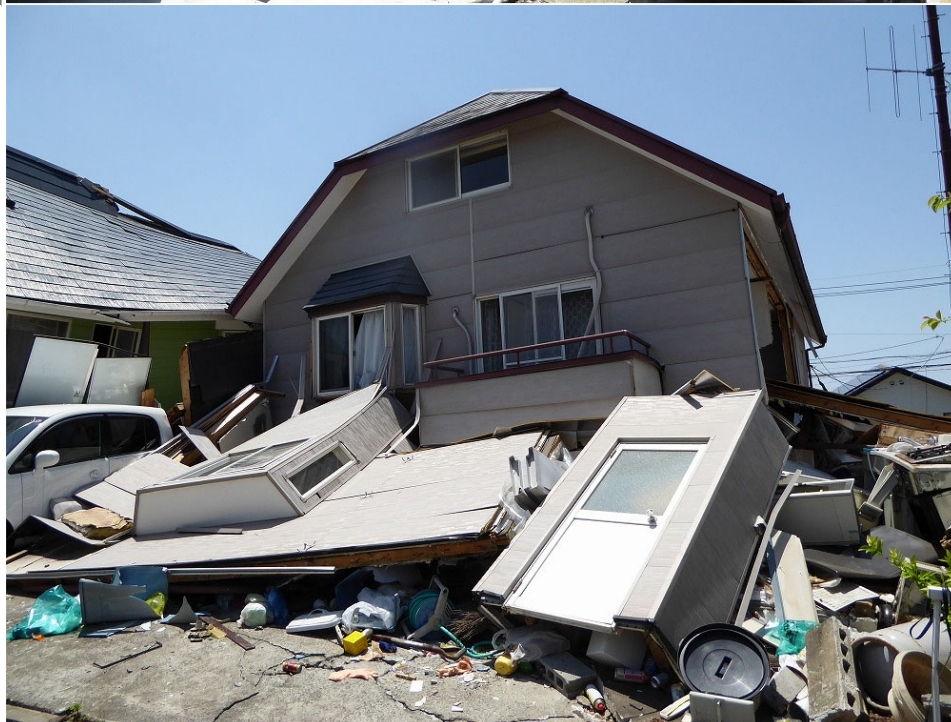
Relatively new wooden houses were also collapsed
in Mashiki town

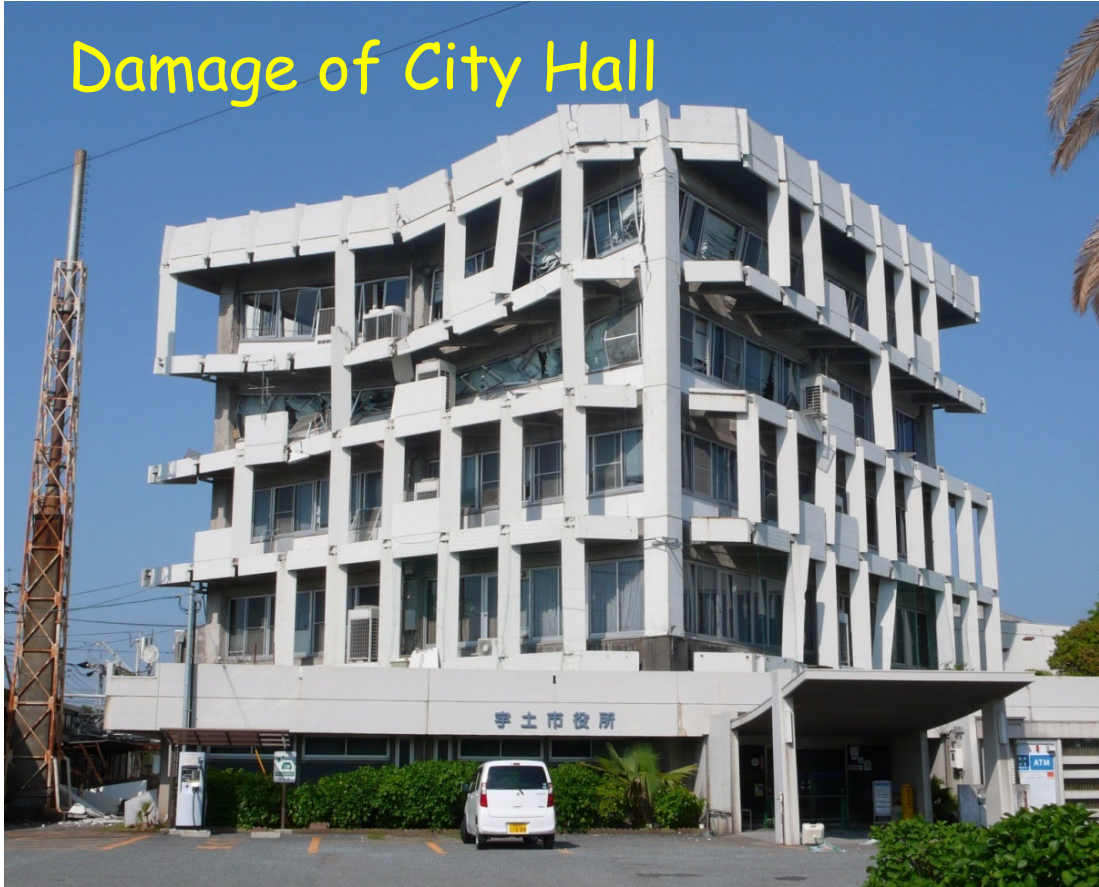
Damage of City Hall

Damage of the city hall
Facilities that become
disaster bases are required
to have higher earthquake
resistance and function
maintenance.

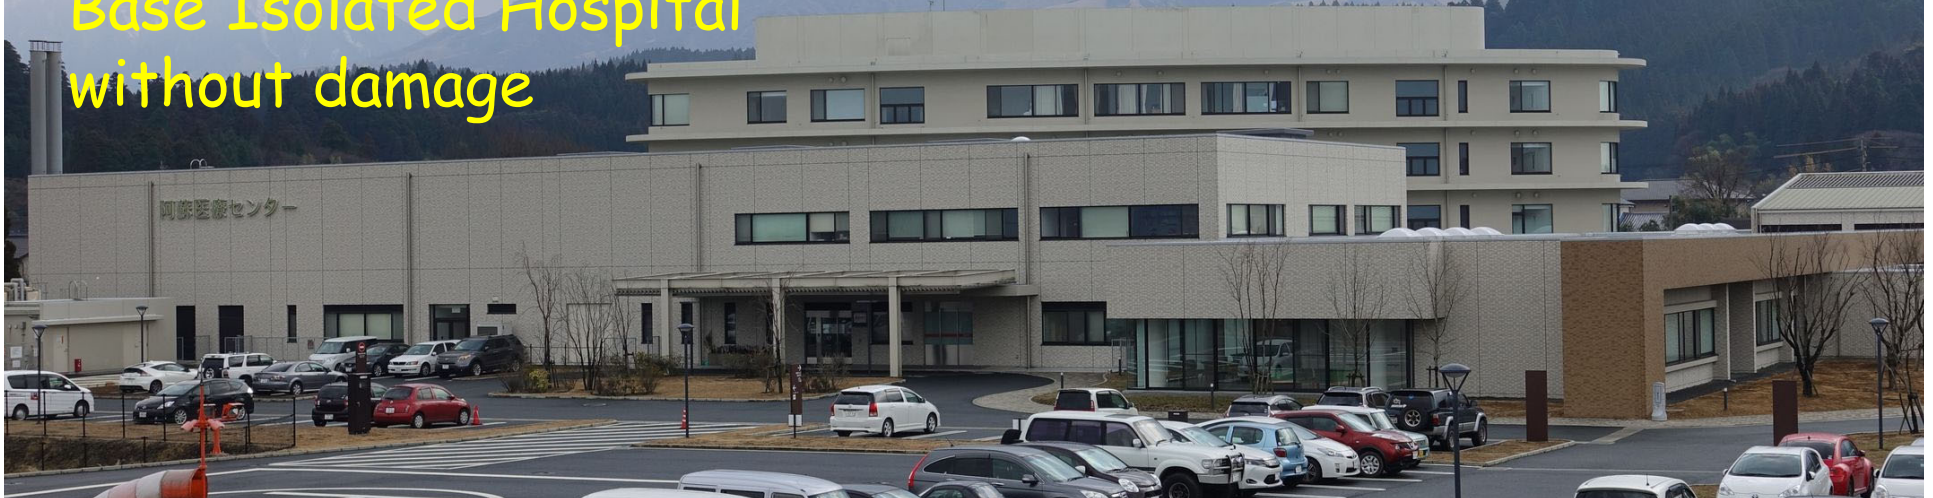
Base Isolated Hospital without damage

In the seismic isolation
hospital, the function is
maintained after the
earthquake without damage,
and medical practice can
continue

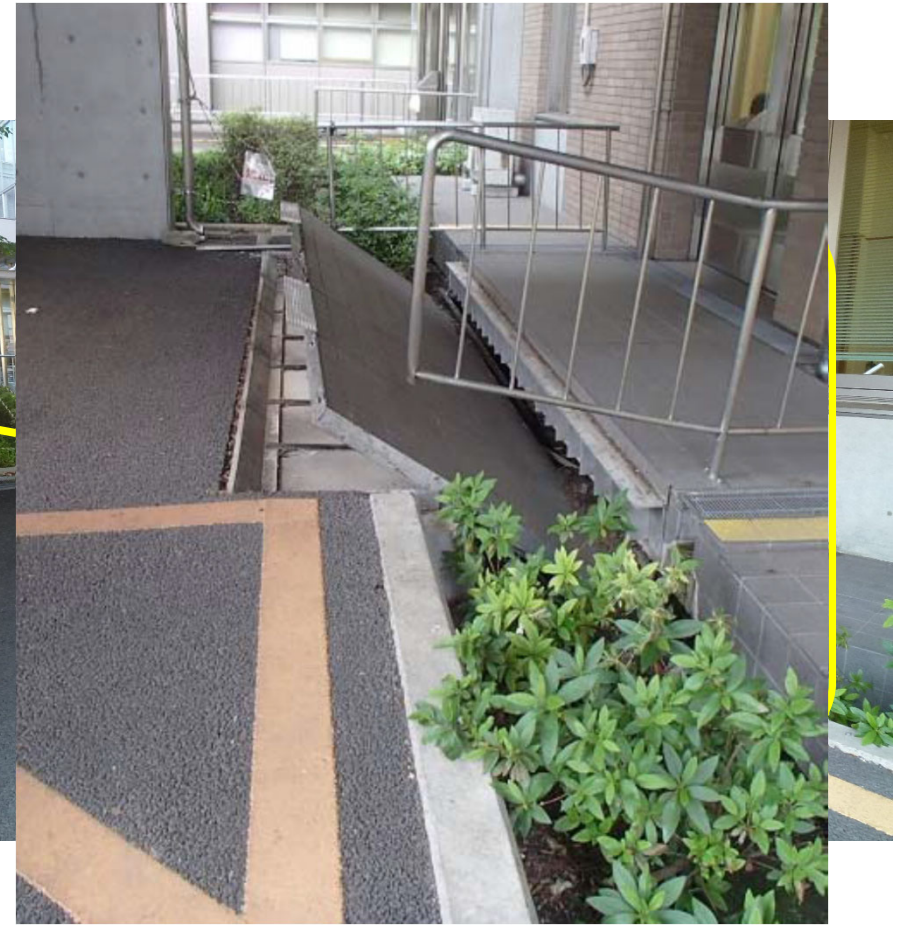
After Main Shock
Just After Main Shock
April 16, '2016

Damage of Hand rail

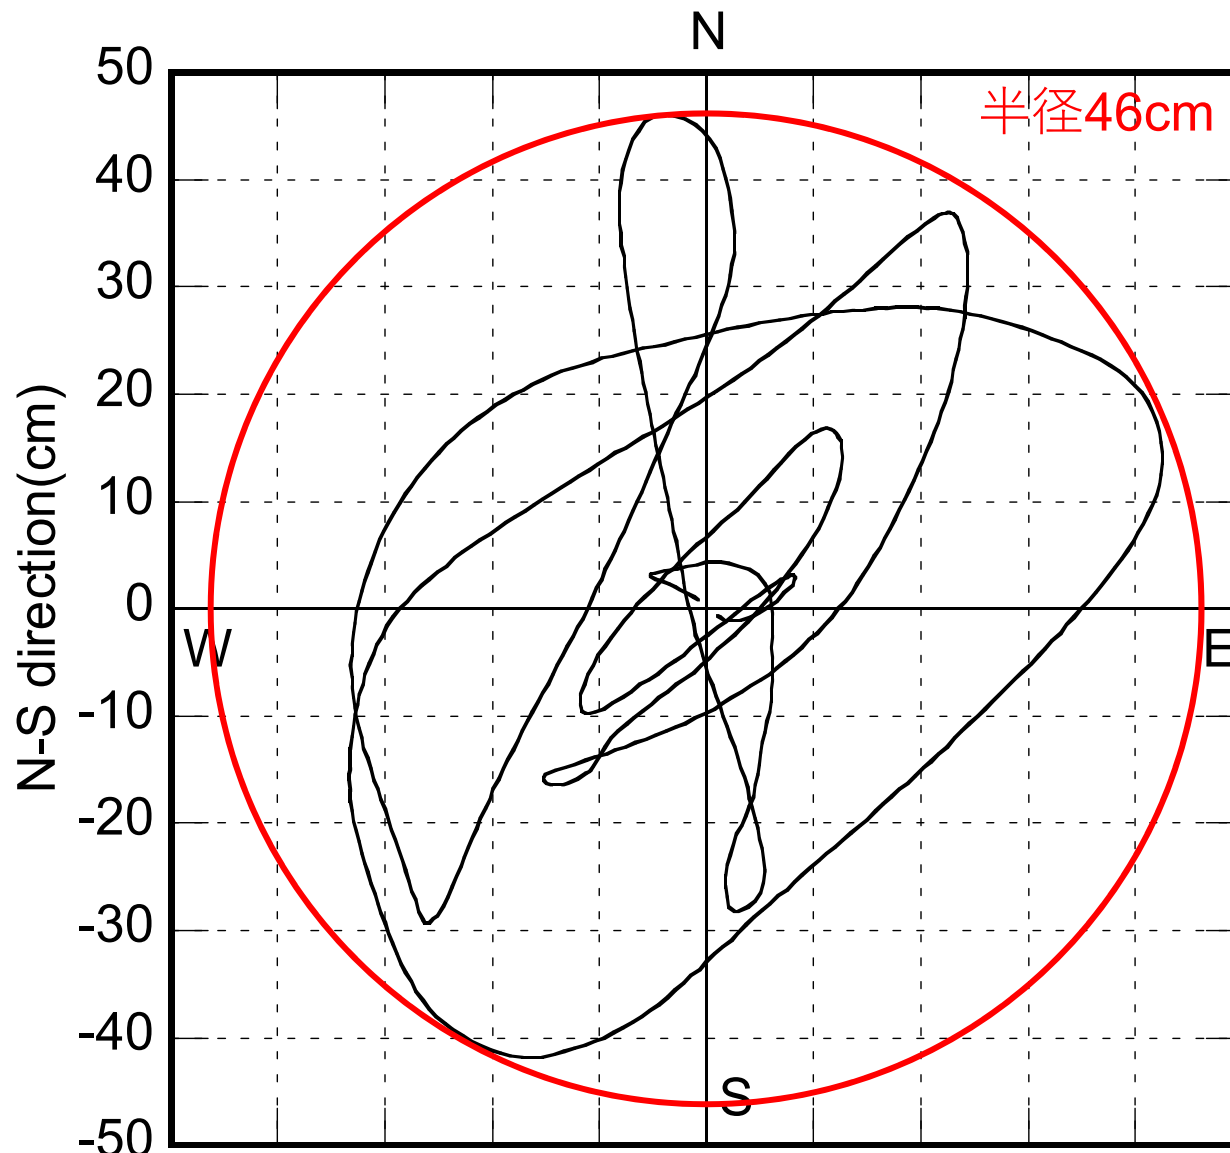
Movement Trace of M-hospital

Max. Deformation 46cm (shear strain 330%)

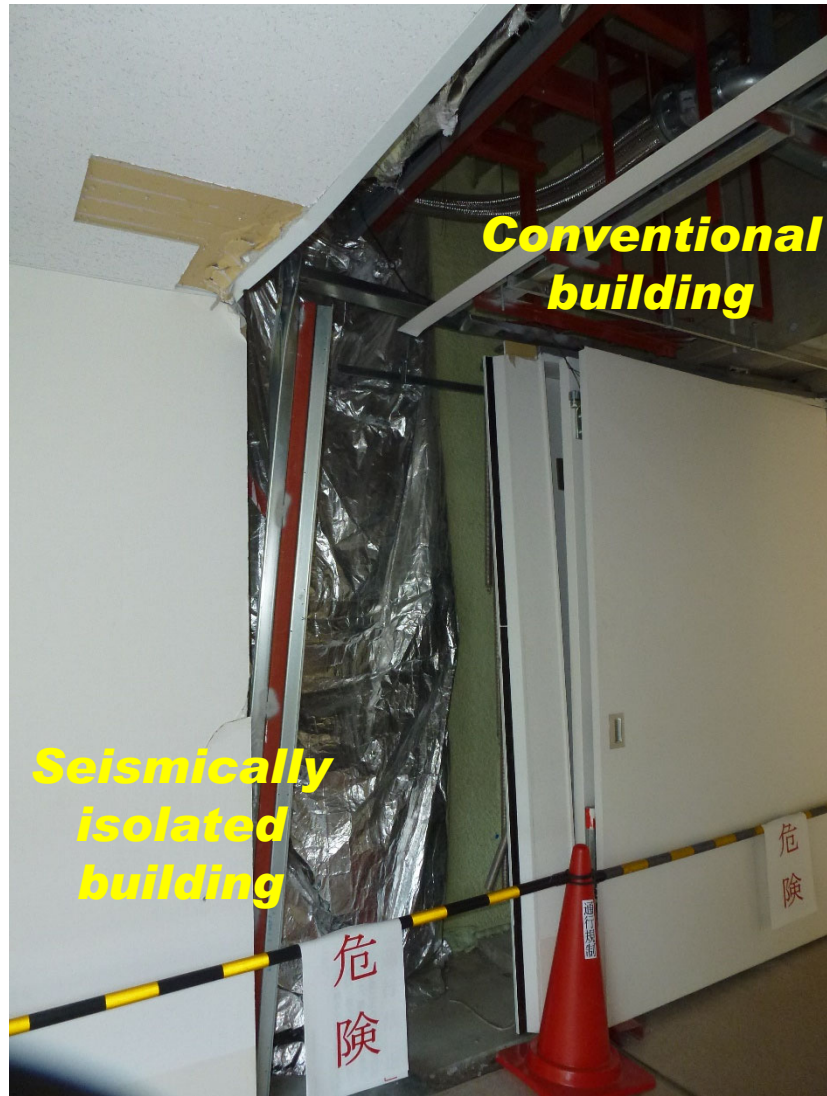
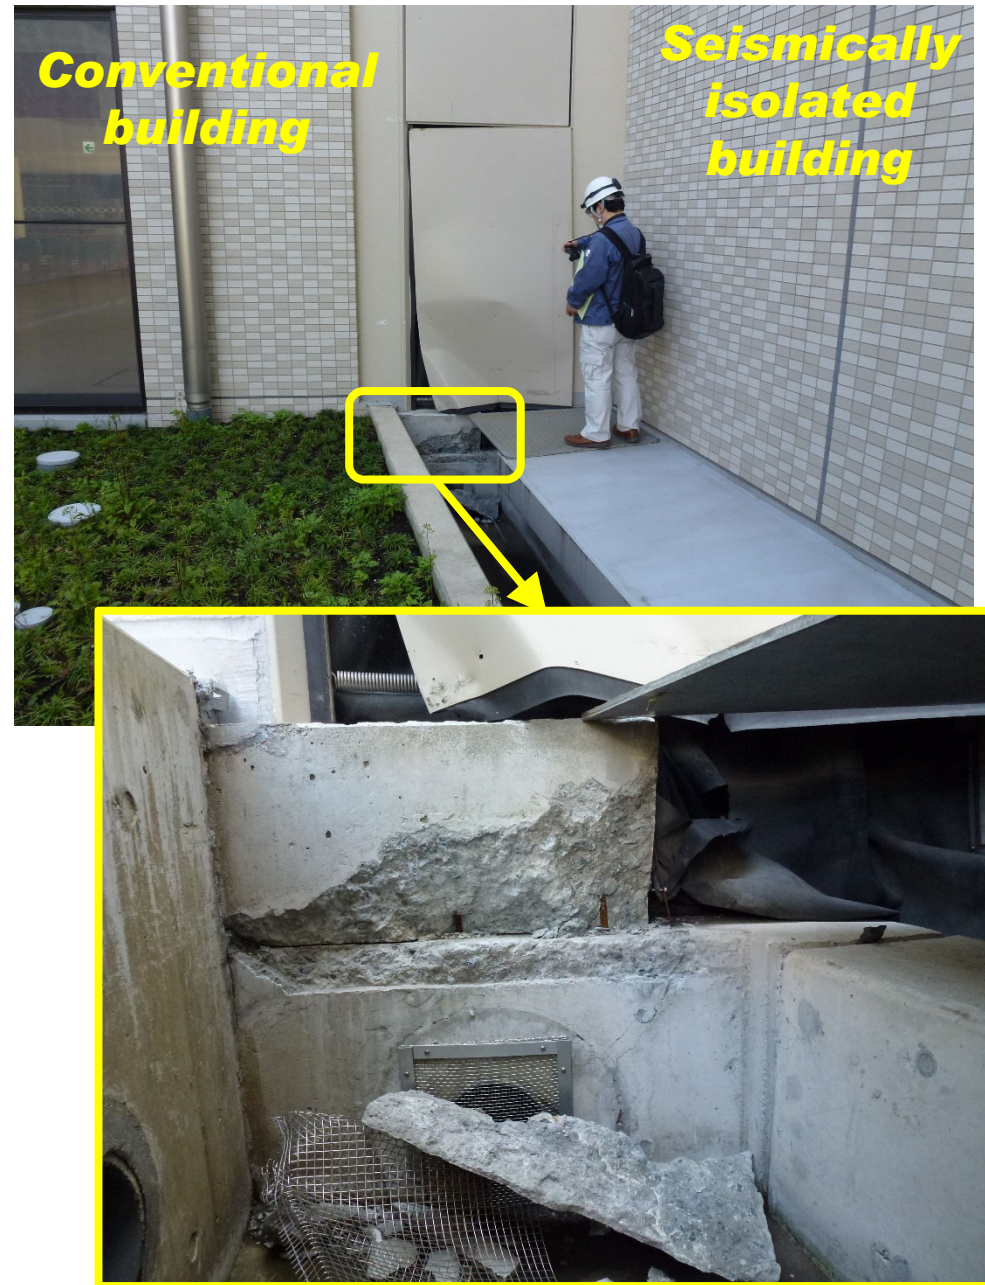
Damage of Expansion Joint
