Performance of Buildings and Nonstructural Components in the South Napa Earthquake

John Gillengerten, S.E.

FEMA P-1024

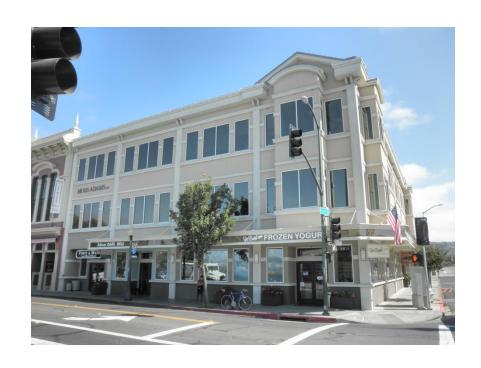
- Buildings constructed to recent codes generally performed well structurally
- Some newer buildings suffered significant nonstructural damage

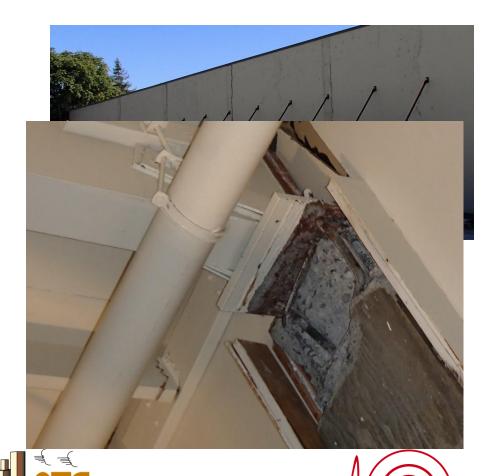
- The vast majority of older, non-URM structures also performed well structurally
- Known vulnerabilities, such as poor wall to roof connections, did result in significant damage and loss of use

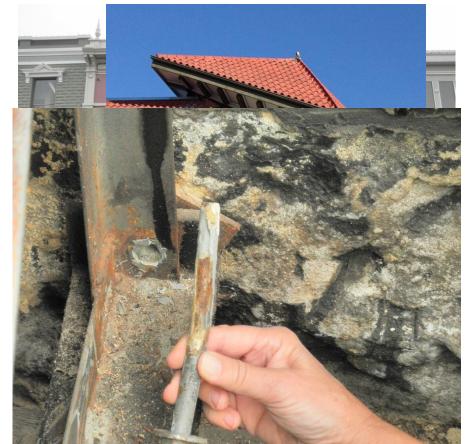
- 13 buildings suffered no structural damage or the damage was deemed insignificant
- 3 buildings suffered minor damage, 1 building moderate damage, 2 were heavily damaged
- Some exterior masonry loosened or fell from three of the damaged buildings

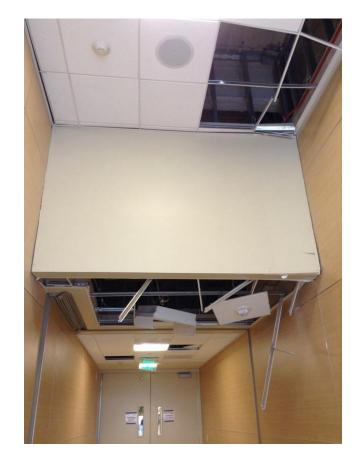
- 5 hospitals and 13 skilled nursing facilities located between 4 and 10 miles from the epicenter
- Wide range of structural types, some buildings over 50 years old
- No facility suffered serious damage
- Nonstructural damage did interfere with the delivery of some healthcare services

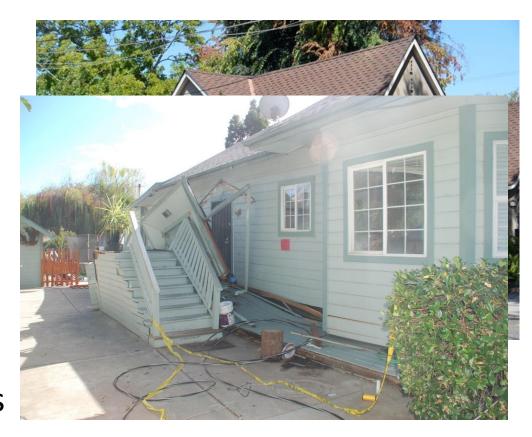
- 61 of 116 buildings in Napa posted UNSAFE were residential buildings
- Damage concentrated heavily on two key deficiencies: masonry chimneys and unbraced cripple walls

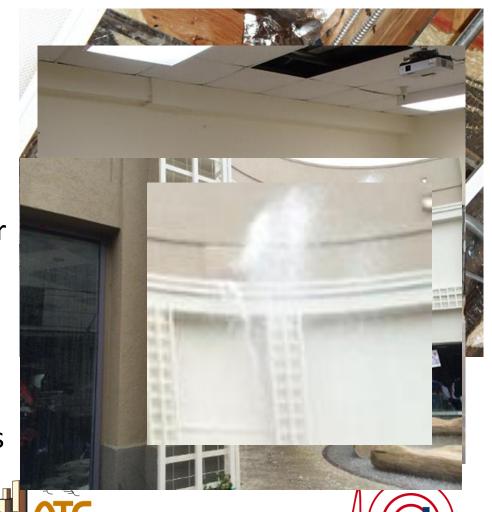
- Fire sprinkler failures
 - Interaction between heads and piping or other components
 - In most cases, the water could not be turned off
 - Serious flooding and water damage in some buildings
 - Pipe and anchor failures

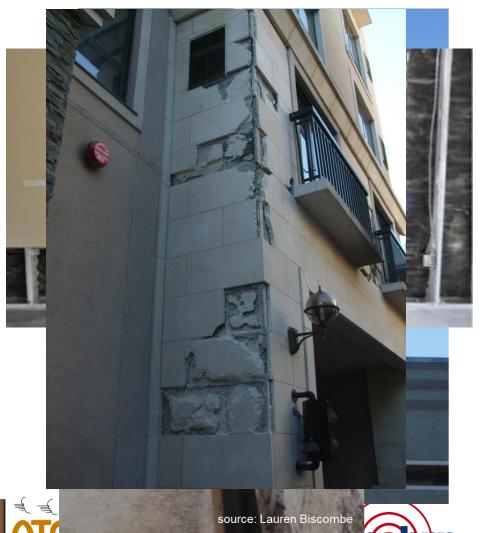
- Light curtain wall systems
 - Some modern structures suffering substantial cracking and loss of veneer
 - In at least one case, the curtain wall system appears to have been designed without a mechanism to accommodate interstory drift without damage
 - The performance of adhered veneer was directly related to the performance of the substrate and the strength and condition of the adhesive material

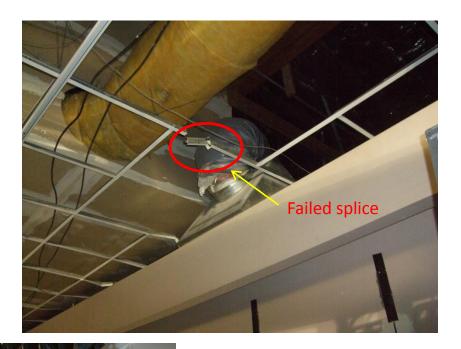
"Free" end dislodged, grid dropped
