Resiliency of Power Systems Earthquake, Wind, Ice, Fire

John Eidinger G&E Engineering Systems Inc.

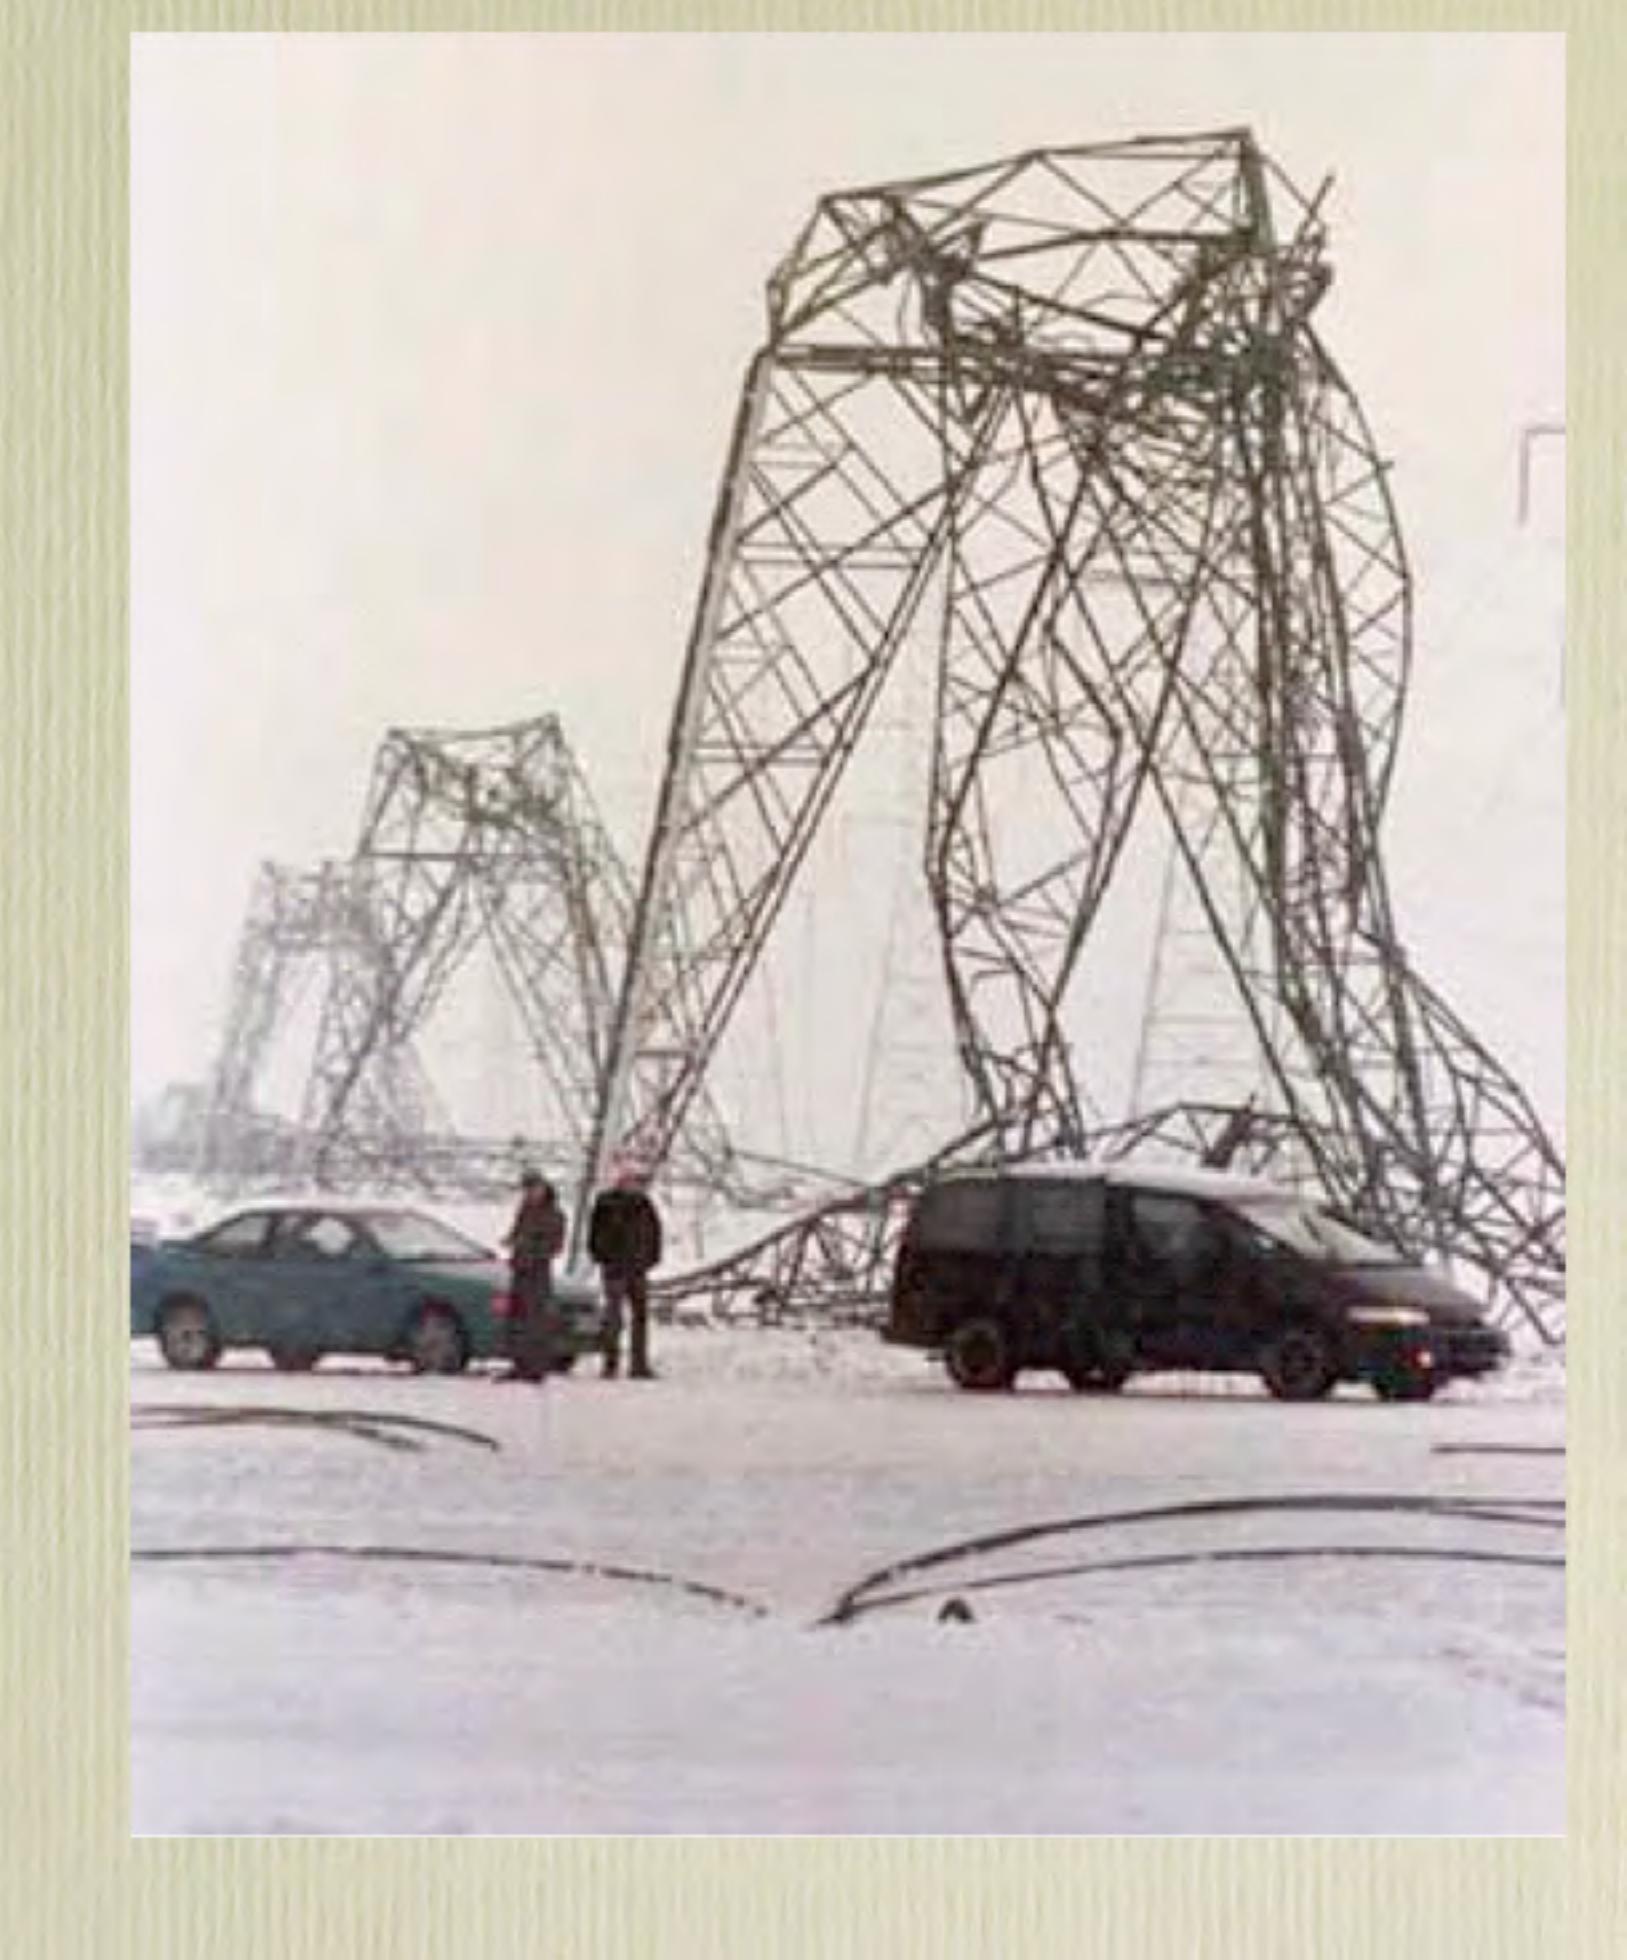
Besides disrupting transportation, heavy ice and snow can damage utilities. Power and telephone lines sagging after heavy ice storm.

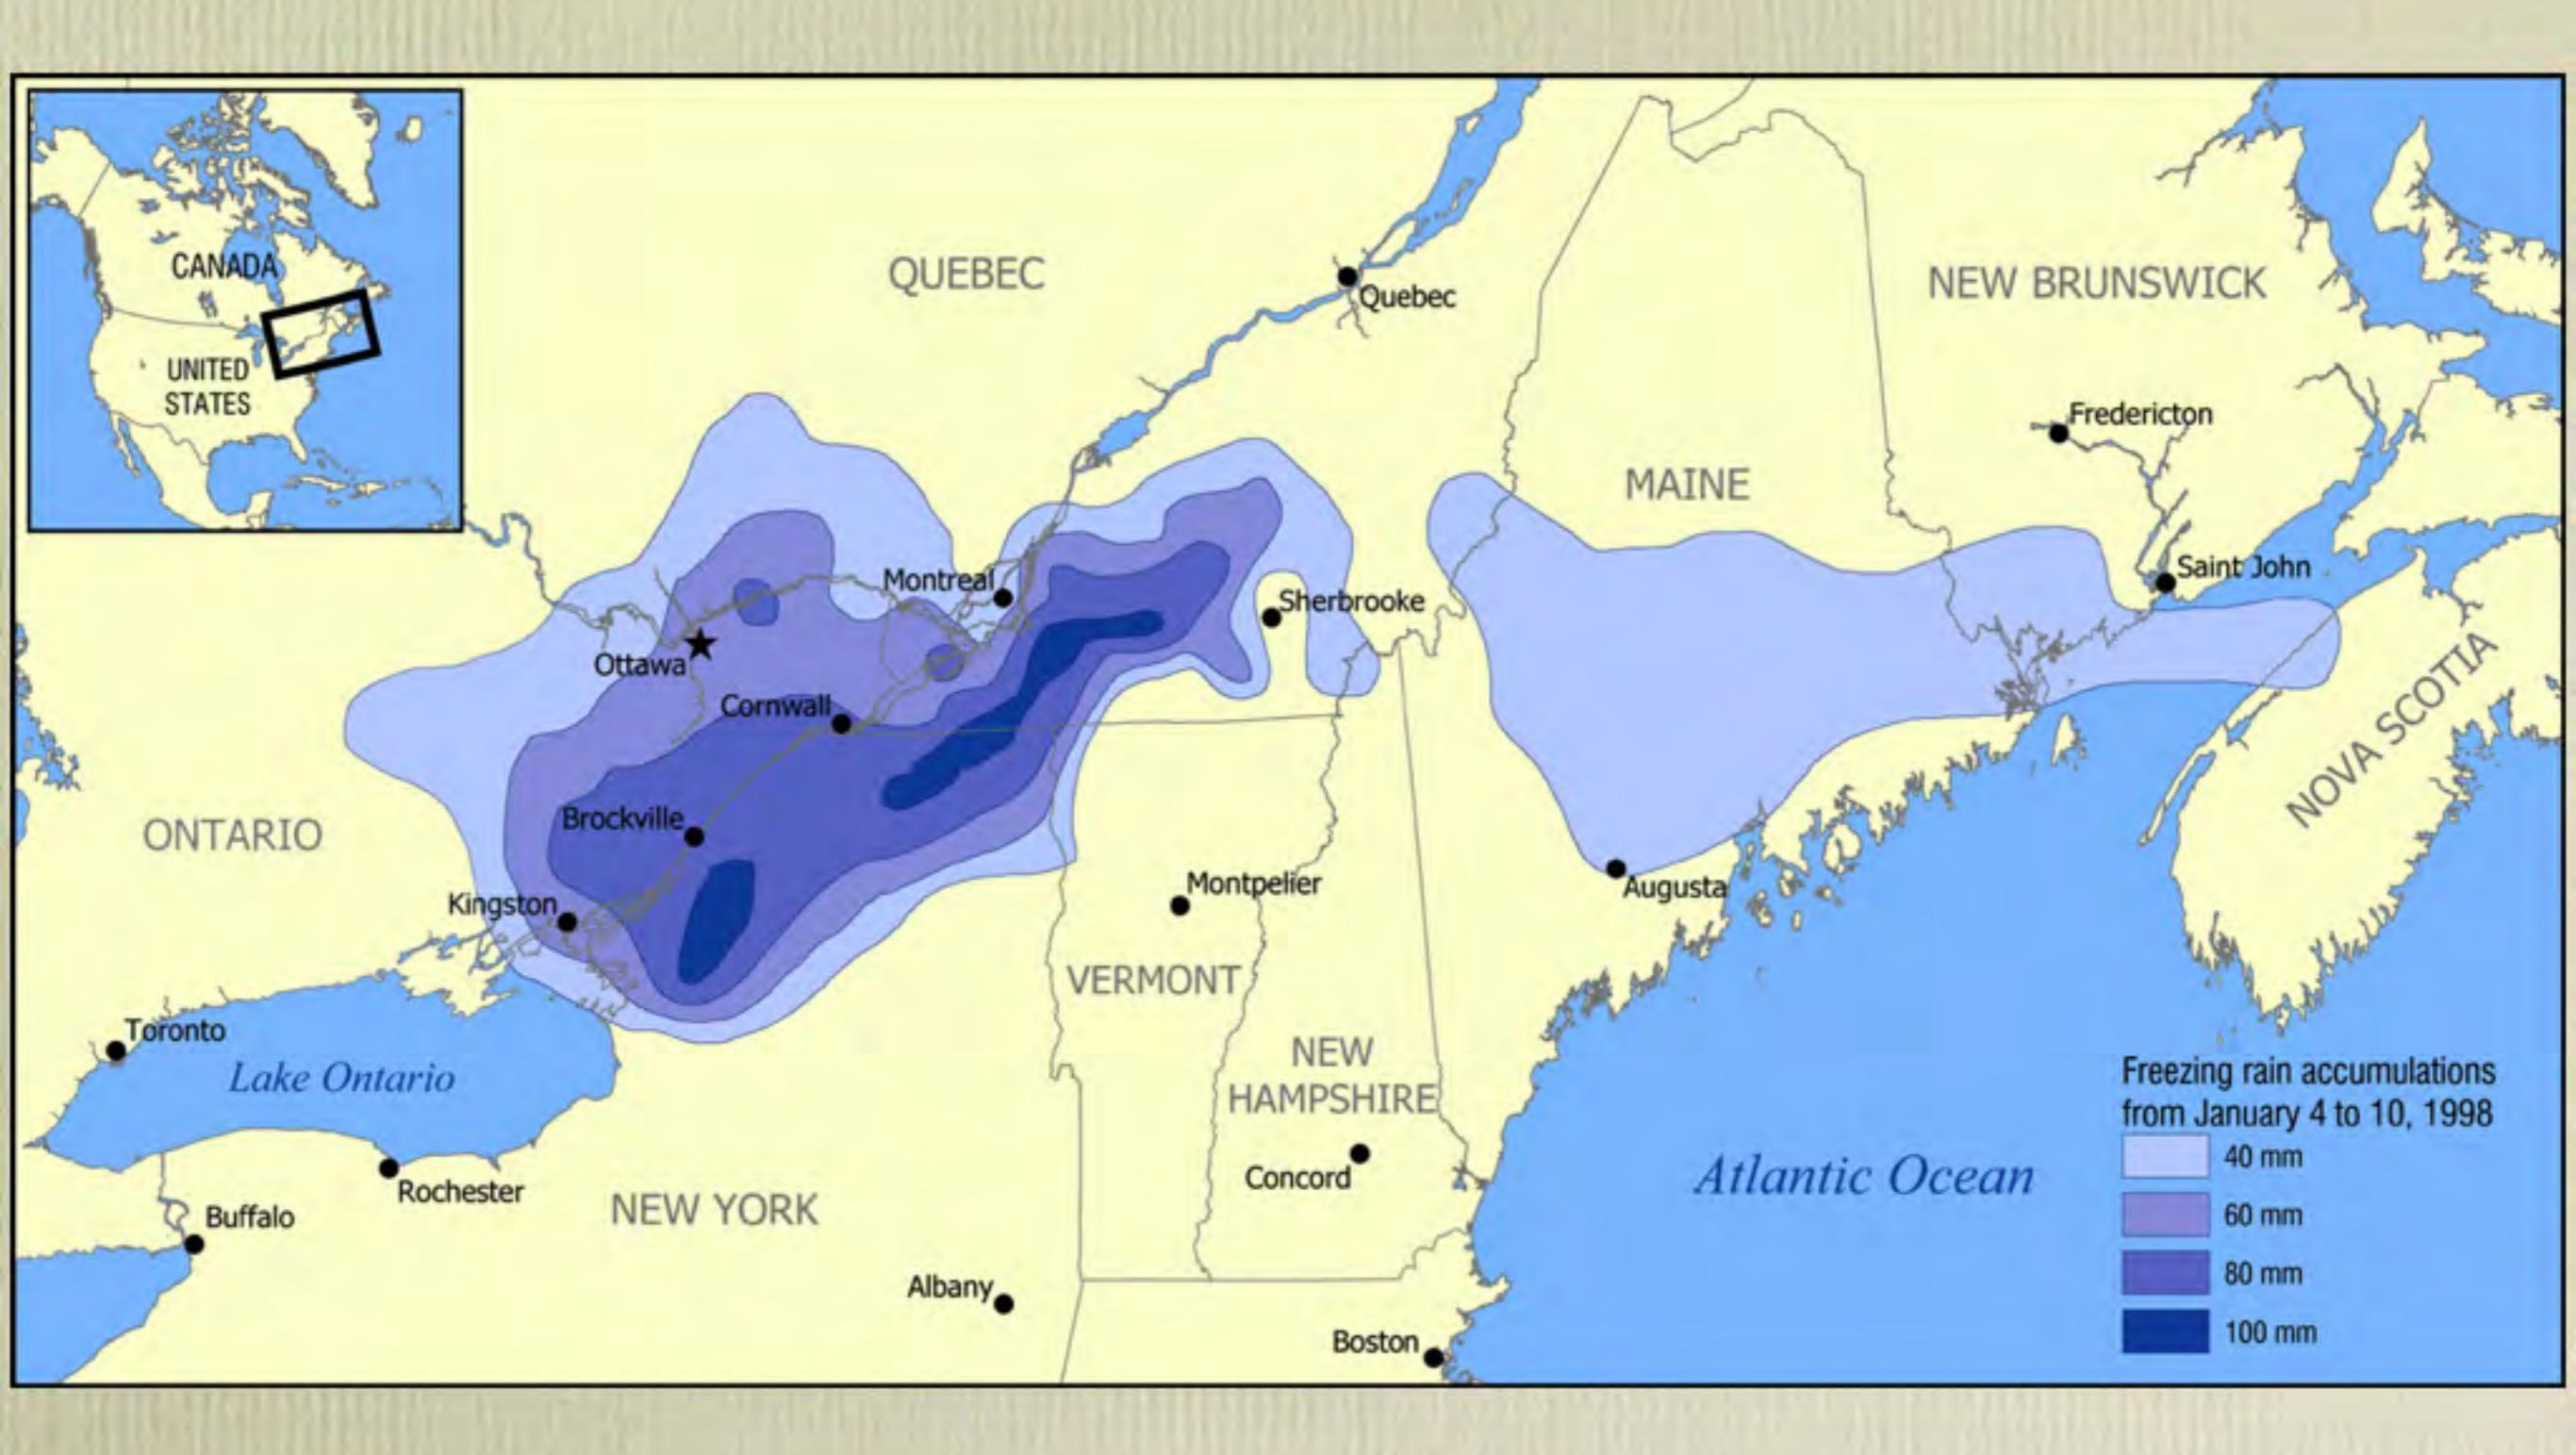
Hydro Quebec, Montreal, Canada, January 5-9, 1998

1,000 steel towers collapsed.

Most are 735 kV

30,000 distribution wood pole failures

6 month outage in some rural areas

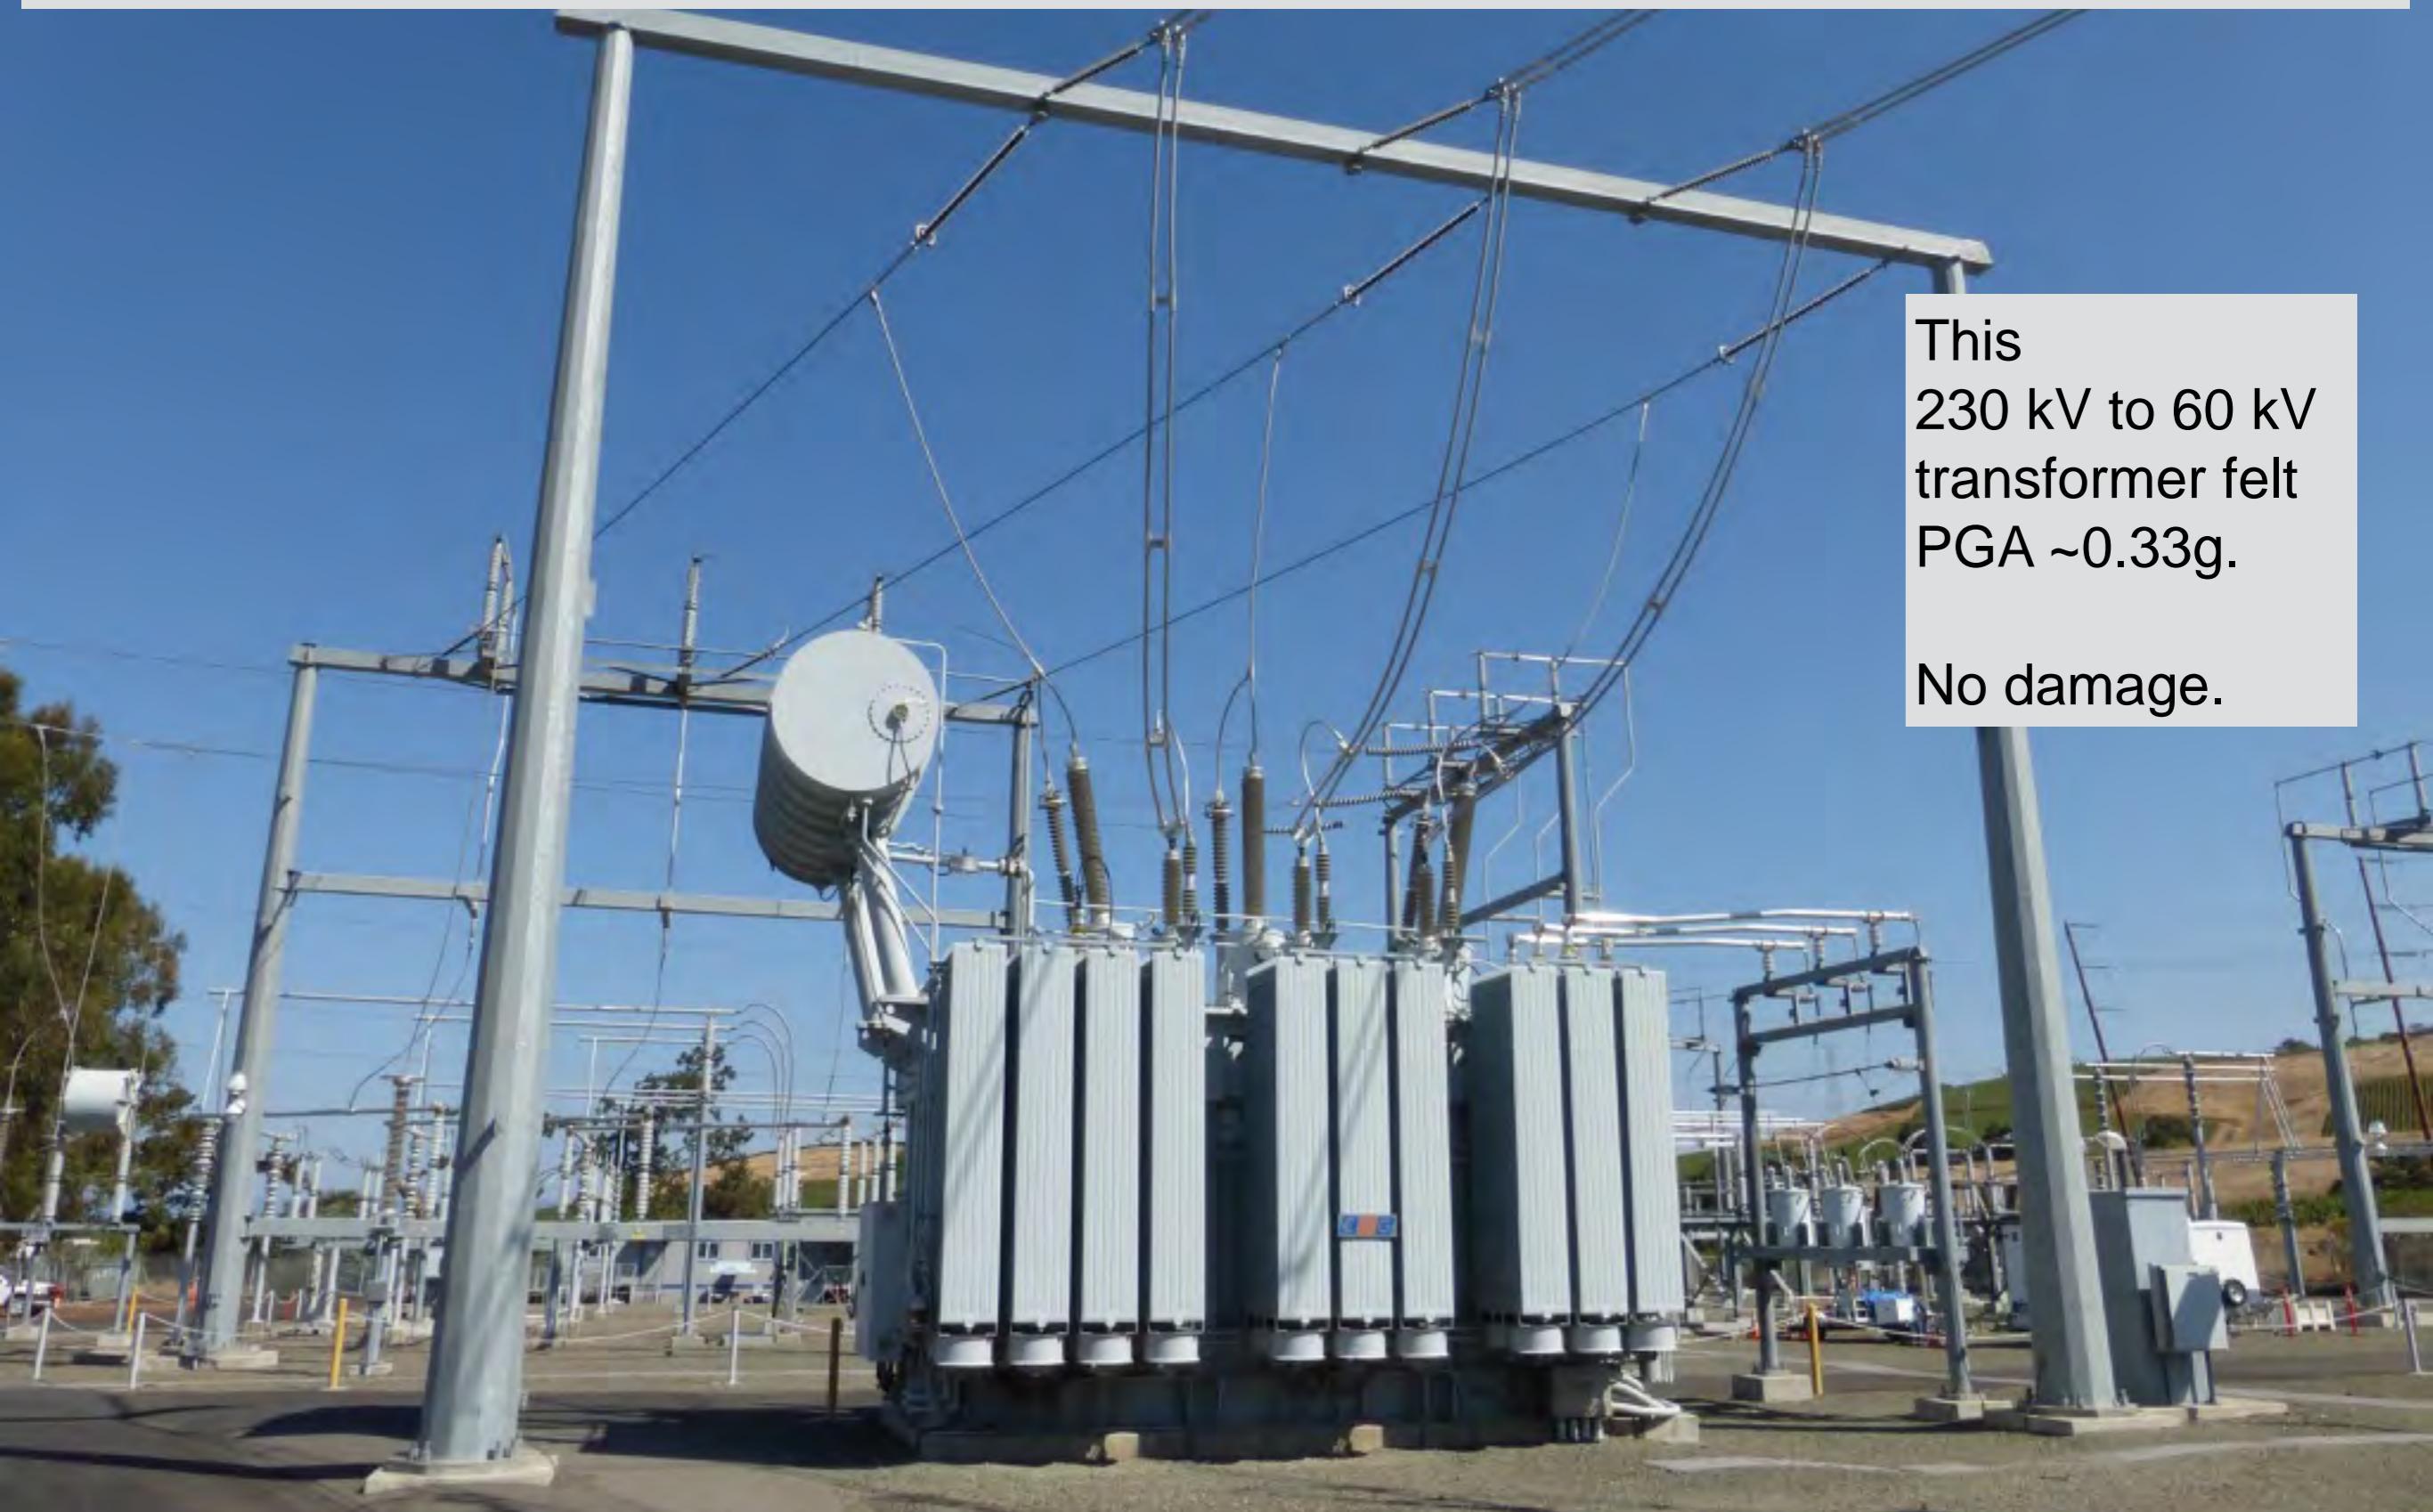
Bank 3. 230 - 60 kV. Anchorage capacity is low (V=0.3W), but PGA small enough to not overcome sliding / rocking, so no damage.

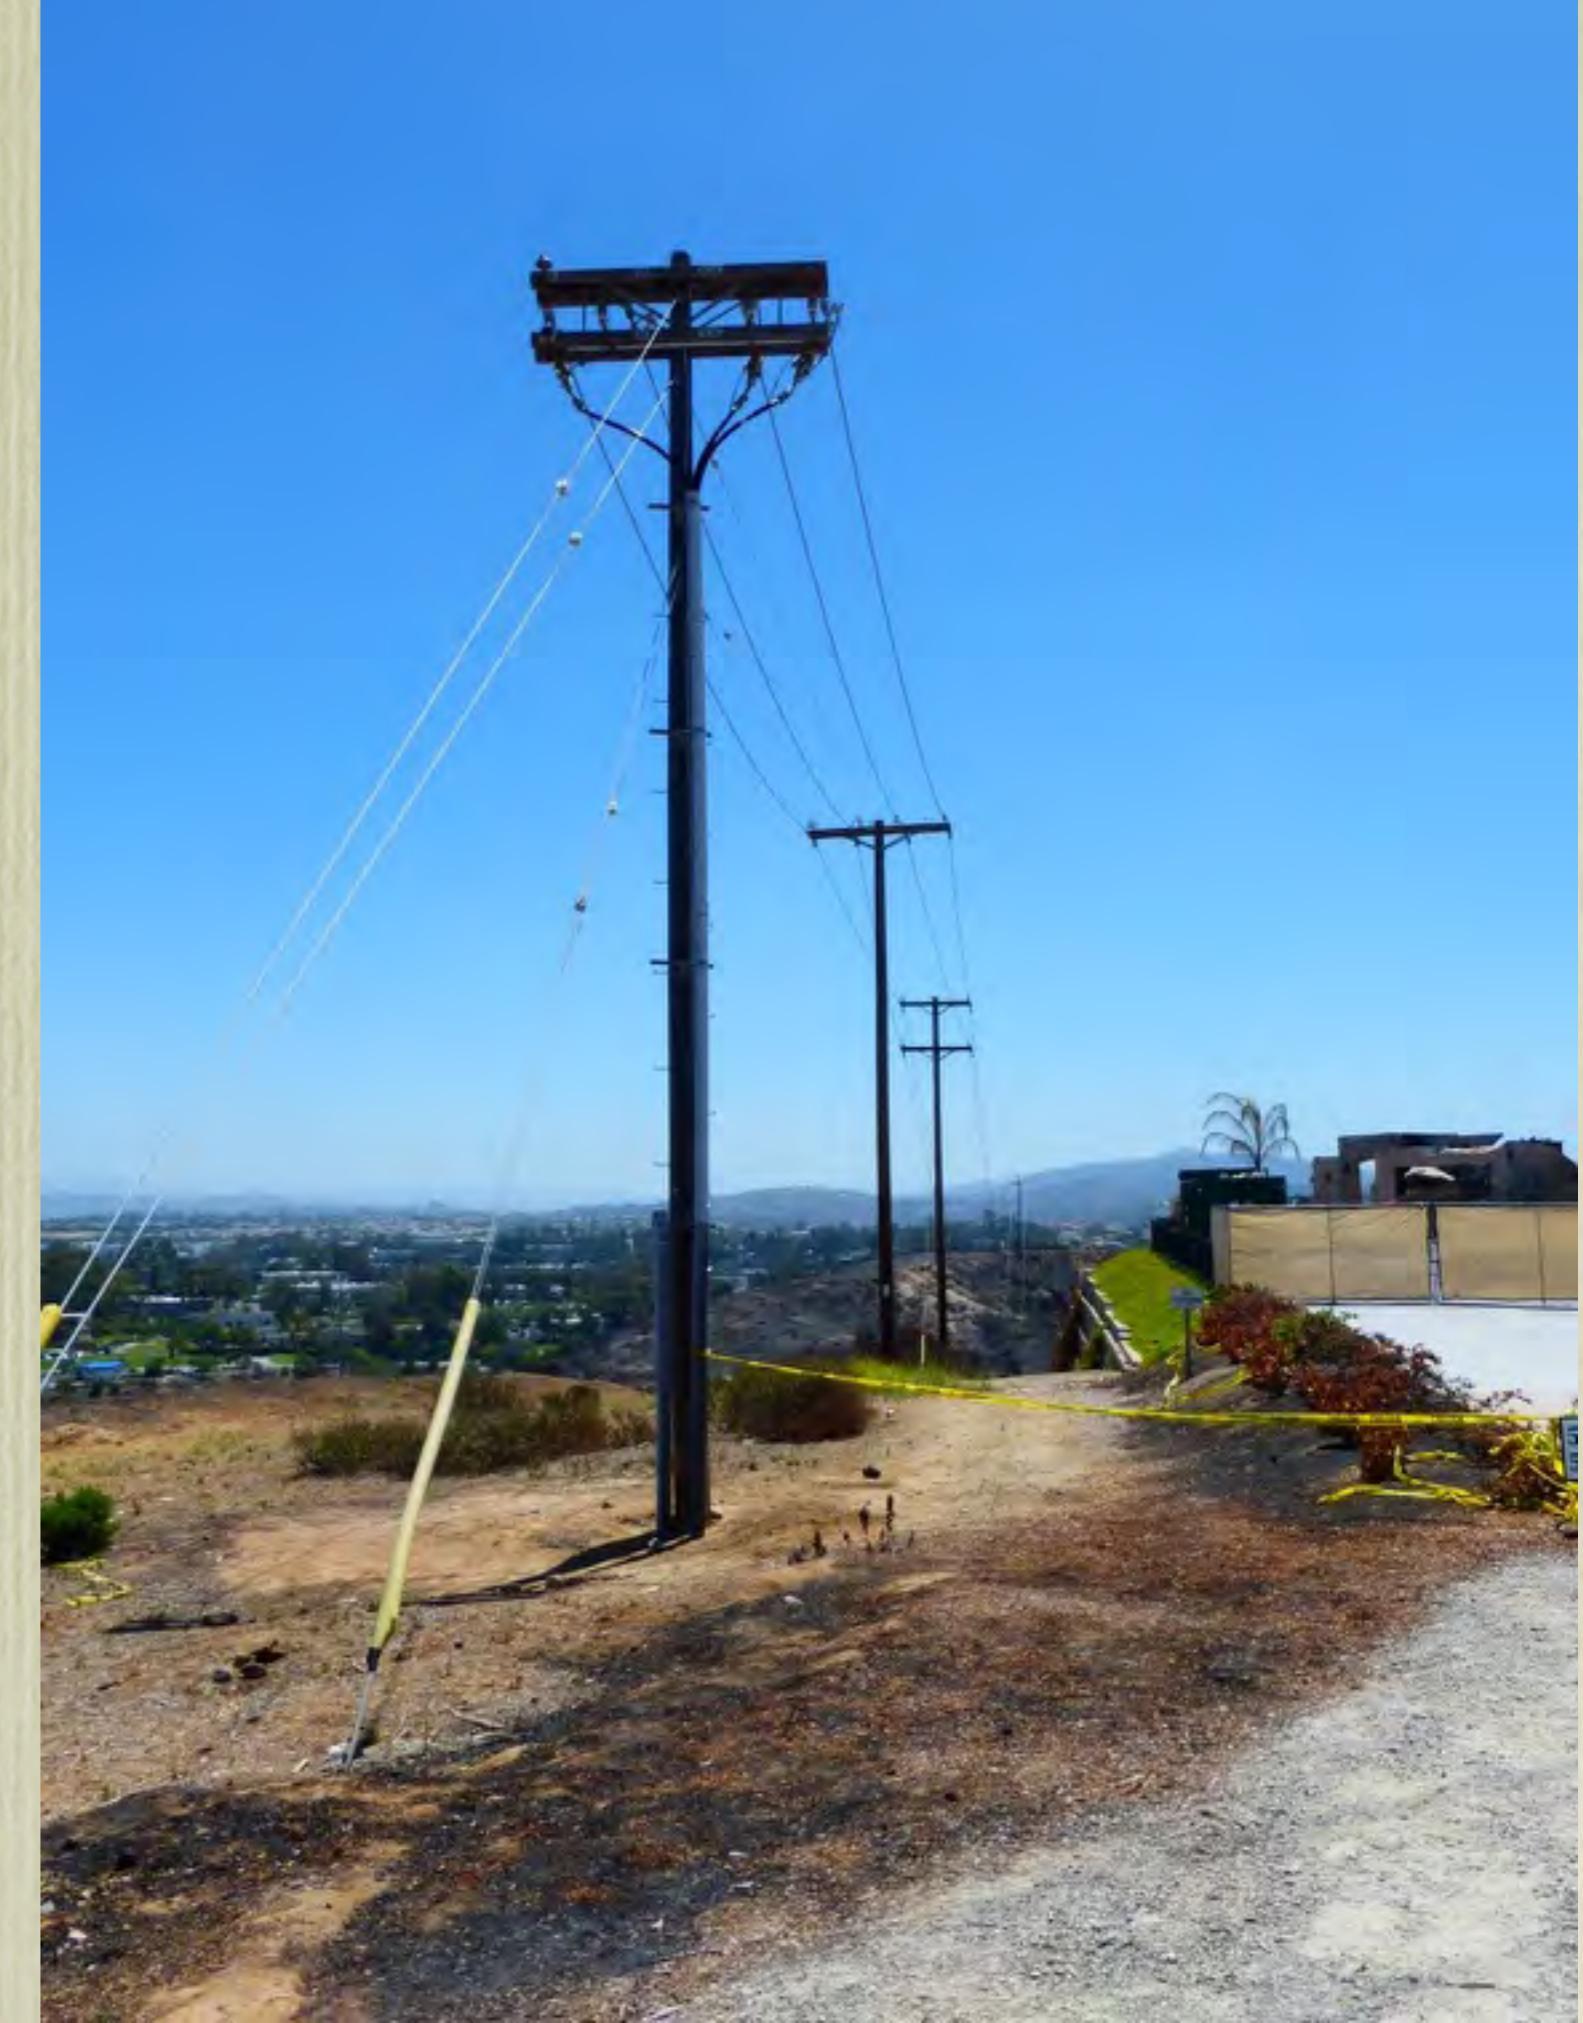
3 wood poles in fire. 1 no damage. 1 minor damage. 1 extensive damage. Nearby house burned.

Extensive damage

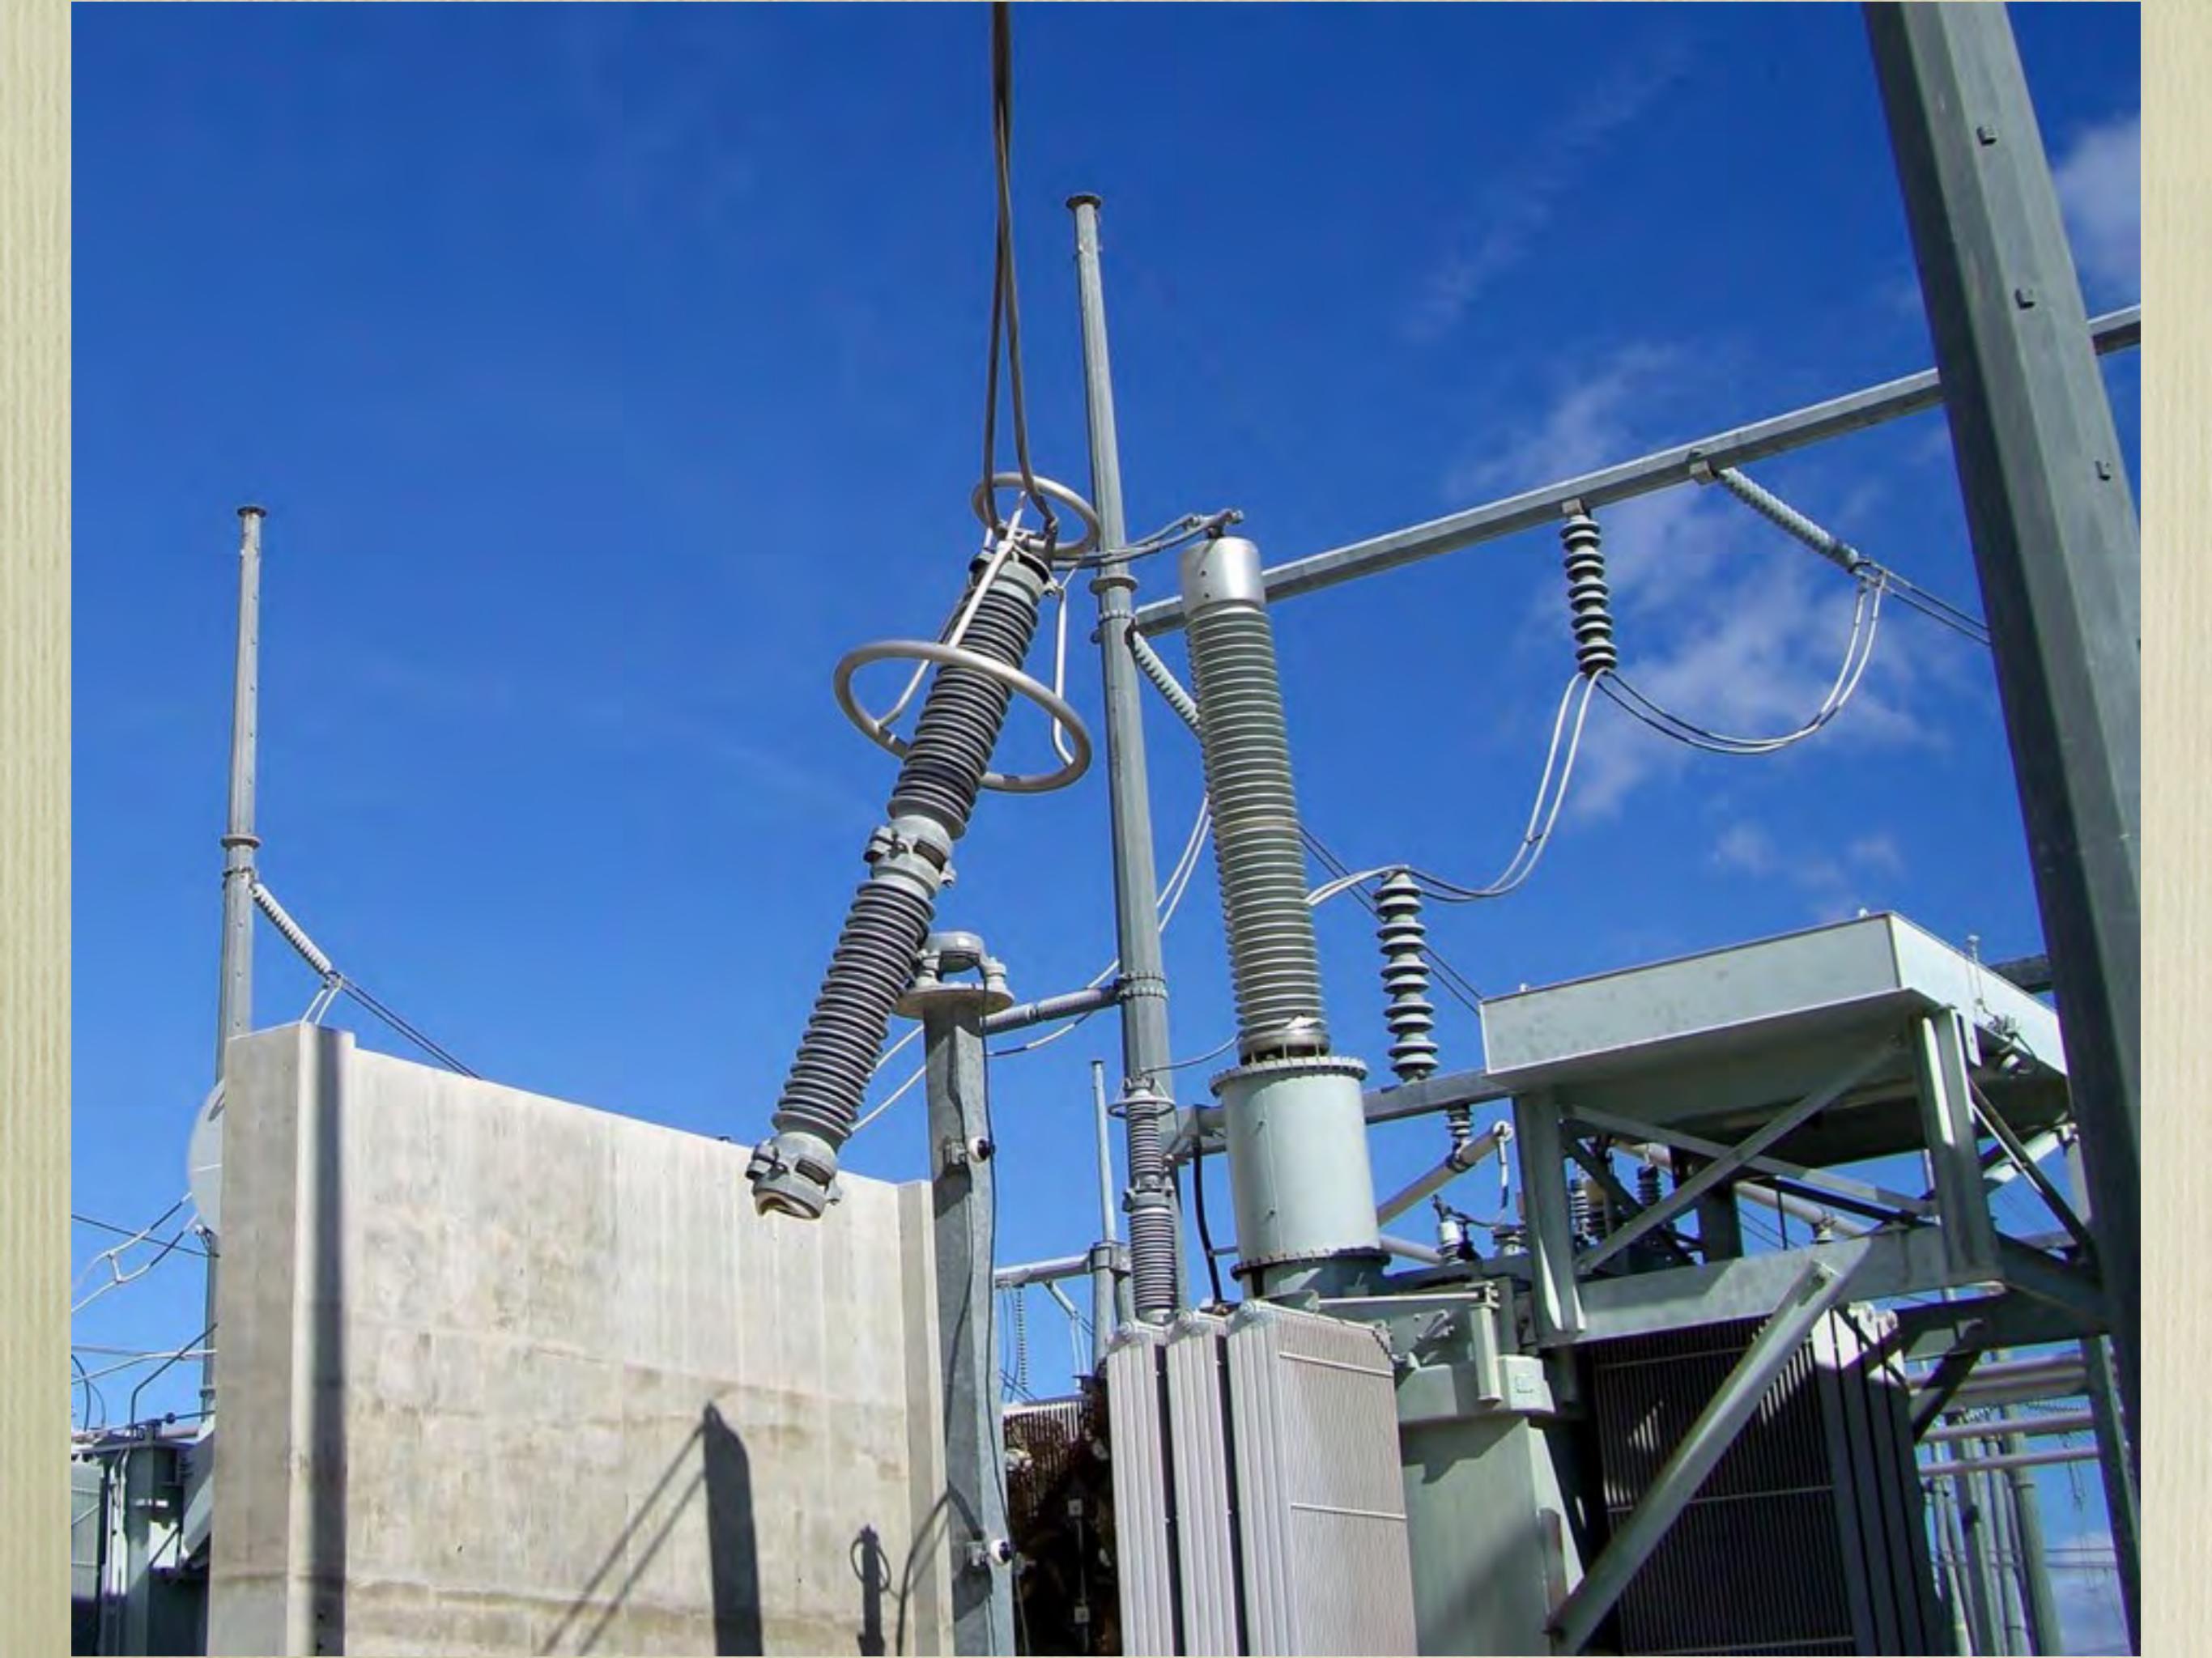
In 2008, these surge arrestors were seismically qualified for PGA = 0.5g with a Factor of Safety of 3, by a world leading company, doing it "on the cheap"

In April 2010, with PGA = 0.30g, 4 of 4 broke.
