Categorization of Damage to Buildings Caused by the 3.11 Tsunami

Damage to RC Buildings and Steel Buildings is discussed in order to develop structural design methods for Tsunami Evacuation Buildings

Hiroshi FUKUYAMA

**Director, Dept. of Structural Engineering,
Building Research Institute (BRI), JAPAN**

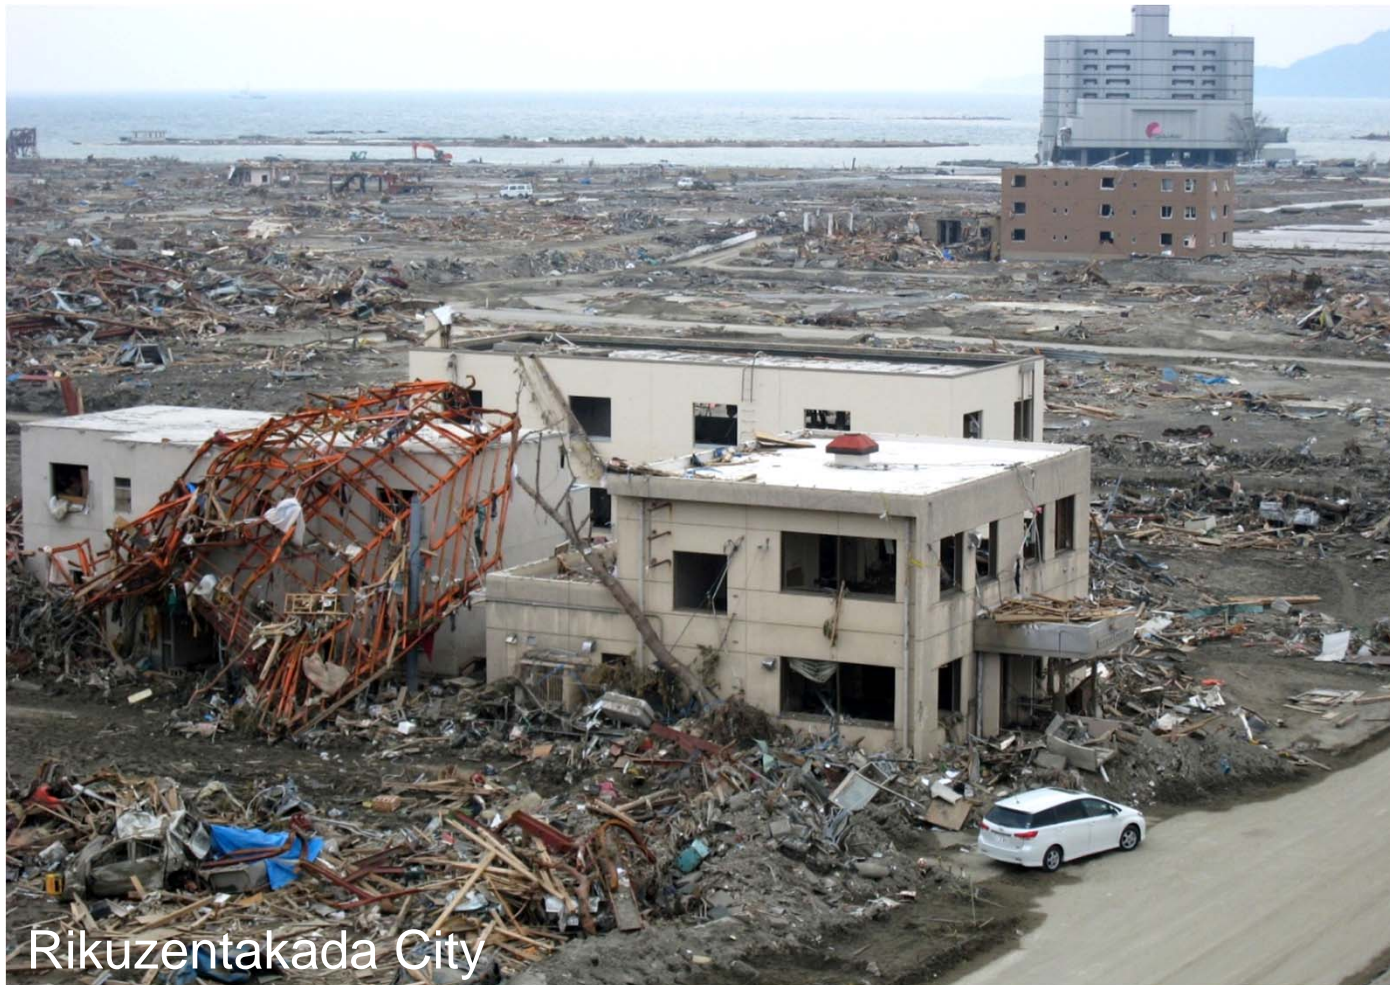
Most of RC buildings survived without any structural damage

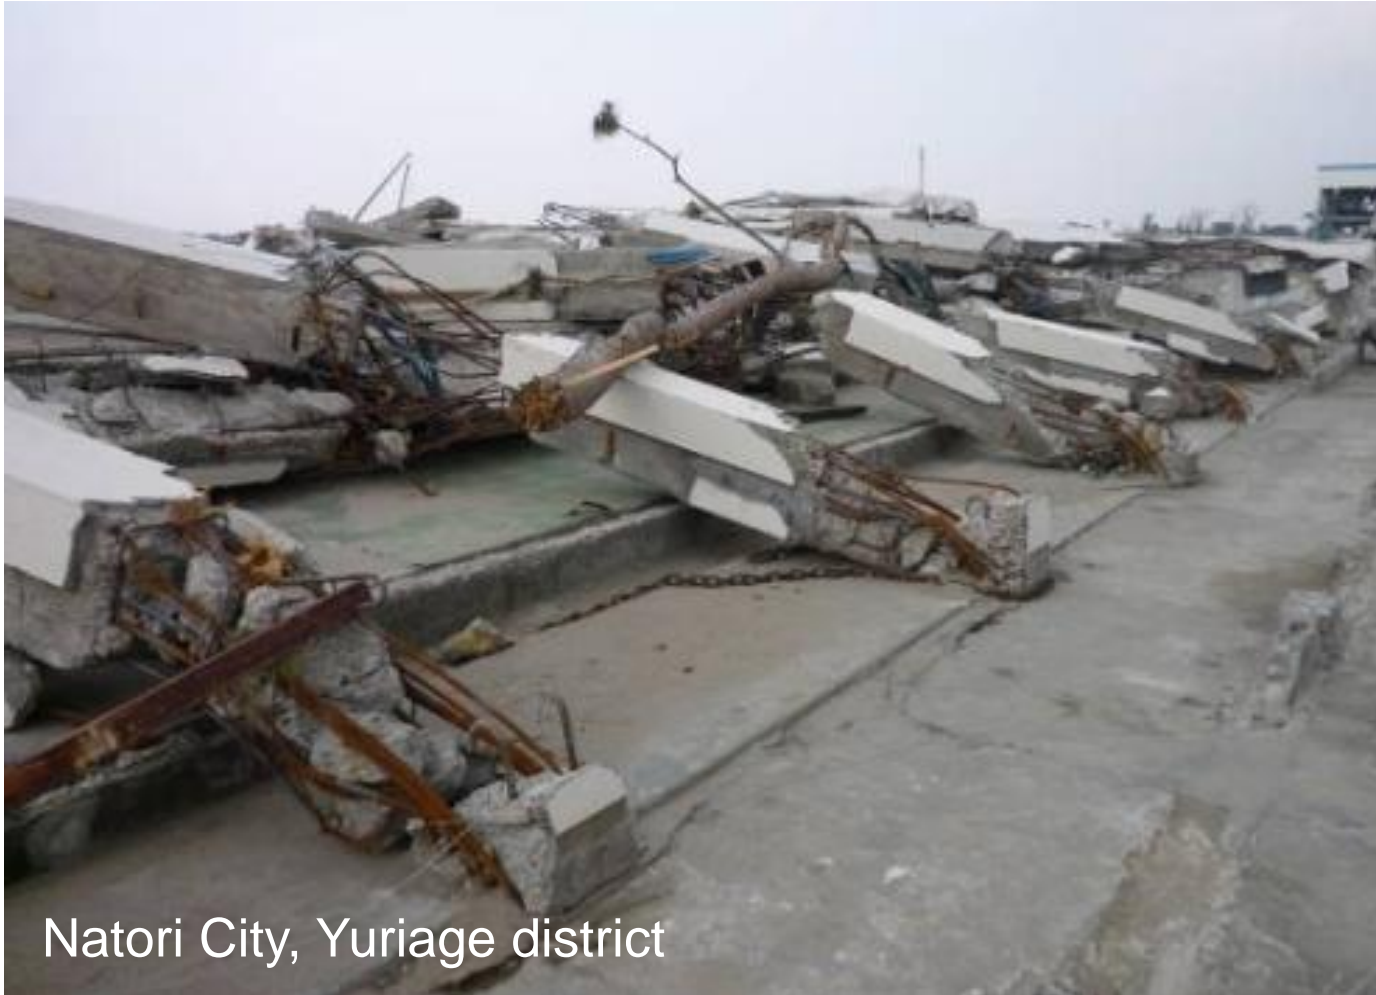
Natori City, Yuriage district

Damage to RC buildings (1) Total collapse

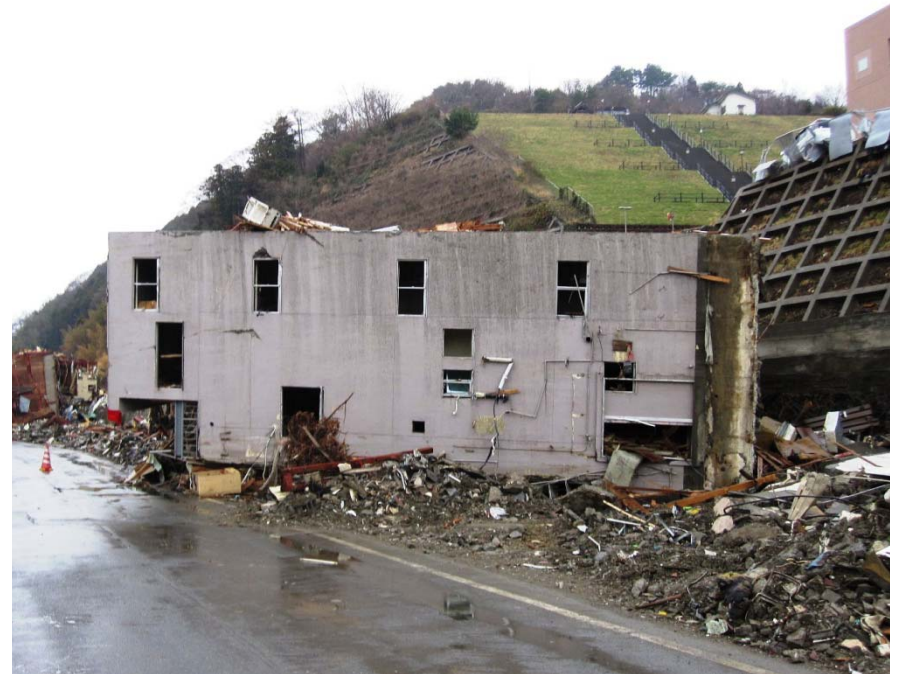
(3) Overturning

Trapped air below floor slab caused buoyant force

Overturning moment by tsunami load will never be higher than the resistance moment considering buoyancy

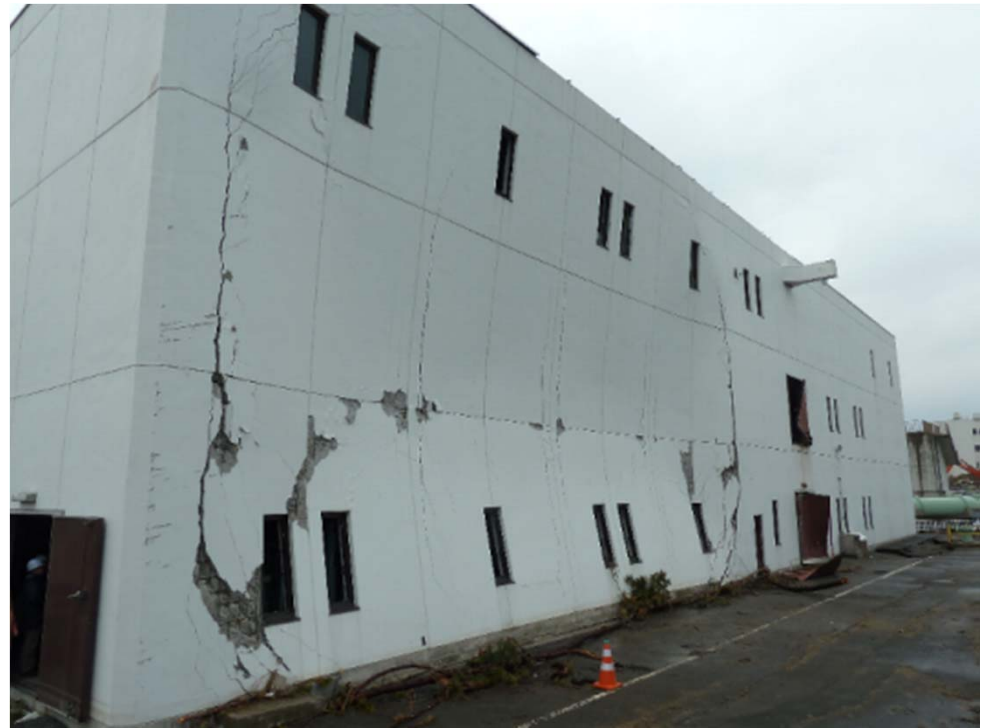
Damage to RC buildings (4) Failure of walls

A filtration plant

- Design for preventing failure of exterior elements (walls & columns)
- Design for debris impact
- Design for scour

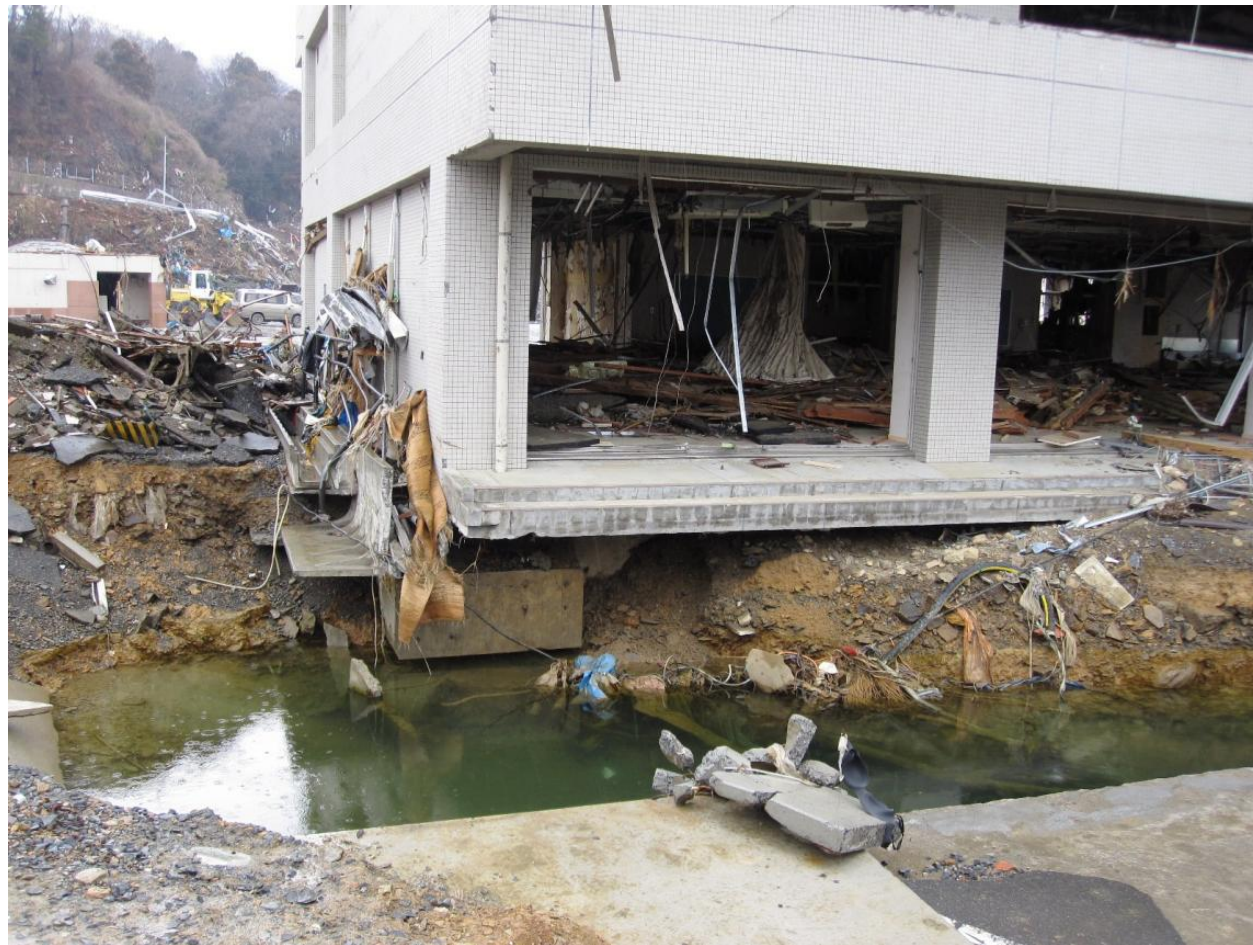
(5) Scour

Very strong stream was generated around the corner of the building, resulted in large holes on the ground

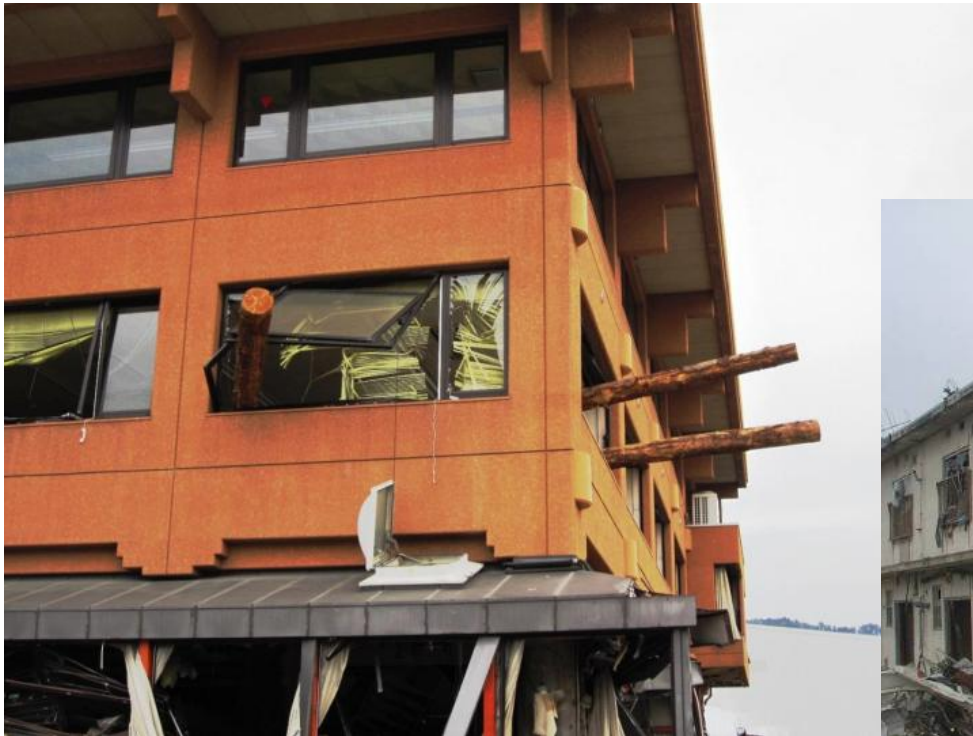
(7) Debris impact

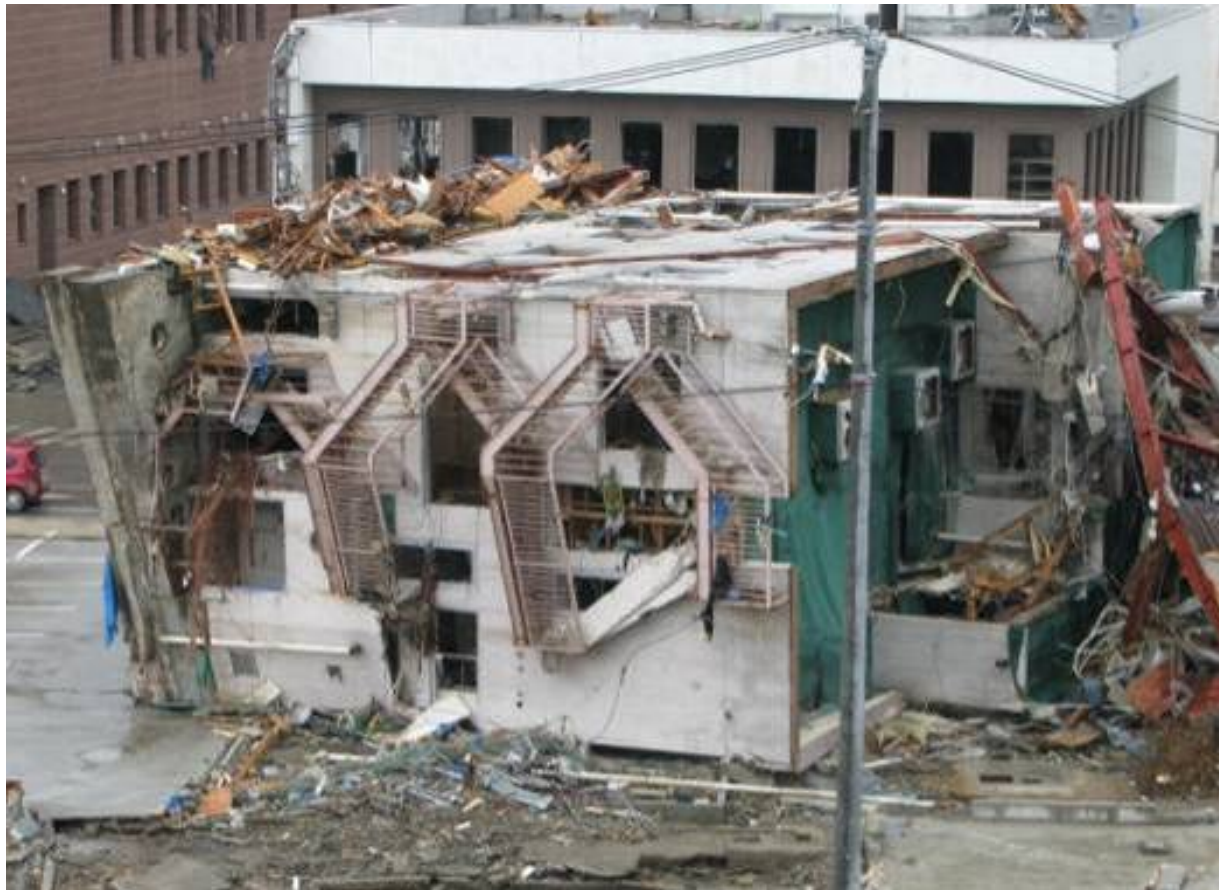
(3) Overturning

Exterior finishing was survived
Then large tsunami load and buoyancy happened

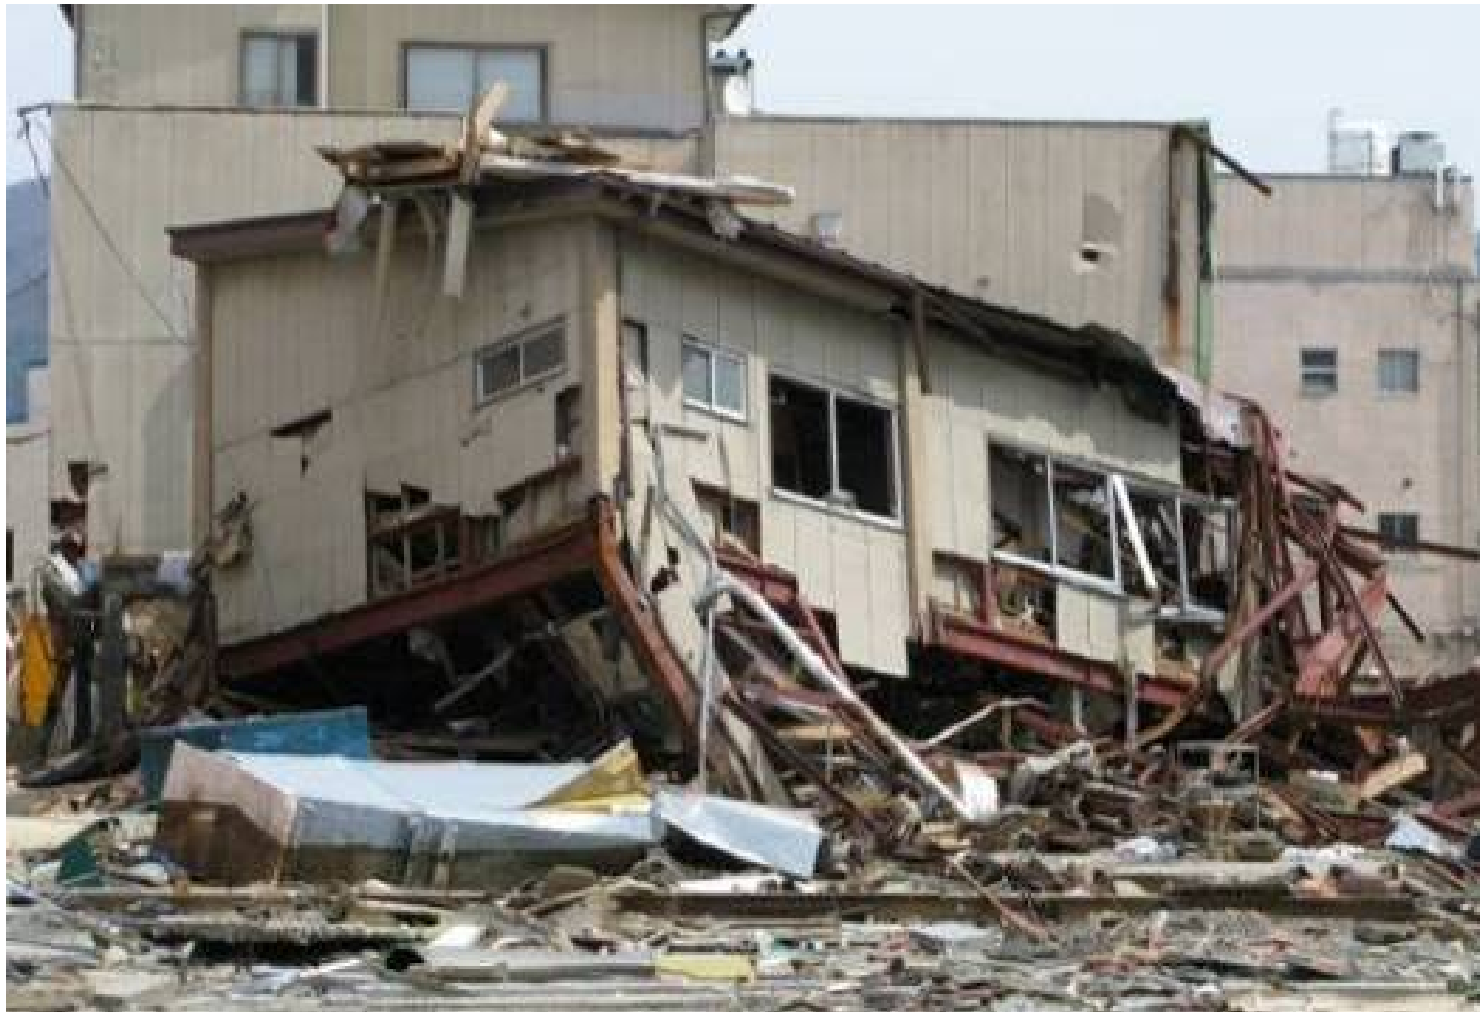
Damage to Steel buildings (6) Collapse of 1st story
