# Categorization of Damage to Buildings Caused by the 3.11 Tsunami

Damage to RC Buildings and Steel Buildings is discussed in order to develop structural design methods for Tsunami Evacuation Buildings

**Hiroshi FUKUYAMA**

**Director, Dept. of Structural Engineering,  
Building Research Institute (BRI), JAPAN**

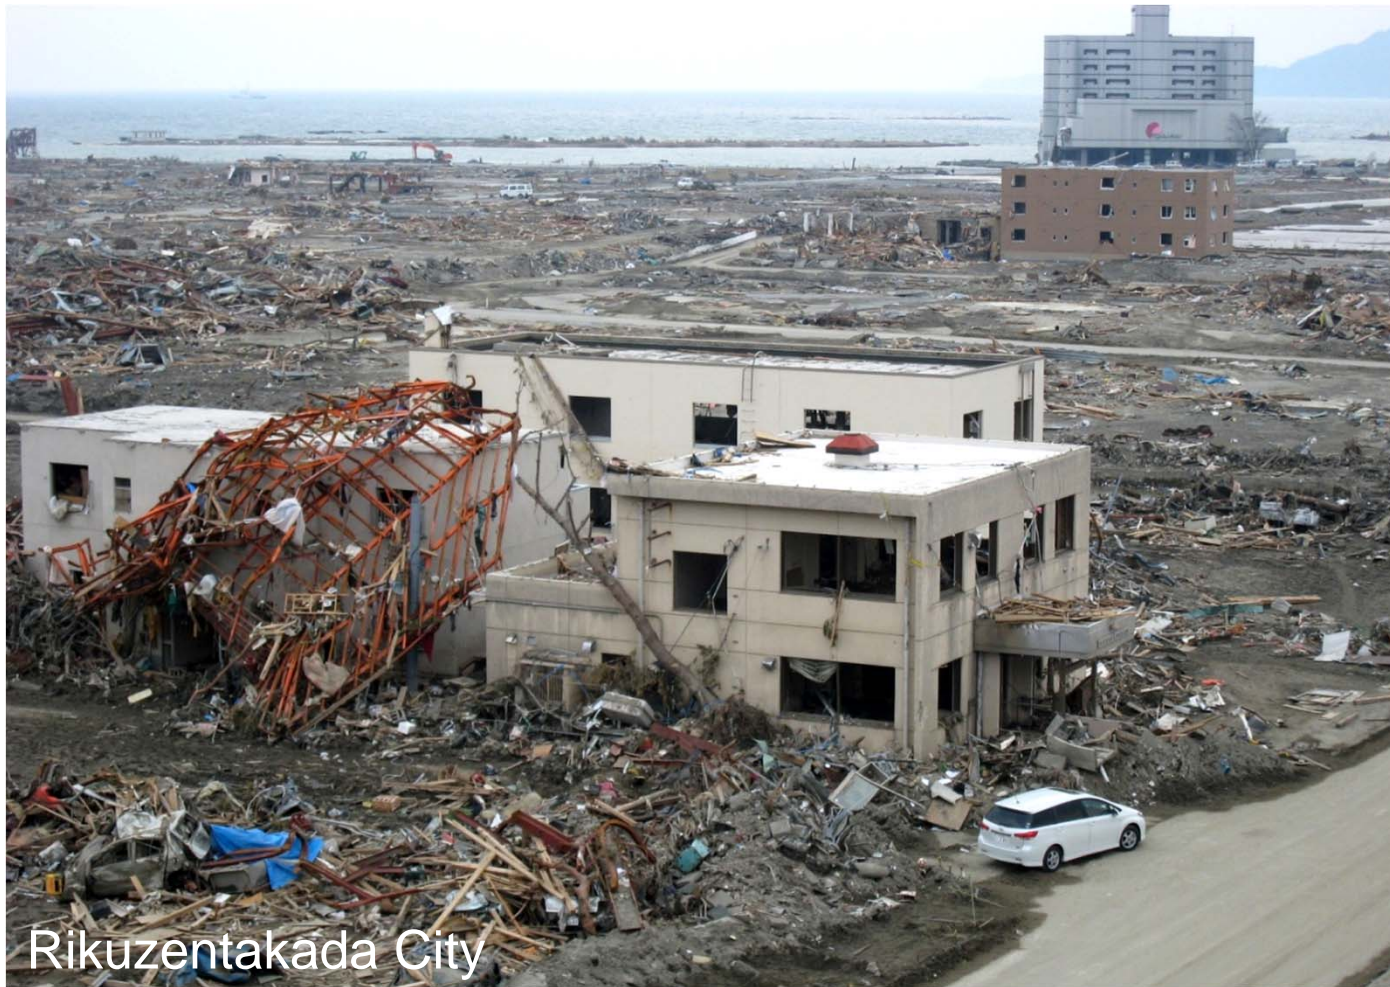
# Most of RC buildings survived without any structural damage

- ▪ ▪ However, severe damage were observed in a part of RC Buildings

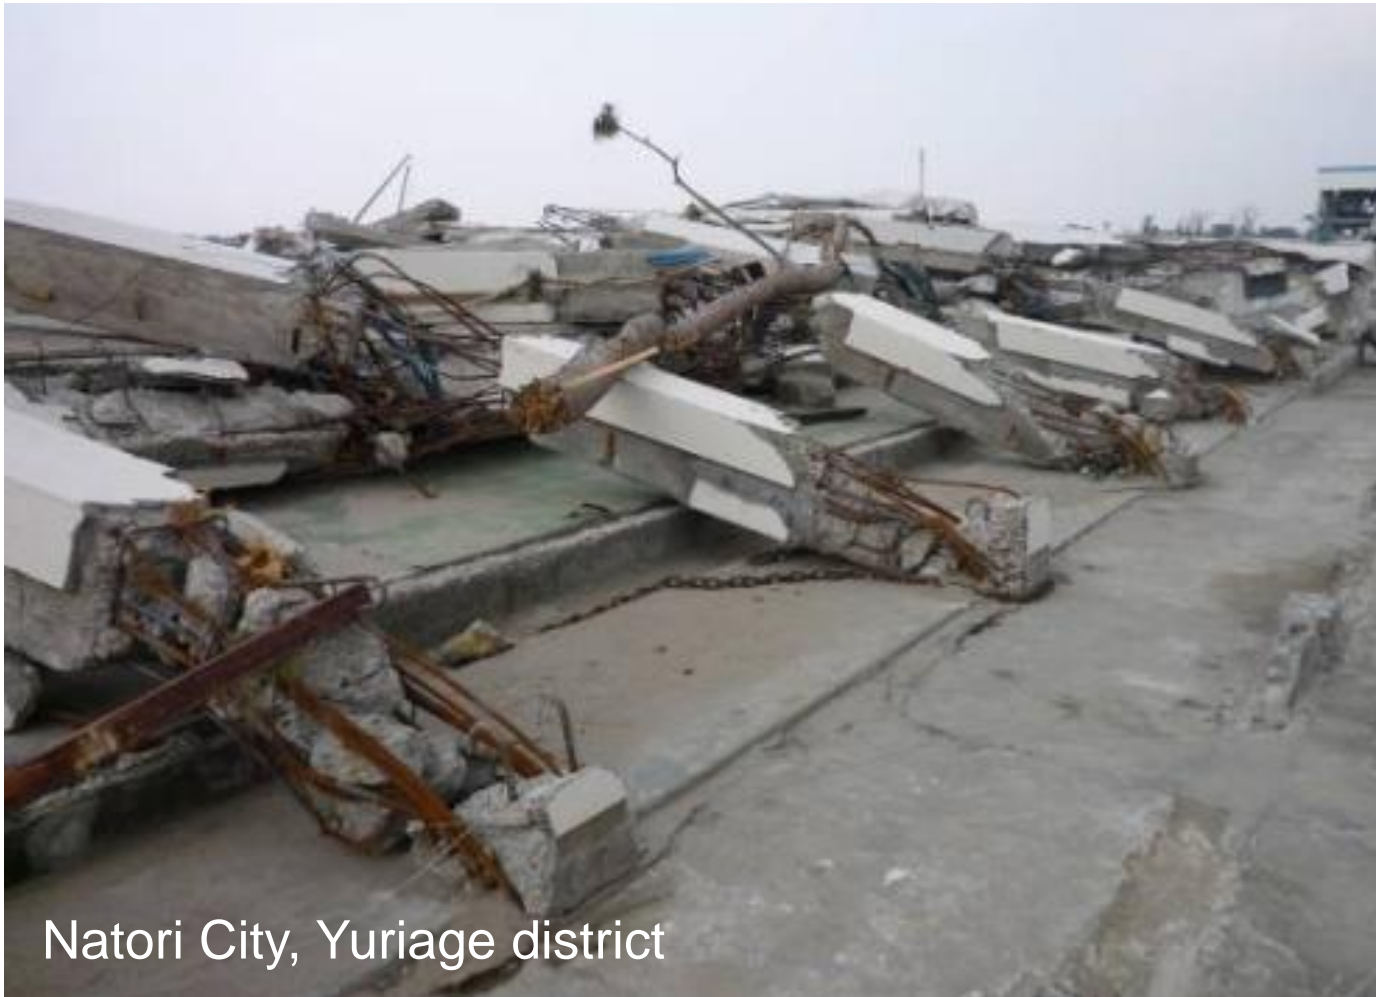
Natori City, Yuriage district

# Damage to RC buildings (1) Total collapse

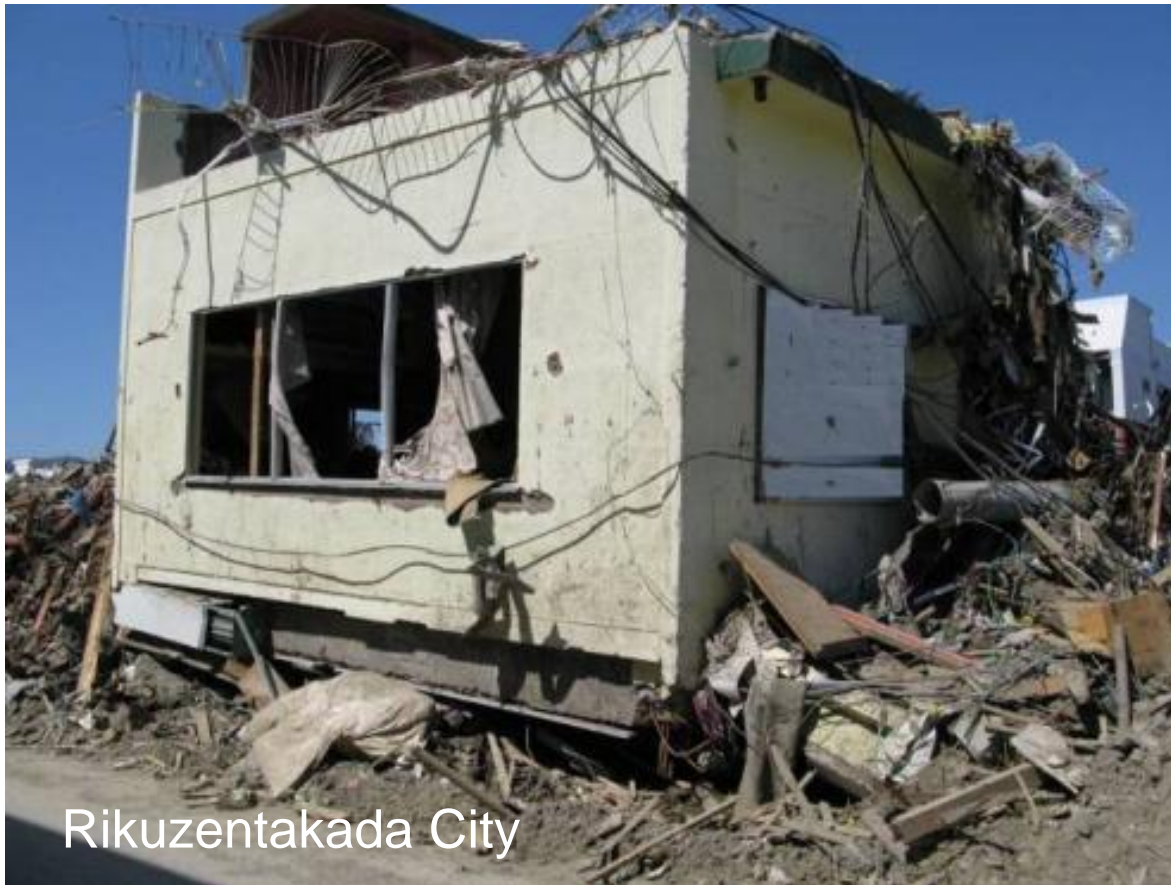
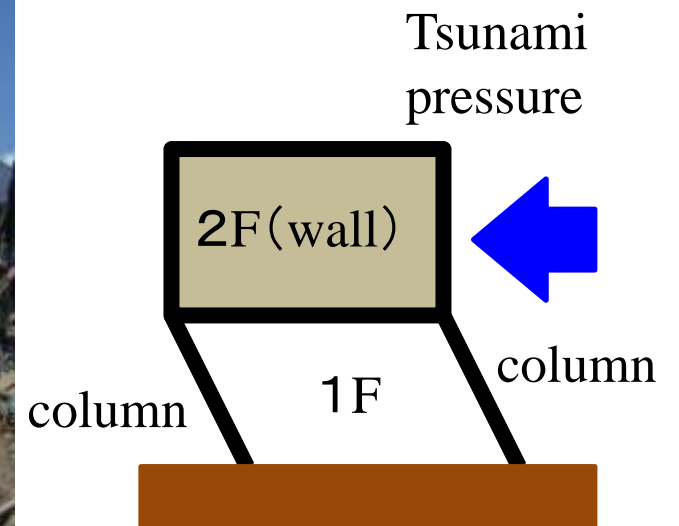
## Damage to RC buildings (2) Collapse of 1<sup>st</sup> story

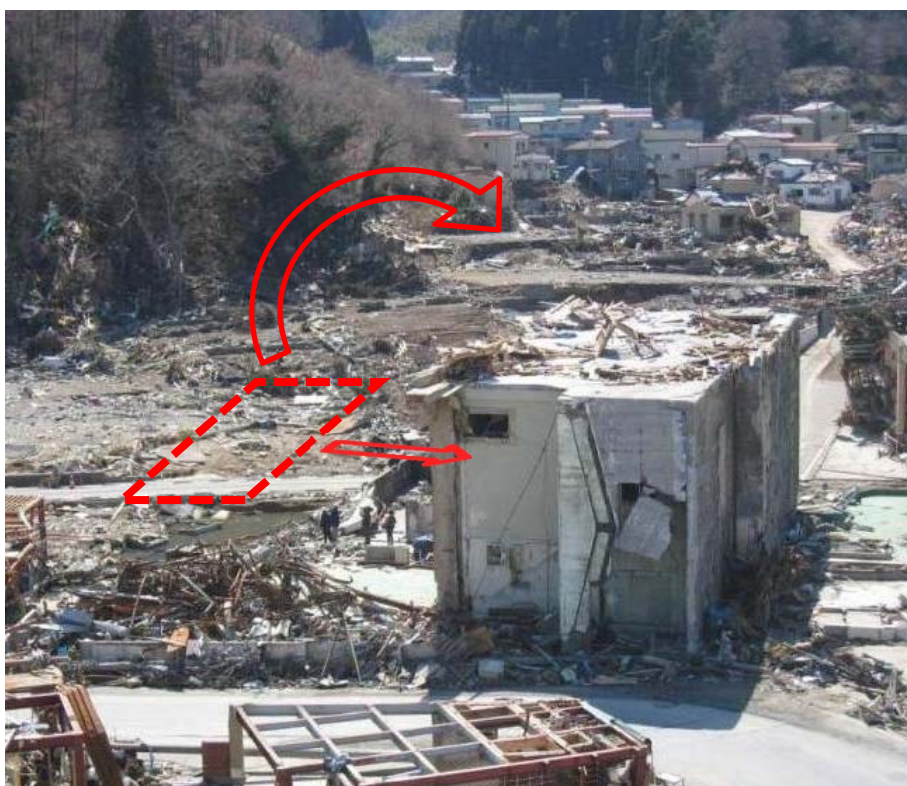
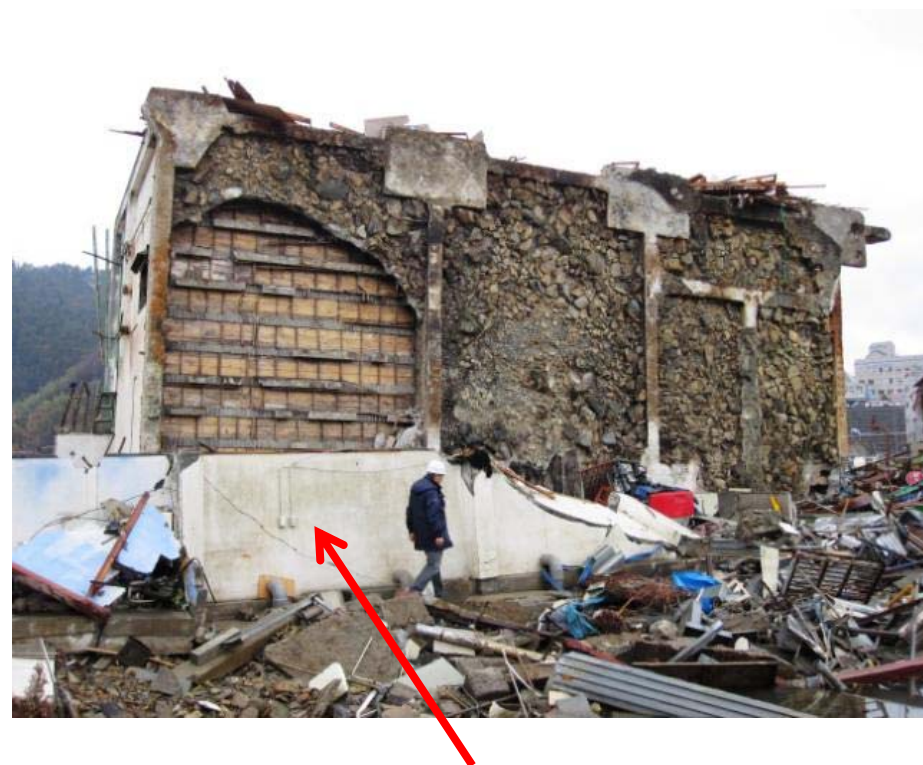
## Damage to RC buildings (3) Overturning

Refrigerated warehouse got over the fence

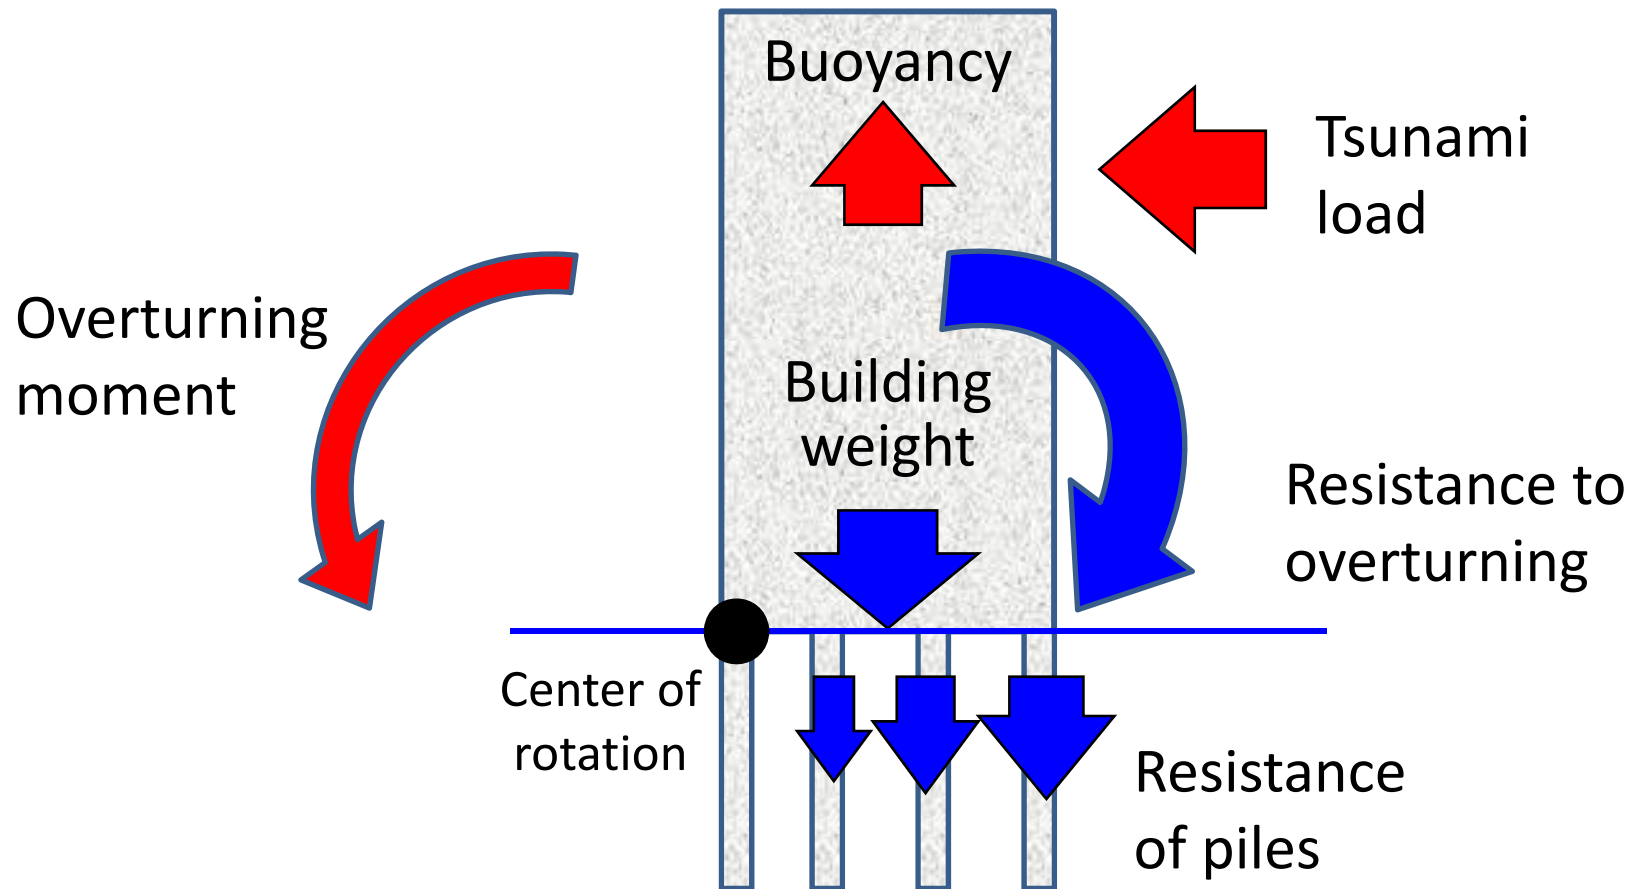
# Mechanism of overturning

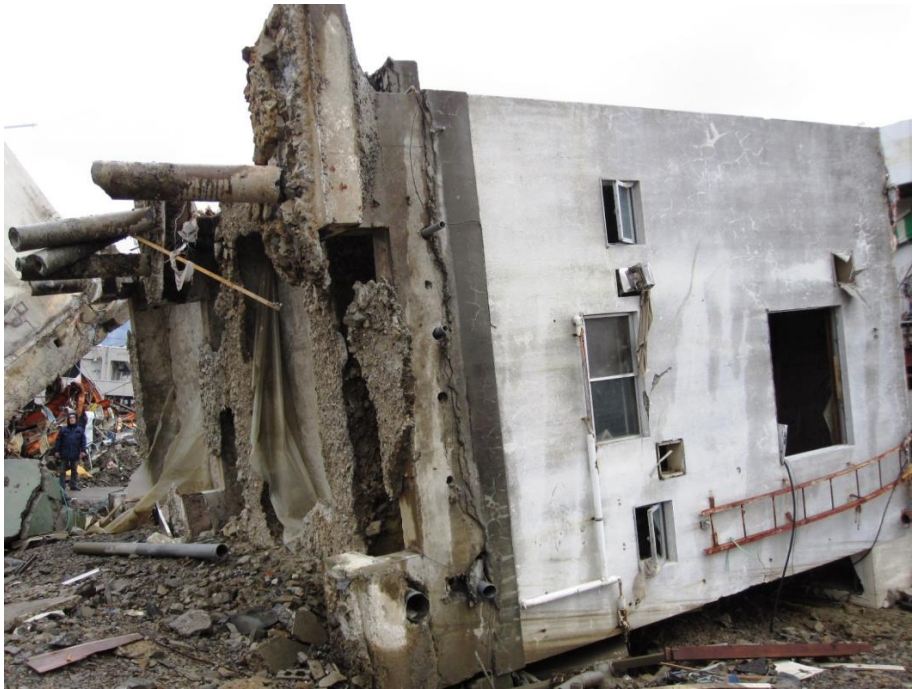
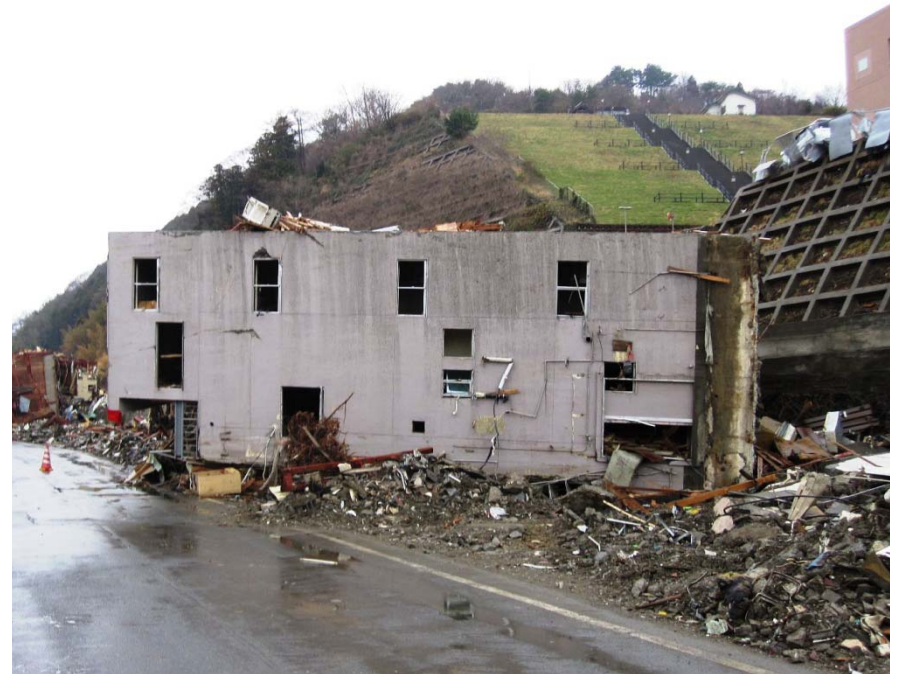
## (3) Overturning

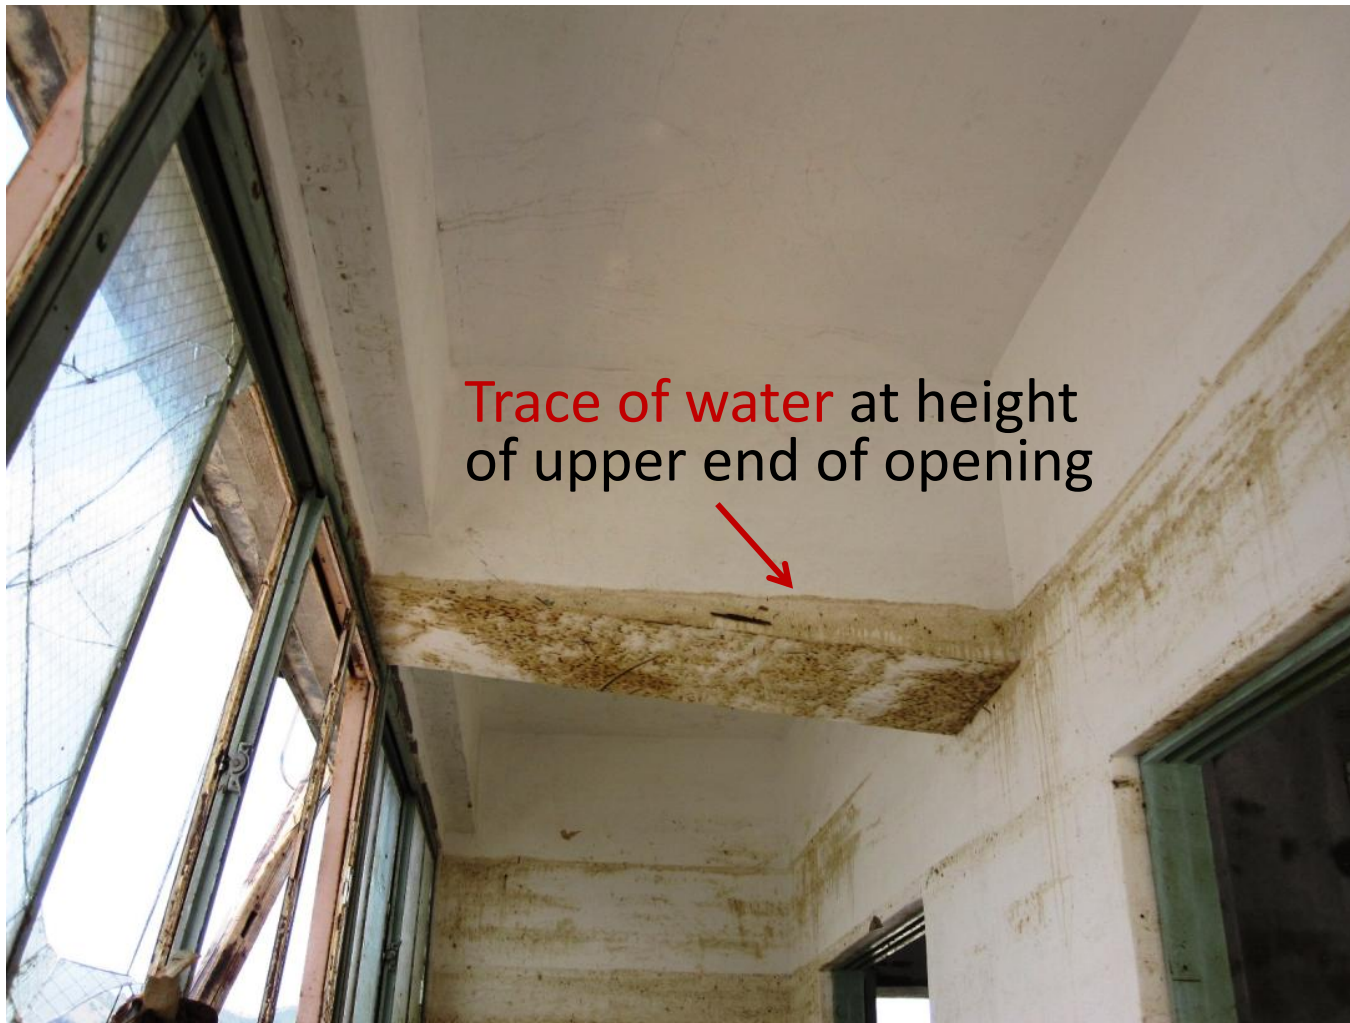
# Trapped air below floor slab caused buoyant force

The building was submerged completely

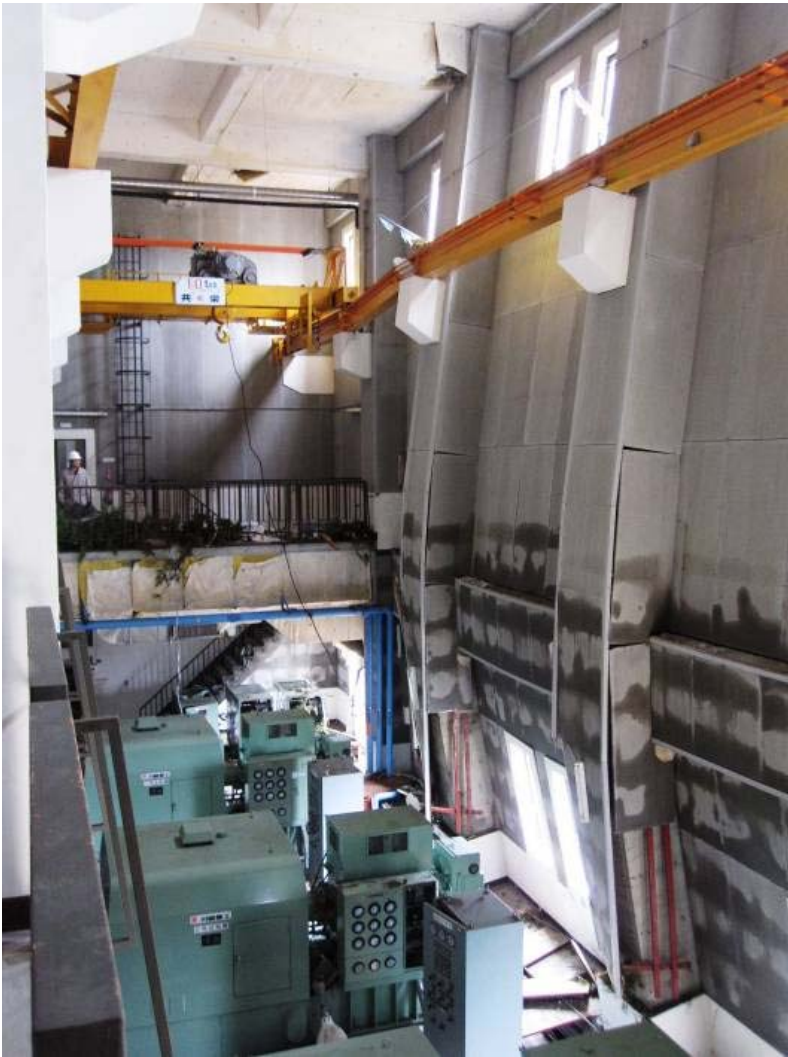
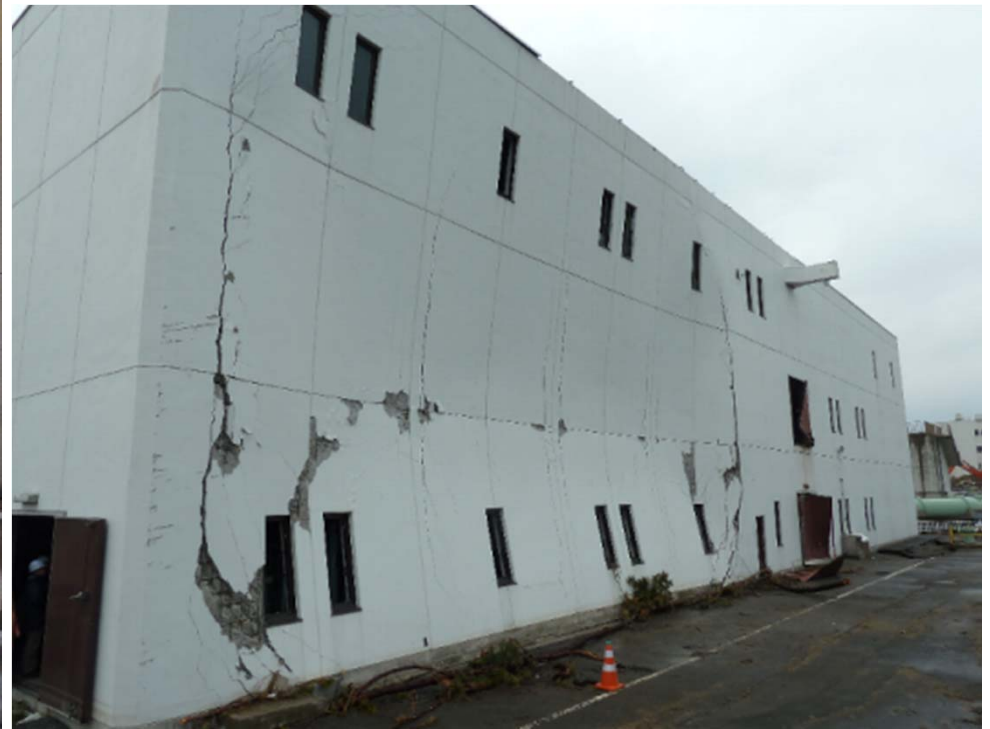
A filtration plant

## Damage to RC buildings (4) Failure of walls

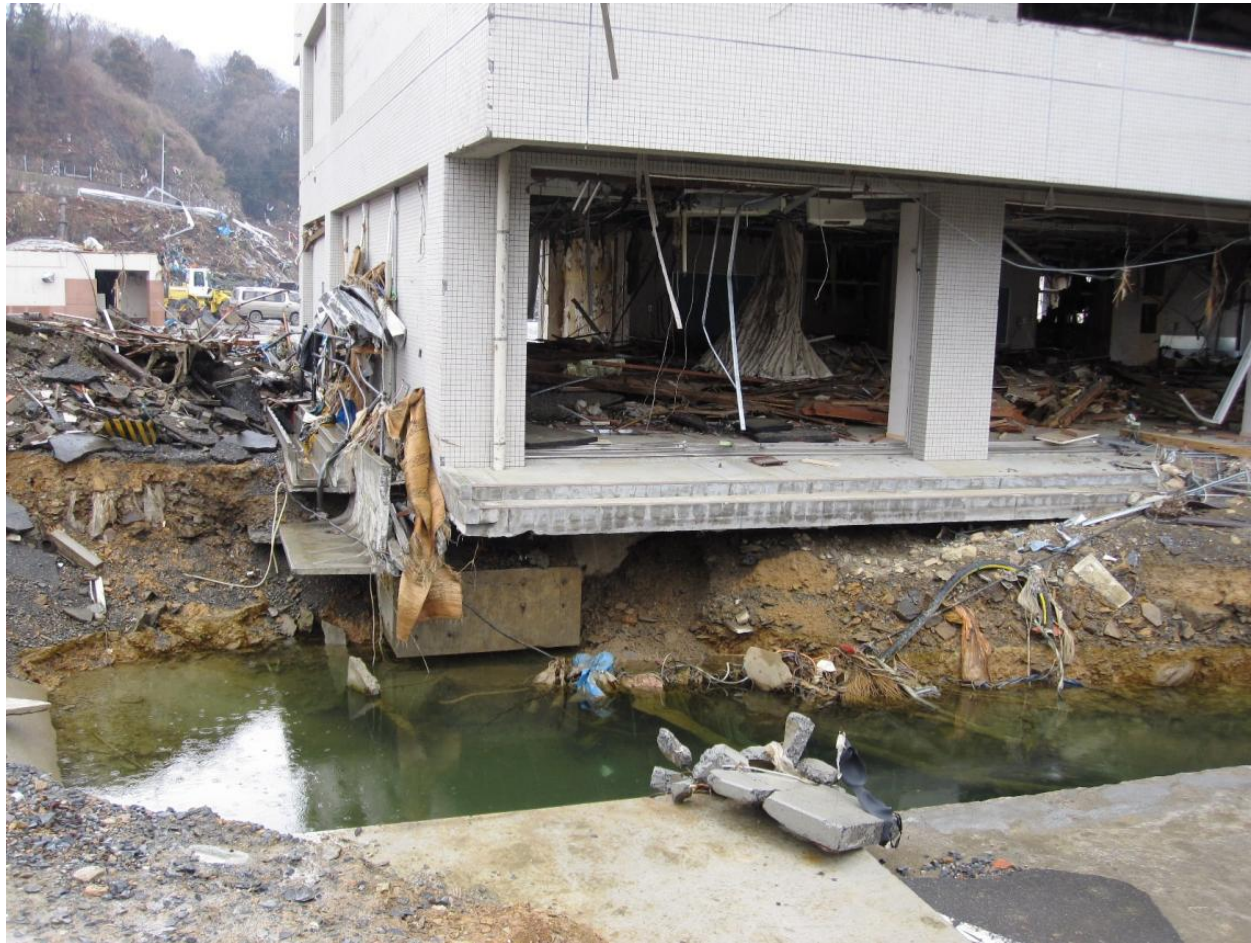
## Damage to RC buildings (5) Scour

Very strong stream was generated around the corner of the building, resulted in large holes on the ground

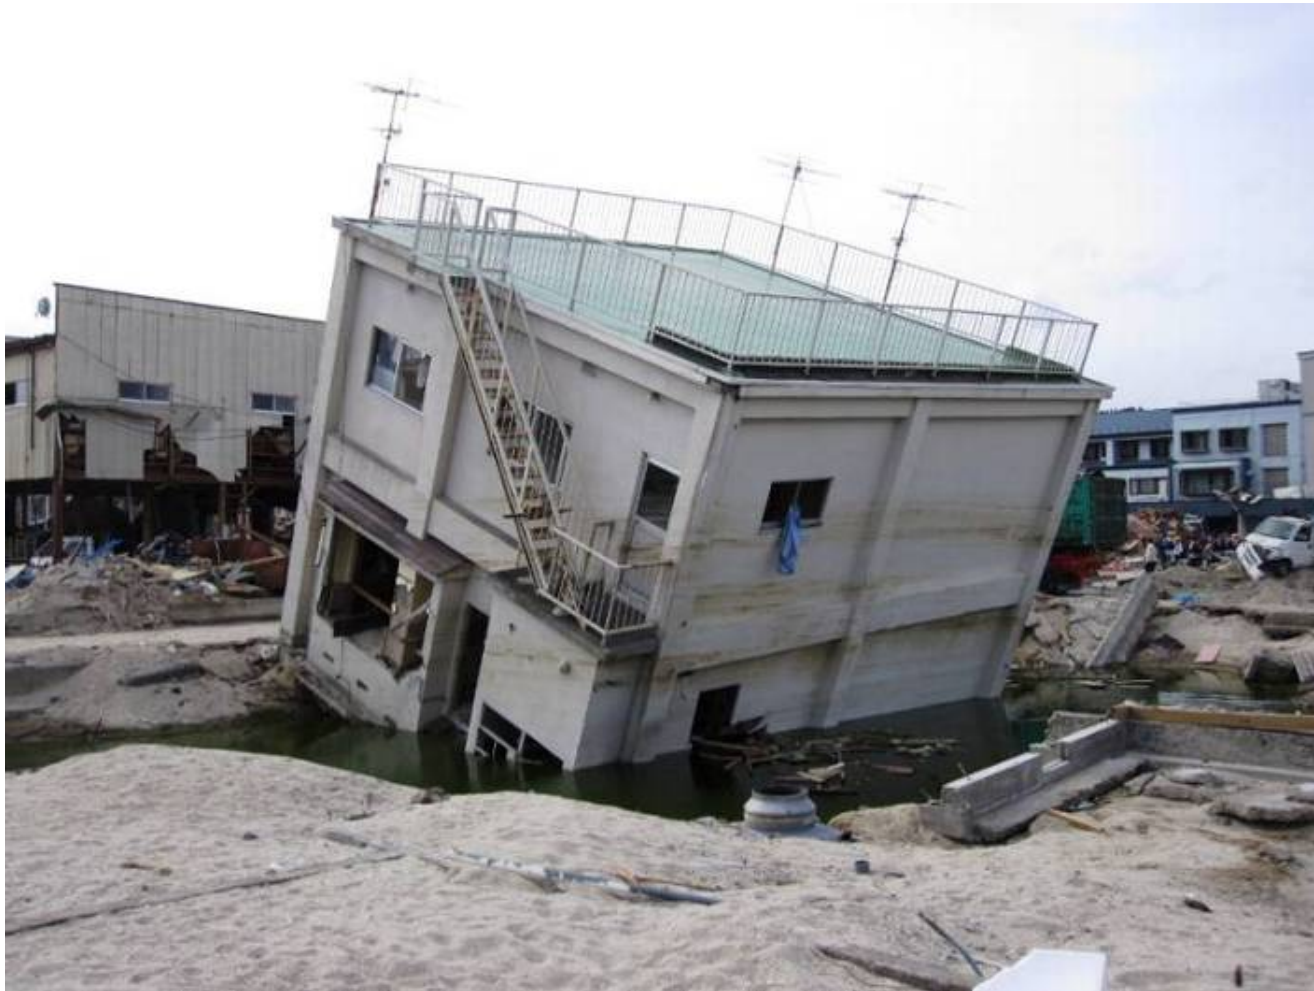
## Damage to RC buildings (5) Scour & Tilting

In case of mat foundation

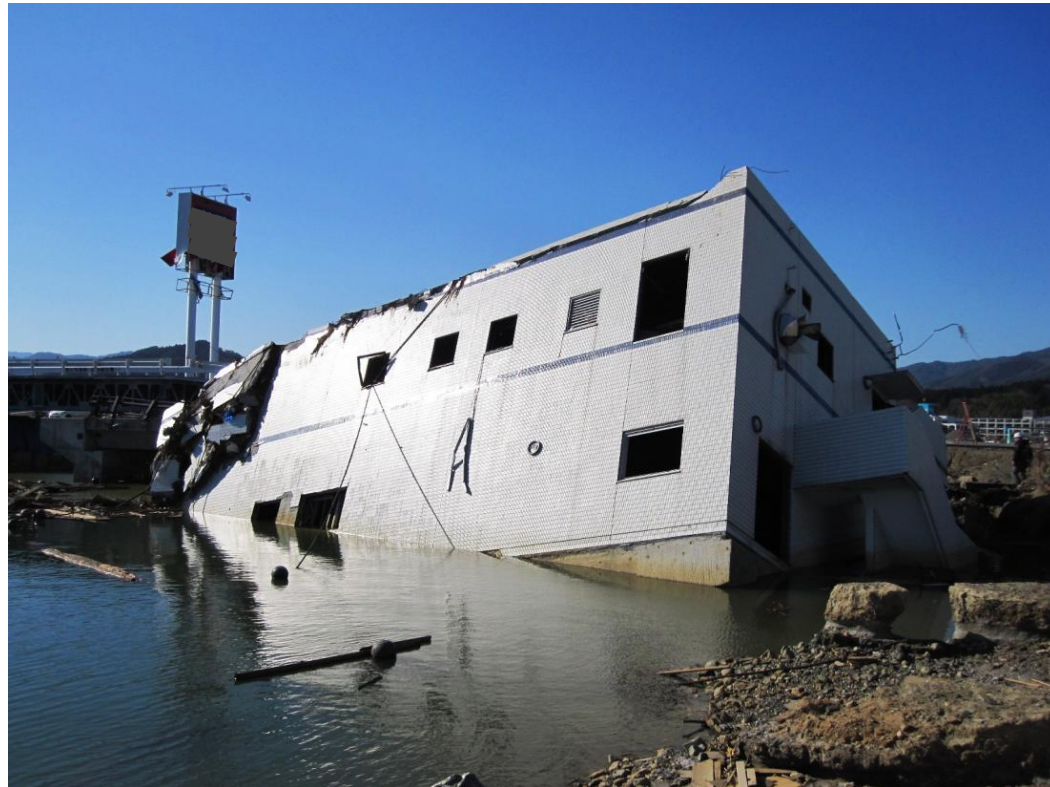
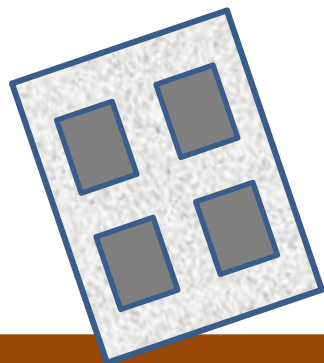
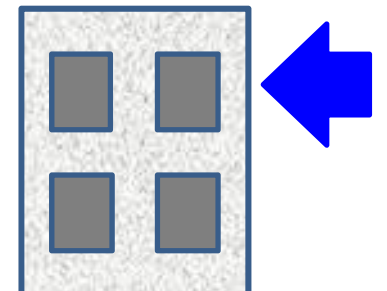
# Damage to RC buildings (6) Sliding

Tsunami pressure

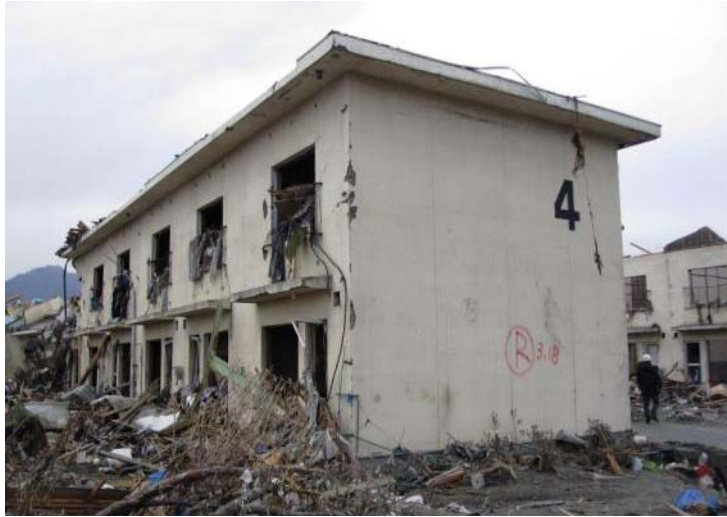
# Overturning, Sliding & Washing away

Survived

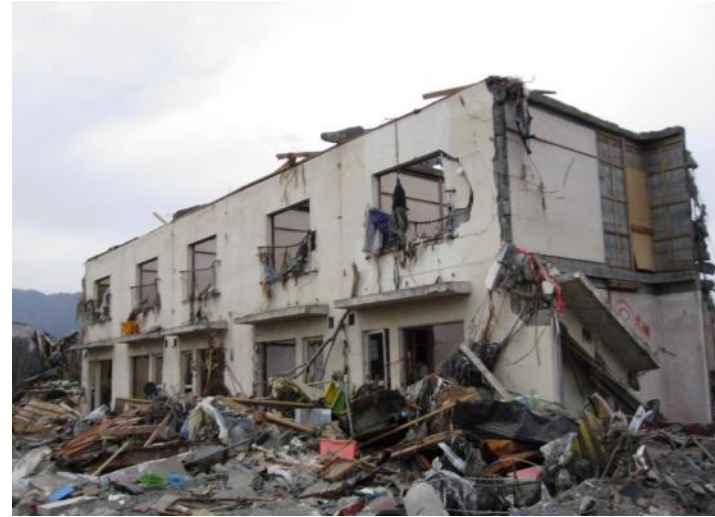
Partially damaged

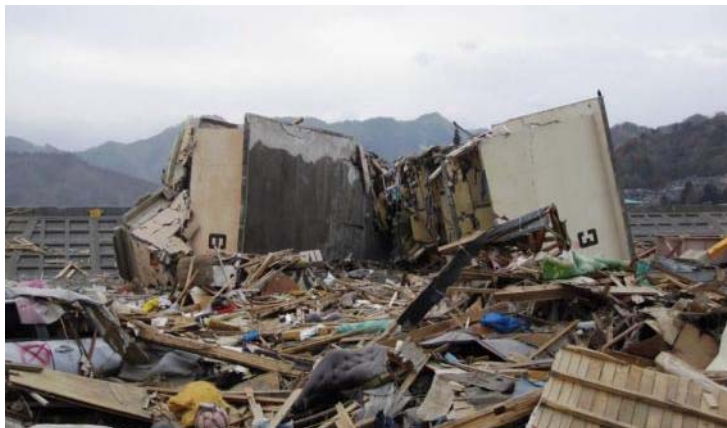
Overturned

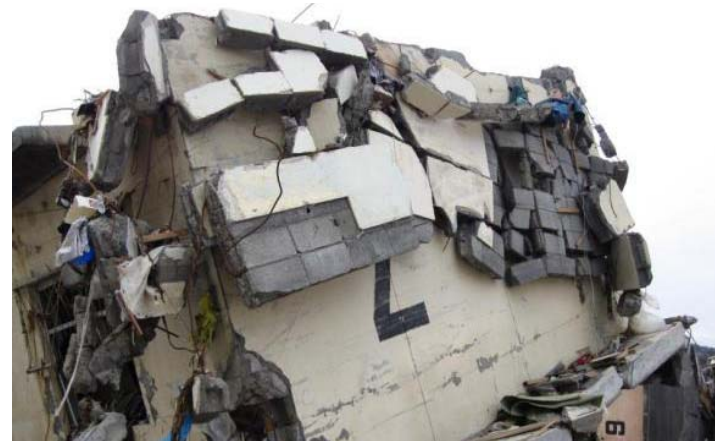
Overturned (upset)

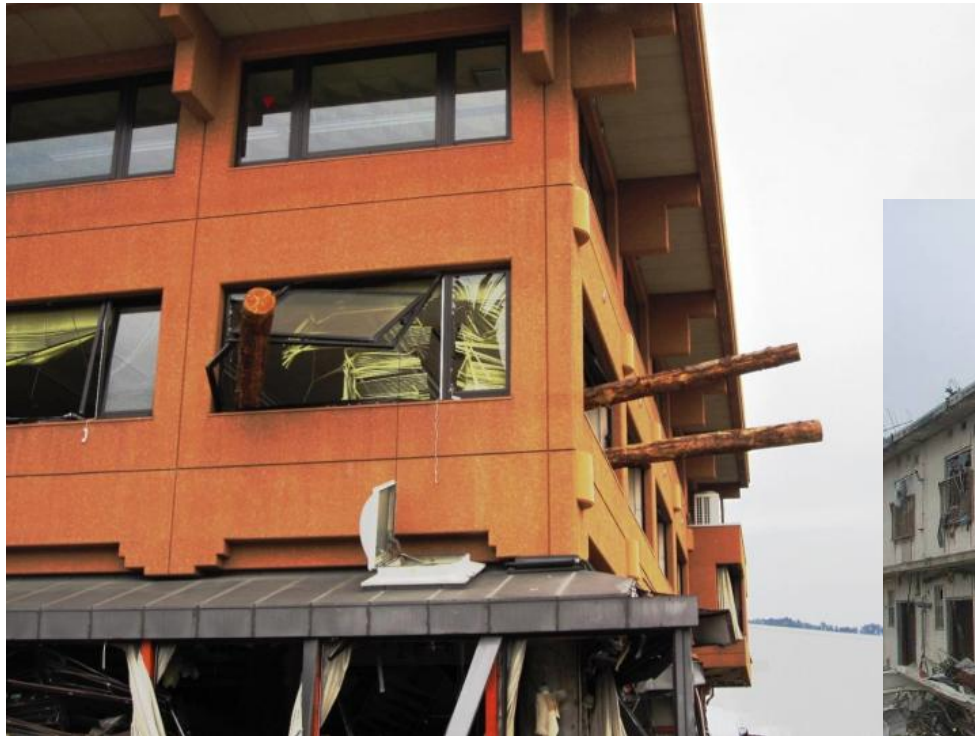
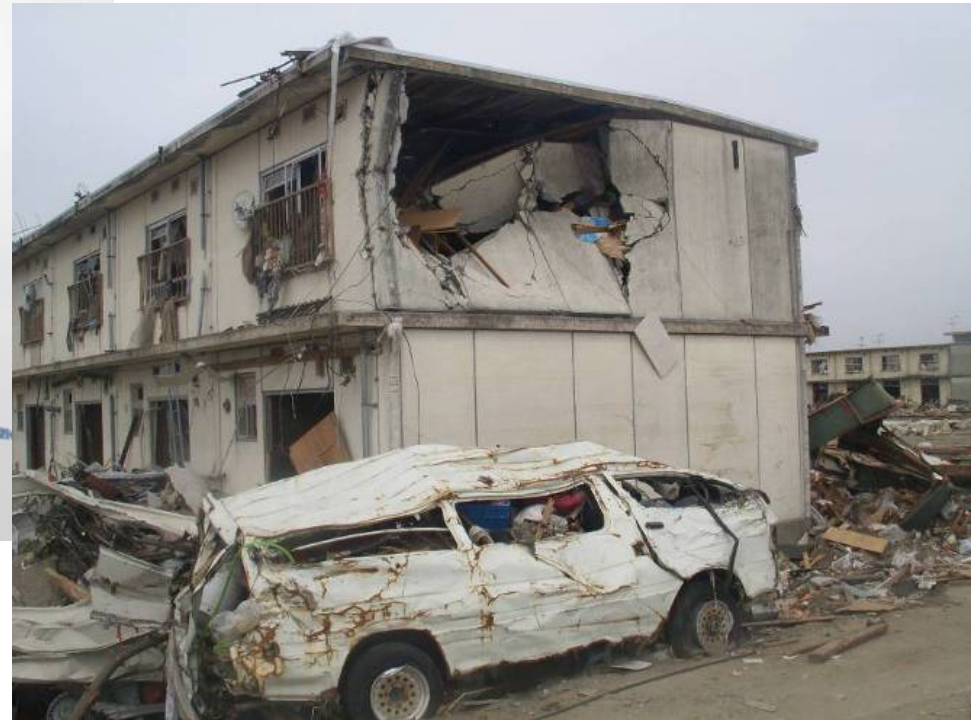
## (7) Debris impact

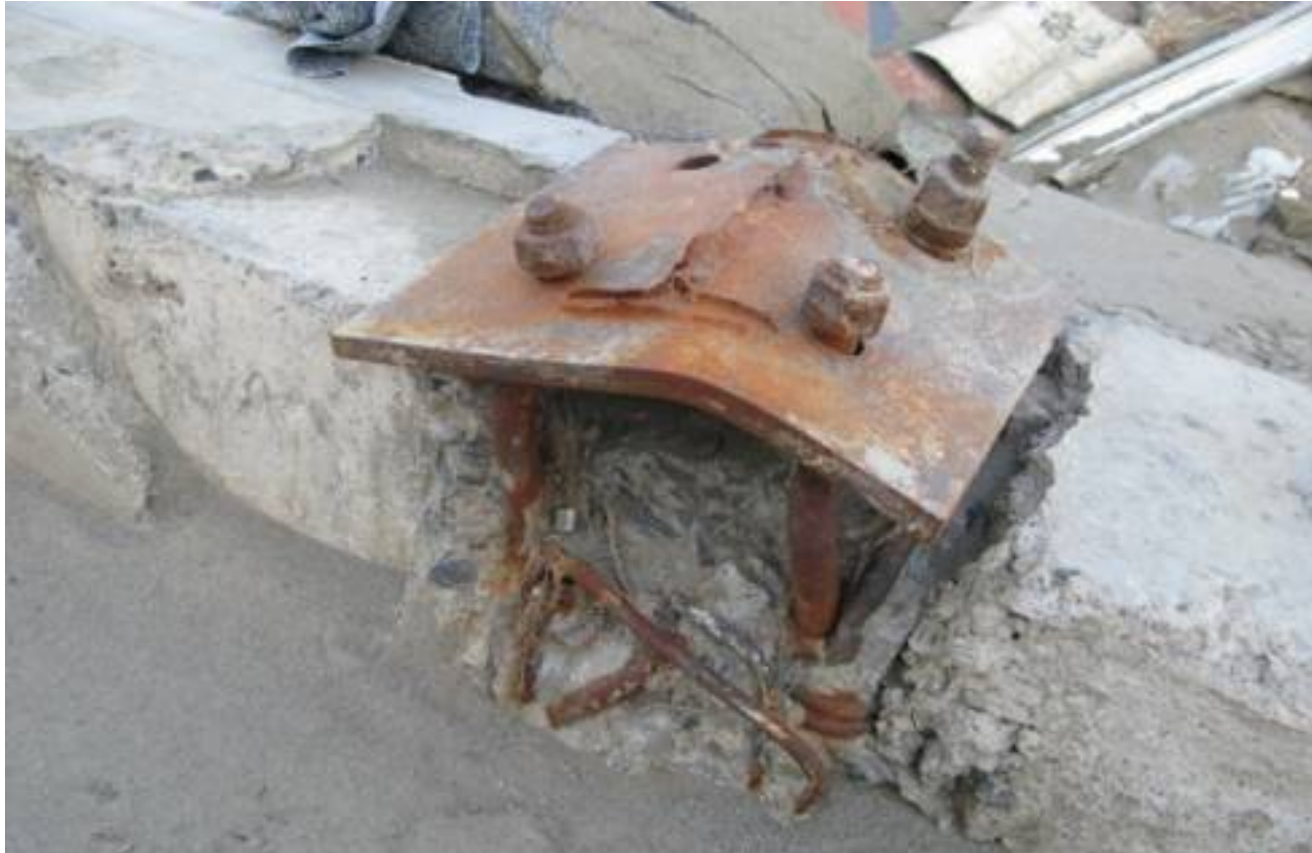
## (1) Failure of exposed column

Rupture of anchor bolt, base-plate or welding part between column and base-plate

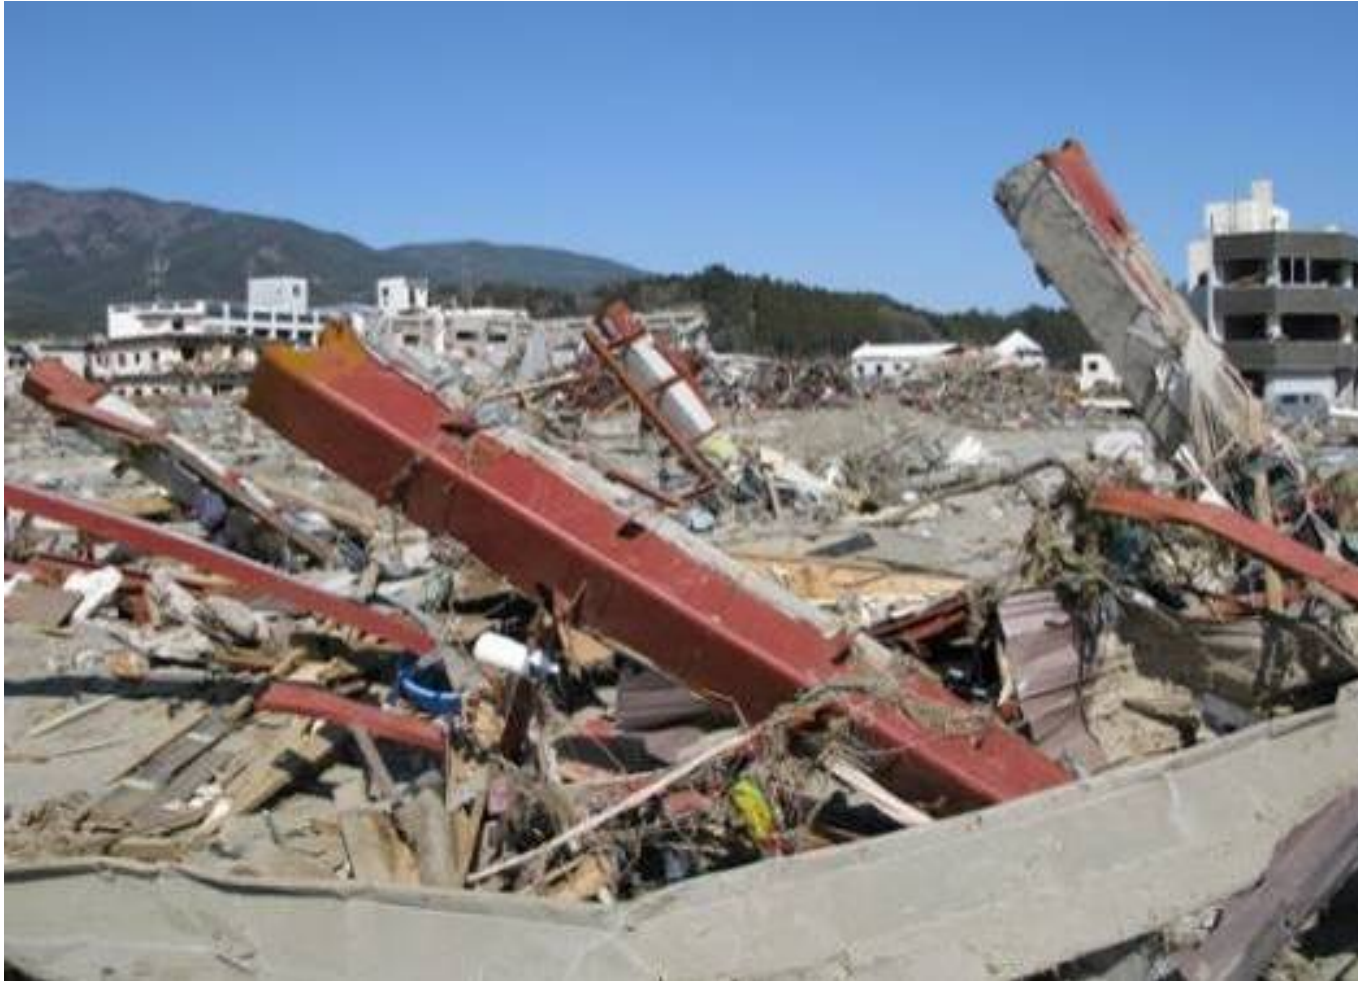
## (2) Failure of column top connection

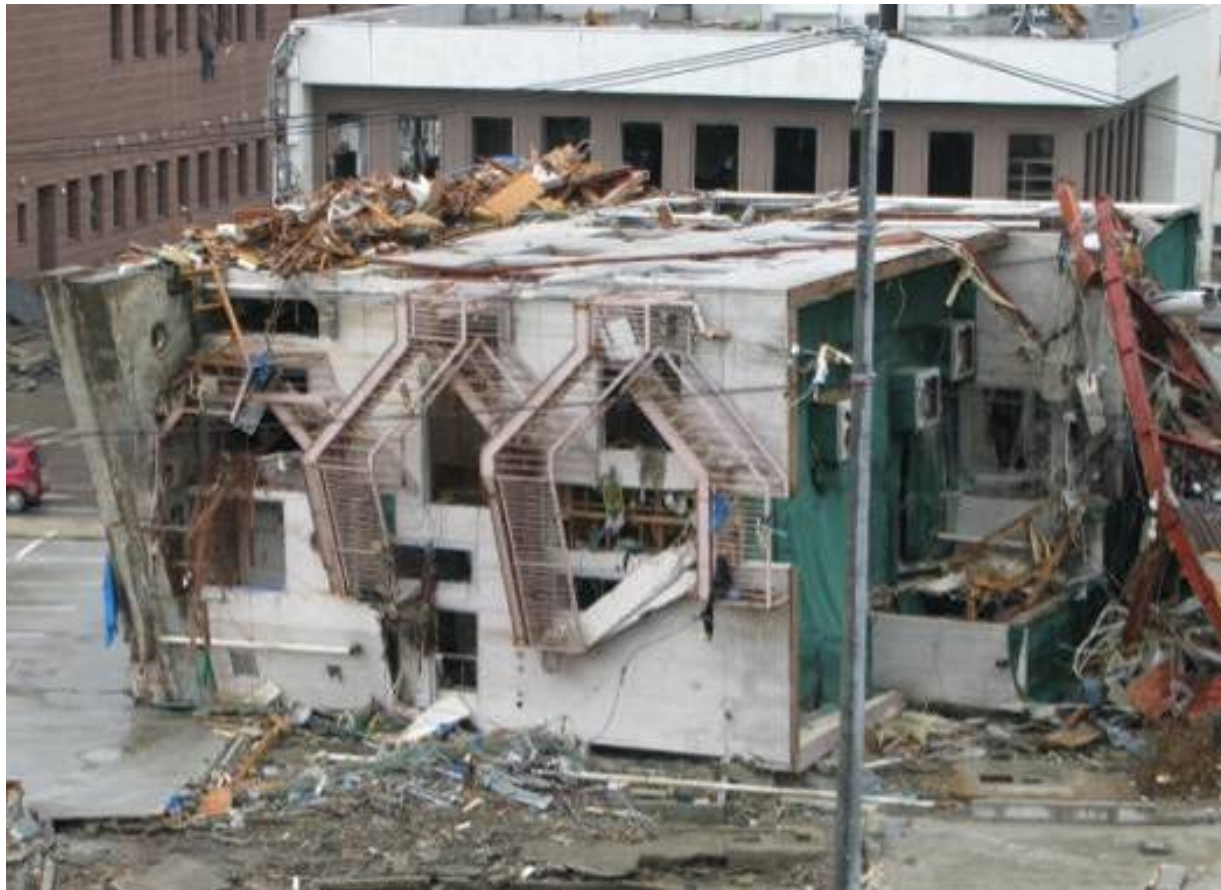
## Damage to Steel buildings (3) Overturning

Exterior finishing was survived  
Then large tsunami load and buoyancy happened

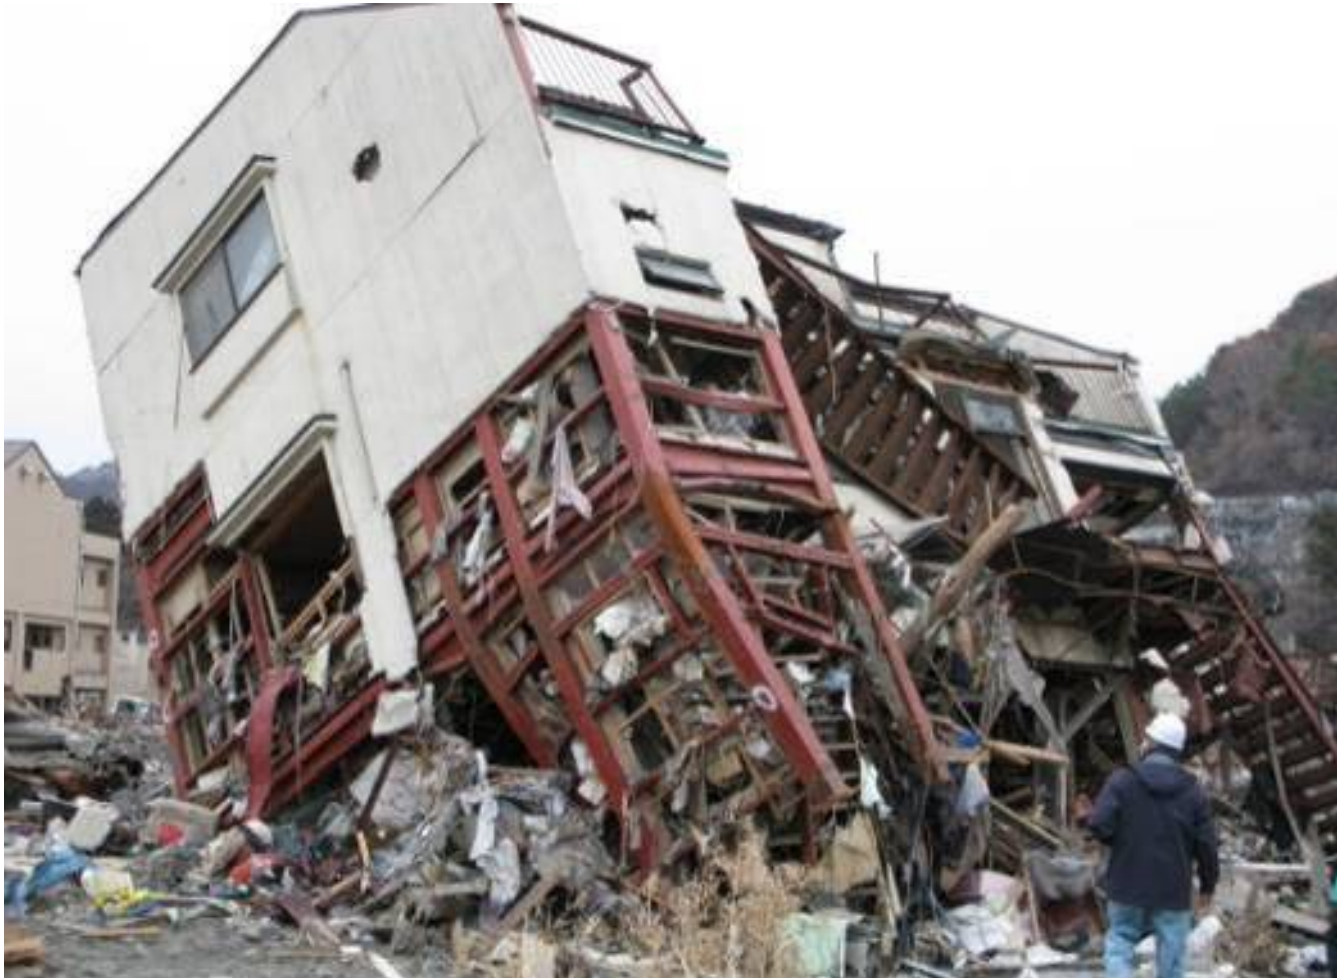
## Overturning due to rupture of anchor bolt and buckling of 1<sup>st</sup> story columns
