# Categorization of Damage to Buildings Caused by the 3.11 Tsunami

Damage to RC Buildings and Steel Buildings is discussed in order to develop structural design methods for Tsunami Evacuation Buildings

**Hiroshi FUKUYAMA**

**Director, Dept. of Structural Engineering,  
Building Research Institute (BRI), JAPAN**

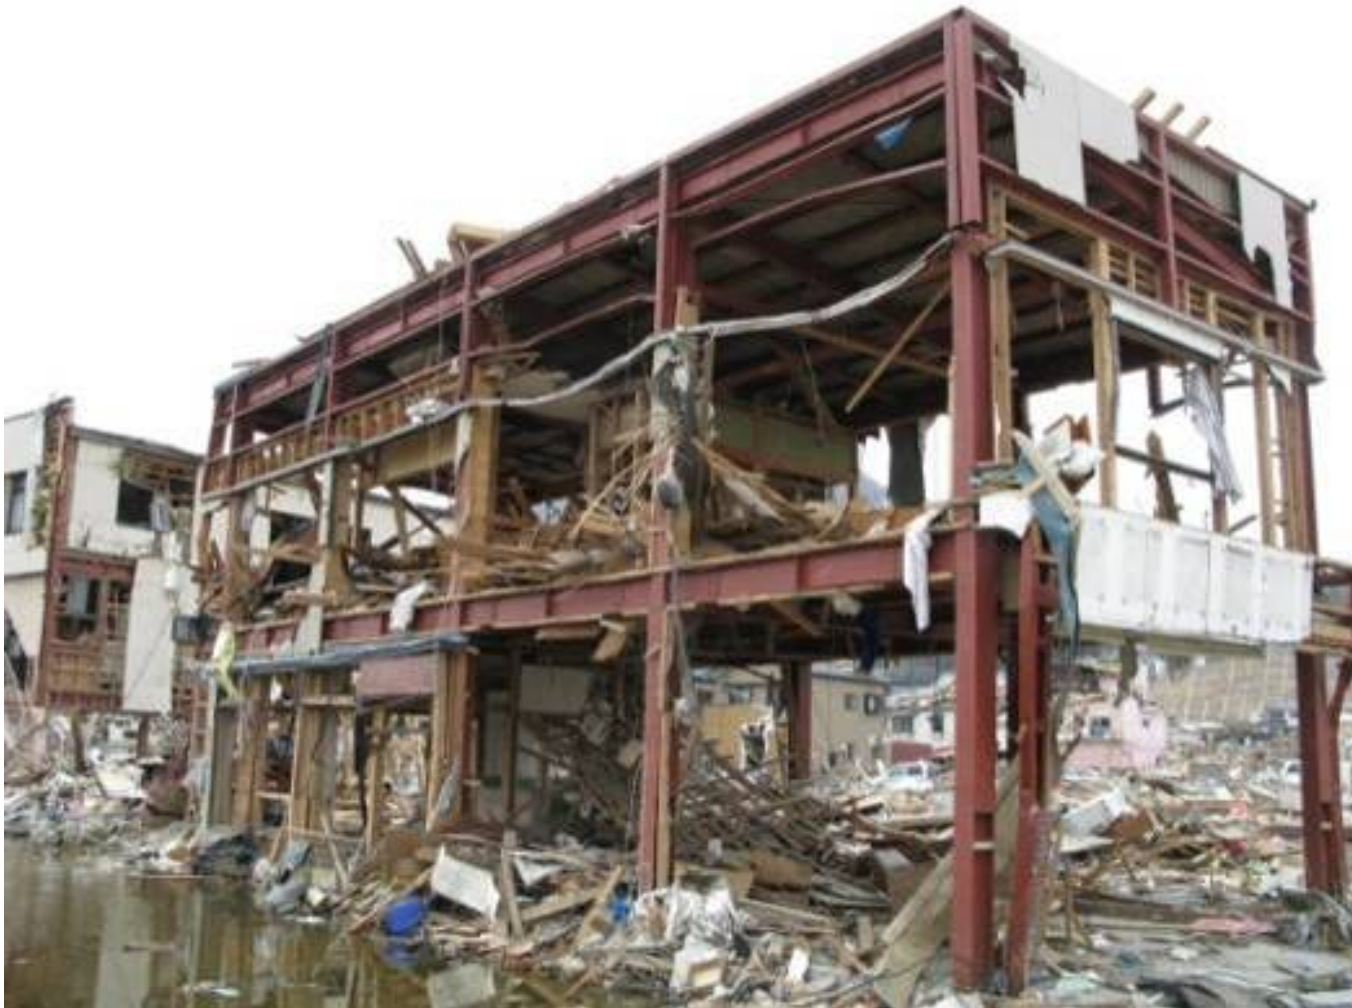
## Damage to Steel buildings (4) Washed away of finishing

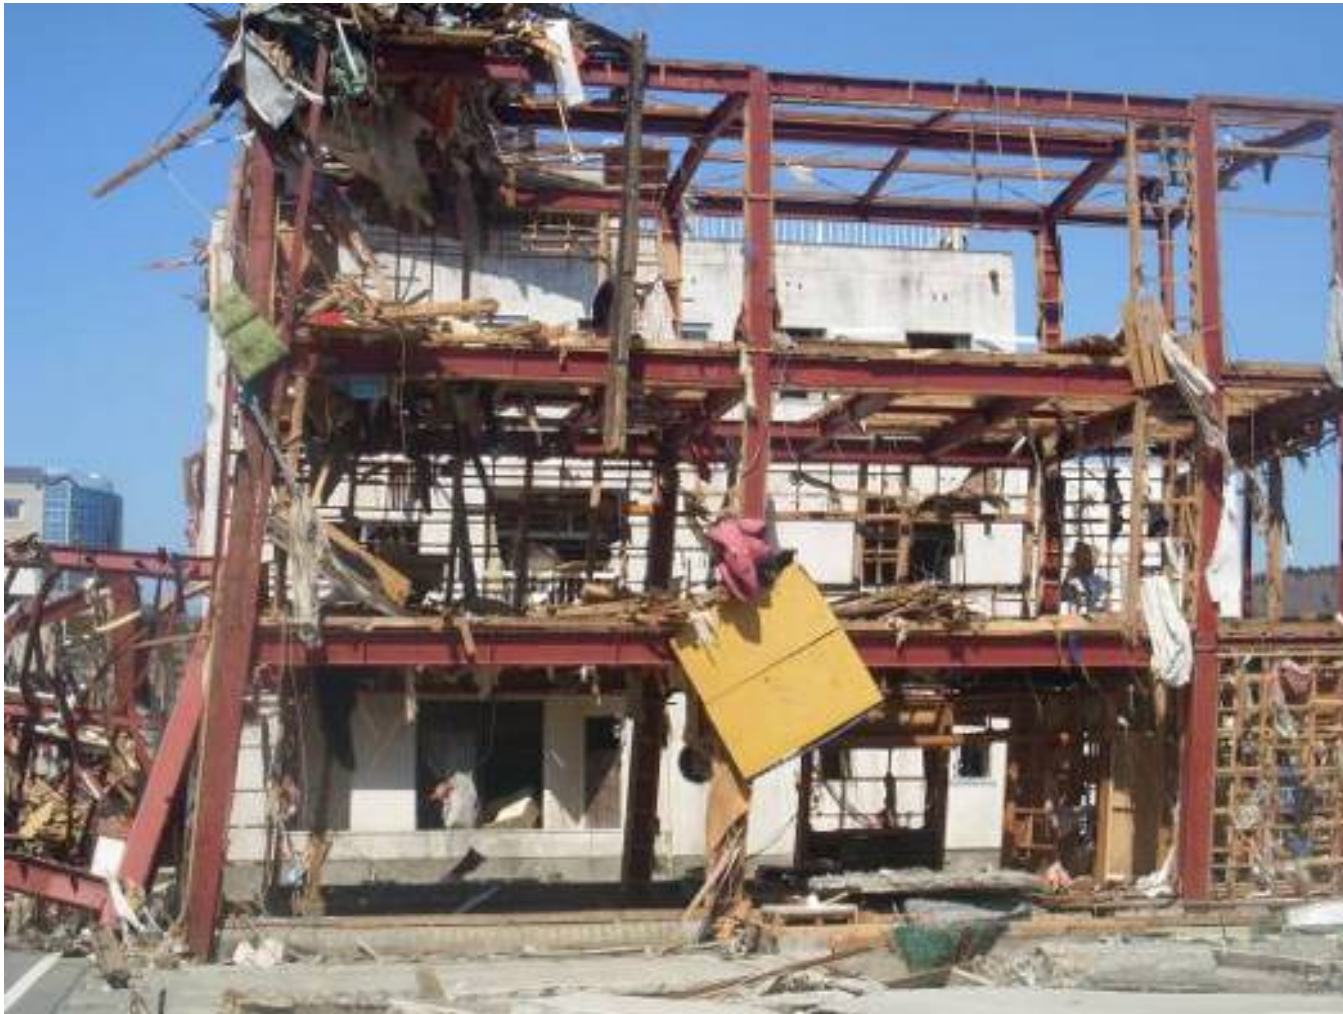
## Damage to Steel buildings (5) Large residual deflection

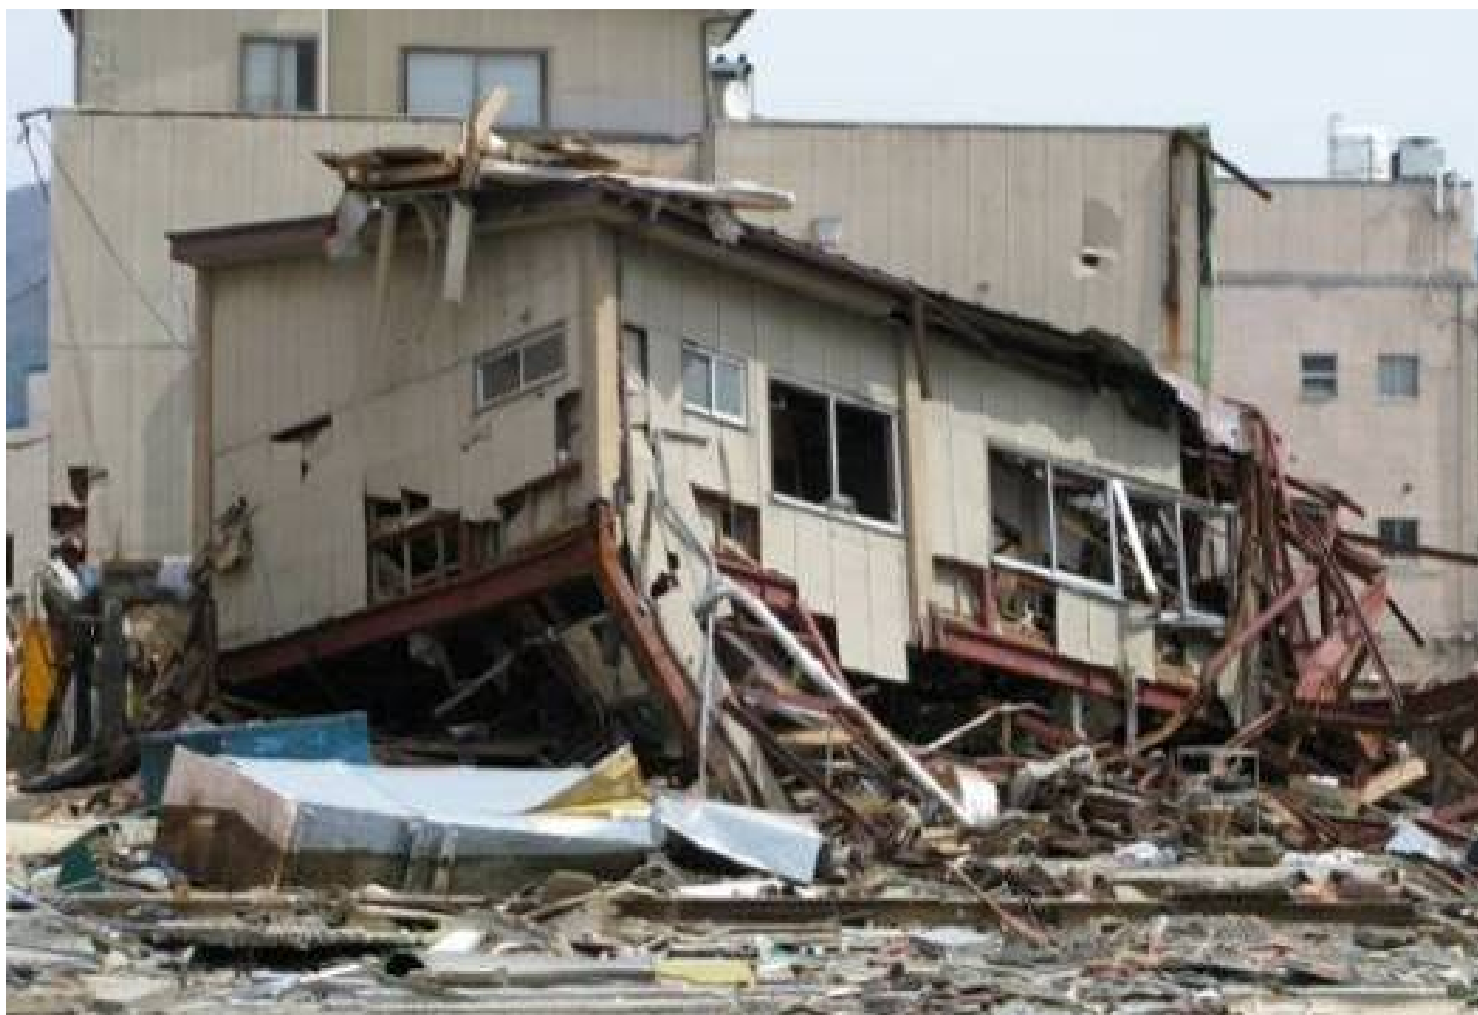
## Damage to Steel buildings (6) Collapse of 1<sup>st</sup> story

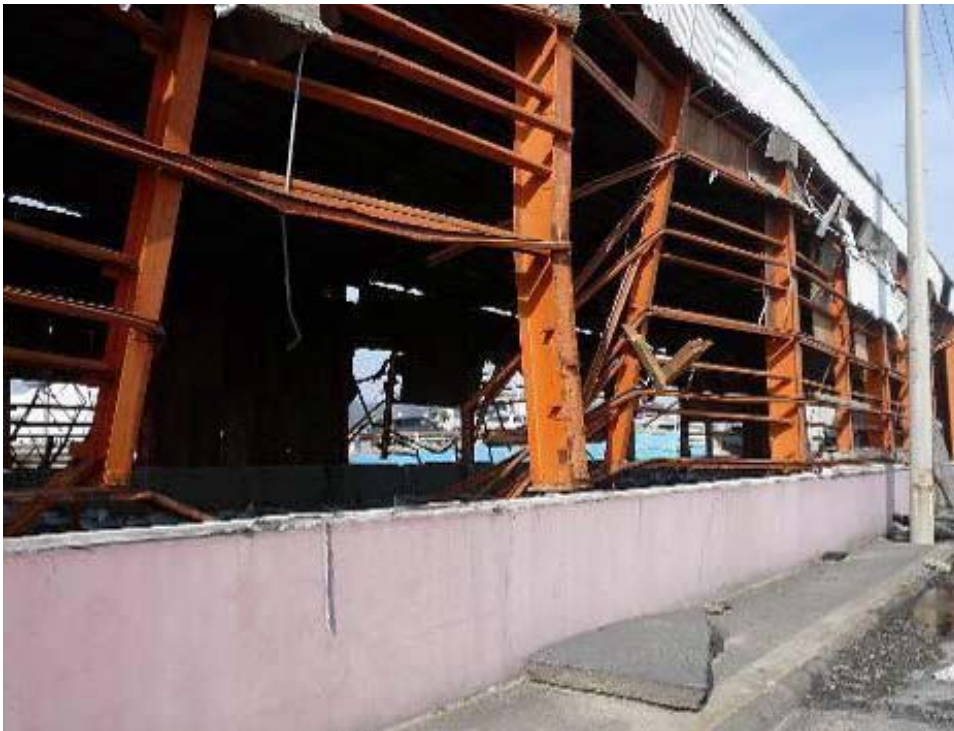
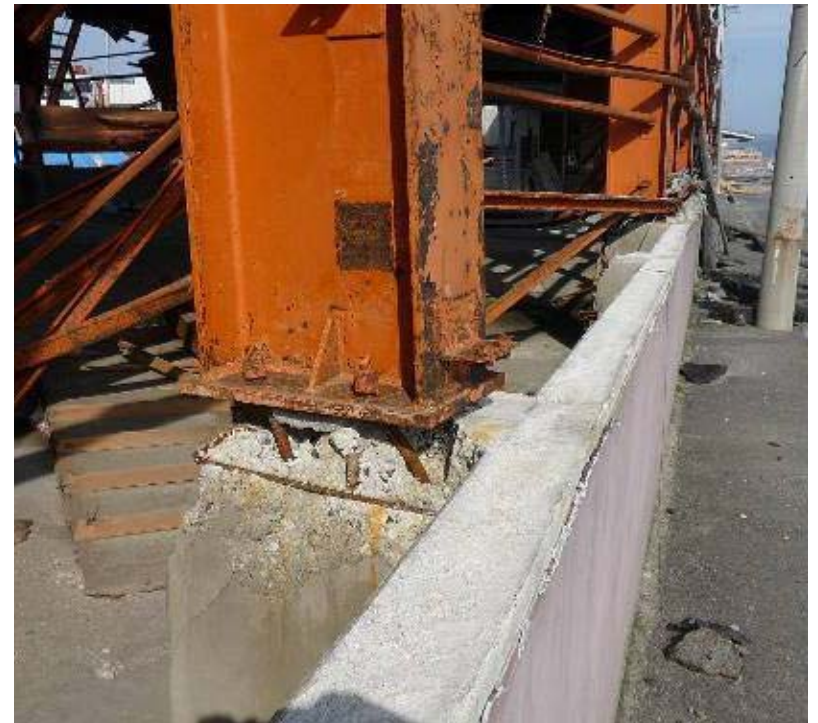
Damage to Steel buildings  
(7) Deformation of columns due to  
tsunami pressure and/or debris impact
