DETERMINATION OF THE POST-EARTHQUAKE CAPACITY OF AN ECCENTRICALLY BRACED FRAME SEISMIC RESISTING SYSTEM

G.C. Clifton and G Ferguson
University of Auckland
Auckland, New Zealand

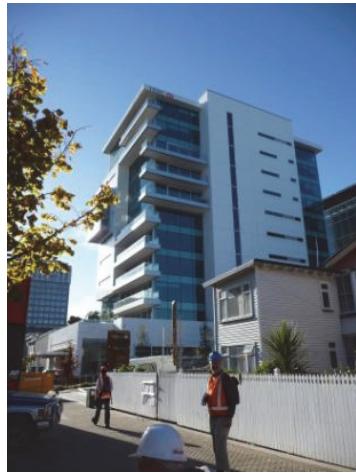
The 2010/2011 Christchurch earthquake series were the first earthquakes worldwide to push EBFs significantly into the inelastic condition and impacted on a range of EBF buildings ranging from 2 to 22 storeys in height (Clifton, Bruneau et al. 2011). One of these, HSBC Tower, is shown in Figure 1; this picture was taken in the week following the most intense earthquake of the series, the earthquake of 22 February 2011.

Figure 1. HSBC building, Christchurch, March 2011 (from Clifton, Bruneau et al. 2011).

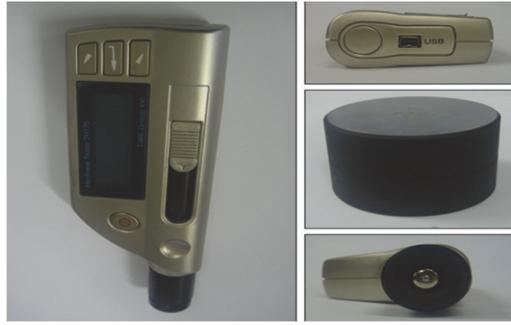
This key step is required in order to determine the peak plastic shear strain that the yielded EBF active link has sustained. The procedures used are those developed by (Nashid 2015), based on the use of the portable, battery powered Leeb Hardness Tester TH170, as shown in Figure 5 . Length limitations in this paper prevents inclusion of the detail; summary of key points is as follows:

Figure 5. Integrated portable leeb hardness tester TH170.
