Determination of the Post-Earthquake Capacity of an Eccentrically Braced Frame Seismic Resisting System

**Paper by G Charles Clifton and George Ferguson
Presentation by Ken Elwood**

November 2015; minor editorial updates June 2016
Status: Final Report

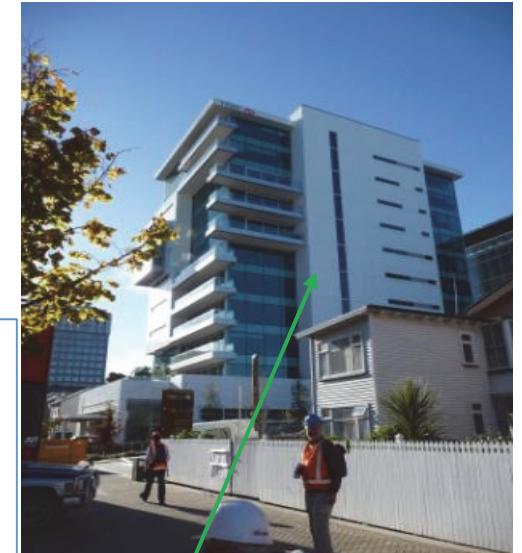
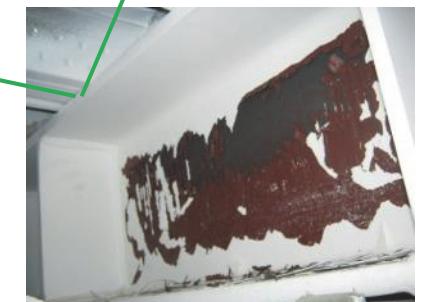
- 22 Feb 2011 Christchurch EQ pushed EBFs into inelastic range
- Inelastic demand occurred within link
- Minor slab cracking
- Buildings self-centred
- **Question:**
Do links need replacing because of the inelastic demand?

That event caused yielding of most of the active links in every EBF building in the Christchurch central business district. Four examples are shown in Figure 2. These include two active links with yielding of the webs and no local buckling, cracking or fracture, Figure 2 (a) and (d); one with yielding of the webs and local buckling of the bottom flange at one end, Figure 2(b) and one which underwent web yielding and then fracture, Figure 2(c).

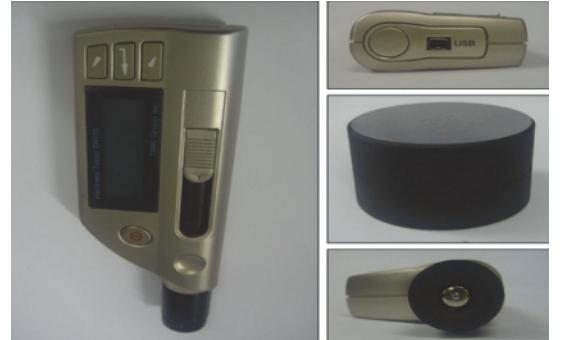
Integrated Portable Leeb Hardness Tester TH170

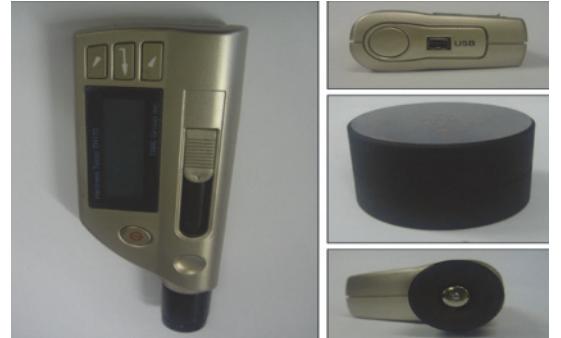
Integrated Portable Leeb Hardness Tester TH170

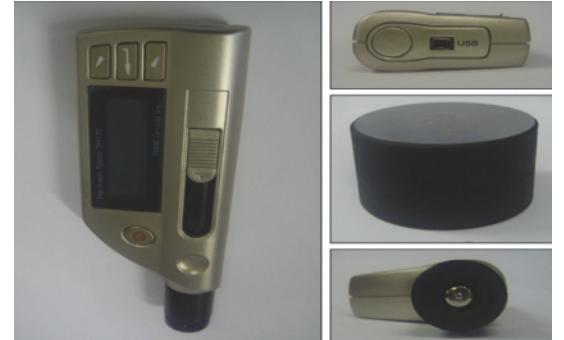
Integrated Portable Leeb Hardness Tester TH170
