EVALUATION AND PERFORMANCE OF TAIWAN HOUSING AND SCHOOLS IN THE KAOHSIUNG/MEINONG EARTHQUAKE

Ramon Gilsanz, Cathy Huang, Jessica Mandrick, Joe Mugford
Gilsanz Murray Steficek LLP (GMS)
New York, NY USA

Shyh-Jiann Hwang, Tsung-Chih Chiou
National Center for Research on Earthquake Engineering (NCREE)
Taipei, Taiwan

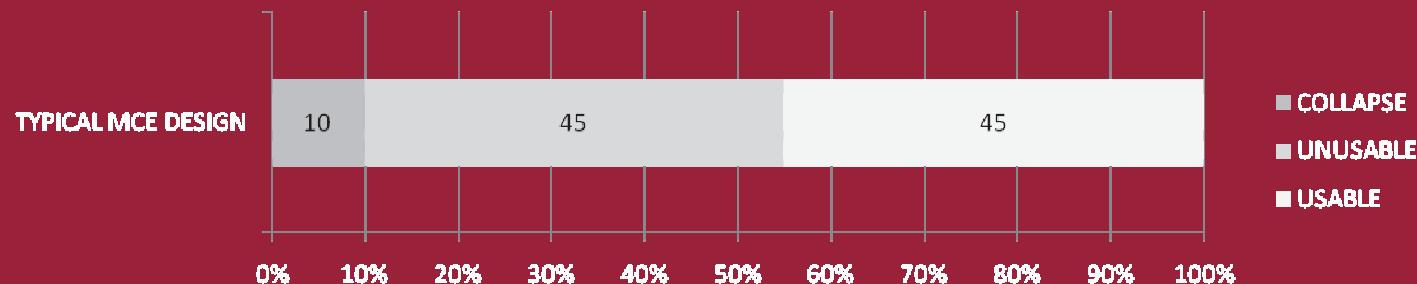
Design code's assigned probability of collapse, major damage rendering a building unusable, and minor damage permitting building usage (ASCE 7-10, ATC 63)

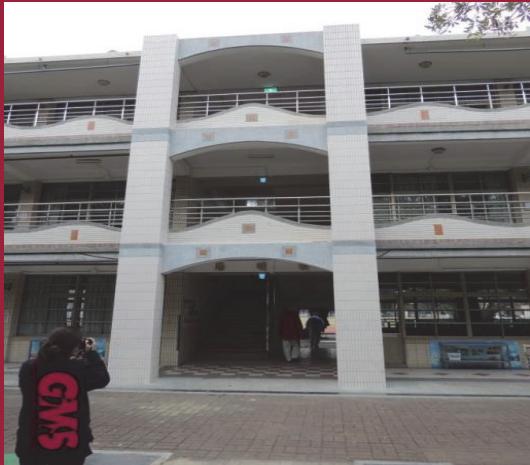
Guiren Middle School Retrofitted with Added Moment Frame (Minor Damage)

- In the Tainan area (near the event epicenter), none of the 58 retrofitted schools were observed to have structural damage.
- 18 of the 85 (21%) school buildings marked for retrofitting were observed to have severe damage.
- Among the school buildings that passed the screening evaluation, only 1 of the 158 (0.6%) buildings was found to suffer severe damage

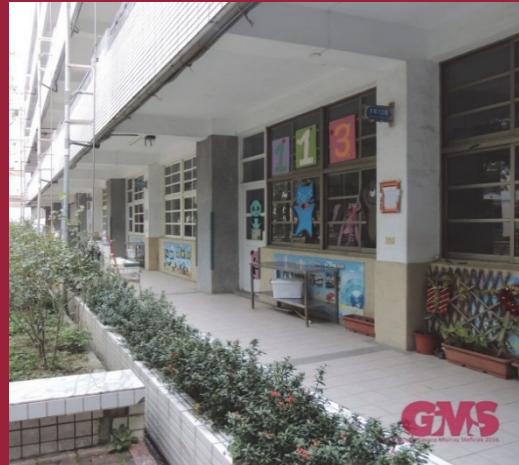
Guiren Middle School Retrofitted with Jacketed Column (No Damage)

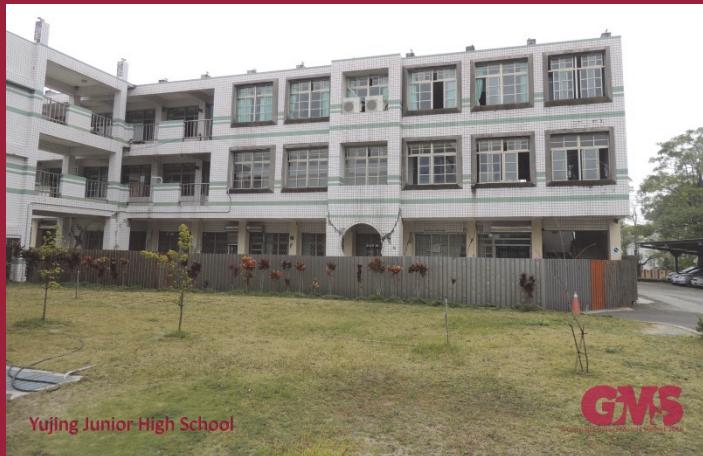
Yujing Junior High School Not Retrofitted (Severely Damage)

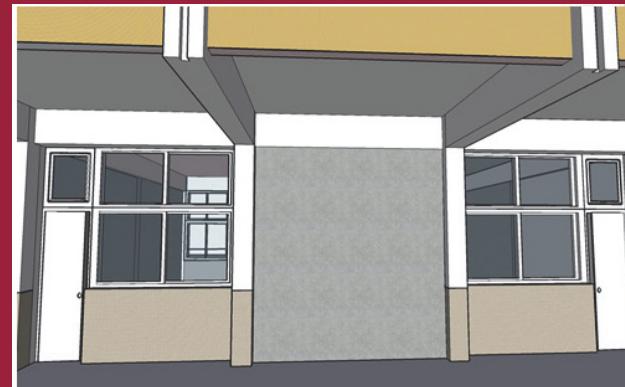
- The NCREE street house website also introduces a few preliminary reinforcing retrofit suggestions

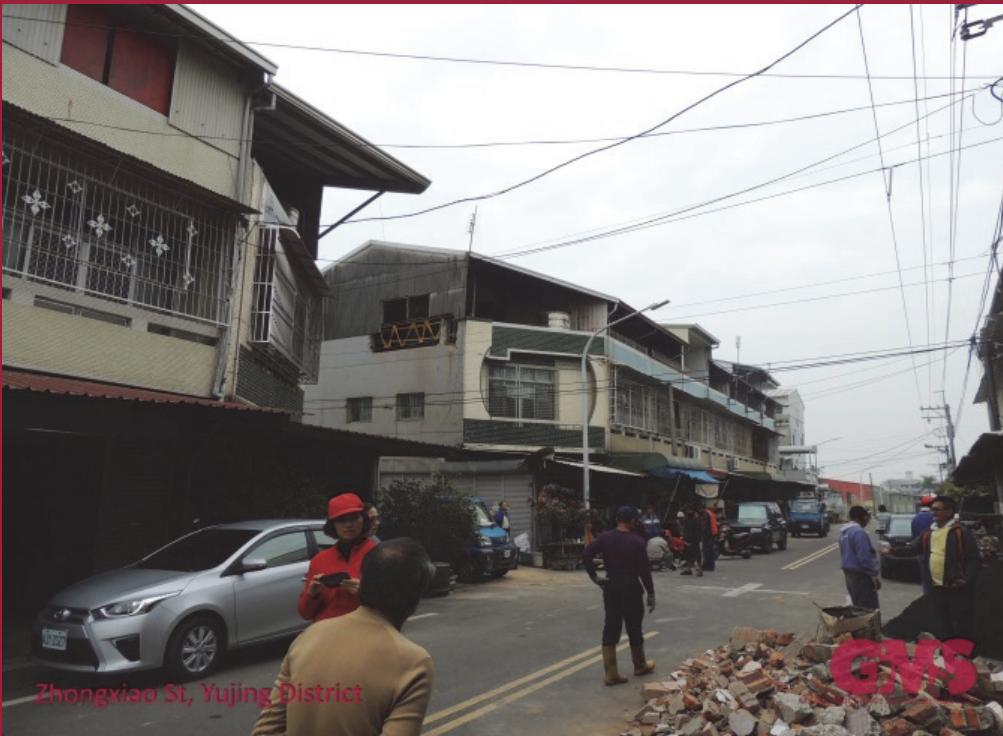
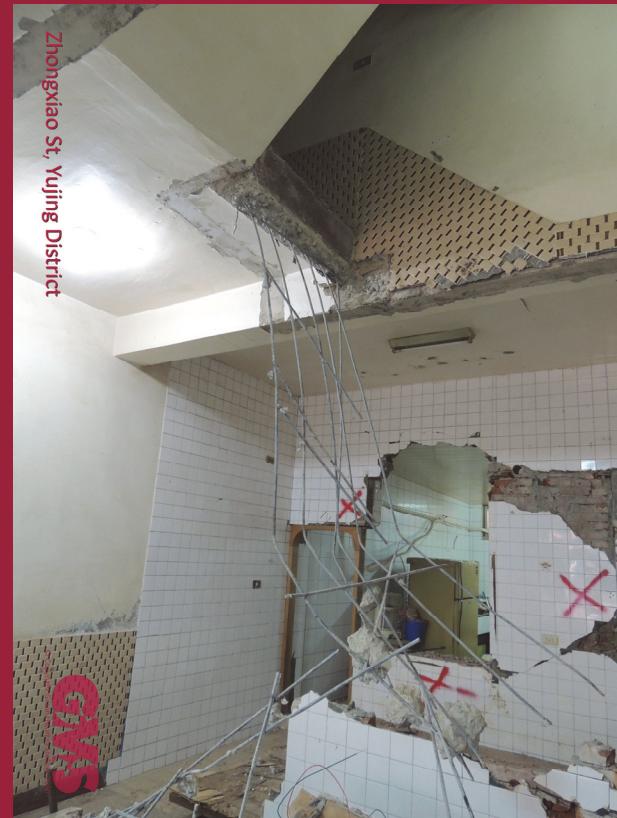
Case Study I: Yujing district “street house”

- 2 Story, multi-family street house in Yujing District with 6 bays parallel to the street.

(1) Column sizes, (2) Column reinforcement ratio, (3) Concrete compression strength (f_{c}'), (4) Column tie spacing, (5) Wall thickness, (6) Concrete wall shear strength, (7) Solid brick wall shear strength								
	1	2	3	4	5	6	7	Computed	
Typical Parameters School House	8"x16" 20cm x 40cm	1.7-2%	2500 psi 175kgf/cm ²	10"-12" 25-30cm	8" 20cm	4 sides restrained: 300psi (21kgf/cm ²) 3 sides restrained: 170psi (12kgf/cm ²)	4 sides restrained: 55psi (3.9kgf/cm ²) 3 sides restrained: 38psi (2.7kgf/cm ²)		
Typical Parameters Street House	8"x16" 20cm x 40cm	1.94-2.16%	2150psi 150kgf/cm ²	10"-12" 25-30cm	8" 20cm	4 sides restrained: 300psi (21kgf/cm ²) 3 sides restrained: 170psi (12kgf/cm ²)	4 sides restrained: 55psi (3.9kgf/cm ²) 3 sides restrained: 38psi (2.7kgf/cm ²)		
Case Study 1 (Interior shear wall failure observed)	35cm x 35cm and 20cm x 35 cm	ASSUME TYPICAL	ASSUME TYPICAL	20 cm	20 cm	ASSUME TYPICAL	ASSUME TYPICAL	CFR=.00577 Ap= 0.242 At=0.28 E= 0.867 Is=0.82<1

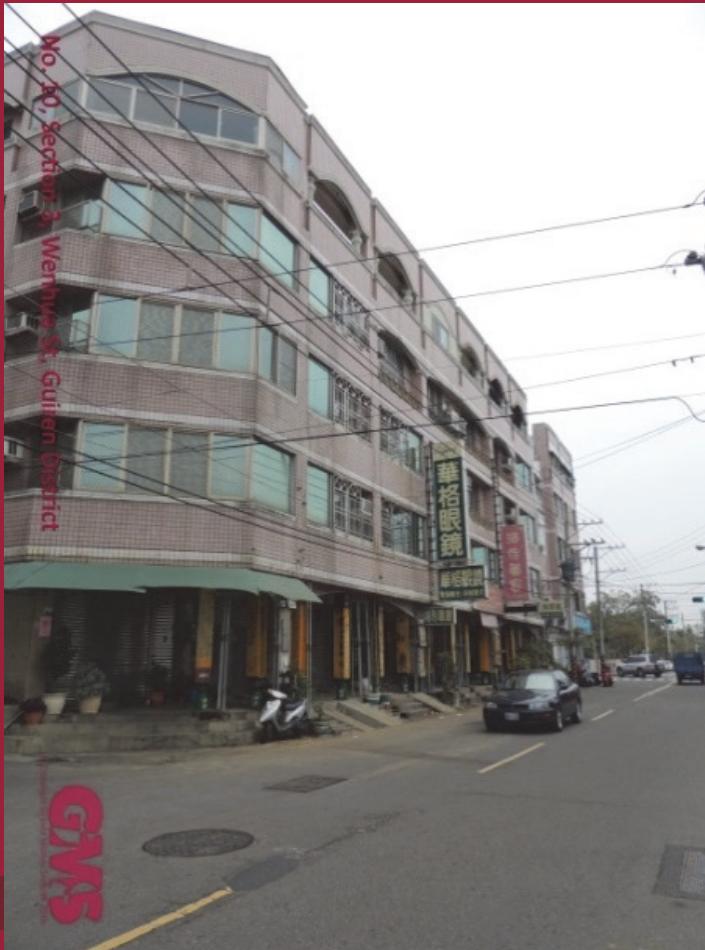
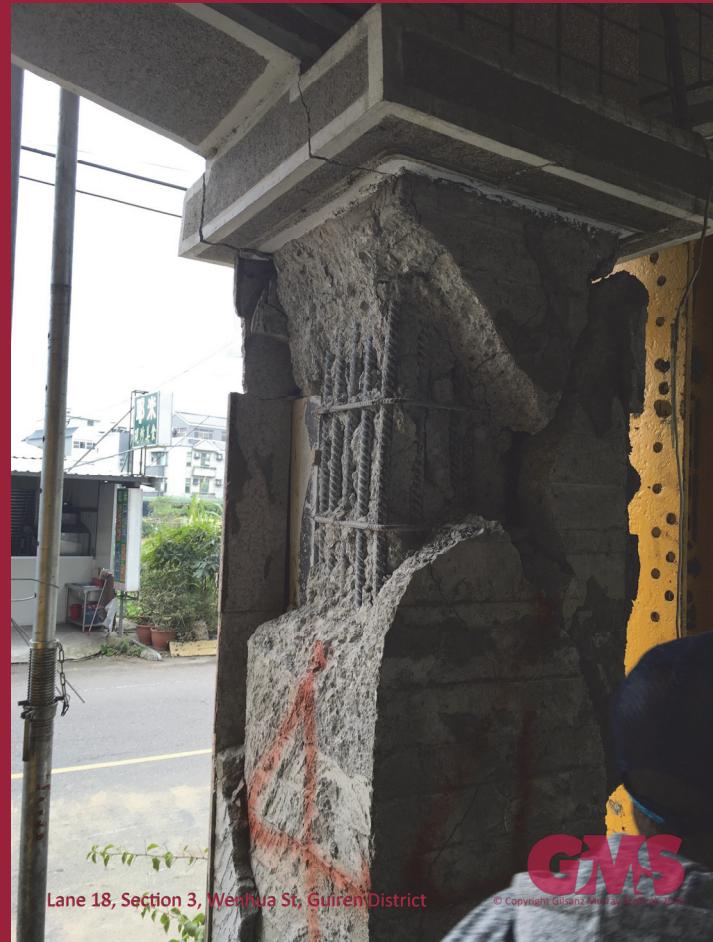
Case Study II, Guiren Tainan “street house”

- 5 story, multi-family street house in Tainan's Guiren District with 12 bays parallel to the street and 5 transferred columns at the first floor level.

Case Study 2 (Exterior column failure observed)	19" x 20" 48cm x 51cm 12"x12" stirrups 30x30cm	2.2%	ASSUME TYPICAL	#3@9"o.c. (23cm)	10" (25cm)	ASSUME TYPICAL	ASSUME TYPICAL	CFP=0.0016 Ap=0 E=0 Is=0
