ATC-58 Development of Performance-Based Seismic Design Guidelines

Proceedings: Mini-Workshop/Invited Meeting on the Identification of Nonstructural Components of Significance

Location: Simpson Gumpertz & Heger Inc., San Francisco, California

Date: August 25, 2005

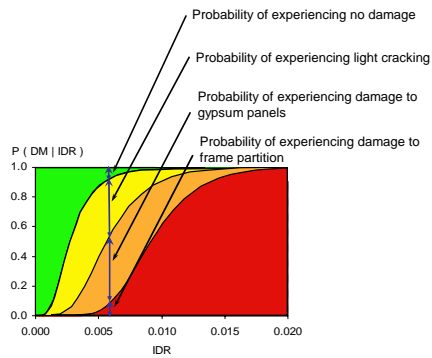
Example of use of a nonstructural fragility function

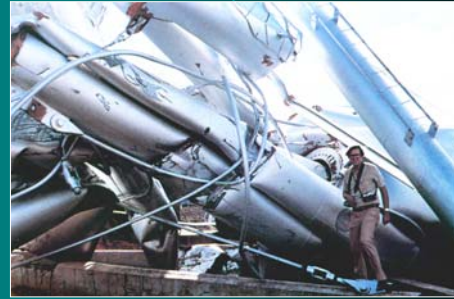
Collapsed Water Tower - Brawley, California

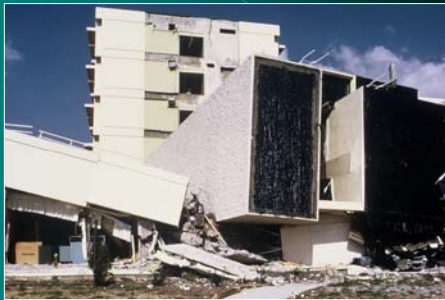
Stair Tower Collapse on Daycare Wing

Olive View Hospital 1971 San Fernando Earthquake

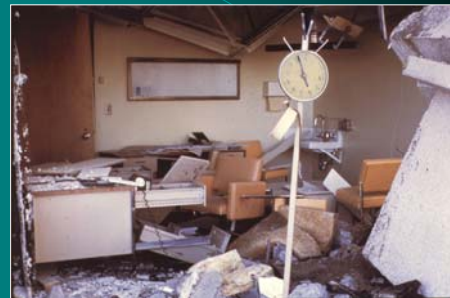
Effects of Tower Collapse

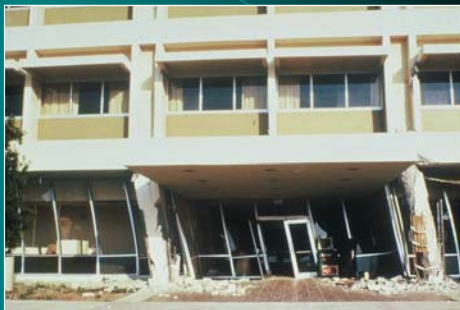
Soft First Story Effect

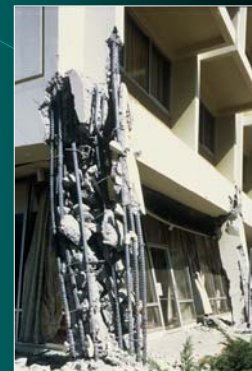
Brittle / Non-ductile Corner Column

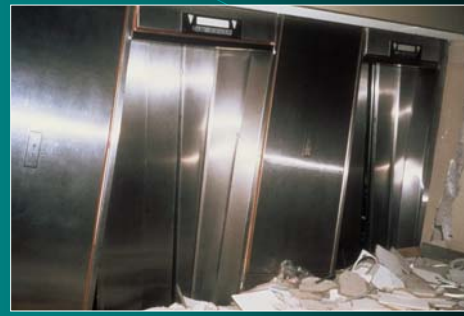
Jammed Elevator Doors

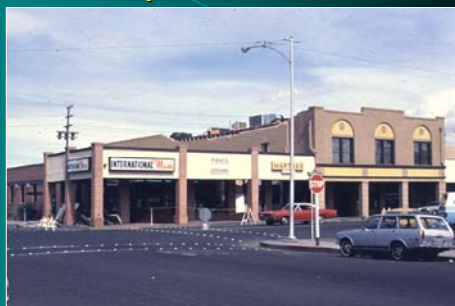
Parapet Wall Failure

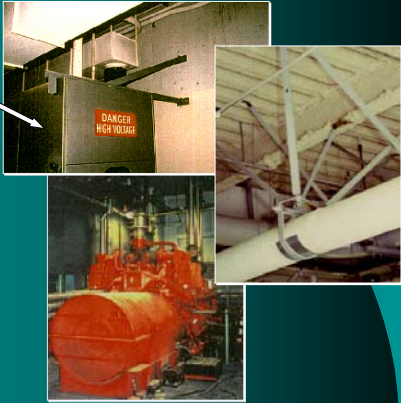
Central Plant Pipe Breaks

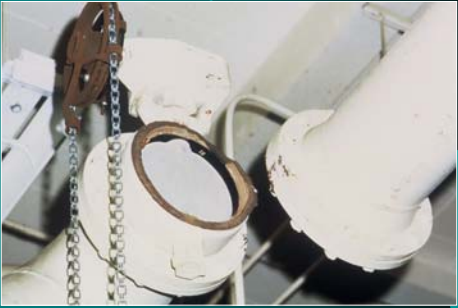
Cast Iron Valve

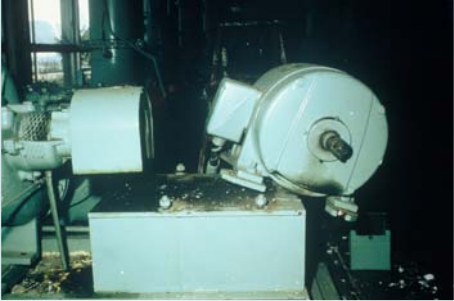
Broken Motor Anchorage

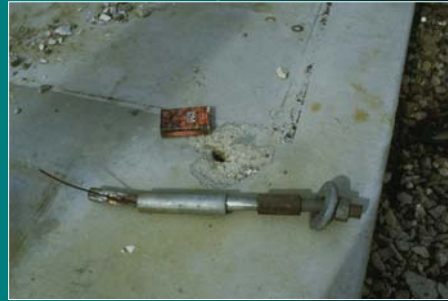
Expansion Anchor Bolt

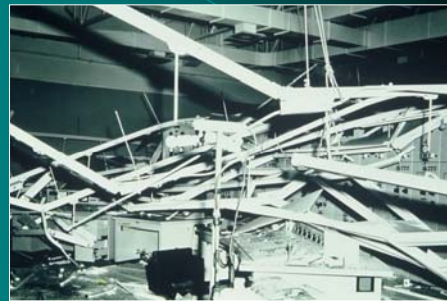
Collapsed Control Room Ceiling

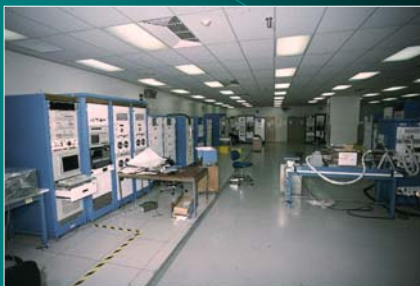
Space Simulation Lab

Before 1994 Northridge Earthquake

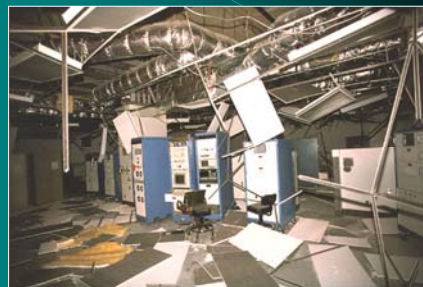
Space Simulation Lab

After 1994 Northridge Earthquake

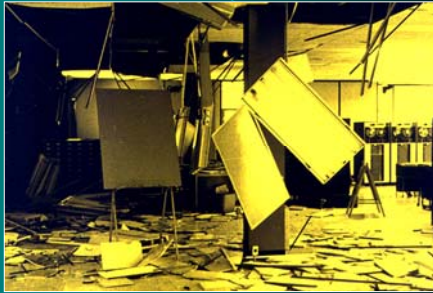
Collapsed Computer Room Ceiling

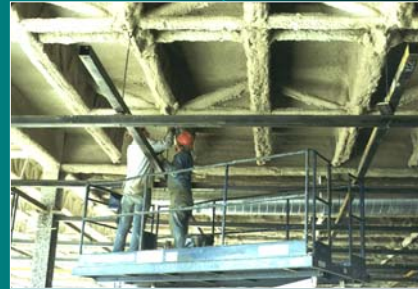
Seismic Ceiling Support Grid

To Support All Above Ceiling Systems

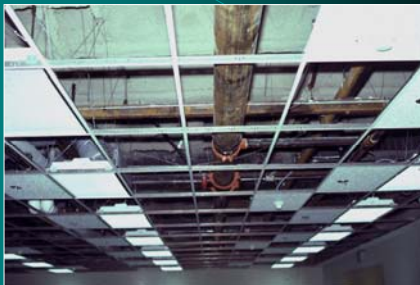
Seismic Ceiling Support Grid

Seismic Ceiling Support Grid Installation

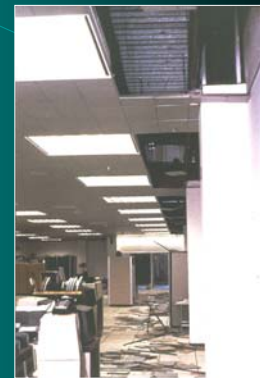
Damaged T-Bar Grid Ceiling

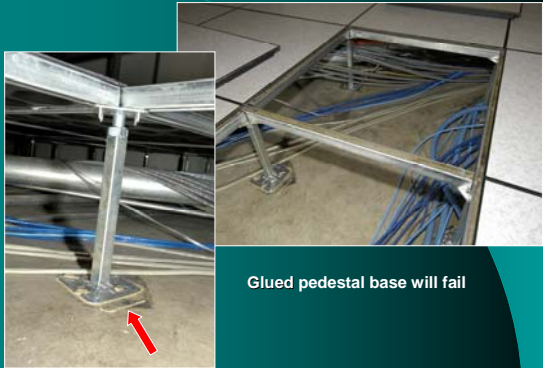
Pedestal Assembly

Glued pedestal base will fail

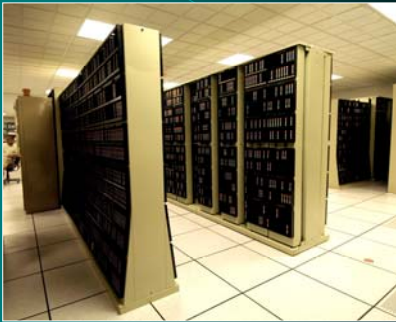
Tape Storage Racks

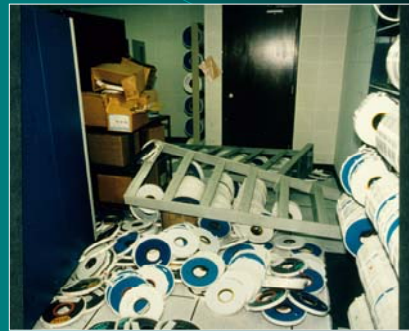
Tape Rack Collapse

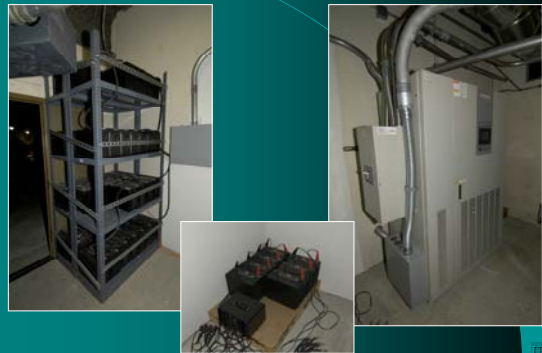
UPS / Battery Room

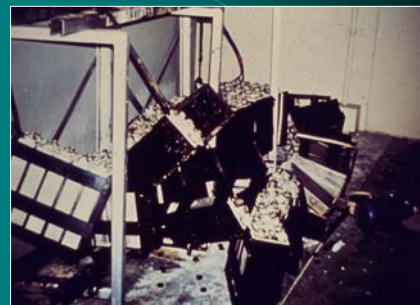
Acid Spill from Cracked Batteries
