Benchmarking Evaluation Methodologies for Existing Reinforced Concrete Buildings

Applied Technology Council

March 2022

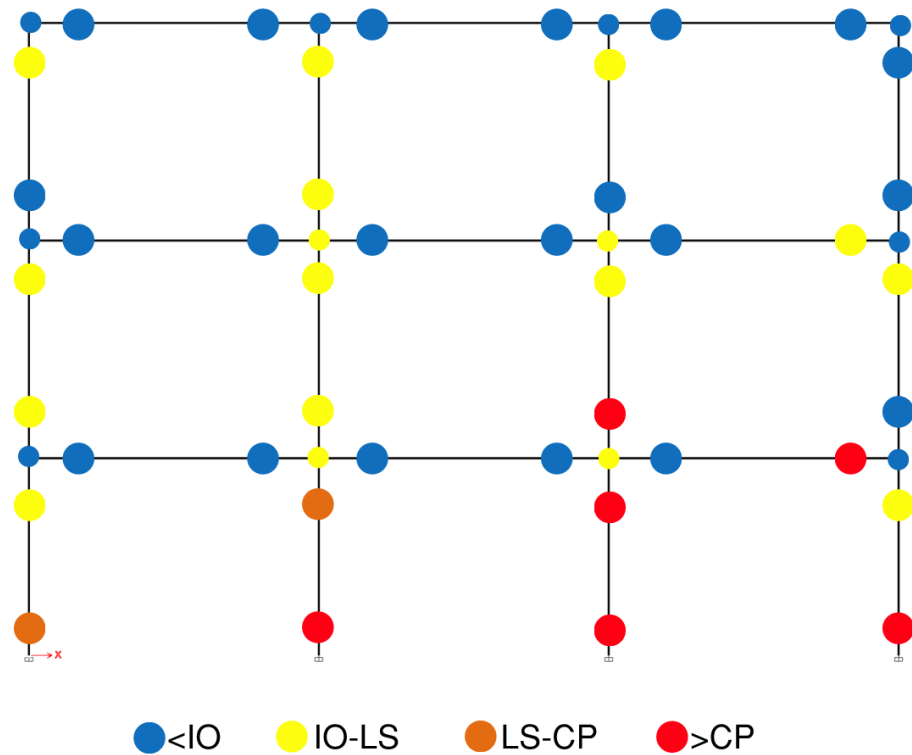
Figure 3-14 NDP Perform3D: Acceptance criteria range results for modeled nonlinear hinges. Shown for Immediate Occupancy (IO), Life Safety (LS), and Collapse Prevention (CP).

The model correctly identifies flexure-shear and ductile flexure yielding in the lower level columns as the overall mechanism, with higher levels of damage in the flexure-shear critical columns compared to the flexure-critical columns. However, the model predicts damage in the second story columns that was not observed in the frame. In Dynamic Test 1, Column B1 sustained axial degradation and shortened while other columns in the first story, including Column A1, did not. Although the model cannot directly capture axial failure of the columns or their load redistribution, the model response does show that flexure-shear critical columns have exceeded modeling parameter b on the backbone curve, which represents loss of vertical load bearing capacity.

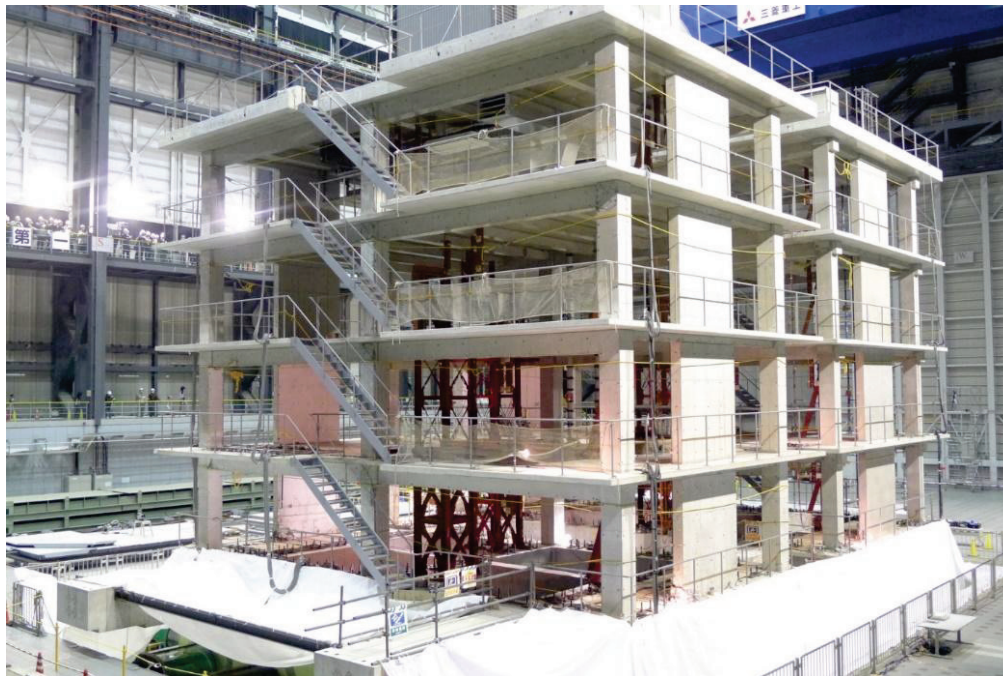
Figure 4-1 Two structures tested at E-Defense shake table, study structure is on the left side of the photo. (Nagae et al., 2015).

This chapter presents benchmarking studies for a 4-story reinforced concrete structure tested on the E-Defense shake table in Japan in 2010, shown in Figure 4-1. Ground motion records and response parameters are available since the structure was tested on a shake table. In this chapter, computed responses for analytical models and predicted damage are compared with measured responses and observed damage for strong motion records from Southern Hyogo Prefecture Earthquake of January 17, 1995.

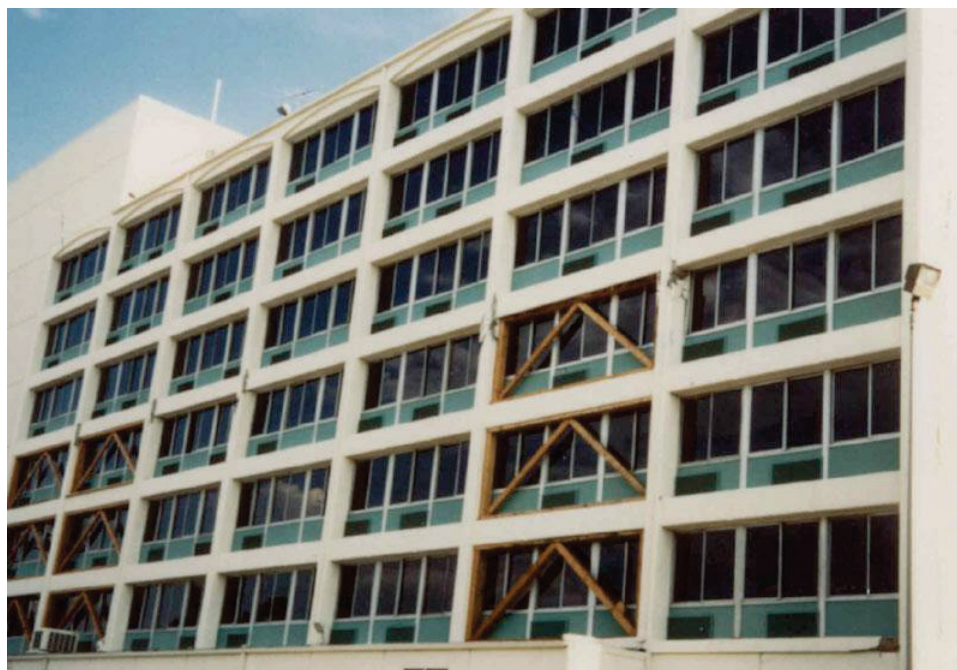
Figure 7-12 Structural damage to columns of south exterior frame after 1994 Northridge Earthquake (Concrete Coalition, 2019). Braced frames added after the earthquake as temporary lateral support.

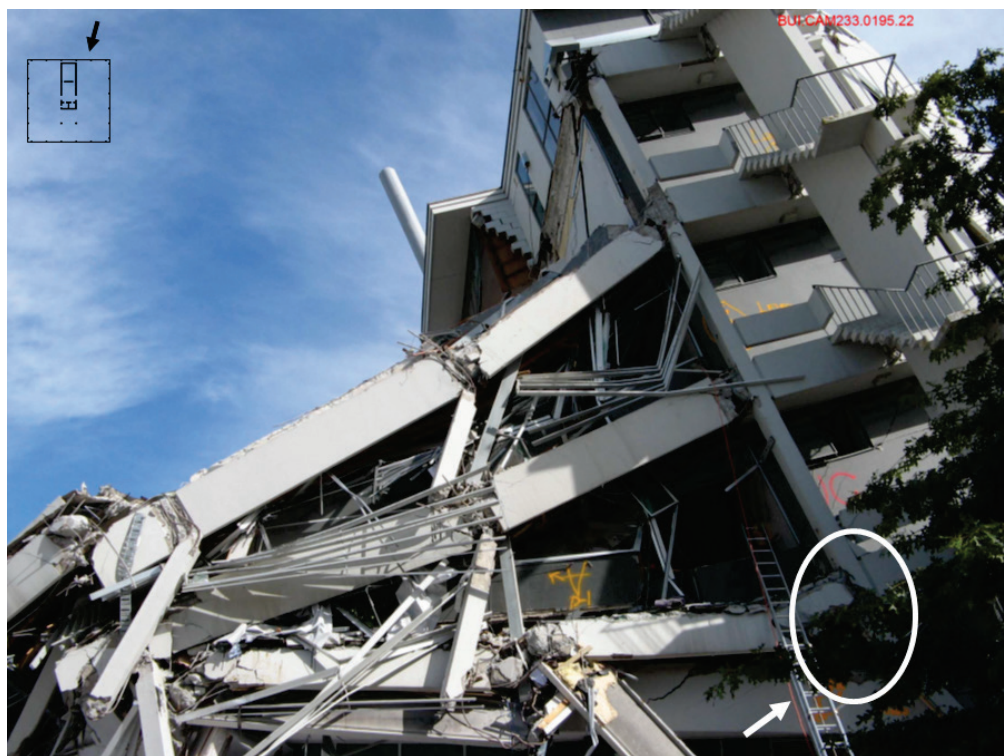
Figure 8-11 Photo showing overview of collapsed building from north; circle indicates location of axial failure of east wall (obscured; adapted from Jury and Sharpe [2011]).
