Special Project for Reducing Vulnerability for Urban Mega Earthquake Disasters (ii) Maintenance and Recovery of Functionality in Urban Infrastructures

# Behavior of Structural Walls of 1/3-Scale 6-Story Reinforced Concrete Building in Shaking Table Tests

Minehiro Nishiyama and Yuki Idosako - Kyoto University

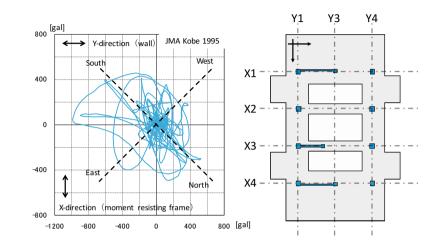
#### ◆Input Wave

Contracted by a factor of 1/V3.3 in time by acceleration law JMA Kobe 1995 + JR Takatori 1995 (for the last run)

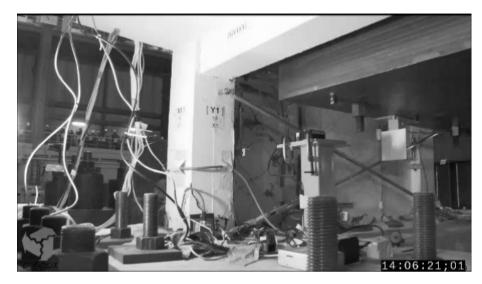
#3-5(JMA Kobe 140%-1) 1/2 wall in X-4 frame on the 1<sup>st</sup> floor

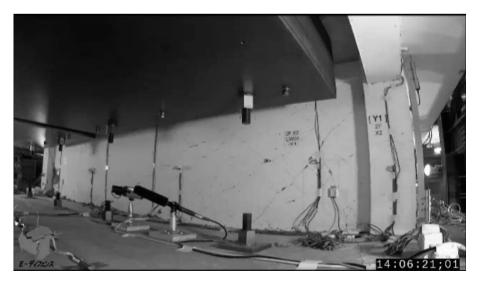
## #3-5(JMA Kobe 140%-1) 1/2 wall in X-2 frame on the 2nd floor

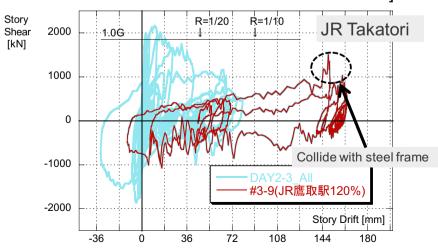
Test results: 1<sup>st</sup> story –wall direction-

DAY2[JMA Kobe100%] ~ DAY3[JMA Kobe120% ~140%~140%~JR Takatori120%]

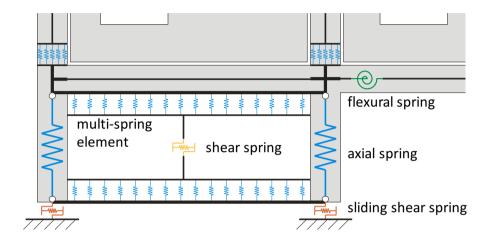
#### Numerical analysis using multi-spring idealization for wall with sliding shear spring at the bottom

- The shaking table test on a 1/3-scale 6-story reinforced concrete condominium was briefly outlined.
- The focus of this paper was primarily on the torsional behavior of the building and sliding observed at the bottom of the structural walls.
- Structural behavior of walls at large displacements were well captured by introducing the idealized sliding shear springs at the bottom of the walls in the analytical model.
