# TOWARDS A NEW DELIVERY APPROACH TO IMPROVE THE PERFORMANCE OF NON-STRUCTURAL ELEMENTS IN NEW ZEALAND

How design, coordination and construction of non-structural elements has a significant effect on the resilience of buildings and the wider New Zealand Economy

Jan M Stanway (WSP Opus)  
Tim J Sullivan (University of Canterbury)  
Rajesh P Dhakal (University of Canterbury)

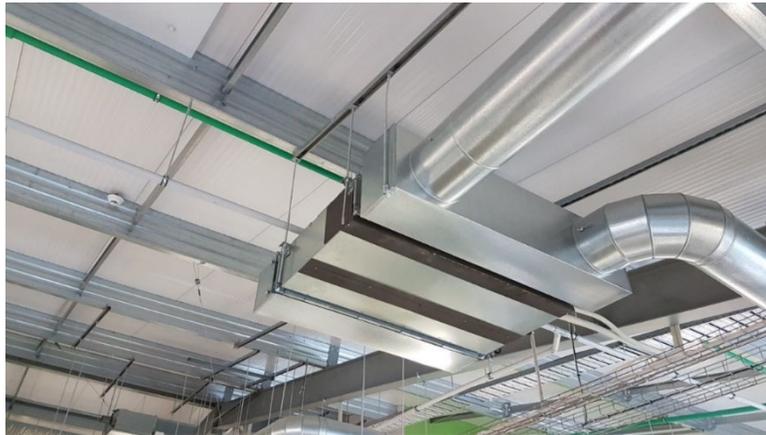
- Non-structural elements suffered extensive damage in the Canterbury (2010, 2011), Cook Strait (2013) and Kaikōura (2016) earthquakes.
- Observations following these earthquakes indicated that recently completed buildings with code compliance certificates did not in many cases meet the NZBC requirements – resulting in considerably more damage to non-structural elements than would be expected for compliant installations.
