Safety Prioritization of School Buildings for Seismic Retrofit using Performance-Based Risk Assessment in the Kyrgyz Republic

Prepared by

APPLIED TECHNOLOGY COUNCIL
201 Redwood Shores Parkway, Suite 240
Redwood City, California 94065
www.ATCouncil.org

This objective of this project, entitled “Seismic Performance-Based Assessment of School Infrastructure in the Kyrgyz Republic” (also named the ATC-142 project), is to provide technical support for the process to establish a prioritization framework for eligible schools that have been shortlisted following selection criteria established by the Ministry of Emergency Situations, Ministry of Education and State Agency for Architecture, Construction and Communal Services of the Kyrgyz Republic. During the conduct of the ATC-142 project, field inspections of selected schools were completed to inform the analytical work that provided the technical basis for the prioritization process.

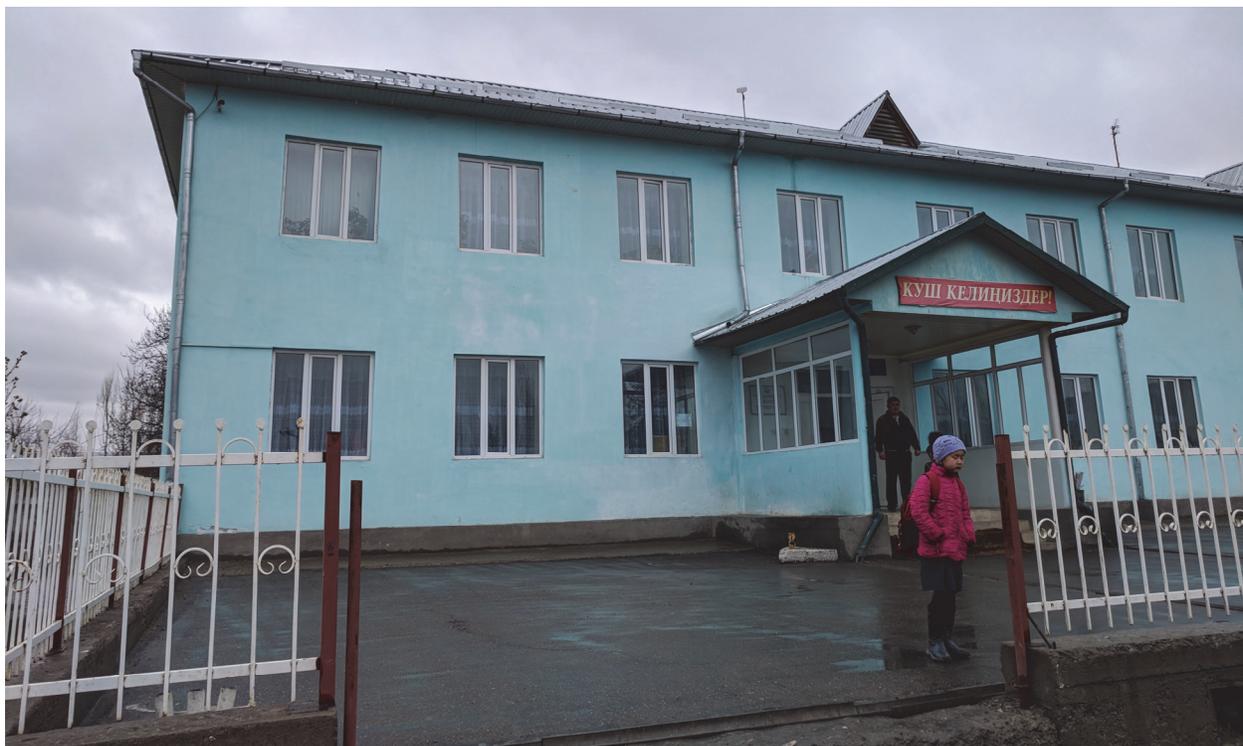
Figure 4-1 Two-story CM school building in Osh that was selected as a representative index building.

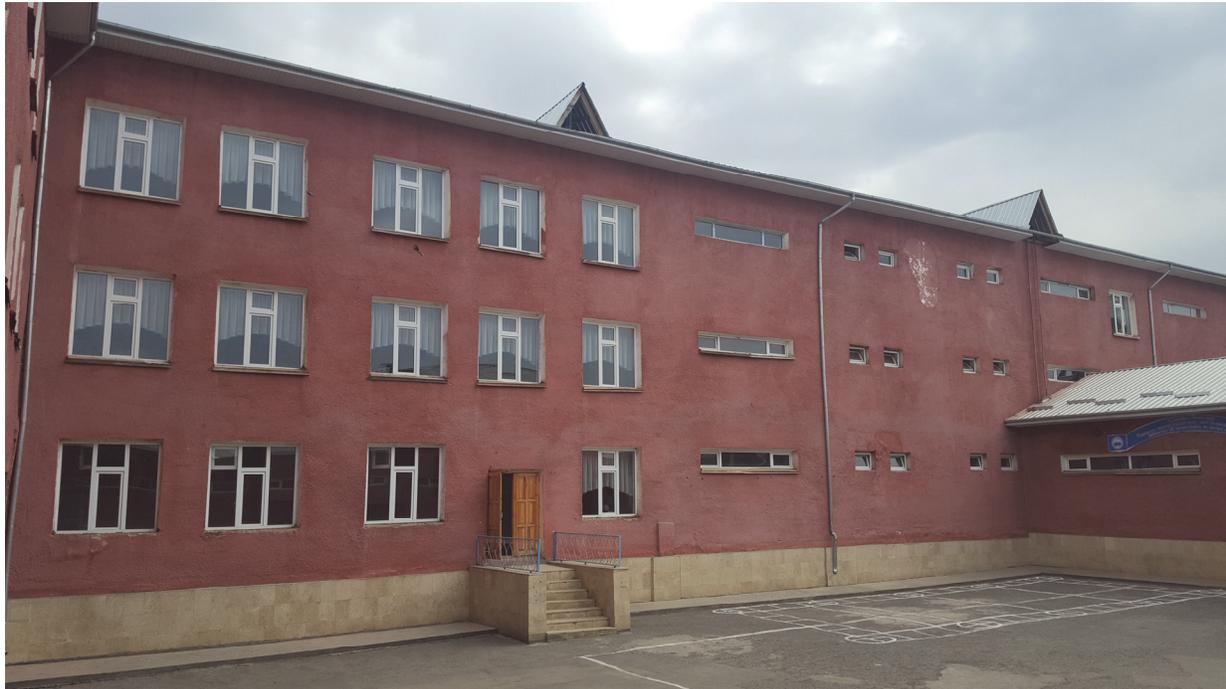
Figure 4-3 Exterior of CMCF school building in Osh that was selected as a representative index building.

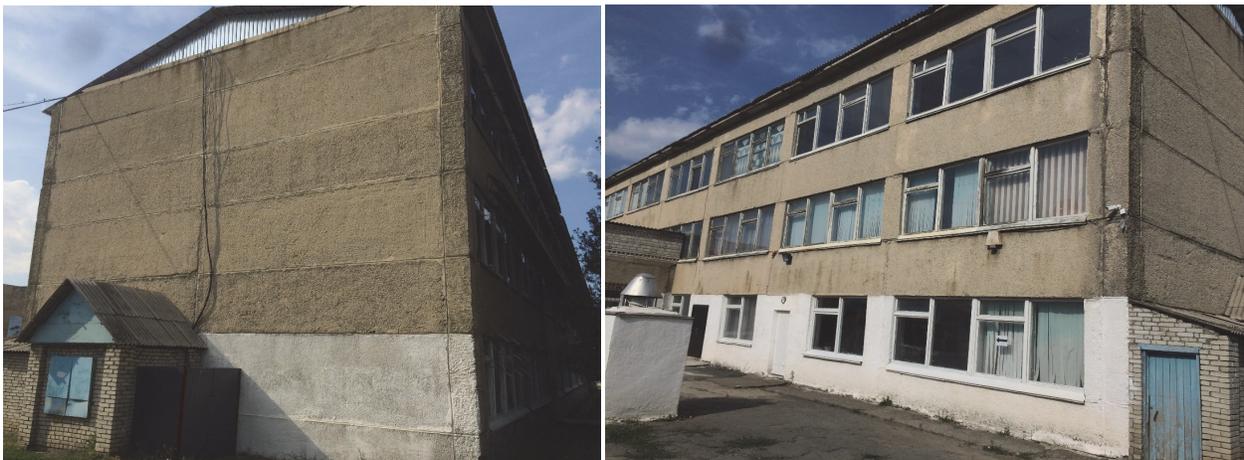
Figure 4-7 Typical RC6 classroom block in Kyrgyz Republic.

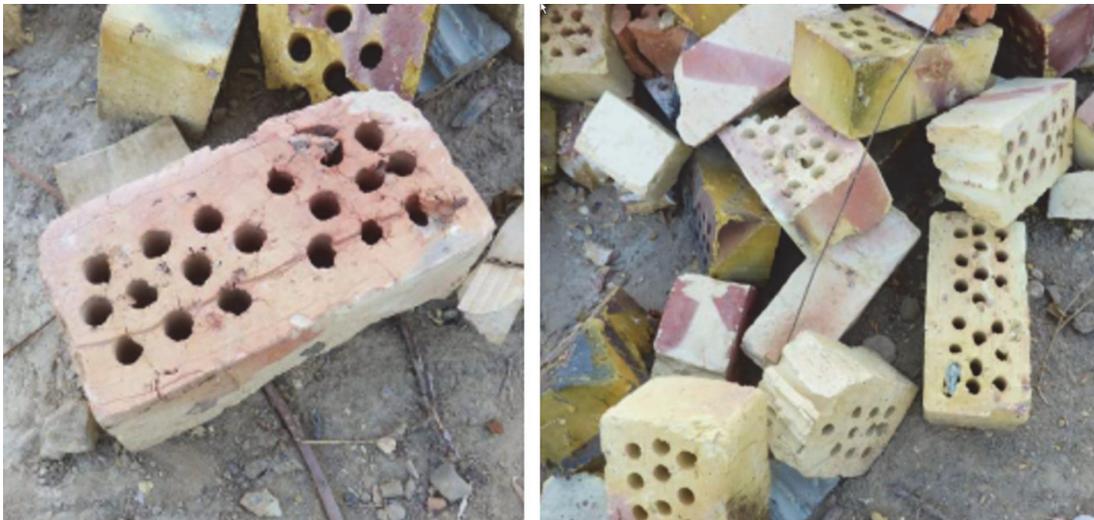
Figure 5-3 Partially fired masonry units from Kyrgyzstan (S. Brzev).

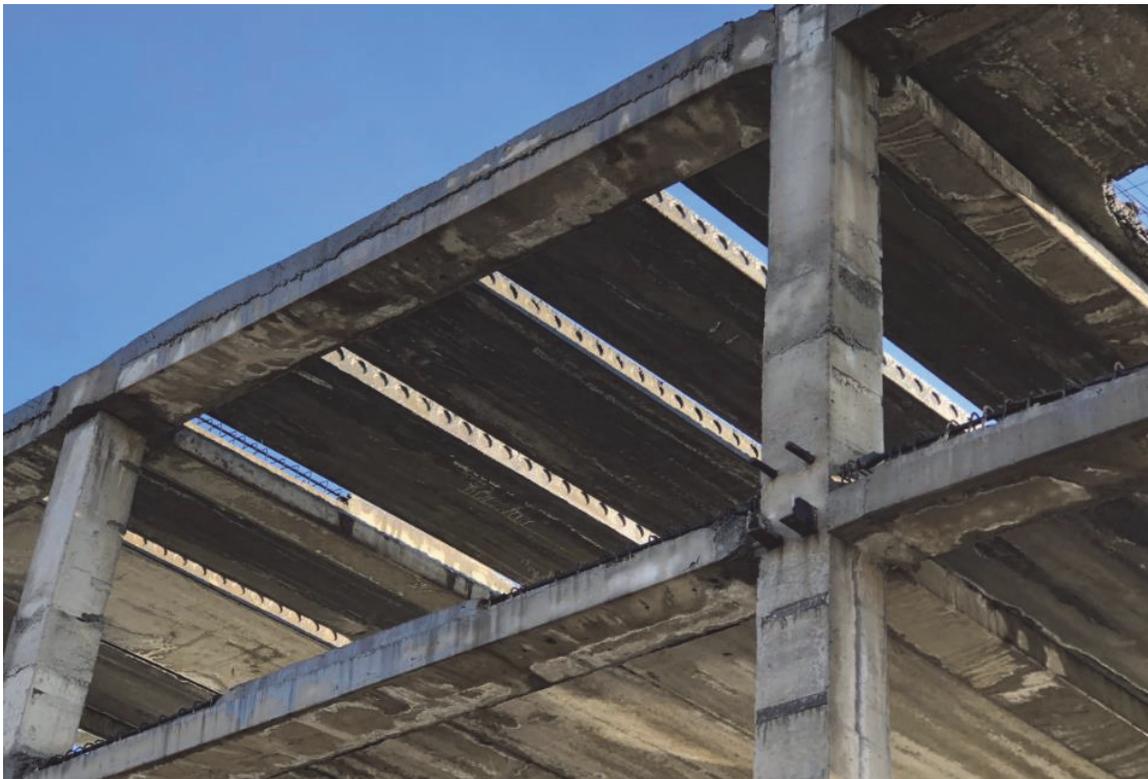
Figure 5-37 Beam-column connection in typical precast lateral-load-resisting system.

The lateral-load-resisting system consists of frame action between the columns and the beams. The columns are three-stories tall and consist of a single piece. The beams are welded to the columns via steel embed elements and embedded rebar (Figure 5-37).

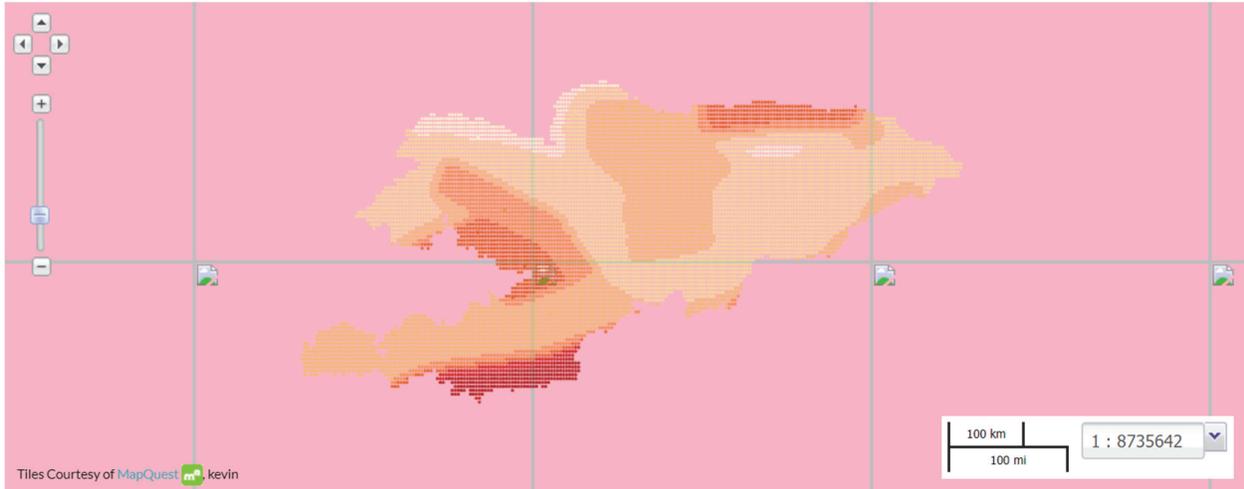
Figure 6-1 Probabilistic seismic hazard assessment map of the Kyrgyz Republic in terms of spectral acceleration expressed as fractions of g (gravit. acceleration) for a probability of exceedance of 10% over 50 years for bedrock conditions ($V_s^{30} = 760$ m/s) (from <http://geonode.mes.kg/>, last accessed February 20, 2019).

Platform at <http://geonode.mes.kg/>, generally referred to here as Geonode. Figures 6-1 and 6-2 show the content of the two layers at the national scale. The two hazard levels equate with mean recurrence rates of 0.00211 events per year (a mean recurrence interval of 475 years) and 0.00103 events per year (a mean recurrence interval of 975 years), respectively.
