*Brief review of building damage by the  
2011 Tohoku Japan earthquake and  
following coping activities*

*Isao Nishiyama\* (BRI), Izuru Okawa (BRI),  
Hiroshi Fukuyama (BRI) and Yasuo Okuda (NILIM)*

*14<sup>th</sup> U.S.-Japan Workshop on Improvement of Structural Design and Construction Practices  
December 3-5, 2012, Makena Beach & Golf Resort*

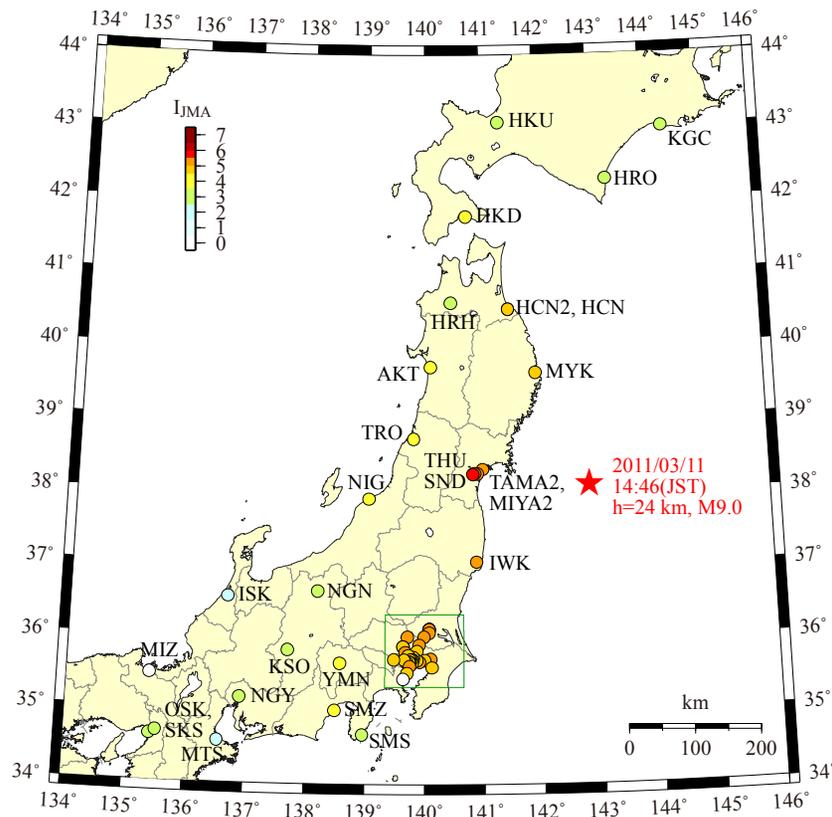
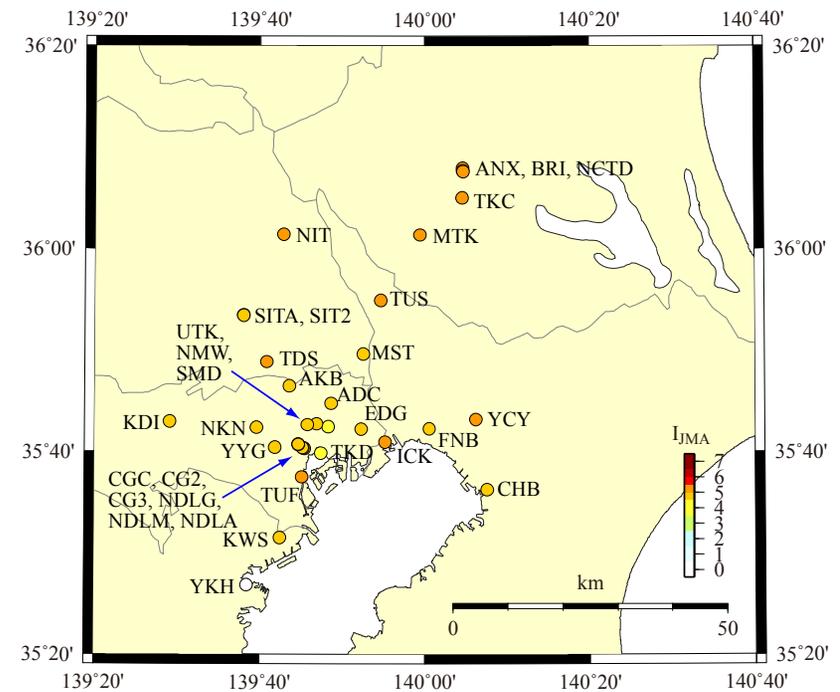
# BRI Strong Motion Network

*In 1957, BRI started strong motion network.*

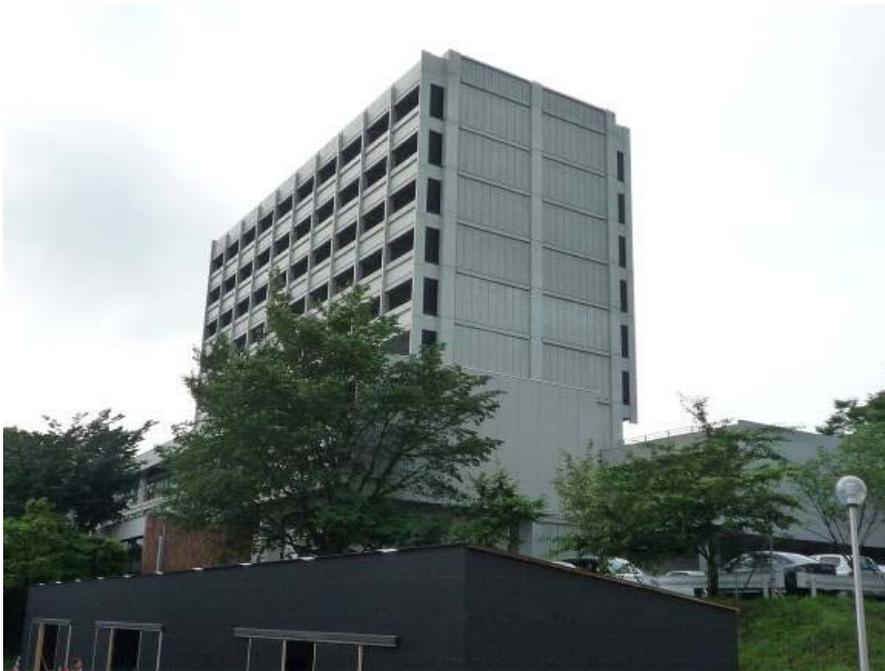
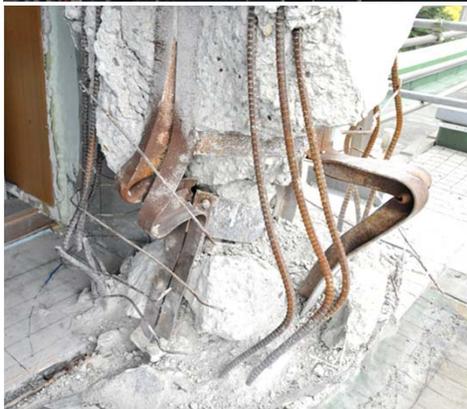
## Damaged Building in Sendai city

Flexural failure of multi-story shear walls which can absorb large earthquake energy was observed. Though the building could secure human lives by preventing its collapse as demand of seismic codes, buckling and/or rupture of steel bars and steel plates in the columns and compressive crushing of concrete were observed. Finally, the building was demolished.

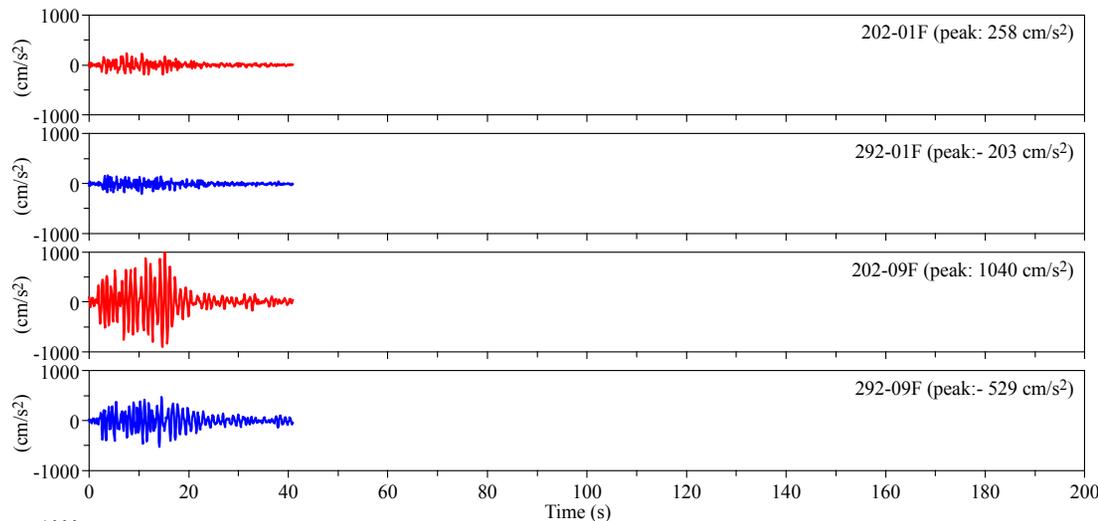
• 1978

1F(NS) 258 cm/s<sup>2</sup>

1F(EW) 203 cm/s<sup>2</sup>

9F(NS) 1040 cm/s<sup>2</sup>

9F(EW) 529 cm/s<sup>2</sup>

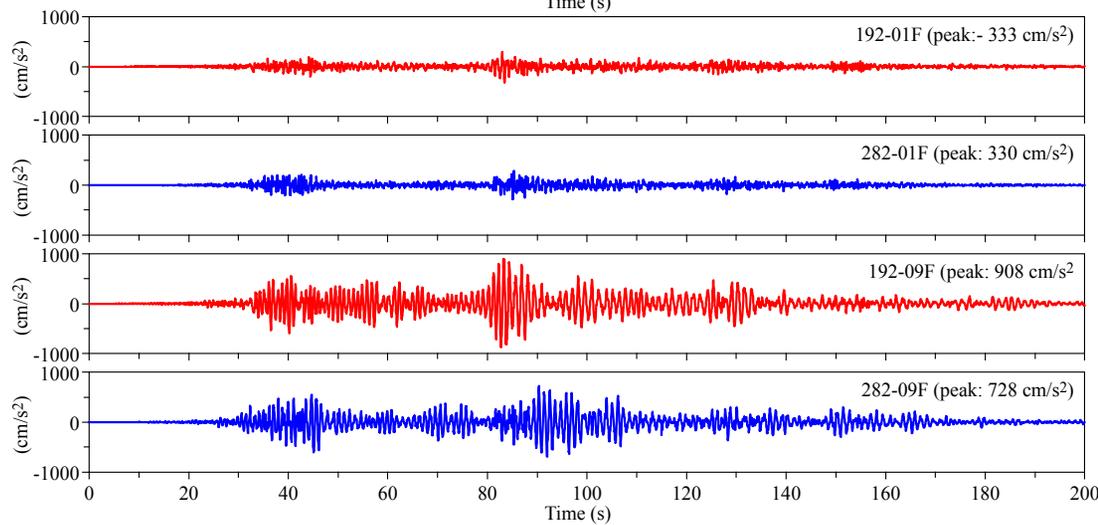
• 2011

1F(NS) 333 cm/s<sup>2</sup>

1F(EW) 330 cm/s<sup>2</sup>

9F(NS) 908 cm/s<sup>2</sup>

9F(EW) 728 cm/s<sup>2</sup>

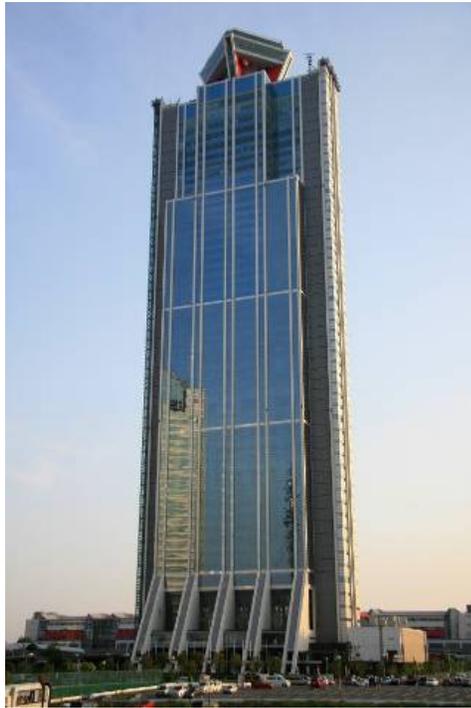
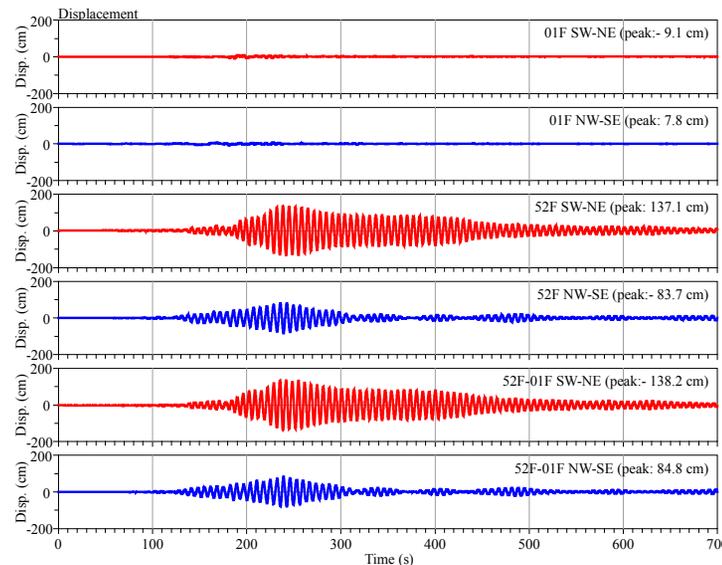
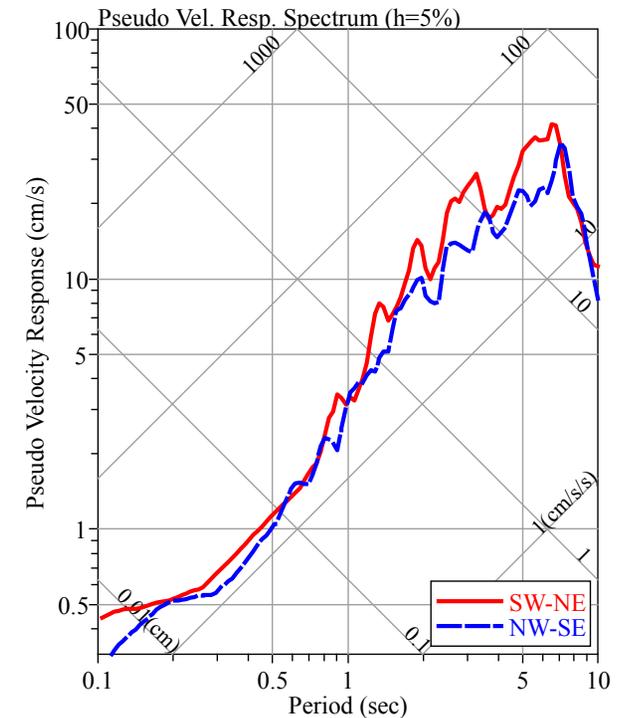
## 52+3 story building in Osaka city

- *The large responses lasted at least 10 minutes in the building in Osaka, 770km from the epicenter. A 137cm maximum displacement occurred on the top floor.*
- *Many non-structural interior members such as ceilings, walls, fire doors, sprinklers, etc. were damaged, and even confinements of passengers in elevators occurred.*

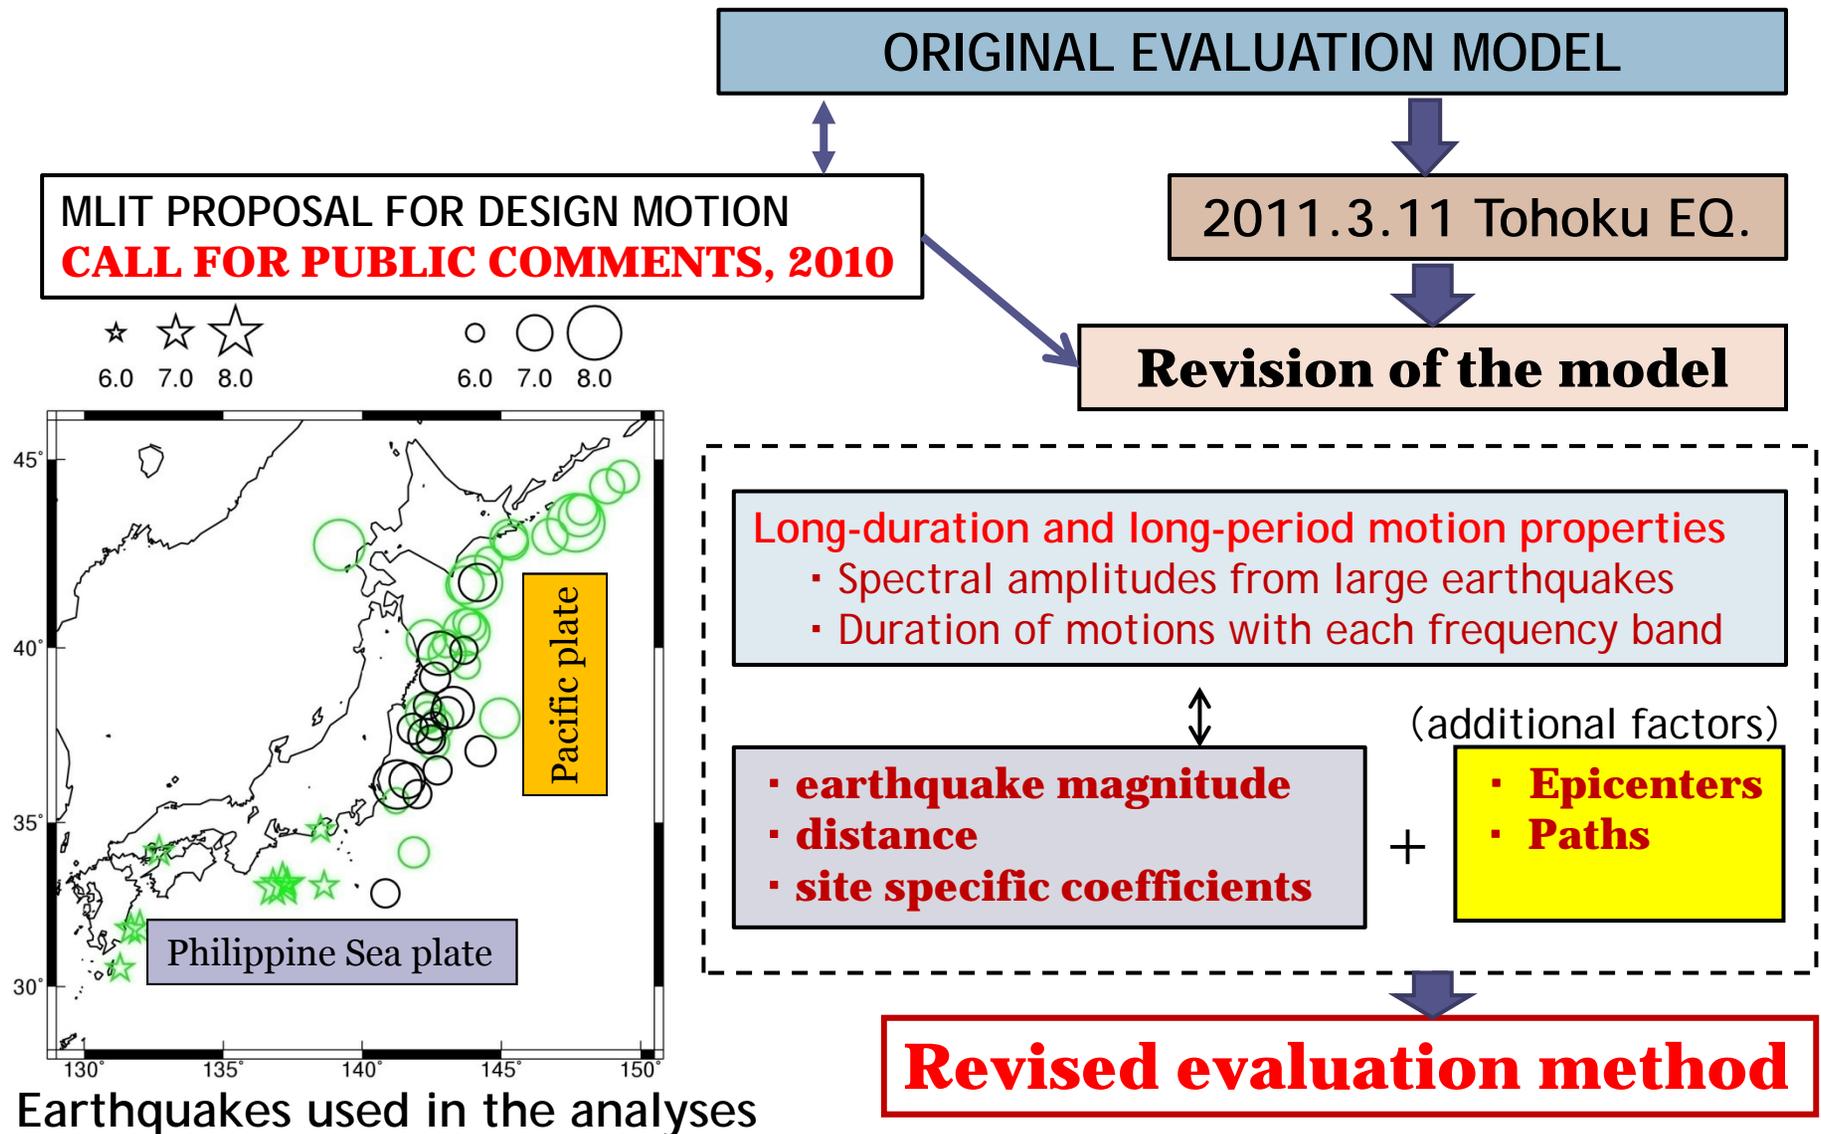
*Long-duration and long-period ground motion prediction method based on observation at about 1600 stations*

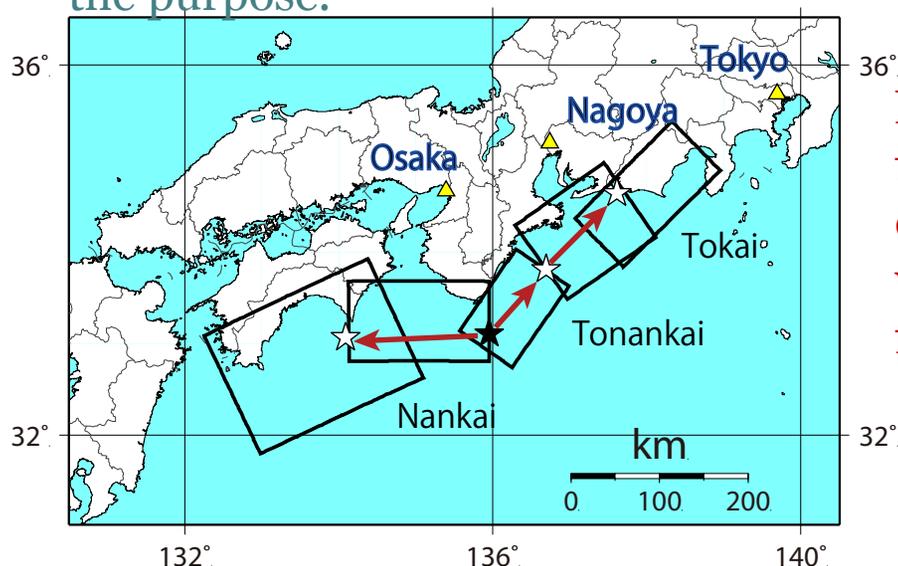
Long-duration and long-period motions were evaluated for major urban areas with two-, three- connected earthquakes, by HERP, CAO, AIJ, etc. MLIT is going to propose a design long-duration and long-period motions and is funding project for the purpose.

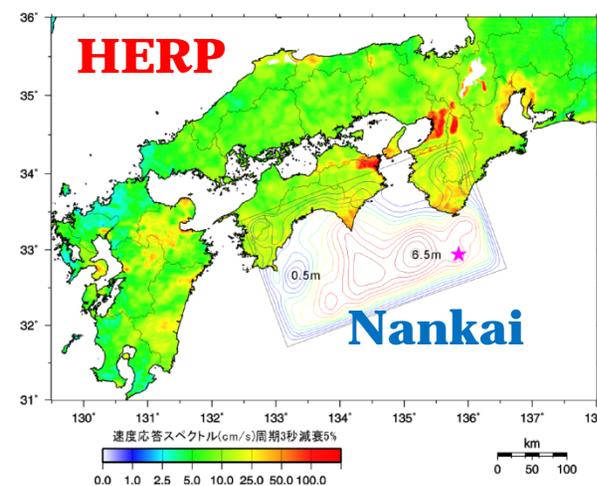
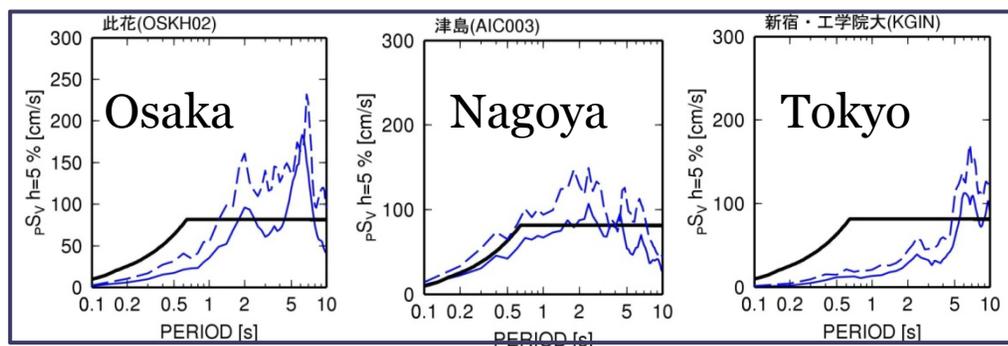
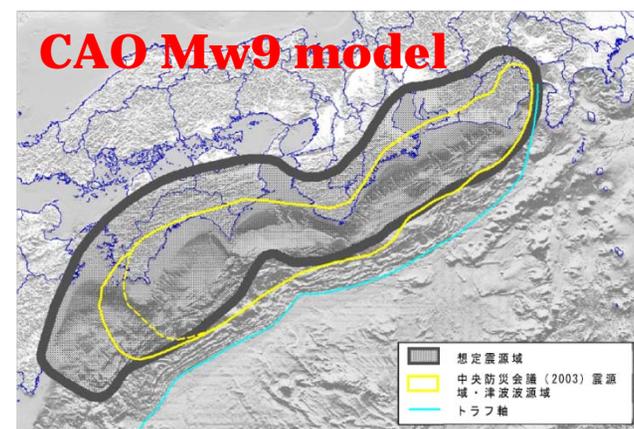
Nankai-trough  
three-connected  
earthquake model  
with revised model  
for major areas

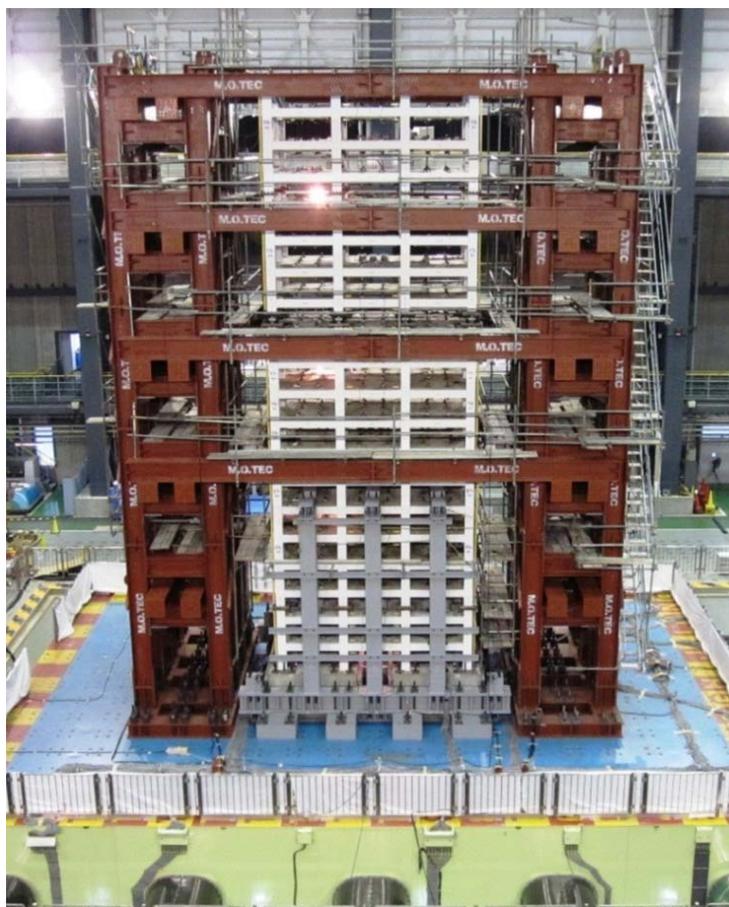
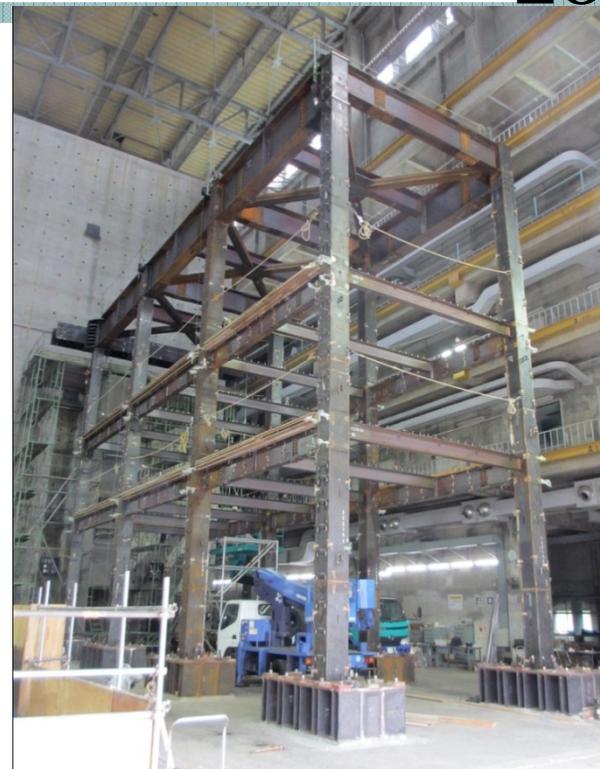
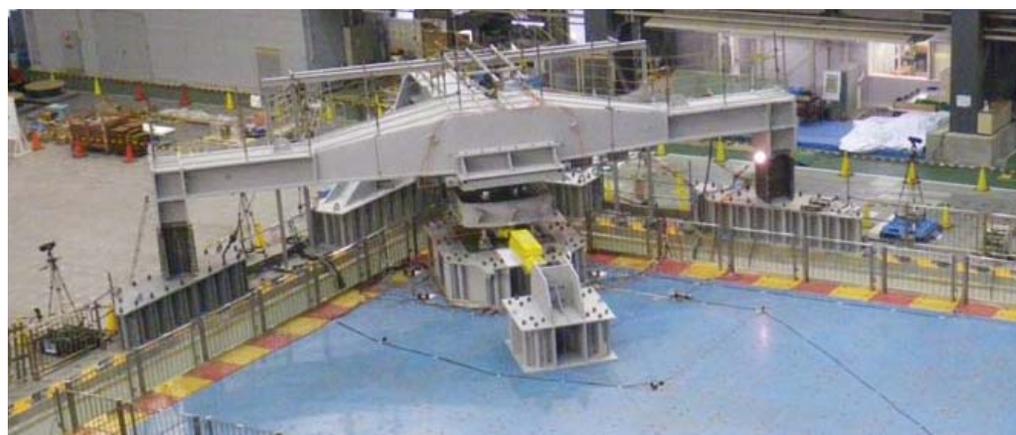
*Structural performance against long-duration and long-period ground motions (full-scale)*

These large-size experiments are carried out under the research cooperation between the BRI and the institutions headed by Obayashi, Kajima and Taisei Co.

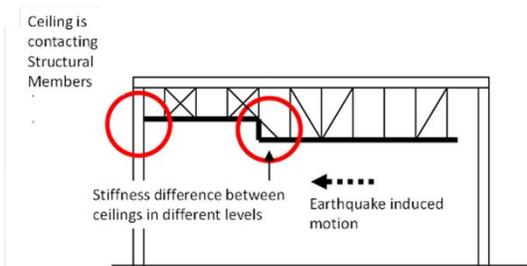
Frequently observed damage by earthquake

- After Geiyo earthquake (2001), a technical advice was issued to recommend putting diagonal braces on ceiling rods, and keep clearance around suspended ceiling. (see left figure)
- Construction companies reported nearly 2,000 cases of fall down of ceilings during Tohoku earthquake. Examples with/without injury are compared. (see right figure)

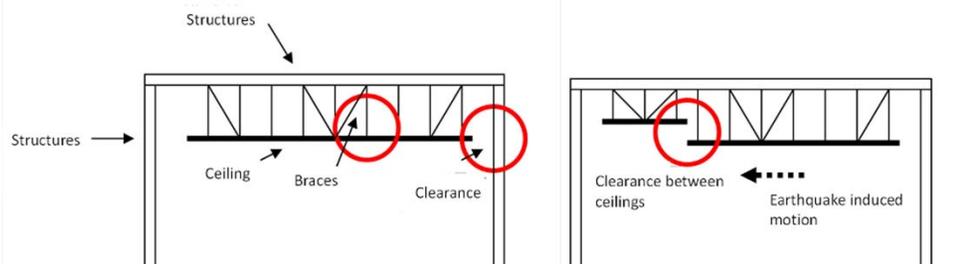
Recommended method in an MLIT technical advice

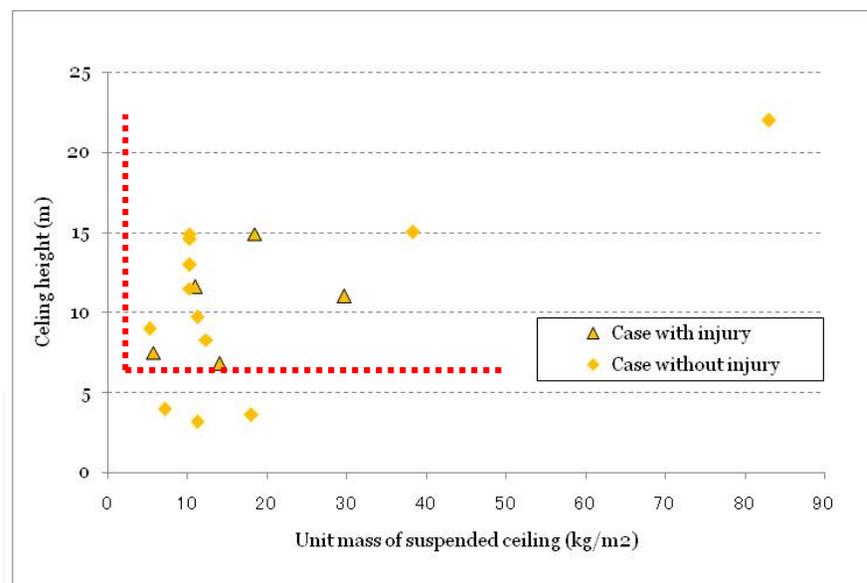
Mass and height of ceiling damaged by earthquake

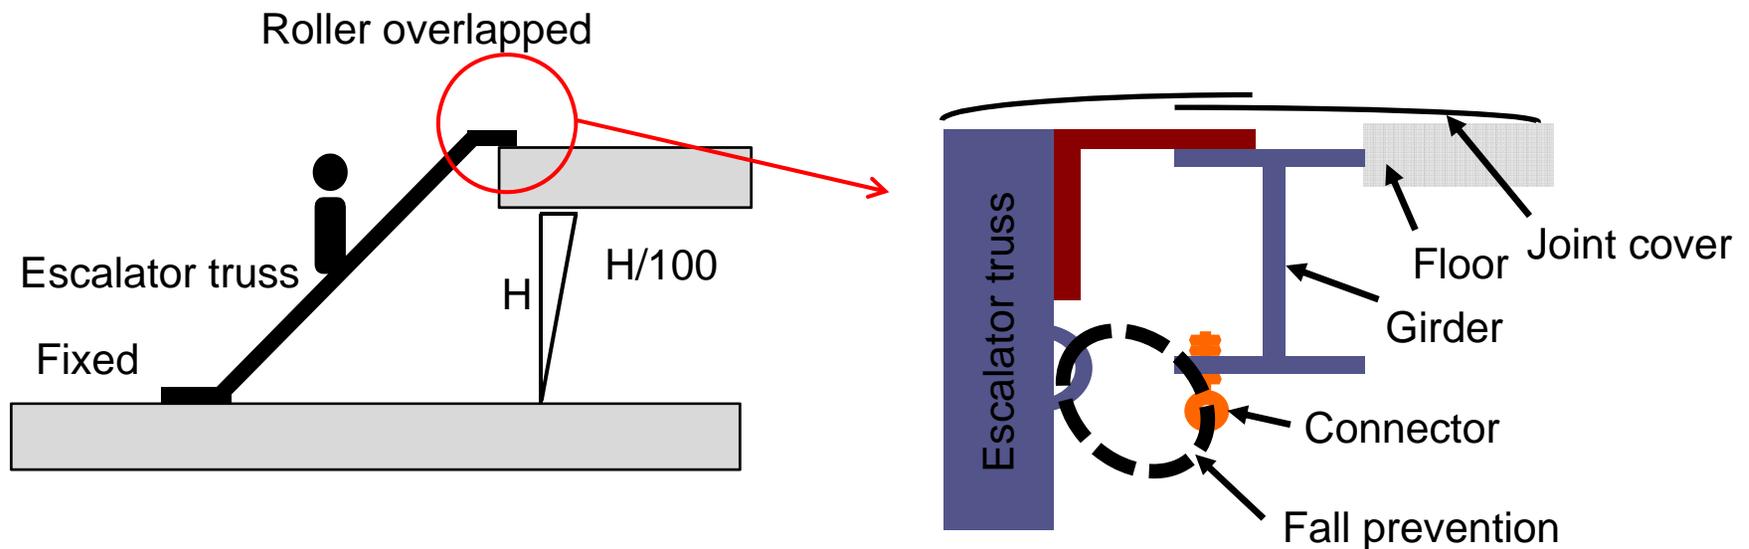
- *(Tentative) Requirement from  $H/100$  (current) to  $H/40$*
- *(Tentative) Exceptional relaxation to  $H/100$  in case of fall prevention device*

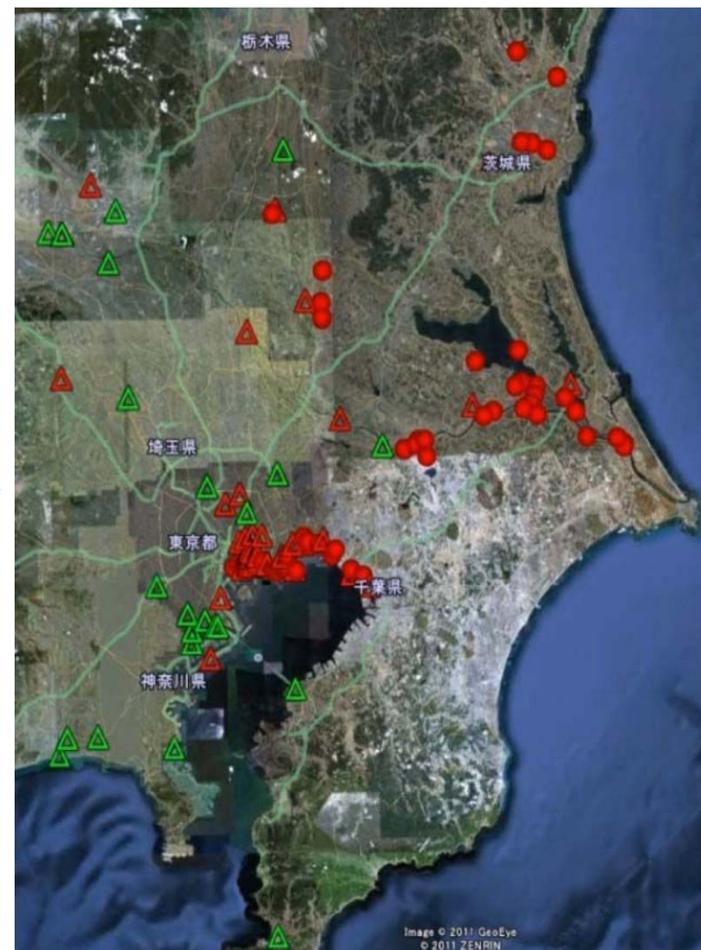
- Liquefaction evaluation was made by  $F_L$ -method at 112 sites in Kanto area, the results were compared with observations.
- Liquefied sites (●) are all predicted ( $F_L \leq 1$ ) but many non-liquefied sites are cautioned (△).
- Improvement of evaluation accuracy is in need.
- $F_L$ -method requires following information.
  - N-value by standard penetration test (SPT)
  - fine fraction content
  - water level
  - maximum design horizontal acceleration at surface
  - earthquake magnitude

Liquefied sites	Non-liquefied sites
$F_L \leq 1$	53 ●	35 △
$F_L > 1$	0 ●	24 △

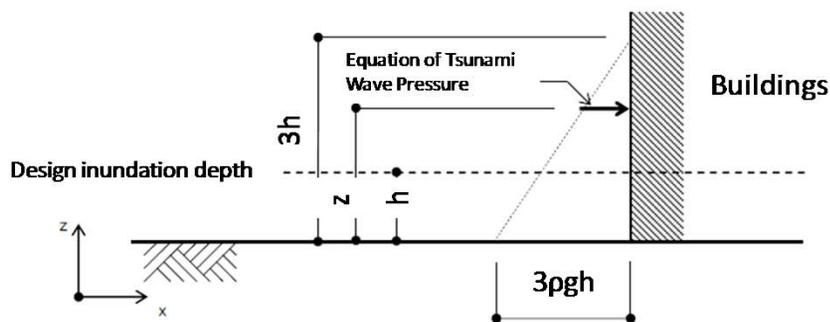
Equation of Tsunami Wave Pressure:  $q_x = \rho g (3h - z)$

$q_x$ : design tsunami wave pressure ( $\text{kN/m}^2$ )

$\rho$ : density of water ( $\text{t/m}^3$ )

$g$ : gravitational acceleration ( $\text{m/s}^2$ )

$h$ : design inundation depth (m)

$z$ : height from the ground ( $0 \leq z \leq 3h$ ) (m)

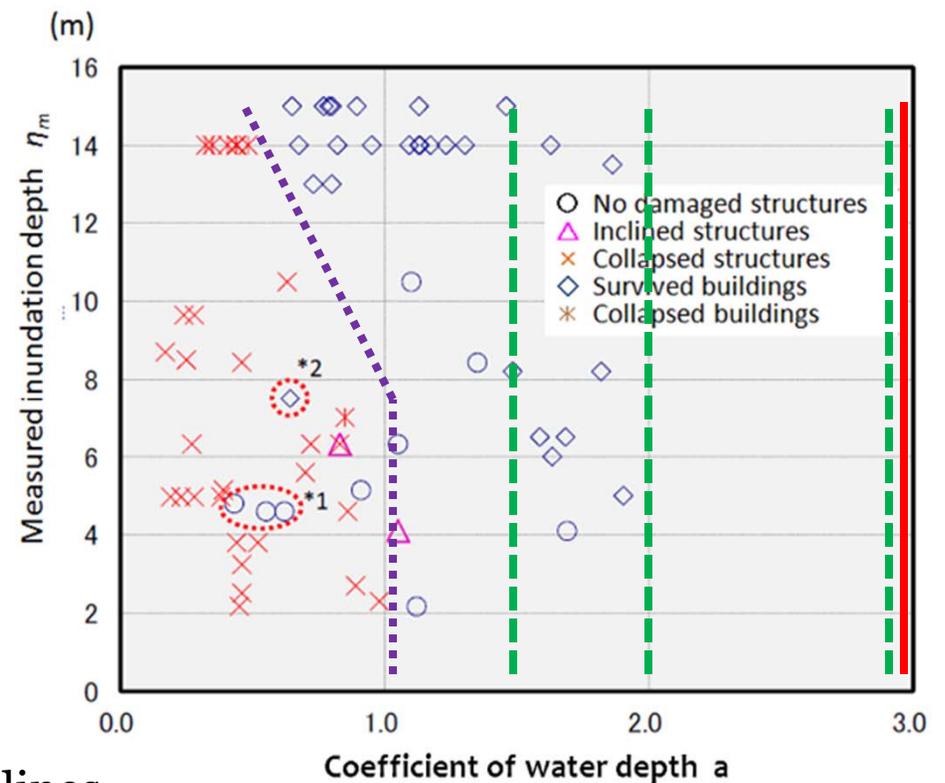
- Previous guidelines
- - - Partially relaxed current guidelines (tentative guidelines)
- ⋯ Observed results by Tohoku Japan earthquake

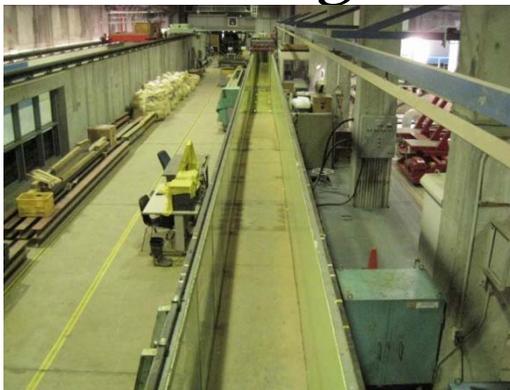
Waterway experiment

- BRI, Kajima Co. and U. of Tokyo have carried out waterway experiments in order to develop (improve) CFD (Computational Fluid Dynamics) technique for evaluation of tsunami pressure on buildings.*
- Improved CFD technique will be applied to evaluate the effects of openings, water infiltration, etc.*
- AIJ discusses adding new chapter of tsunami loads on buildings into “(Revised) Recommendations for Loads on Buildings” in 2014.*

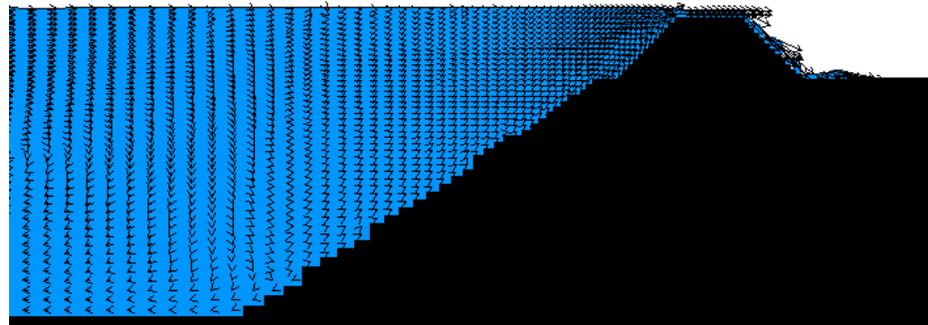
Numerical simulation of Tsunami over seawall
