# DEVELOPMENT OF RESILIENT REINFORCED CONCRETE BUILDING STRUCTURE

Seitaro Tajiri, Hiroshi Fukuyama, Tomohisa Mukai Building Research Institute

Toshikazu Kabeyasawa The National Institute for Land and Infrastructure Management

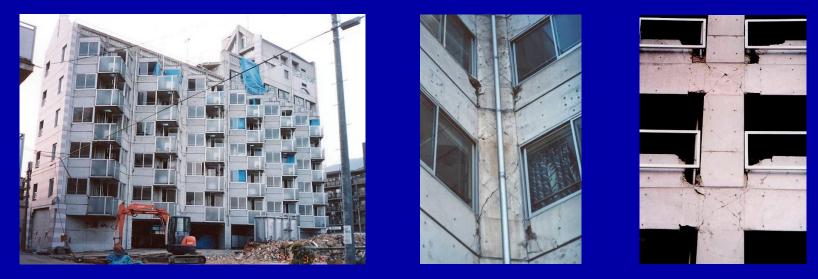
#### Great Hanshin-Awaji Earthquake in 1995

Many buildings avoided collapse and saved people's lives as required by the law

Dwelling functions were lost.

Restoration costs were so expensive that these buildings were demolished and rebuilt.

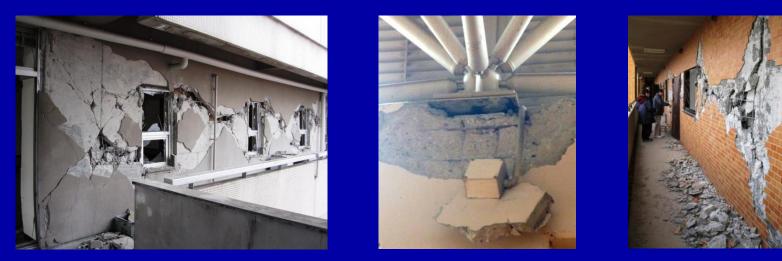
#### The 2011 Great East Japan Earthquake

- Government buildings, which should have become on-site countermeasure centers, were damaged.
- Gymnasiums expected to be used as evacuation sites were damaged.

• Apartment houses were so badly damaged that the dwelling functions were lost.

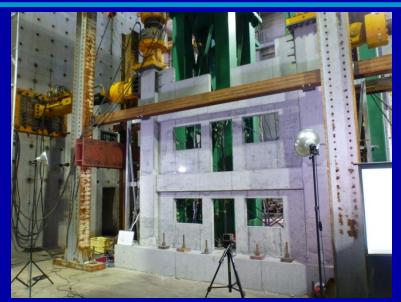
### **Comparison with Conventional and Proposed**

The strength of the specimen without slits showed more than twice as high as those with slits.

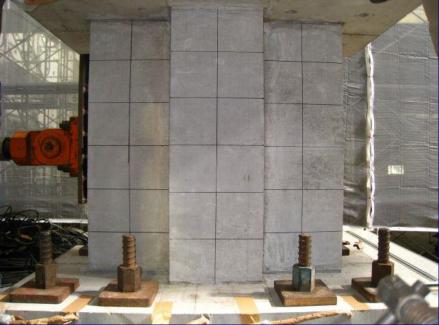
A column with side-walls

- It is necessary to develop member models which define beams and columns with nonstructural walls for structural designs.
- -> Experimental study to clarify structural properties of beams and columns with nonstructural walls.

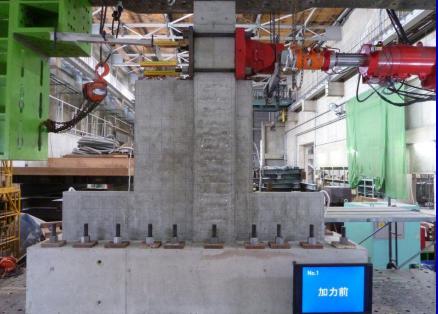
A beam with side, hanging and standing walls

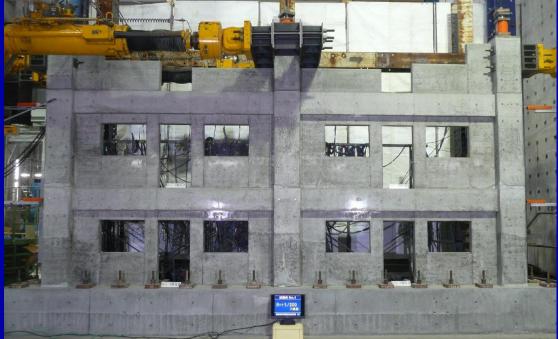
# Frame with Nonstructural Walls

- It is necessary to decide rigid zones at the end of a beam and at the end of a column.
- In the case that a mullion-wall is attached, it is necessary to consider its influence.
- -> Experimental study to evaluate the structural properties of frames with nonstructural walls.

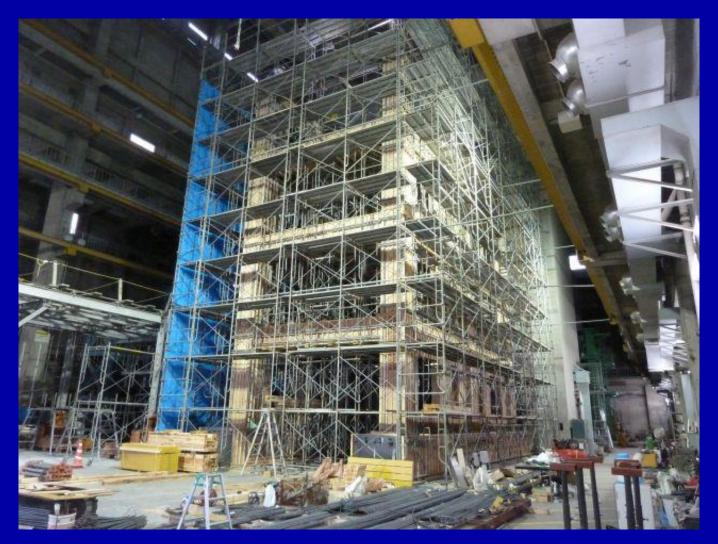
### **Full-scale Test**

#### Five-story full-scale test will be conducted soon.
