Earthquake Aftershocks— Entering Damaged Buildings

Ronald P. Gallagher, R. P. Gallagher Associates, Inc.
Paul A. Reasenber, U. S. Geological Survey
Chris D. Poland, Degenkolb Engineers

ATC TechBrief

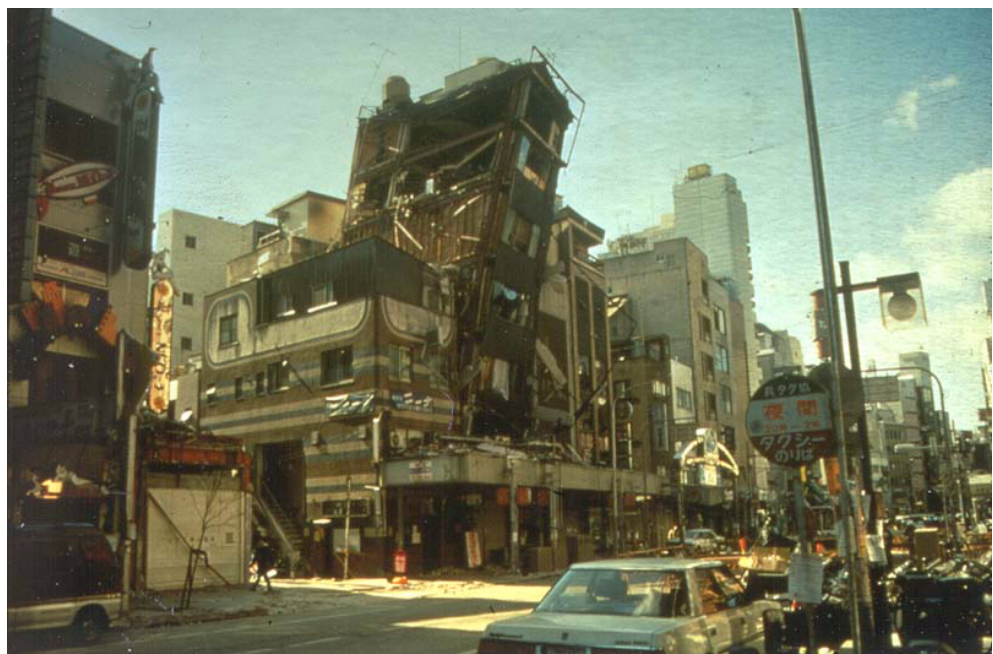
Figure 1: Buildings such as this office building in Kobe, Japan, are generally unstable and may collapse in an aftershock.

Earthquake aftershocks can cause significant damage to buildings. Occasionally, they can result in building collapse. This risk is highest for previously damaged buildings (Figure 1).

After a large earthquake, a state of suspended animation often exists. If the mainshock has caused widespread damage, some buildings may have collapsed and others may be poised to collapse. Many buildings may be damaged and some may have falling hazards (that is, a hazardous situation exists from an item poised to fall) caused by broken chimneys or damage to other nonstructural components. Seriously damaged buildings, such as the one shown in Figure 1, are posted UNSAFE, and entry is prohibited.

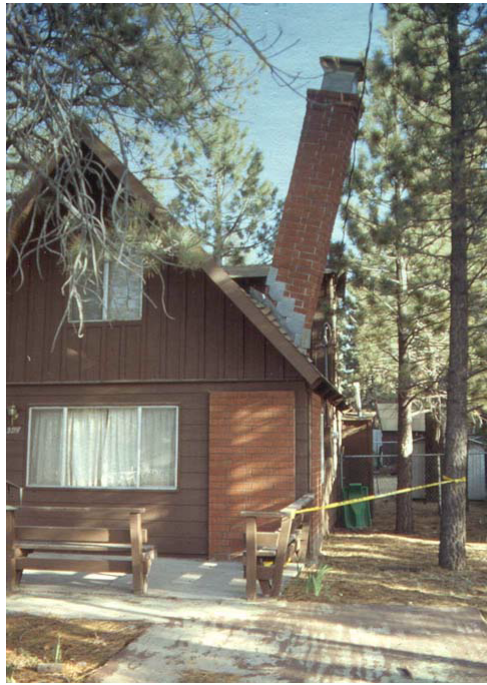
Figure 2: A house with a broken chimney, while posted yellow, RESTRICTED USE, may be entered except for the restricted area.

building can be entered and used, but some restrictions have been placed on its use. The house in Figure 2 has received a RESTRICTED USE posting because of the

leaning chimney. The house can be occupied, but the fireplace may not be used, the room with the broken chimney may not be entered, and an area outside the house and under the chimney is restricted.

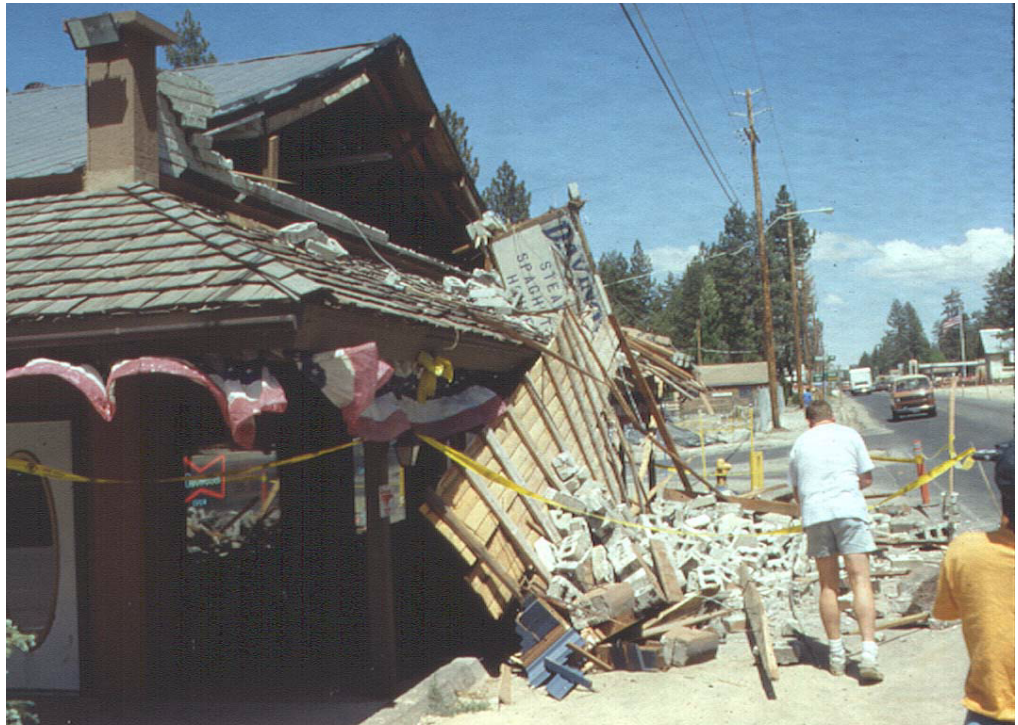
Figure 3: The M 6.2 aftershock of the M 7.5 1992 Landers, California, earthquake caused this gable end wall to collapse.

The drop in stress on the mainshock fault causes a redistribution of stresses in all nearby faults. Sometimes, an increased stress is great enough to trigger aftershocks on these nearby faults. For example, three hours after the magnitude 7.5 1992 Landers, California, earthquake, a magnitude 6.2 aftershock occurred in the vicinity of Big Bear Lake on another fault system approximately perpendicular to the Landers fault system. The aftershock epicenter was 35 km from the mainshock epicenter. The aftershock caused significant damage, including partial collapse of a building, as shown in Figure 3.

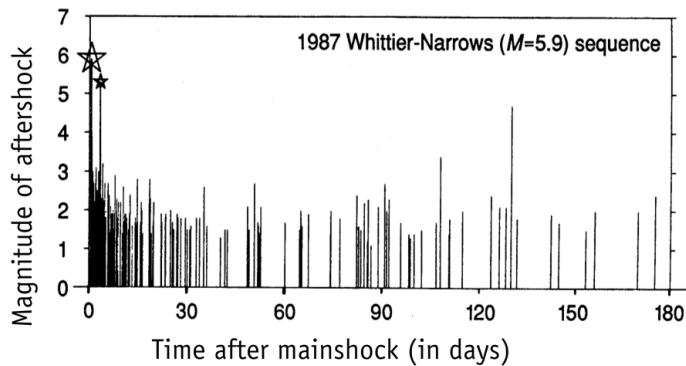
Figure 4: The aftershock sequence after the M 5.9 1987 Whittier Narrows, California, earthquake. Each line represents an aftershock.

A mainshock large enough to cause damage will probably be followed by several felt aftershocks within the first hour. The rate of aftershocks dies off quickly with time, as is illustrated visually in Figure 4, and the rate is inversely proportional to the time since the mainshock. Aftershocks at each magnitude level decrease with time at the same rate. *On average*, the second day will have approximately 1/2 the number of aftershocks of the first day, and the tenth day will have approximately 1/10 the number of the first day. These patterns describe only the average behavior of aftershocks; the actual times, numbers, and locations of the aftershocks are random. One large aftershock sometimes occurs as much as six months after the main event. For example, a magnitude 5.4 aftershock

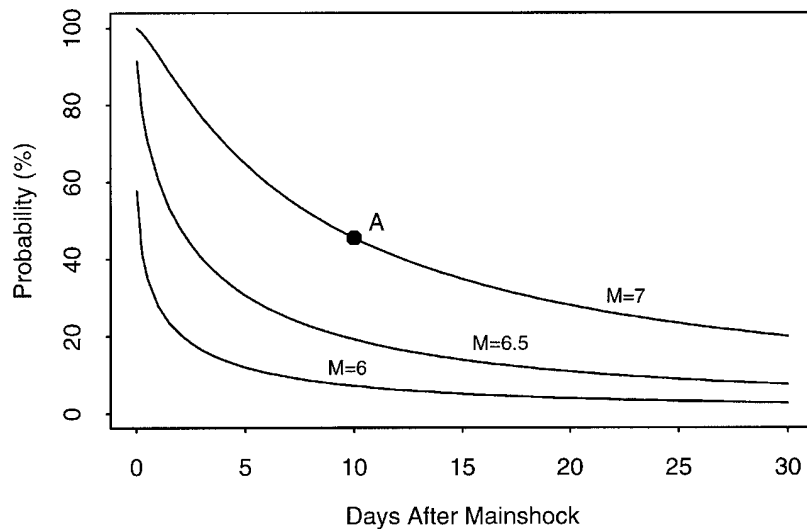
Figure 5: Probability of an aftershock with a magnitude 5.0 or larger occurring somewhere in the aftershock zone during a 7-day period starting at a specified time after a mainshock. Curves shown are for mainshocks of magnitude 6, 6.5, and 7. For example (point A), the probability is 46% during the 7-day period beginning 10 days after an M 7 mainshock. Curves are based on general trends from past earthquakes.

Figure 5 displays the probability of aftershocks of magnitude 5 or larger occurring in a 7-day period, as a function of the magnitude and time since the mainshock. While these curves were developed for California earthquakes, they can be useful elsewhere, in the absence of

more specific information. Point A in Figure 5 indicates that 10 days after a magnitude 7 earthquake, the probability of an aftershock with a magnitude of 5.0 or greater in the next seven days, somewhere in the aftershock zone, is slightly less than 50%. Smaller magnitude aftershocks are more likely, and larger magnitude aftershocks less likely.

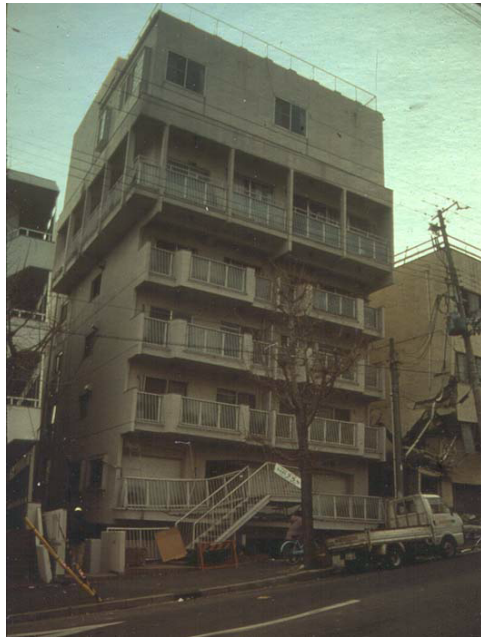
Figure 7: This reinforced concrete building was determined to be stable even though leaning slightly, because of the presence of substantial concrete shear walls on all sides.

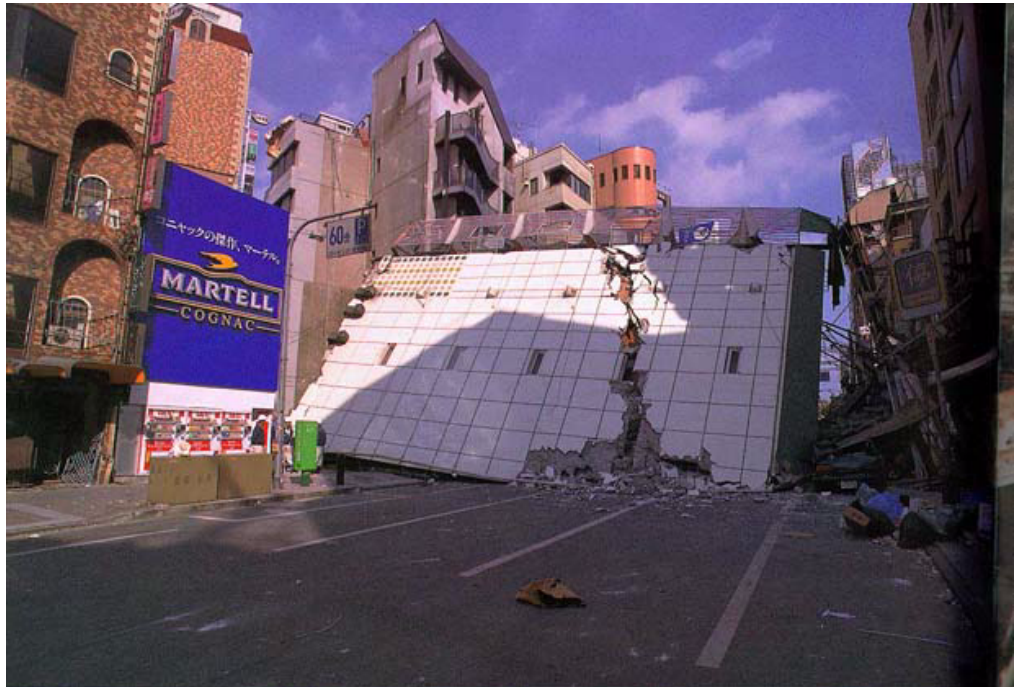
Figure 8: This Kobe office building was unstable after the mainshock and collapsed under its own weight in less than 24 hours.

The importance of assessing the stability of a structure is demonstrated in the following example. In the 1989 Loma Prieta, California, earthquake, one seriously damaged residential building developed a lean at the first level. The building was posted UNSAFE and was judged to be unstable when the local building department monitored the lean and determined that it was increasing due to the weight of the building. Collapse occurred within 48 hours. Figure 8 shows a collapsed building that had been standing after the Kobe, Japan, earthquake, but was unstable.
