OBSERVED RESPONSE OF SEISMICALLY ISOLATED BUILDINGS DURING THE 2016 KUMAMOTO EARTHQUAKE

Mineo Takayama, Keiko Morita
Faculty of Engineering, Fukuoka University
Fukuoka, Japan

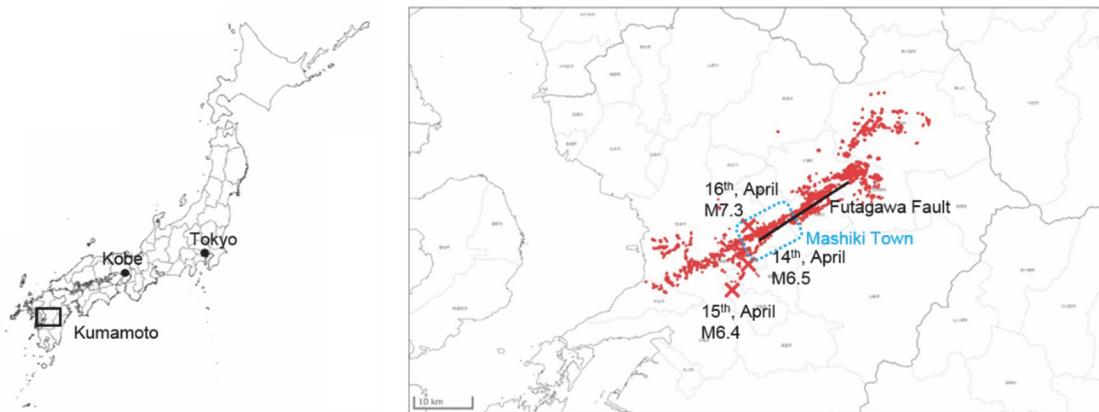
Figure 1 shows the epicenters of the Kumamoto Earthquakes and the distribution of fissures appearing on the ground surface. Most of the fissures occurred along the Futagawa fault zone. The largest earthquake on April 16th is believed to have been caused by activity in the Futagawa fault zone. The probability of an earthquake occurring within the next 30 years in this zone had been assessed to be between 0% - 0.9%. According to announcements by the Kumamoto Prefecture (as of January 13, 2017), 50 people lost their lives due to causes such as building collapse, and if deaths from related causes such as the burden of living in shelters are included, a total of 181 people died from the series of earthquakes in Kumamoto. For residential structures, 8,373 completely collapsed, 32,593 partially collapsed, and 139,637 were partially damaged. The number of evacuees peaked at 183,882 on April 17, 2016.

Figure 1. Epicenters of the Kumamoto Earthquakes and distribution of fissures appearing on the ground surface (processed Geospatial Information Authority of Japan (GSI) data [1]).

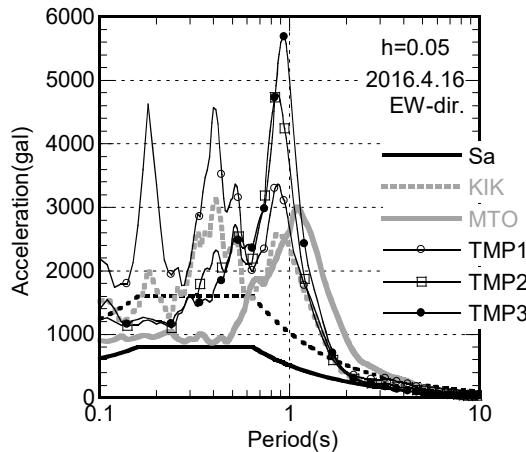
Figure 2 is the acceleration response spectrum (at 5% damping) based on the mainshock (EW component) records measured at Mashiki Town [2]. In the figure, MTO is a seismograph installed at the Mashiki Town Office, while KiK-net Mashiki (KIK), which is operated and maintained by the National Research Institute for Earth Science and Disaster Resilience (NIED), is installed around 650 m north of Mashiki Town Office. TMP1, TMP2 and TMP3 are observation points temporarily set up by Hata et al., and were able to record the April 16 ground motion [3]. The solid black line shows the Building Standards Law spectrum specified for engineering bedrock, while the dotted black line is the same spectrum multiplied by 2 for ground surface equivalent to ground type 2 (zoning coefficient Z = 1.0). The observation record for TMP3, was taken in a district where the building collapse rate was high. Based on this spectrum, it can be seen that larger tremors were measured in a southward direction from KIK to TMP1, and then to TMP3. Also, it can be seen that large input seismic motion occurred at Mashiki Town, exceeding the ground motion given in the Building Standards Law.

Figure 2. Acceleration response spectrum for observation records at Mashiki Town [2]/[3] (April 16 mainshock record, EW component).

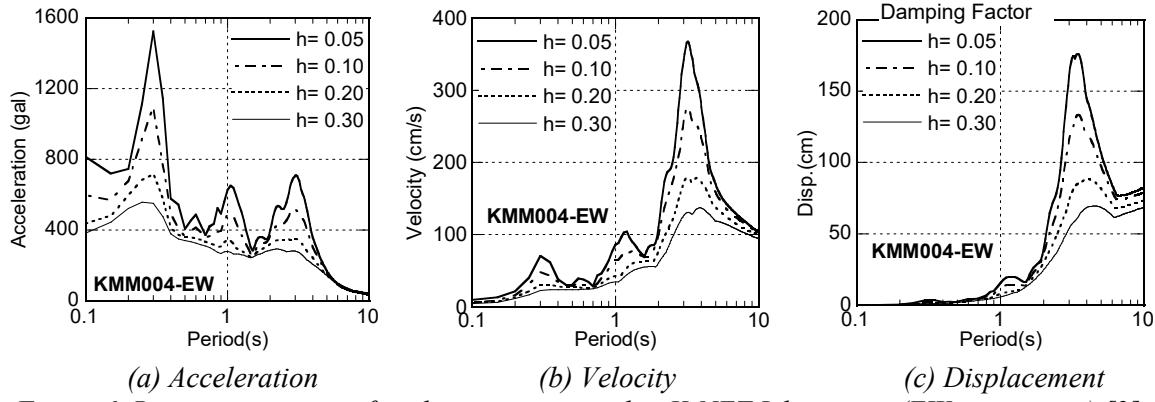
The seismograph station K-NET Ichinomiya, located close to Medical Facility M in Aso City, measured a seismic intensity of 6-lower during the main shock. The record on the scratch plate in the isolation level of Medical Facility M immediately after the foreshock showed a locus smaller than 5 mm in diameter. A single amplitude of 46 cm was recorded during the main shock, which indicates its severity. Also, the dominant period of the seismic motion measured at K-NET Ichinomiya was 3 seconds as shown in Figure 6, and the amount of deformation of the isolation level estimated from the displacement response

spectrum was well over 1 m. The large difference between this and the response deformation at the medical facility **M** in Aso City requires investigation.

Figure 6. Response spectrum for observation record at K-NET Ichinomiya (EW component) [2].
