Simplified Seismic Assessment of Detached, Single-Family, Wood-Frame Dwellings

FEMA P-50 / May 2012

APPLIED TECHNOLOGY COUNCIL
201 Redwood Shores Parkway, Suite 240
Redwood City, California 94065
www.ATCouncil.org

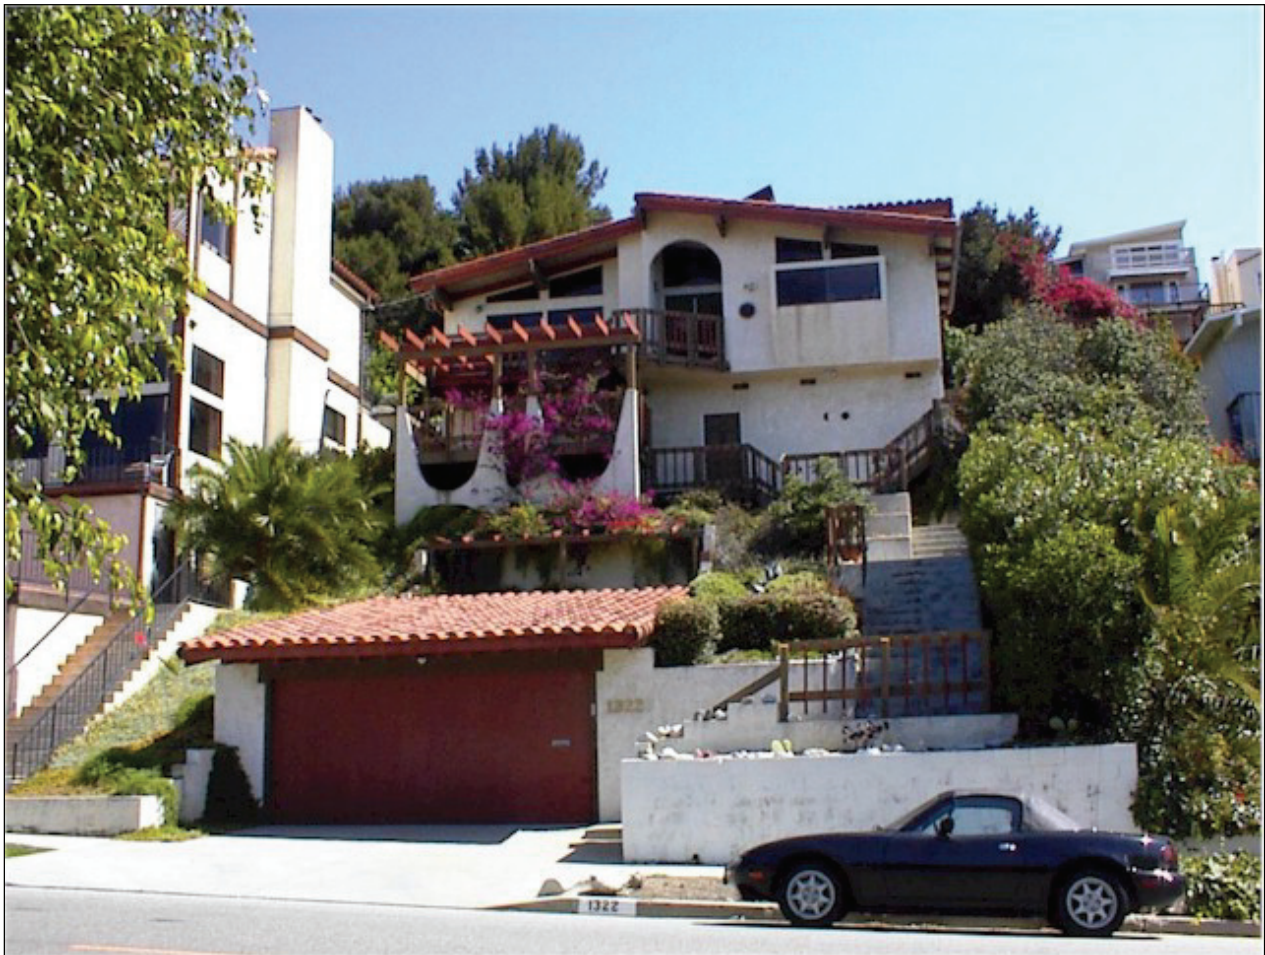
Simplified Seismic Assessment Form
For Detached, Single-Family, Wood-Frame Dwellings
 (Please print all information)

This house is a hillside home located on a steep slope. The house is approximately 37 years old with split-level floors and several other irregularities. Despite the presence of anchor bolts at the foundation, there are many other penalized elements in the dwelling.

D+
Grade

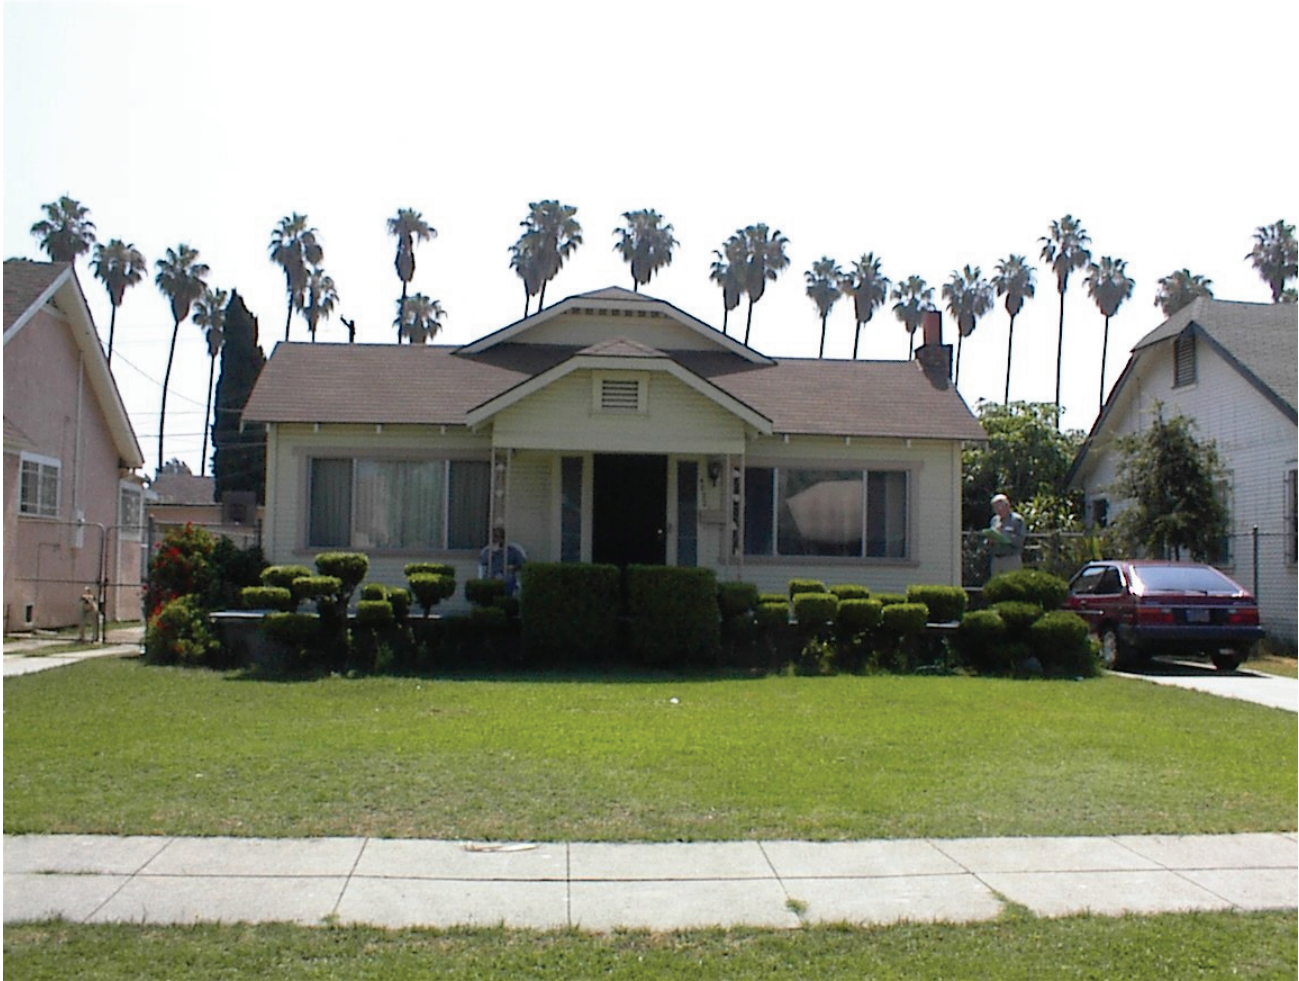
Simplified Seismic Assessment Form
For Detached, Single-Family, Wood-Frame Dwellings
 (Please print all information)

This house in southern Los Angeles was built prior to 1977 but was seismically rehabilitated after the 1994 Northridge earthquake.

B
Grade

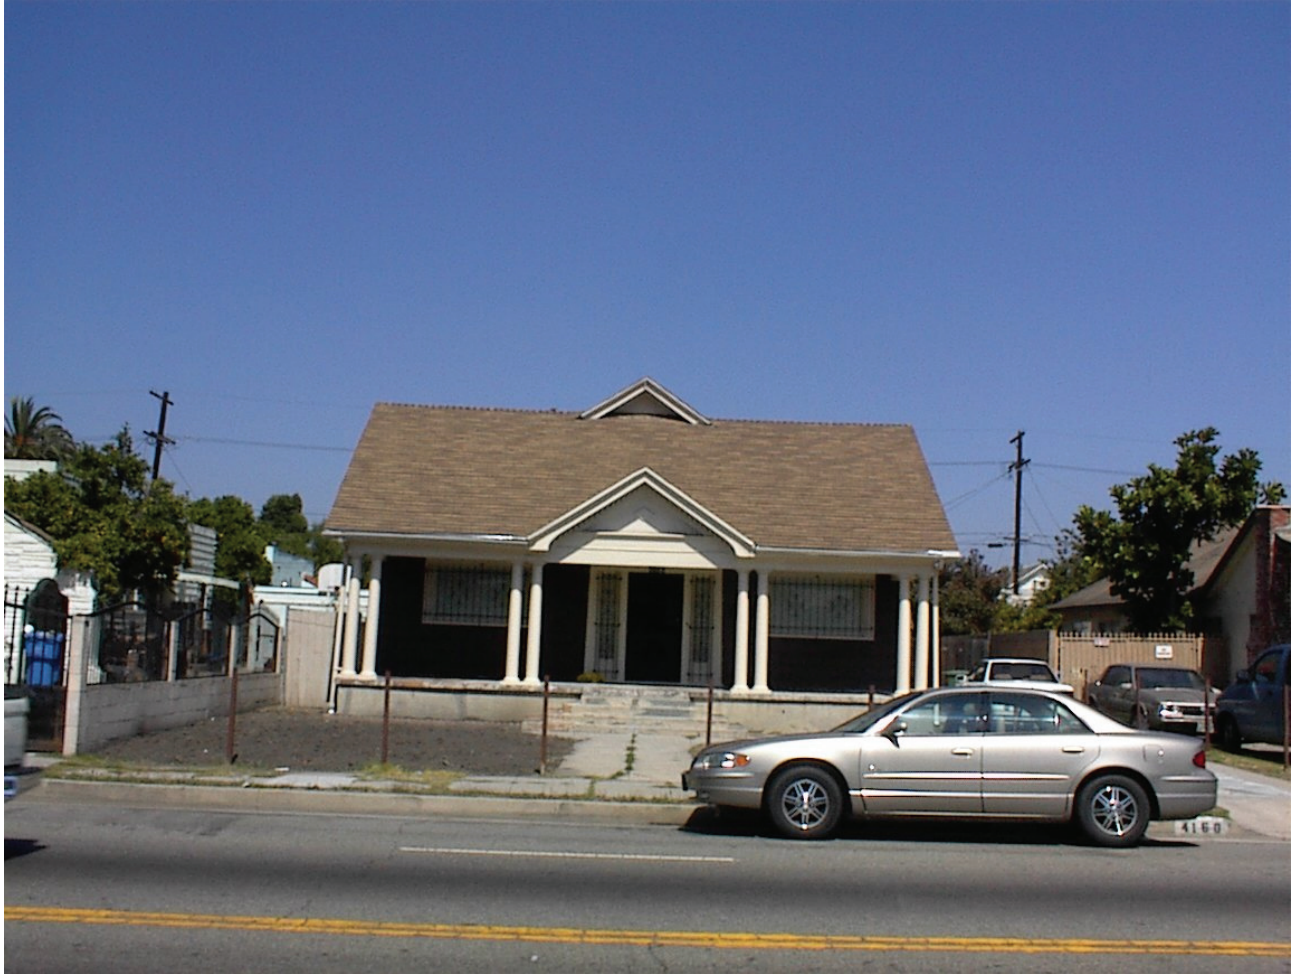
Simplified Seismic Assessment Form
For Detached, Single-Family, Wood-Frame Dwellings
 (Please print all information)

This single-story home has a raised floor supported by an unbraced cripple wall. Additionally, the cripple wall is not bolted to the foundation.

D
Grade

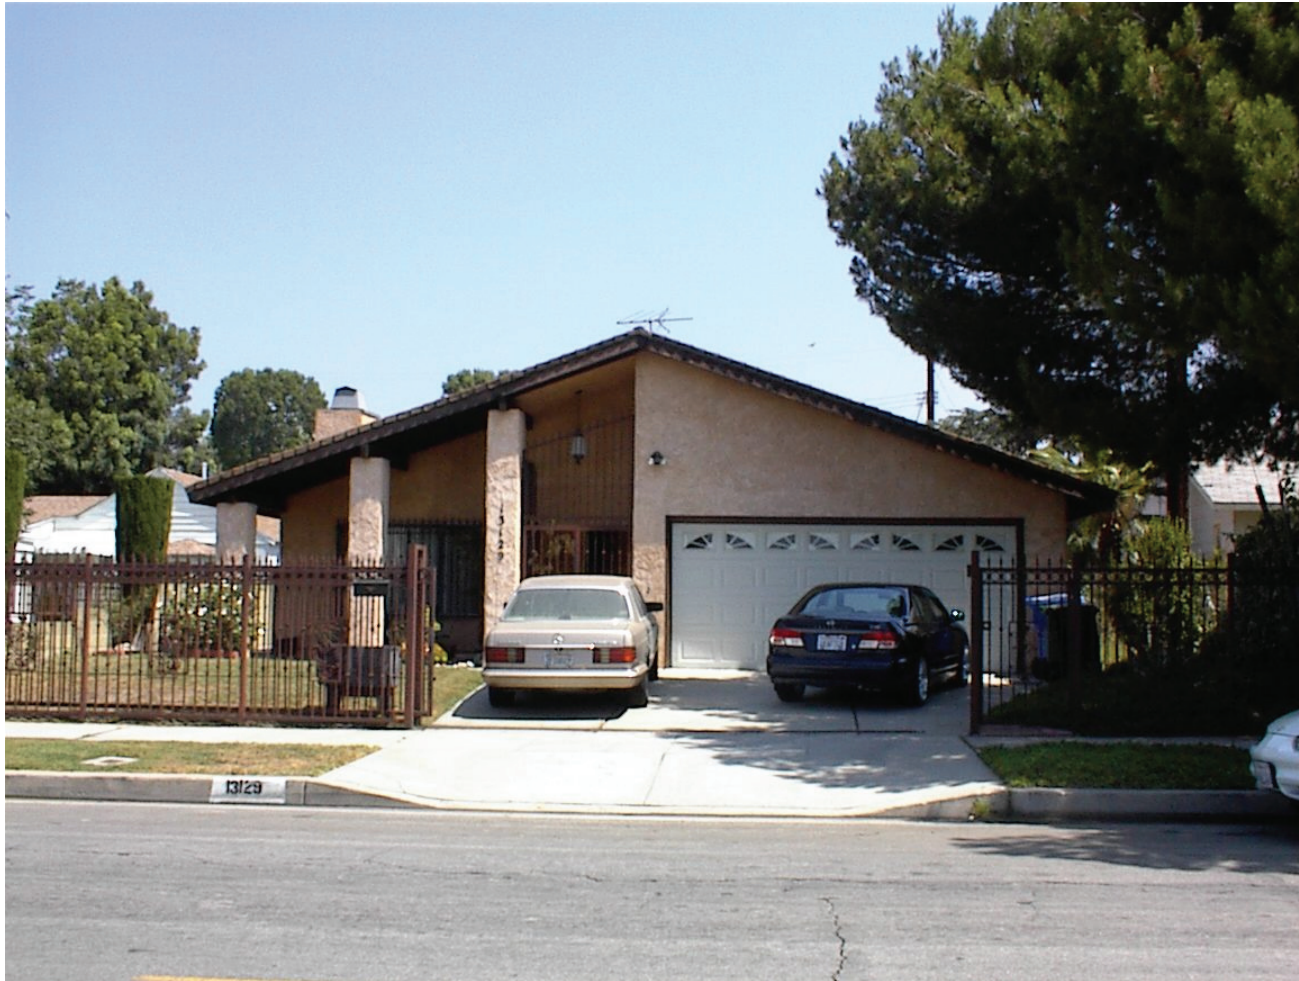
Simplified Seismic Assessment Form
For Detached, Single-Family, Wood-Frame Dwellings
 (Please print all information)

This house is located in the Panorama City area of Los Angeles. Because of the slab-on-grade floor construction, it received no penalties in the foundation section of the form. The house was built after 1977, and received relatively low penalties on the other sections of the form.

B+
Grade

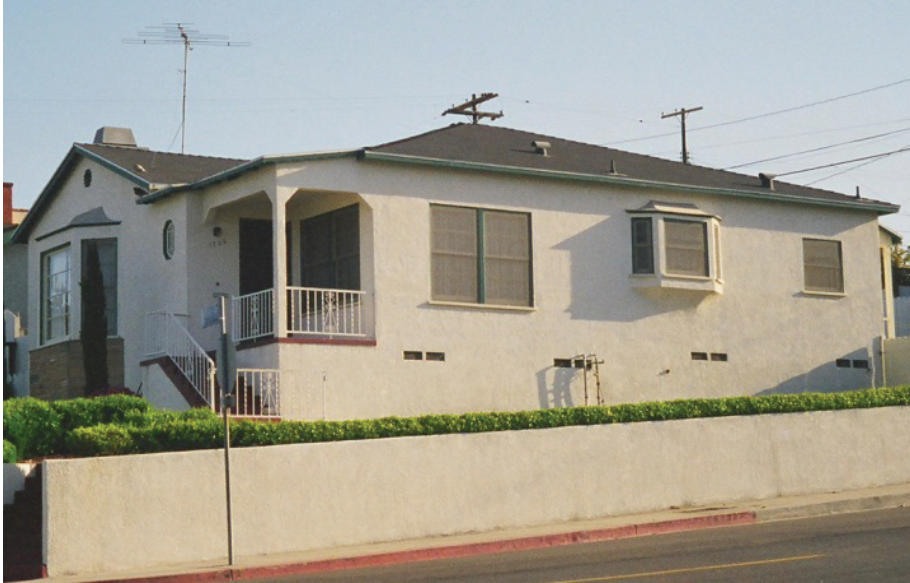
Figure C-2 Typical one-story cripple-wall crawl-space house (from ATC, 2002a).

Cripple-wall dwellings are typically one- and two-story structures (Figures C-2 and C-3) with a perimeter foundation of unreinforced or reinforced concrete, brick masonry, or concrete block. The perimeter foundation typically comprises a stem wall supported by a wider footing. The stem wall

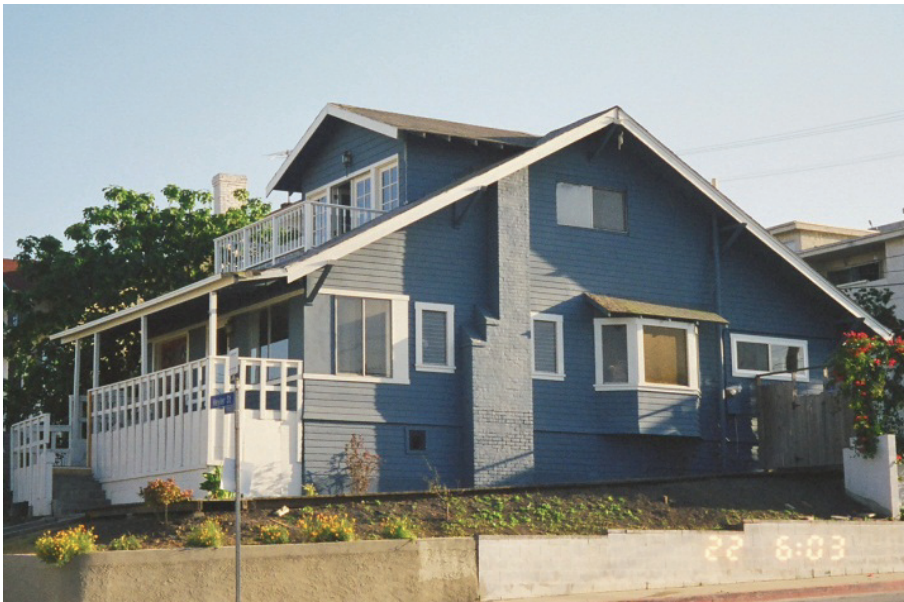
Figure C-3 Typical older one and one-half-story cripple-wall crawl-space house (from ATC, 2002a).

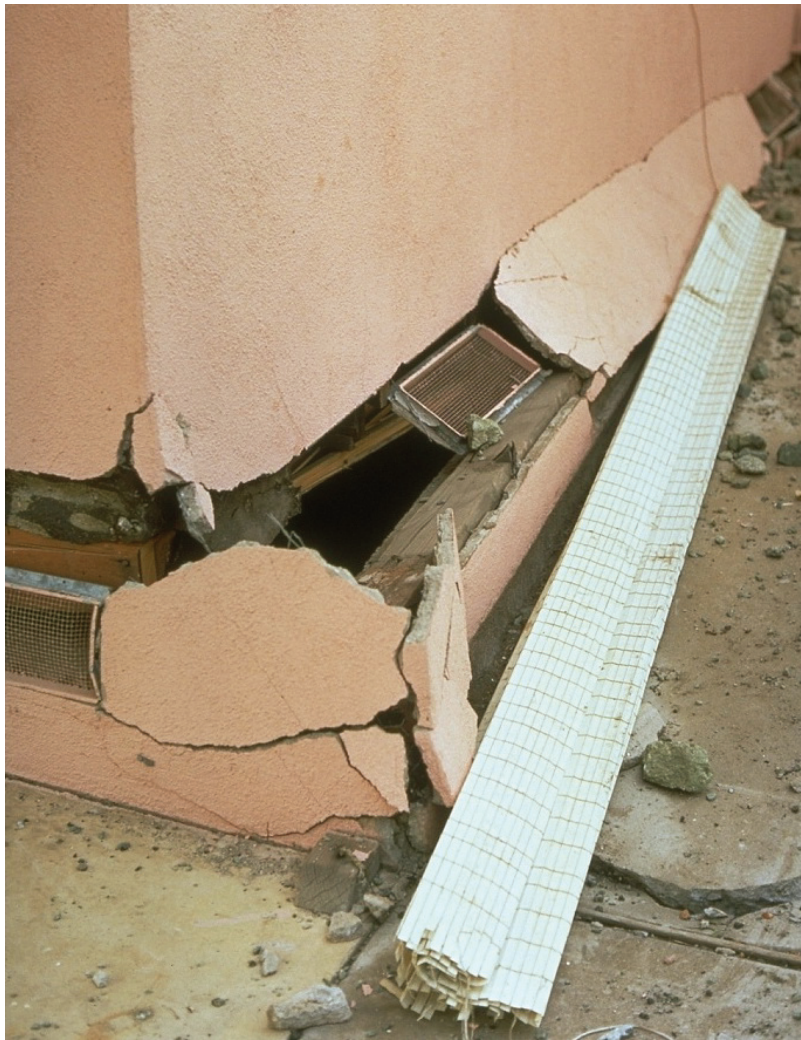
Figure C-5 Typical earthquake damage to a cripple-wall house (from ATC, 2002a).

Two common seismic vulnerabilities in cripple-wall dwellings are the insufficient strength of the cripple wall exterior sheathing [Form assessment item B-8] and the lack of anchor bolts between the cripple wall sill and the foundation [Form item A-5]. Figure C-5 shows typical earthquake damage to the cripple wall. It is also common for crawlspace posts to shake out, leaving the beams and joists with no support [Form item B-8, exterior posts, Form item A-3, interior posts].

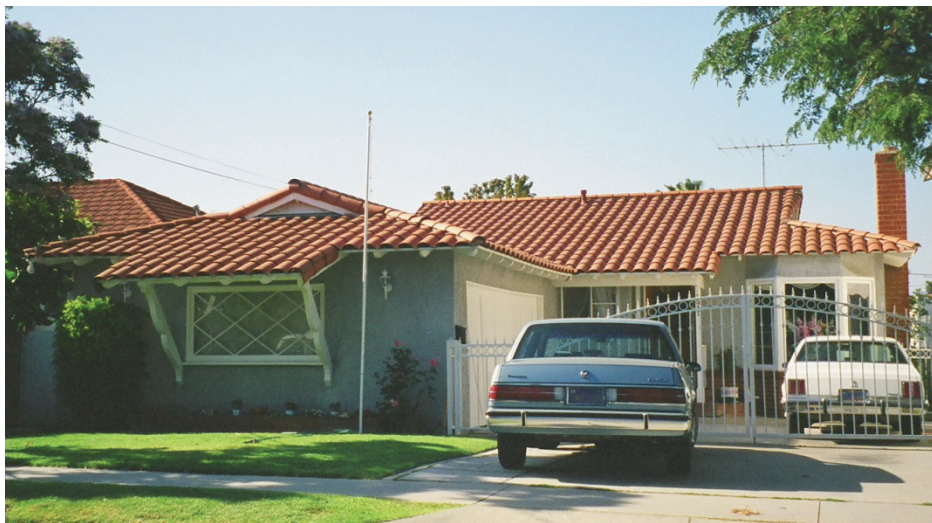
Figure C-6 Typical one-story slab-on-grade house (from ATC, 2002a).

Slab-on-grade dwellings (see example in Figure C-6) have foundations formed by cast-in-place concrete slabs that lie directly on leveled soil. Most of the foundation consists of a ground floor concrete slab of about four-inch

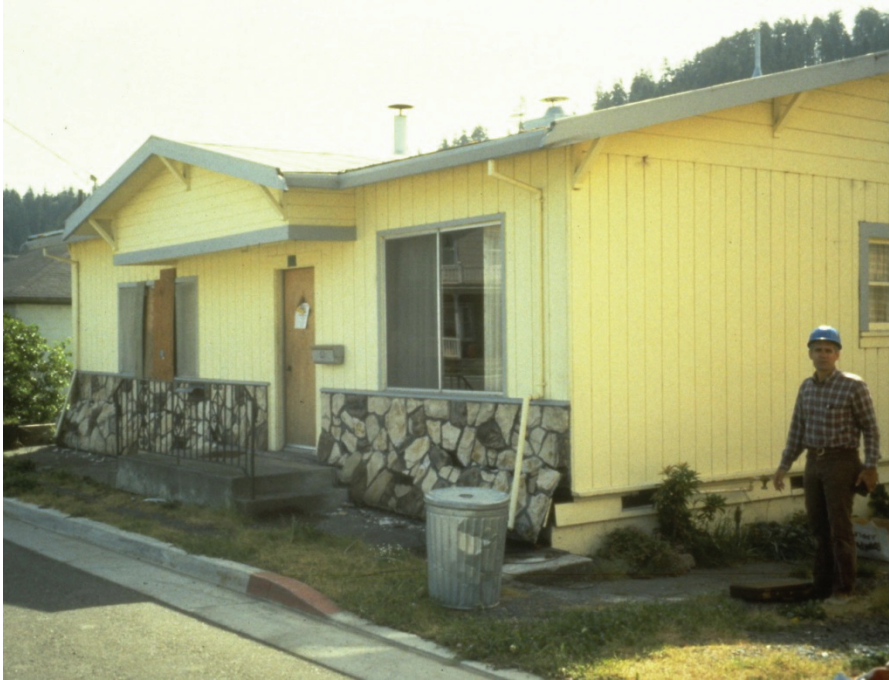
Figure C-10 Damage to a basement-type dwelling where the sill plate slid on the top of the foundation wall (from ATC, 2002a).

A common seismic vulnerability in basement and foundation stem wall dwellings is the lack of anchor bolts between the sill plate and the basement wall [Form item A-5]. A dwelling of this type that was damaged in the Cape Mendocino earthquake of 1992 is shown in Figure C-10; in this case the sill plate slid along the top of the basement wall.

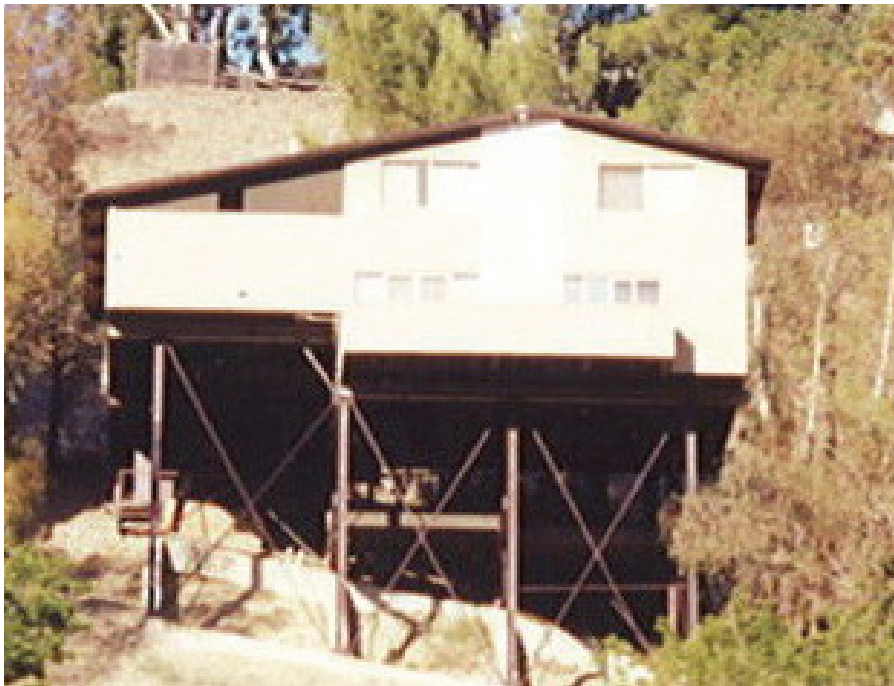
Figure C-11 Post-and-pier foundation house on sloping site (from ATC, 2002a).

Dwellings with post-and-pier foundation can be located either on sloping sites (Figure C-11) or flat sites (Figure C-12). Dwellings of this type have

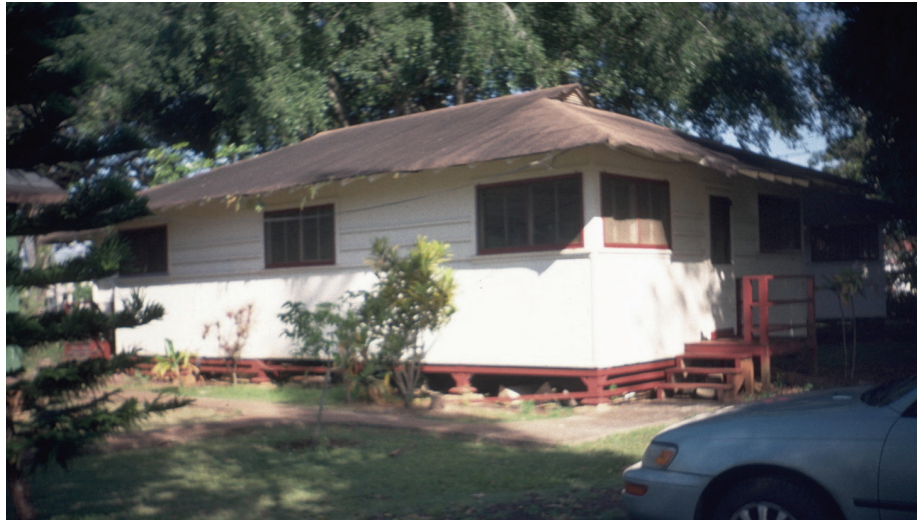
Figure C-12 Post-and-pier house on flat site (from ATC, 2002a).

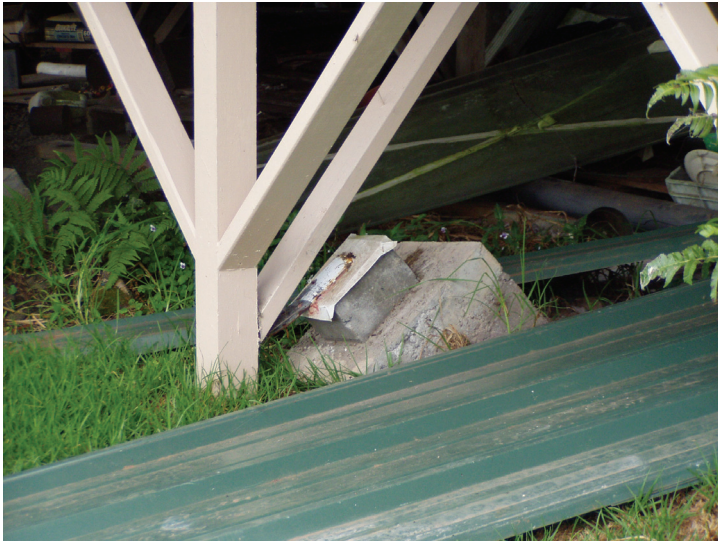
Figure C-13 Earthquake-damaged perimeter post-and-pier foundation (from ATC, 2002a). The diagonally braced post has slid off the pier footing.

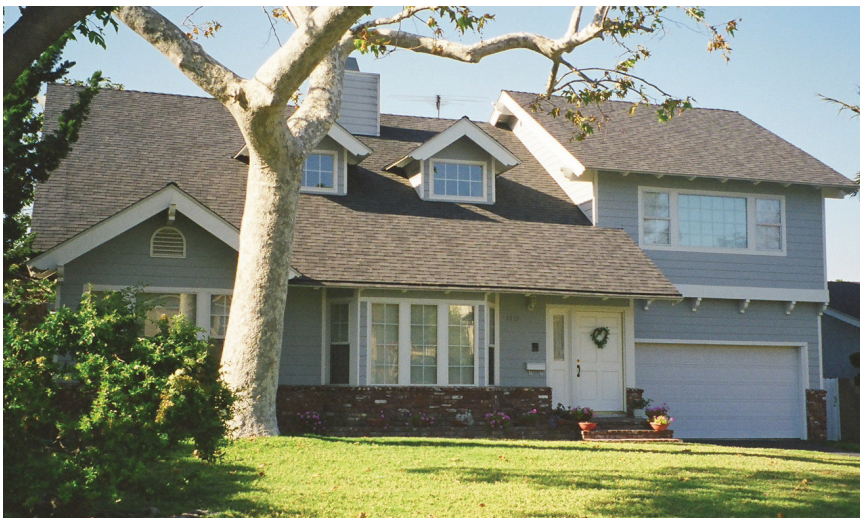
Figure C-14 Split-level house, where the section of flooring above the garage is at a lower level than the main second-floor level (from ATC, 2002a).

Dwellings where adjacent floor levels are separated by less than a full-story height are usually designated split-level dwellings. One typical configuration is shown in Figure C-14. The right part of the dwelling is of two-story slab-on-grade wood-frame construction, with the garage space occupying the lower floor. The attached portion on the left side is of one-story cripple-wall construction. Other split-level dwellings may have all slab-on-grade ground floors at different elevations, and may not have living spaces over the garage. These dwellings may be on either flat or sloped sites. On flat sites, the two lower levels may be at nearly the same elevation.

A common seismic vulnerability in split-level dwellings with living spaces over the garage is inadequate strength of the walls at each side of the garage door to resist seismic forces from the dwelling portion above [Form item B-4]. Damage that was in part initiated by this vulnerability is shown in Figure C-14. Another common vulnerability is insufficient strength of the cripple wall under the single-story portion of the dwelling, when present, causing damage similar to that of Figure C-5 [Form item B-8]. This configuration is also penalized under form item B-1, split-level floor construction.

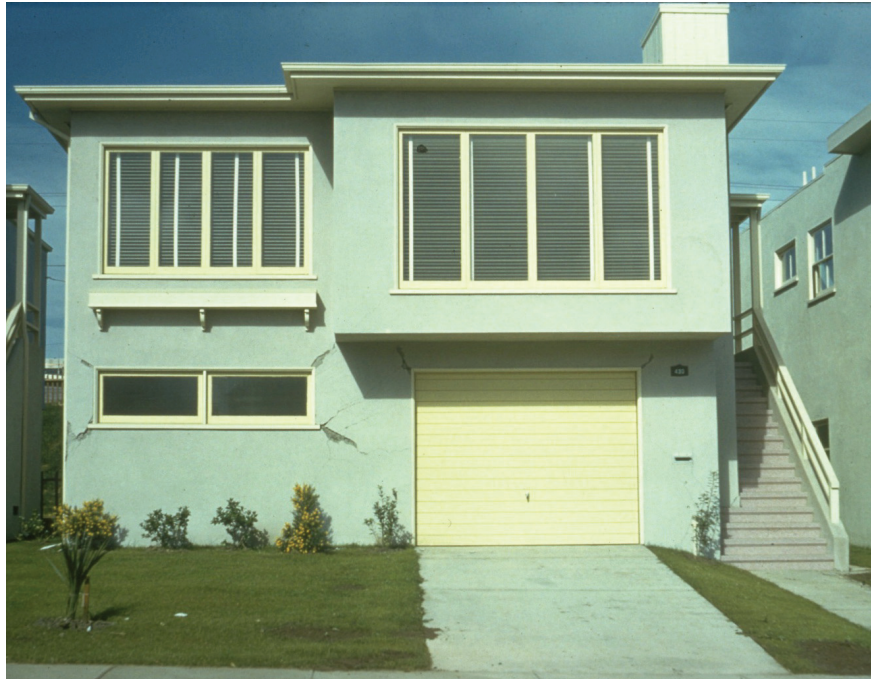
Figure C-15 Cracking damage to stucco first-floor walls (from ATC, 2002a).

A common seismic vulnerability in dwellings is the insufficient lateral-force-resisting strength of the first floor exterior and interior walls due to the large number of door and window openings in these walls [Form item B-2] and the limited strength of the sheathing materials [Form item B-5]. Typical earthquake damage to the first-story walls is shown in Figures C-15 and C-16.

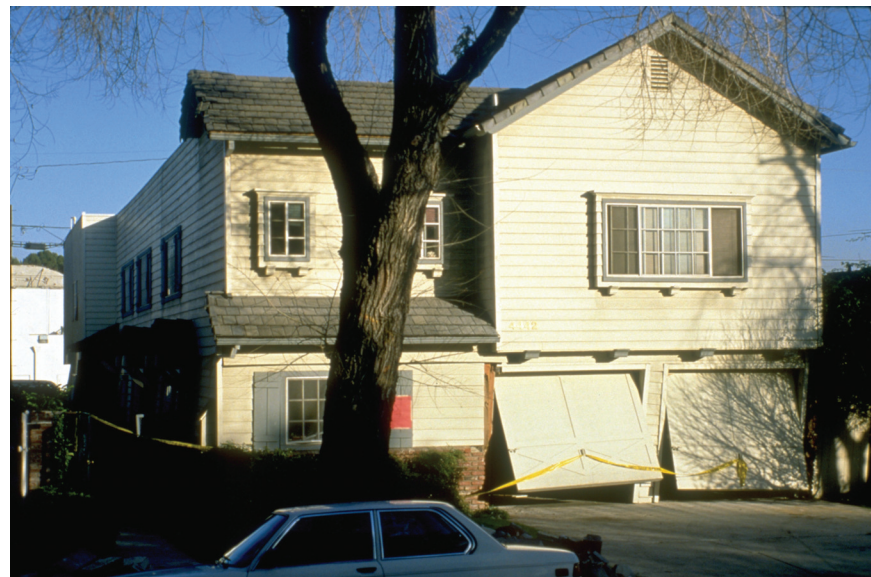
Figure C-16 Damage and racking displacement in the first floor walls (from ATC, 2002a).

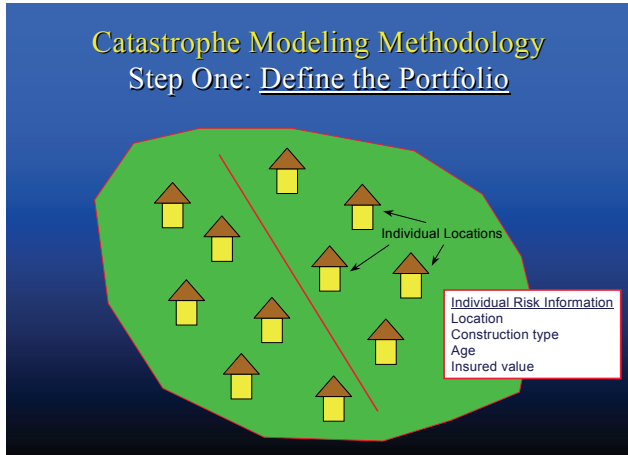
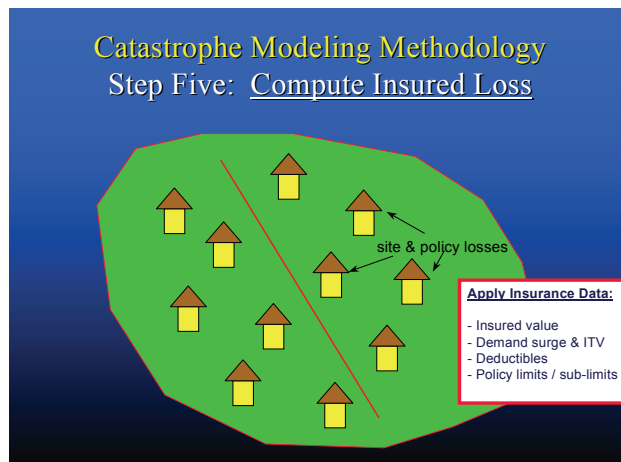
Figure D-1 Generalized portfolio loss estimation analysis methodology.

The overall loss-estimation methodology is displayed in Figure D-1.

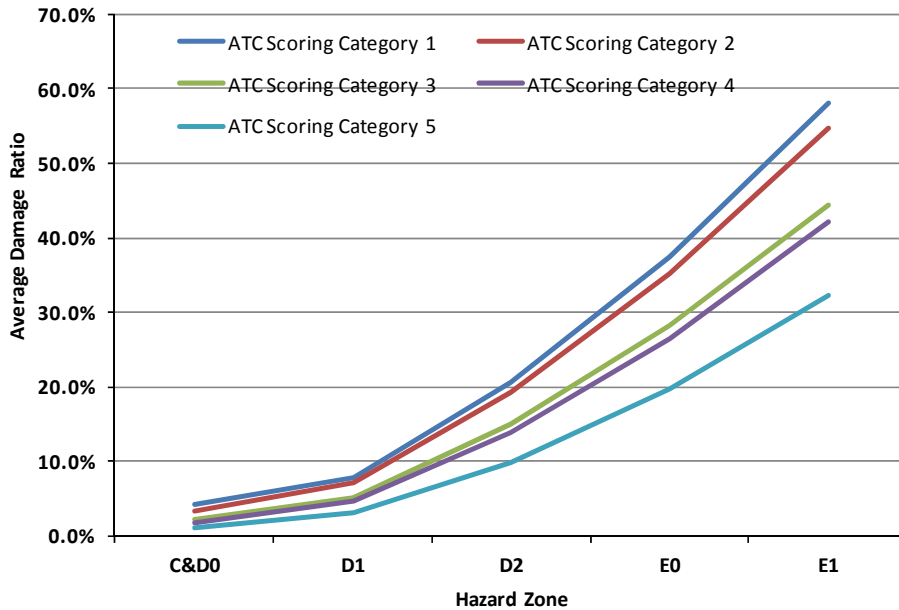
Figure D-2 Average 500-year return period damage ratio across different hazard zones. ATC Scoring Category = Structural Scoring Category. Hazard Zones are defined in terms of Seismic Design Category, as shown in Figures 2-1 through 2-4. Notation here is not subscripted as it is in those figures.

A pictorial representation of the variation of average damage ratio for each Structural Scoring Category across different hazard zones is presented in Figure D-2. Similarly, Figure D-3 shows the variation in damage ratio by Structural Scoring Category, for each hazard zone.

Figure D-2 indicates that damage increases disproportionately to increased hazard, particularly notable beginning in Hazard Zone D2. This reflects the fundamental nonlinearity in structural fragility curves.

In Figure D-2, there is notable proximity of the two curves for Scoring Categories 3 and 4, across the full range of Hazard Zones. This can be understood by observing that Structural Scoring Categories 3 and 4 each have a range of 10 points whereas the “width” of Structural Scoring Categories 1, 2, and 5 are 46, 19, and 15 points, respectively. Likewise, structures in Structural Scoring Categories 1 and 2 show similar scores. This can be understood by recognizing that the two most-penalizing characteristic subtract 14 and 15 scoring points. Most other penalties subtract 1 to 4 points. Therefore, it requires a large number of penalties – and associated structural deficiencies – for a structure to be classified in Structural Scoring Category 1. Only a limited number of structural configurations would be placed in the lowest-scoring category.

Embedded in the model is high-resolution soil classification. Thus, damage results as reported in Table D-4, Figure D-2, and Figure D-3 account for variation in soil amplification at any given site. This differs from the approach used in the FEMA P-50 document to establish the Seismic Hazard Score, where site class D is assumed for all locations. In order to assess the sensitivity of damage ratios to soil conditions, two additional analyses were performed. The first set of analyses used firm soil conditions (site class D, $V_{S30} = 270$ m/s) for all 100 sites. The second set of analyses used site class B as the reference soil condition ($V_{S30} = 760$ m/s) for all 100 sites. As expected, the damage ratios from the analysis using site class D were significantly higher than the corresponding damage ratios obtained by using site class B as the reference soil condition. Overall, for each of the structural and hazard

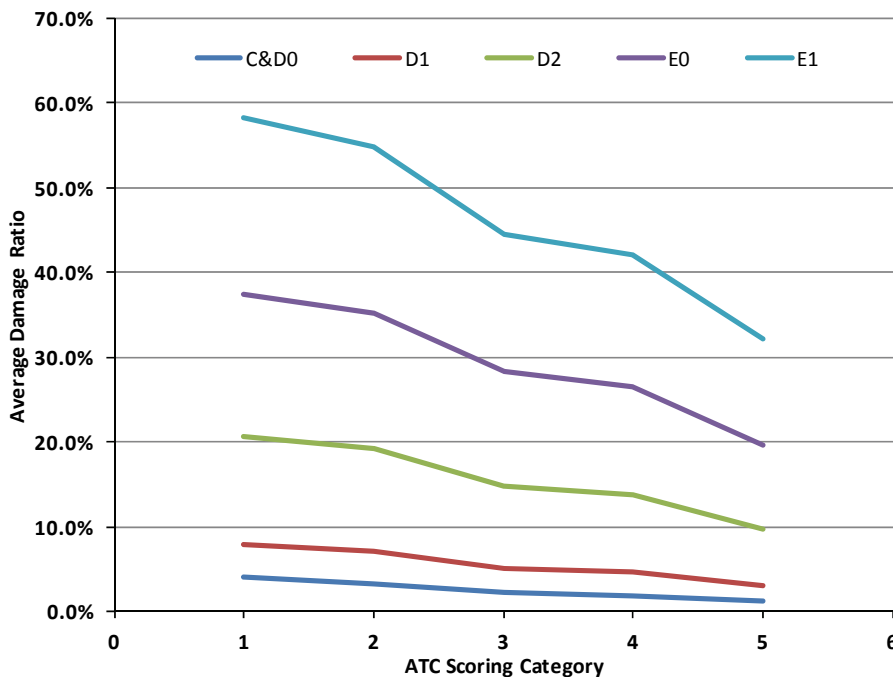
Figure D-3 Average 500-year return period damage ratio across different scoring category. ATC Scoring Category = Structural Scoring Category. Hazard Zones are defined in terms of Seismic Design Category, as shown in Figures 2-1 through 2-4. Notation here is not subscripted as it is in those figures.

As expected, Figure D-3 shows a downward trend in damage with higher Scoring Category, across all Hazard Zones. Figure D-3 also shows that the difference in damage between a good-performing structure and a poor-performing structure are more dramatic in the higher Hazard Zones than the lower Hazard Zones. Finally, the trends observed in Figure D-2 are also apparent in Figure 3: similarity in relative damage ratios between Structural Scoring Categories 3 and 4, and between Structural Scoring Categories 1 and 2. A plot similar to Figure D-3, but with a horizontal axis scaled by numerical score, would show smoother curves for any given Hazard Zone.
