Earthquake Damage Assessment and Repair Guidelines for Residential Wood-Frame Buildings

Volume 1 | GENERAL GUIDELINES

CEA-EDA-01 2020

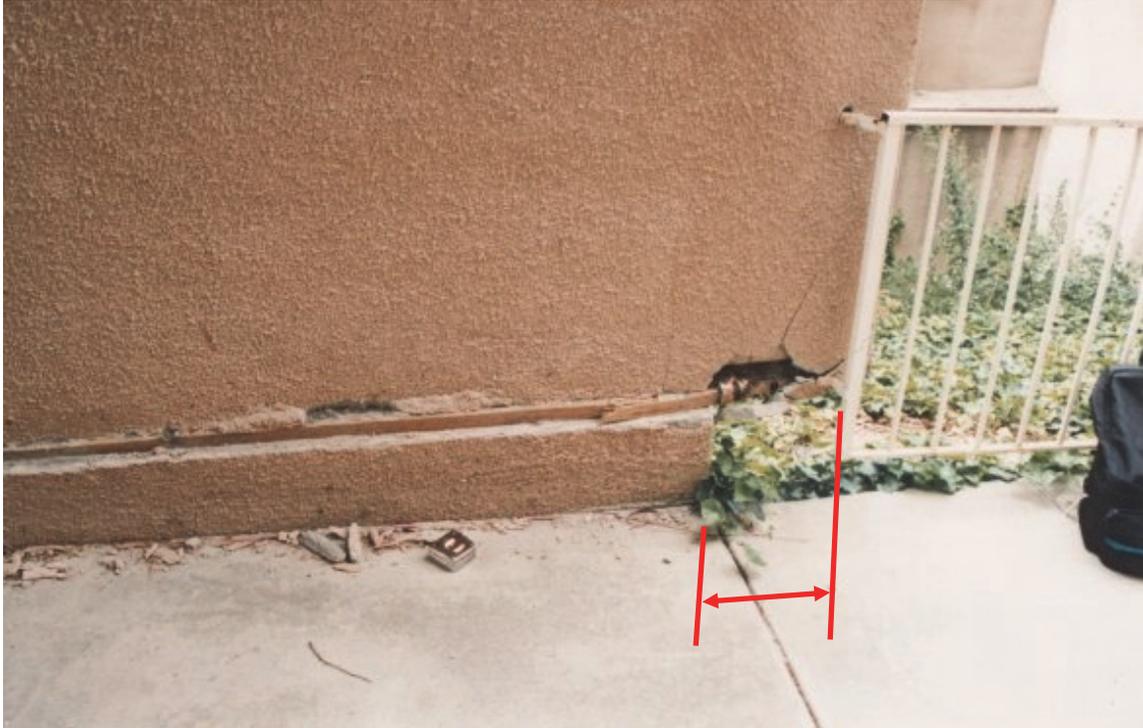
Figure 2-4 Earthquake-caused sliding of superstructure at foundation. The wall has shifted to the right several inches relative to the foundation, stucco wall finishes have cracked and spalled along the sill plate, and the sill plate is fractured near the right end of the wall (photo credit: Exponent).

Figure 2-4 shows substantial sliding, readily observed, with fracture of the sill plate and conspicuous damage to the wall finishes along the sill plate. Figure 2-5 shows less obvious sliding, initially noticed only because of inoperable doors within the affected wall line.

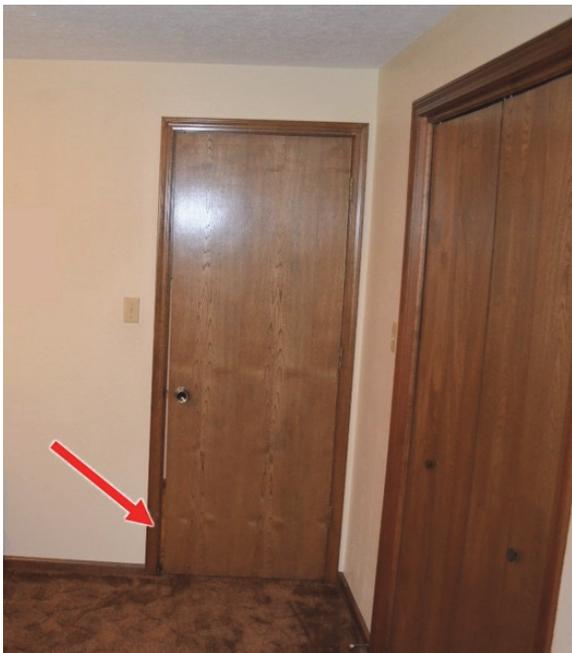
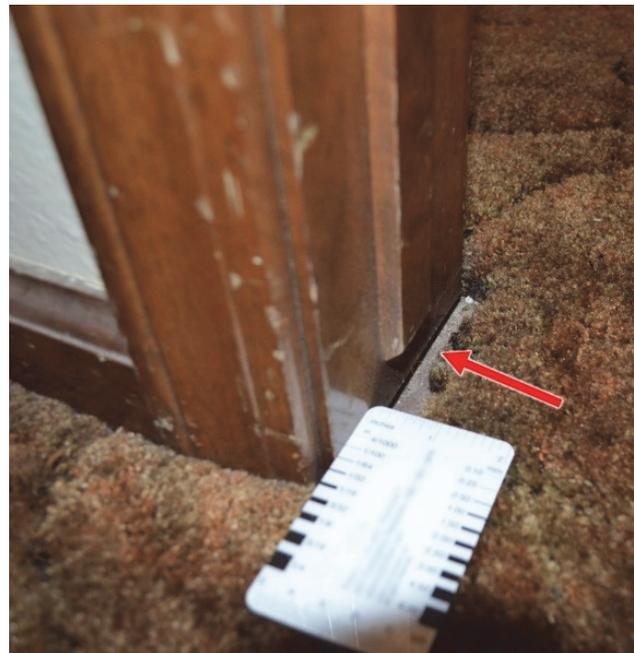
Figure 2-5 Earthquake-caused sliding of superstructure at floor slab. The wall has shifted less than 1 inch to the left, as evidenced in the left photo by the tapered gap between the left side of the door and doorjamb and in the right photo by the gap between the carpet and doorjamb (photo credit: Exponent).

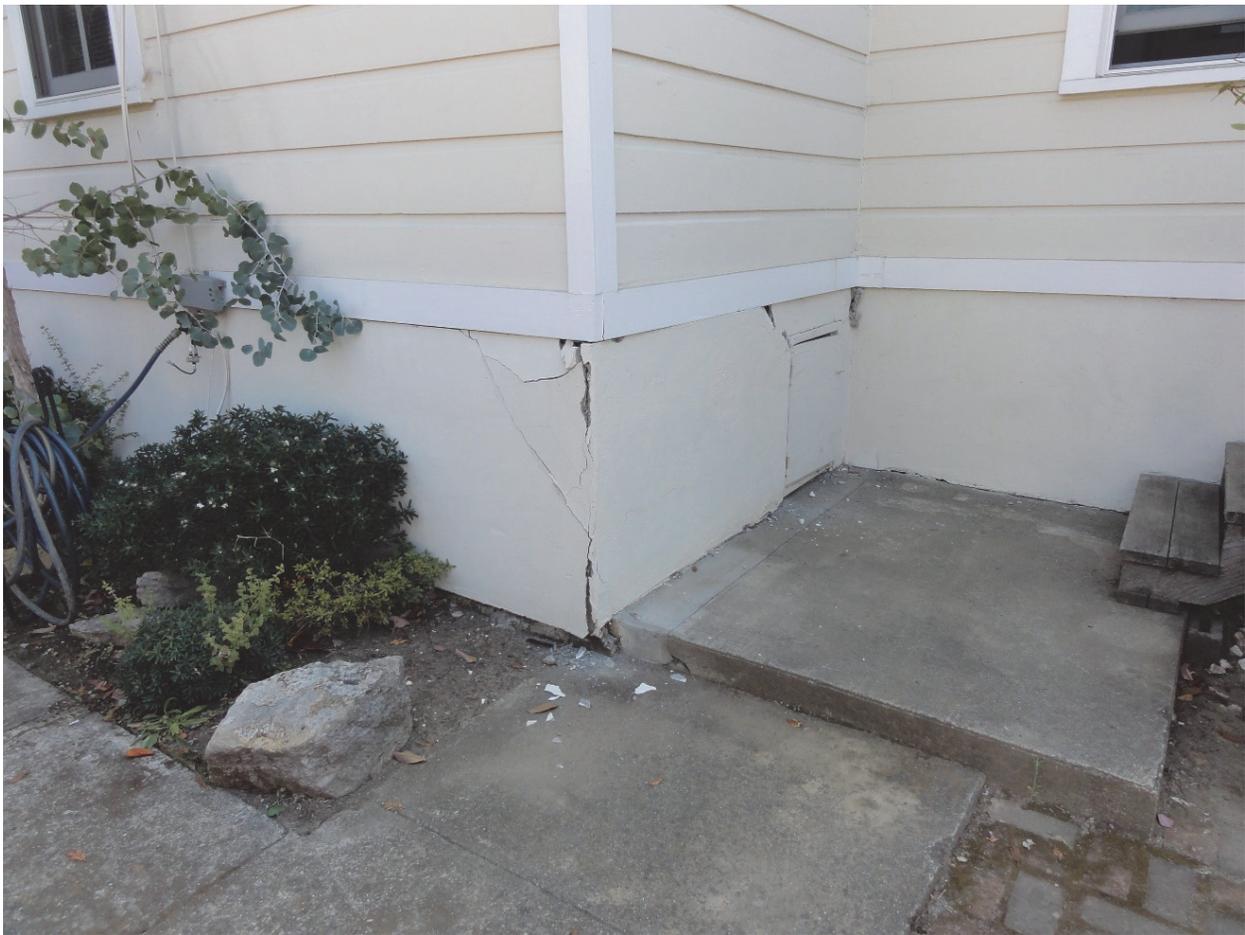
Figure 2-6 Damage to cripple wall finishes caused by the 2014 South Napa, California earthquake (photo credit: Exponent).

A cripple wall is a wood-frame wall between the foundation and the underside of the first-floor framing, enclosing a crawlspace. Where the cripple wall is inadequately braced, permanent drift over the height of the cripple-wall is a common (and costly) earthquake damage mechanism. Where the drift is moderate, it is typically associated with damage to the wall finishes that provide nominal strength and stiffness to an otherwise unbraced cripple wall (Figure 2-6), damage to the cripple wall framing, and damage to connections between the cripple wall and the wall or floor framing above. If the in-plane cripple wall drift in one direction becomes large, the cripple walls in the other direction will lean out-of-plane and be prone to collapse (Figure 2-7). In addition to structural damage, large cripple wall drift or collapse may damage mechanical, electrical and plumbing components commonly located in the crawlspace. Adding plywood or oriented strand board (OSB) along the interior faces of cripple walls is a common retrofit measure to improve the earthquake performance of the house with respect to this earthquake vulnerability.

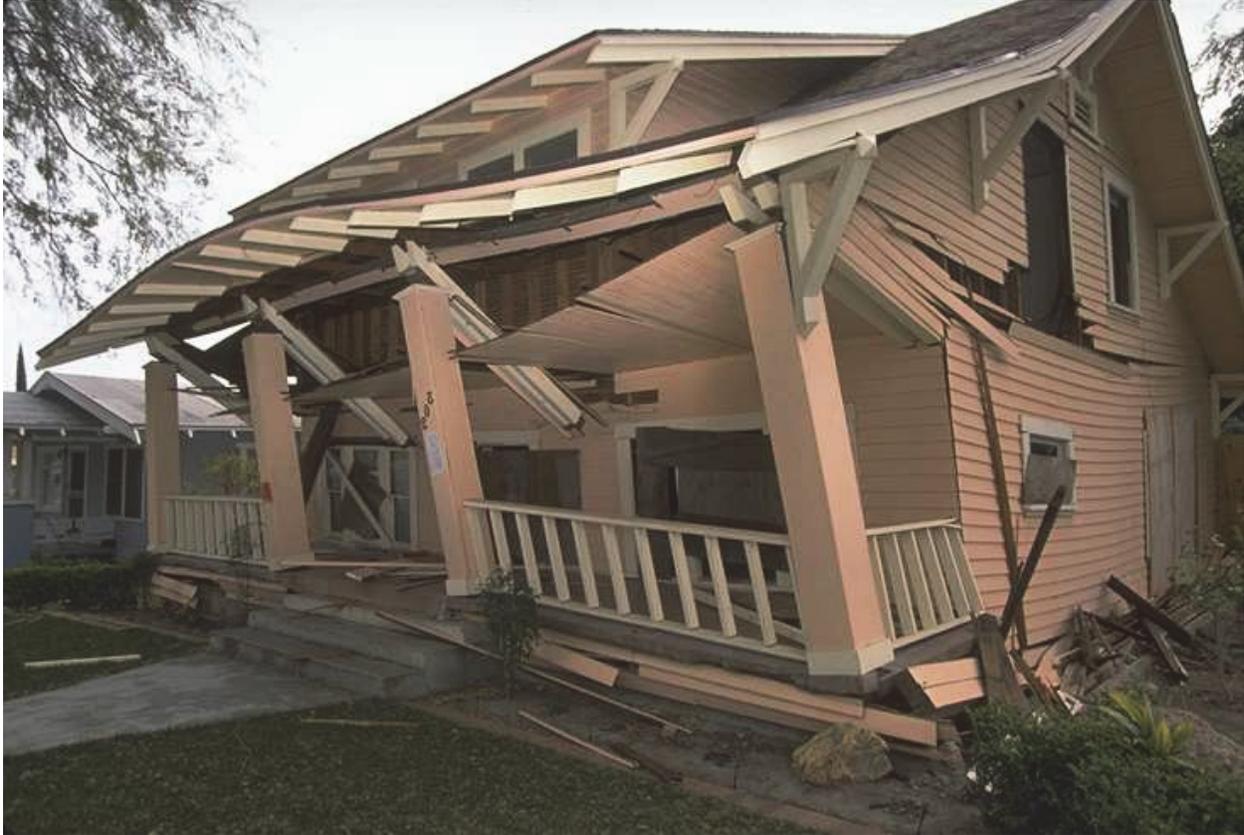
Figure 2-7 Cripple wall collapse caused by the 1994 Northridge, California earthquake resulting in widespread related damage in upper-story framing and relative movement between the main house and the covered porch (photo credit: Federal Emergency Management Agency, or FEMA).

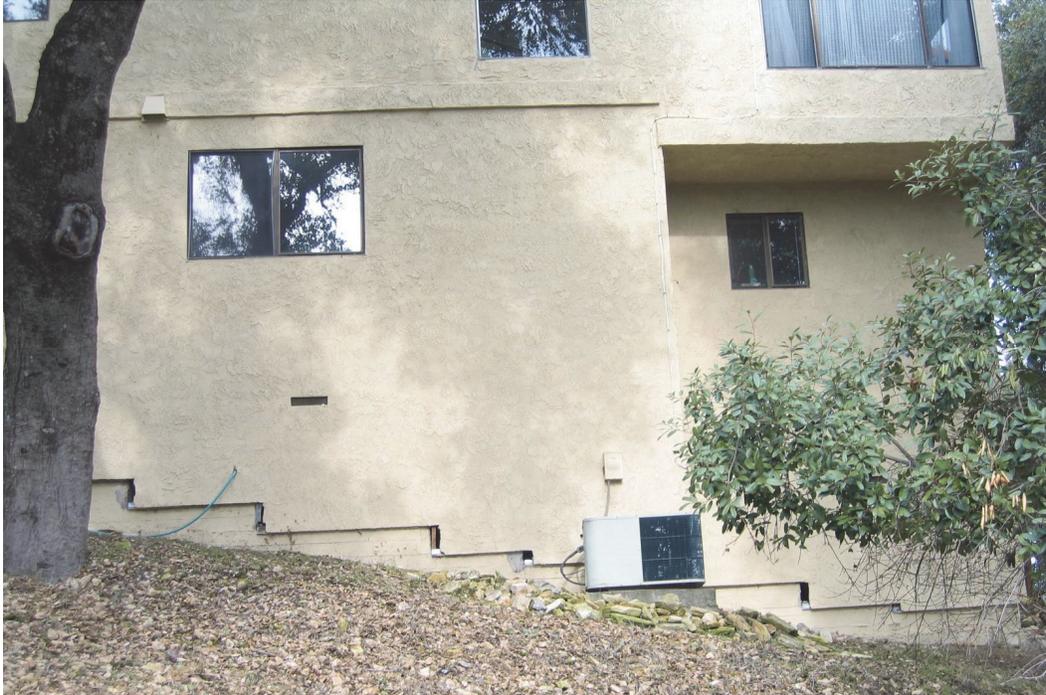
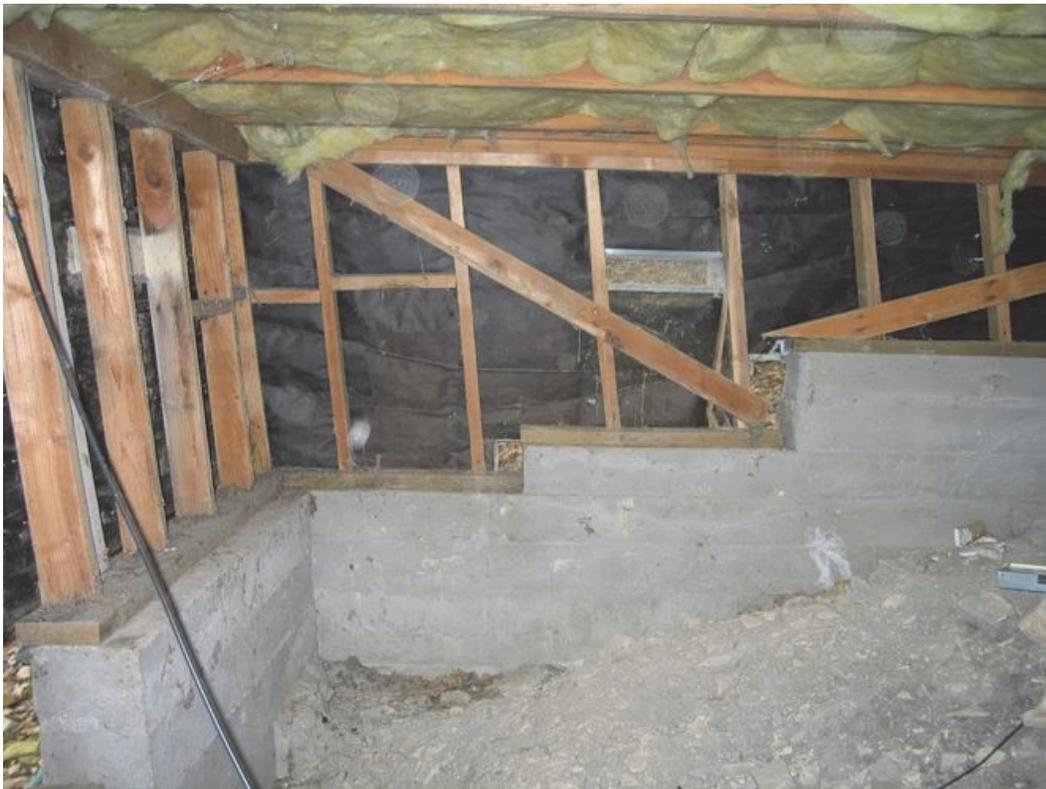
Figure 2-8 Damaged framing enclosing the underfloor area of a hillside house caused by the 2003 San Simeon, California earthquake. The damage includes detachment of the stucco relative to the wall framing and both in-plane and out-of-plane lean of the wood-frame walls (photo credit: Exponent).

Hillside houses typically incorporate stepped or sloped perimeter foundations (or stemwalls) along their sides (Figure 2-8). Posts or wood-frame walls enclosing the underfloor area along these lines may range in height from twenty or more feet at the downhill end to effectively zero at the uphill end, where the floor framing is attached to the uphill foundation with a sill plate or ledger. The tall posts or walls, if inadequately braced, may allow excessive deformation at the downhill end, causing torsional response (overall twisting) and increasing demands on the uphill framing-to-foundation connections. This damage mechanism typically includes framing deformation and damage (Figure 2-8), and in the worst cases, localized loss of support for floor framing at the uphill end (Figure 2-9) or complete separation of the house from the uphill foundation resulting in collapse. Hillside houses with no sidewalls, or only short sidewalls at the uphill end, are particularly prone to this damage mechanism. In addition to structural damage, mechanical, electrical, and plumbing components commonly located below the house can also be damaged.

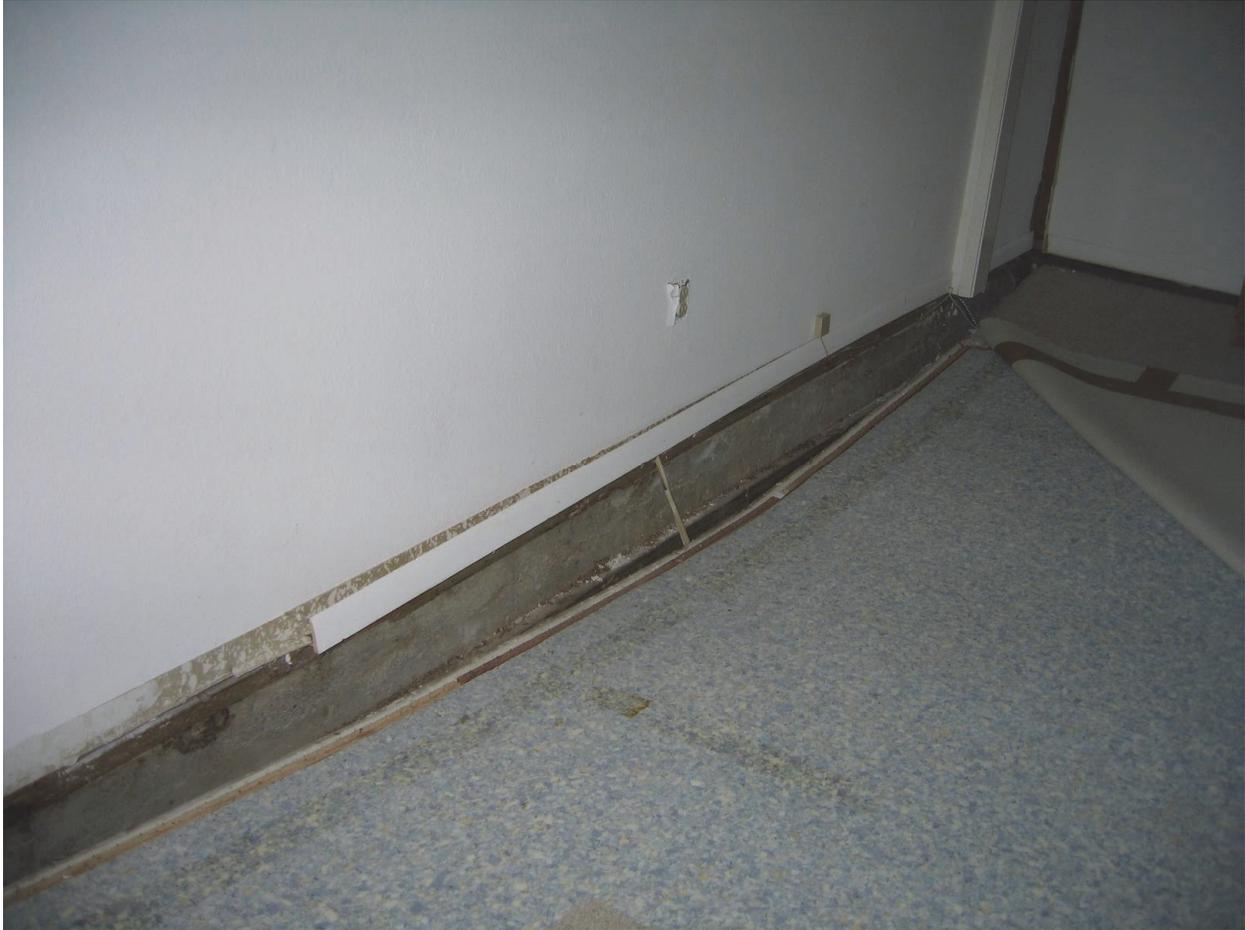
Figure 2-9 Damage at uphill end of a hillside house caused by the 2003 San Simeon, California earthquake. The floor framing detached and pulled away from the uphill foundation, causing the floor to sag (photo credit: Exponent).

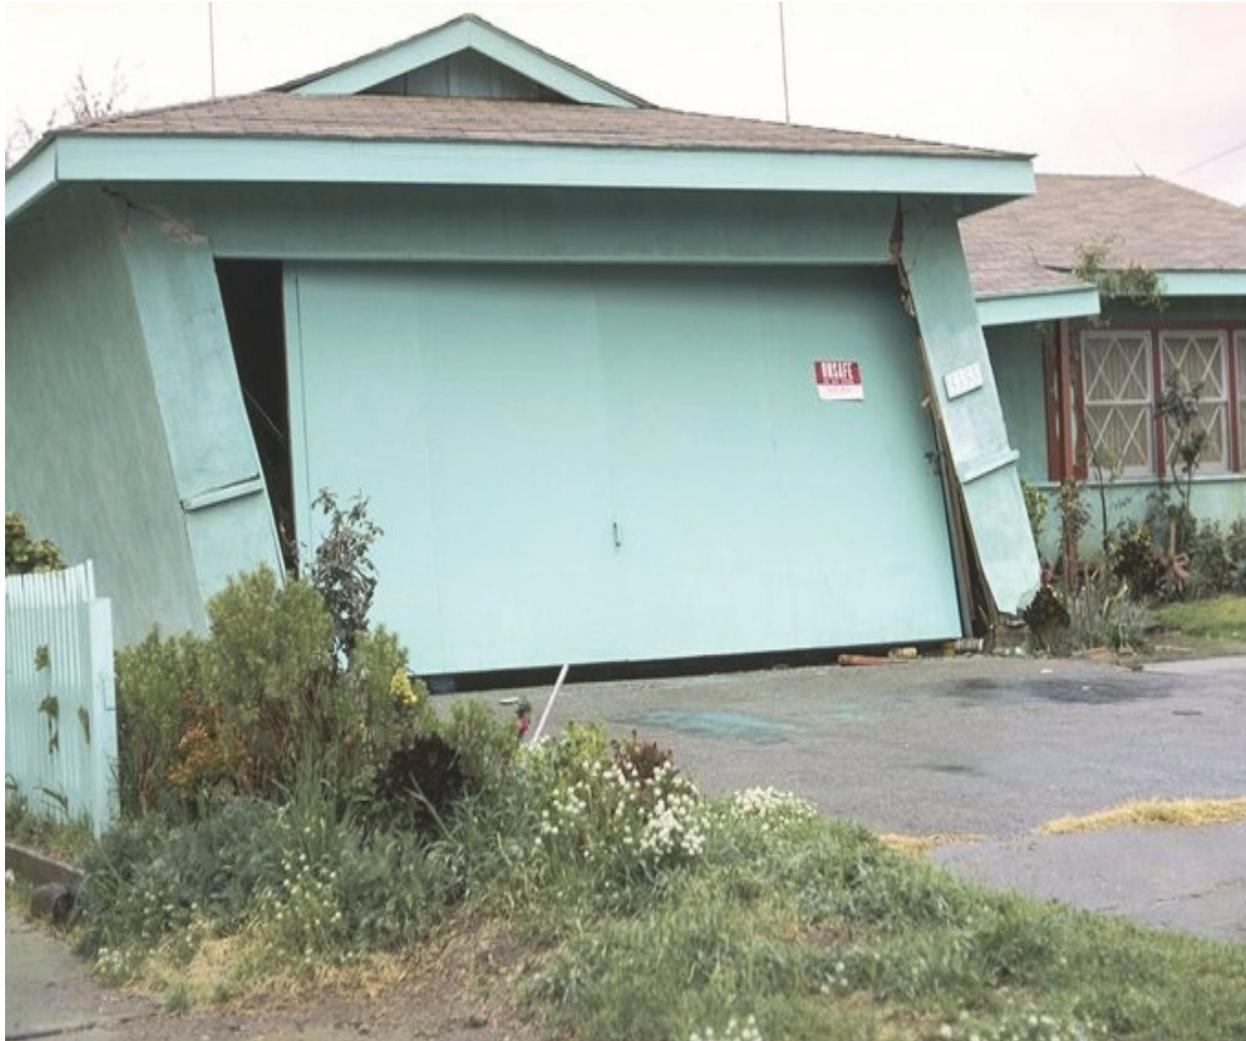
Figure 2-10 Large in-plane drift of narrow wall piers at garage door opening caused by the 1971 San Fernando, California earthquake (photo credit: National Information Service for Earthquake Engineering, or NISEE).

Where window and door openings leave only narrow wall segments to resist earthquake forces, wall lines can be prone to excessive in-plane drift (Figure 2-10) and possibly collapse. Where wider wall segments are not possible, newer houses avoid this vulnerability by using portal frame systems, proprietary engineered wall piers, or even structural steel elements. This mechanism can result in damage to wall pier finishes and sheathing, damage to the wall pier framing, damage to connections at the tops and bottoms of the wall piers, and inoperability of doors and windows within the racked wall line.

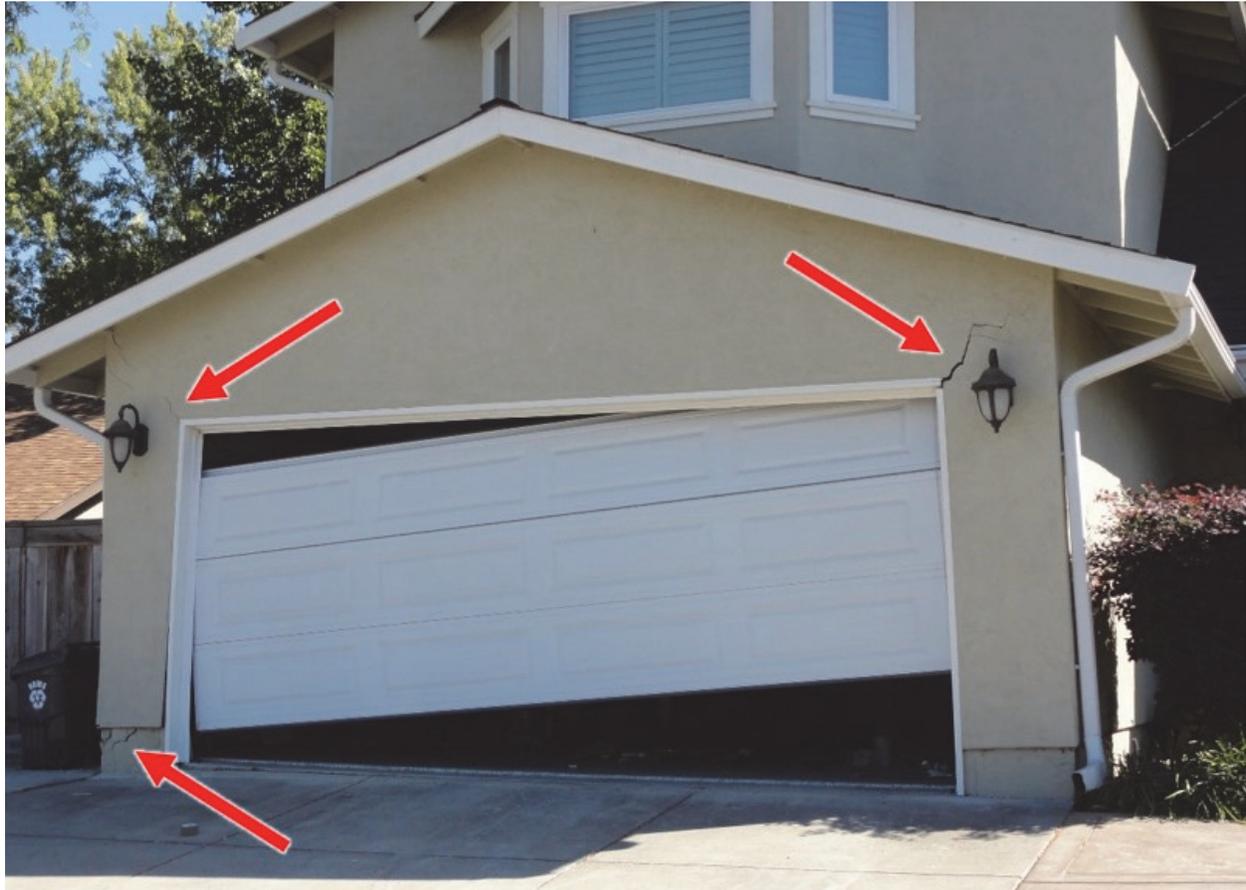
Figure 2-11 Damage related to living space over garage caused by the 2014 South Napa, California earthquake. In-plane racking of the front wall line of the garage caused cracking and possible framing damage in the narrow wall segments on either side of the garage door (photo credit: Exponent).

Multi-story houses with attached garages often have living space directly over relatively open garage area. Where only narrow wall segments are provided on either side of a wide garage door, the additional weight of the upper story can make an already weak condition even more prone to excessive drift (Figure 2-11) and possibly collapse.

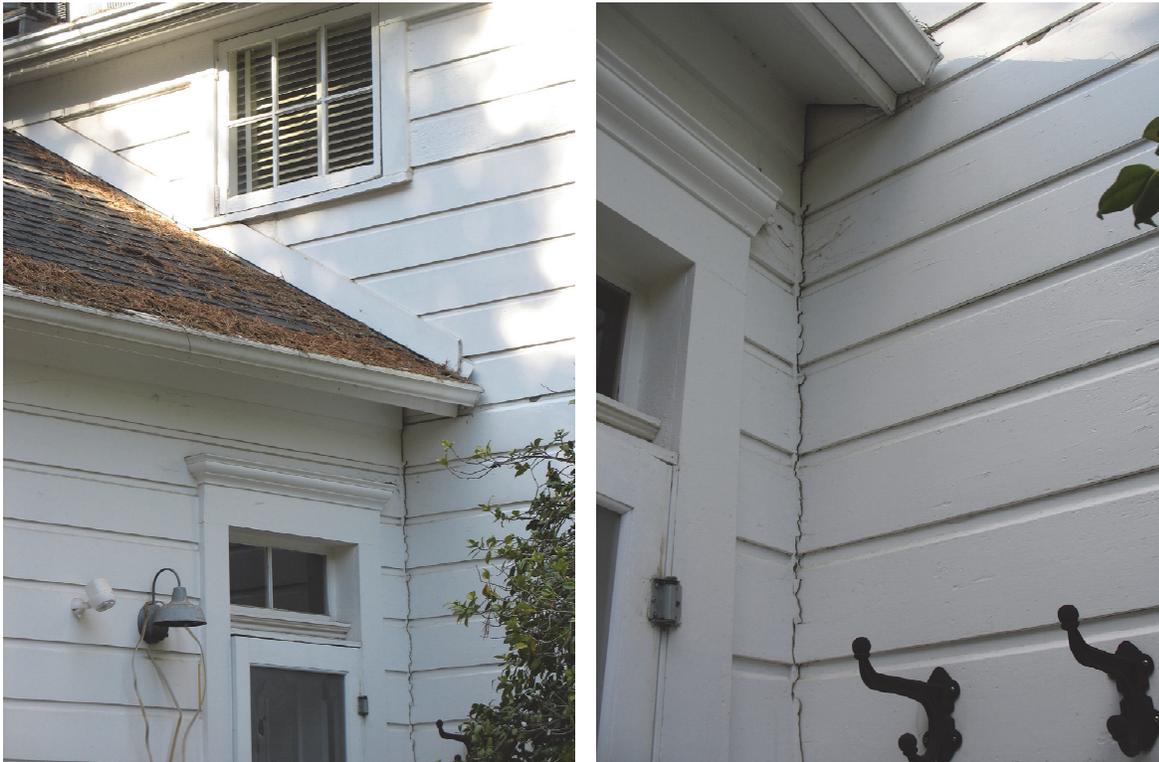
Figure 2-12 Left: Adjoining wings of a house create a framing discontinuity. Right: Separation of wood siding at intersection of adjoining wings caused by the 2014 South Napa, California earthquake. The separation was not structurally significant because there was no continuous framing or structural connection between the wings (photo credit: D. Bonowitz).

Earthquake damage is often concentrated where structural framing is discontinuous from one story to the next or between wings of a house in plan. Earthquake damage associated with these framing discontinuities includes concentrated damage to finishes, residual separations, and framing damage. In split-level houses, where the floor or roof framing is discontinuous between the one-story and two-story portions, differential movement and lack of effective connection between the portions can lead to damage. Where the common wall between the portions provides support for the lower-story floor or roof, the separation can result in local collapse. Where two wings of a house join, relative movement between the wings can lead to damage along the intersection (Figure 2-12).

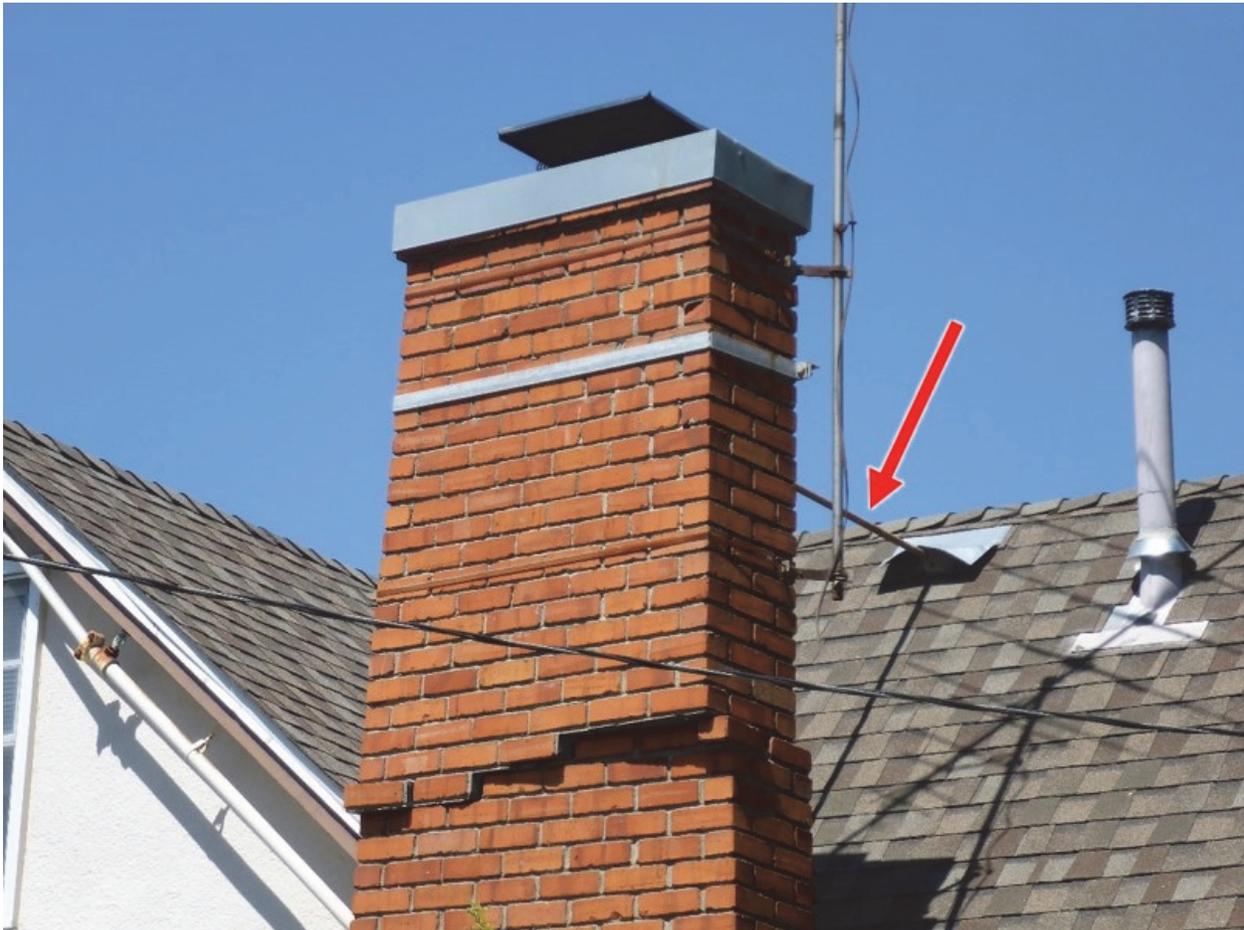
Figure 2-13 Earthquake-induced fractured chimney near the roof line. The brace between the chimney and roof, visible behind the chimney, was not adequate to prevent the damage (photo credit: Exponent).

Though they are not considered structural elements, masonry chimneys are among the most vulnerable elements of houses. Unreinforced chimneys are vulnerable to cracking near the roofline (Figure 2-13), sometimes breaking away and falling. If the top portion of a chimney falls onto the roof, it can cause damage to the roofing and roof framing. Reinforced chimneys can separate from the wall of the house (Figure 2-14) and exhibit residual outward leaning following an earthquake. Many chimneys were built with steel straps embedded in the masonry and attached to floor or roof framing. Where inadequately connected, the straps can pull out, damaging the framing members or roof sheathing.

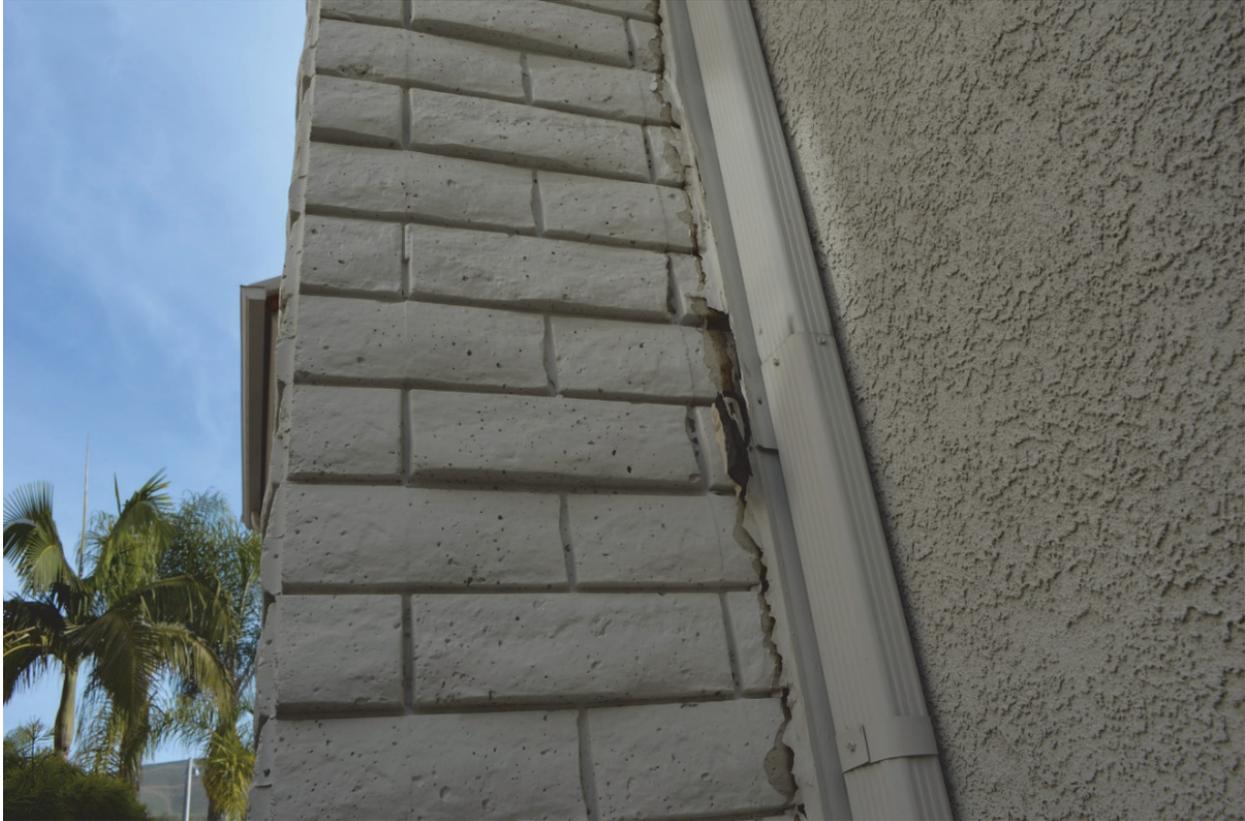
Figure 2-14 Separation of chimney from house caused by the 2014 La Habra, California earthquake. The separation was relatively minor, and the chimney remained attached to the house (photo credit: Exponent).

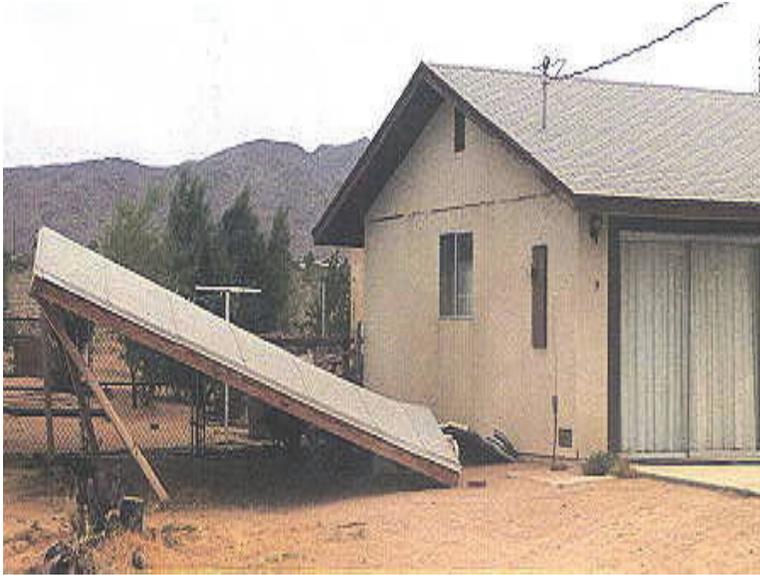
Figure 2-15 Earthquake-caused detachment of the carport from the house wall, resulting in collapse (photo credit: California Office of Emergency Services).

Earthquake damage tends to concentrate where parts of a house with different construction abut or attach to each other. This often occurs at appurtenances, such as exterior decks, porch roofs, carports, or patio covers, where the damage is likely to include cracked finishes, damage to ledgers or fasteners, and residual separations. An appurtenance with no seismic-force-resisting system of its own can be vulnerable to collapse if its attachment to the main structure is damaged (Figure 2-15). Damage to an appurtenance, such as a deck at an entry door, can block ingress and egress to a house.

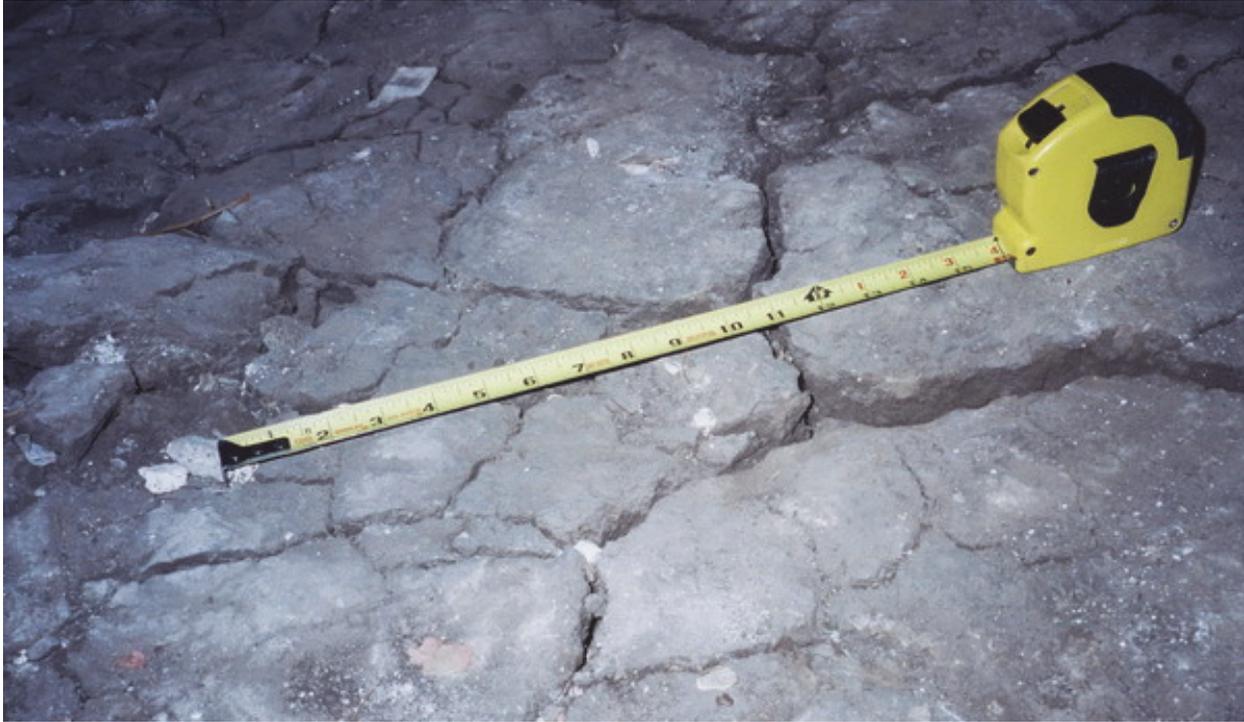
Figure 3-4 Long-term, non-earthquake desiccation cracking of expansive soil within a crawlspace (photo credit: Exponent).

Shrinking or swelling of expansive soil occurs when the water content of the soil is reduced (drying) or increased (wetting). Certain clays are particularly sensitive to water content changes. Cycles of shrinking and swelling may occur in soil layers near the ground surface that are subjected to evaporation, transpiration, rainfall, or rising or falling groundwater table (Figure 3-2 and Figure 3-3). The water content variation can be seasonal (e.g., summer to winter) or can follow a long-term trend (e.g., from changes in landscaping and vegetation or installation of pavements that change surface drainage patterns) or can be more transient, such as from irrigation or utility line leaks. A good indication that expansive soils are present at a site is desiccation cracking (a web-like network of cracks as shown in Figure 3-4) in the soil surface during dry seasons of the year.

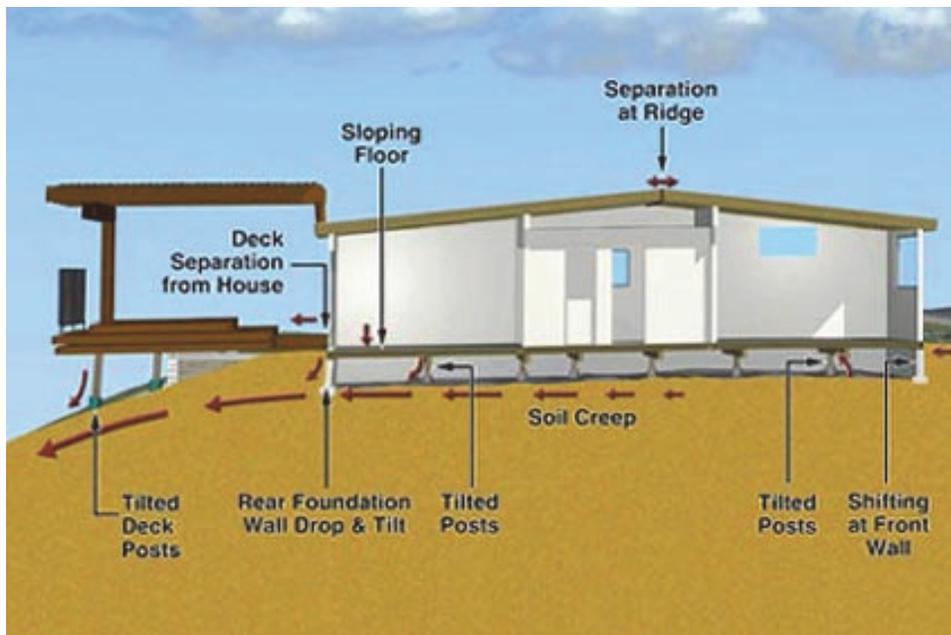
Figure 3-5 Schematic of damage to residence resulting from long-term, non-earthquake soil creep (image credit: Exponent).

Slope deformation may sometimes occur due to soil creep—the slow down-slope movement of fill, soil, or rock, usually confined to areas along a slope face or near the top of slope (Figure 3-5). Some creep takes place in almost all steep earth and rock slopes. The rate of creep is dependent on factors such as material type, slope inclination, and water content fluctuations within the slope. Slope creep occurs within shallow soil or rock materials, and hence damage is generally confined to areas along a slope face or near the top of the slope.

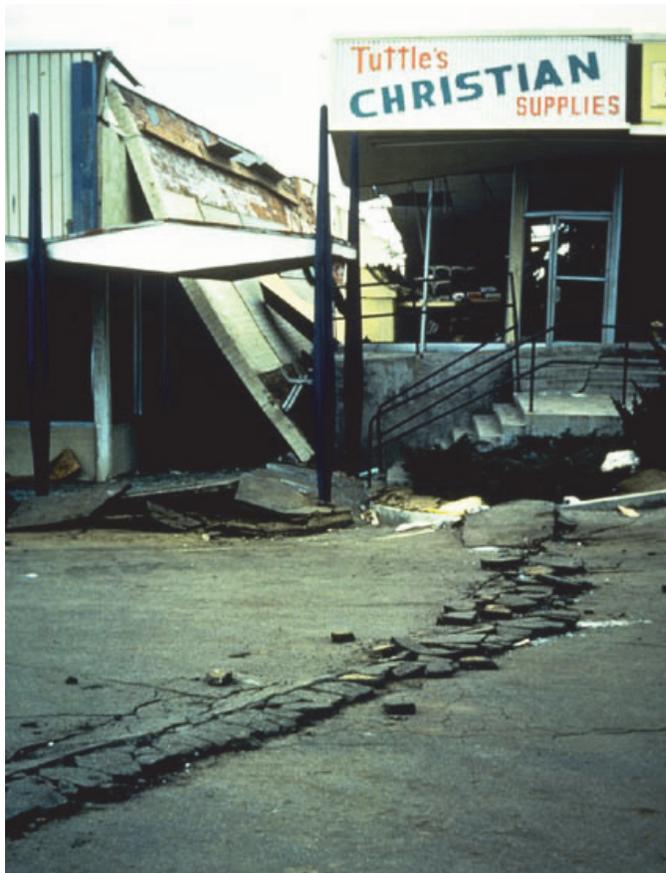
Figure 3-6 Surface fault rupture from the 1971 San Fernando, California earthquake and associated damage to pavement and buildings (photo credit: National Information Service for Earthquake Engineering, or NISEE).

Earthquakes result from relative displacement (i.e., slip) of blocks of rock on opposite sides of the fault surface deep within the earth's crust. Surface fault rupture occurs when these displacements reach the surface of the ground (Figure 3-6 to Figure 3-10).

If ground rupture is confined to a relatively narrow zone, then the total offset will appear as a linear feature that makes the rupture easier to identify. Any buildings, pavements, or utility lines crossing the fault could be destroyed (Figure 3-6 and Figure 3-7). Sometimes fault rupture occurs along multiple branch traces or movement is distributed across wider zones, hundreds of feet wide. In this case, the total offset is distributed across a larger area making it difficult to identify the exact location of ground rupture (Figure 3-10).

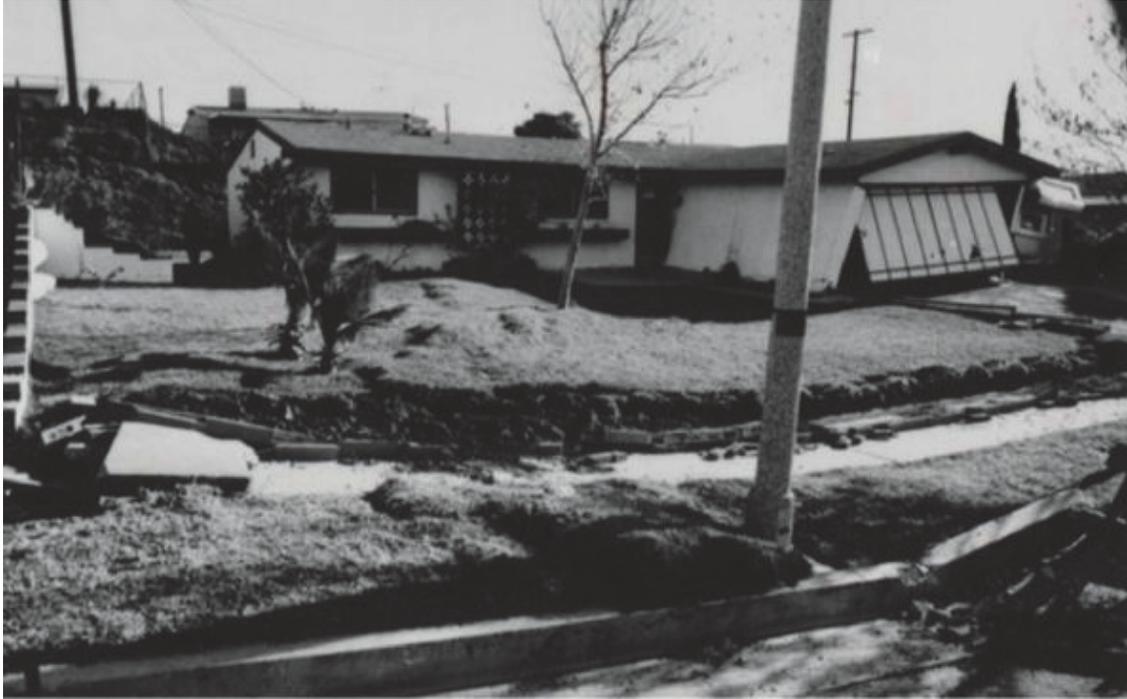
Figure 3-7 House damaged by surface fault rupture from the 1971 San Fernando, California earthquake (photo credit: Applied Technology Council, or ATC).

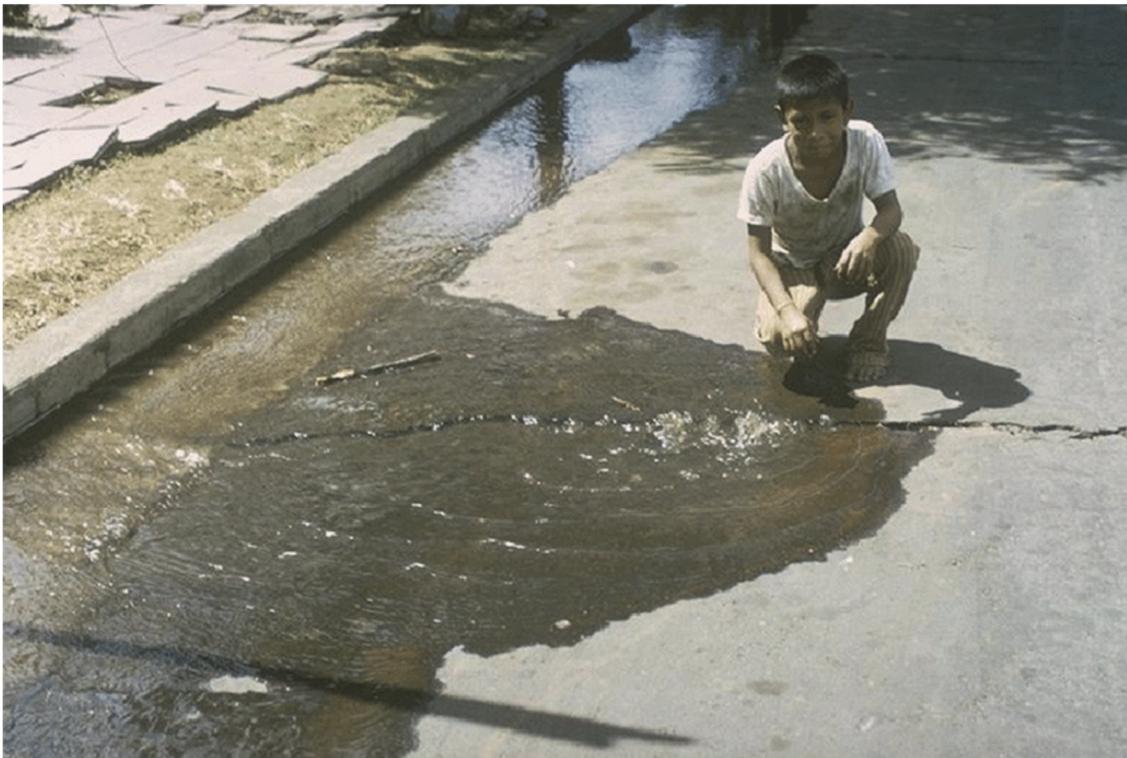
Figure 3-8 Waterline break along fault rupture from the 1972 Managua, Nicaragua earthquake (photo credit: NISEE).

- **Utility Lines.** Damage to underground utility lines on the property, such as water service lines, sanitary sewer lines, and gas lines, are indicators of possible earthquake-induced permanent ground deformation (Figure 3-8, Figure 3-40, and Figure 3-41). The condition of these lines, and service-ability of the lines (i.e., recent clogging of sewer lines) relative to their condition prior to the earthquake are also important and can be indicative of earthquake-induced damage. Although uncommon, underground utilities can also be damaged by transient earthquake ground movements, without any accompanying permanent ground deformations.

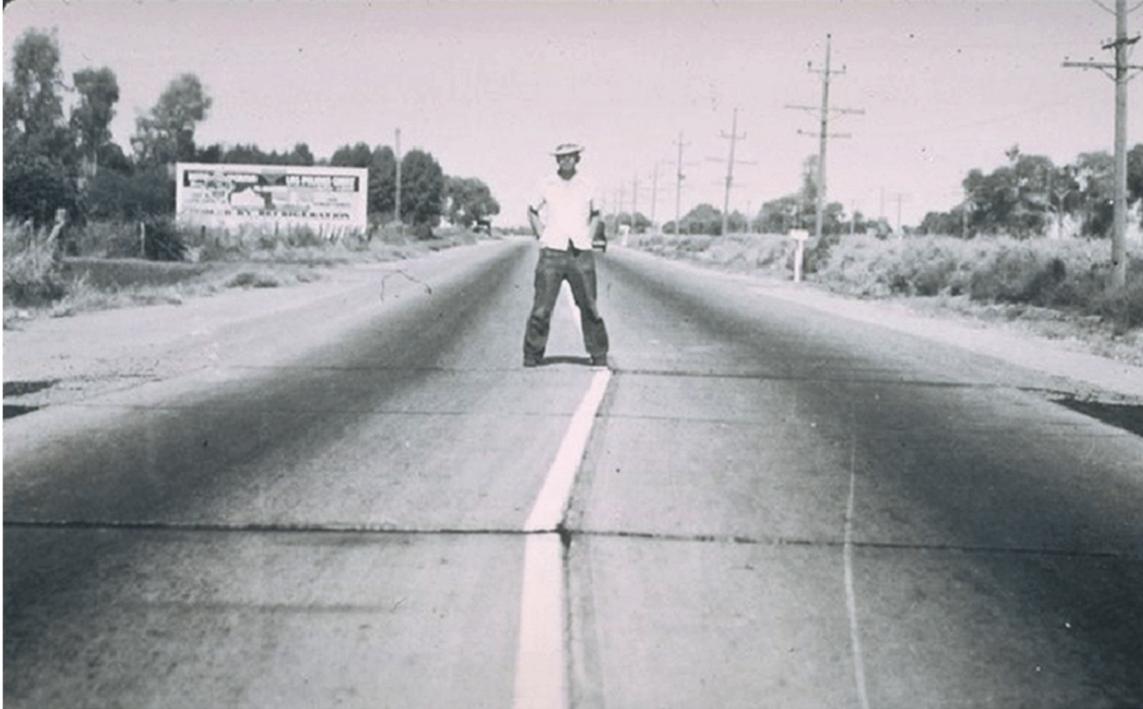
Figure 3-9 Surface faulting midway between El Centro and Holtville from the 1940 El Centro, California earthquake (photo credit: NISEE).

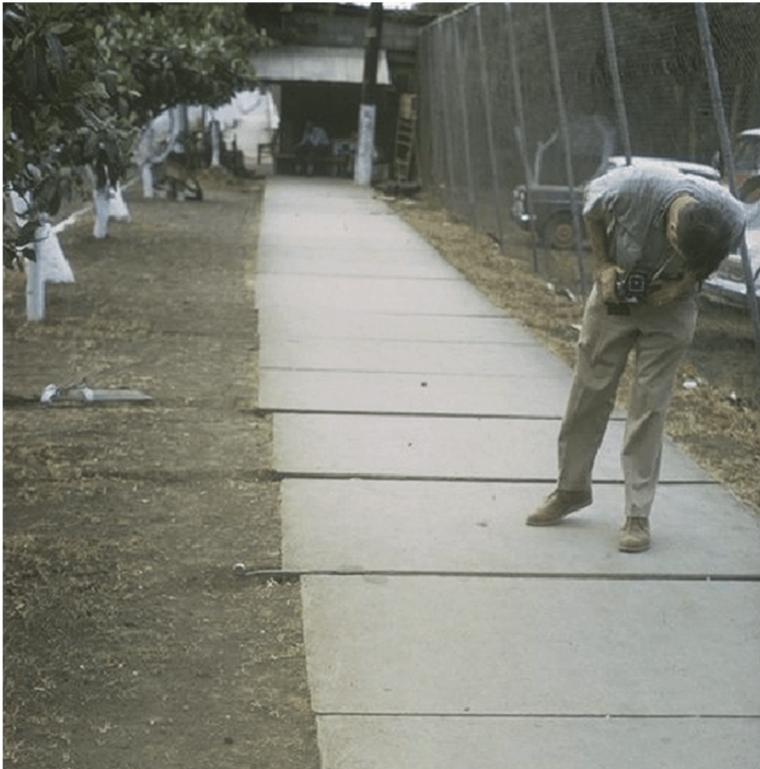
Figure 3-10 Sidewalk displaced by distributed faulting from the 1972 Managua, Nicaragua earthquake (photo credit: NISEE).

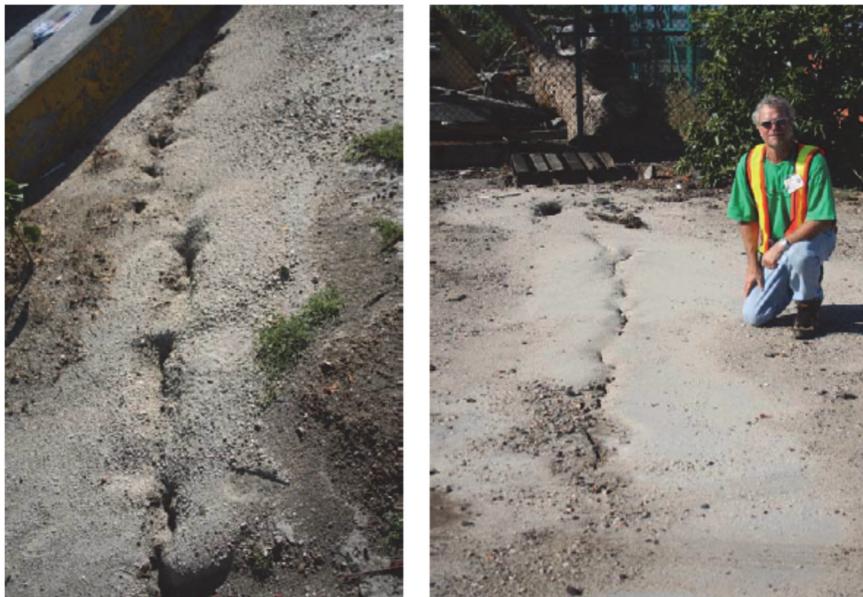
Figure 3-11 Sand boils at Kawaihae Harbor from the 2006 Kiholo Bay, Hawaii sequence of earthquakes (photo credit: UHM).

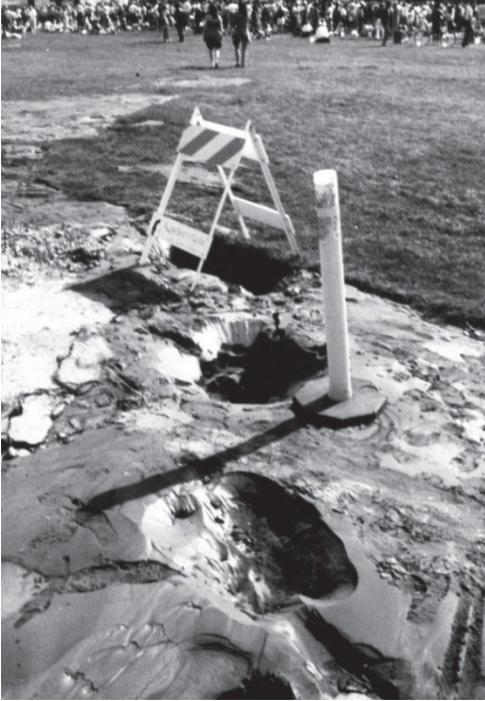
Figure 3-12 Sand boil due to liquefaction of old, poorly compacted, water-saturated fill during the 1989 Loma Prieta, California earthquake (photo credit: G. Plafker, USGS Denver Library Photographic Collection).

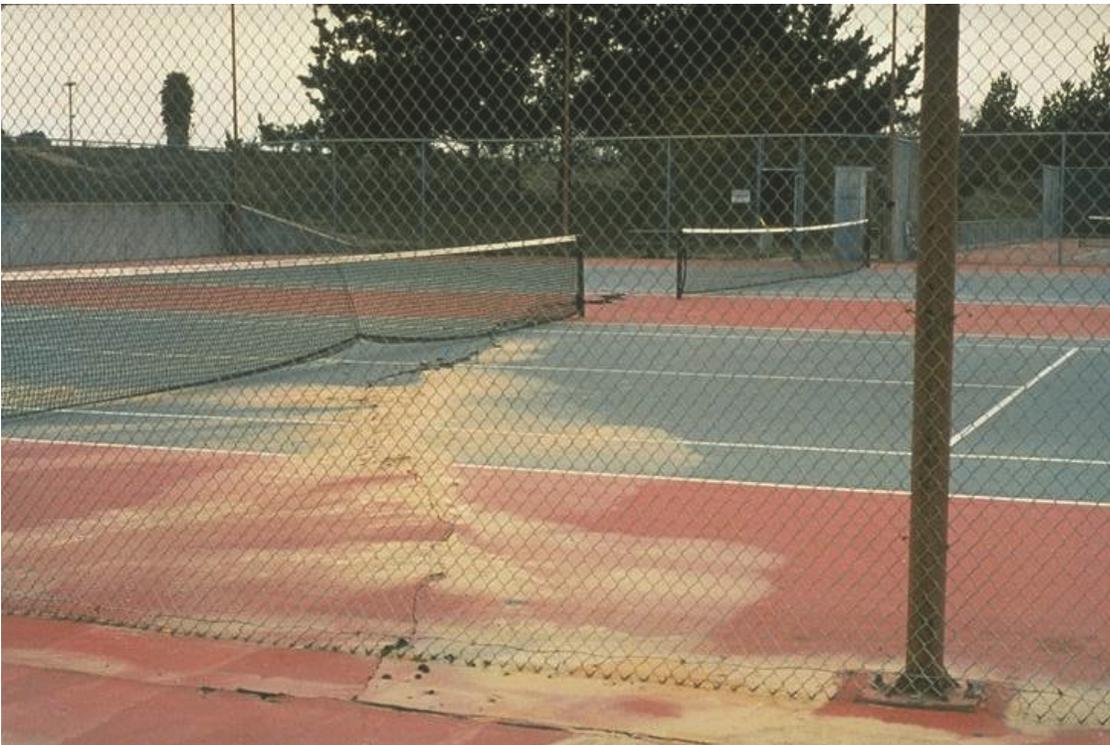
Figure 3-13 Tennis court damage with ejection of wet sand from soil liquefaction (site is adjacent to a river) during the 1989 Loma Prieta, California earthquake (photo credit: NISEE).
