Earthquake Damage Assessment and Repair Guidelines for Residential Wood-Frame Buildings

Volume 1 | GENERAL GUIDELINES

CEA-EDA-01 2020

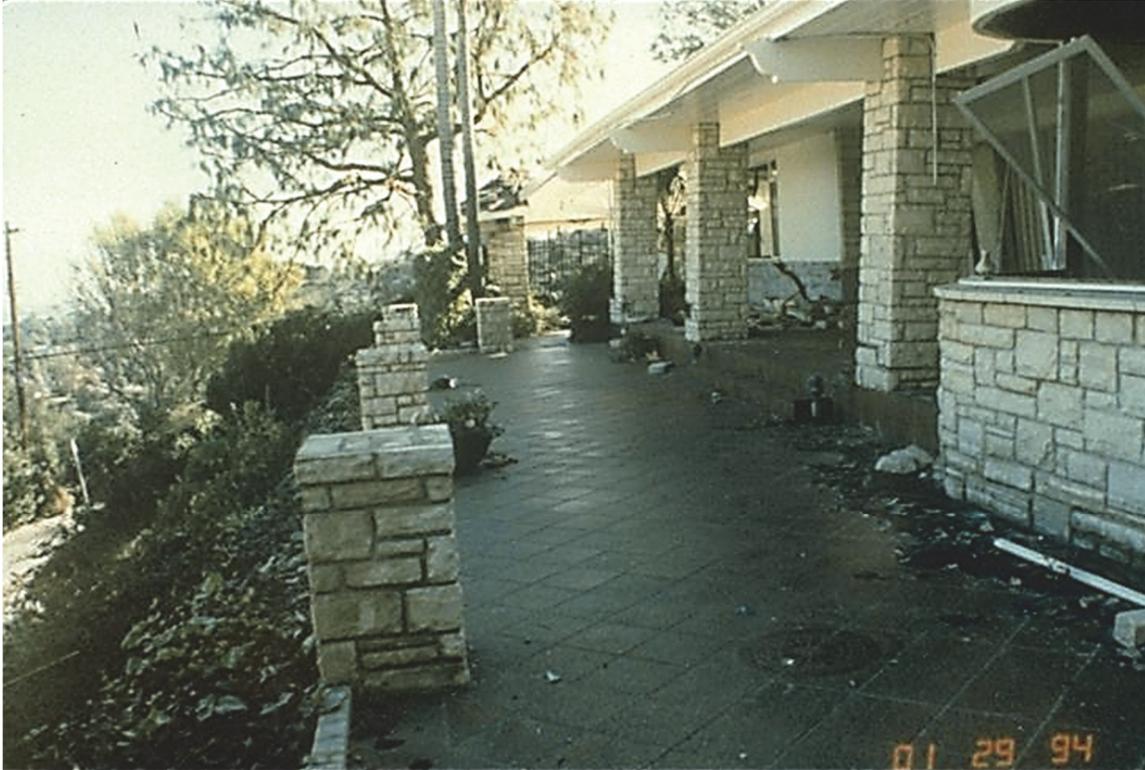
Figure 3-15 Building damaged by movements in hillside fill during the 1994 Northridge, California earthquake (photo credit: NISEE).

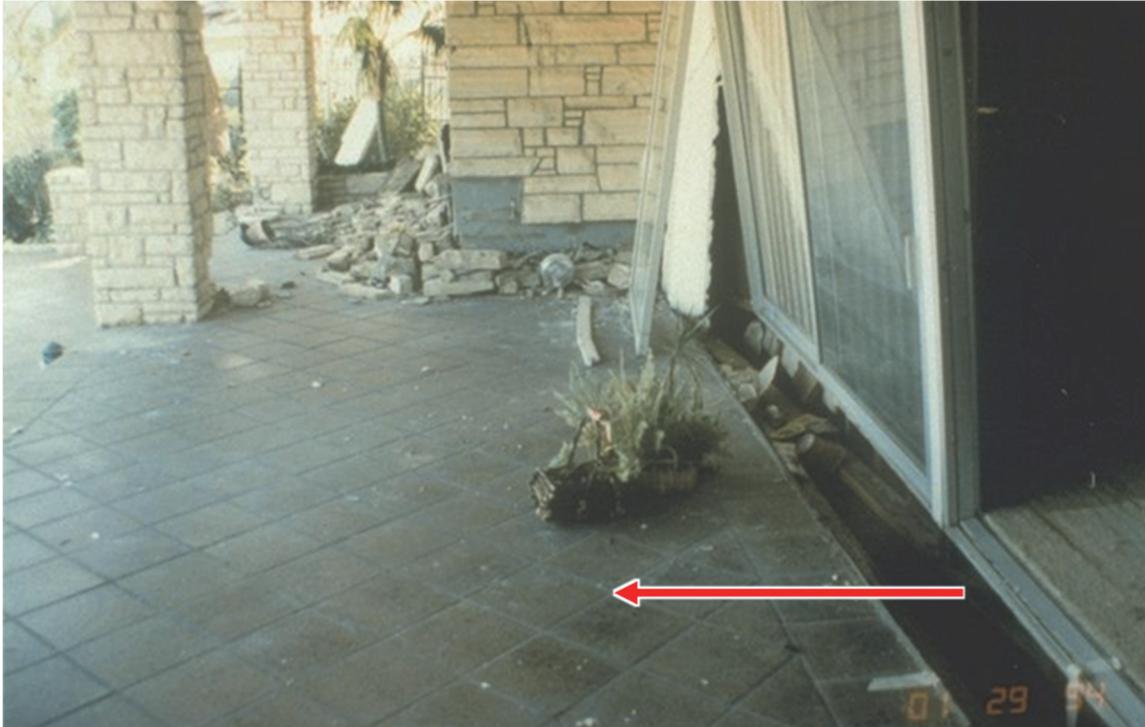
Figure 3-16 Evidence of lateral ground movement in the direction of the arrow, near back of building shown in Figure 3-15 (photo credit: NISEE).

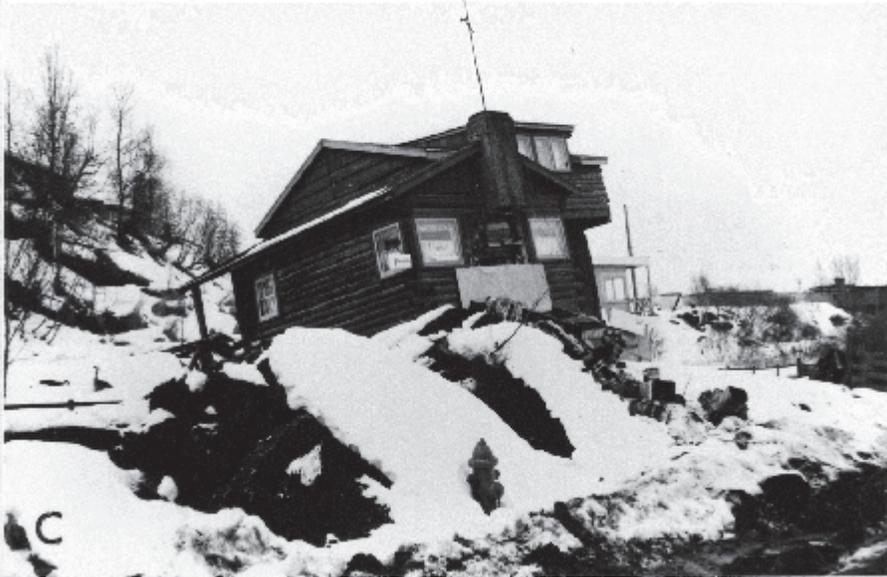
Figure 3-18 House displaced by large blocks of soil uplifted at toe of L Street landslide, Anchorage district, during the 1964 Alaska earthquake (photo credit: USGS).

Inertial forces introduced during strong earthquake shaking can cause slopes to experience downslope movement (Figure 3-18 to Figure 3-21). This movement can occur in slopes consisting of fill, soil, or rock and can range in size from a few feet across to spanning hundreds of acres. Buildings located near the moving part of the slope can be taken down with it, and those beneath the slope can be pushed aside or covered with the debris. Less dramatic movement is also possible. Depending on the level of shaking, geometry and soil conditions, the slope response can include toe bulging at the bottom of the slope, cracking near the crest and some downhill movement of mass near the crest. Homes located very close to the toe of an unstable slope can be damaged by the lateral forces imposed by the bulging mass near the toe. Near the crest, the foundation of a home can be pulled apart or distorted by cracks near the crest of the slope. If left unrepaired, it is possible that minor earthquake-induced ground cracking on or behind a slope or minor earthquake-induced slope movement could lead to the slope being more susceptible to rain-induced landsliding.

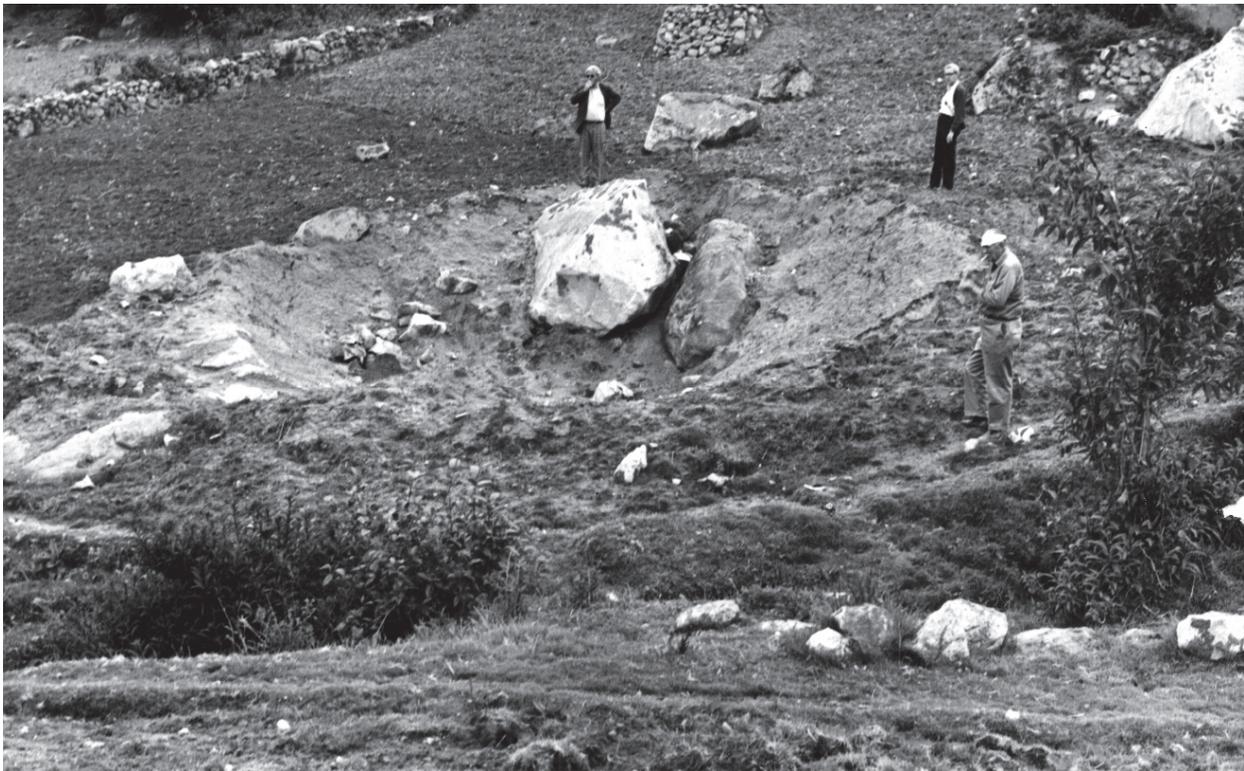
Figure 3-19 Rockfall from the 1970 Peru earthquake (photo credit: G. Plafker, USGS Denver Library Photographic Collection).

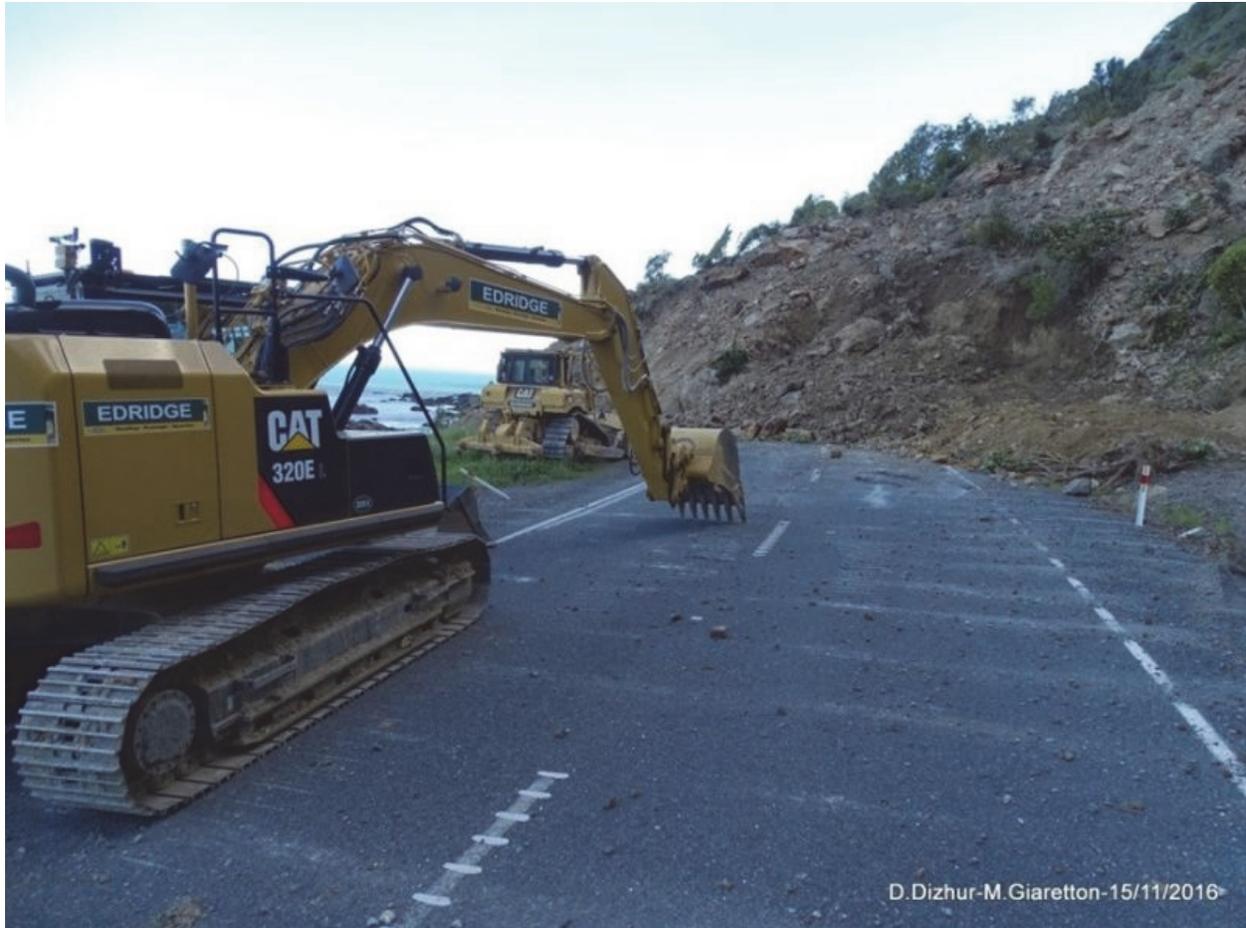
Figure 3-20 Rockfall from the 2016 Kaikoura, New Zealand earthquake (photo credit: D. Dizhur and M. Giaretton, EERI Library).

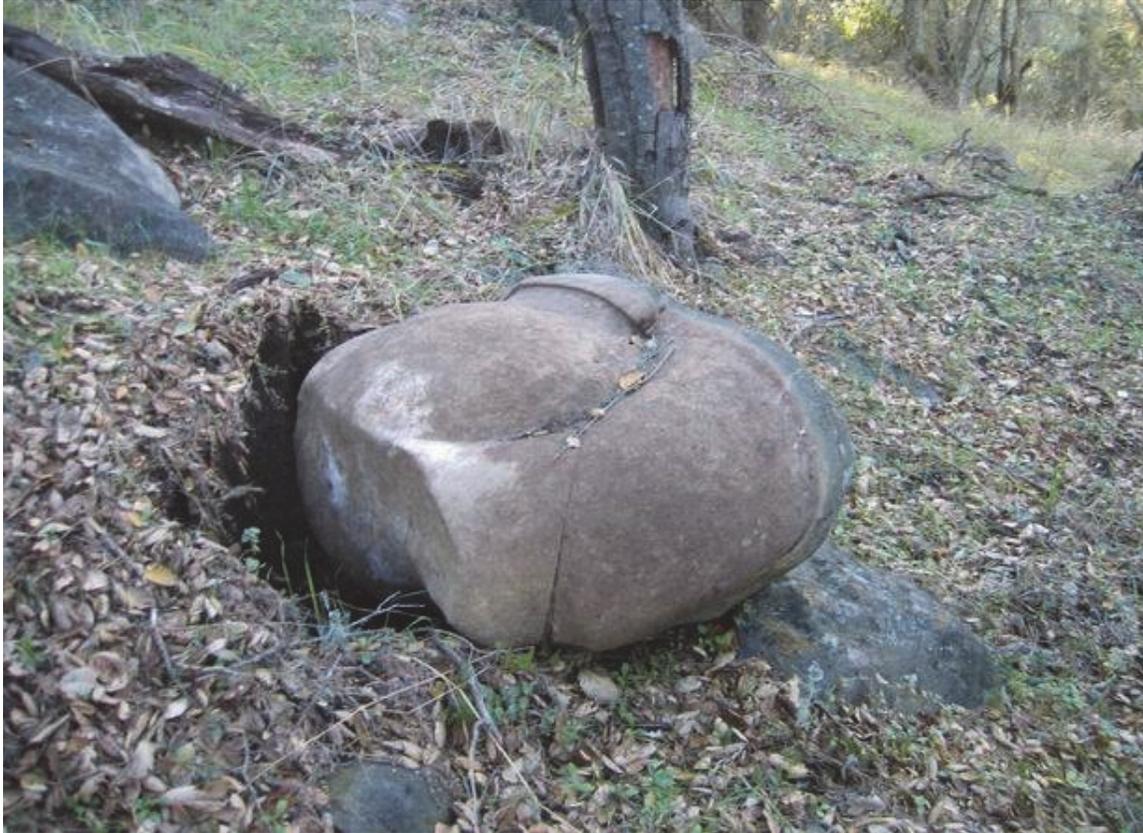
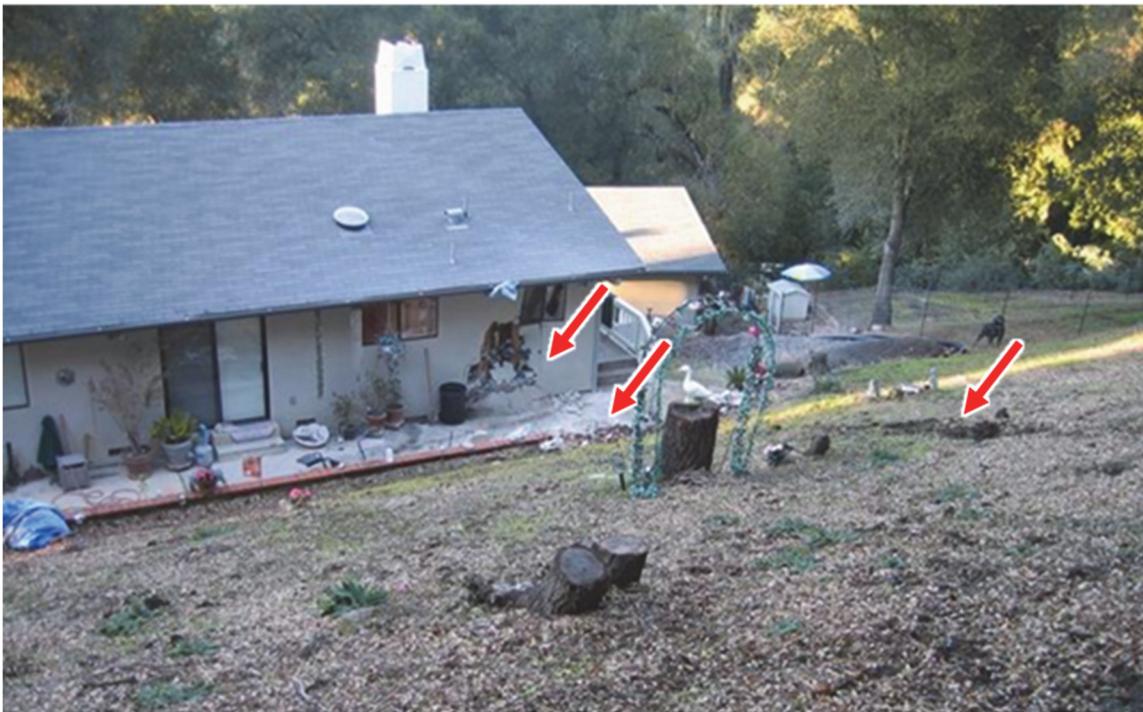
Figure 3-21 Top: rockfall from the 2003 San Simeon, California earthquake; bottom: similar rockfall occurred downslope and impacted the pictured house—impact marks on slope and house indicated by arrows (photo credit: Exponent).

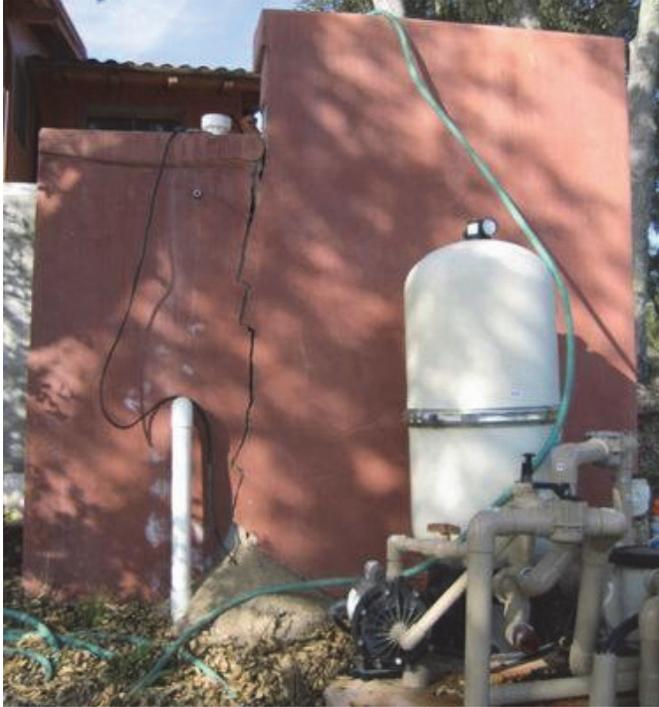
Figure 3-23 Retaining wall damage during the 2003 San Simeon, California earthquake caused backfill to spill from a new crack in the retaining wall (photo credit: Exponent).

During an earthquake, ground shaking can generate lateral forces in the soil behind retaining walls that combine with the sustained, long-term pressures on the wall, resulting in sliding, rotation, bending, or settlement of the wall, all of which can lead to damage to structural elements of the wall (Figure 3-22 to Figure 3-24). In those cases where a retaining wall supports a building, movement of the wall can also cause damage in the supported building. The seismic performance of retaining walls depends on the soil properties, water drainage features, structural properties of the wall, and the level of strong shaking during the earthquake. Cantilever and gravity retaining walls can move by sliding or tilting or both. Reinforced soil slopes/walls deform in a ductile manner without formation of a distinct failure surface and may produce minor settlement of the backfill, face bulging or spalling, and minor cracking in the backfill.

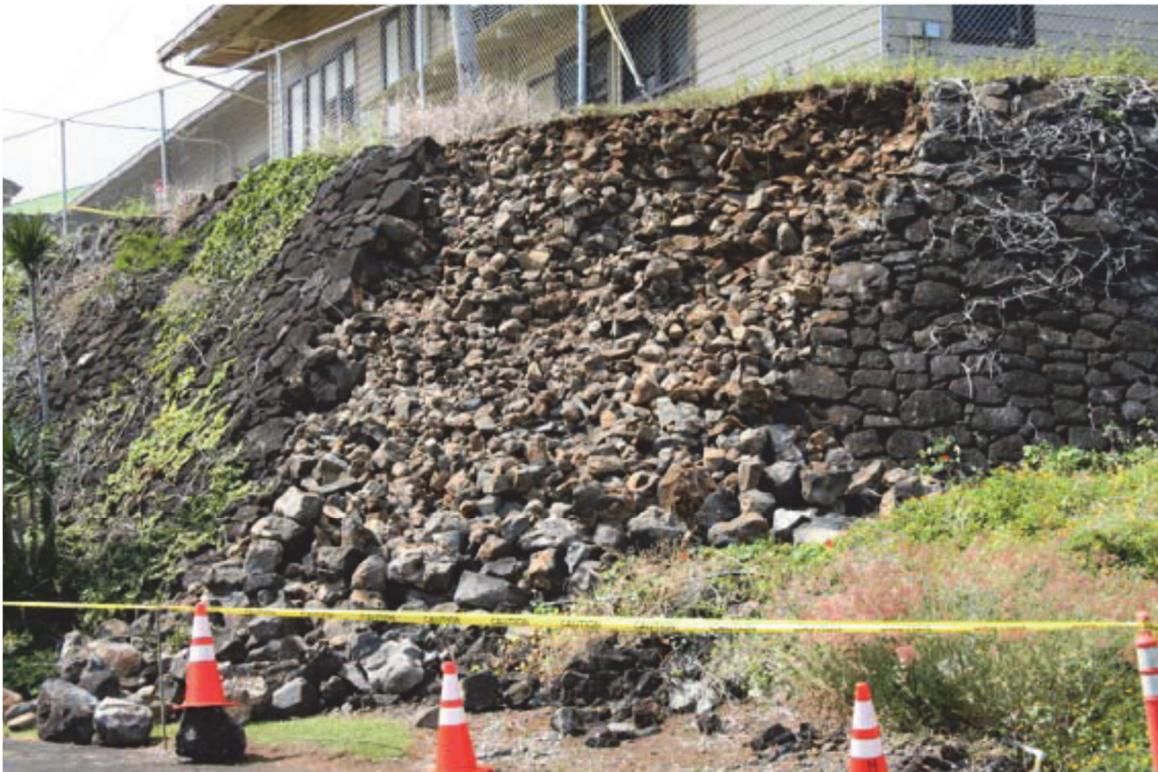
Figure 3-24 Collapse of unmortared and unreinforced stone retaining wall in Honokaa, Hawaii, during the 2006 Kiholo Bay, Hawaii sequence of earthquakes (photo credit: UHM).

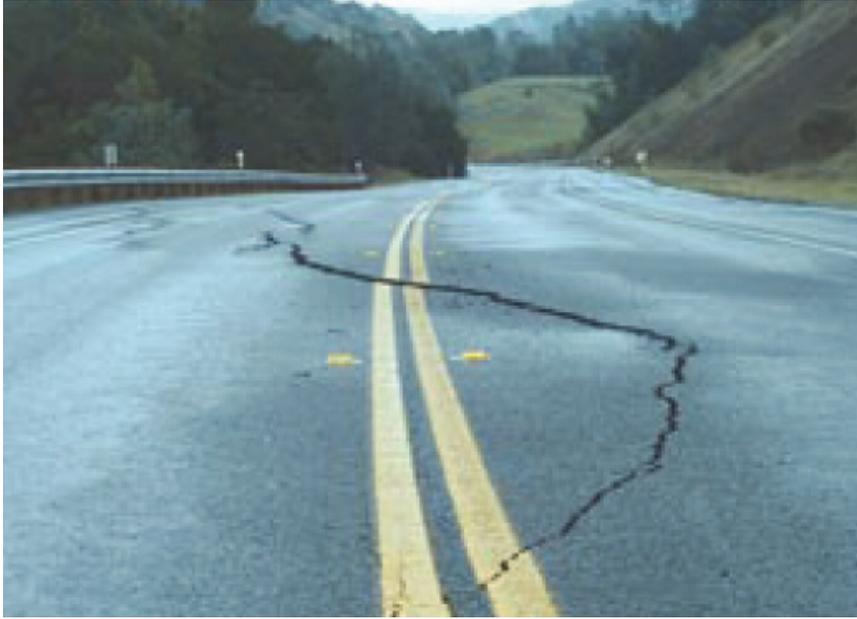
Figure 3-26 Asphalt pavement rupture as a result of a deep rotational slope failure in fill during the 2014 Iquique, Chile earthquake (photo credit: Gabriel Candia A., EERI Library).

- **Hardscape (e.g., driveways, patios, sidewalks).** Fresh cracks in hardscape, or the significant widening of pre-existing cracks and construction joints, are good indicators of earthquake-induced permanent ground deformation (Figure 3-26 to Figure 3-33). Also, fresh out-of-levelness in driveways, patios, decks, and other hardscape not consistent with normal construction practices (e.g., patios adjacent to buildings are usually sloped away from the building for drainage) (Figure 3-34) or evidence of movement of exterior improvements relative to the building (Figure 3-35 through Figure 3-37) are indicators of possible earthquake-induced permanent ground deformation. Features such as

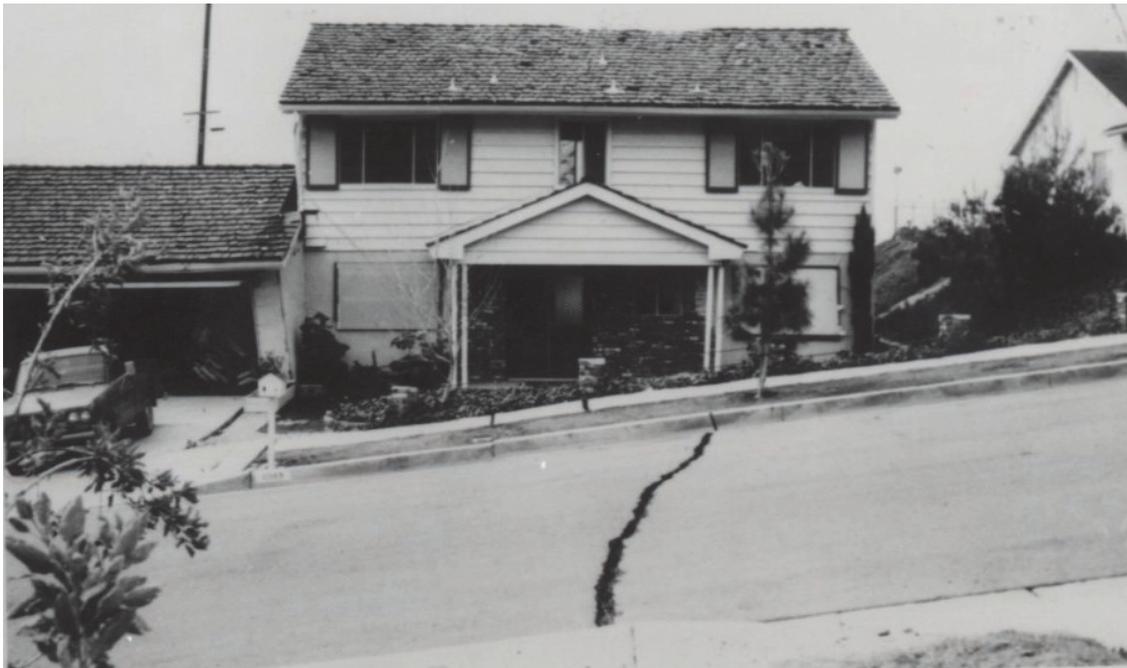
Figure 3-27 Street and house damaged by several inches of landslide displacement during the 1971 San Fernando, California earthquake; displacement is readily visible as street crack in photograph (photo credit: ATC).

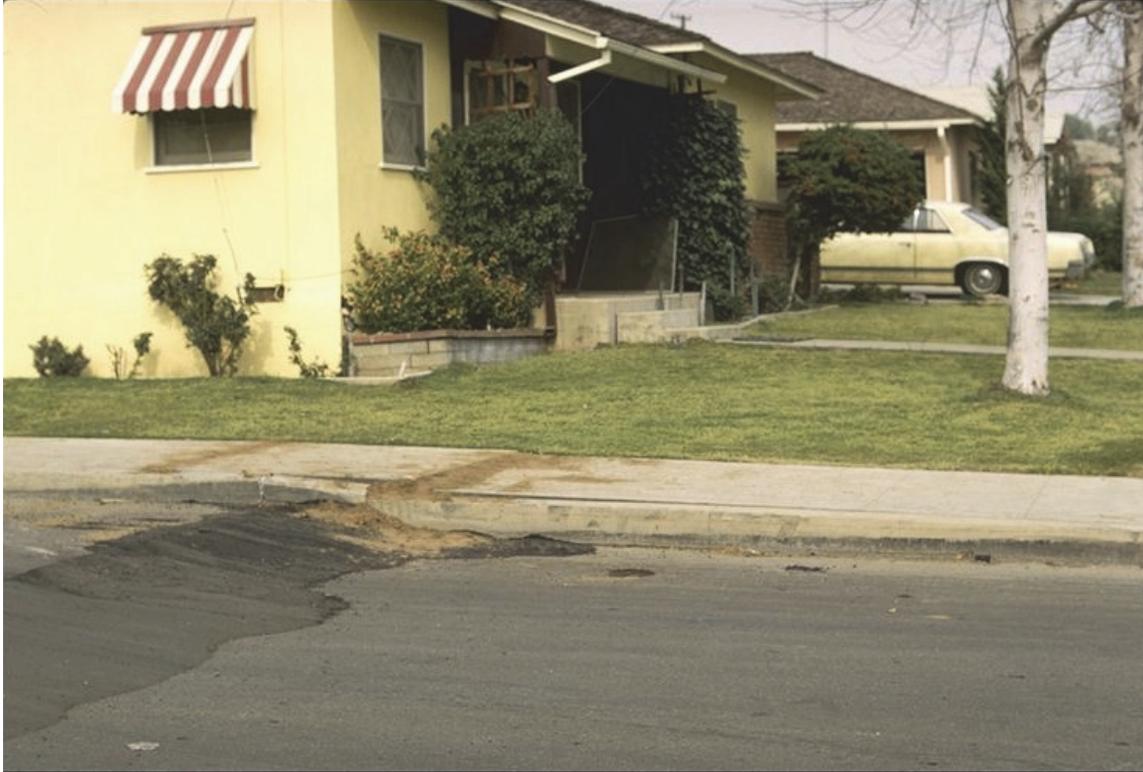
Figure 3-28 Pavement patching and damage to adjacent sidewalk in San Fernando following the 1971 San Fernando, California earthquake (photo credit: NISEE).

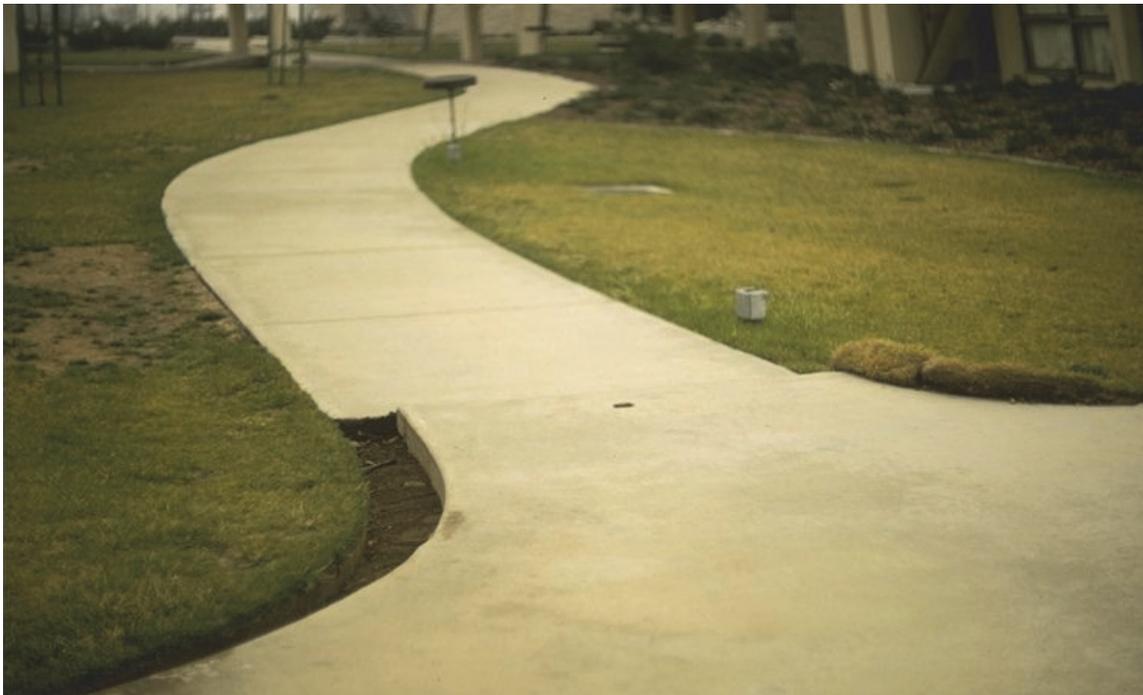
Figure 3-29 Offset sidewalk from the 1971 San Fernando, California earthquake (photo credit: NISEE).

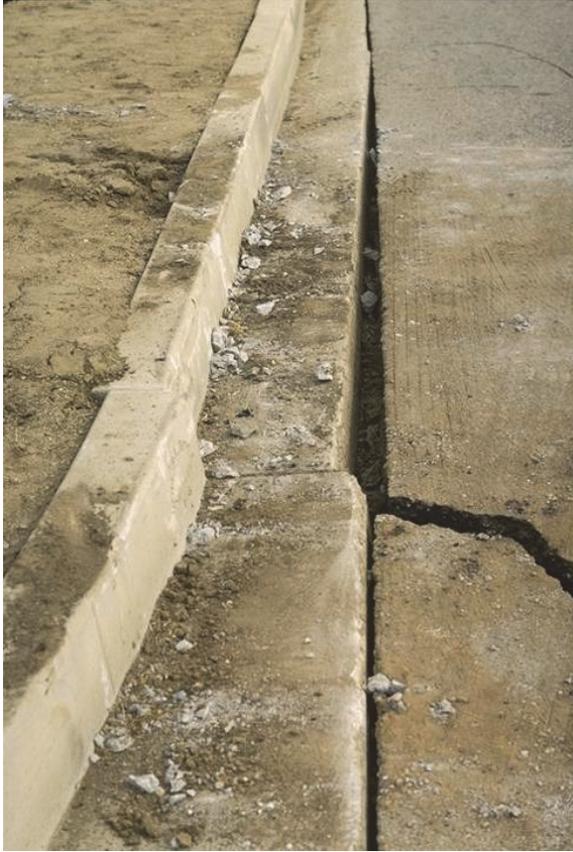
Figure 3-30 Damaged street, gutter, and curb from the 1971 San Fernando, California earthquake (photo credit: NISEE).

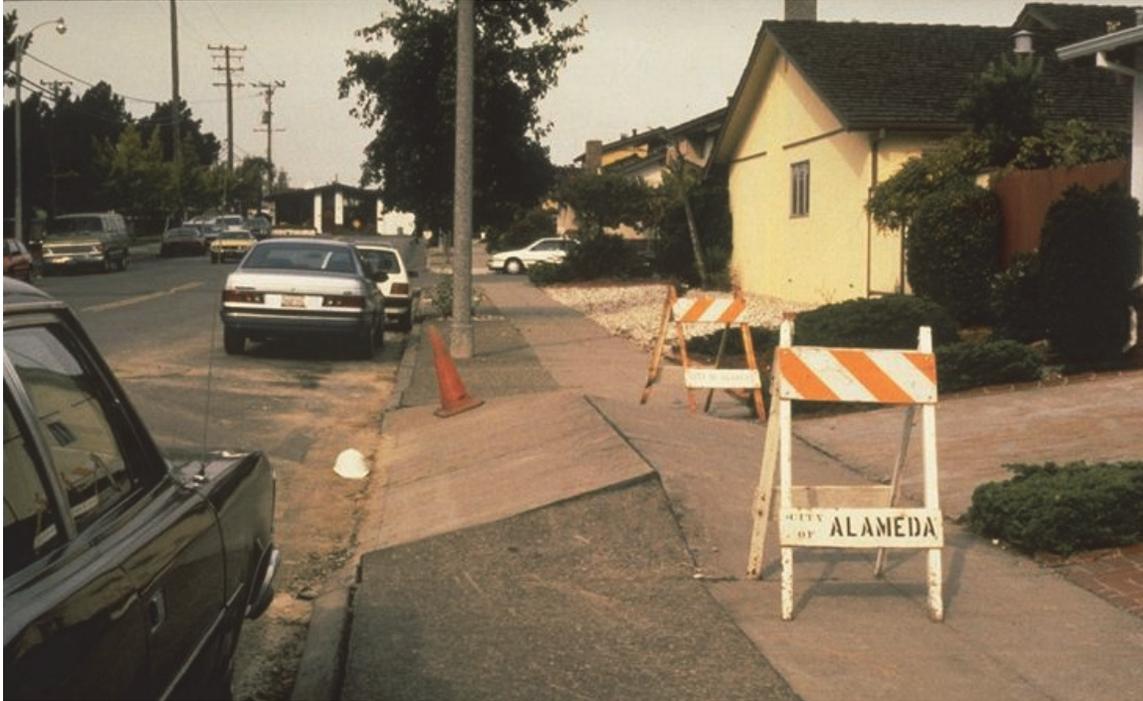
Figure 3-31 Buckling of driveway due to liquefaction during the 1989 Loma Prieta, California earthquake (photo credit: NISEE).

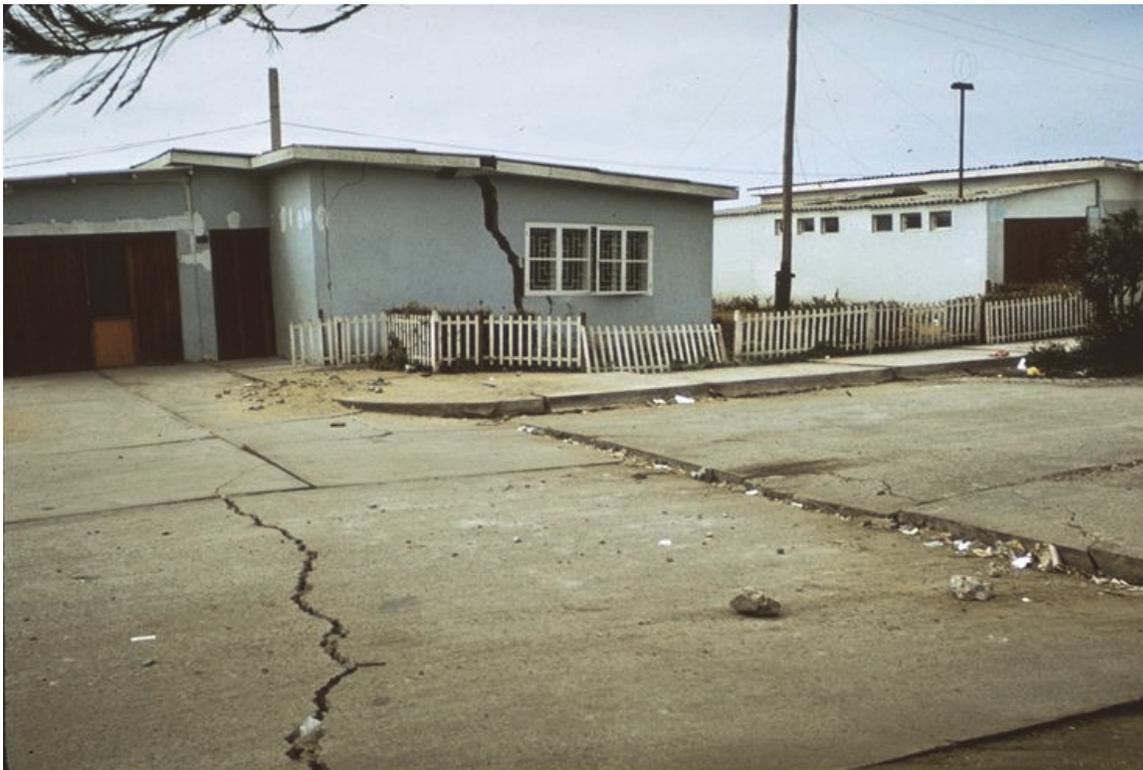
Figure 3-32 Projection of liquefaction-induced ground cracking through a building in the city of Chimbote during the 1970 Peru earthquake (photo credit: NISEE).

- Out-of-levelness consistent with conspicuous earthquake damage to adjacent wall finishes (Figure 3-32, Figure 3-47 to Figure 3-50). The presence of patched cracks, debris within cracks, and evidence of previous releveling (Figure 3-51) are indicators of long-term, recurring ground movement unrelated to the earthquake. Careful attention to detail is necessary to distinguish the effects of long-term foundation movement from movement associated with earthquake-induced permanent ground deformation.

- **Building Finishes.** Finish elements that should be inspected and documented include wall finishes (as discussed in Chapter 5) and masonry block walls or fences—elements that tend to be vulnerable to shaking-induced damage. Hence, the presence of damage to such elements is not necessarily indicative of earthquake-induced permanent ground deformation. To assess the possible contribution of earthquake-induced permanent ground deformation to damage in these elements, a pattern of cracking consistent with settlement—such as vertical cracks coincident with ground cracks or parallel diagonal cracks—should be present that is consistent with an earthquake-induced ground deformation mode (Figure 3-32, Figure 3-43, Figure 3-44, and Figure 3-47 to Figure 3-49).

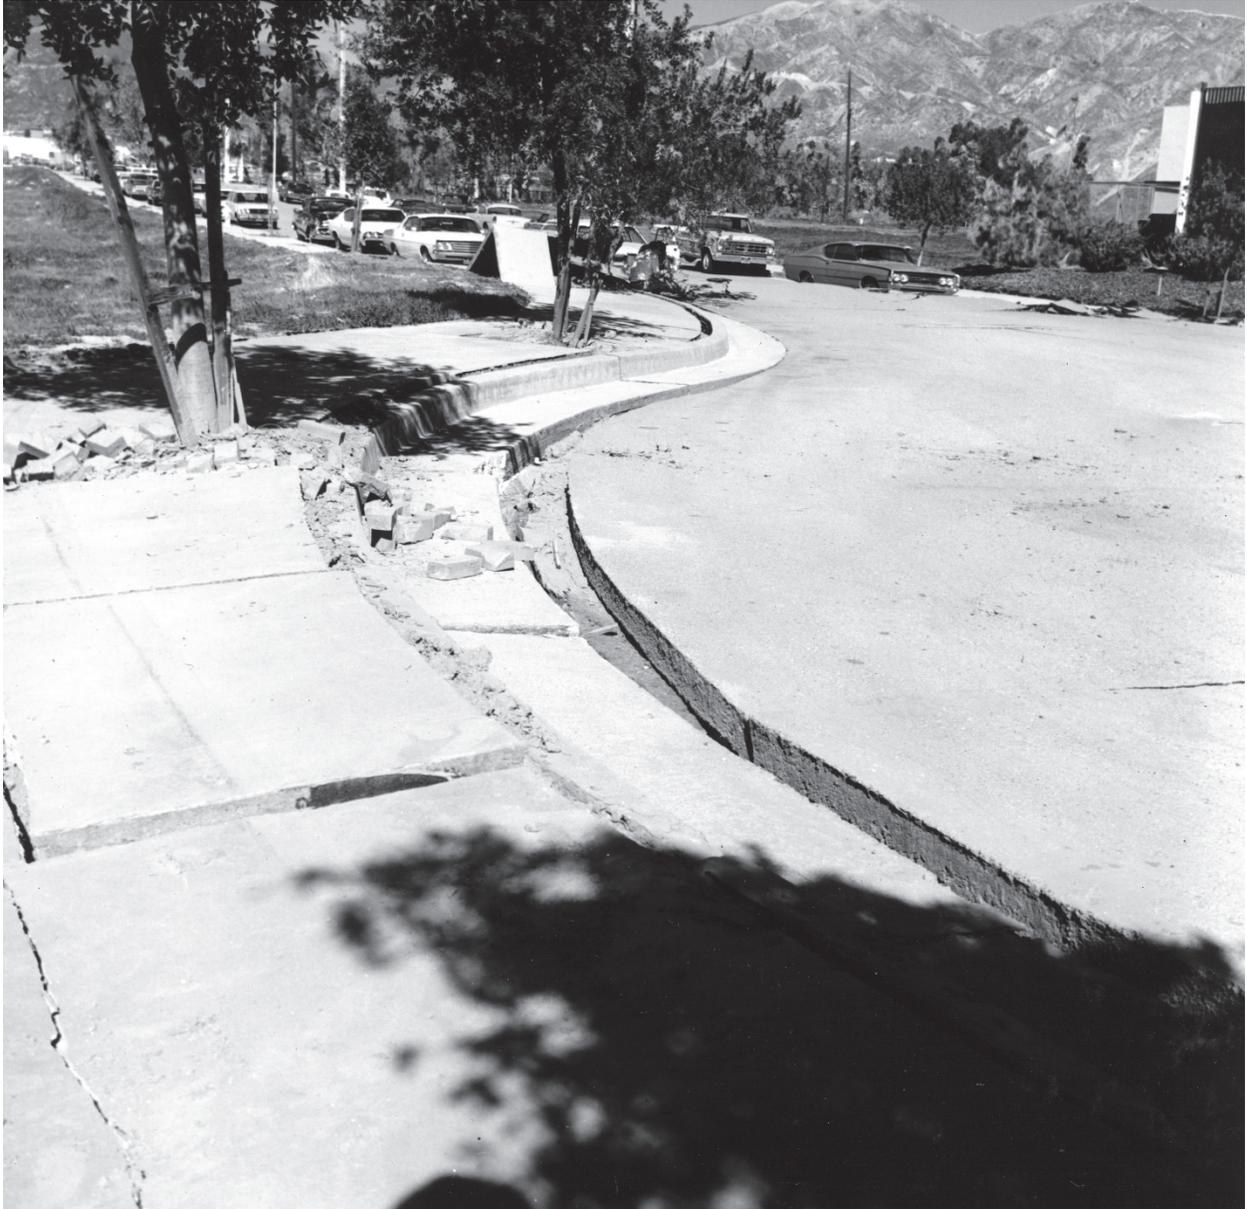
Figure 3-33 Driveway cracking following the 1971 San Fernando, California earthquake (photo credit: USGS Denver Library Photographic Collection).

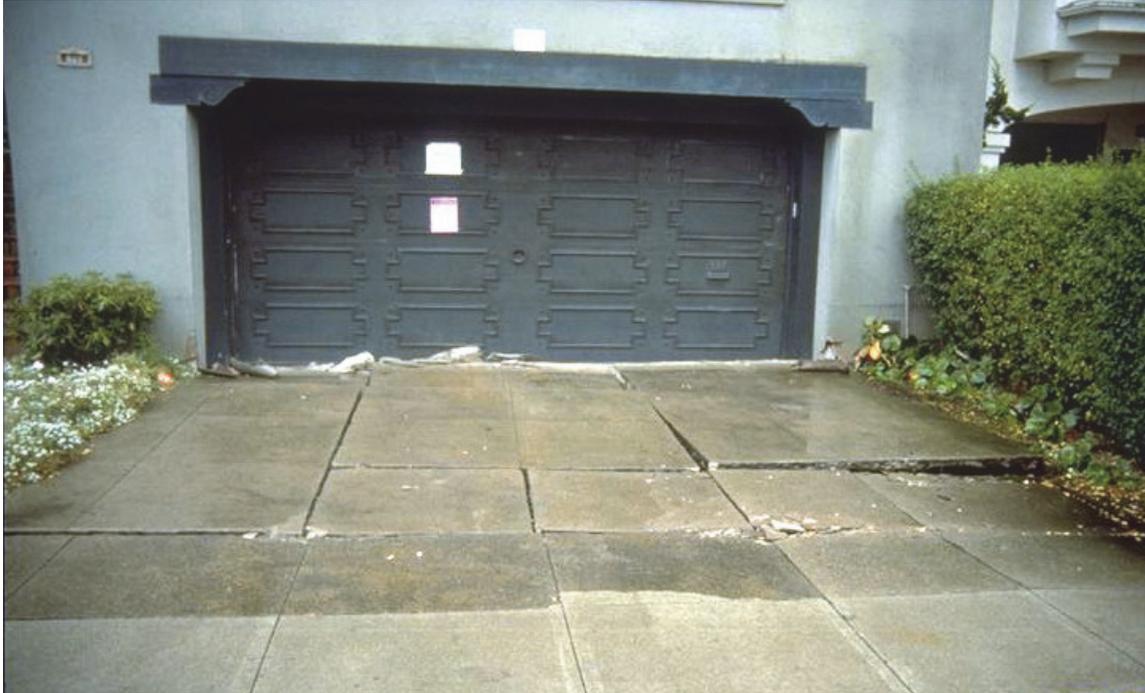
Figure 3-34 Driveway cracking and differential settlement following the 1989 Loma Prieta, California earthquake (photo credit: NISEE).

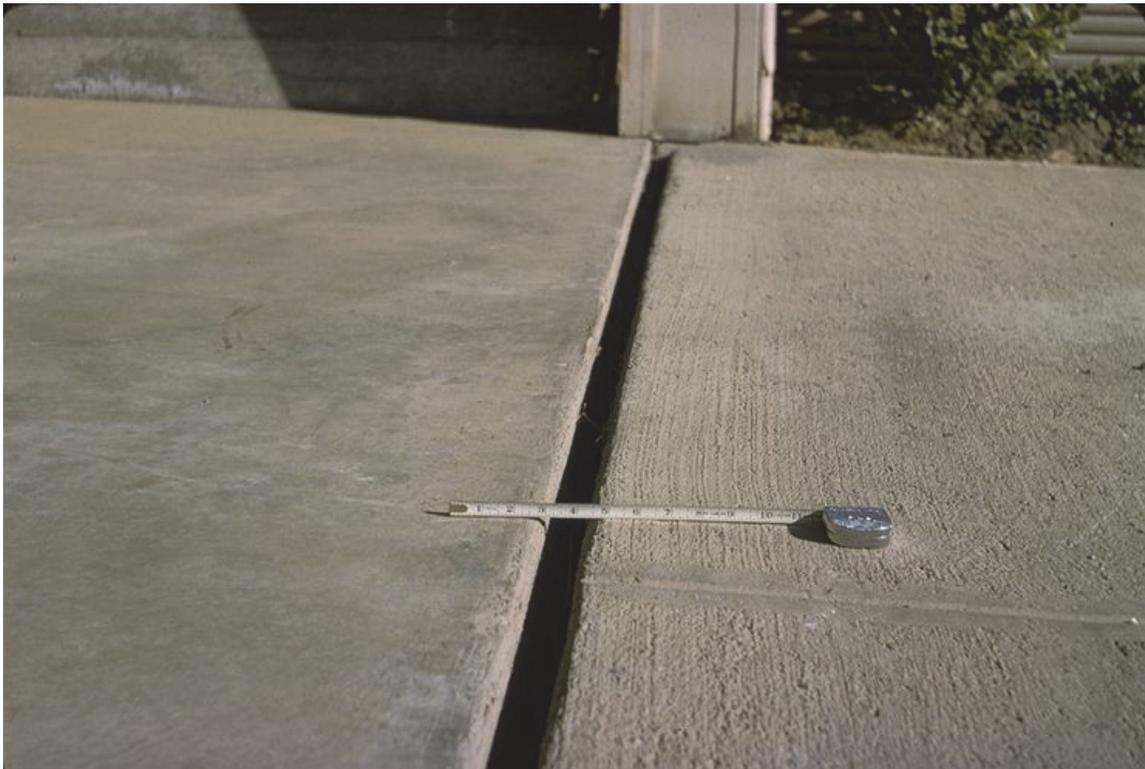
Figure 3-35 Two-inch separation at the construction joint between the garage slab and driveway slab following the 1957 Daly City, California earthquake (photo credit: NISEE)

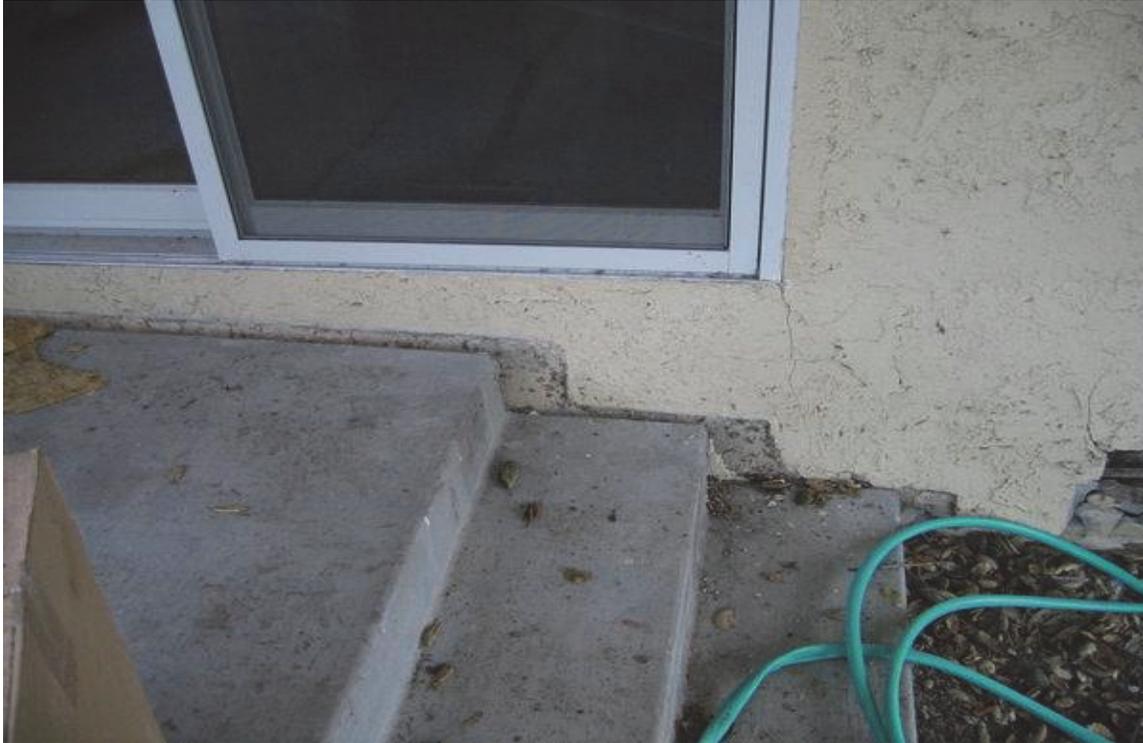
Figure 3-36 Concrete porch and steps offset from original position by earthquake-induced permanent ground deformation, as evidenced by exposed foundation concrete (photo credit: Exponent).

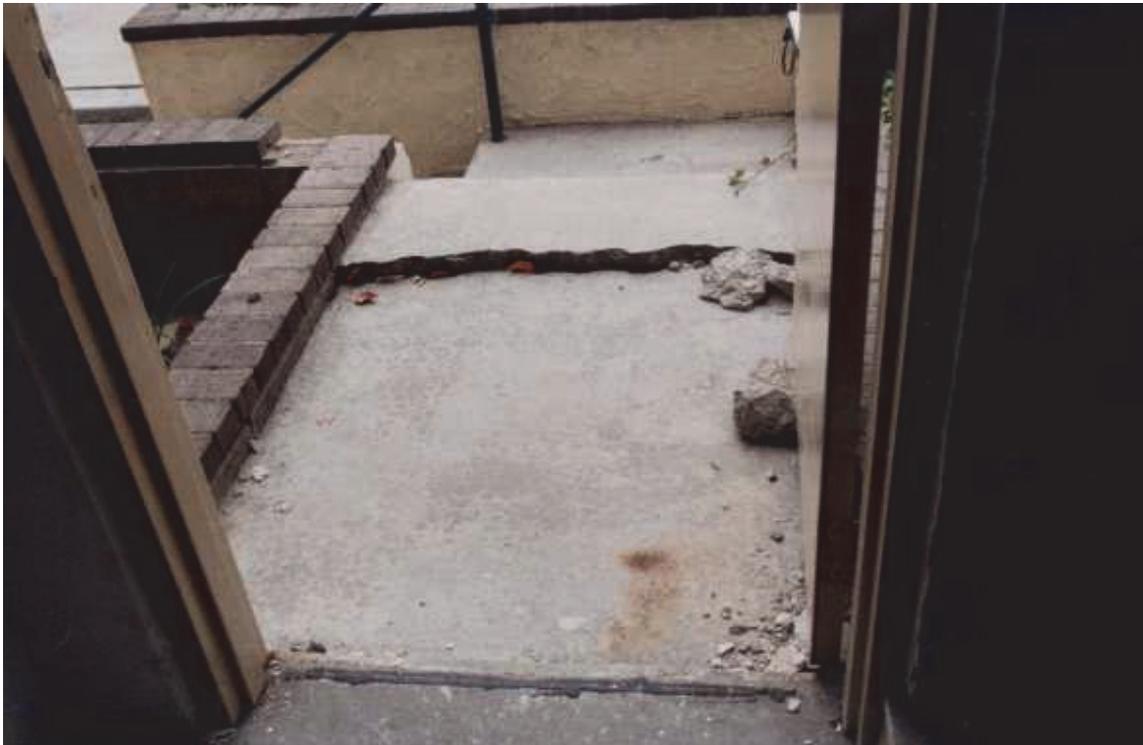
Figure 3-37 Dropping of entry walkway supported on poorly compacted backfill during the 1994 Northridge, California earthquake (photo credit: Exponent).

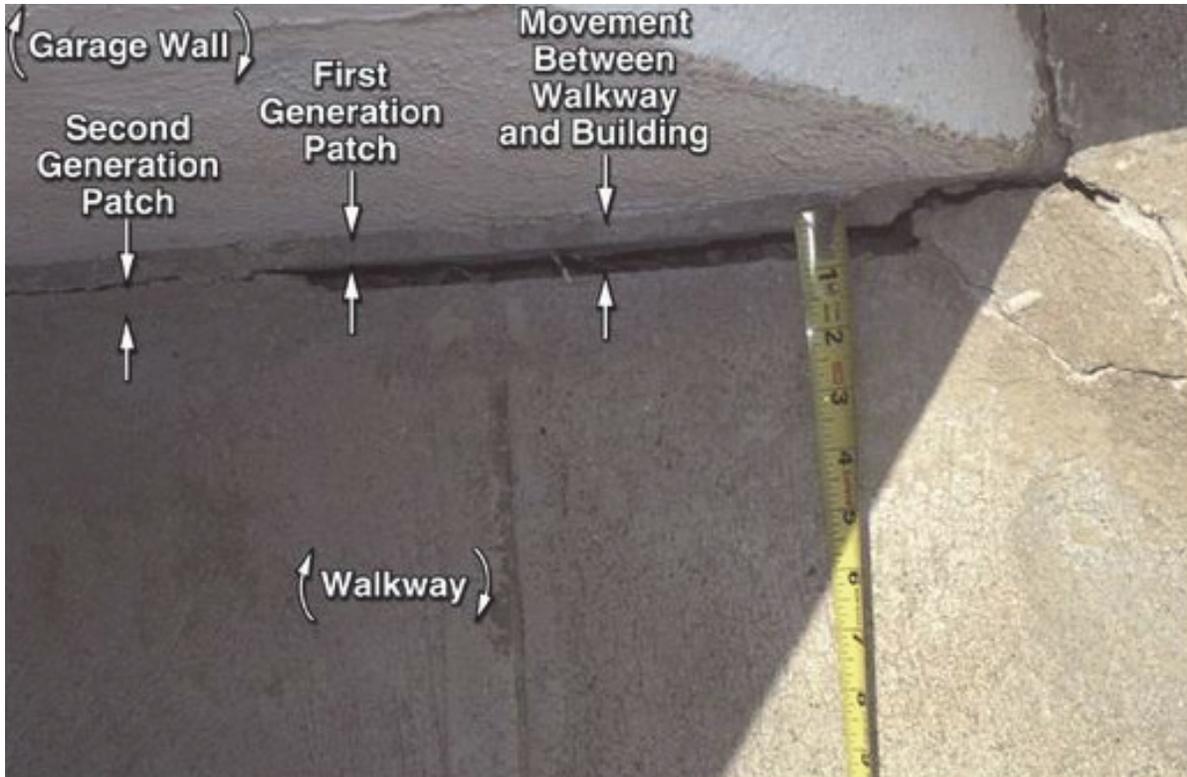
Figure 3-38 Different vintages of grout between a sidewalk and residence near a top of slope indicating a history of lateral movement as a result of slope creep rather than earthquake damage (photo credit: Exponent).

paint or debris within cracks, previous patching of cracks, and previous releveling of wood decks are indicators of a pre-existing condition, possibly associated with non-earthquake geotechnical processes (e.g., consolidation or slope creep, Figure 3-38 and Figure 3-39). See Section 4.7.2 for guidance on determining whether a fracture is recent.

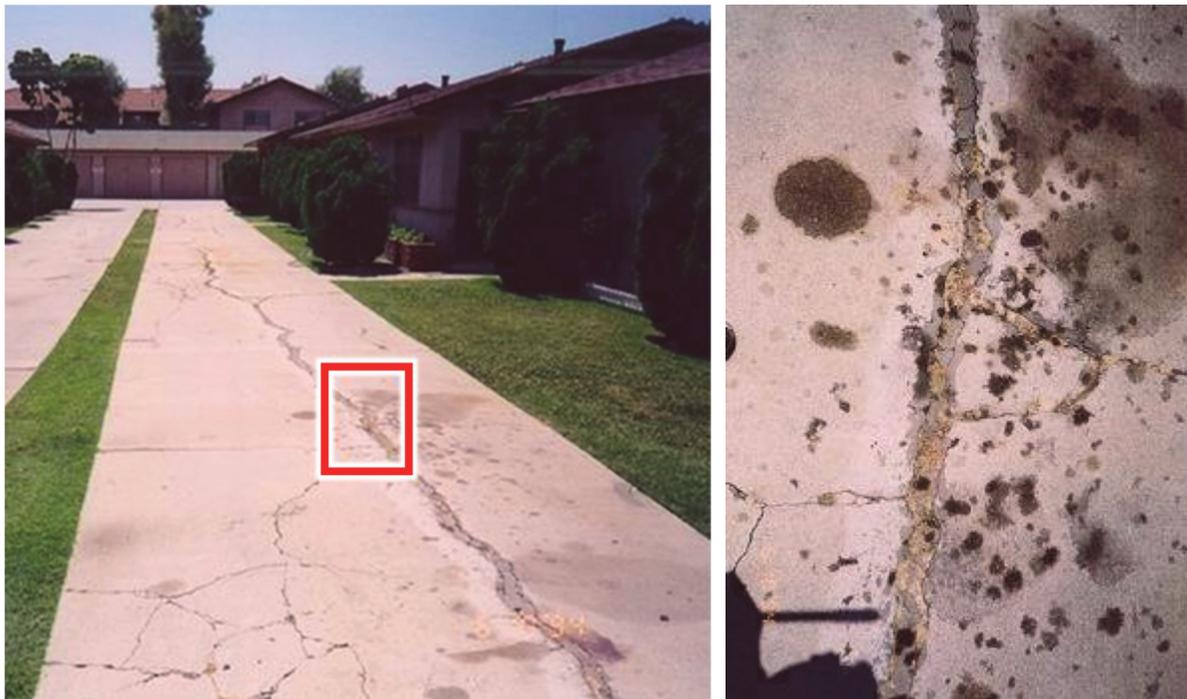
Figure 3-39 Grout within driveway slab-on-grade crack indicating long-term problem with expansive soil beneath driveway rather than earthquake damage (photo credit: Exponent).

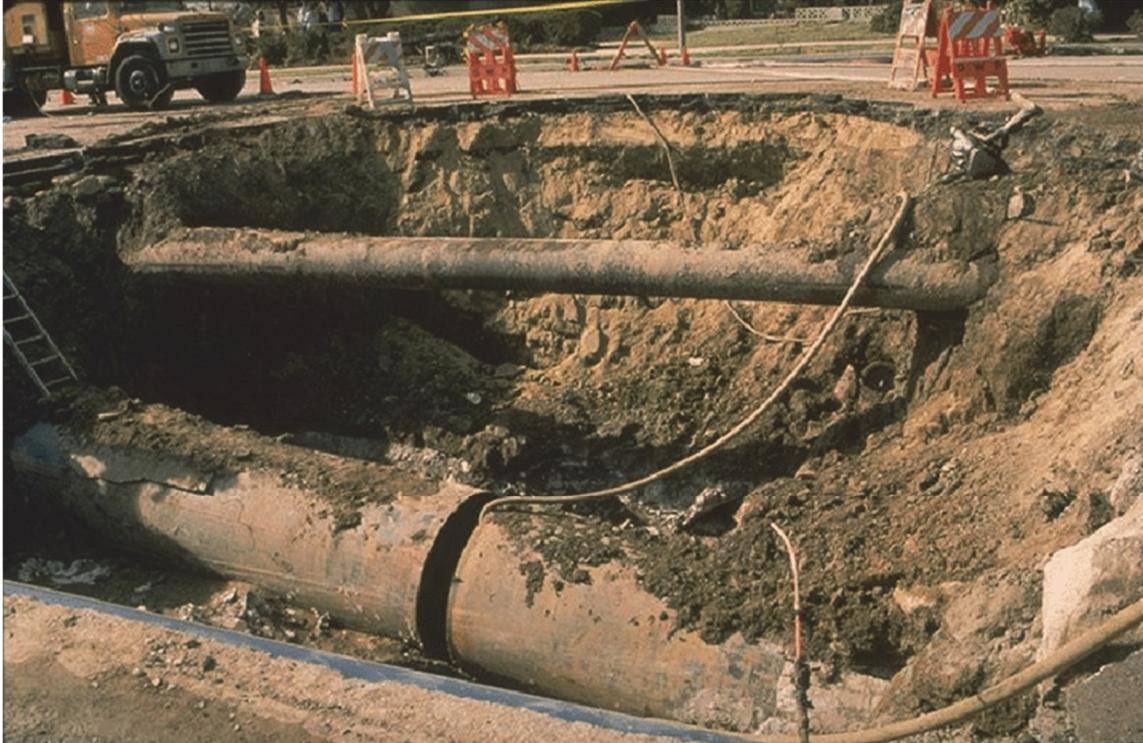
Figure 3-40 Utility pipe ruptured by lateral spreading from the 1994 Northridge, California earthquake (photo credit: NISEE).

- **Utility Lines.** Damage to underground utility lines on the property, such as water service lines, sanitary sewer lines, and gas lines, are indicators of possible earthquake-induced permanent ground deformation (Figure 3-8, Figure 3-40, and Figure 3-41). The condition of these lines, and service-ability of the lines (i.e., recent clogging of sewer lines) relative to their condition prior to the earthquake are also important and can be indicative of earthquake-induced damage. Although uncommon, underground utilities can also be damaged by transient earthquake ground movements, without any accompanying permanent ground deformations.
