Earthquake Damage Assessment and Repair Guidelines for Residential Wood-Frame Buildings

Volume 1 | GENERAL GUIDELINES

CEA-EDA-01 2020

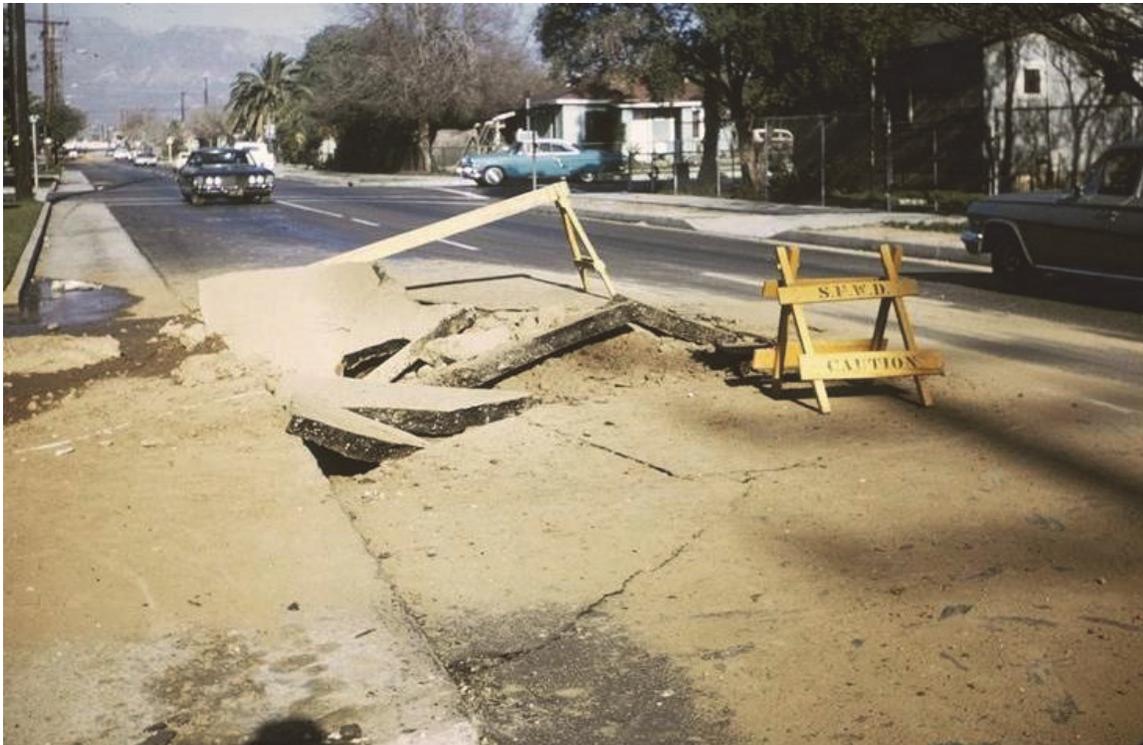
Figure 3-41 Pipe failures and resulting pavement distress and settlement from the 1971 San Fernando, California earthquake (photo credit: NISEE).

- **Utility Lines.** Damage to underground utility lines on the property, such as water service lines, sanitary sewer lines, and gas lines, are indicators of possible earthquake-induced permanent ground deformation (Figure 3-8, Figure 3-40, and Figure 3-41). The condition of these lines, and service-ability of the lines (i.e., recent clogging of sewer lines) relative to their condition prior to the earthquake are also important and can be indicative of earthquake-induced damage. Although uncommon, underground utilities can also be damaged by transient earthquake ground movements, without any accompanying permanent ground deformations.

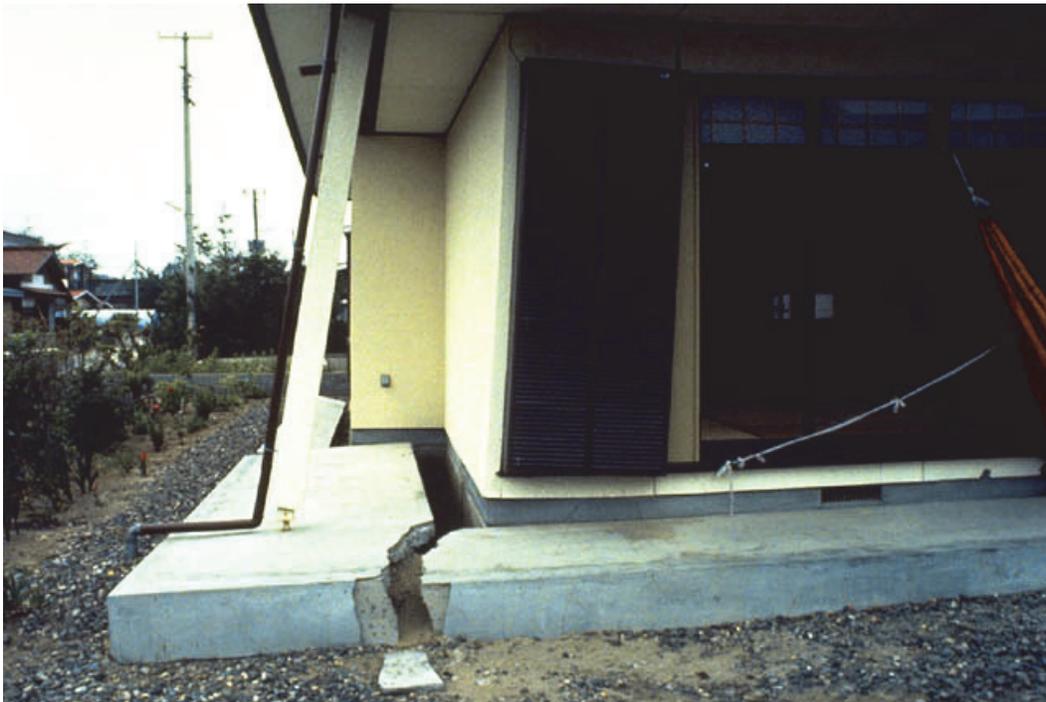
Figure 3-43 Damage to house foundation from lateral spreading in Wakami, Japan, during the 1983 Nihonkai-Chubu, Japan earthquake (photo credit: NISEE).

- Fresh cracking or the significant widening of pre-existing cracks in concrete stemwalls or footings (Figure 3-43 to Figure 3-46).
 - Soil deformations adjacent to foundations (e.g., bulging or tension cracks).

- **Building Finishes.** Finish elements that should be inspected and documented include wall finishes (as discussed in Chapter 5) and masonry block walls or fences—elements that tend to be vulnerable to shaking-induced damage. Hence, the presence of damage to such elements is not necessarily indicative of earthquake-induced permanent ground deformation. To assess the possible contribution of earthquake-induced permanent ground deformation to damage in these elements, a pattern of cracking consistent with settlement—such as vertical cracks coincident with ground cracks or parallel diagonal cracks—should be present that is consistent with an earthquake-induced ground deformation mode (Figure 3-32, Figure 3-43, Figure 3-44, and Figure 3-47 to Figure 3-49).

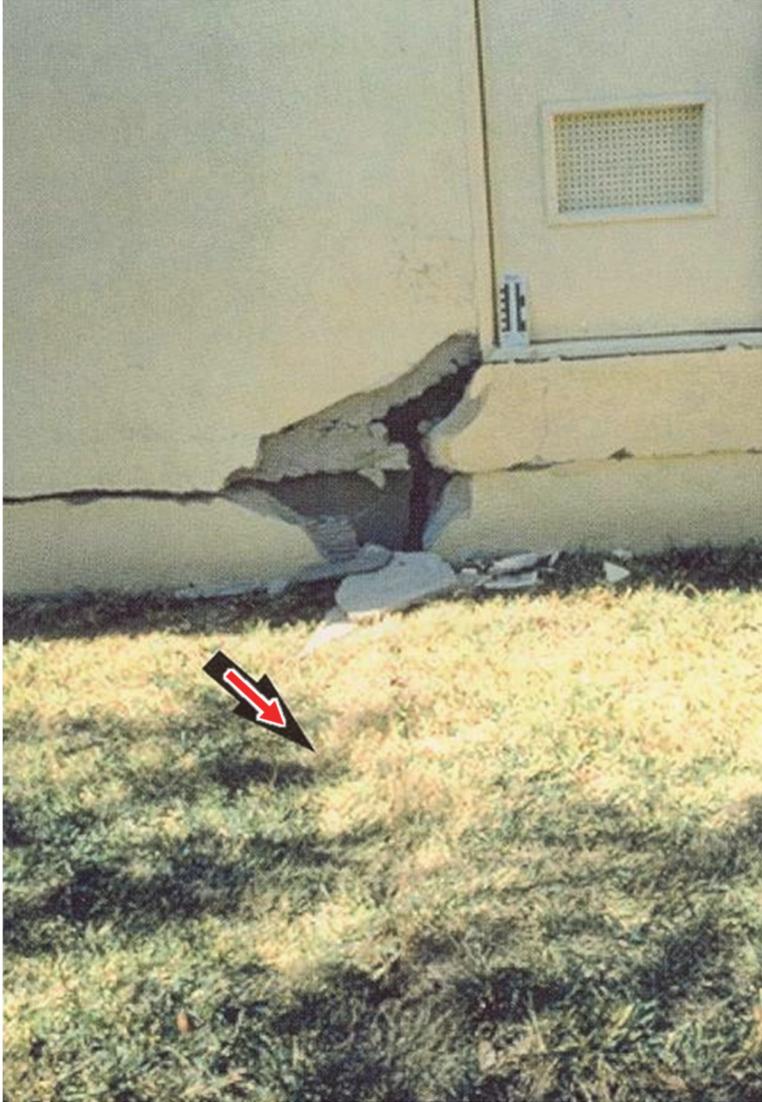
Figure 3-44 Damage to foundation slab and wall of house by small settlement and ground cracking evident in the lawn (arrow) during the 1994 Northridge, California earthquake (photo credit: USGS).

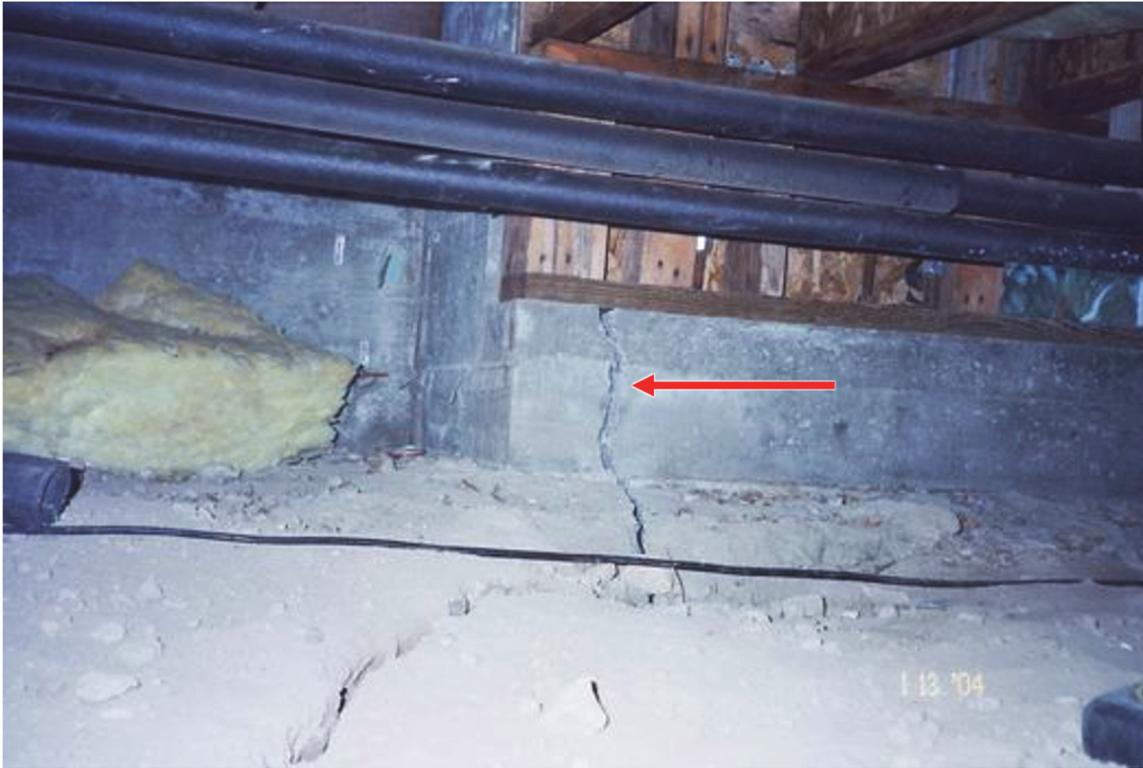
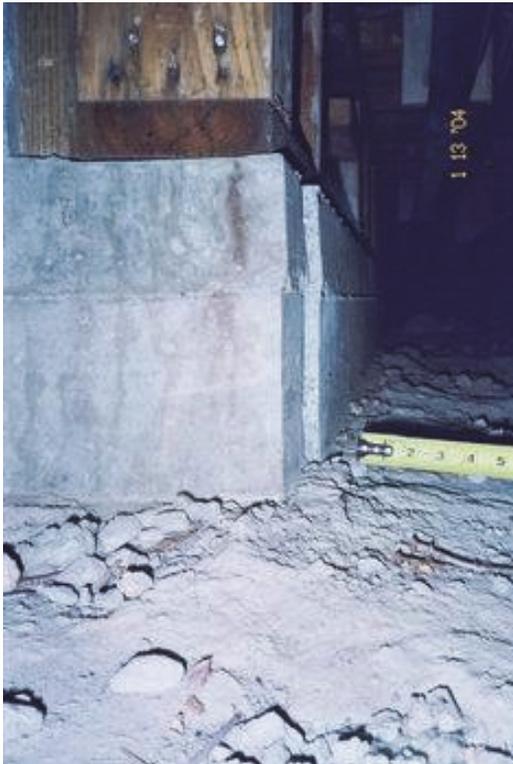
Figure 3-45 Foundation and ground cracking following the 2003 San Simeon, California earthquake; bottom shows the out-of-plane offset present across the foundation crack shown in top photograph (photo credit: Exponent).

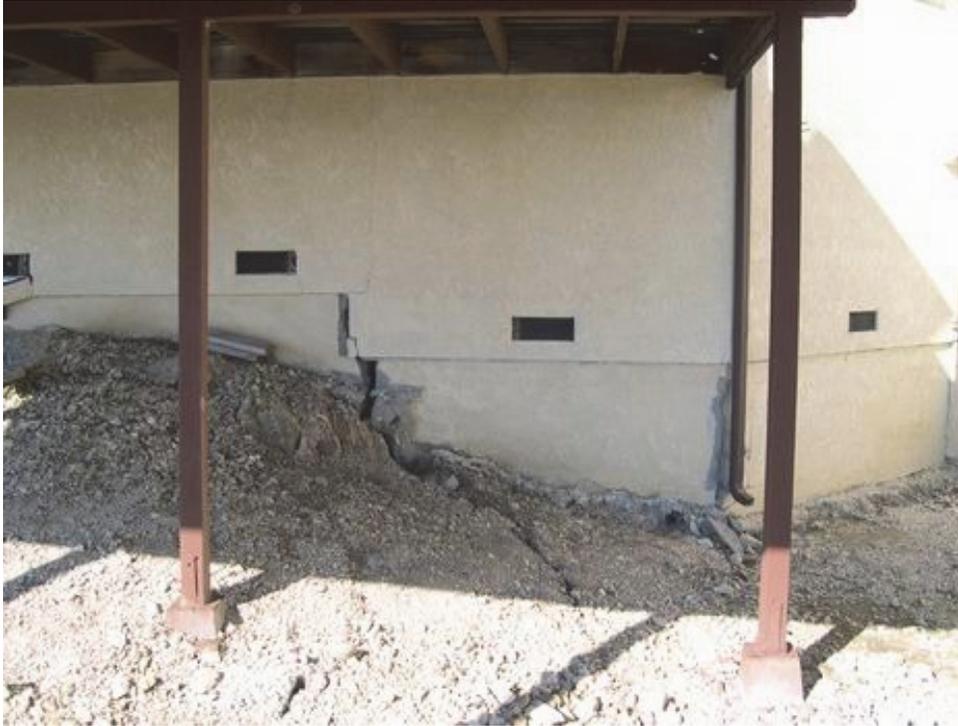
Figure 3-46 Foundation and ground cracking following the 2003 San Simeon, California earthquake (photo credit: Exponent).

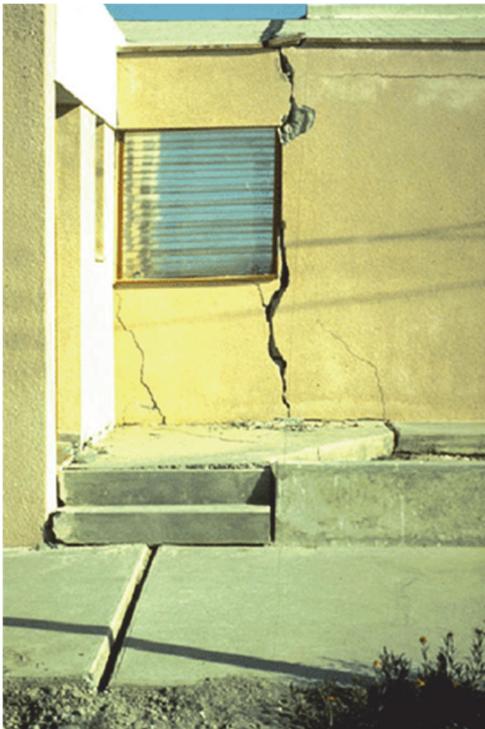
Figure 3-47 One-story masonry house damaged due to differential settlement caused by liquefaction in the town of Caucete during the 1977 Caucete, San Juan, Argentina earthquake. Damage to the interior slab is shown in Figure 3-48 (photo credit: NISEE).

- Out-of-levelness consistent with conspicuous earthquake damage to adjacent wall finishes (Figure 3-32, Figure 3-47 to Figure 3-50). The presence of patched cracks, debris within cracks, and evidence of previous releveling (Figure 3-51) are indicators of long-term, recurring ground movement unrelated to the earthquake. Careful attention to detail is necessary to distinguish the effects of long-term foundation movement from movement associated with earthquake-induced permanent ground deformation.

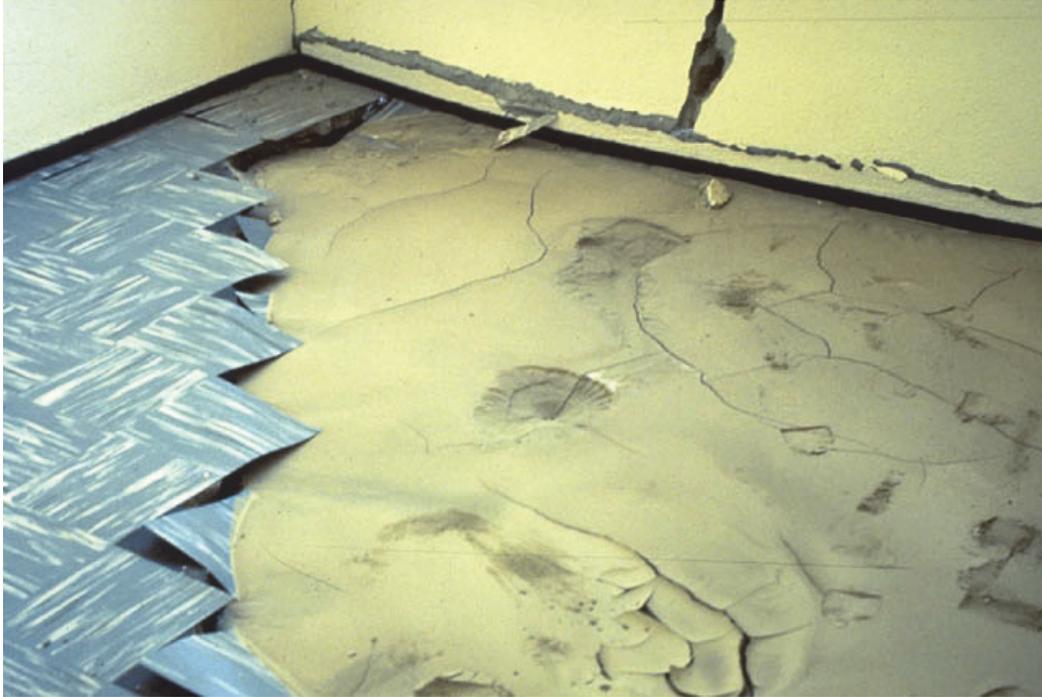
Figure 3-48 Damaged concrete slab-on-grade floor of the house shown in Figure 3-47; sandy mud ejected by liquefaction covers part of the floor (photo credit: NISEE).

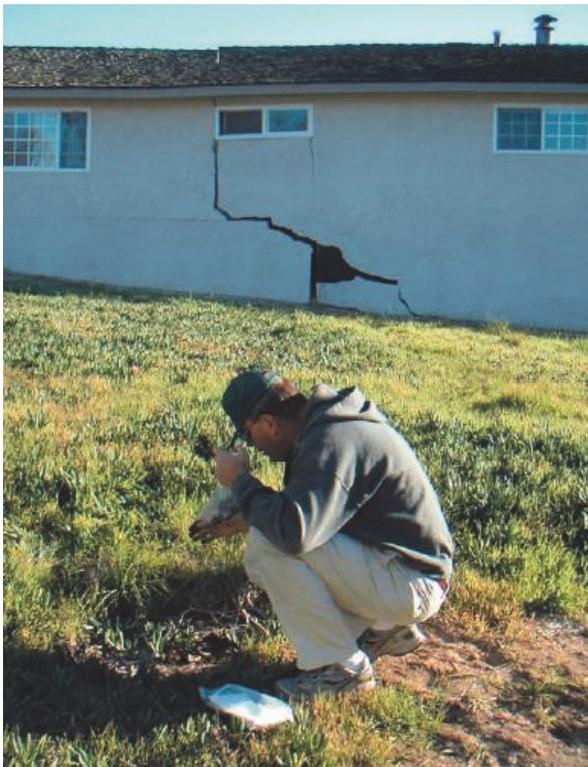
Figure 3-49 Damage to a residence from lateral spreading following the 2003 San Simeon, California earthquake (photo credit: USGS).

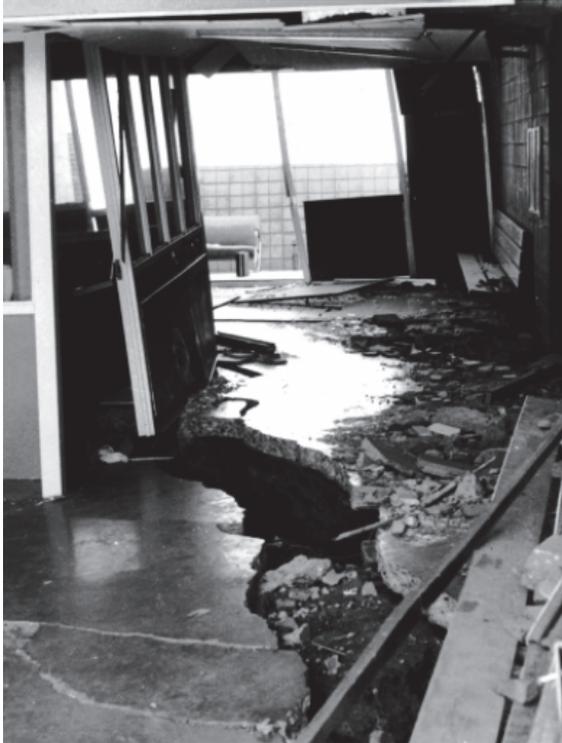
Figure 3-50 Damage to a slab-on-grade from liquefaction during the 1971 San Fernando, California earthquake (photo credit: J. Meehan).

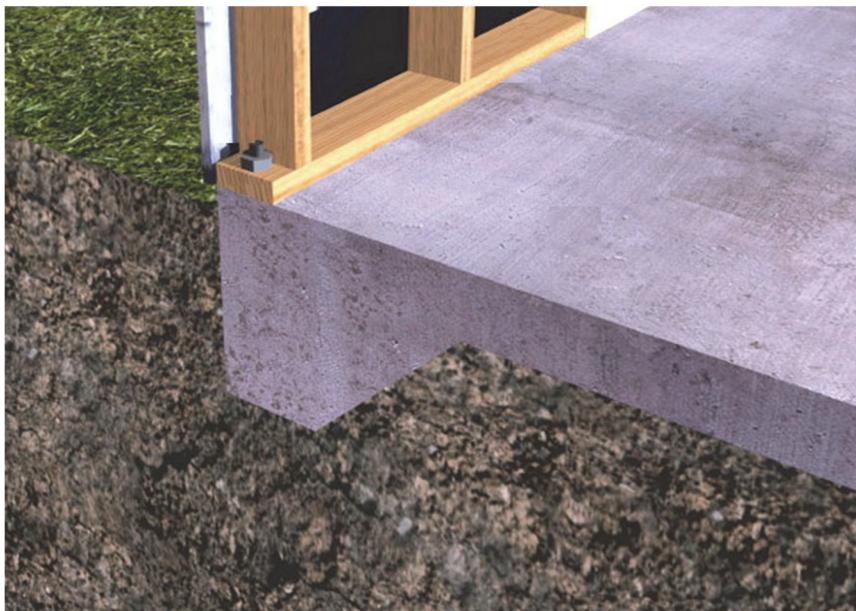
Figure 4-1 Continuous footing at perimeter of a slab-on-grade—single-pour system (image credit: Exponent).

- thickened slab edges around the perimeter of concrete slab-on-grade floors (Figure 4-1),
- continuous strip footings around the perimeter of a slab-on-grade (Figure 4-2),
- continuous strip footings under wood-frame stud walls (i.e., cripple walls) that support the first-floor framing over a crawlspace (Figure 4-3),
- continuous stemwalls from the soil to the underside of the first-floor framing over a crawlspace (Figure 4-4),
- isolated pads or pedestals (sometimes pre-cast) supporting wood posts that support the first-floor framing over a crawlspace (Figure 4-5), and
- drilled piers and grade beams supporting wood floor framing over a crawlspace (this type of foundation is often visually indistinguishable from a stemwall foundation, although structurally it functions much differently; Figure 4-6).

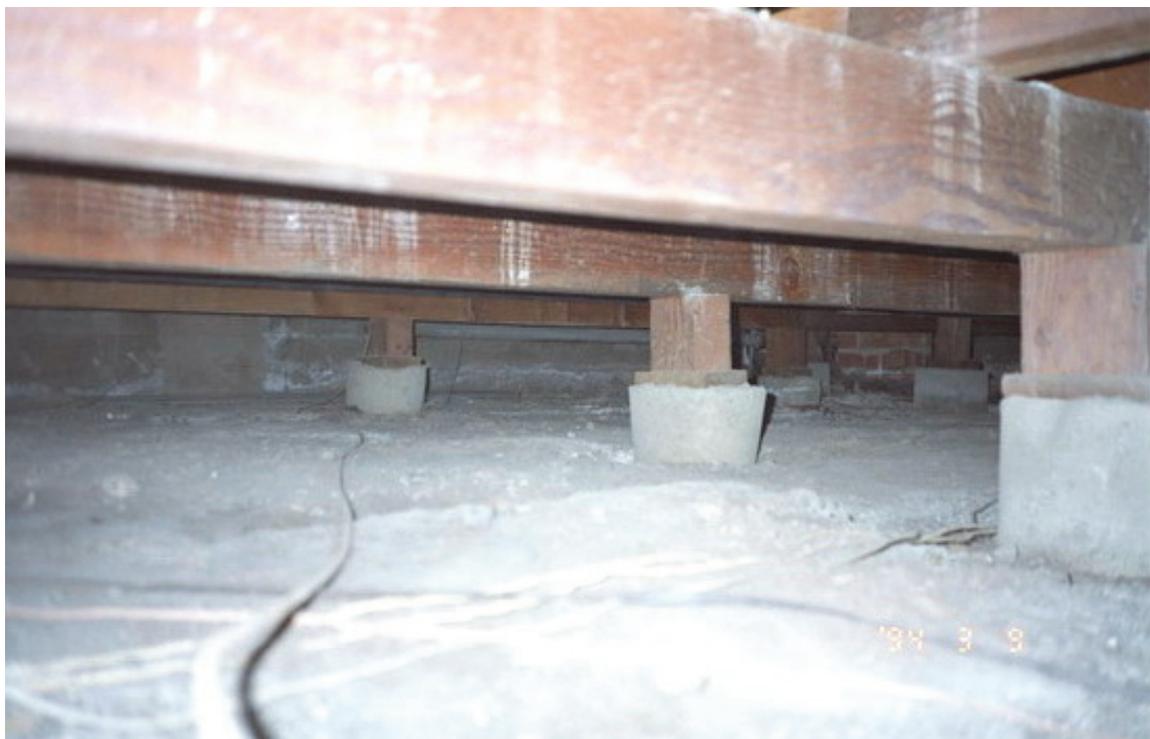
Figure 4-5 Isolated footings supporting wood posts of first-floor wood framing (photo credit: Exponent).

It is also necessary to identify relevant details of the foundation construction. If the house has a raised foundation, are there wood cripple walls over concrete footings (Figure 4-3), or is the crawlspace enclosed by full-height stemwalls (Figure 4-4)? Is the interior of the house supported in the same way as the perimeter, or are there individual wood posts on concrete or masonry piers (Figure 4-5)? In addition to the raised portion, does the house also have a more recent slab-on-grade addition?

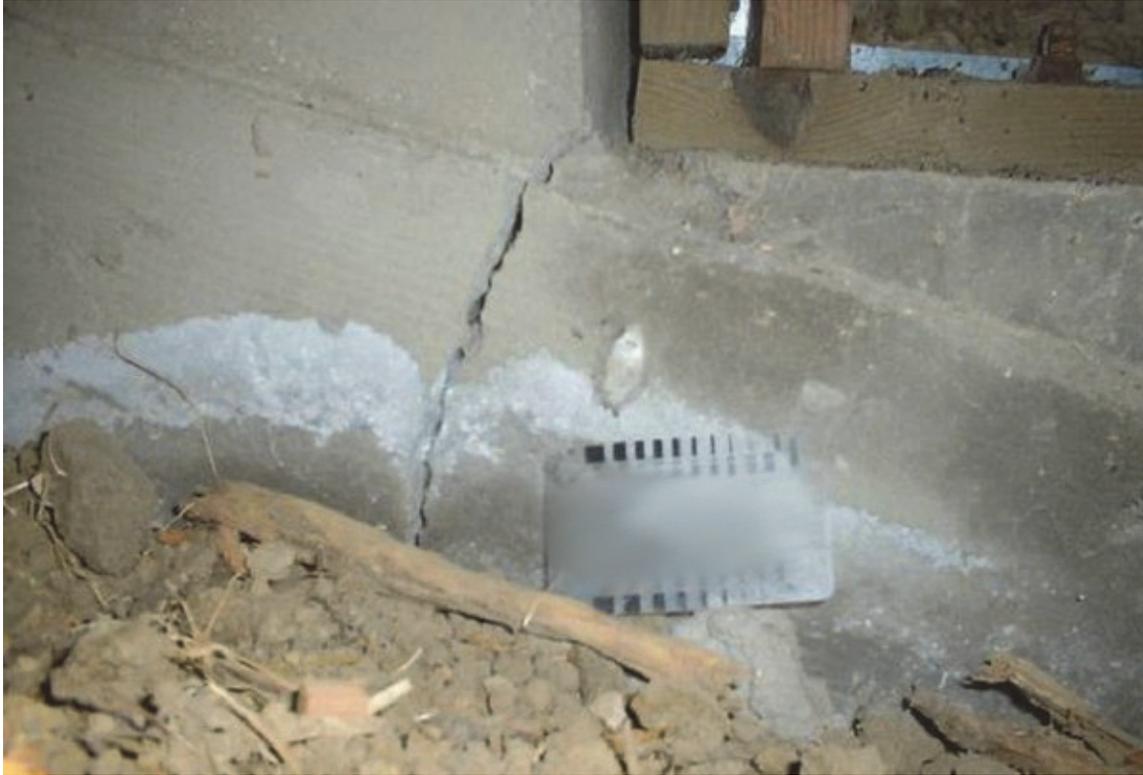
Figure 4-7 Concrete shrinkage crack emanating from reentrant corner at a step in a perimeter stemwall (photo credit: Exponent).

In footings and stemwalls, shrinkage cracks develop at openings for access, vents, plumbing, and ductwork, as well as at corners, "steps" (changes in elevation of the top of the stemwall) (Figure 4-7), anchor bolts (Figure 4-8), and recesses (or pockets) in the stemwall for supporting floor beam (Figure 4-9). Otherwise, cracks develop at essentially random locations along the length of the footing or stemwall, subdividing it into shorter lengths. Without aggravating soil conditions, the cracks are generally near vertical and of uniform width or slightly wider toward the top of the stemwall, having no offset across the crack.

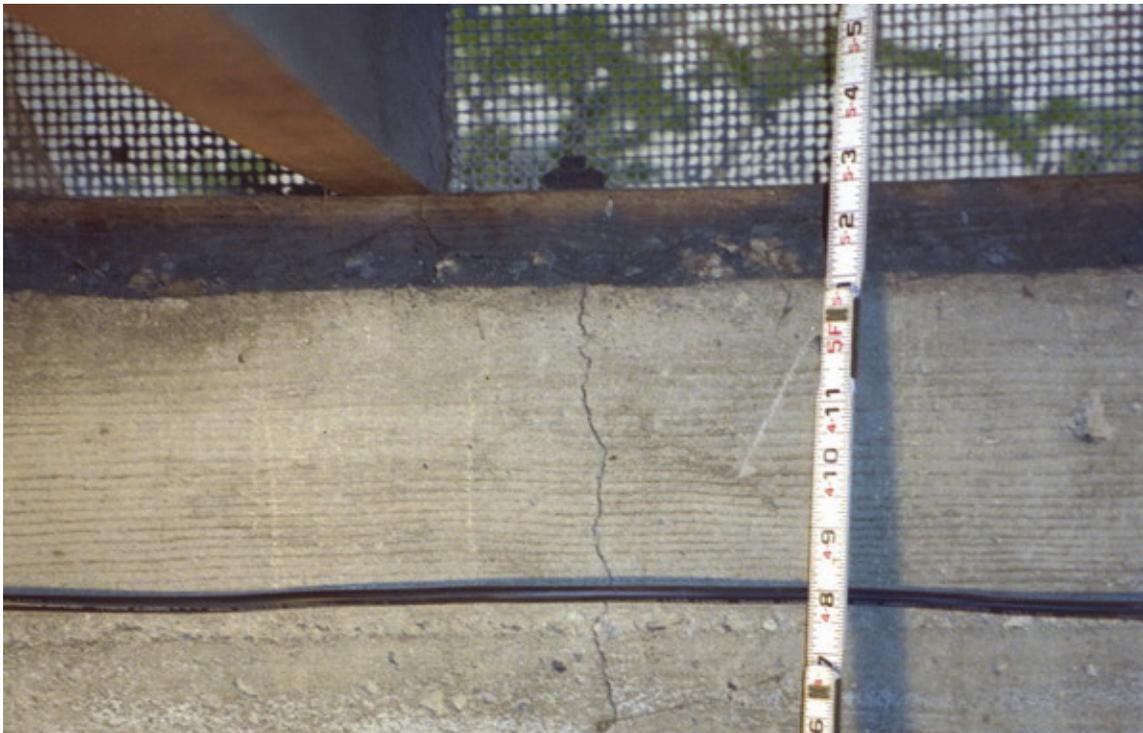
Figure 4-8 Shrinkage crack in a concrete stemwall emanating from an anchor bolt (photo credit: Exponent).

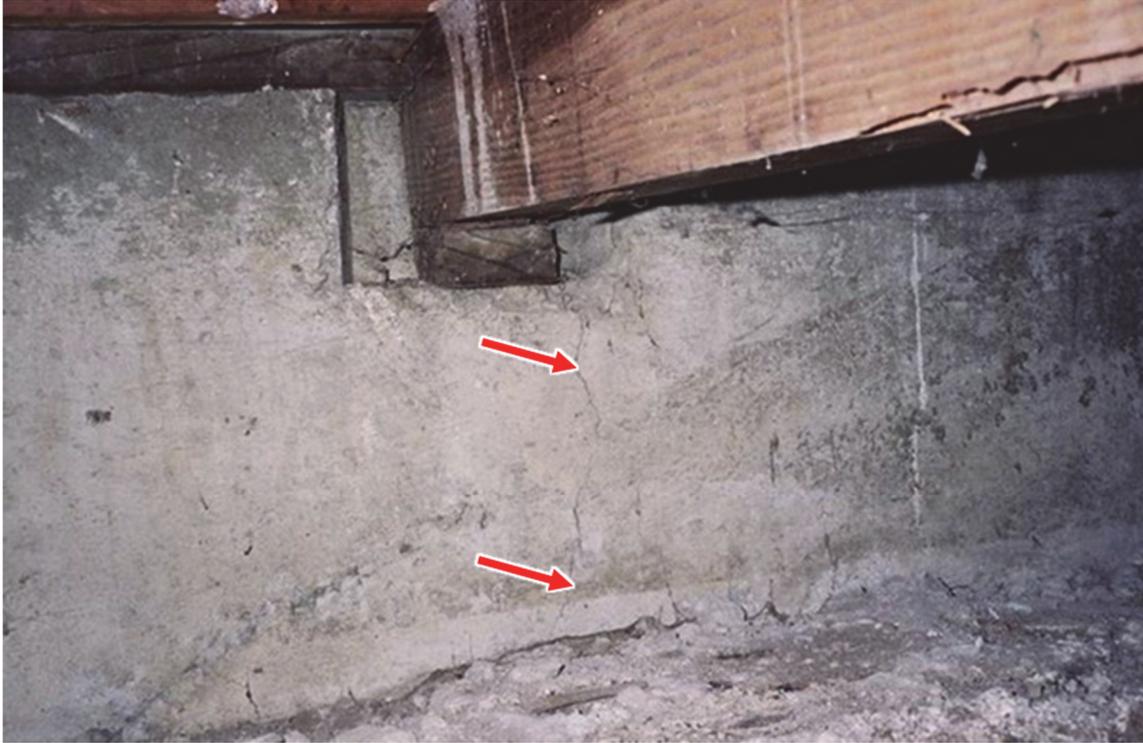
Figure 4-9 Shrinkage crack in a concrete stemwall emanating from a beam pocket (image credit: Exponent).

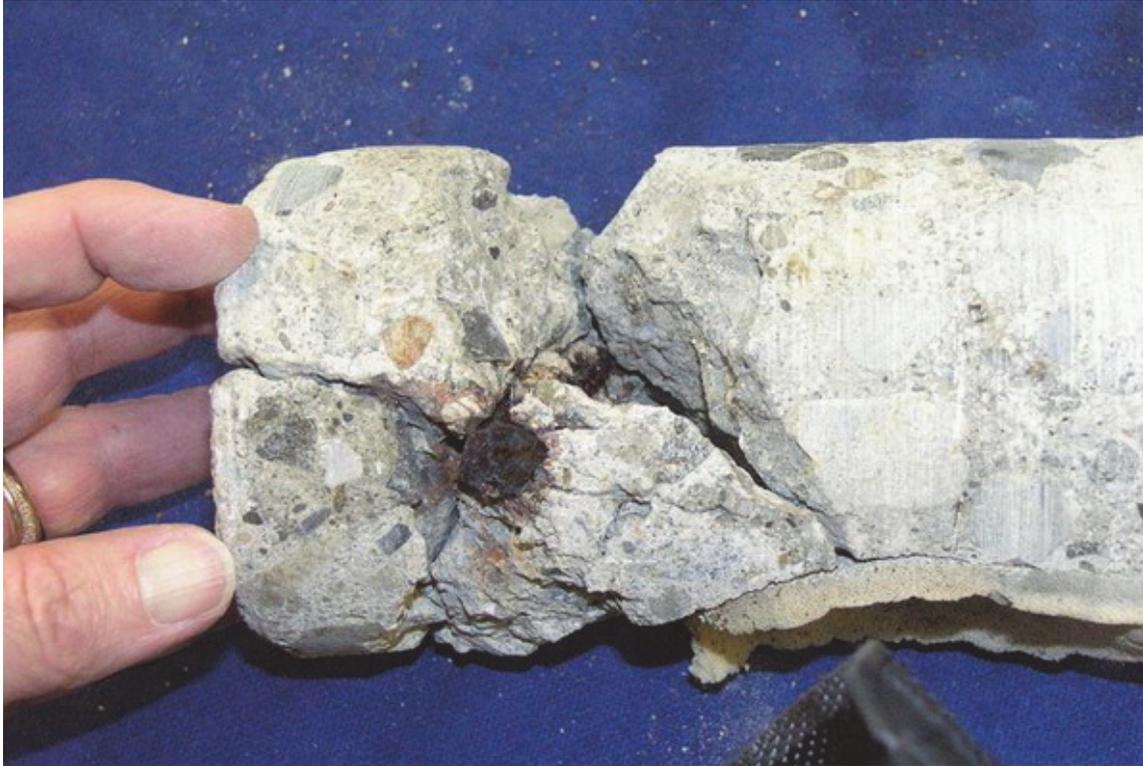
Figure 4-12 Core extracted from concrete stemwall showing cracking caused by swelling pressure generated by corroding reinforcing steel (photo credit: Exponent).

- corrosion of reinforcing steel, as shown in Figure 4-12, or anchor bolts (especially in marine environments or where deicing salts are used),
- tree roots, vines, or other vegetation, as shown in Figure 4-13,
- vehicle traffic loads, especially where the underlying soil has been eroded or softened, for example by a sprinkler system, as shown in Figure 4-14,
- changes in site drainage conditions or vegetation coverage and irrigation, including paving of areas adjacent to the foundation or slab that were previously vegetated, and
- extensive burrowing of gophers or other rodents.

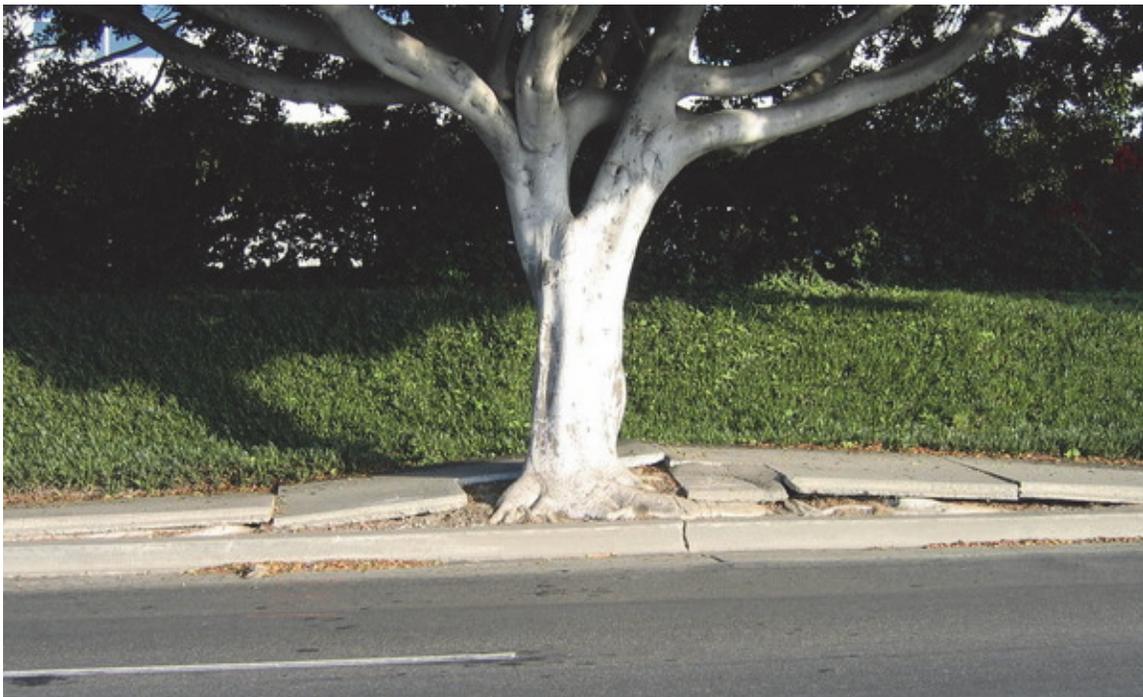
Figure 4-13 Uplift and cracking of concrete sidewalk caused by tree roots (photo credit: Exponent).

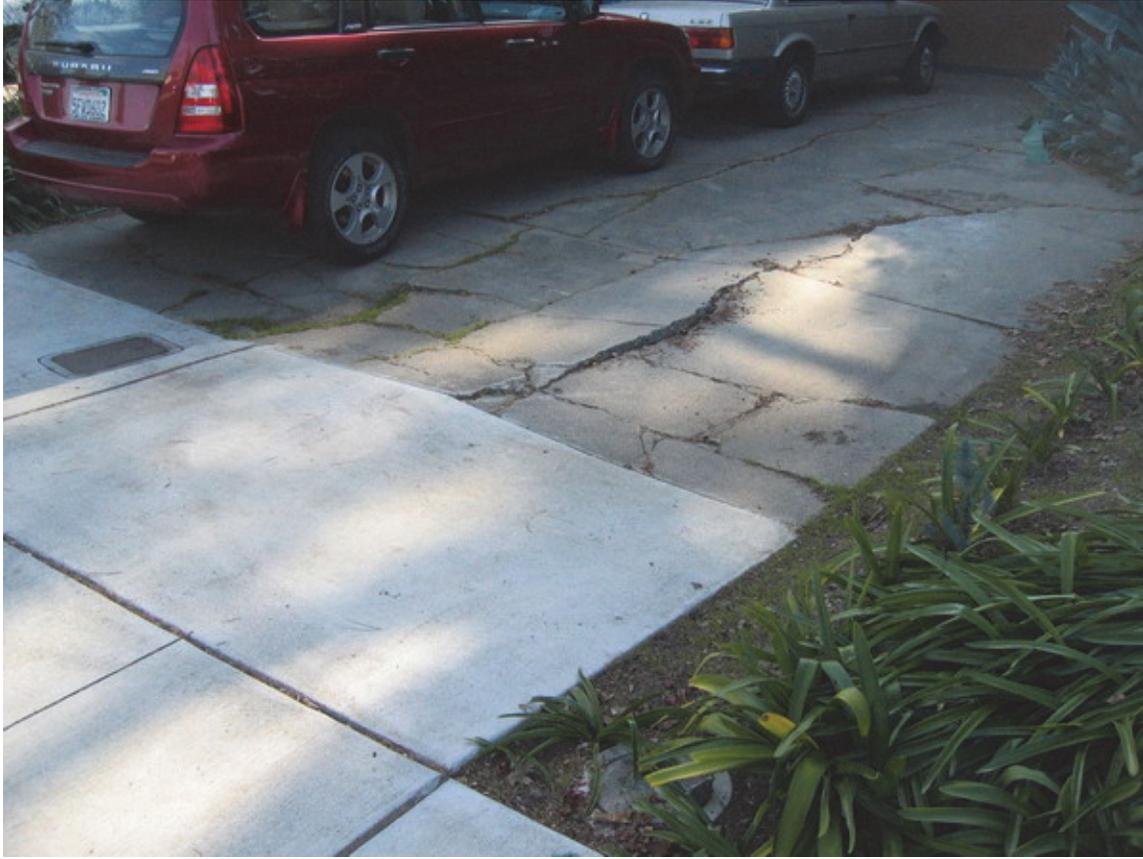
Figure 4-14 Cracking due to vehicle loads on a concrete driveway over soft soil (photo credit: Exponent).

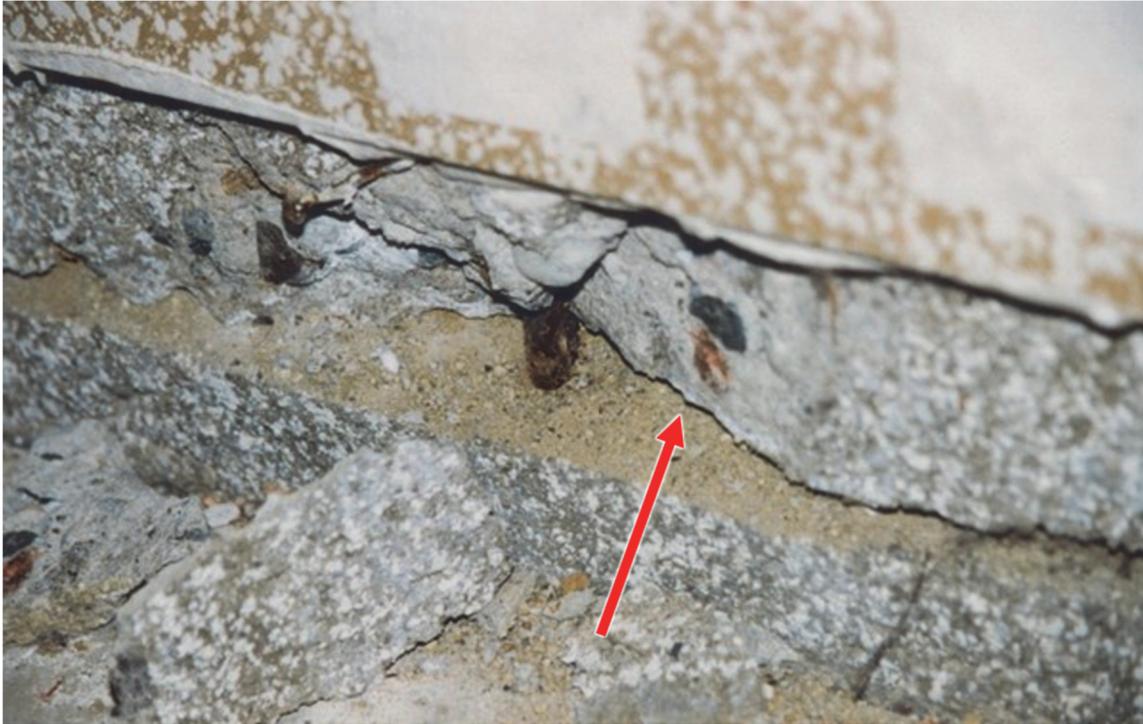
Figure 4-15 Earthquake-induced relative movement at slab-footing interface in two-pour slab-on-grade construction due to sand covering the footing during construction (photo credit: Exponent).

The most common occurrence is minor relative movement across the horizontal construction joint between the footing and the slab-on-grade in two-pour systems. When the plastic vapor barrier or sand fill is extended over the top of the footing (Figure 4-15), the strength of the connection between slab and foundation is reduced. While the result of this movement is spalling and cracking of stucco or concrete patching material around the perimeter of the foundation (Figure 4-16) or cracking of brittle floor finishes at interior steps or floor level changes (Figure 4-17), there are, as a practical matter, no consequences beyond the need for cosmetic repair. Significant earthquake-induced sliding of the slab relative to the foundation will show as a consistent pattern of slab-footing offset and will likely be accompanied by spalling of concrete at anchor bolts, substantial damage to the house walls, and damage to utility lines that penetrate the floor slab.

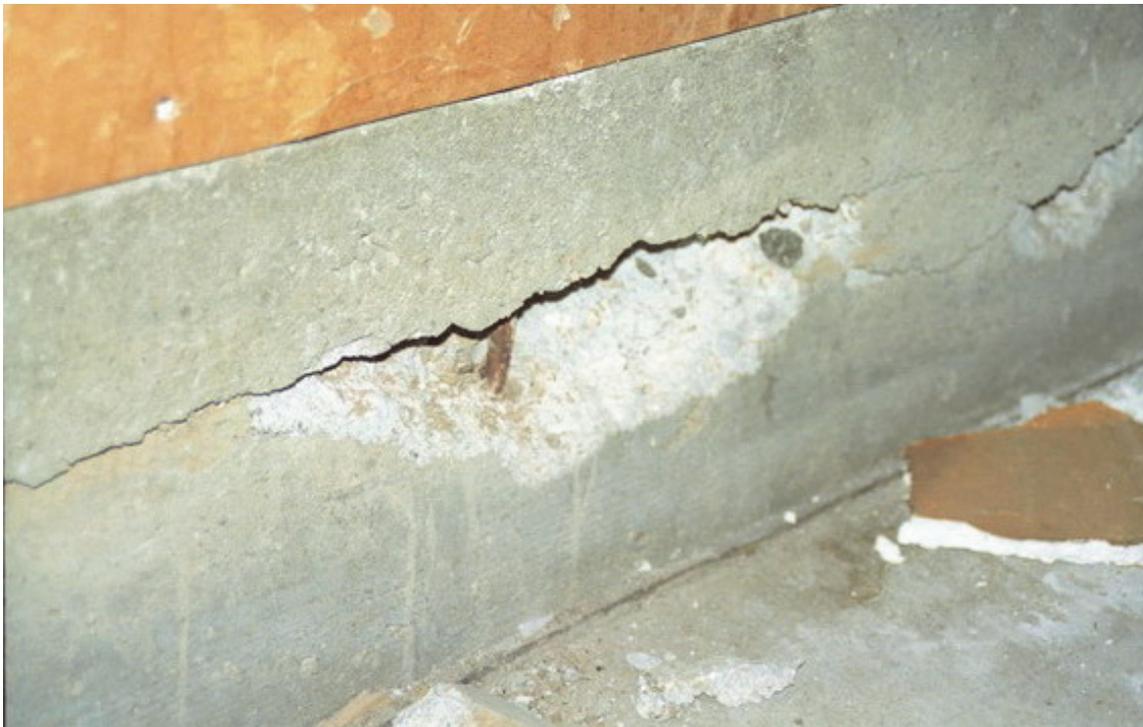
Figure 4-16 Earthquake-induced differential movement and spalling at cold joint between stemwall and slab in two-pour construction (photo credit: Exponent).

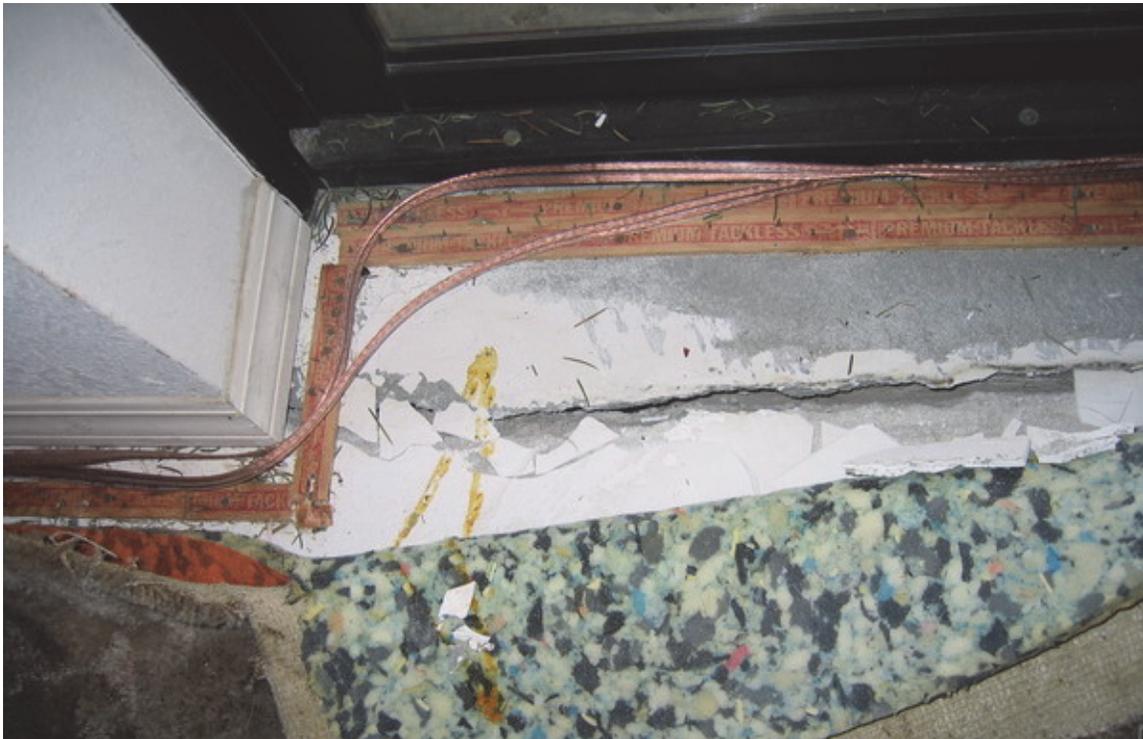
Figure 4-18 Earthquake-induced opening of cold joint between floor slab and perimeter footing (photo credit: Exponent).

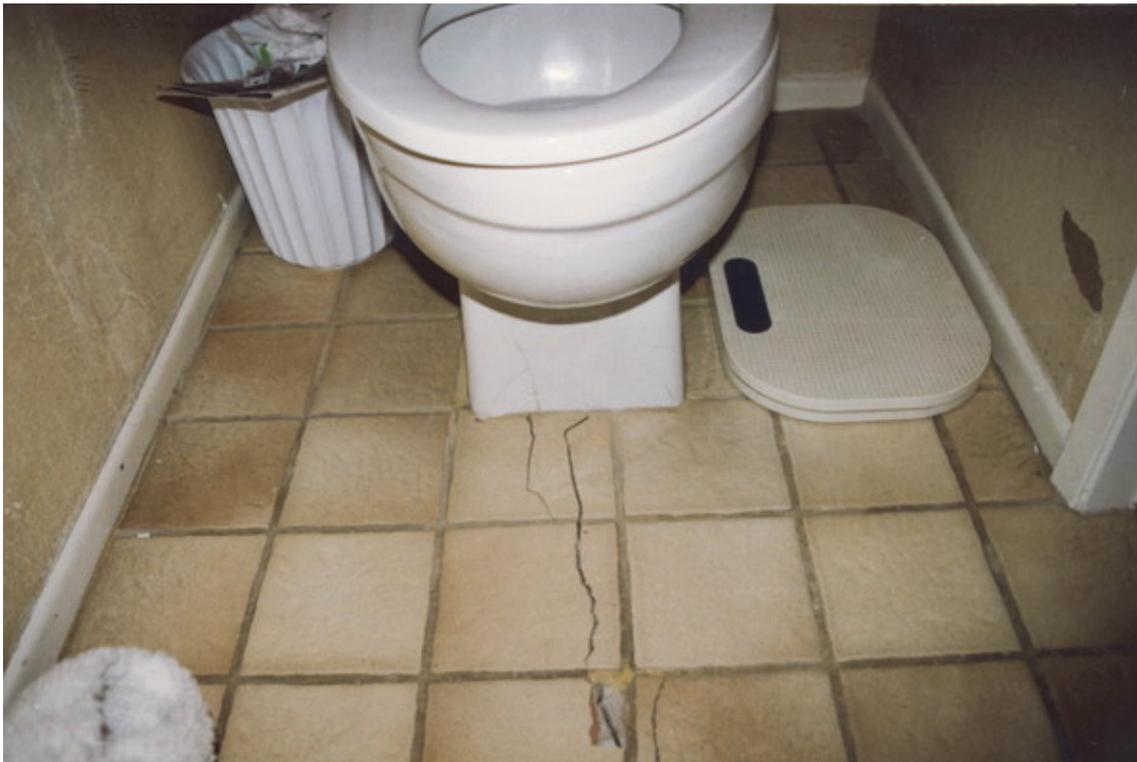
Figure 4-19 Earthquake-induced cracking of ceramic tile on a slab-on-grade (photo credit: Exponent).

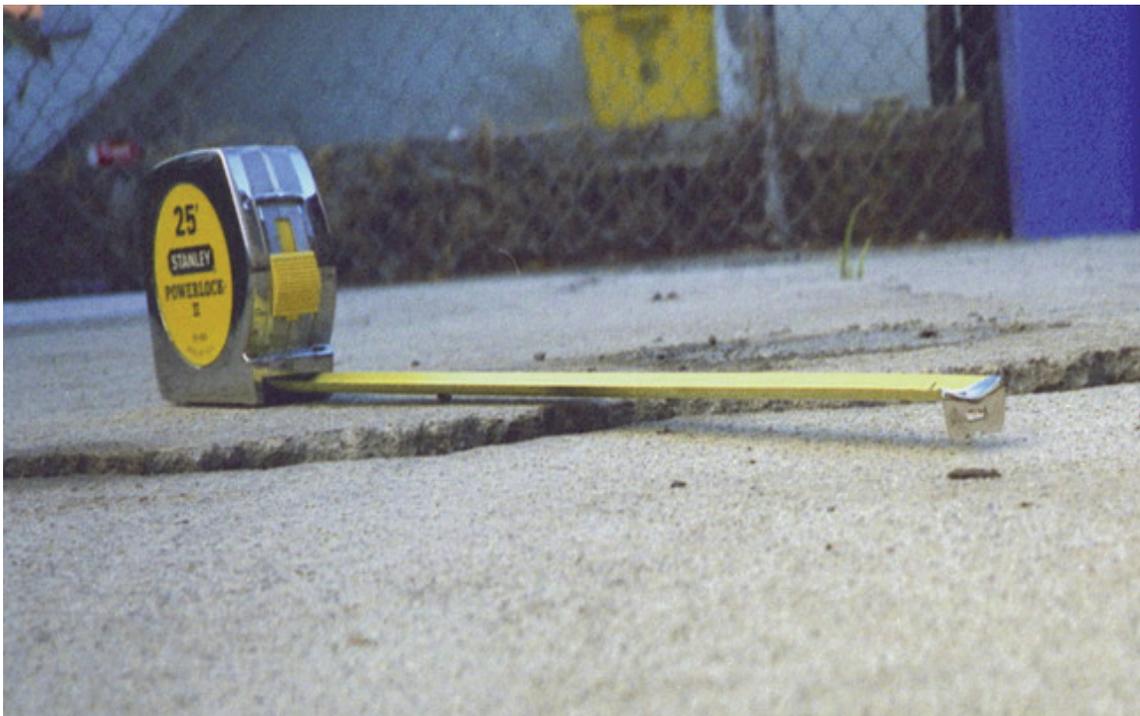
Figure 4-20 Illustration of out-of-plane offset in a concrete slab-on-grade. Concrete slab on one side of the crack is higher than on the other side (photo credit: Exponent).

- fresh-appearing cracks wider than 1/2 inch or offset by more than 1/16 inch out of plane, as illustrated in Figure 4-20 (in all foundation and slab-on-grade elements except basement walls)
- fresh-appearing cracks wider than 1/8 inch in basement walls
- extensive or large cracks (with signs of recent movement) in the foundation far in excess of what would be expected from normal shrinkage and settlement (see Section 4.5)
- perceptible slopes in floors, slabs-on-grade (other than drainage slopes), or swimming pools that had not been noticed before the earthquake
- vertical or horizontal out-of-plane offsets exceeding 1/16 inch (the thickness of a nickel) across any earthquake-caused cracks
- indication of earthquake-induced permanent ground deformation

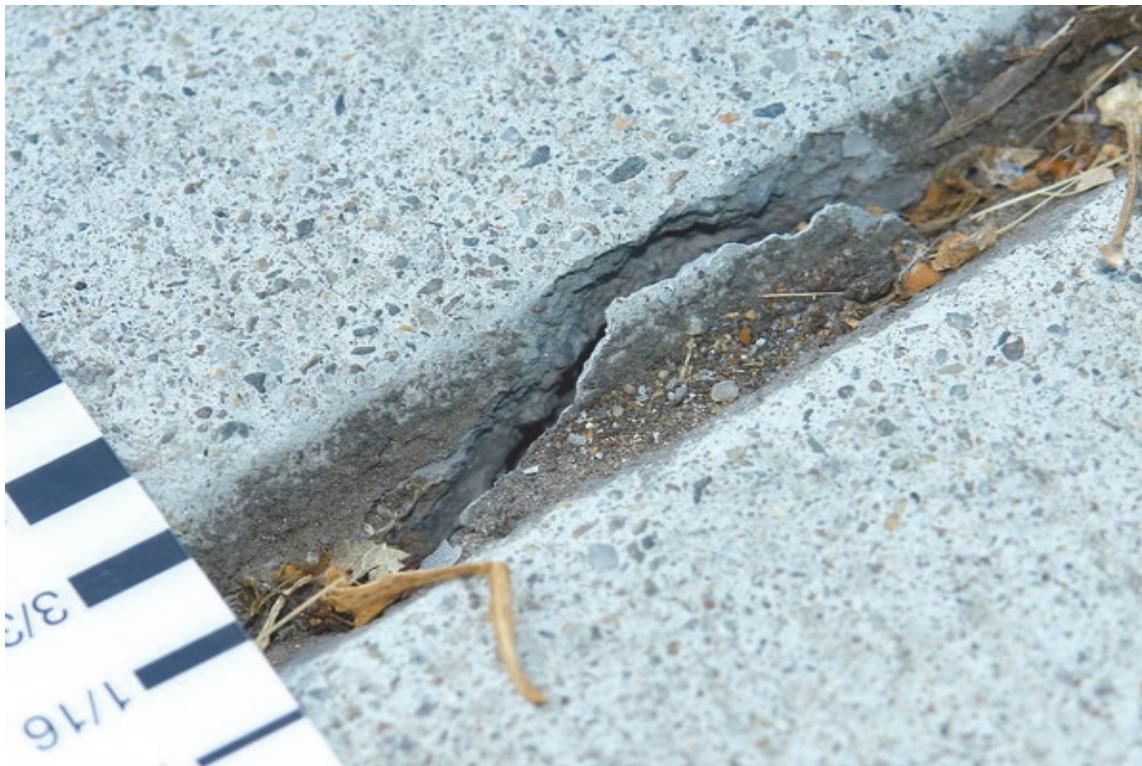
Figure 4-21 Fresh crack in concrete exhibiting sharp edges, crack faces free of contamination and gap clear of debris (photo credit: Exponent).

- Sharpness of the crack edge: Fresh cracks exhibit sharp edges free of weathering, rounding, or erosion. Cracks in protected locations, such as within a crawlspace or beneath a floor covering, will not “weather” and may look sharp and fresh for many years. Figure 4-21 shows a fresh crack in Portland cement concrete, whereas Figure 4-22 shows an older crack with worn and rounded edges.

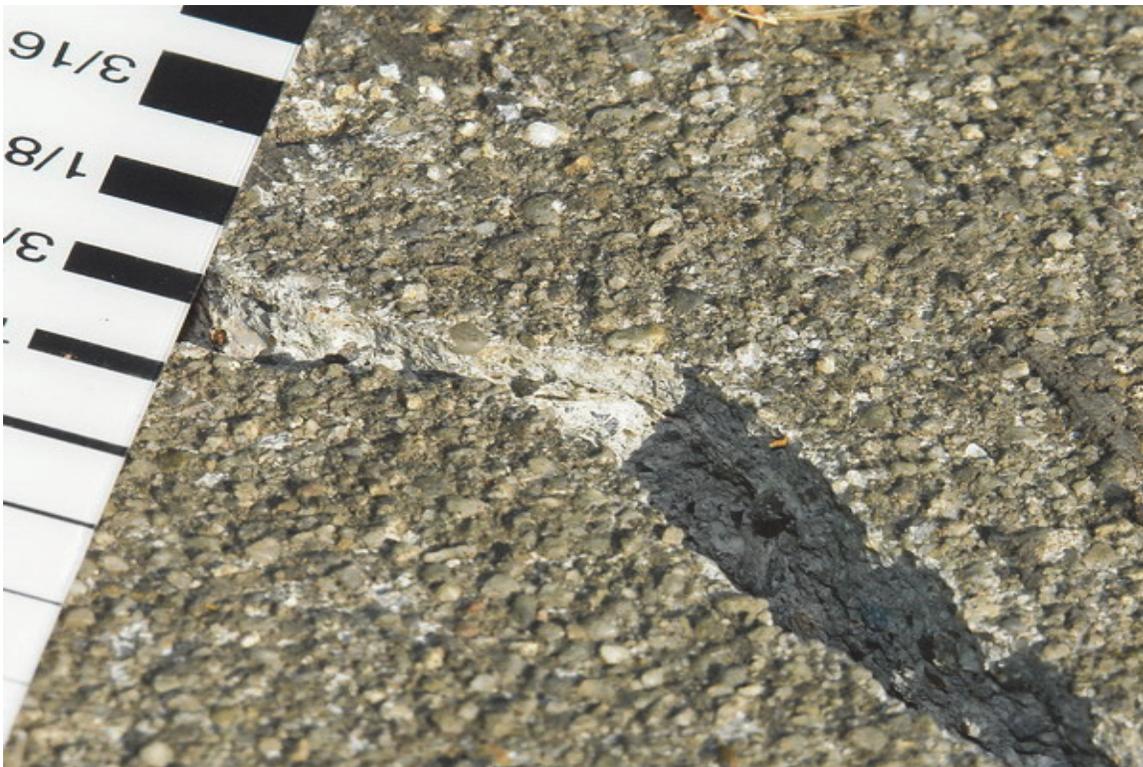
Figure 4-23 Fresh crack in concrete exhibiting lighter color on crack face relative to weathered surface (photo credit: Exponent).

- Relative color of crack surfaces and exposed surface of the element: A fresh crack will typically be a different shade than the exposed, weathered surface, as shown in Figure 4-23.

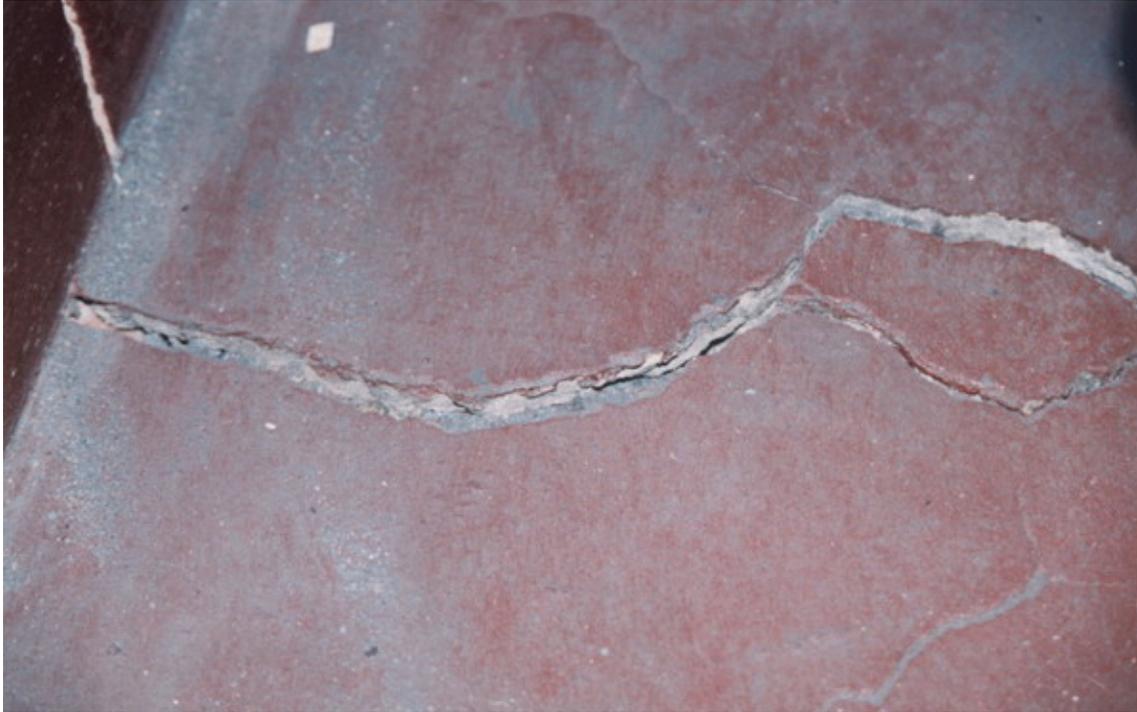
Figure 4-24 Older crack in concrete exhibiting worn and rounded edges contaminated with paint (photo credit: Exponent).

- Condition of crack surfaces: Fresh cracks exhibit clean fracture surfaces. Older cracks may exhibit contamination with paint (Figure 4-24), oil, grease, floor covering adhesive (Figure 4-25 and Figure 4-26), sawdust, drywall joint compound (Figure 4-27), or other foreign matter that may have accumulated since the crack initially developed.
