Earthquake Damage Assessment and Repair Guidelines for Residential Wood-Frame Buildings

Volume 1 | GENERAL GUIDELINES

CEA-EDA-01 2020

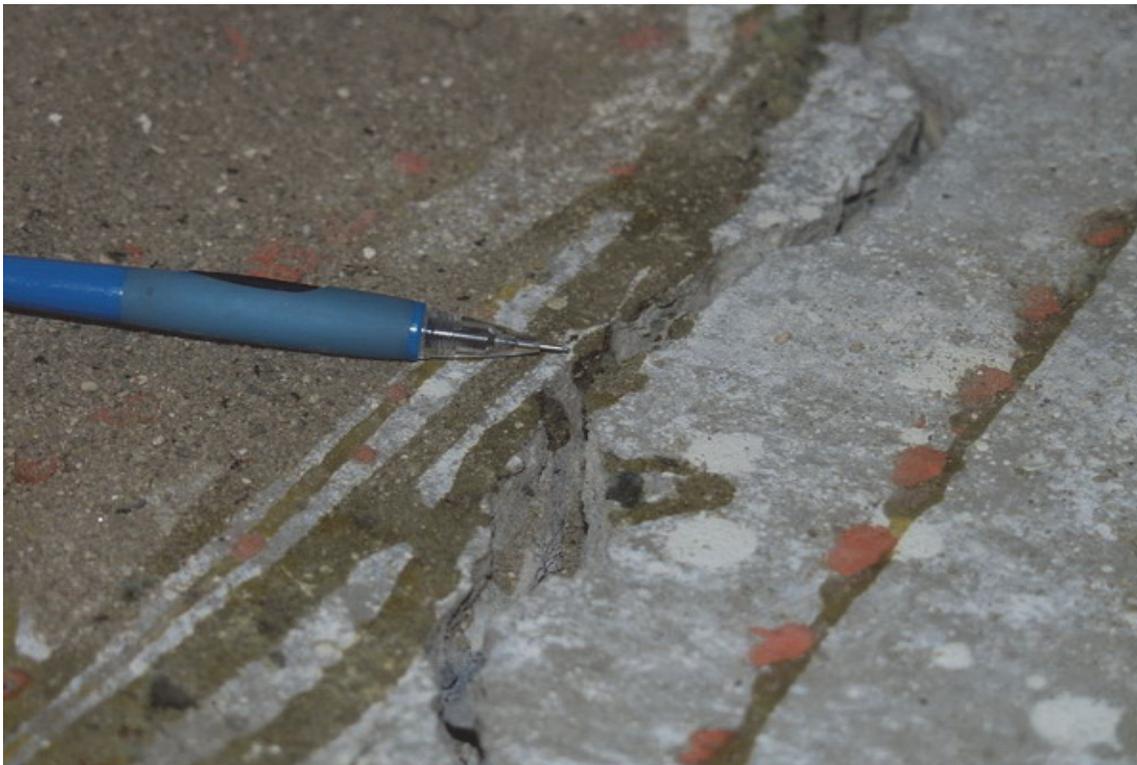
Figure 4-25 Older crack in concrete floor slab contaminated with carpet pad adhesive (photo credit: Exponent).

- Condition of crack surfaces: Fresh cracks exhibit clean fracture surfaces. Older cracks may exhibit contamination with paint (Figure 4-24), oil, grease, floor covering adhesive (Figure 4-25 and Figure 4-26), sawdust, drywall joint compound (Figure 4-27), or other foreign matter that may have accumulated since the crack initially developed.

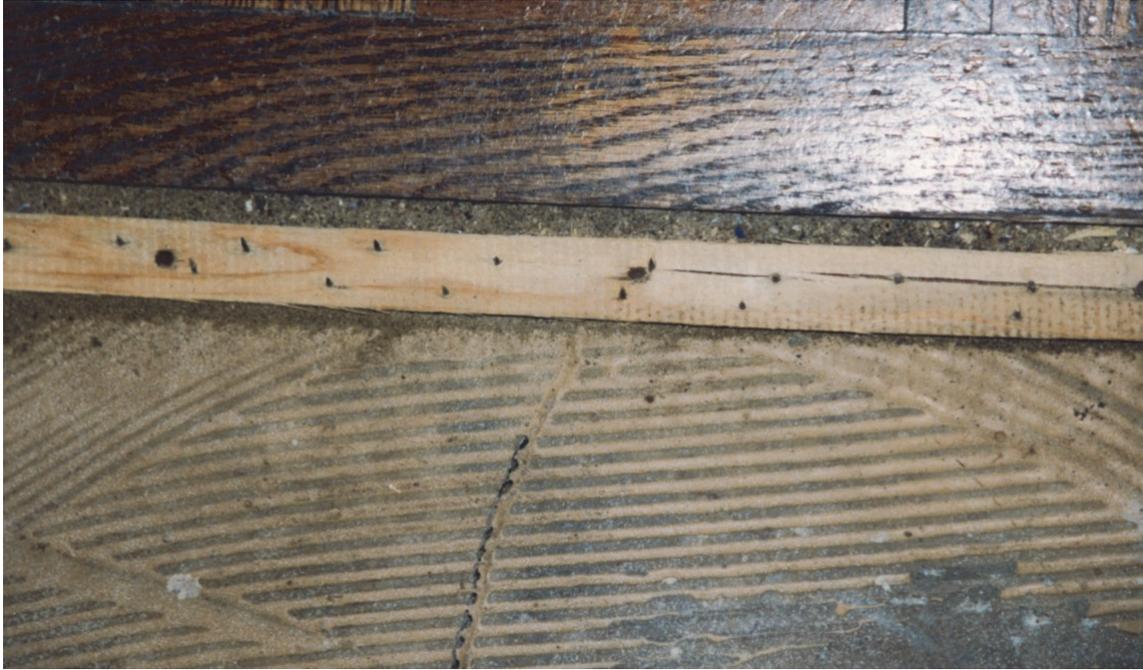
Figure 4-26 Parquet flooring adhesive filling crack in concrete slab (photo credit: Exponent).

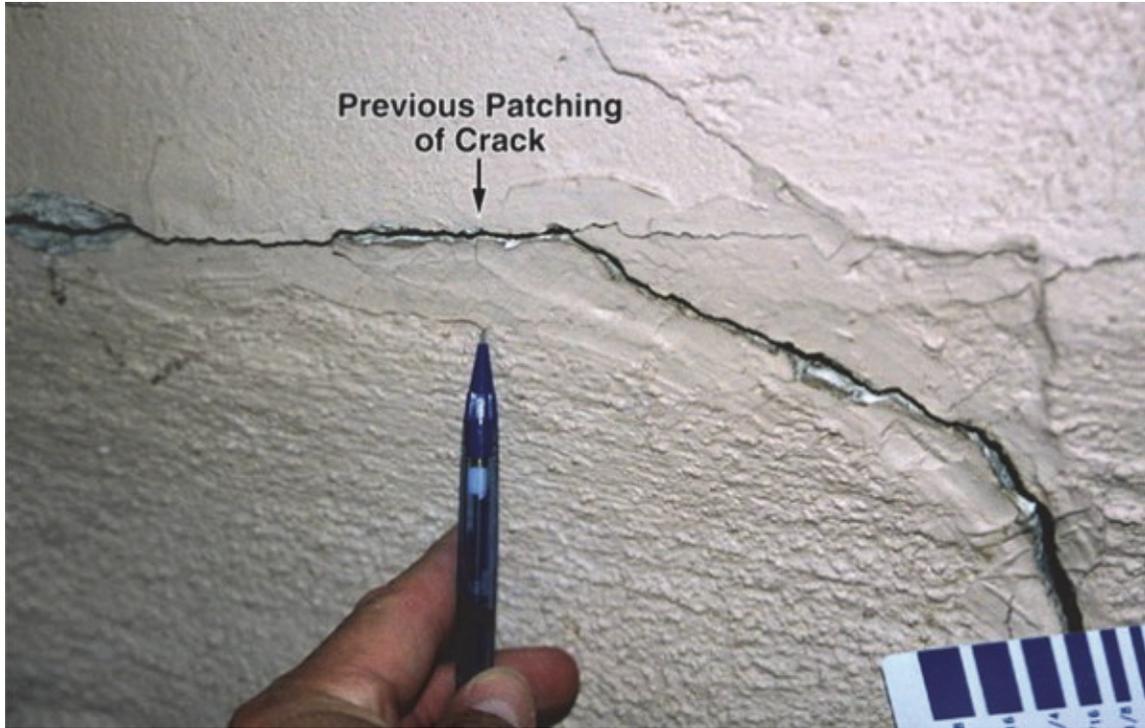
Figure 4-28 Older crack in foundation stemwall exhibiting prior patching and painting (photo credit: Exponent).

- Grout, caulk, or other patching or repair material in the crack, as shown in Figure 4-28 through Figure 4-30.
- Leveling material adjacent to or spanning the crack, as shown in Figure 4-31.

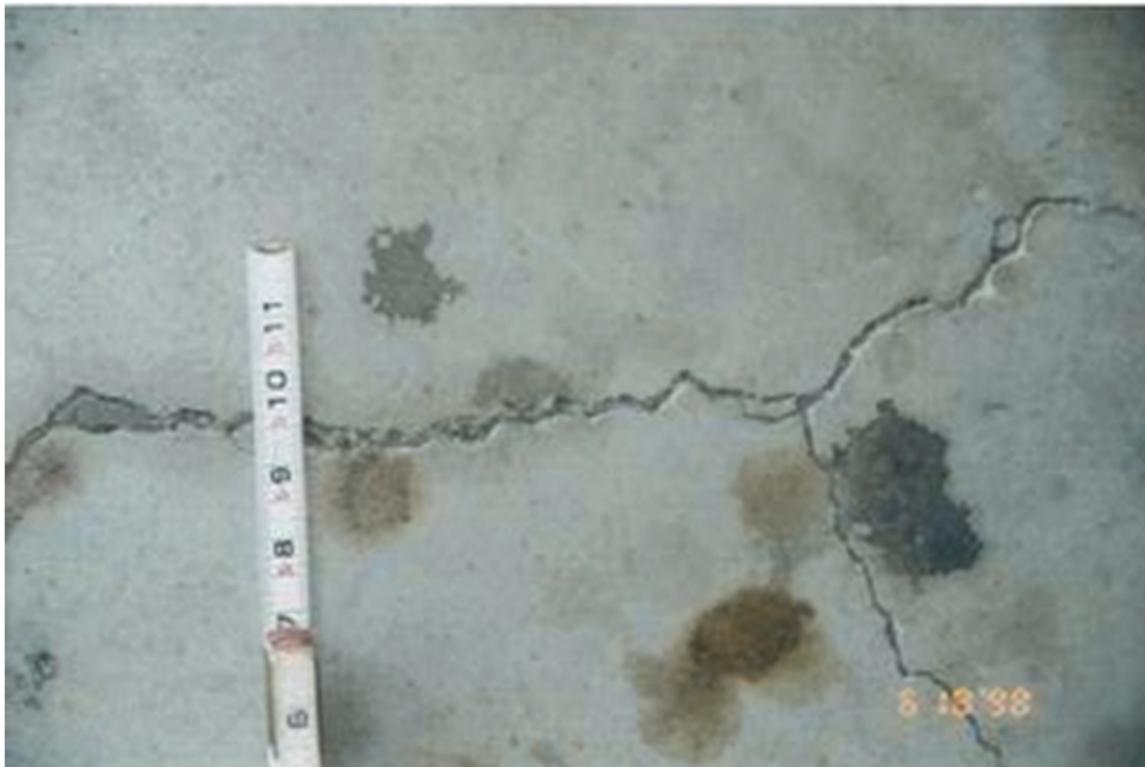
Figure 4-29 Mortar within garage slab-on-grade crack indicates previous patching of crack (photo credit: Exponent).

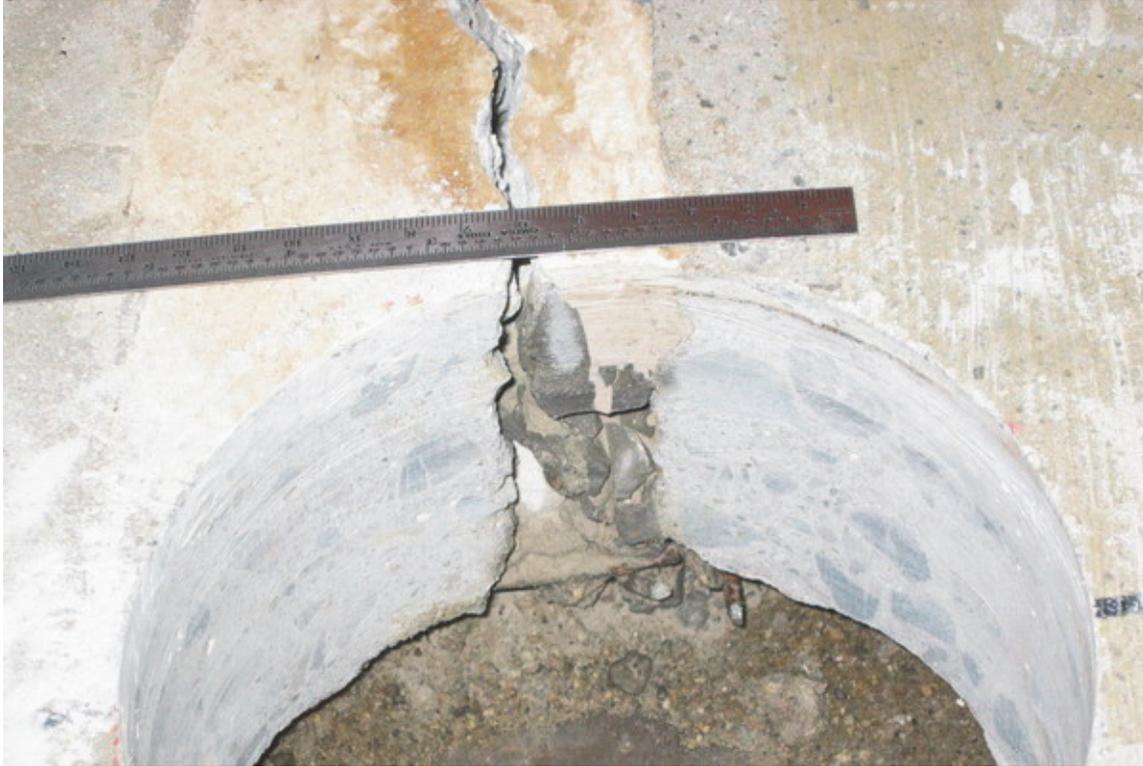
Figure 4-30 Crack in concrete slab-on-grade floor that exhibits two prior generations of patching, as well as opening since last patching (photo credit: Exponent).

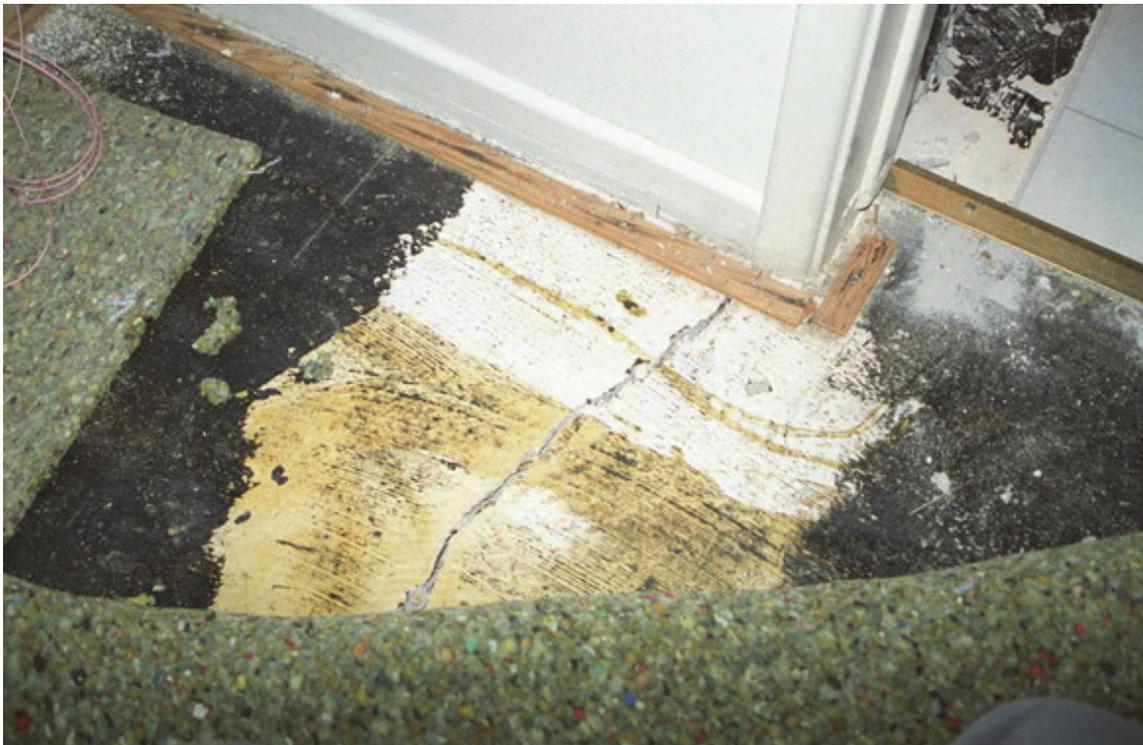
Figure 4-31 White leveling compound spread across existing crack at time of carpet installation (photo credit: Exponent).

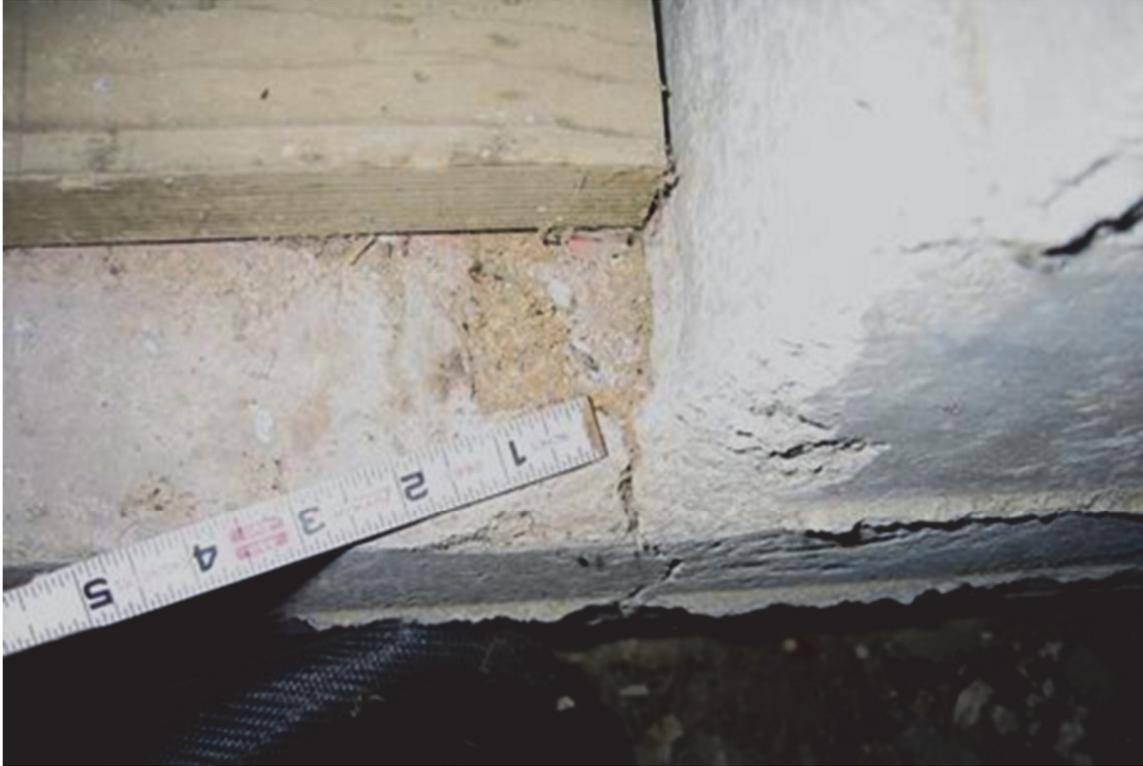
Figure 4-32 Debris (sawdust) from original construction indicates foundation crack is not recent (photo credit: Exponent).

- Dirt, dust, debris, or vegetation in the crack, as shown in Figure 4-32 through Figure 4-34.
- Where slabs are covered with an adhered floor finish, setting mortar or adhesive may extend into the crack (Figure 4-35), or the bottom side of finish material that spanned a pre-existing crack may show an impression of the crack in the pattern of adhesive trowel marks or setting mortar, as shown in Figure 4-36.

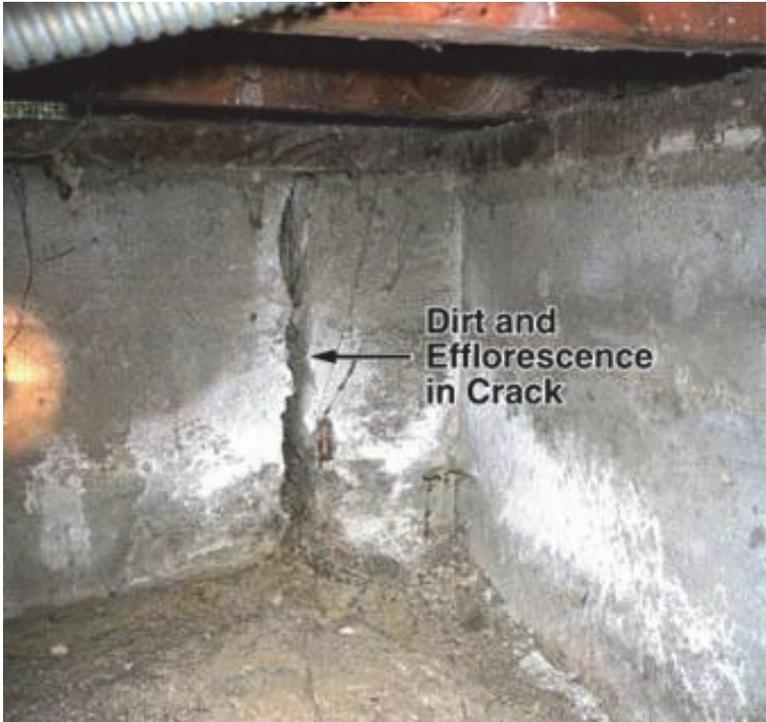
Figure 4-33 Dirt and efflorescence indicates age of foundation wall crack is not recent (photo credit: Exponent).

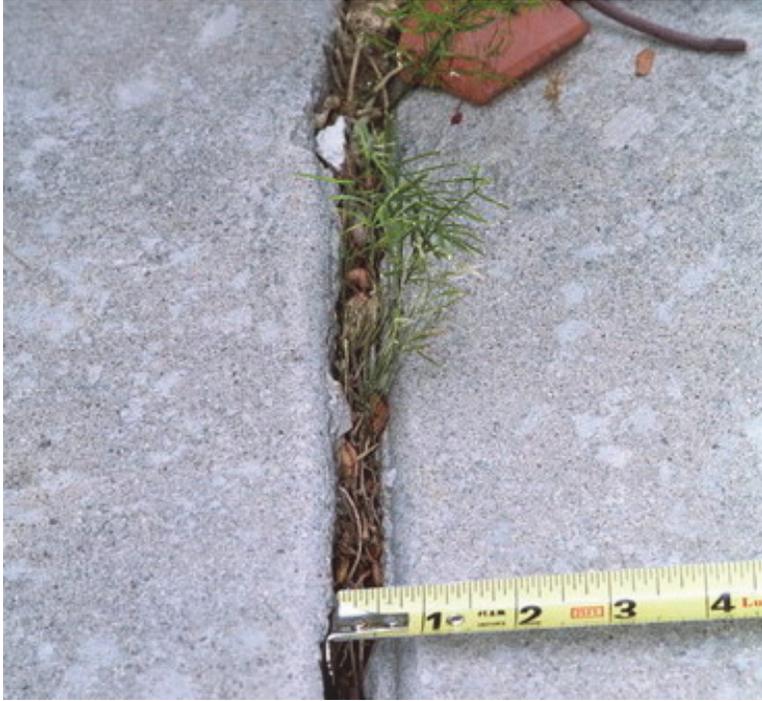
Figure 4-34 Debris and vegetation in older crack (photo credit: Exponent).

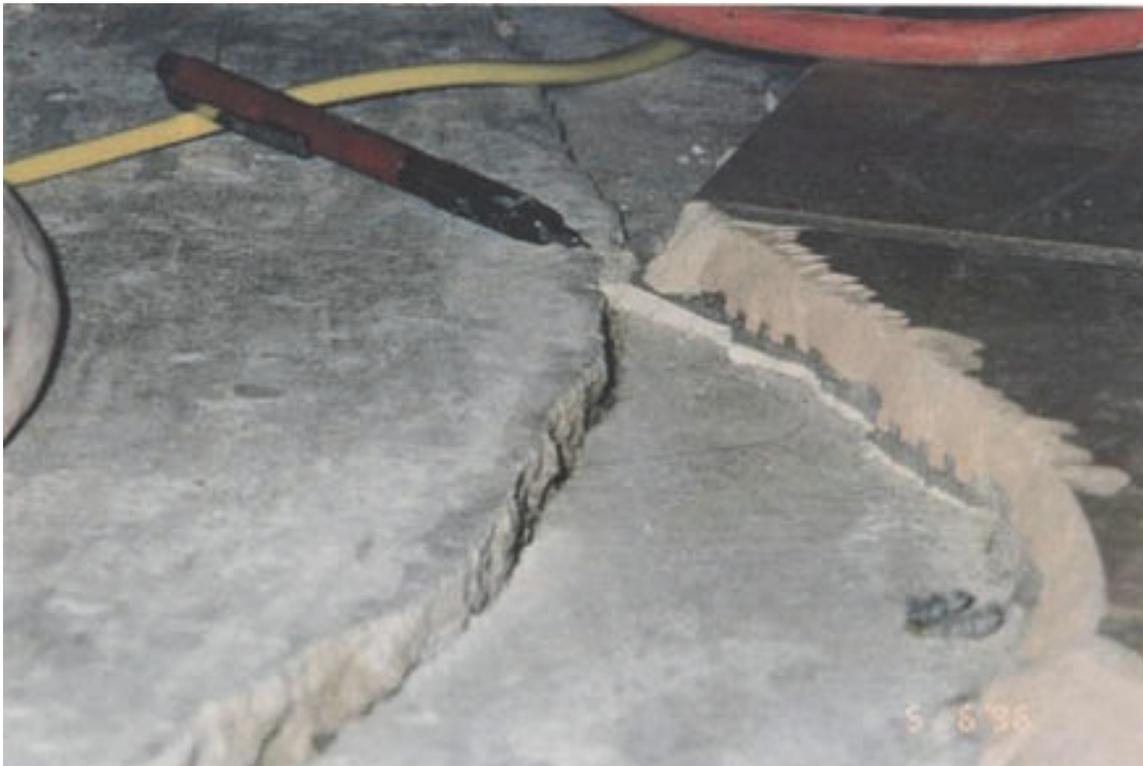
Figure 4-35 Grout completely filling slab-on-grade crack indicates that slab crack was present at the time of the tile installation and has not experienced movement since tile installation (photo credit: Exponent).

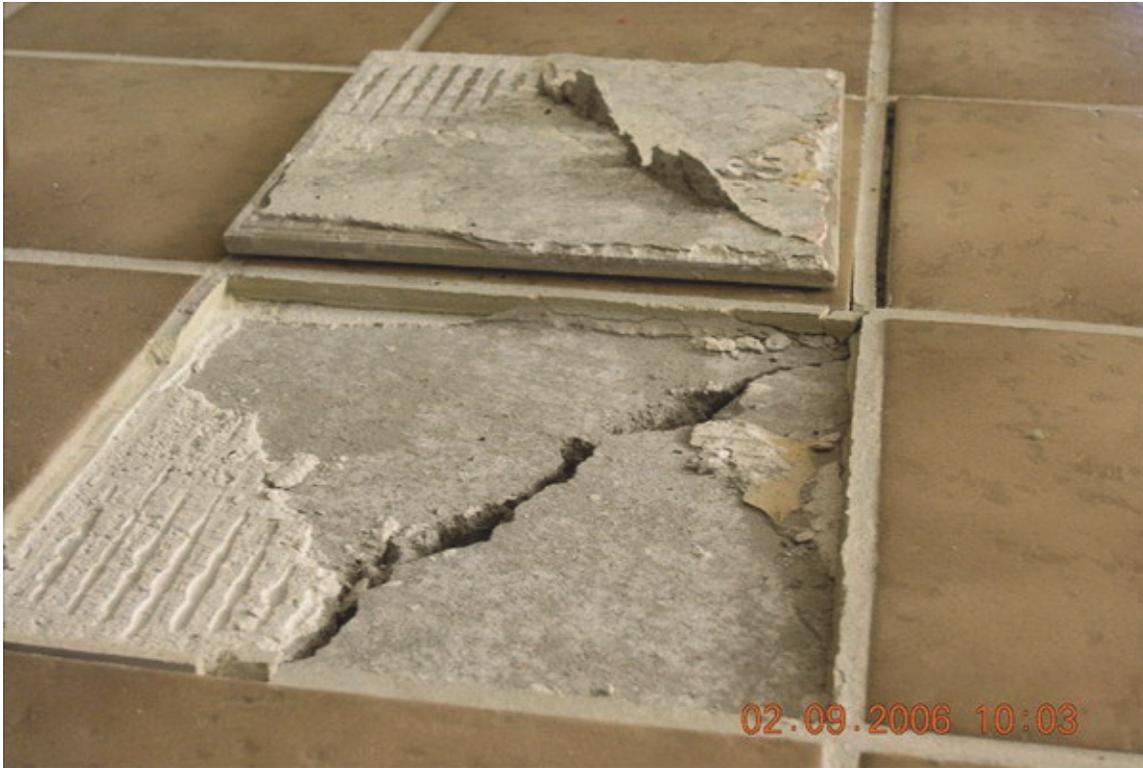
Figure 4-36 Setting mortar that had flowed into an existing slab crack that remained bonded to the backside of a ceramic tile when the tile was removed, indicating that the concrete slab was cracked when the tile was installed (photo credit: Exponent).

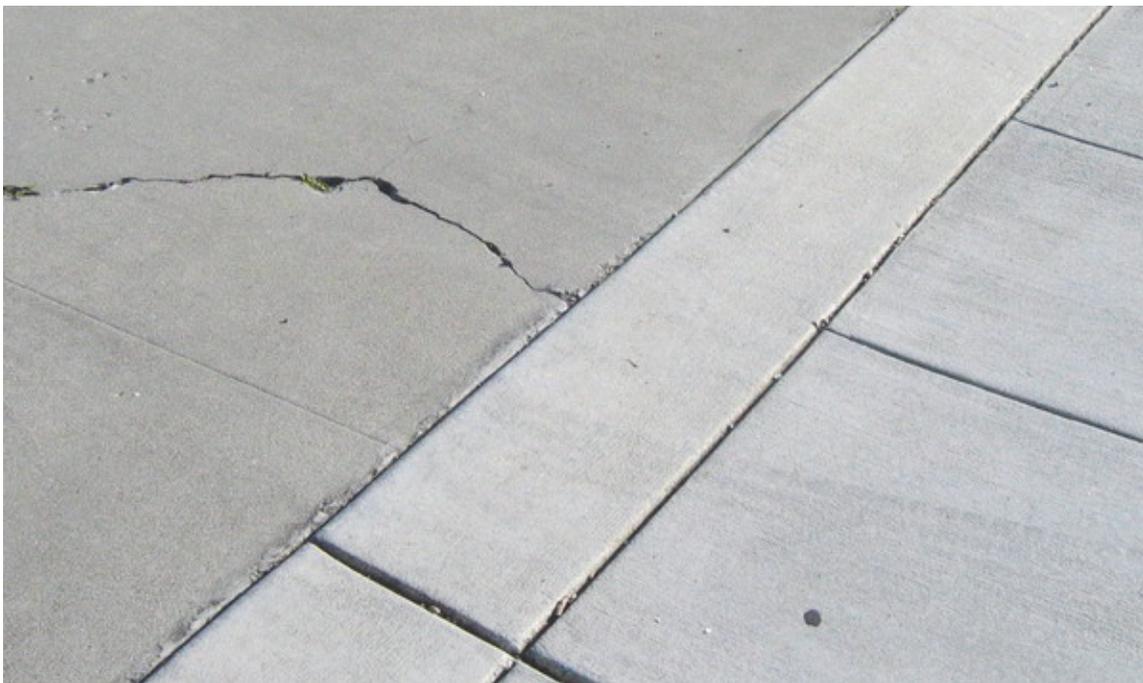
Figure 4-37 Termination of crack in older concrete (upper left) where it abuts newer concrete (lower right) indicates that crack existed prior to the installation of the newer concrete (photo credit: Exponent).

- Examination of the interface where two vintages of concrete meet can indicate the relative age of cracks. Recent cracks will extend through both vintages of concrete, while older cracks will be present only in the older vintage of concrete, as shown in Figure 4-37.

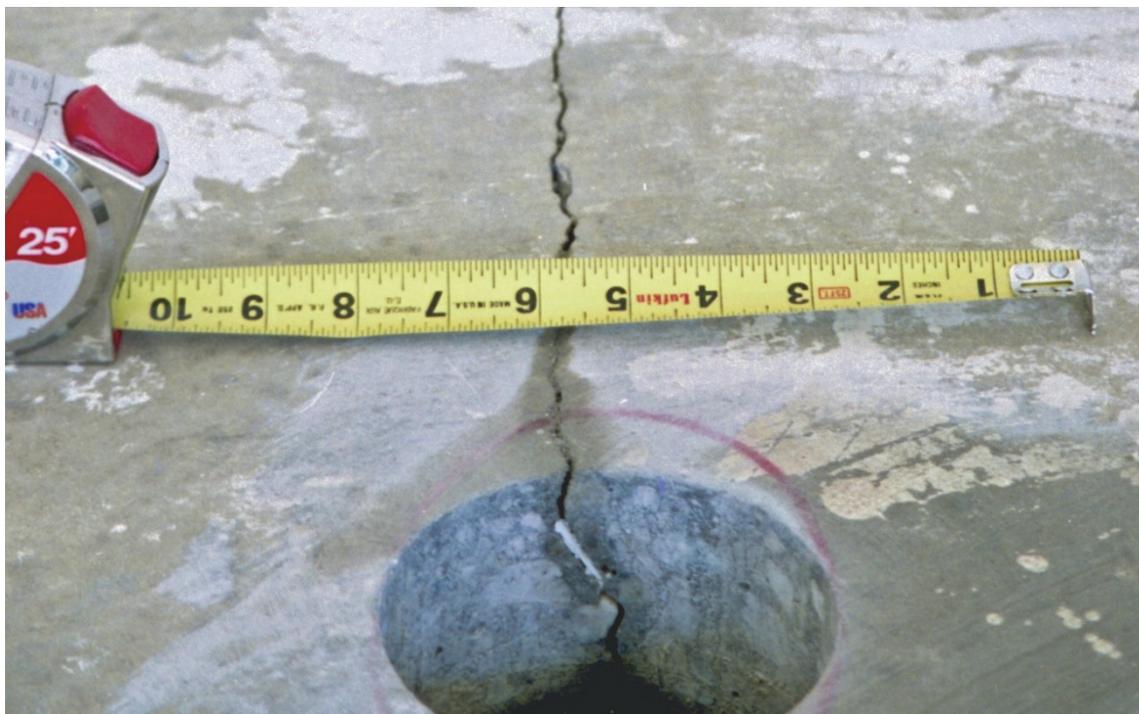
Figure 4-39 Linear shrinkage crack in concrete floor slab at location of a concealed control joint created by a "zip strip" (photo credit: Exponent).

- Typical shrinkage crack patterns for concrete slabs-on-grade were described previously. In addition, concealed control joints (formed with “zip strips”), as shown in Figure 4-39, and construction joints associated with additions or modifications, look like very straight shrinkage cracks. A very straight shrinkage crack can also indicate where slab reinforcing was not properly lapped or was intentionally separated.

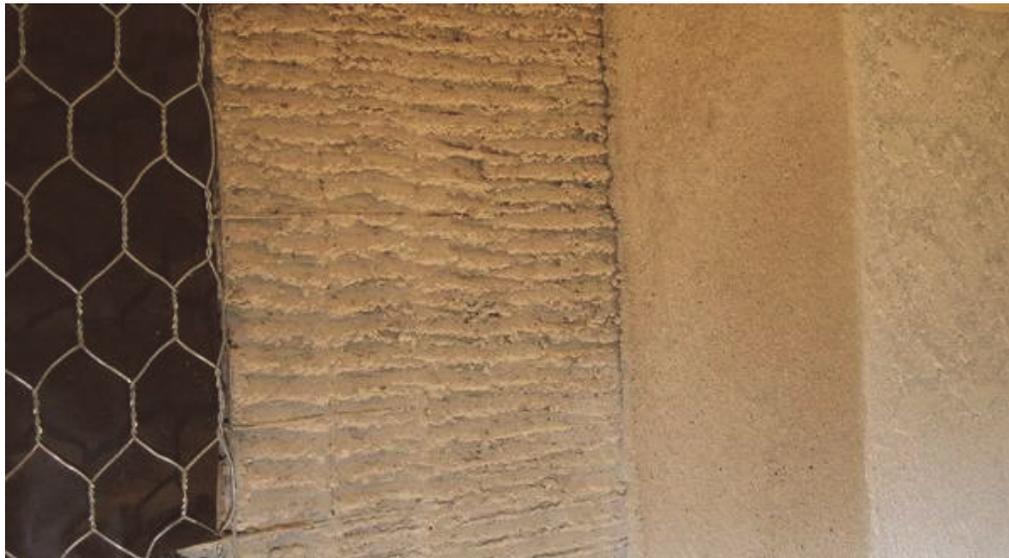
Figure 5-3 Mock-up of typical three-coat stucco showing building paper, wire lath, scratch coat, brown coat, and finish or color coat (photo credit: Exponent).

Conventional stucco is typically a 7/8-inch thick layer of Portland cement plaster reinforced with wire mesh that is sprayed or troweled onto the wall in three layers and cures to a hard, durable finish, as illustrated in Figure 5-3. The three layers are termed scratch, brown, and finish or color coat. Stucco may be applied to open framing or over wood sheathing. Where applied to open framing, regularly spaced line wire is stretched across the framing to provide temporary support for the building paper during the application of the scratch coat of stucco. Wire mesh nailed or stapled to the wall framing or sheathing provides both reinforcement of the cement plaster and attachment of the stucco to the building.

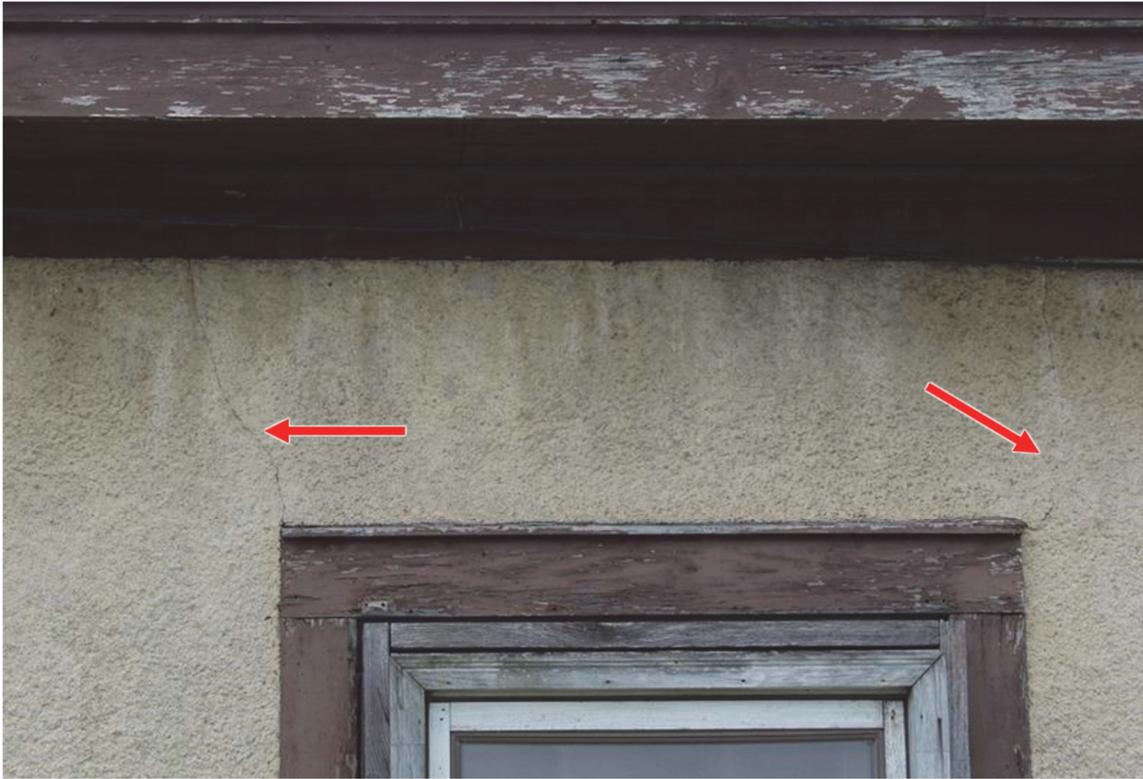
Figure 5-5 Diagonal non-earthquake shrinkage cracks extending from the corners of a wall opening in stucco (photo credit: Exponent).

- Diagonal cracks extending from the corners of door and window openings, as shown in Figure 5-5. Where openings are close together, cracks will tend to extend from the corner of one opening to the next, rather than extending diagonally.

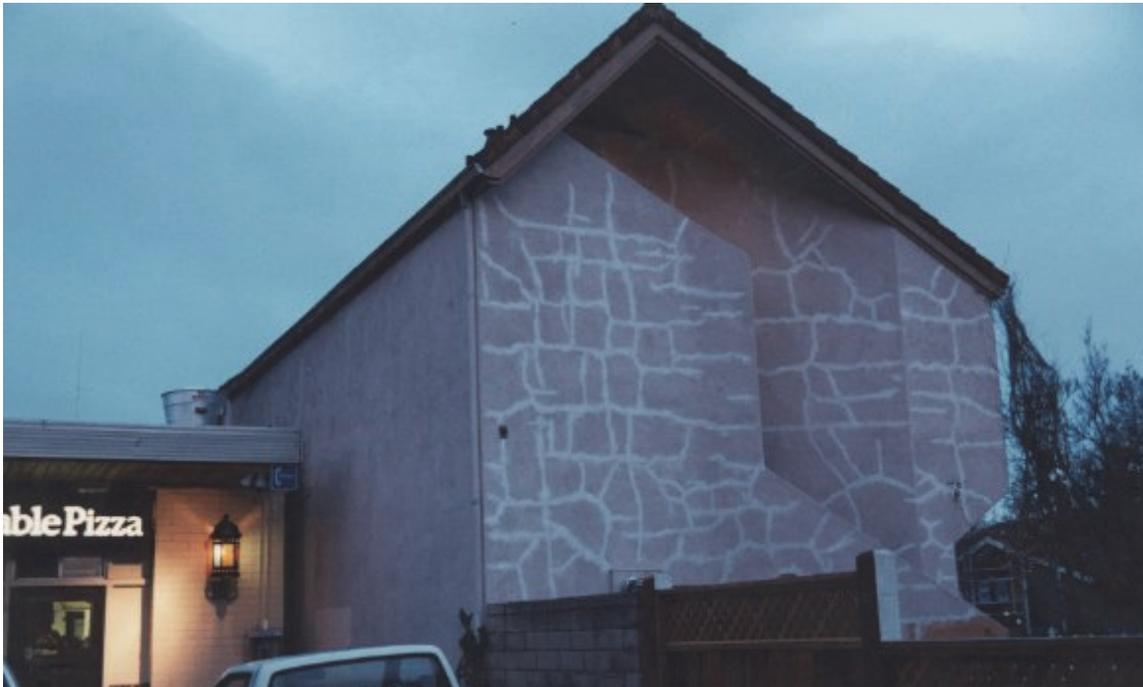
Figure 5-6 Semi-random, semi-orthogonal grid work of non-earthquake shrinkage cracks in stucco—the cracks are highlighted by patching material applied in the course of repainting the building (photo credit: Exponent).

- Semi-random, semi-orthogonal pattern (i.e., a grid work) of cracks in portions of walls without openings, as shown in Figure 5-6. This pattern can often be seen when the thin finish coat is sandblasted during the course of a cosmetic renovation.

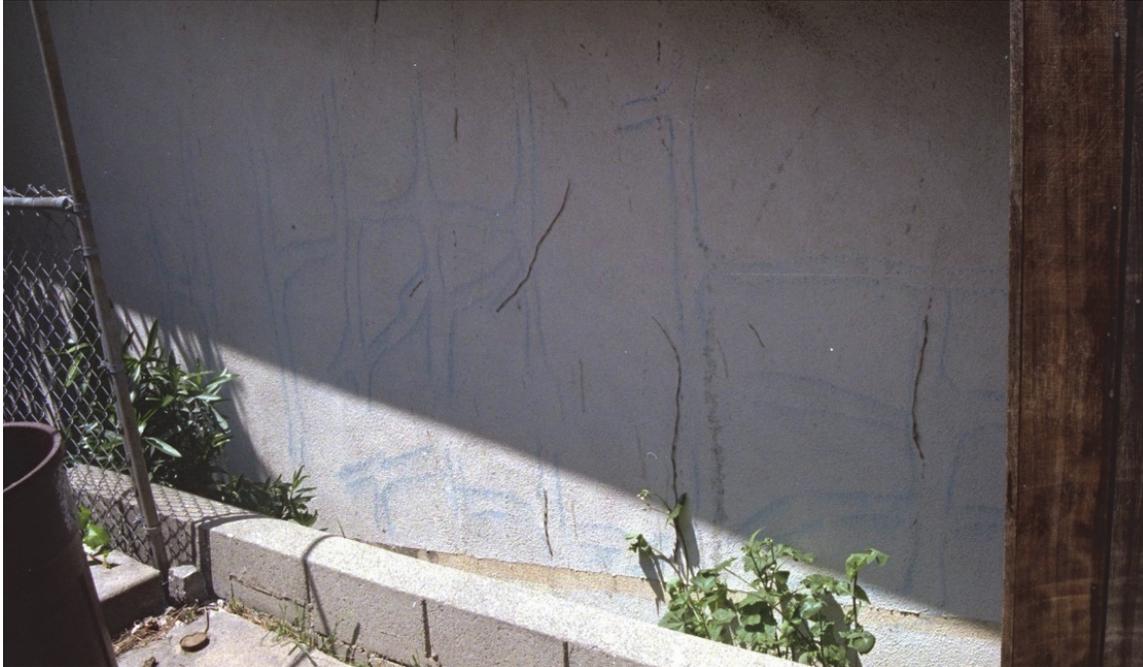
Figure 5-7 Roughly linear vertical non-earthquake shrinkage cracks corresponding to the locations of underlying studs; crack locations have been highlighted with parallel lines of blue chalk (photo credit: Exponent).

- Roughly linear vertical cracks regularly spaced at about 16-inch intervals along the wall corresponding to the underlying studs, as shown in Figure 5-7. This pattern is due to uneven application of the stucco: thick between the studs but thin (and therefore prone to cracking) where the studs provided a rigid backing during application.

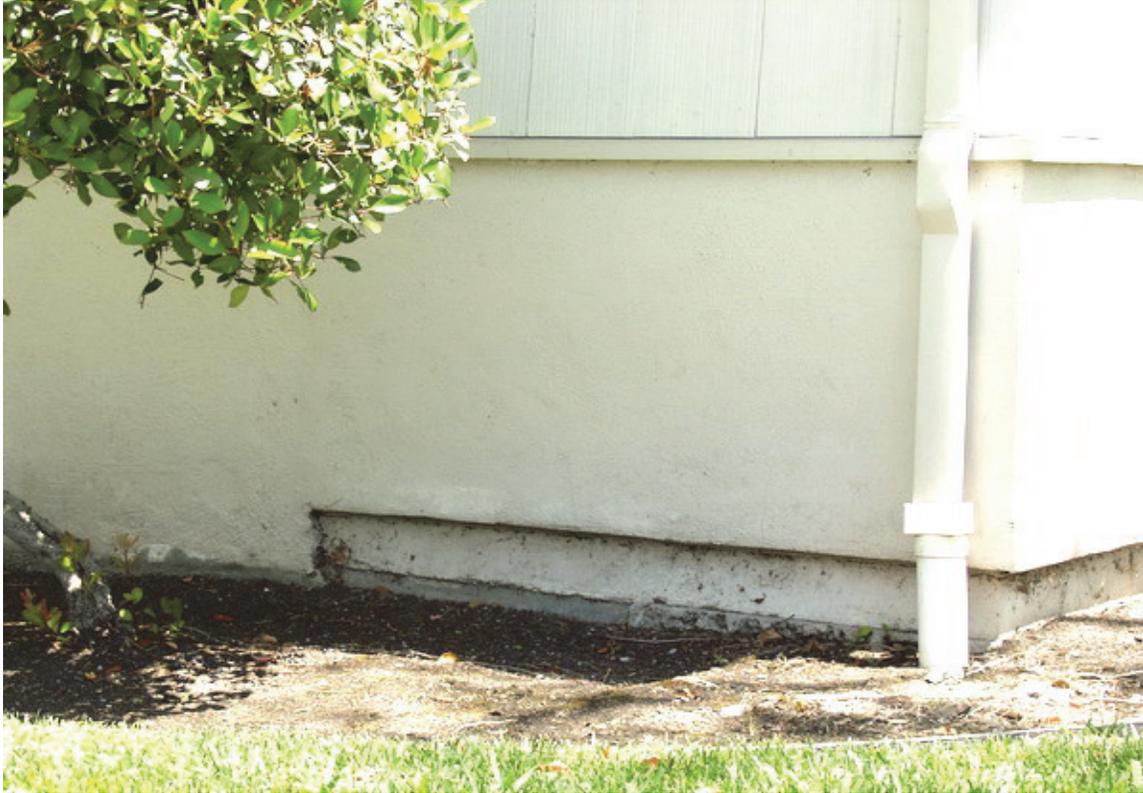
Figure 5-9 Stucco terminated at weep screed on mudsill of recent addition at the right side of the image juxtaposed with stucco extended down onto the original foundation at the left side of the image (photo credit: Exponent).

- Sill line cracking: For houses built in California prior to the early 1970s, it was common practice to extend the stucco seamlessly down over the concrete foundation to the ground surface (Figure 5-9). Due to a variety of factors, a horizontal crack often develops in the stucco along the line between the wood-frame superstructure and the concrete foundation—the sill line. In newer houses, a sheet-metal weep screed eliminates this crack because the stucco is not continuous over the wood-concrete interface.

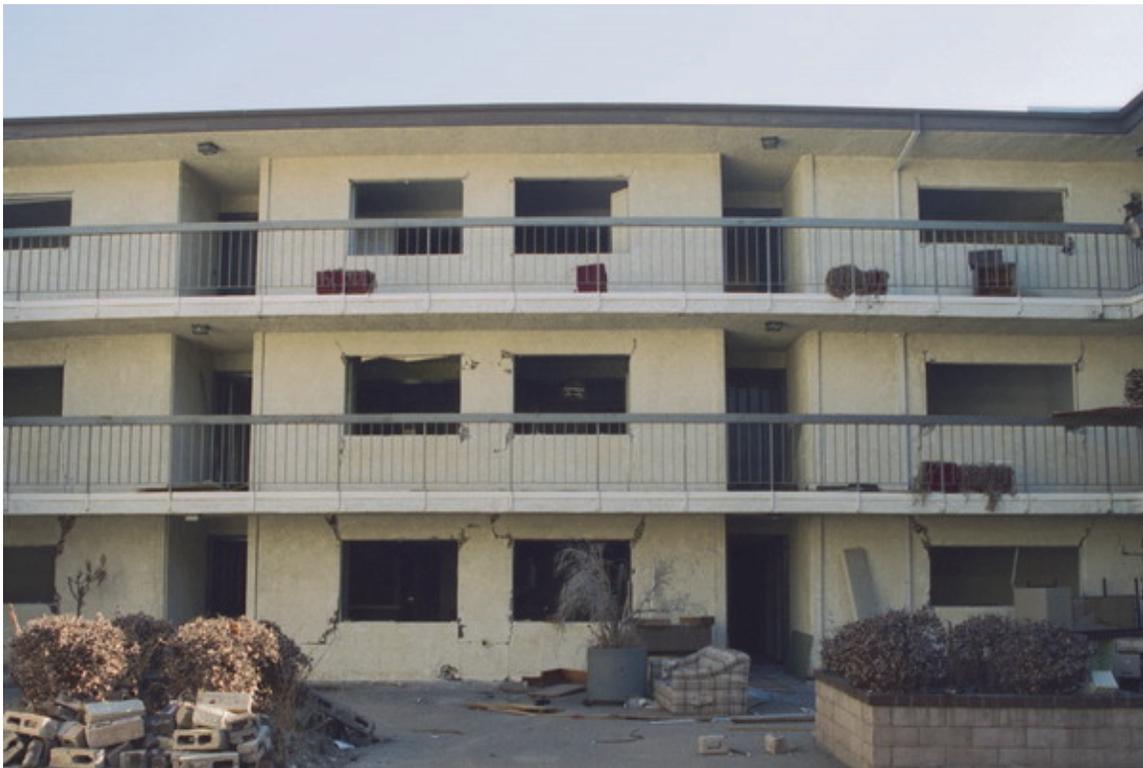
Figure 5-11 Severity of earthquake-induced cracking of wall finishes of multi-story buildings generally decreases at upper stories (photo credit: Exponent).

A key characteristic of earthquake-induced wall cracking is a symmetric pattern of diagonal cracks in wall finishes with similar diagonal cracks radiating from all four corners of window openings, as illustrated in Figure 5-10. Cracking will typically be present in similar locations on both faces of a wall, inside and outside in the case of perimeter walls, and for most multi-story residential buildings, larger and more concentrated in the lowest story, as shown in Figure 5-11.

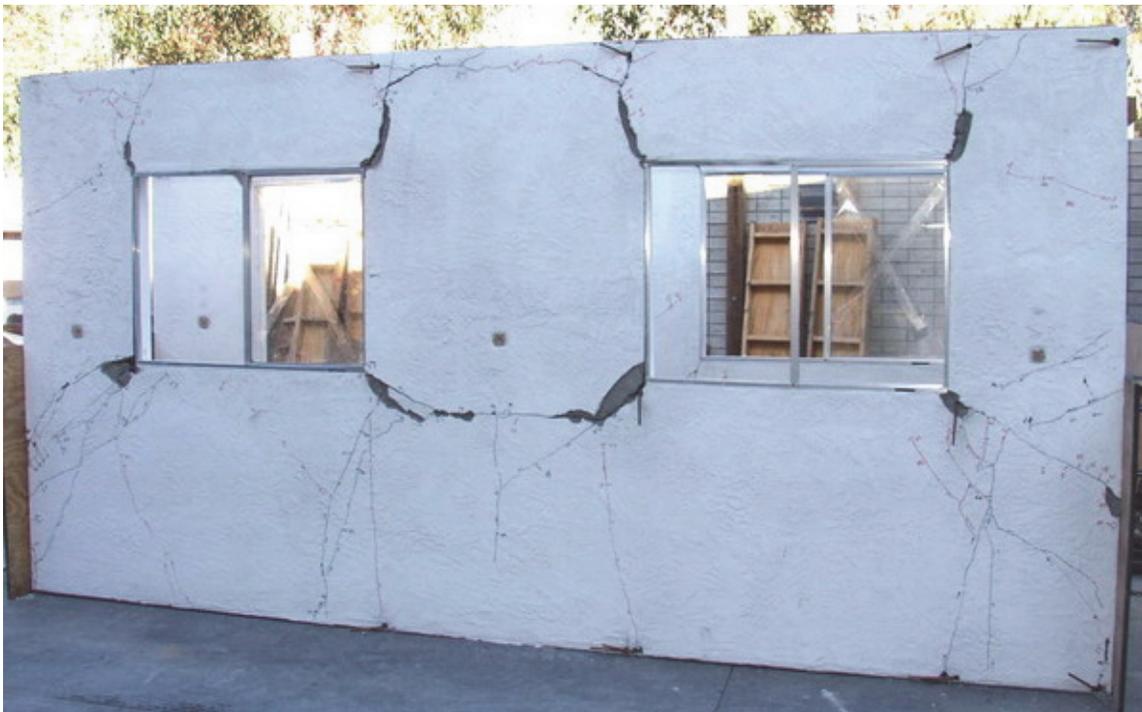
Figure 5-12 Severe cracking and spalling of stucco wall test specimen after earthquake load testing (photo credit: Exponent).

Diagonal cracks at door, window, and vent openings are the first stucco cracks to form (assuming an absence of shrinkage cracks) in an earthquake. The extent of this cracking may be indistinguishable from normal temperature and shrinkage cracking. With stronger ground shaking, the diagonal cracks widen, spalling of stucco along cracks can occur (Figure 5-12), and “X” cracks (Figure 5-13) can form in stucco panels between window openings. Figure 5-14 illustrates the relationship between cracking and racking of a laboratory specimen of a wood-frame wall sheathed with stucco and drywall. If the shaking is strong enough, the stucco attachments can be damaged, and the stucco panels can detach in sheets from the wood framing. This failure mode, called delamination, is most likely in long stiff wall lines with few openings or in solid segments of walls between full-height openings, such as doors, as shown in Figure 5-15. It generally begins as detachment from the sill plate along the base of the wall. Walls where the stucco mesh was not fastened to the sill plate are especially vulnerable to this mode of failure.

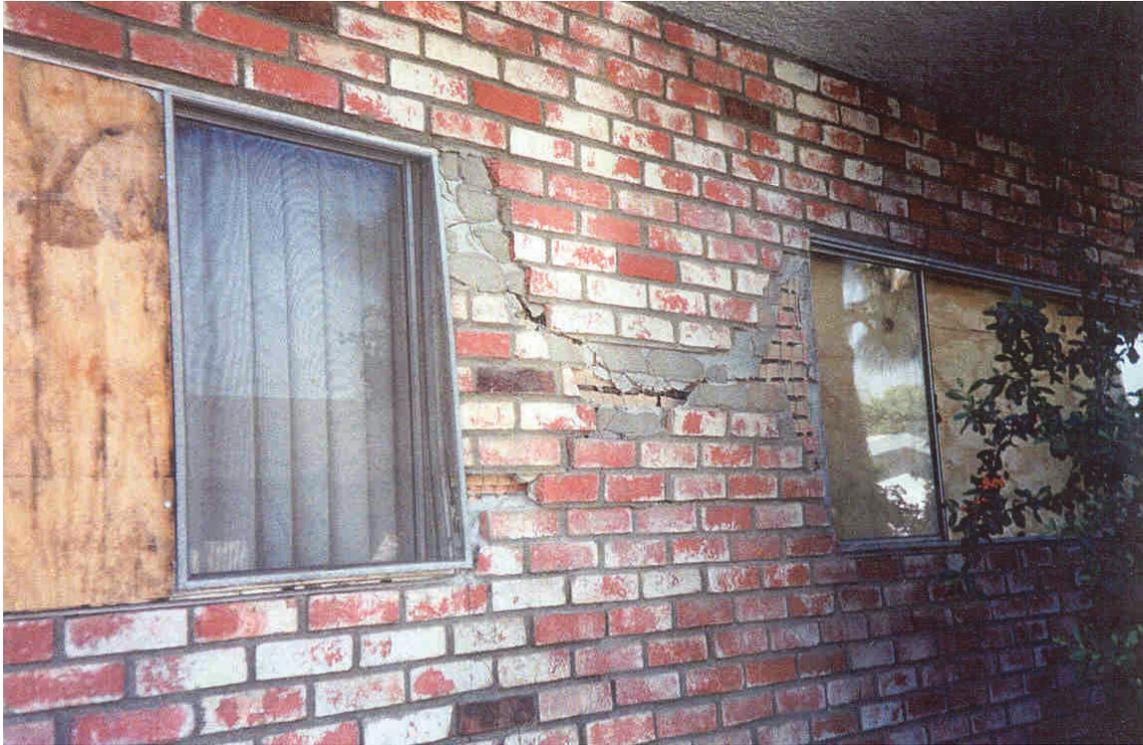
Figure 5-13 Earthquake-induced “X” cracking between windows in stucco panels with a thin brick veneer (photo credit: Exponent).

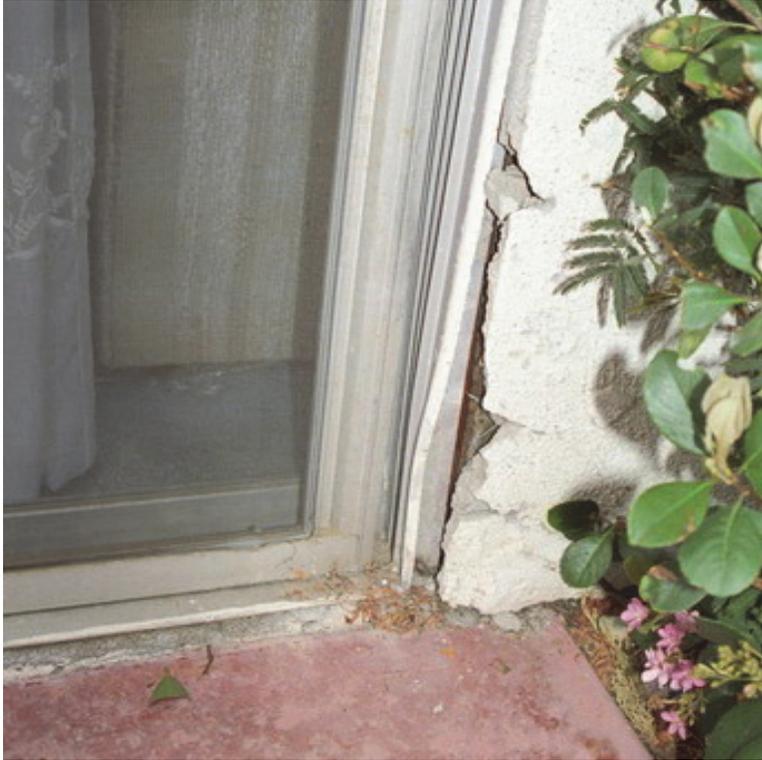
Figure 5-15 Earthquake-induced delamination of stucco from wood framing and associated damage to aluminum door frame (photo credit: Exponent).

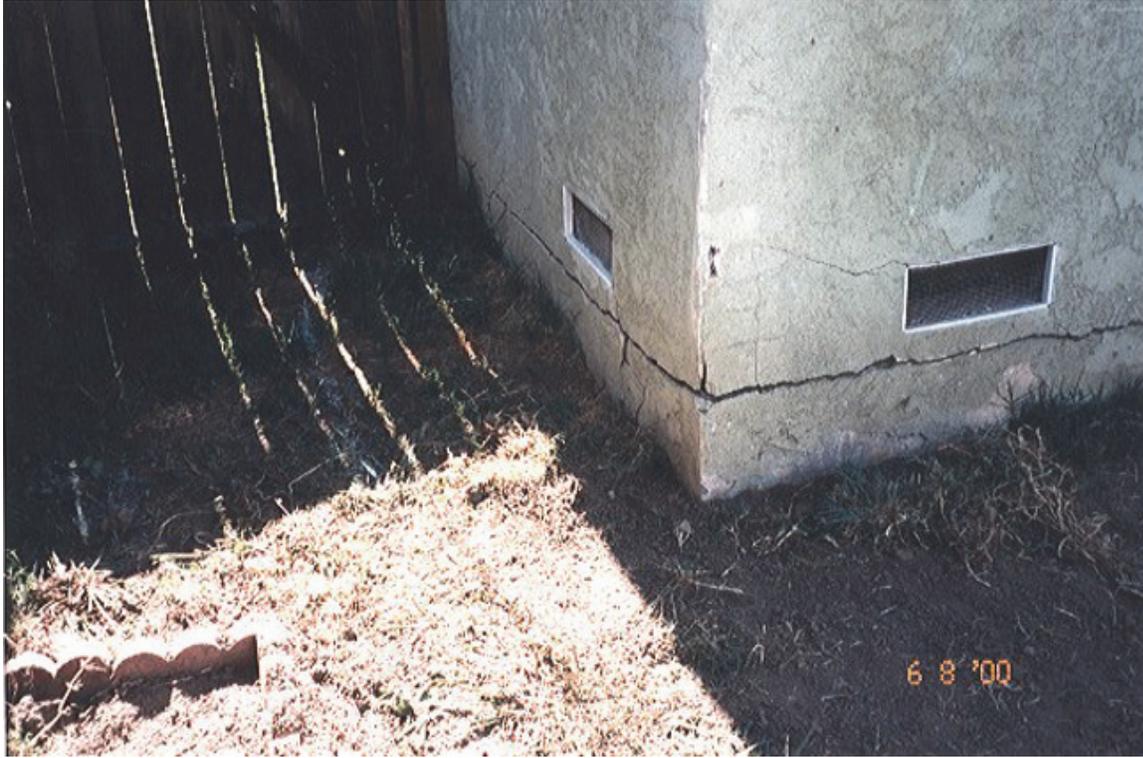
Figure 5-16 Earthquake-induced crack in stucco at sill line where stucco was extended down over the foundation (photo credit: Exponent).

Stucco that extends down over the concrete foundation is susceptible to cracking along the sill plate line, as shown in Figure 5-16. Fresh cracking that is continuous around the building with signs of relative movement between the superstructure and the foundation is cause for assessment by a structures specialist. Care should be taken to differentiate between cracking caused by the earthquake and non-earthquake related cracking at this location as discussed above. Inspectors should look along the sill plate and at wall ends for consistent offsets exceeding 1/4 inch that would indicate sliding of the wall line on its foundation. In multi-story houses, especially those built over crawlspaces, buckling of the stucco will occasionally occur just above the sill plate line, as shown in Figure 5-17.

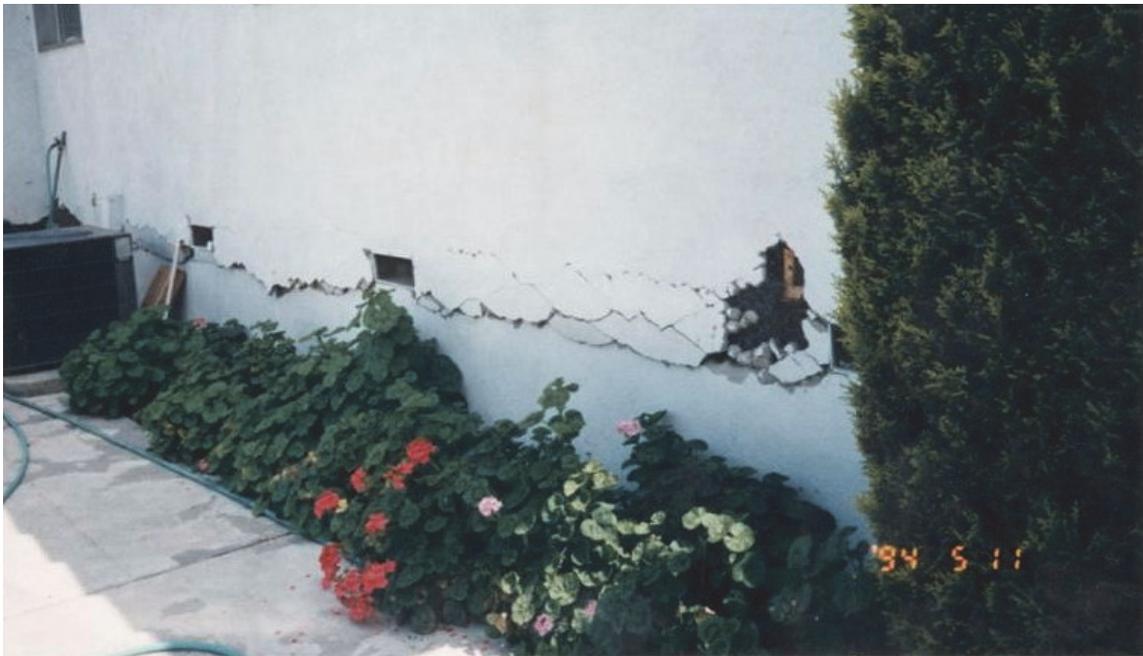
Figure 5-17 Earthquake-induced cracking and buckling of stucco at the sill line where stucco was extended onto the perimeter concrete stemwall (photo credit: Exponent).

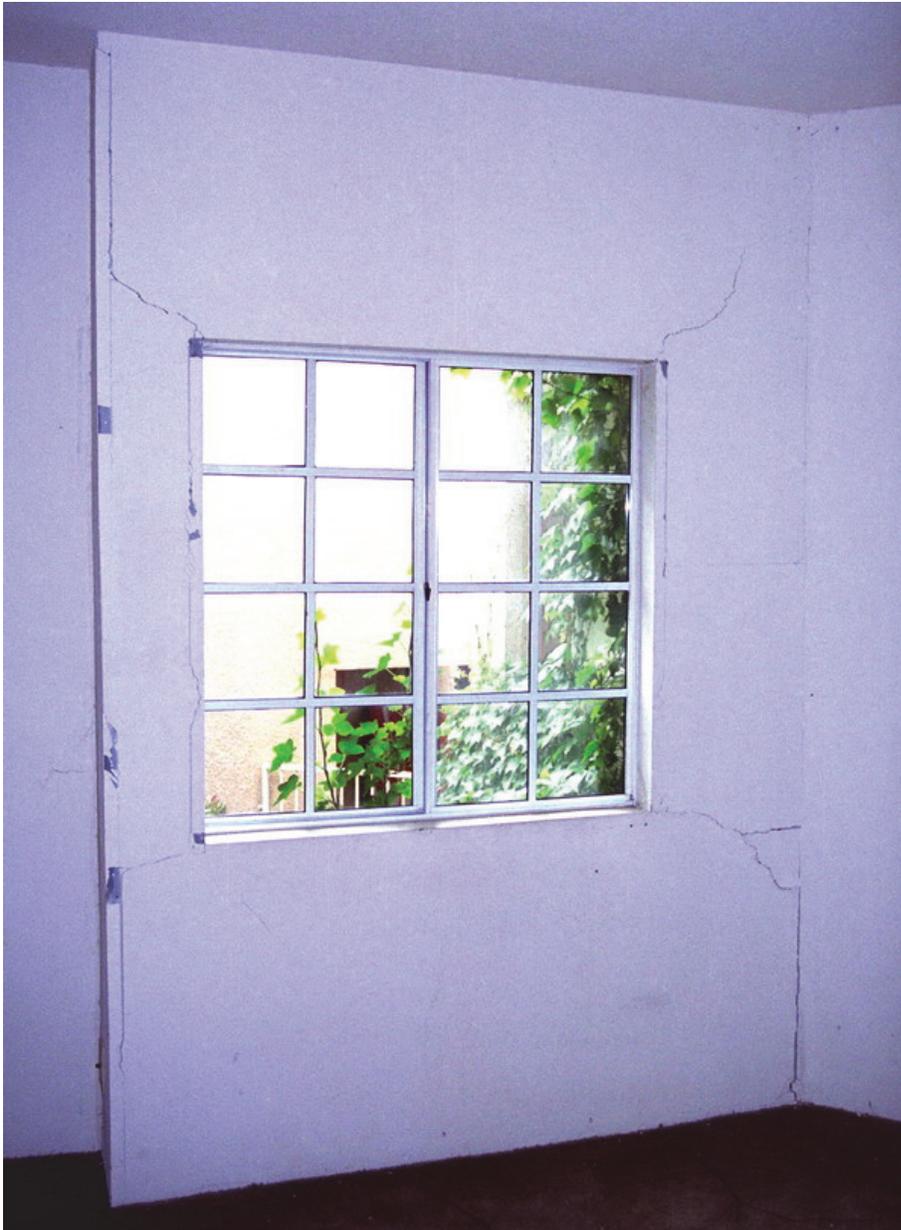
Figure 5-18 Earthquake-induced cracking of drywall as a result of strong shaking (photo credit: Exponent).

The first earthquake-related cracks to form in drywall usually occur at the corners of door, window, and vent openings; along taped joints near those openings; and at locations of previously patched cracks. As the strength of shaking increases, these cracks will extend in length and width, and cracks can form along corner beads, interior wall corner joints, wall-to-ceiling joints, or tape joints between drywall sheets (Figure 5-18). Nail pops can form along the edges of a wall, especially near the ceiling. With stronger shaking, the diagonal cracks widen, and “X” cracks can form, particularly at panels between windows. In severe shaking, it is possible for drywall to detach from the framing.
