Earthquake Damage Assessment and Repair Guidelines for Residential Wood-Frame Buildings

Volume 1 | GENERAL GUIDELINES

CEA-EDA-01 2020

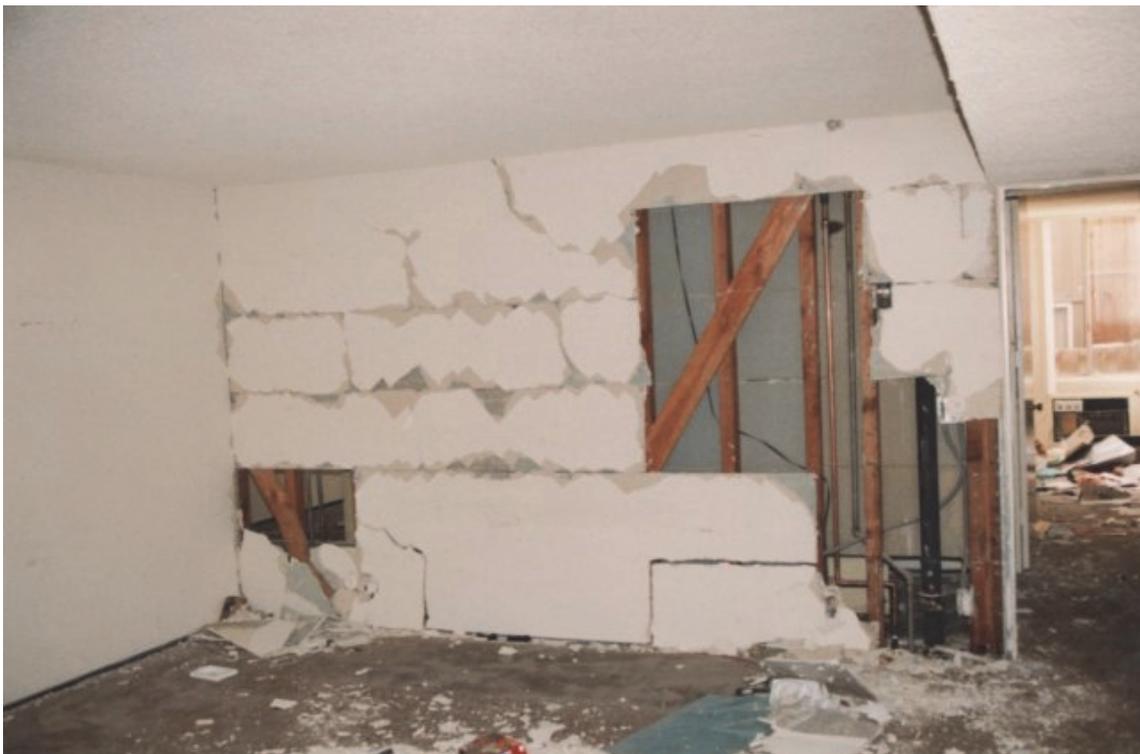
Figure 5-19 Earthquake-induced cracking and delamination of gypsum lath and plaster (photo credit: Exponent).

Plaster is like weak stucco, while gypsum lath is panelized, similar to drywall. Earthquake damage patterns in a lath and plaster system are thus combinations of those typical of stucco and drywall. The first earthquake damage to appear usually includes diagonal cracks at the corners of door and window openings. With more intense shaking, the plaster will generally crack and spall along the lath panel joints, often in a stair step pattern, as shown in Figure 5-19. In severe shaking, detachment of the lath from the framing is possible.

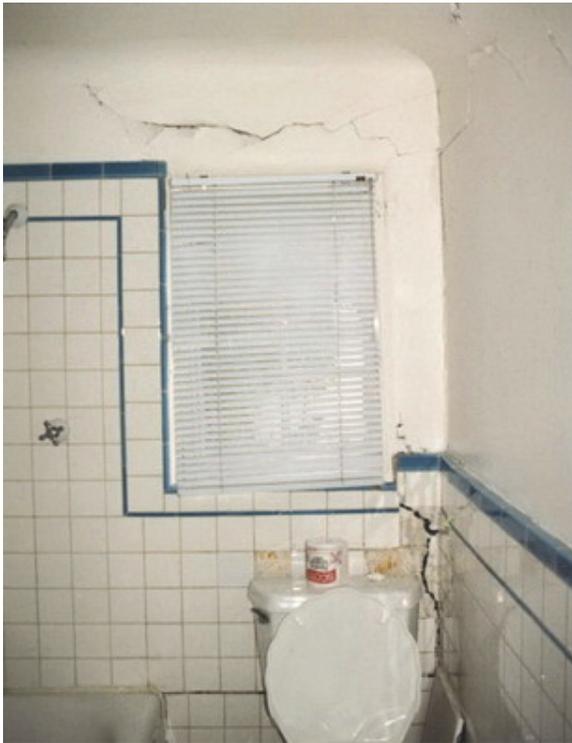
Figure 5-20 Earthquake-induced cracking of ceramic tile (photo credit: Exponent).

Earthquake damage patterns in ceramic and stone tile wall finishes are similar to those of other wall finishes, as shown in Figure 5-20. Diagonal cracking of tile or stair step cracking of grout lines at reentrant corners around wall openings (if present) and cracking of grout lines at wall corners and wall-floor intersections are most common.

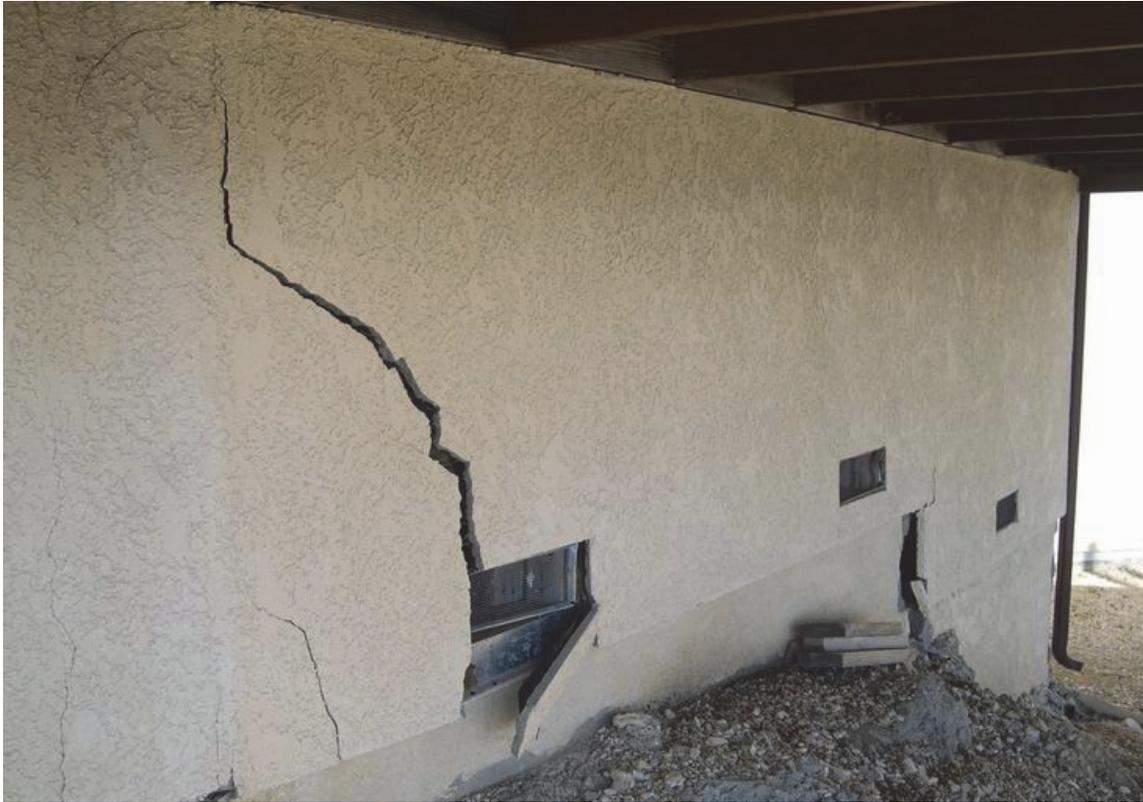
Figure 5-21 Earthquake-induced stucco cracking and buckling at a cripple wall (photo credit: Exponent).

- Cracking, particularly adjacent to wall openings, at reentrant corners, along the sill line (Figure 5-21), and around the exterior of the fireplace or chimney.

- Bulging or buckling of the stucco or wall finishes, as shown in Figure 5-21.
- Detachment of the stucco from the framing, using visual inspection and checking for delamination where the studs are exposed (e.g., inside the garage, as shown in Figure 5-22) and along exposed edges of the wall surface materials or sheathing (e.g., along the sill line and at door openings). A mirror is useful for examining the bottom edge of the stucco. Hand pressure or hand pull along the bottom edge of the stucco can also be used to feel for any detachment from stud framing.

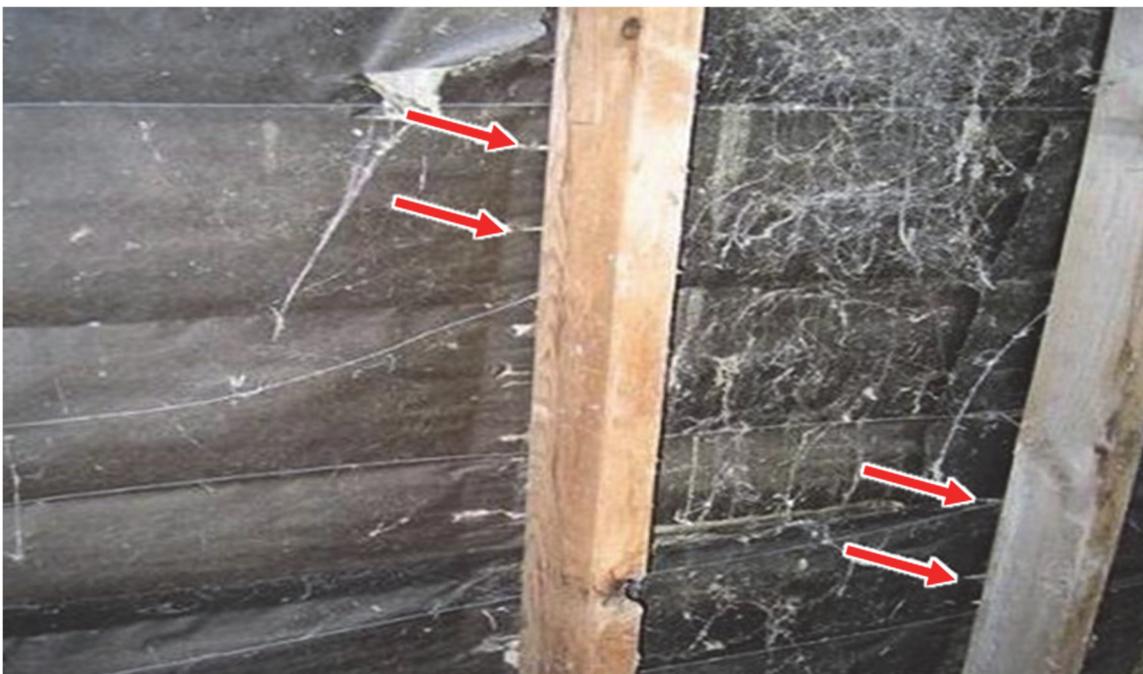
Figure 5-22 Earthquake-induced racking and delamination of stucco as viewed from the interior of a wall within a garage. Arrows point to nails that have pulled through (photo credit: Exponent).

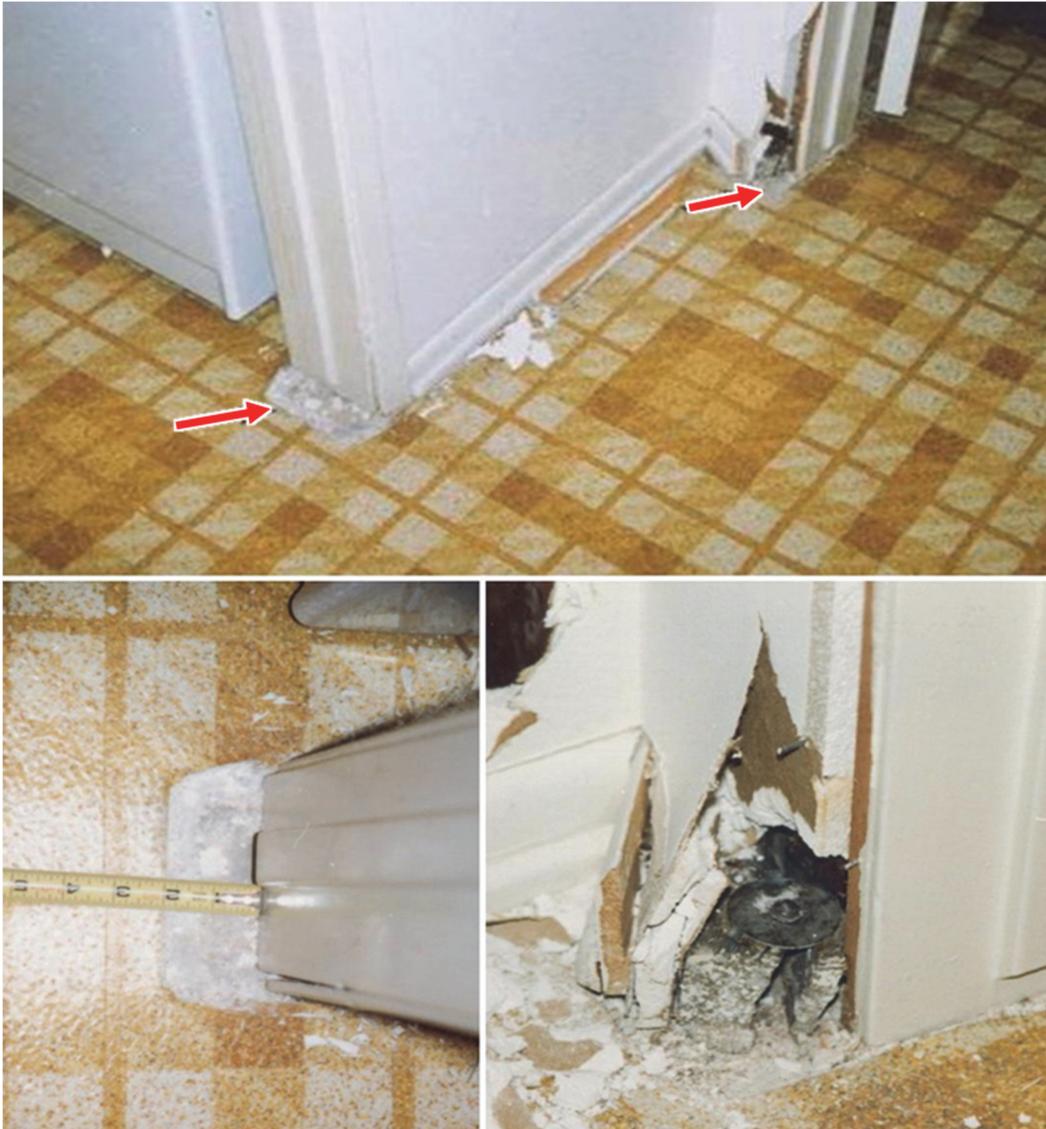
Figure 5-23 Earthquake-induced displacement of an interior partition due to inadequate attachment to floor slab (photo credit: Exponent).

- Fresh separations between the wall and the floor (Figure 5-23) or between the wall and the ceiling.
- Differential movement or separation around the fireplace.

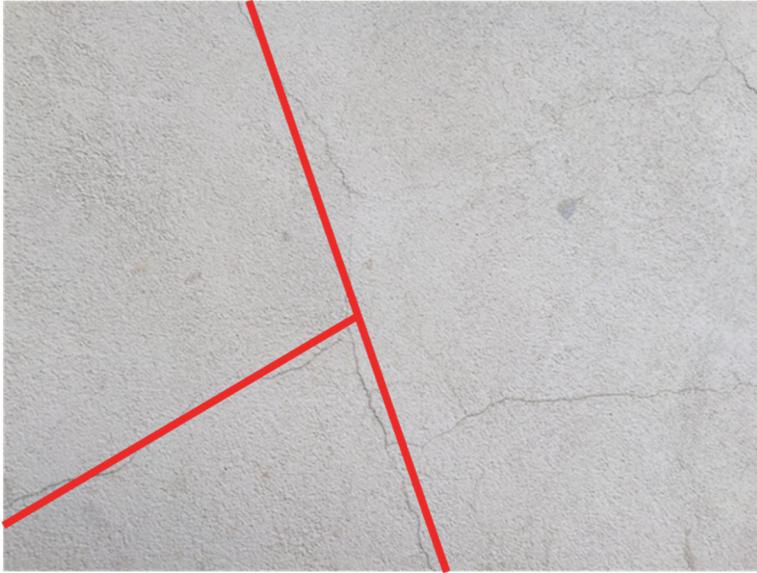
Figure 5-24 Photo of “T”-shaped cracks in stucco. Dark lines added for emphasis (photo credit: D. Dyce).

In addition to details of individual cracks, the pattern of cracking provides an excellent indication of the source, cause, and age of cracks in wall sheathing. Shrinkage cracks occur at planes of weakness or emanate from openings or reentrant corners. Initial earthquake-induced cracking of wall finishes also occurs at these locations, so distinguishing between the two causes is not always easy. Where cracks appear consistently at corners of multiple openings in both the interior and exterior finishes of a given wall line, the cracks are, absent indicators to the contrary, most likely earthquake induced. More random cracking or cracking that occurs in only the exterior or interior finish is likely due to non-earthquake causes. Earthquake-induced cracking should be reasonably consistent over the length of any given wall line, as illustrated in Figure 5-10. Cracking confined to only a portion of the building may be due to non-earthquake causes. For example, cracking caused by differential settlement is associated with changes in floor slopes and generally occurs, or is much more pronounced, in one portion of the building, as illustrated in Figure 5-4. If there are signs of earthquake-induced permanent ground deformation at the site and a technical consultant concludes that the earthquake caused differential foundation movement, then the associated cracking of wall finishes is likely earthquake related. Otherwise, highly localized cracking of wall finishes is likely related to non-earthquake causes. Very straight vertical cracks indicate a construction joint, a control joint, or an addition to the building. Very straight horizontal cracks can indicate a location of poorly lapped wire mesh; such a location is likely to attract shrinkage cracking. Cracks in the shape of a “T” are generally not caused by earthquakes. These are commonly found in exterior stucco and are usually caused by shrinkage (Figure 5-24).

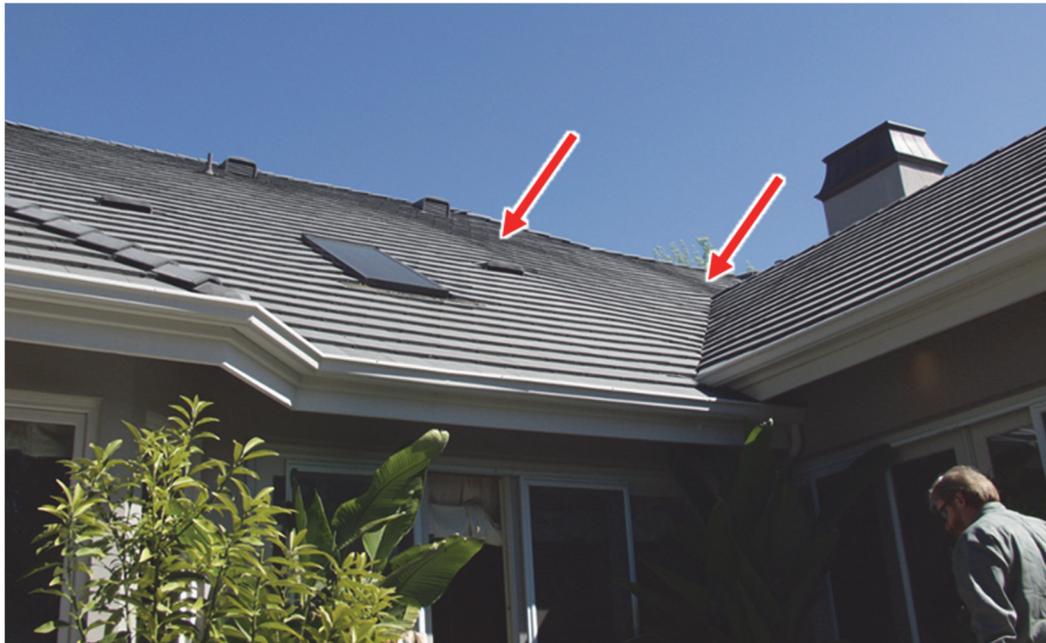
Figure 6-3 Heavy tile roof sagging between wall supports, indicated by arrows (photo credit: Exponent).

In non-snow areas, roof structures are typically designed to be as light as possible with little or no consideration of deflection. As a result, many roofs will exhibit some degree of sag, which will increase with time. Without reinforcing the roof structure, installation of multiple layers of roofing or replacement of wood shakes with concrete tile will exacerbate the visible sag. Sag will often be most noticeable in areas where support conditions of the roof change, such as where a wall intersects the roof framing (Figure 6-3). Sag in the roof is generally not an indication of a serious structural defect.

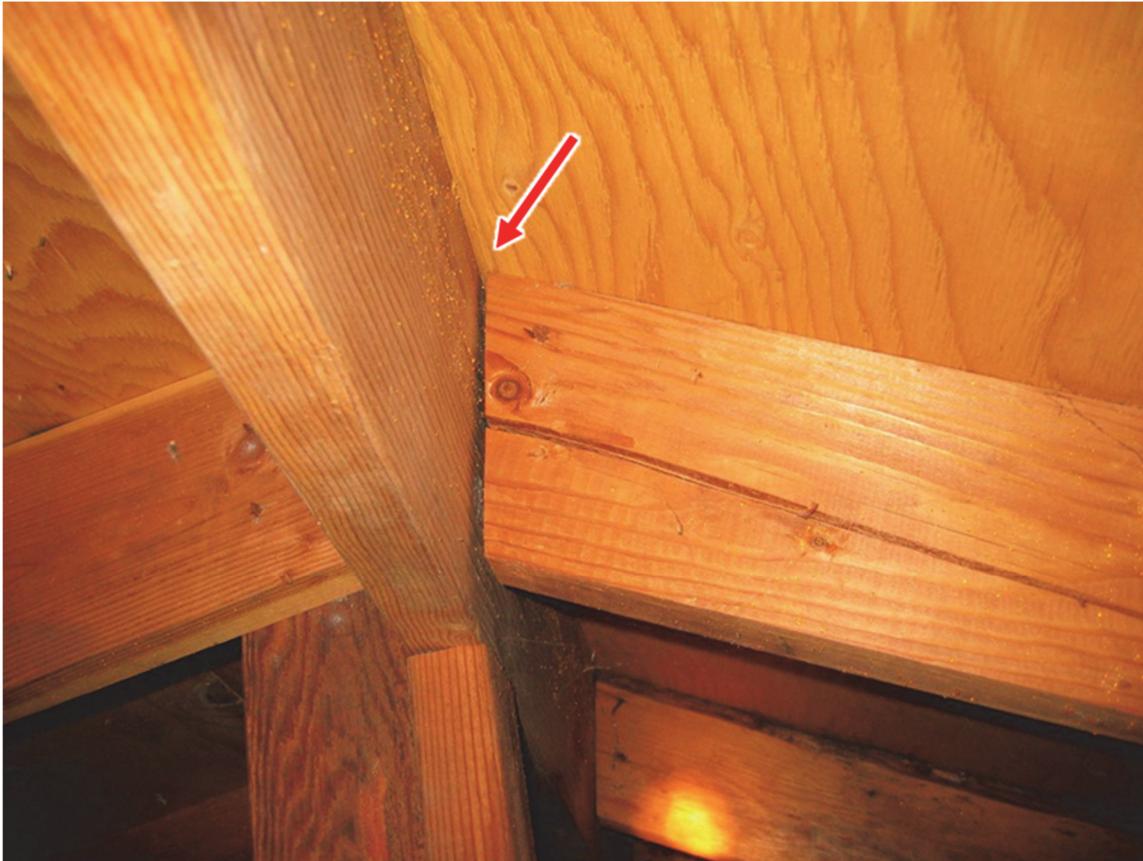
Figure 6-4 Poor fit-up of roof framing at rafter-to-ridge board junction (photo credit: Exponent).

Neither great craftsmanship nor the finest materials are generally employed in the construction of roofs. Thus, it is common to find nails that have missed their target, poorly made joints, and misaligned framing in attics (Figure 6-4). In addition, framing lumber will shrink, twist, and split as it dries. Due to the fact that wood shrinks much more across the grain than it does along the grain, miter cuts made in wood will change angle as the wood dries, becoming more acute and giving the visual impression that the rafters have splayed outward.

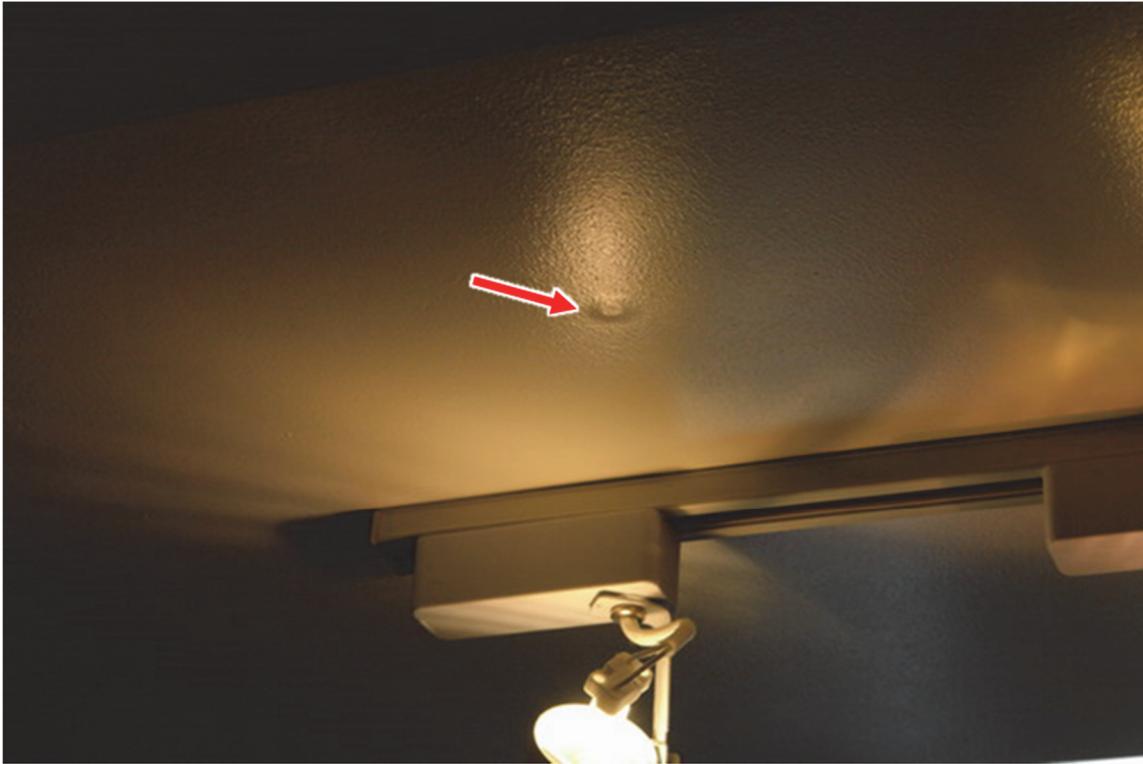
Figure 6-7 Nail pop visible in ceiling (photo credit: Exponent).

- Nail pops: If wood framing dries and shrinks after drywall installation, or if the drywall nails or screws are not drawn tight, the fastener head will, in time, cause a circular crack or a slight bump in the finish over the fastener, as shown in Figure 6-7. Nail pops generally occur in random locations (unless one part of the house was subject to the poor workmanship of a single drywaller during construction).

The most common imperfection with drywall ceilings is tape joints that are visible under low light angles on ceilings with smooth finish. Joints will be spaced at 4 feet in one direction and at 8 feet to 12 feet in the other direction. Related is the problem of nail pops (or dimpling) at fasteners, which develop over time and are generally associated with changes in moisture content in the wood framing (Figure 6-7). The difficulty of preventing nail pops and making inconspicuous tape joints over large ceiling areas is one of the reasons that heavy texture finishes are so widely used for ceilings. A related problem is irregularity of ceiling framing, which shows up as surface irregularities in the drywall finish.

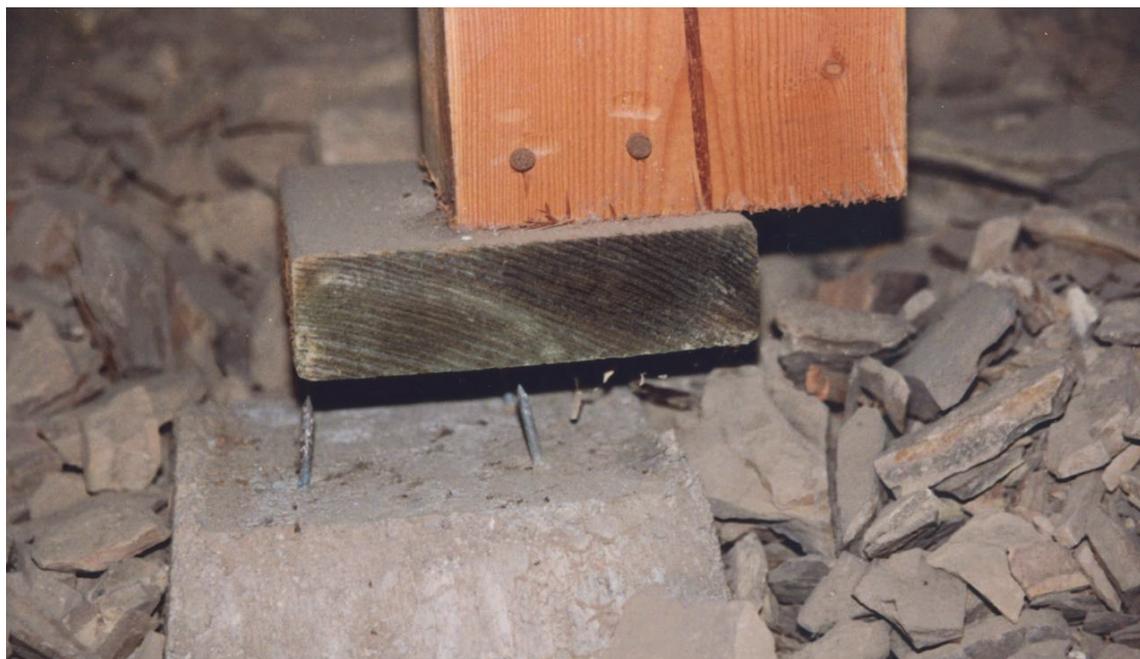
Figure 6-8 Gap between post and pier foundation in crawlspace (photo credit: Exponent).

Many houses in California, especially older houses, are built on unstable soils, which over time can lead to differential movement of the foundation and superstructure. The result will often be floors that are out of level with noticeable slope (i.e., greater than 1 inch in 20 feet). Differential foundation movement can also result in gaps between posts and beams in the crawlspace (Figure 6-8). These gaps leave the beams unsupported, resulting in a sag and bounce in the floor in the vicinity. Soils on or near the tops of slopes can creep or move laterally over time, stretching the foundation and raised wood floor, resulting in tilted support posts (Figure 6-9), cracked mudsills (Figure 6-10), and gaps or cracks in floor finish materials (Figure 6-11).

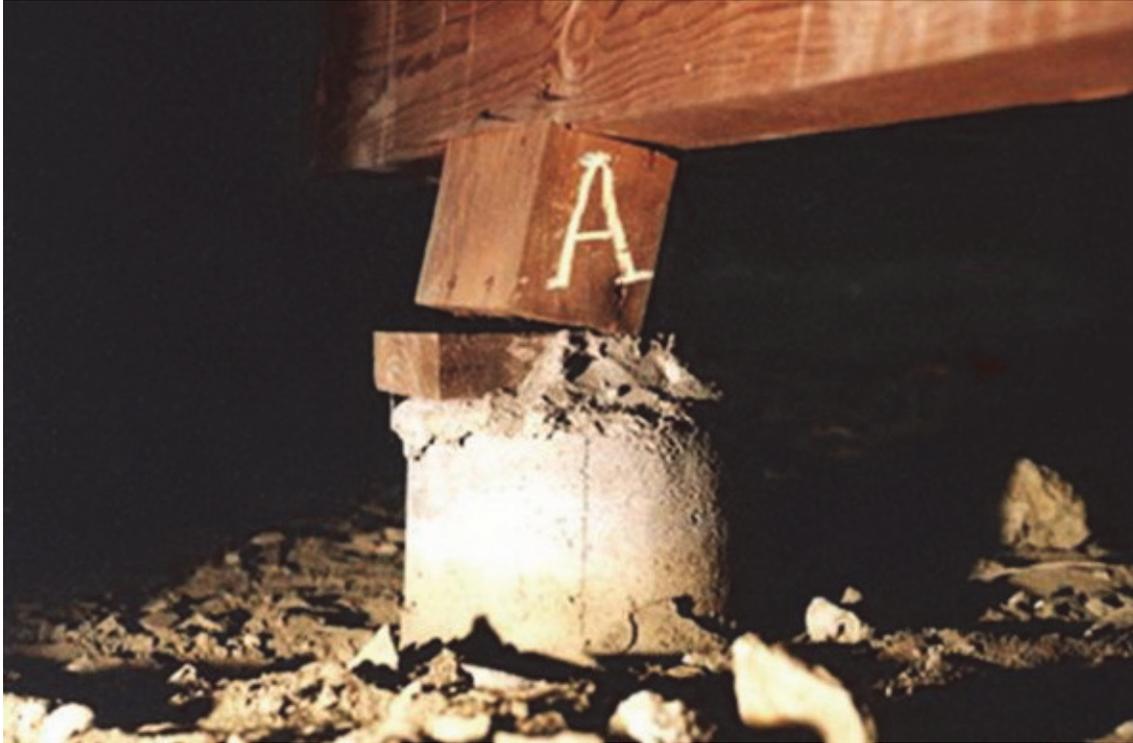
Figure 6-9 Tilted support posts in crawlspace (photo credit: Exponent).

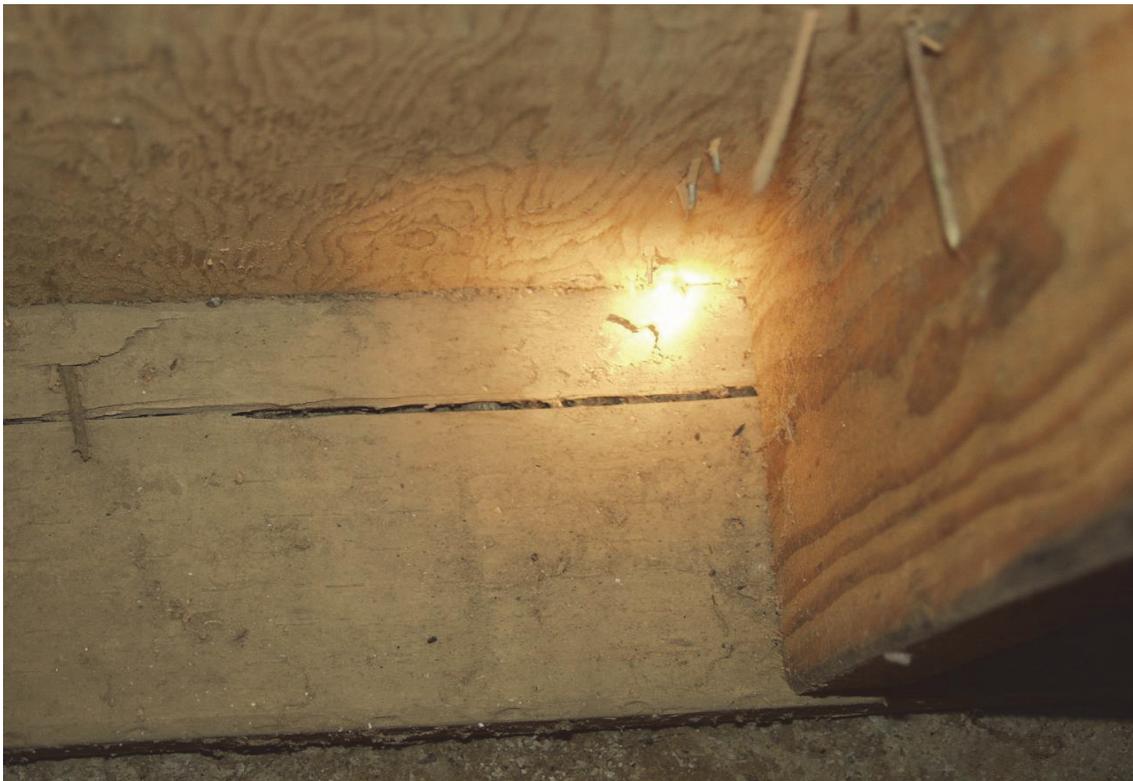
Figure 6-10 Cracked mudsill and missed nails (photo credit: Exponent).

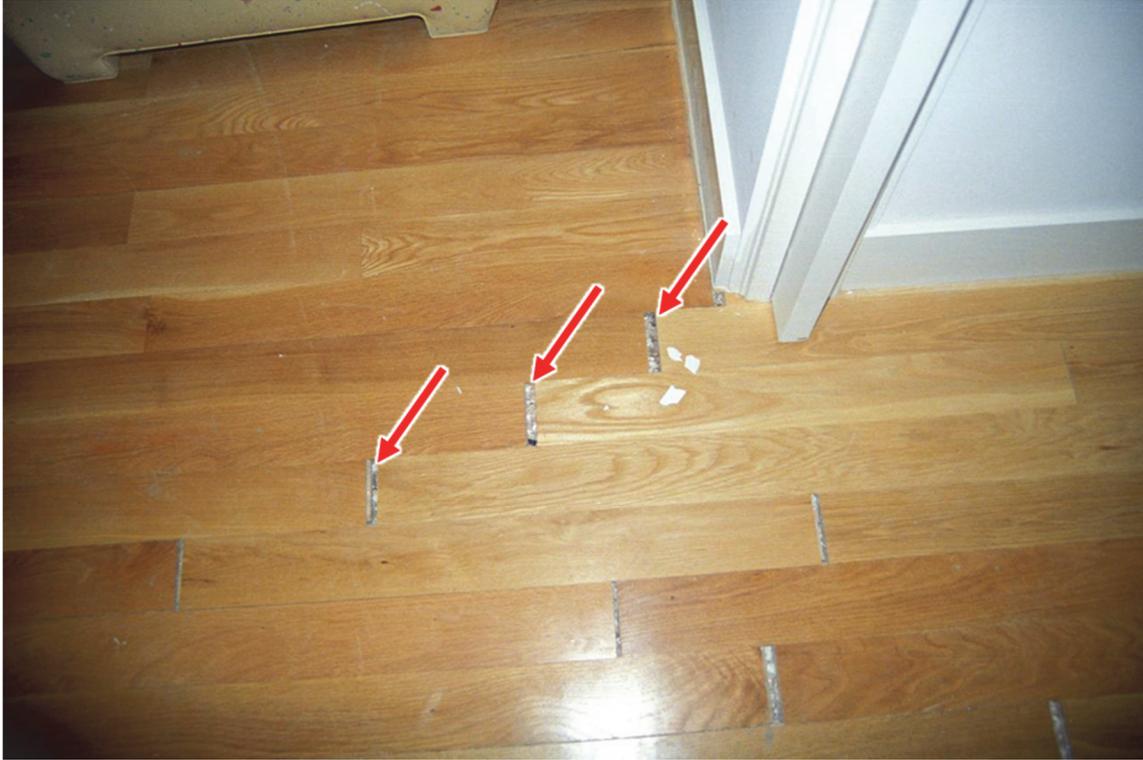
Figure 6-11 Gaps in flooring due to elongation of floor diaphragm caused by non-earthquake-induced slope movement (photo credit: Exponent).

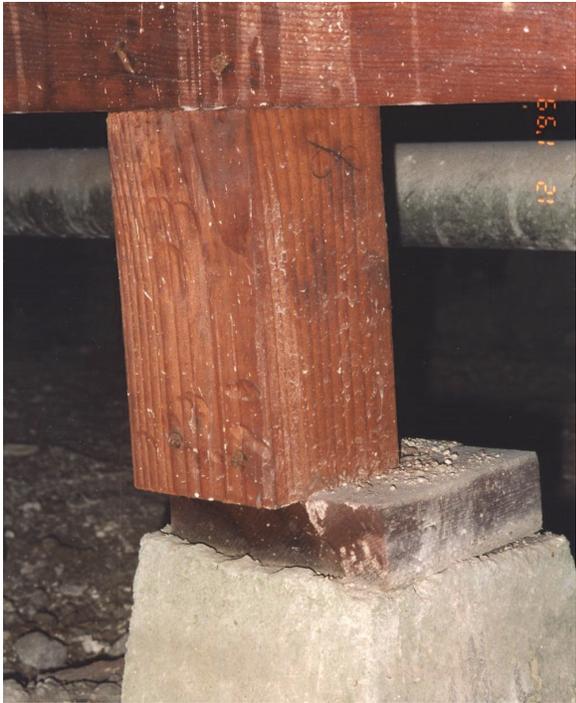
Figure 6-12 As-built misalignment between girder and footing accommodated with offset post (photo credit: Exponent).

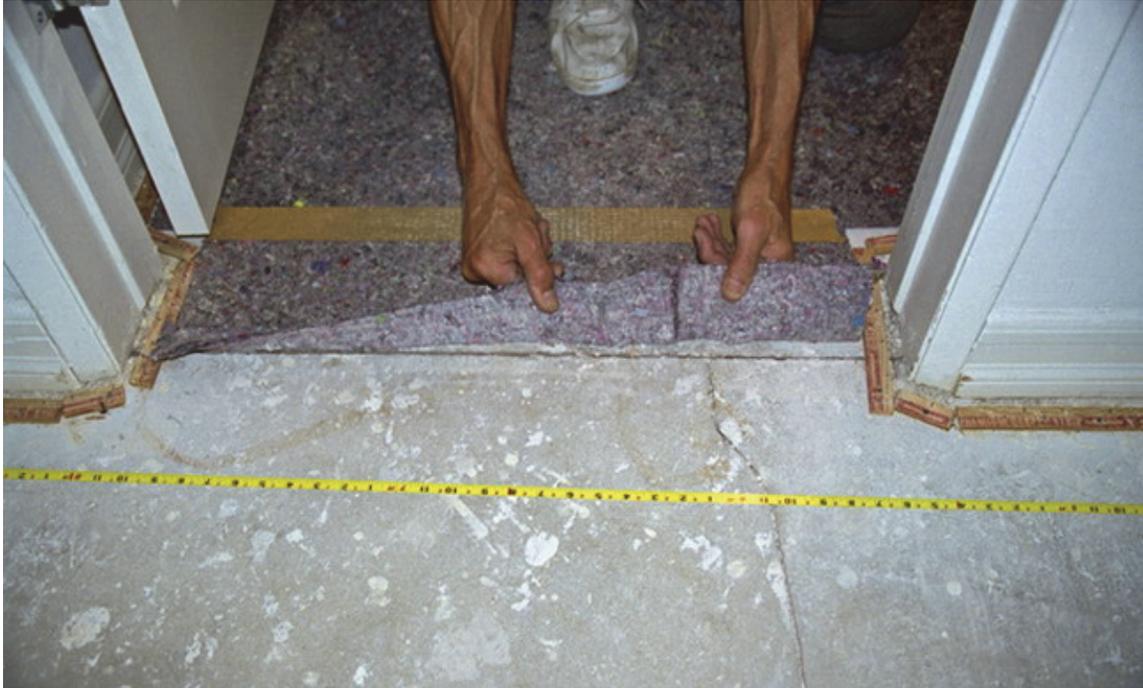
Figure 6-13 Shrinkage cracks in lightweight concrete fill (photo credit: Exponent).

While not common in single-family houses, a 1 1/2-inch-thick layer of lightweight concrete is often used in place of underlayment for sound control in multi-family wood-frame buildings. That fill is unreinforced, placed with a high-water content, and of low strength, resulting in the development of cracks from shrinkage or traffic loads and deterioration (Figure 6-13).

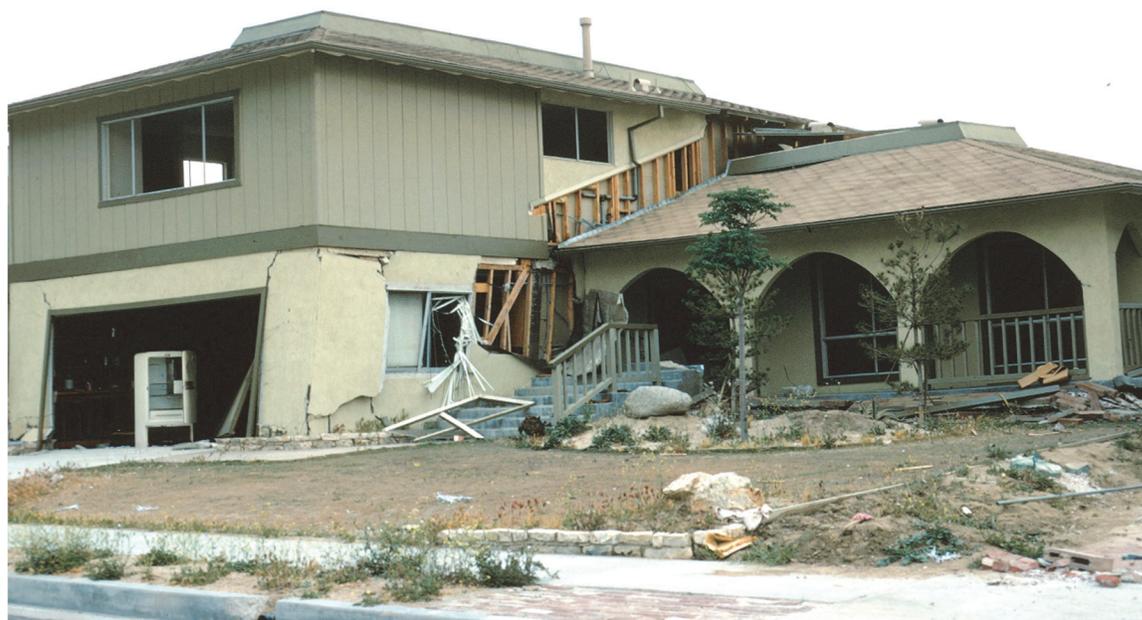
Figure 6-15 Stemwall anchorage failure and earthquake-induced separation across discontinuous floor and roof diaphragms of a split-level house (photo credit: R. Kachadoorian, USGS Denver Library Photographic Collection).

Damage at vertical irregularities occurs when the portions of the building on either side of the irregularity move in opposing directions. If the structural tie across the irregularity is not sufficiently strong (a common situation, especially in older buildings), separation will occur at the discontinuity of the structural diaphragms, with damage ranging from minor finish damage to complete structural separation. Split-level houses represent vertical irregularities in the lateral load path that can lead to separation in discontinuous floor and roof framing (i.e., the horizontal diaphragms). In the past, split-level houses have suffered serious damage due to this discontinuity, as shown in Figure 6-15. Modern seismic design principles discourage this condition or provide special detailing to accommodate it. Discontinuities in horizontal diaphragms should be inspected carefully for indications of framing separation.

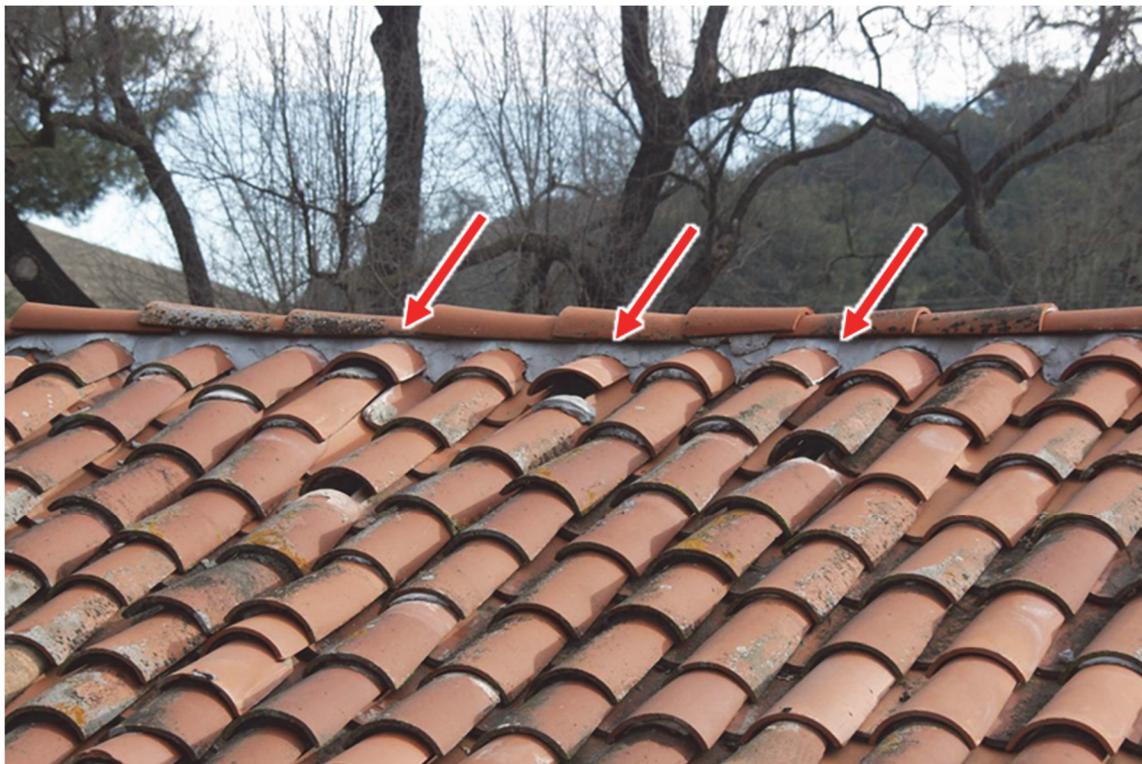
Figure 6-16 Clay roof tile and mortar joints shifted by earthquake shaking (photo credit: Exponent).

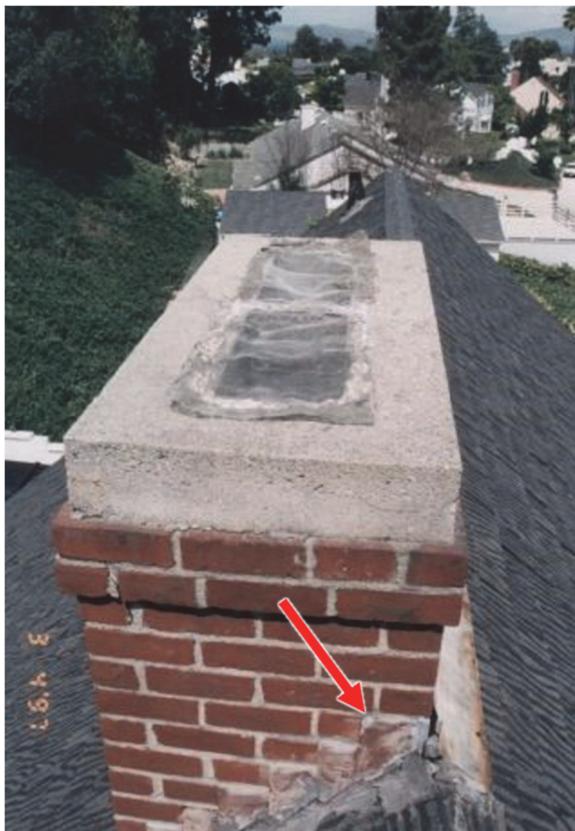
Figure 6-17 Buckled chimney flashing due to earthquake shaking (photo credit: Exponent).

Roofs can be damaged by masonry chimneys by three means: flashing damage due to relative motion between the chimney and building (Figure 6-17), impact damage from toppling chimneys (Figure 6-18), and damage to framing where steel strap ties from the chimney are attached to roof framing (Figure 6-19). Flashing damage will typically only be discoverable by a rooftop inspection. The other two modes of damage should be readily observable from the ground. If either of the latter two conditions exists, framing in the vicinity of the chimney should be inspected from within the attic.

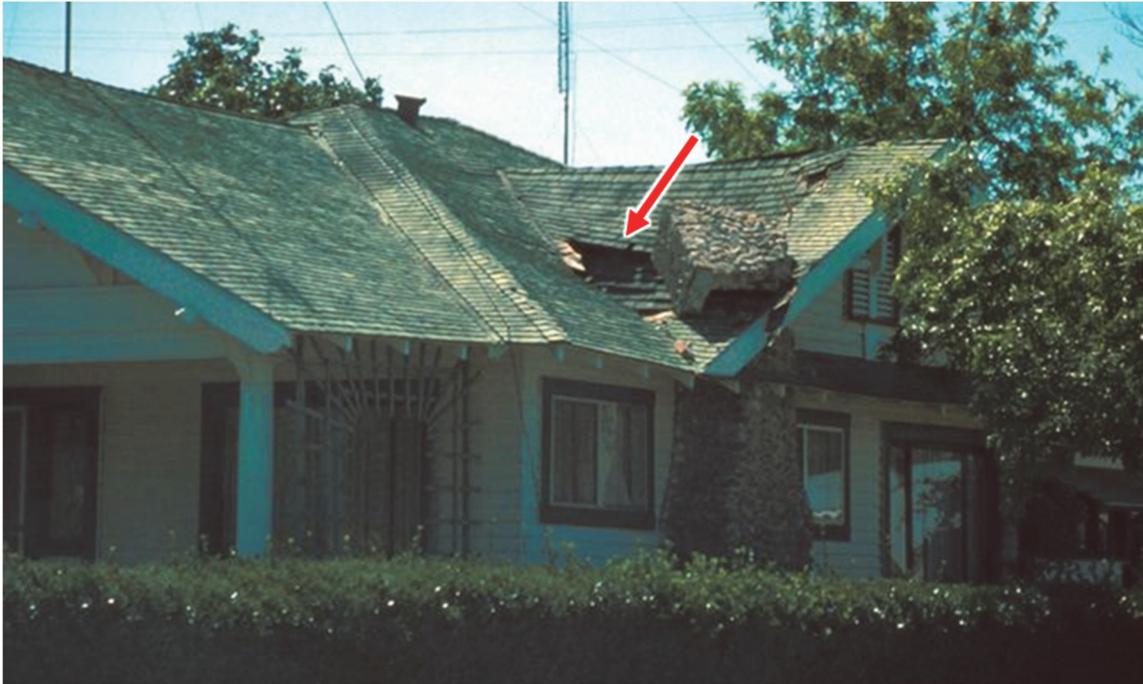
Figure 6-18 Earthquake damage from impact of falling masonry chimney (photo credit: USGS).

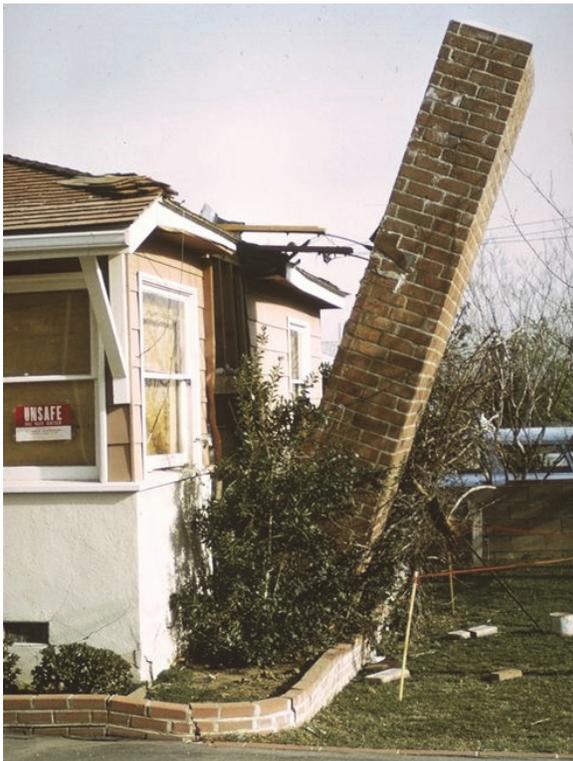
Figure 6-19 Masonry chimney and fireplace that have tilted away from the house. The chimney tore loose the wood framing to which steel tie straps from the chimney were attached (photo credit: L. S. Cluff, NISEE e-Library).

The most common type of roof framing damage occurs due to failure of an adjacent chimney. Many masonry chimneys, some dating back to the 1930s, are attached to the house with steel straps, where one end is embedded in the chimney mortar and the other is nailed to the framing (e.g., roof, ceiling, or second floor). During an earthquake, when the chimney shifts away from the house, the framing connected to the strap can be damaged. If it appears that the chimney has shifted more than 1/4 inch from the house, an attic inspection should be conducted to inspect the adjacent framing.

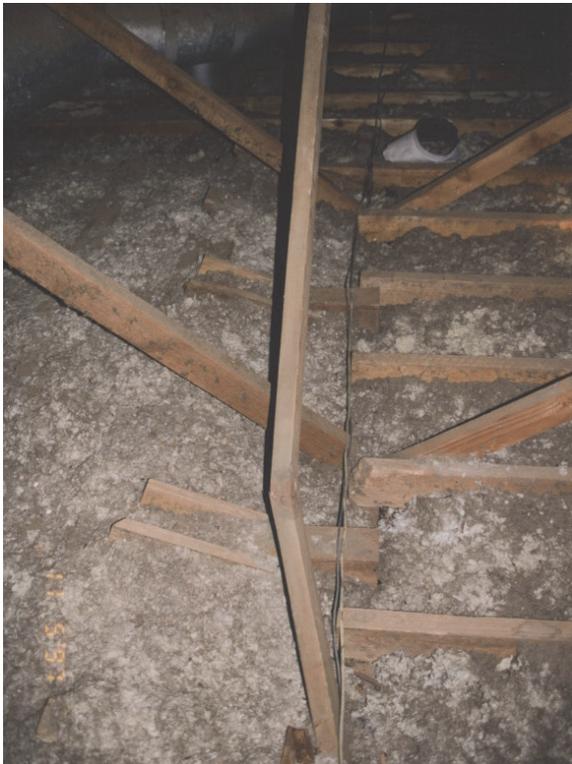
Figure 6-20 Diagonal ridge brace buckled due to earthquake; this brace is in line with the brace shown in Figure 6-21 (photo credit: Exponent).

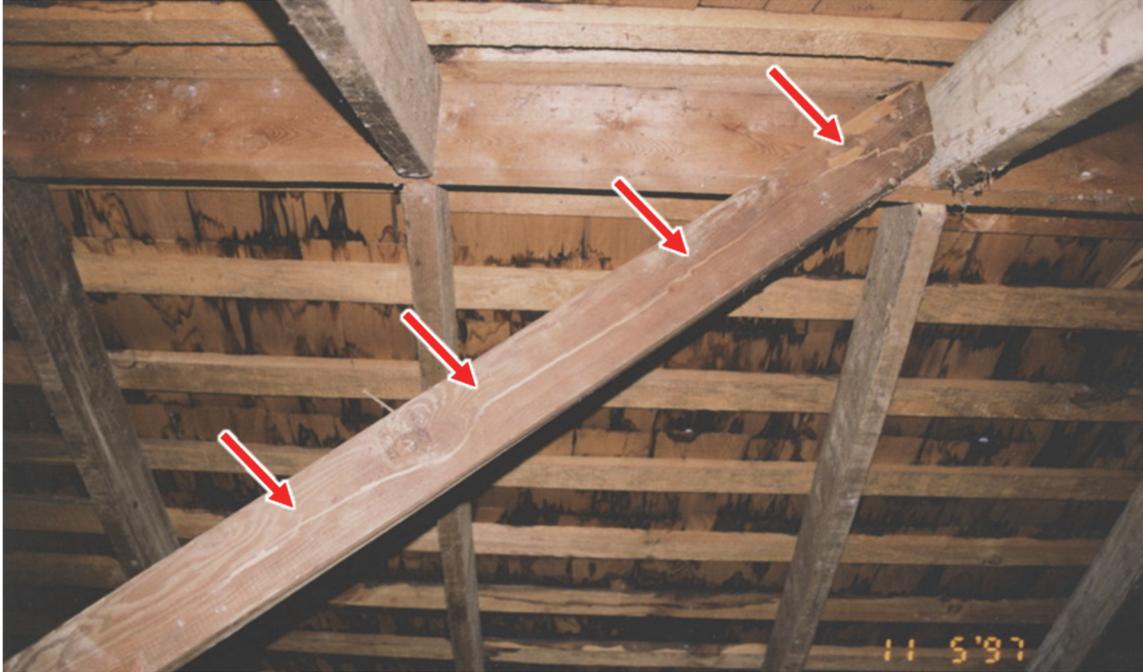
Figure 6-21 Diagonal ridge brace cracked during earthquake; this brace is in line with the brace shown in Figure 6-20 (photo credit: Exponent).

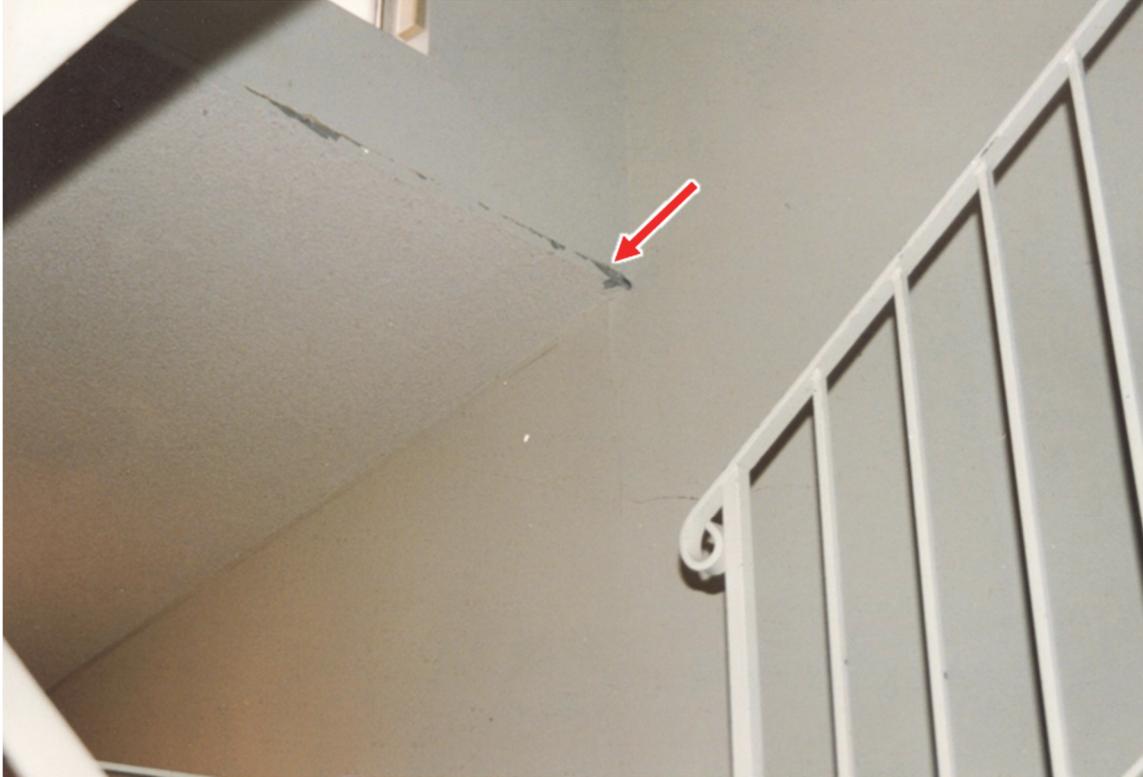
Figure 6-22 Earthquake damage to ceiling corner bead at stairwell (photo credit: Exponent).

The most common type of earthquake-induced ceiling damage is minor cracking of ceiling finishes at re-entrant corners and cracking along corner beads at the intersection between the ceiling and an opening, conditions commonly found at stairwell openings (Figure 6-22). Ceilings can also sustain damage in areas adjacent to chimneys, where tie straps from the chimney damage framing as the chimney pulls away from the building. Where there are irregularities in the lateral load path, such as building plans where the second story is set back to mid-length of the garage, cracking of drywall finishes can occur along tape joints (Figure 6-23).

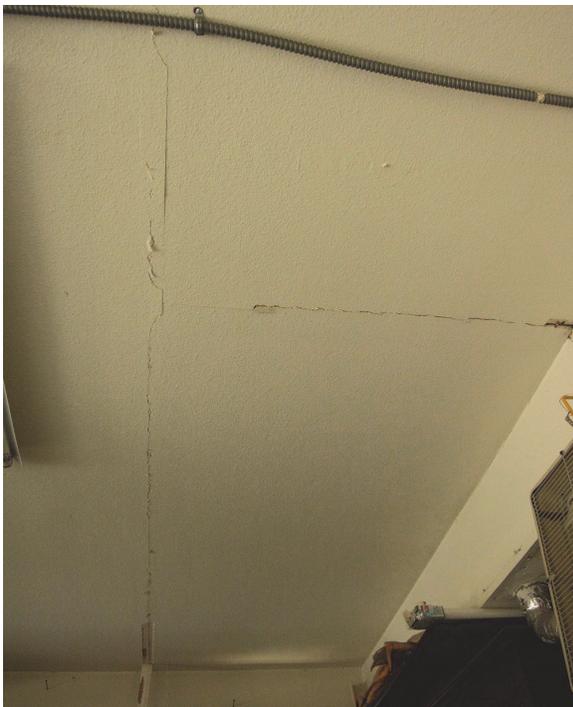
Figure 6-23 Earthquake damage to tape joints at vertical load path irregularity (photo credit: Exponent).

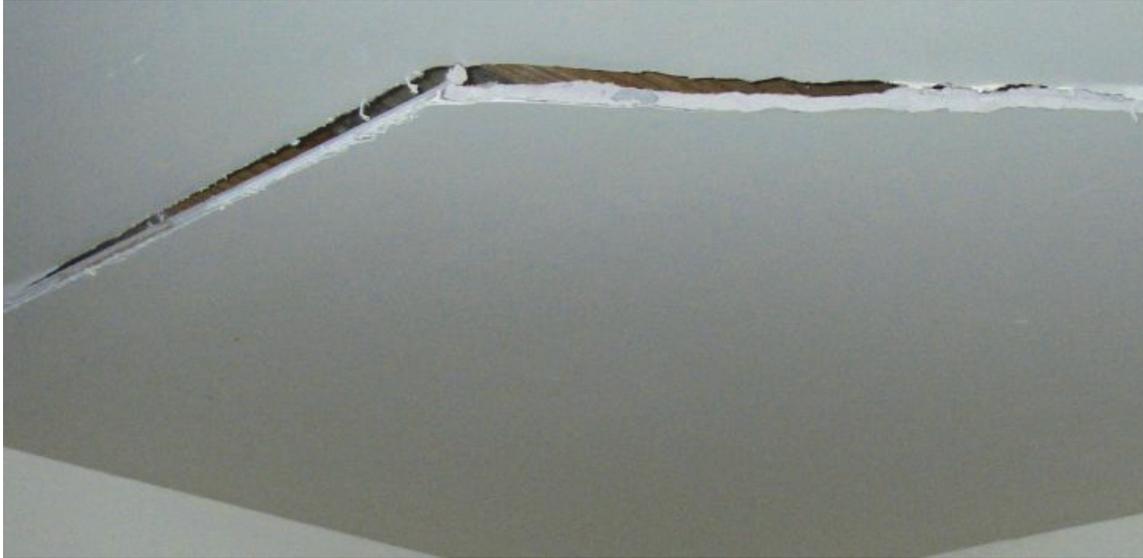
Figure 6-24 Earthquake damage to ceiling finish (photo credit: M. Heller, EERI Library).

Where ceilings include exposed wood framing, or where there is significant finish damage, framing should be inspected carefully for signs of earthquake-induced movement or shifting (Figure 6-24). It is important to recognize that natural imperfections in wood, including shrinkage, cracks, twisting, and warping, as well as irregular gaps where other finish materials abut the wood, are quite common and often mistaken for earthquake damage.

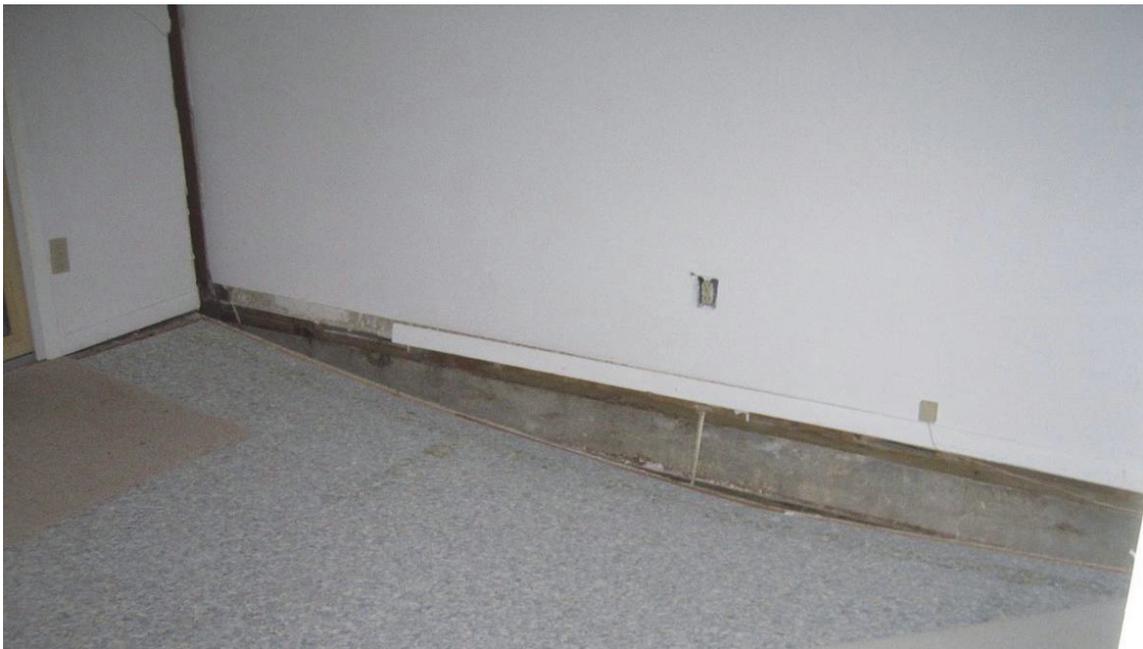
Figure 6-25 Sagging floor due to earthquake-induced shifting and loss of support (photo credit: Exponent).

The most common and serious failure modes for floors are lateral movement and loss of vertical support. Floors are restrained from lateral movement either by direct attachment to the foundation or through walls that are anchored to the foundation. Failure of a supporting wall, as discussed in Chapter 5, will cause failure of the floor (Figure 6-25). As a result of the strength required to support building occupants and contents, floors generally have sufficient strength to resist the lateral forces imposed by earthquakes, and structural damage associated with the direct effects of earthquake shaking is uncommon.
