Earthquake Damage Assessment and Repair Guidelines for Residential Wood-Frame Buildings

Volume 1 | GENERAL GUIDELINES

CEA-EDA-01 2020

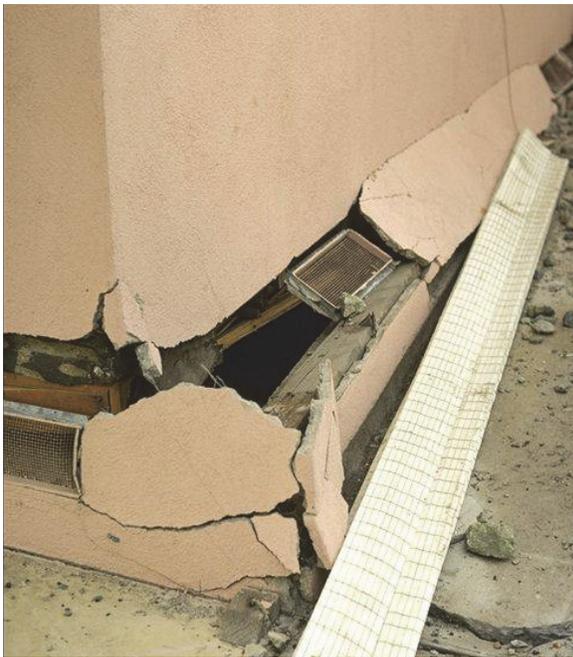
Figure 6-26 Sliding of joists on mudsill due to earthquake (photo credit: NISEE).

Sills that are inadequately attached to the footing with anchor bolts can split and slide on (or off) the foundation. Sometimes the mudsill is well bolted, but the joists are not adequately nailed to the mudsill, a condition that also leads to a sliding failure (Figure 6-26) or bulging. Sliding of sill plates or sliding (or bulging) of the framing on the sill plate can typically be seen by the damage to exterior finishes. Another indication of sliding or failure of the mudsill is uniform leaning of post supports in the crawlspace consistent with the direction of movement of the floor.

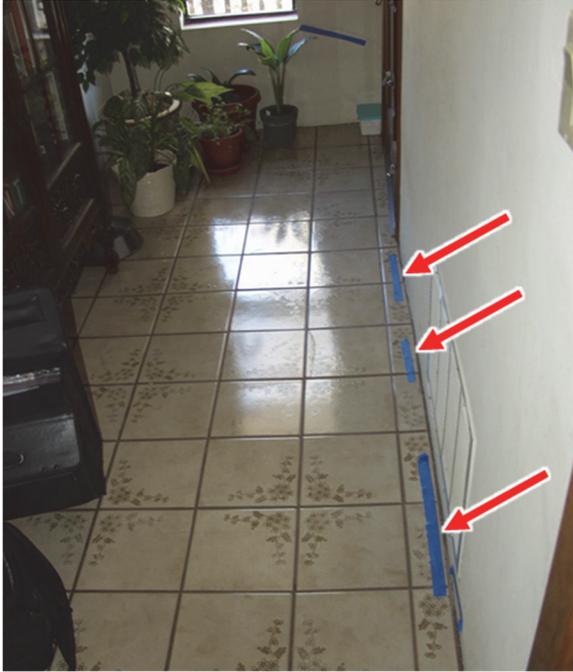
Figure 6-27 Earthquake-induced gap between floor and wall supported on retaining wall on uphill side of house on sloped lot (photo credit: Exponent).

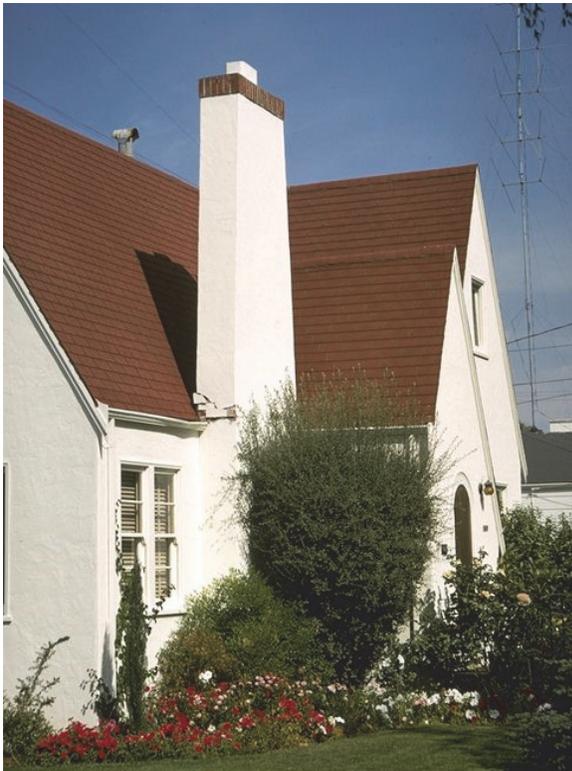
Figure 7-1 Damage to masonry chimney at shoulder (photo credit: K. V. Steinbrugge, NISEE e-Library).

- Unreinforced brick masonry chimneys constructed with Portland cement-based mortars. These mortars exhibit greater strength properties than lime-based mortars and have resulted in chimneys exhibiting somewhat better performance during earthquakes (Figure 7-1).

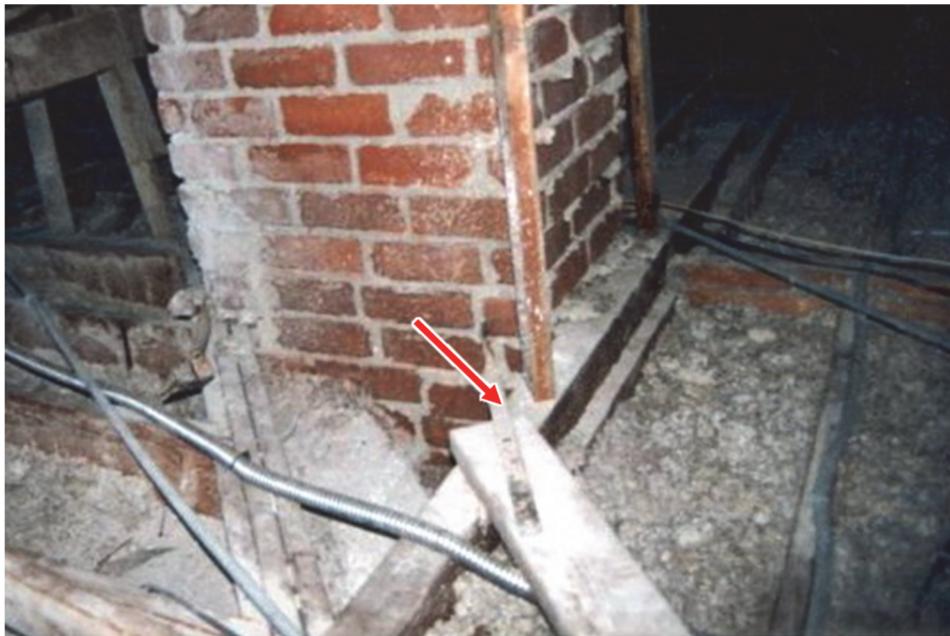
Figure 7-4 Chimney visible in attic with undamaged steel tie strap between chimney and framing (photo credit: Exponent).

As illustrated in Figure 7-2 through Figure 7-4, the main components of a masonry fireplace and chimney structure are:

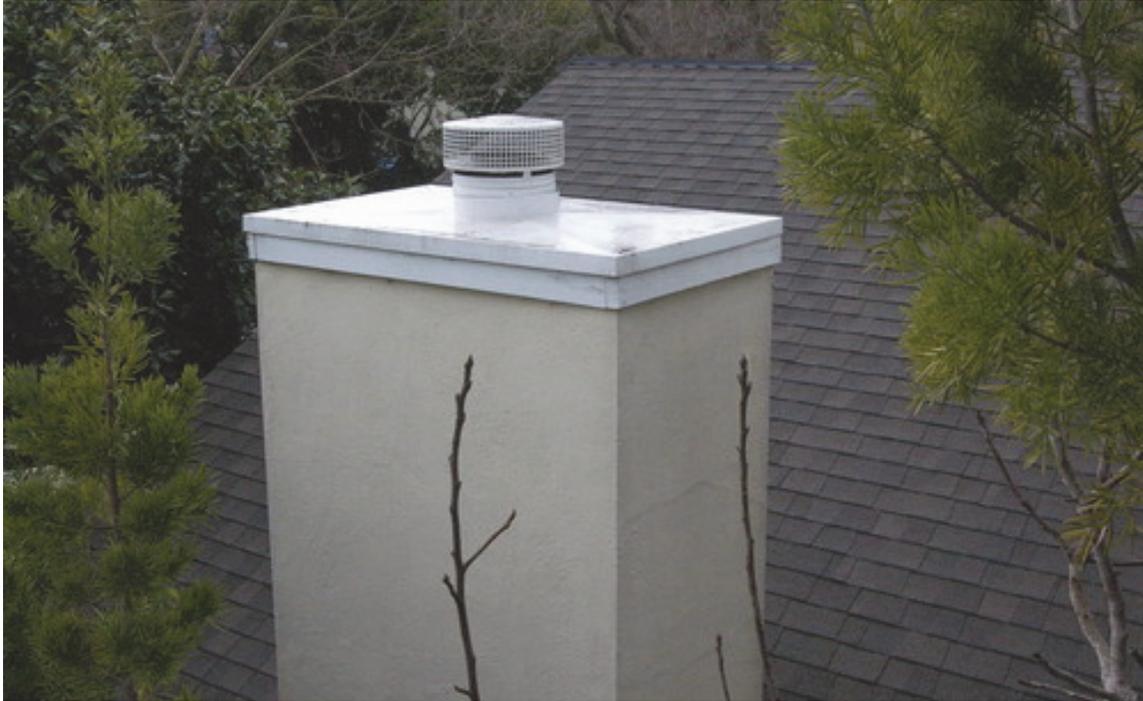
Figure 7-8 Undamaged stucco-clad, wood-frame chimney chase (photo credit: Exponent).

As illustrated in Figure 7-5 through Figure 7-9, the main components of a factory-built fireplace and chimney are:

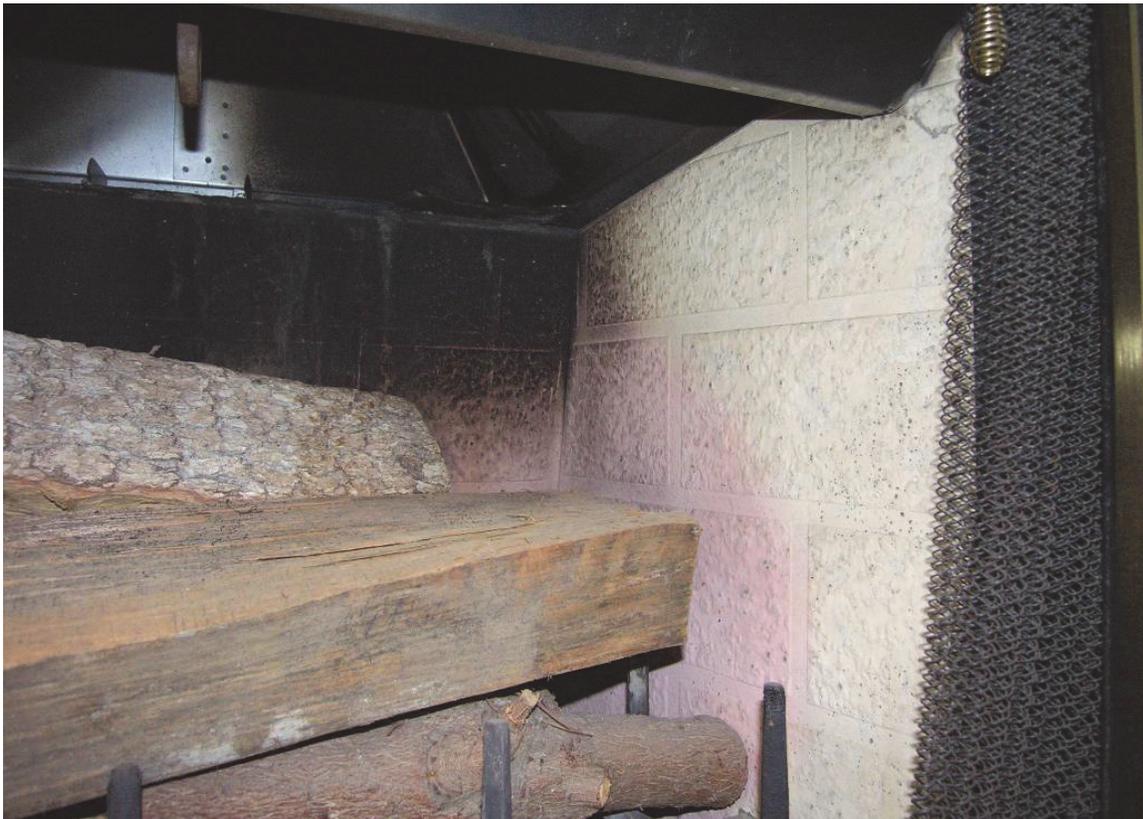
Figure 7-9 Undamaged firebox of factory-built fireplace with brick patterned refractory panels (photo credit: Exponent).

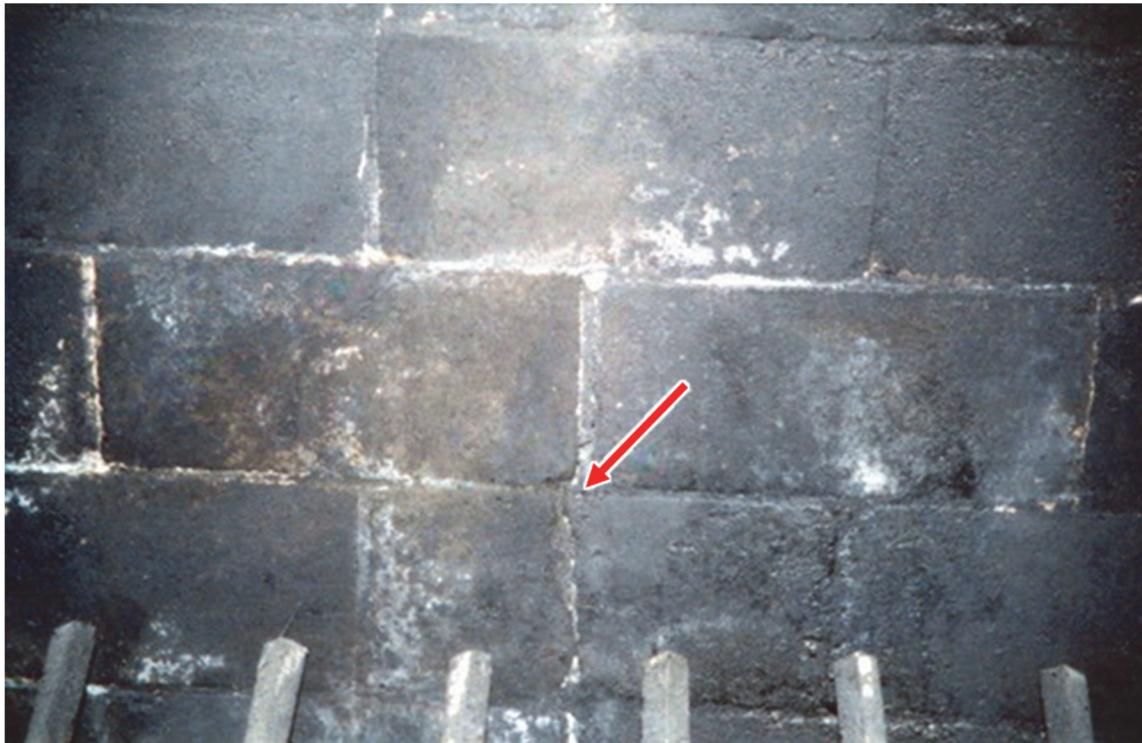
Figure 7-10 Typical thermal cracking of firebrick and mortar lining firebox of a masonry fireplace (Source: Exponent).

It is extremely common to observe cracked masonry firebrick in the hearth and firebox from thermal-related stresses. This cracking can occur along mortar joints and through the firebrick (Figure 7-10). Such cracking generally has rounded edges and is limited in size and extent. Most of the thermal cracks are less than 1/16-inch wide.

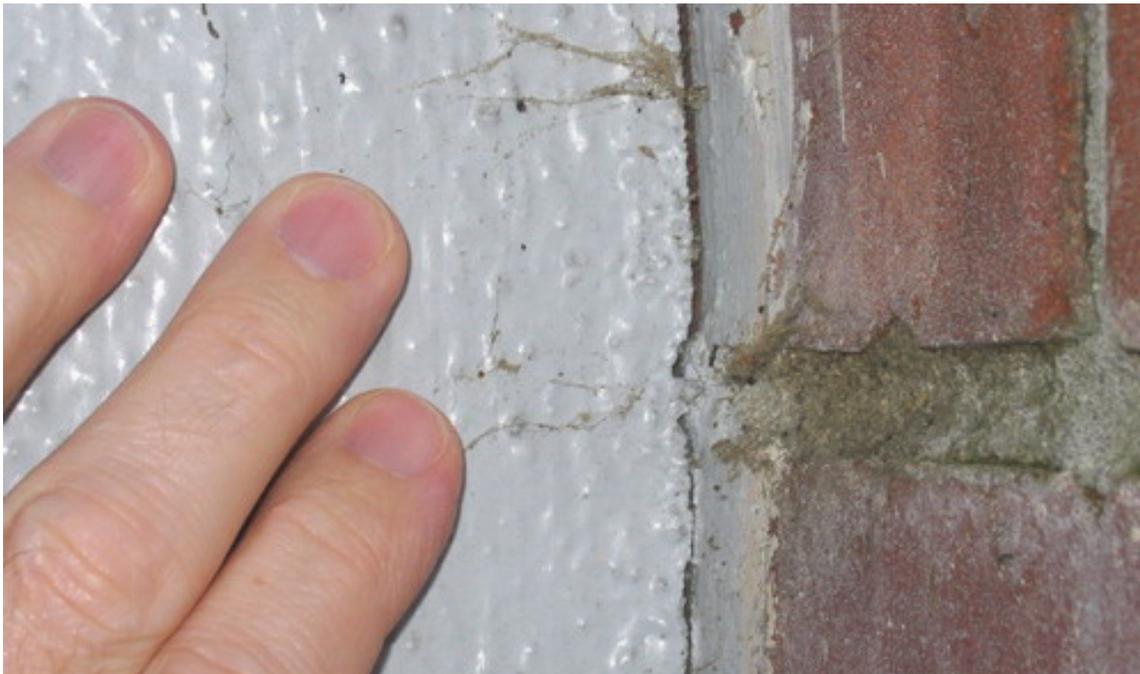
Figure 7-11 Normal crack between masonry fireplace and chimney and exterior stucco wall (photo credit: Exponent).

- Hairline crack between masonry and exterior wall: A cold joint or discontinuity exists between masonry fireplaces and chimneys and the surrounding wall finishes. Hairline cracking at the joint is normal (Figure 7-11).
- Long-term settlement: Compared to the adjacent wood-frame building, masonry fireplaces and chimneys are relatively heavy structures and are often supported on independent, shallow concrete foundations. Differential settlement can occur between the chimney and the house, resulting in distress to the roof flashing and exterior siding or finishes at their interface with the chimney. For a

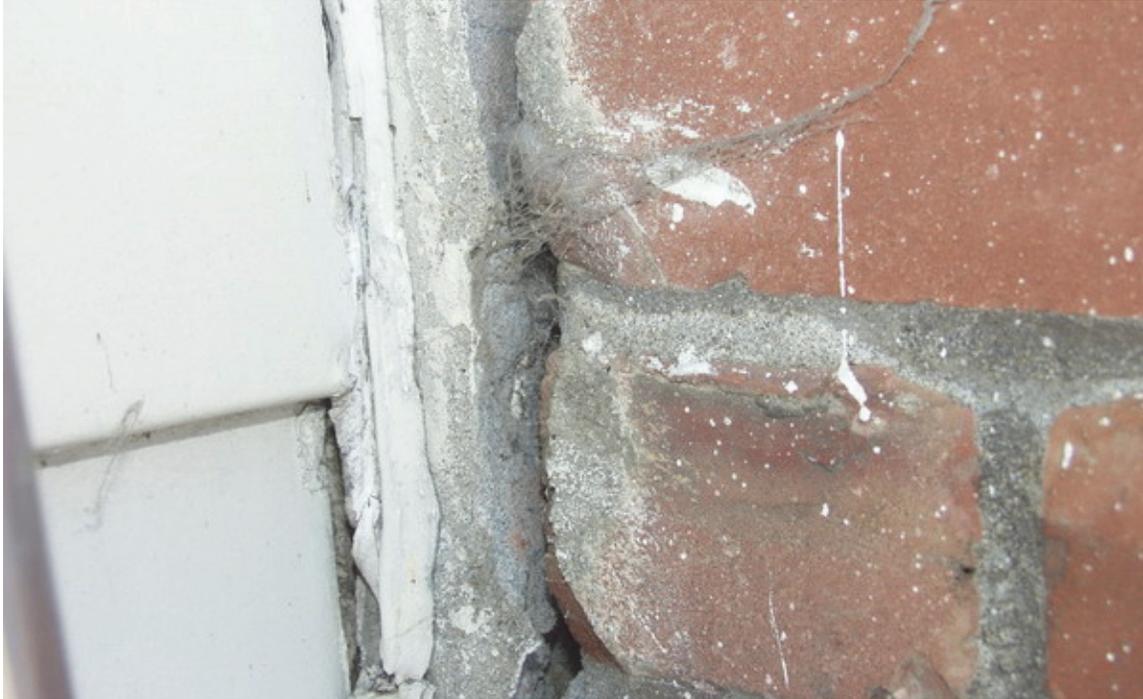
Figure 7-12 Gap between chimney and house, where mortar filler was used to fill the previous gap. Since the repair, the gap has widened, evidenced by paint in the gap and the cobweb spanning the gap (photo credit: Exponent).

chimney located on an exterior wall, the differential settlement of a chimney foundation can result in gaps (Figure 7-12) between the chimney and house that gradually increase in width towards the top of the chimney (Figure 7-13).

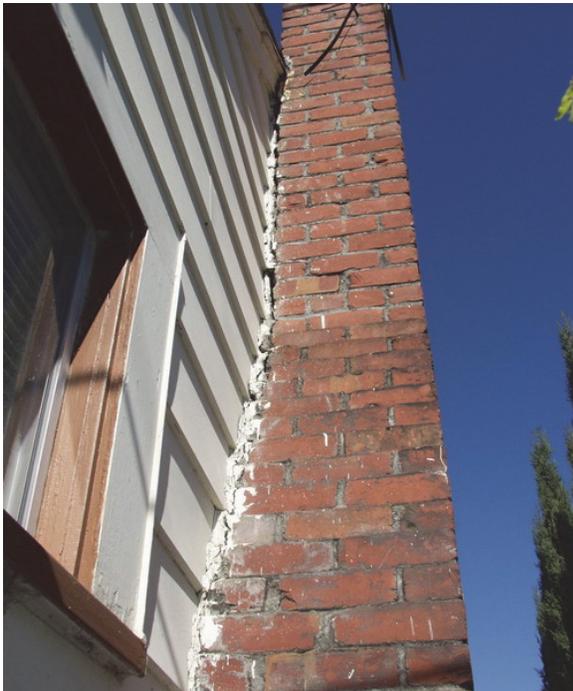
Figure 7-13 Tapered gap between chimney and house that has resulted from long-term differential settlement of fireplace foundation. Mortar filler was used to fill the previous gap (photo credit: Exponent).

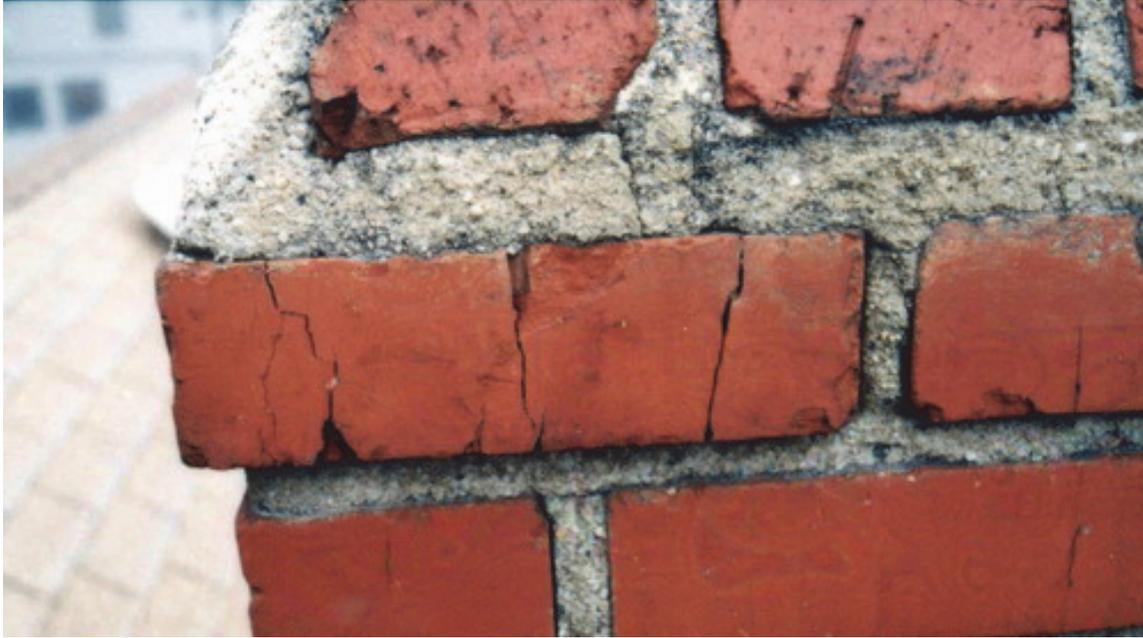
Figure 7-14 Random isolated cracking of brick and mortar joints commonly found on masonry fireplaces and chimneys (photo credit: Exponent).

- Isolated cracks: Random cracking of individual bricks (Figure 7-14) and random, isolated cracking of mortar joints are commonly found on most chimneys.

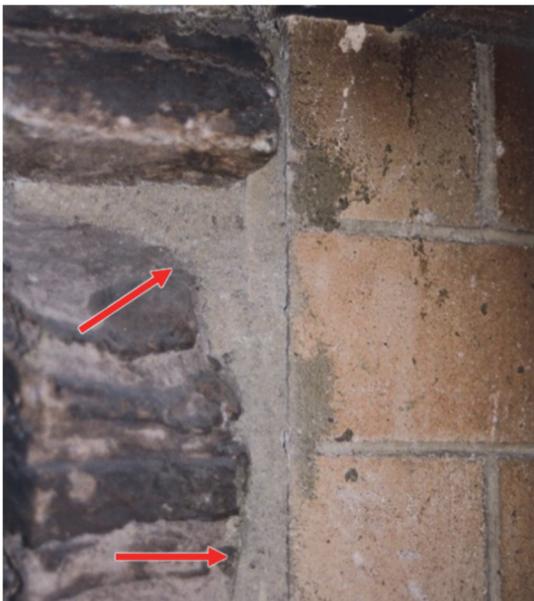
Figure 7-15 Mortar joint between firebox and masonry facing where hairline cracks are frequently found (photo credit: Exponent).

Interior masonry facings are generally not well secured to either the wall or firebox. As a consequence, hairline cracks are commonly found at the mortar joint between the facing and the firebox (Figure 7-15) and at the intersection or mortar joint between the facing and wall finishes. Isolated random cracking of the brick or stone and mortar joints of the facing is also common.

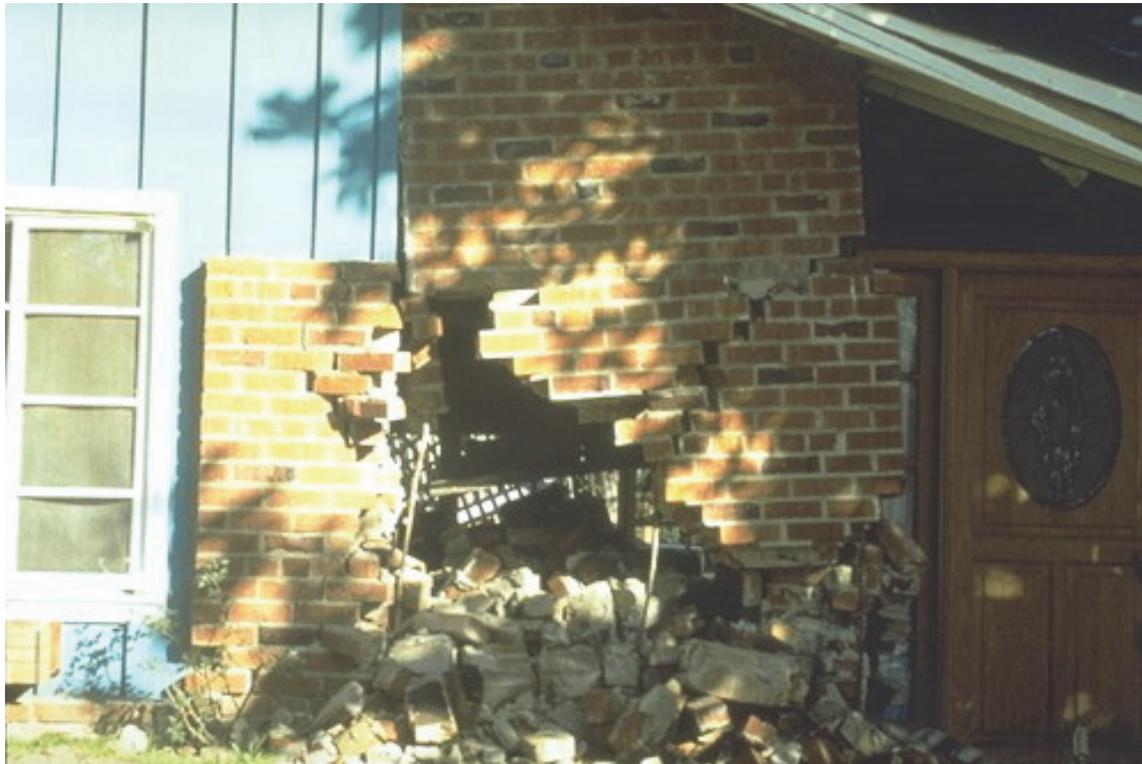
Figure 7-16 Earthquake-induced failure of masonry fireplace at firebox level (photo credit: R. Reitherman).

The firebox of masonry fireplaces typically will not be damaged during an earthquake but will, in general, exhibit cracking as a result of thermal stresses that develop during normal usage. Earthquake-related cracking of the firebrick generally is a result of significant and obvious damage to the surrounding masonry structure (Figure 7-16).

- Failures at and below the firebox (Figure 7-16 and Figure 7-23) are less common and often associated with movement of the entire building relative to the foundation.
- Relative movement between the chimney and the wood-frame building that can create a gap between the chimney and wall (Figure 7-24 and Figure 7-25), damage flashings (Figure 7-26 and Figure 7-27), and possibly damage framing where straps from the chimney are attached (Figure 7-24).
- Separations of outer masonry layers (also called wythes) from inner layers of the chimney masonry.

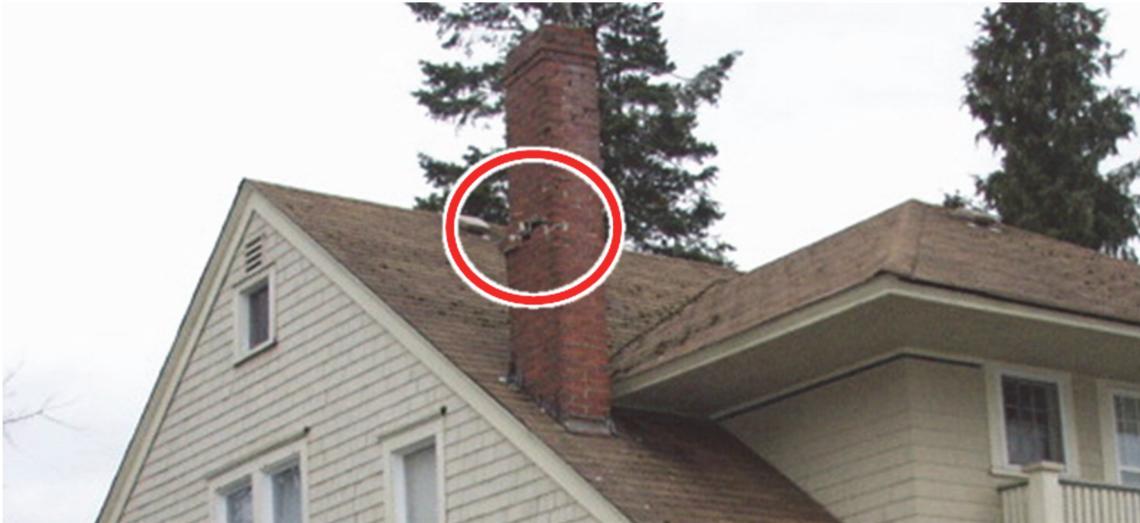
Figure 7-17 Earthquake-induced damage to masonry chimney above roofline (photo credit: Exponent).

- “Bending” failures where horizontal cracks develop (generally at the roof line or shoulder at the top of the fireplace), and the upper portion of the chimney may shift or topple (Figure 7-17 through Figure 7-22).

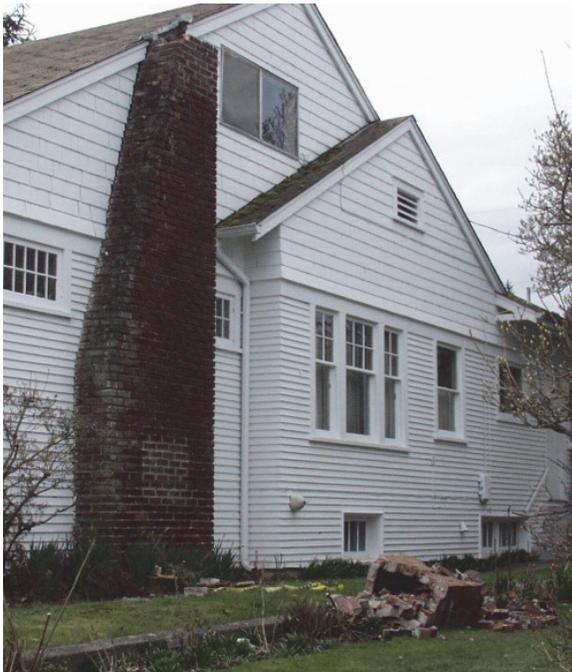
Figure 7-18 Earthquake-induced failure of masonry chimney at roofline (photo credit: Exponent).

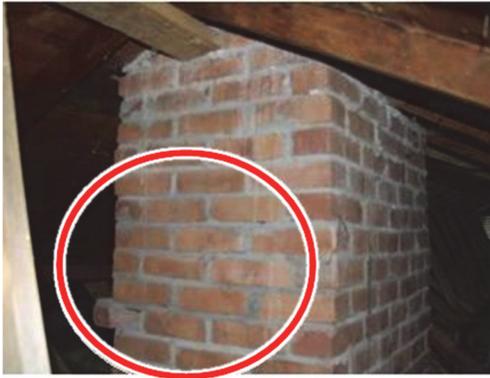
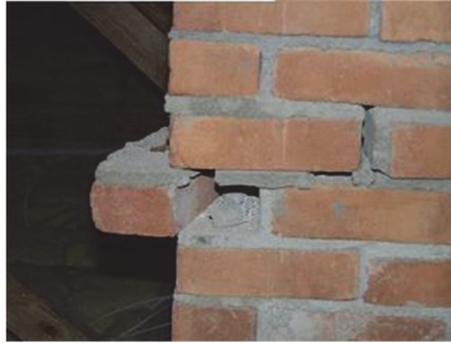
Figure 7-19 Earthquake-induced damage to masonry chimney in attic (photo credit: Exponent).

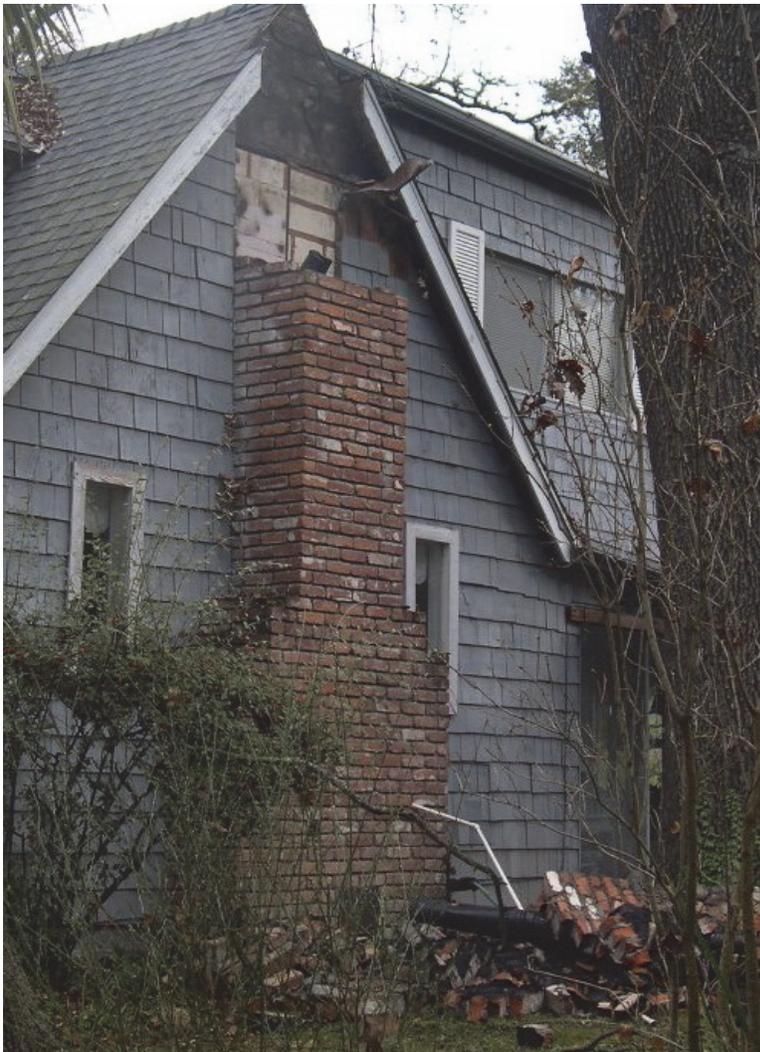
Figure 7-20 Earthquake-induced failure of masonry chimney at gable (photo credit: Exponent).

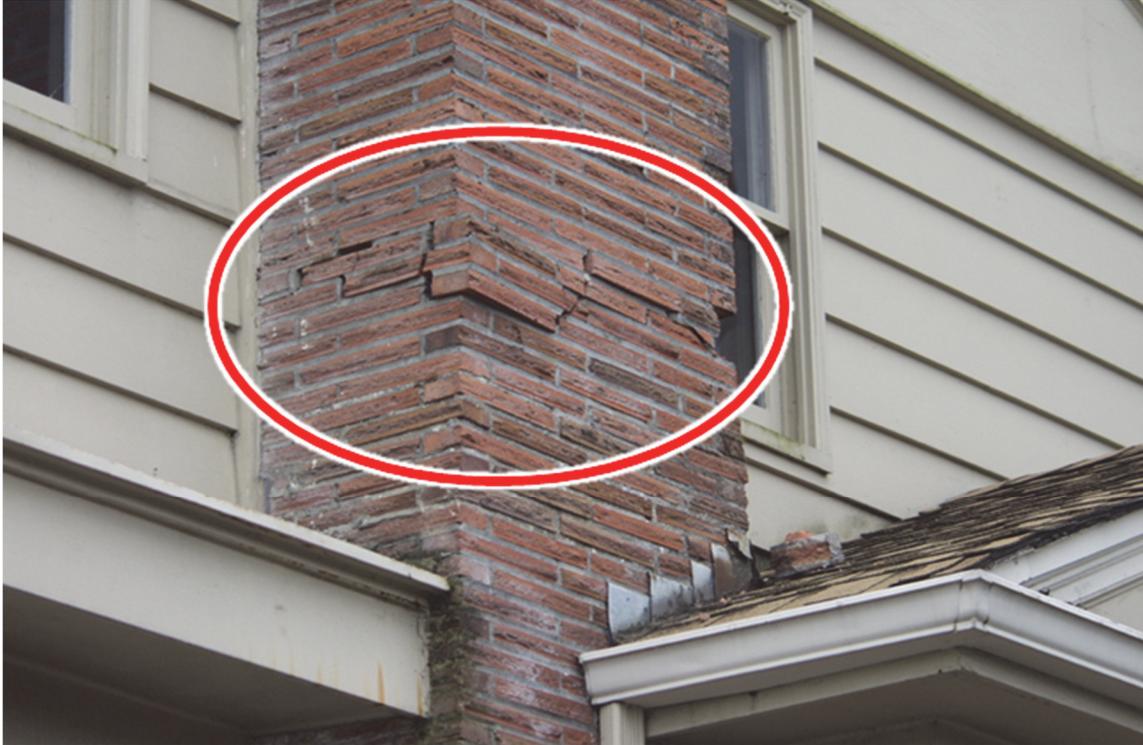
Figure 7-21 Earthquake-induced damage to masonry chimney at mid-story (photo credit: Exponent).

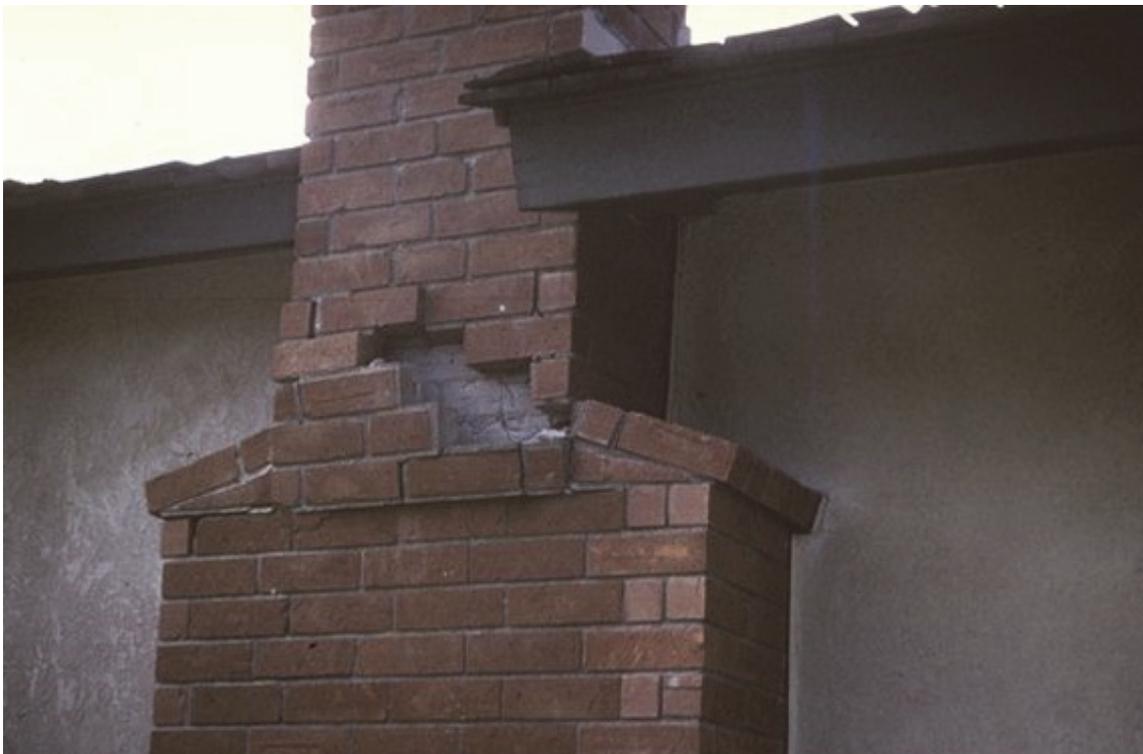
Figure 7-22 Earthquake-induced damage to masonry chimney at shoulder (photo credit: F. Lewis, NISEE e-Library).

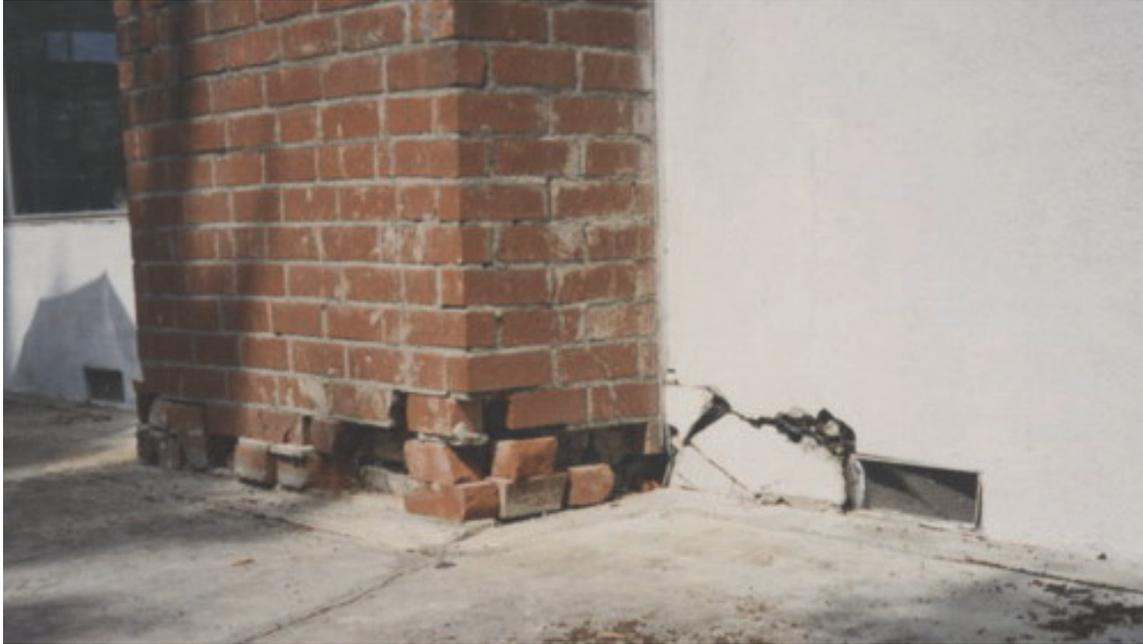
Figure 7-23 Earthquake-induced damage to masonry fireplace at foundation level (photo credit: Exponent).

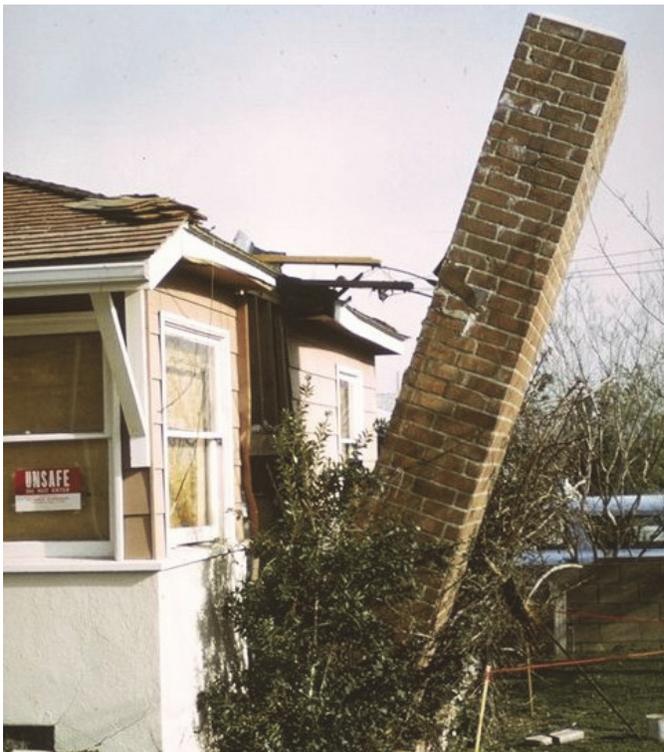
Figure 7-24 Earthquake-induced masonry chimney and fireplace that have tilted away from the house. The chimney tore loose the wood framing to which steel tie straps from the chimney were attached (photo credit: L. S. Cluff, NISEE e-Library).

Chimneys constructed along an exterior wall have a tendency to pull away from the building, either creating a gap between the chimney and building or completely overturning. Unreinforced chimneys tend to break into smaller sections (Figure 7-29), whereas reinforced chimneys generally hold together and move or overturn about the base as a single unit (Figure 7-24).

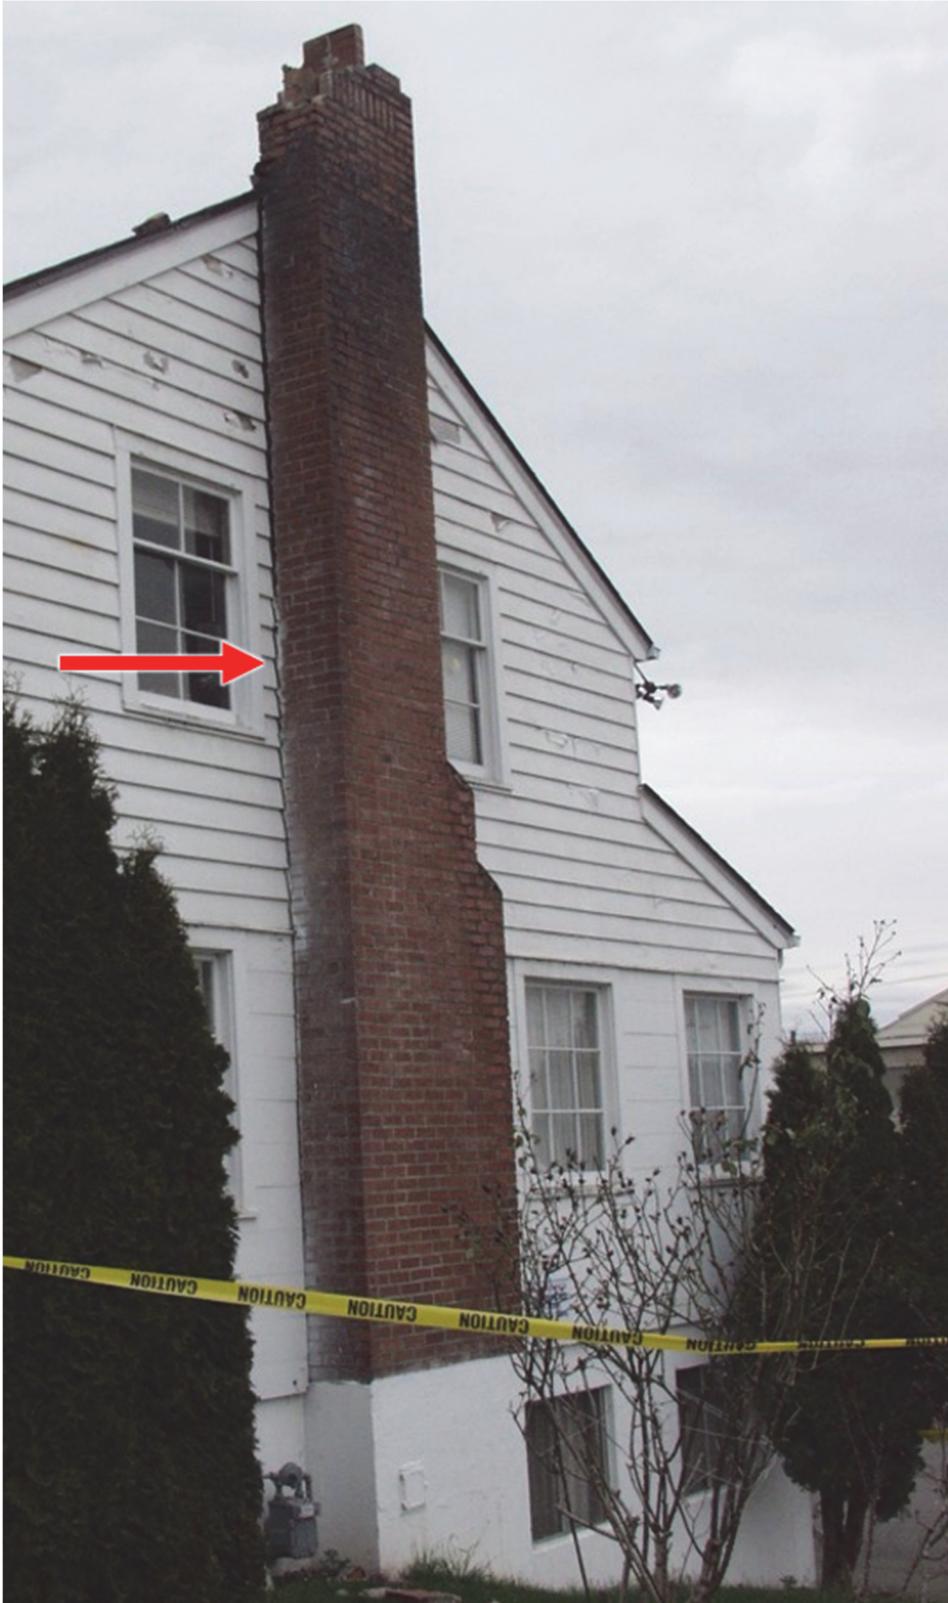
Figure 7-25 Earthquake-induced tapered separation between masonry chimney and exterior wall. There is also damage to the top of the chimney due to deterioration of mortar (photo credit: Exponent).

A masonry chimney located on an exterior wall may exhibit a separation along the vertical joint between the chimney and building, which grows in width towards the top of the chimney (Figure 7-25). This separation may be earthquake-induced because masonry chimneys are essentially independent structures and are constructed on their own foundations. This separation can also be caused by long-term differential settlement of the chimney foundation relative to the building's foundation. If a separation is observed, close examination of the joint between the chimney and building is required to better assess the cause. If there are one or more generations of intact sealant between these two elements, it is clear that the earthquake was not the cause. If this gap is open or a failed sealant is observed, additional investigation is necessary to determine the nature and extent of any damage to the chimney or attached framing. A fresh, unweathered appearance to this gap may indicate that the separation resulted from the earthquake. This conclusion should, if possible, be verified at the chimney flashing. By contrast, the accumulation of dust, debris, cobwebs, or paint in an open joint indicates that long-term foundation settlement is the more likely cause.

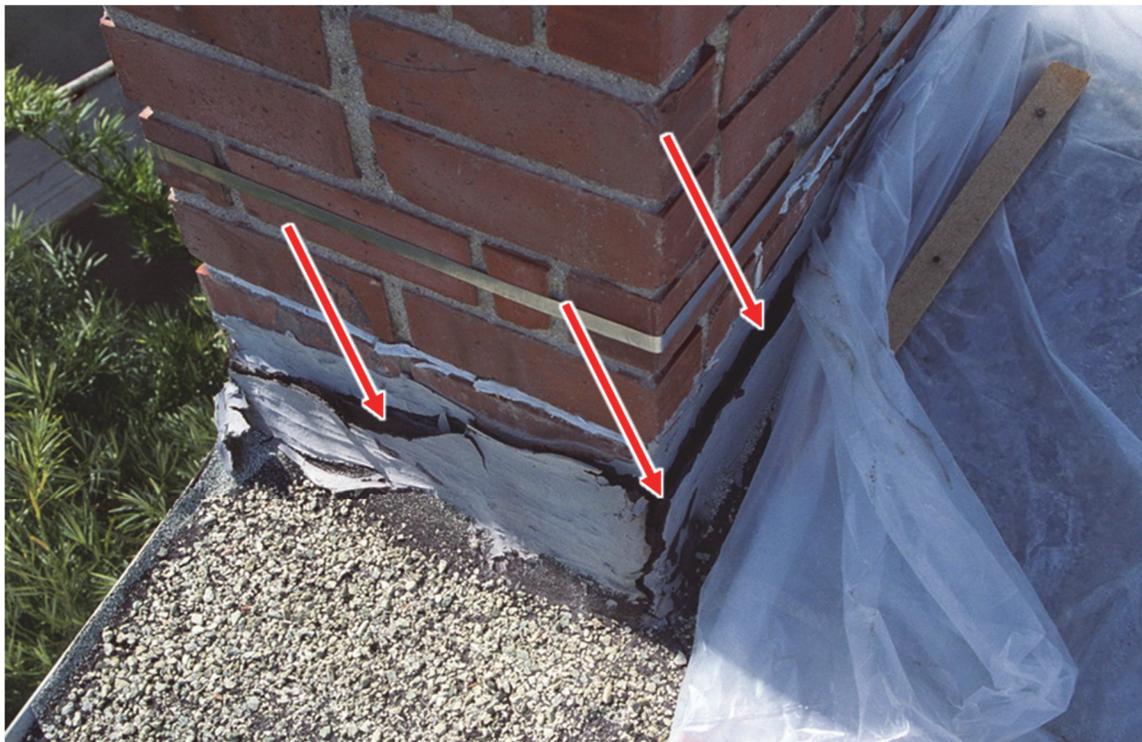
Figure 7-27 Tearing of flashing between chimney and roof caused by relative movement between chimney and building during earthquake (photo credit: Exponent).

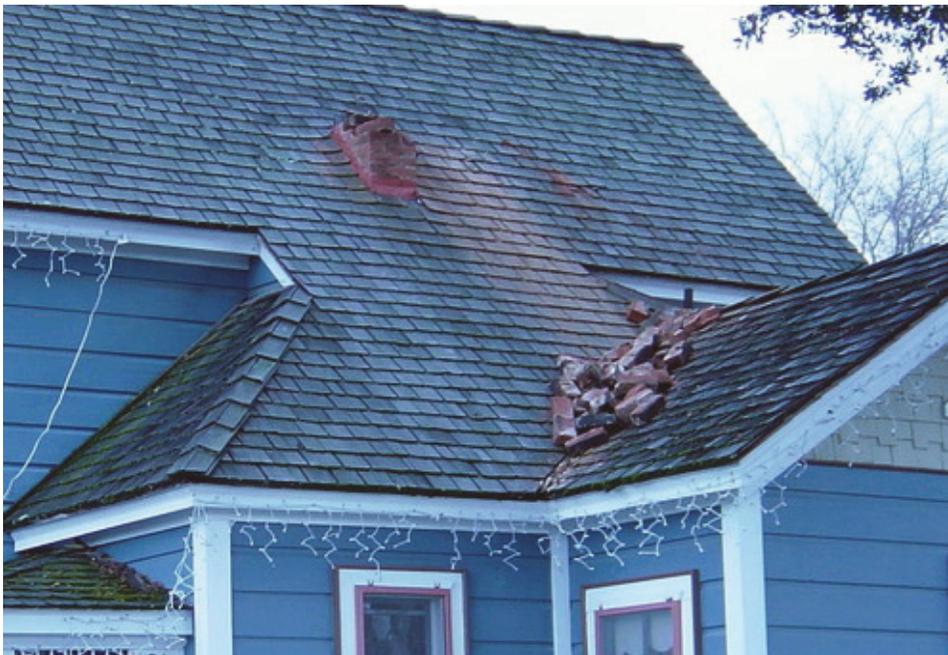
Figure 7-28 Rooftop debris from collapse of masonry chimney during earthquake (photo credit: D. Dyce).

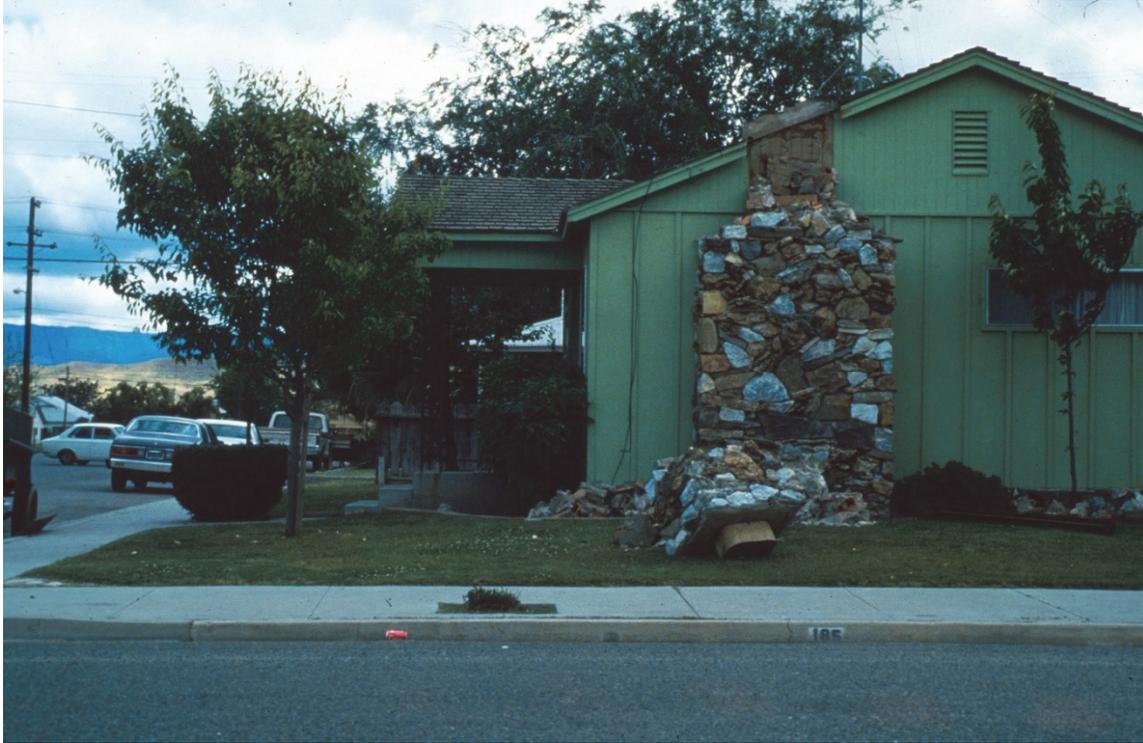
Figure 7-29 Collapsed unreinforced stone chimney caused by earthquake (photo credit: M. G. Hopper, USGS Denver Library Photographic Collection).

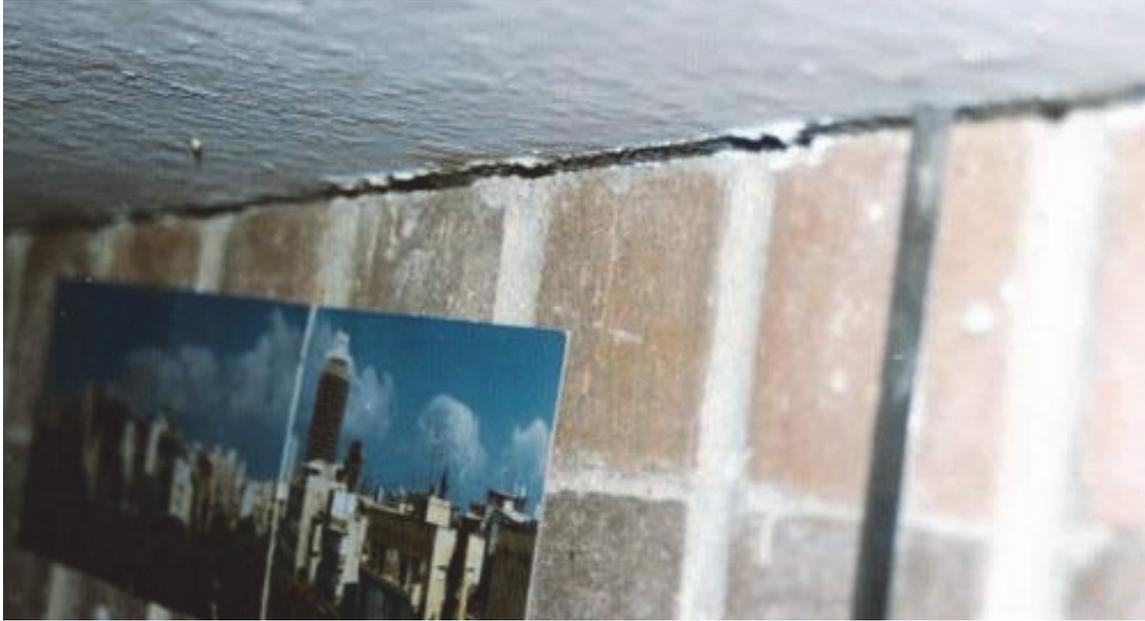
Figure 7-30 Masonry mantle that separated slightly from the wall finish during earthquake (photo credit: Exponent).

Interior masonry facings (e.g., hearth, mantel) are often not well secured. Consequently, they can pull away from the wall (Figure 7-30) or collapse (Figure 7-31). Hairline cracks at the intersection between the facing and wall finishes, or the intersection between the facing and the firebox, should not be mistaken for earthquake-related damage.

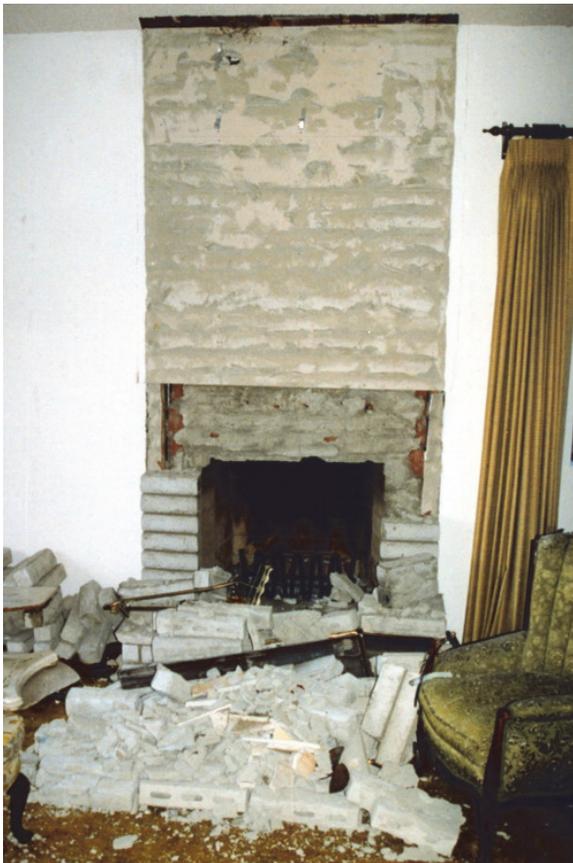
Figure 7-31 Collapsed masonry facing caused by earthquake (photo credit: Exponent).

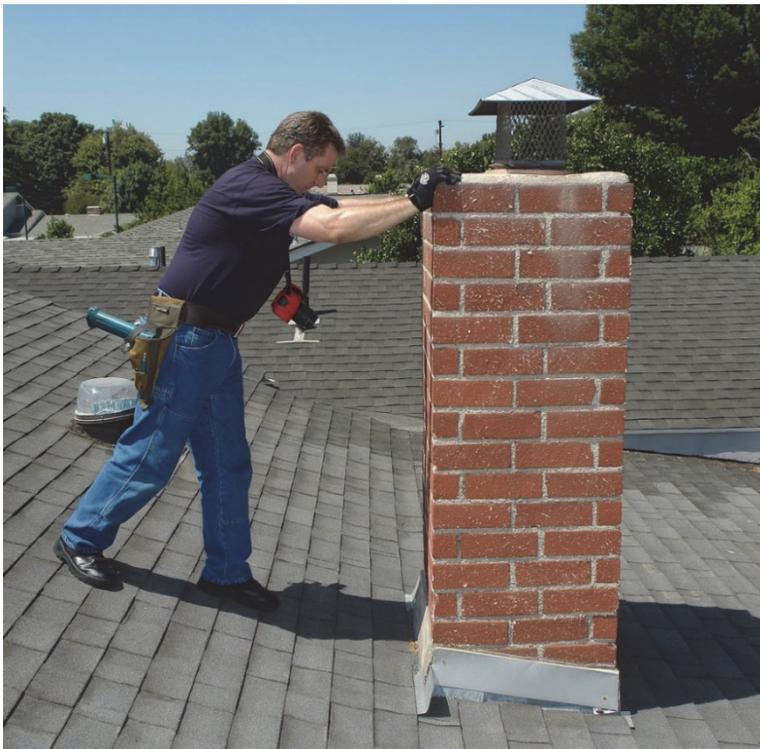
Figure 7-32 Illustration of rocking procedure for checking chimney for earthquake-induced cracking (photo credit: Exponent).

For unreinforced masonry chimneys that do not exhibit visible damage from the roof, attempt to rock the top of the chimney (from all four sides, if possible) by firmly pushing it, as shown in Figure 7-32. This task should be performed with extreme caution. Ensure that no harm from any falling masonry will occur before commencing. This inspection may require another person to look for a separation that opens during pushing; although, an experienced inspector can detect cracking by the “feel” of the chimney’s response to rocking. There is a distinctly different feel when pushing a cracked chimney—the chimney will rock slightly if damaged, but a chimney that is not cracked will feel quite solid and will not rock. This procedure should not be performed on any chimneys with lime mortars or severe weathering due to their extremely poor bond strength. Perform a screwdriver test to check for weak lime mortar or deterioration of Portland-cement mortar.

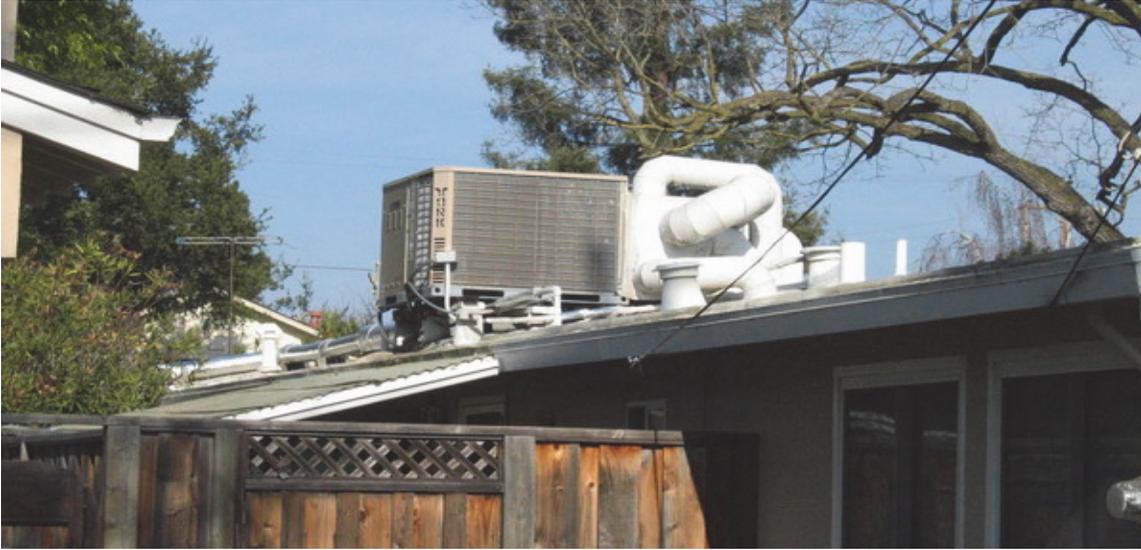
Figure 8-1 Undamaged rooftop HVAC unit (photo credit: Exponent).

Typical residential MEP systems consist of one or more heating and air conditioning systems (Figure 8-1); electrical service and branch circuits to which plumbing or mechanical equipment may be hard wired; low voltage wiring for phones and alarm systems; coaxial cable TV wiring; built-in appliances; plumbing fixtures; water and gas supply lines; and sewer lines.
