Earthquake Damage Assessment and Repair Guidelines for Residential Wood-Frame Buildings

Volume 1 | GENERAL GUIDELINES

CEA-EDA-01 2020

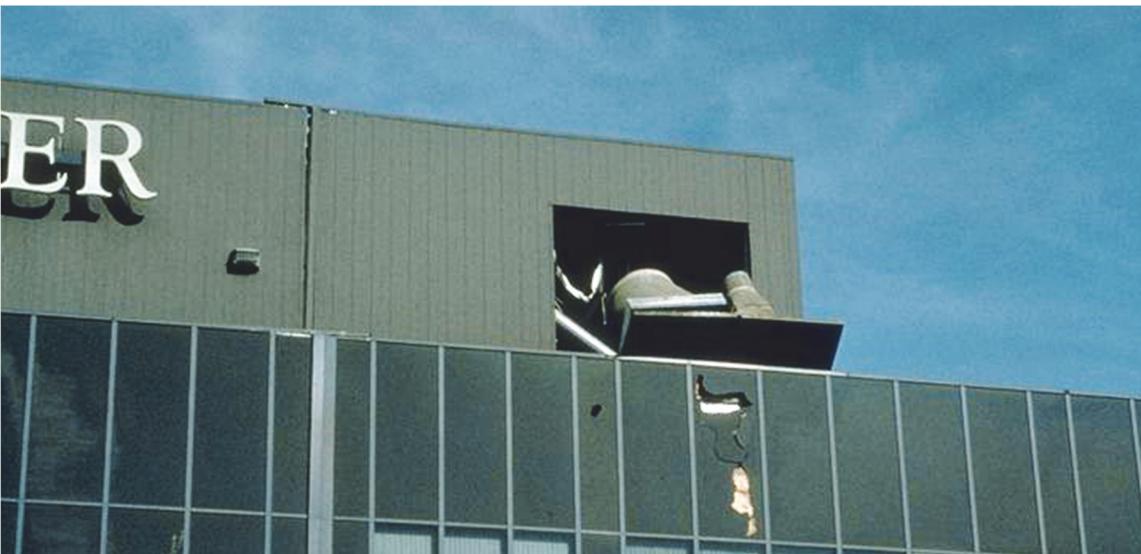
Figure 8-2 Earthquake-caused damage to rooftop HVAC unit (photo credit: R. K. Reitherman, NISEE e-Library).

- large, heavy pieces of equipment (e.g., water heaters, propane tanks, fuel tanks) are not properly restrained, as shown in Figure 8-2 and Figure 8-3,
- rigid water, gas, refrigerant, electrical, or other connections to equipment do not allow relative motion between the equipment and the building,
- significant displacement occurs at penetrations of partitions or slabs resulting in breakage of pipes or conduits, or
- permanent earthquake-induced ground displacement ruptures buried utility lines.

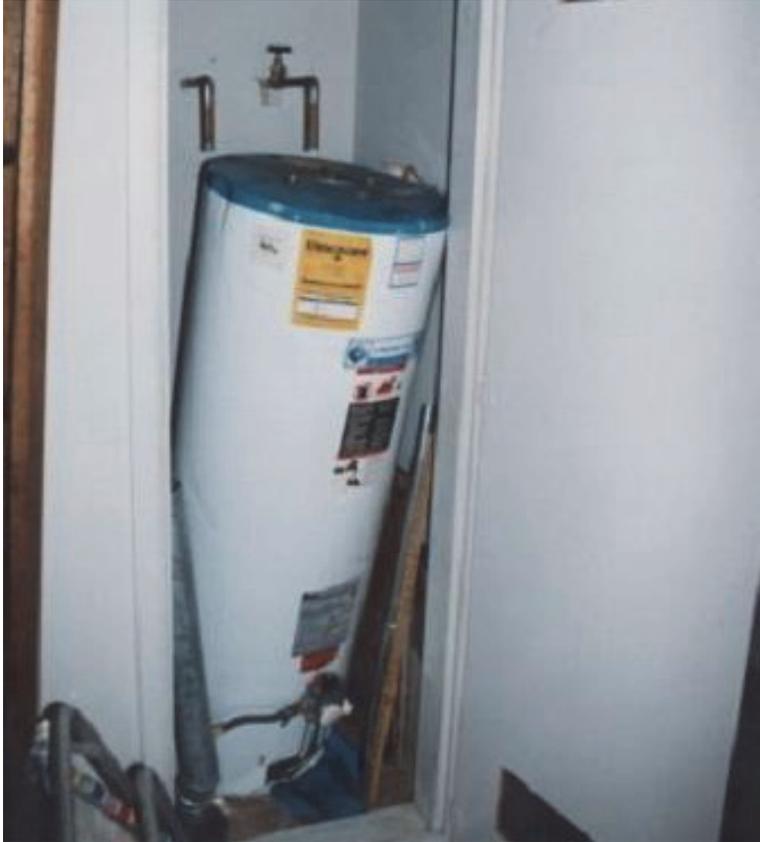
Figure 8-3 Earthquake-caused displacement of unsecured water heater (photo credit: Exponent).

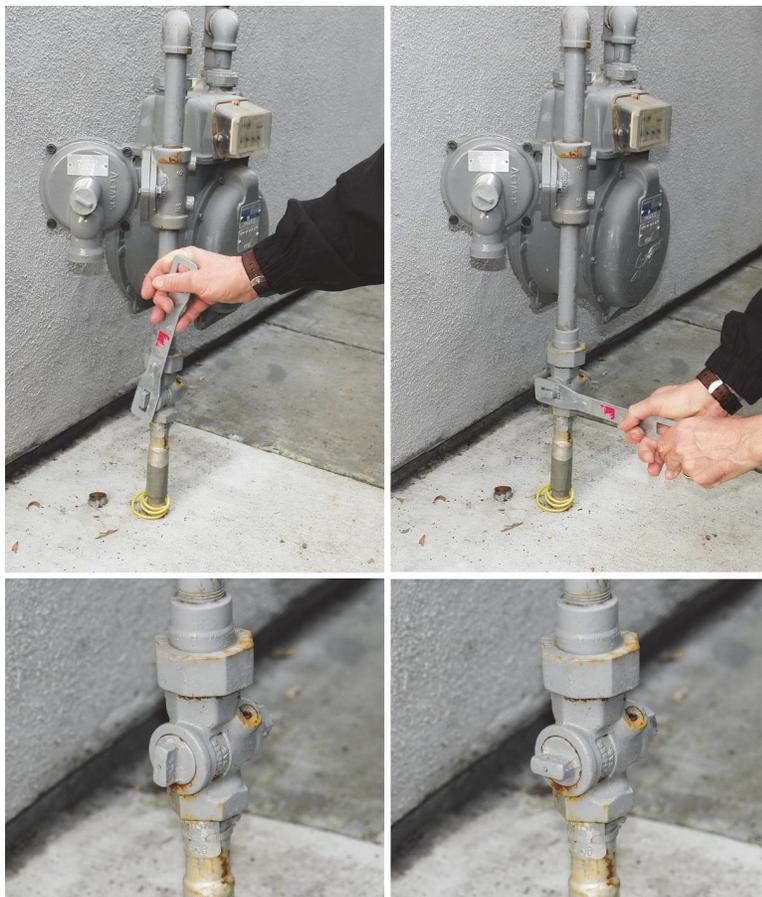
Figure 8-4 Manual gas shut-off valve, where photos on the right show the valve closed (photo credit: Exponent).

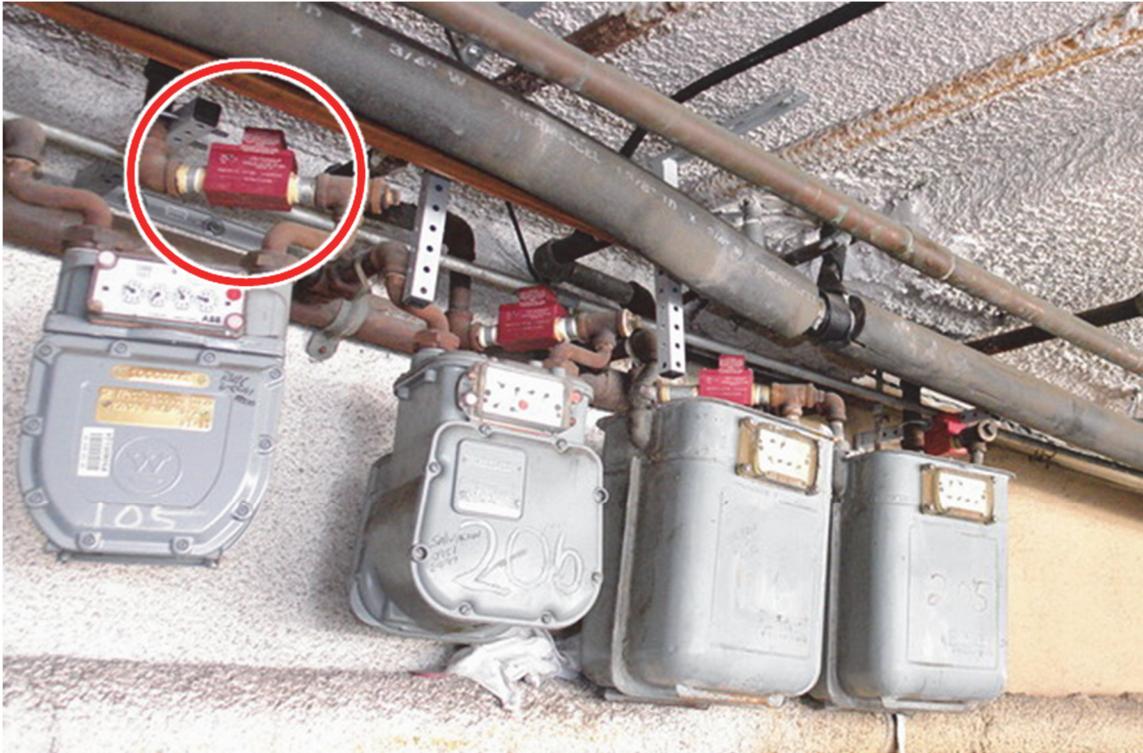
Figure 8-5 Gas meters with seismic shut-off valves (photo credit: Exponent).

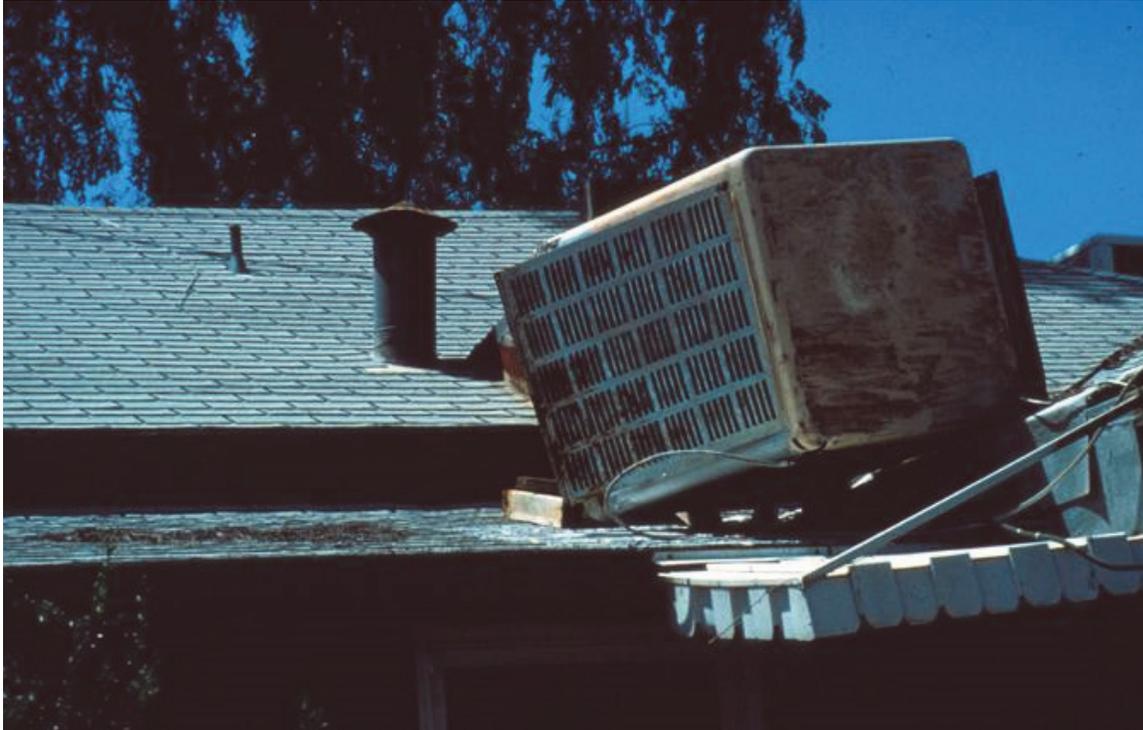
Figure 8-6 Toppled “swamp cooler” due to earthquake (photo credit: Exponent).

Evaporative cooling units (i.e., “swamp coolers”) are common in areas of dry heat (Figure 8-6). These units use evaporation of a water mist to cool incoming air and consist of a large housing, filter media, and a large blower. The units are generally mounted on the roof and connected to the living space via direct ducting.

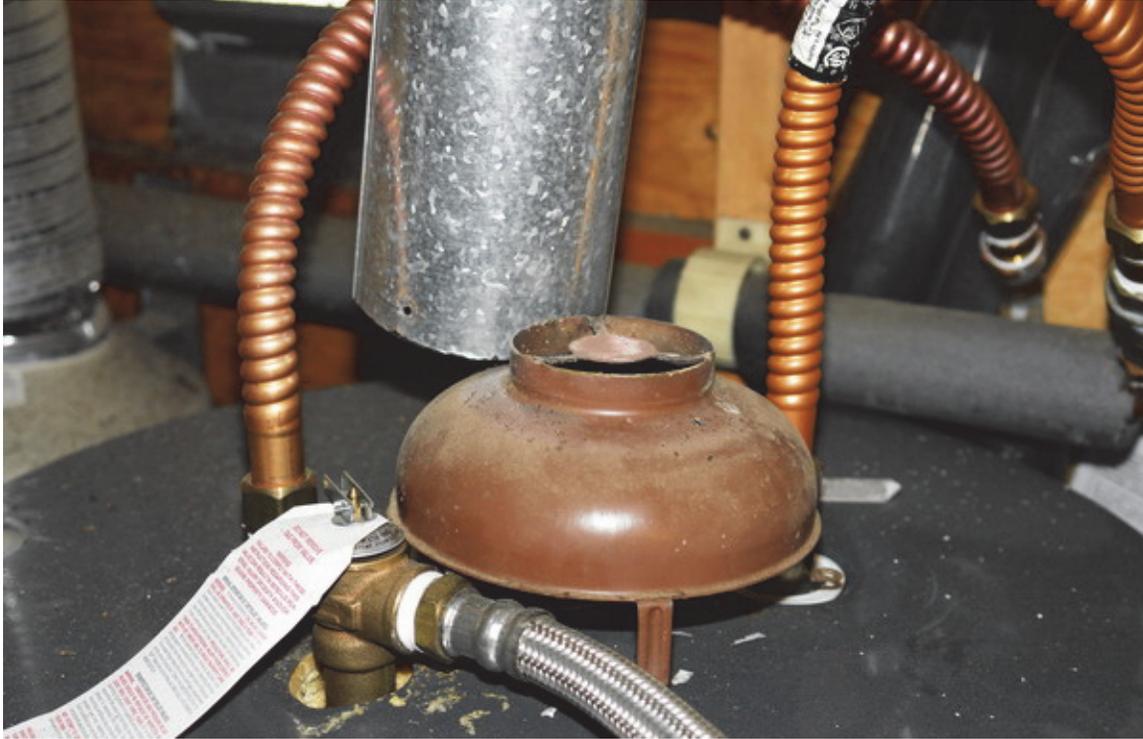
Figure 8-7 Earthquake-caused displacement of unsecured water heater vent (photo credit: Exponent).

- Rocking or toppling of water heaters, resulting in damage ranging from dislodged vent piping (Figure 8-7) to breakage of water piping connections and destruction of the water heater. While most water heaters in California are now required by code to be “strapped” (Figure 8-8) to reduce the chances of toppling, many of those straps are not sufficient to prevent damaging movements of the water heater during strong shaking. Newer water heaters are also connected to the house piping with flexible tubing (Figure 8-9) that will accommodate minor differential movement of the water heater without failure of the connections. Older installations may be hard piped (Figure 8-10) and are thus much more susceptible to development of leaks in the connecting piping under minor differential movement. Older water heaters (those near the ends of their service lives) may develop leaks due to thermal and pressure cycling as a result of the loss and resumption of water pressure and gas supply following an earthquake.

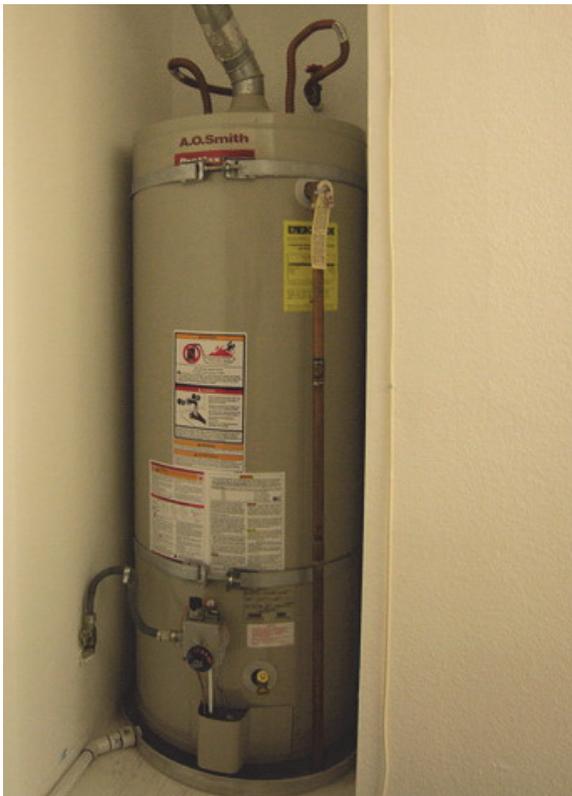
Figure 8-8 Undamaged water heater with flexible piping and strapping (photo credit: Exponent).

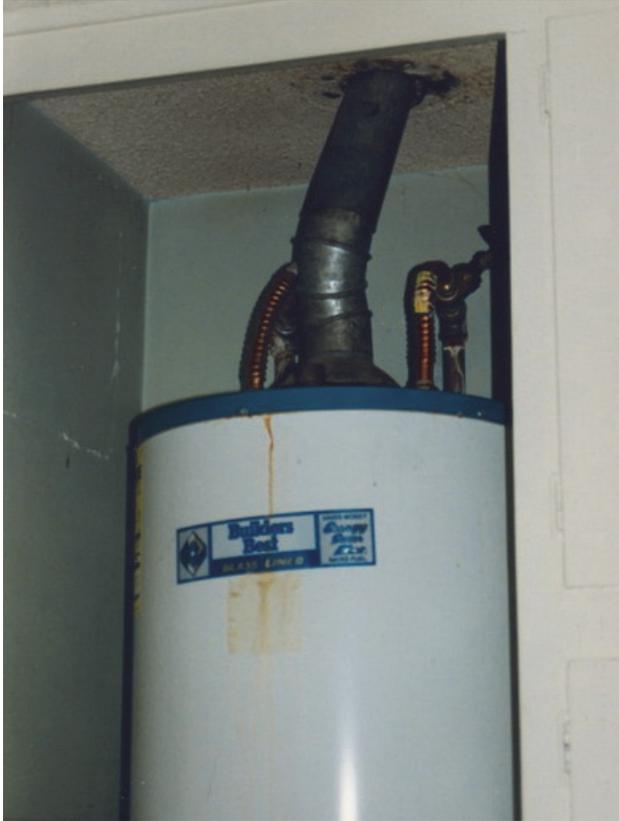
Figure 8-9 Undamaged flexible piping between unsecured water heater and house piping (photo credit: Exponent).

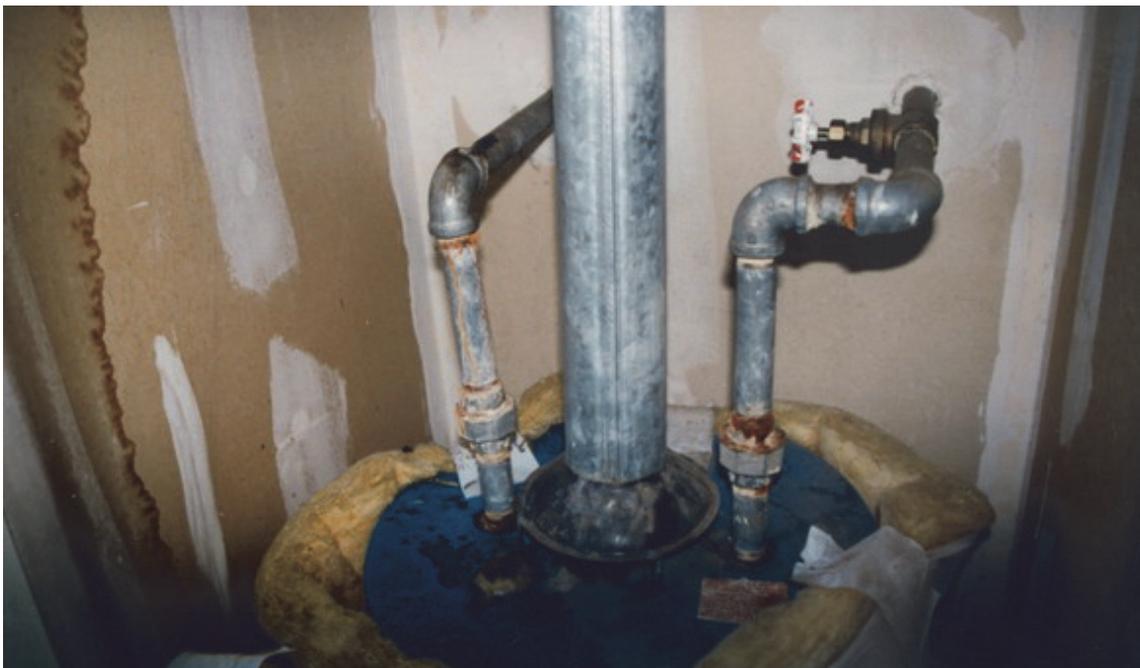
Figure 8-10 Undamaged water heater with hard piping (photo credit: Exponent).

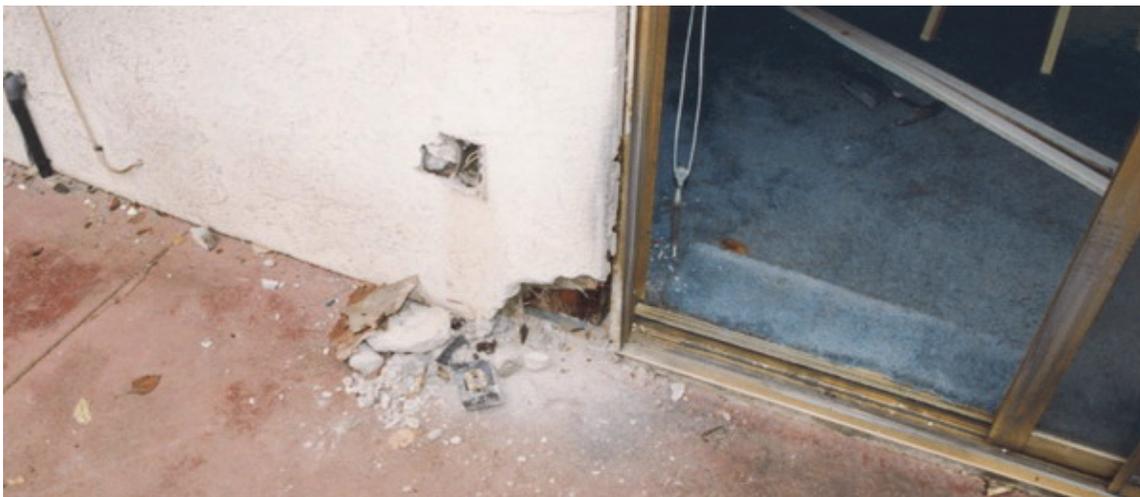
Figure 8-11 Earthquake-caused racking and delamination of exterior stucco resulting in damage to electrical outlet (photo credit: Exponent).

- Damage to electrical wiring and fixtures caused by serious structural damage or collapse, as illustrated in Figure 8-11 and Figure 8-12.
- Failure of connections due to shifting or toppling of hard-wired fixed equipment, such as furnaces, air conditioners, and electric water heaters.
- Damage to hanging fixtures, such as chandeliers or ceiling fans, due to impact with walls or ceilings from earthquake-induced swaying.
- Short circuit of damaged electrical fixtures when electricity remains on or is eventually restored, possibly resulting in fire.

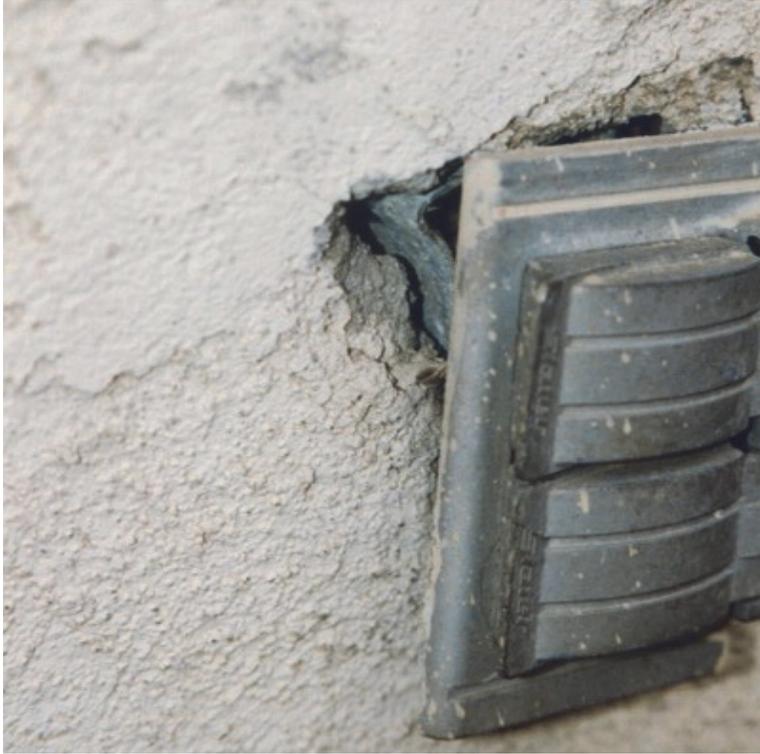
Figure 8-12 Close-up of earthquake damage to electrical outlet box (photo credit: Exponent).
