Earthquake Damage Assessment and Repair Guidelines for Residential Wood-Frame Buildings

Volume 2 | ENGINEERING GUIDELINES

CEA-EDA-02 2020

Earthquake Damage Assessment and Repair Guidelines for Residential Wood-Frame Buildings, Volume 2 – Engineering Guidelines

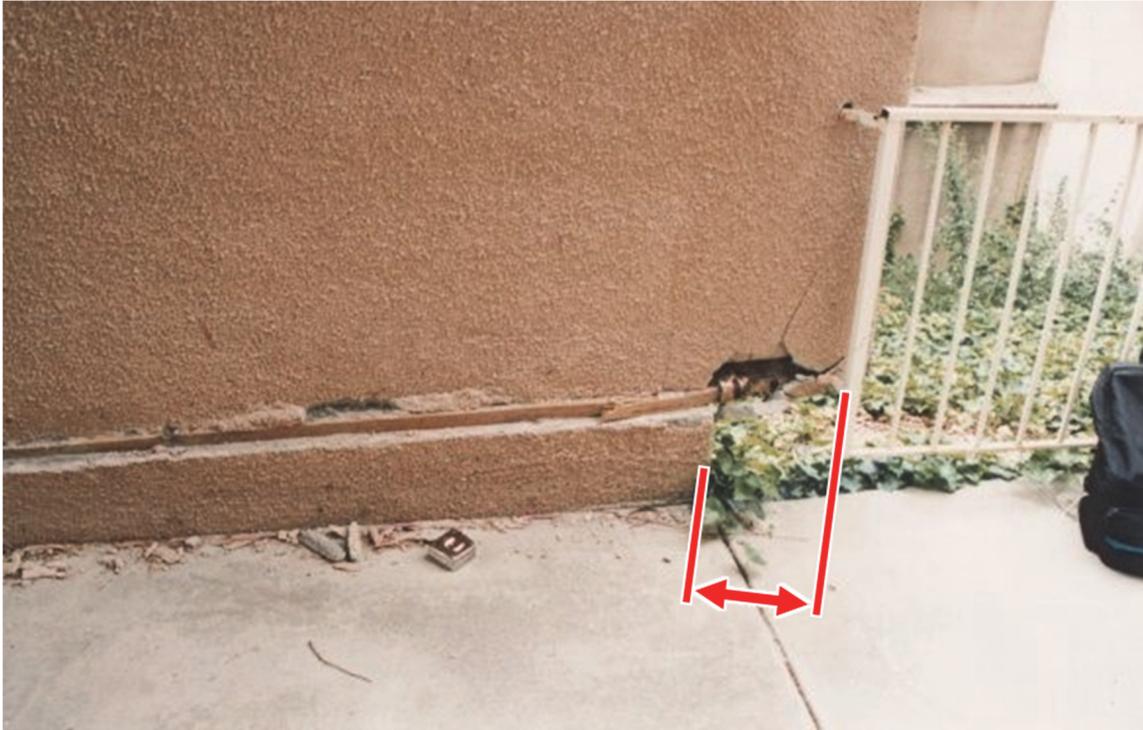
Figure 2-1 Earthquake-caused sliding of superstructure at foundation. The wall has shifted to the right several inches relative to the foundation, stucco wall finishes have cracked and spalled along the sill plate, and the sill plate is fractured near the right end of the wall (photo credit: Exponent).

Figure 2-1 shows substantial sliding, readily observed, with fracture of the sill plate and conspicuous damage to the wall finishes along the sill plate. Figure 2-2 shows less obvious sliding, initially noticed only because of inoperable doors within the affected wall line.

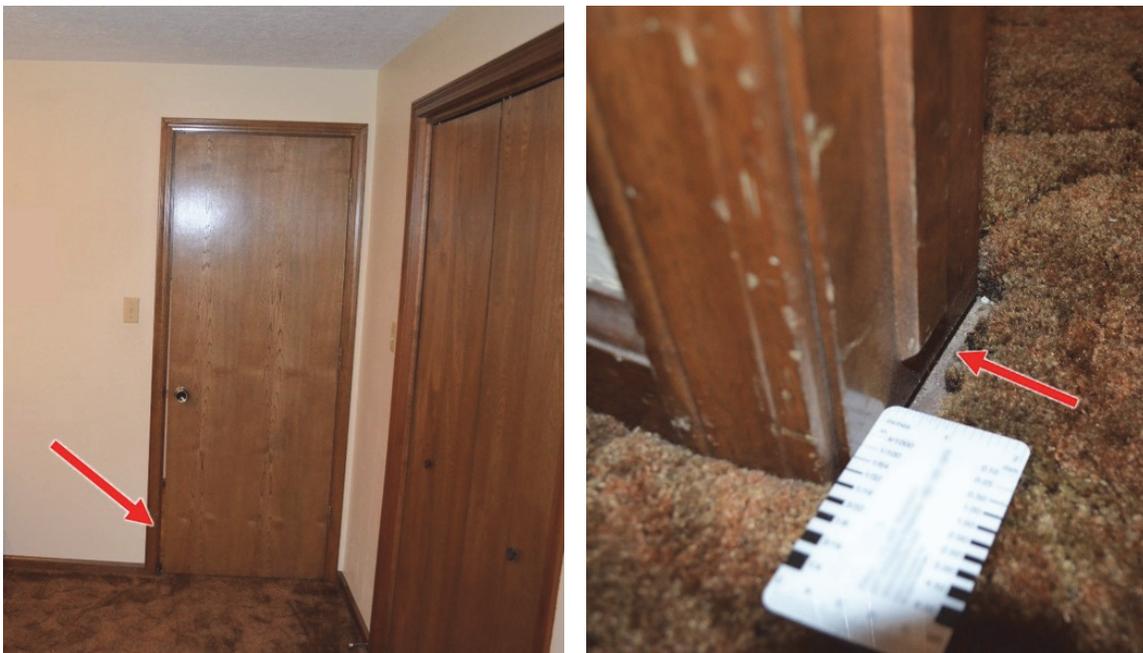
Figure 2-2 Earthquake-caused sliding of superstructure at floor slab. The wall has shifted less than 1 inch to the left, as evidenced in the left photo by the tapered gap between the left side of the door and doorjamb and in the right photo by the gap between the carpet and doorjamb (photo credit: Exponent).

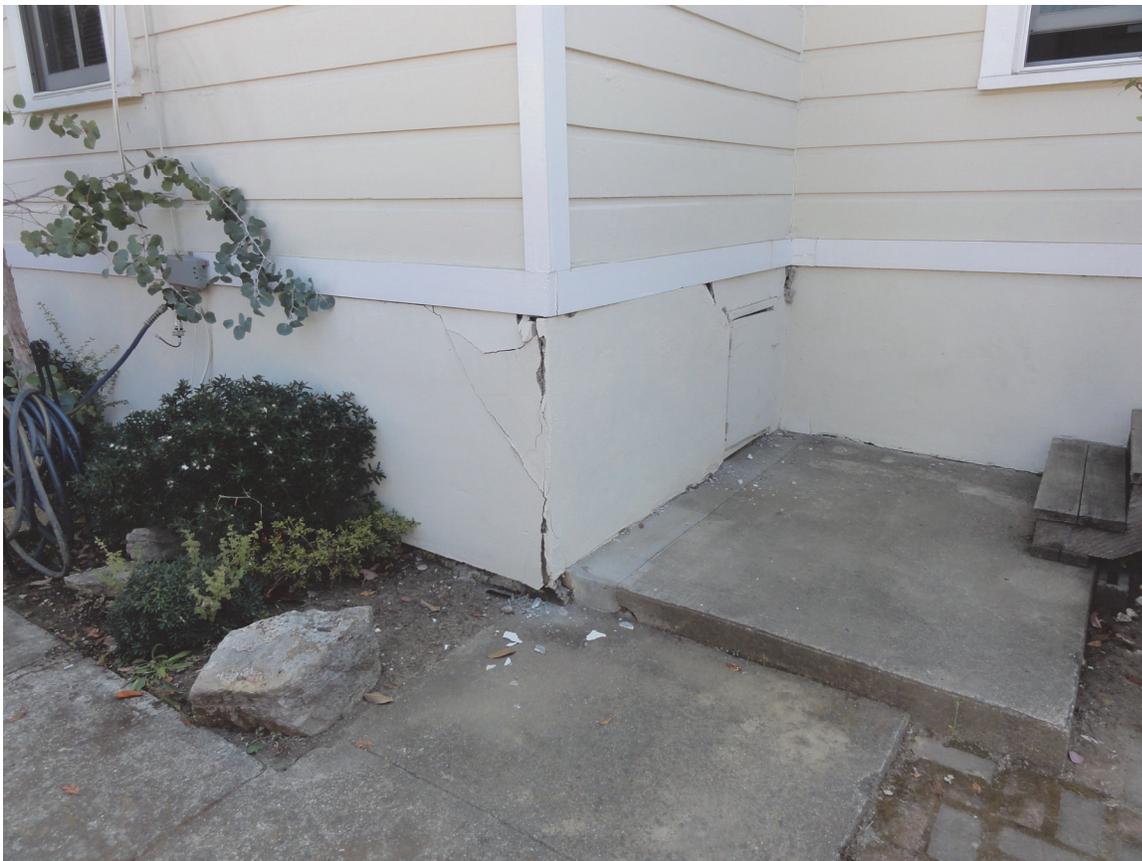
Figure 2-3 Damage to cripple wall finishes caused by the 2014 South Napa, California earthquake (photo credit: Exponent).

Where a cripple wall is inadequately braced, permanent drift over the height of the cripple wall is a common (and costly) earthquake damage mechanism. Where the drift is moderate, it is typically associated with damage to the wall finishes that provide nominal strength and stiffness to an otherwise unbraced cripple wall (Figure 2-3), damage to the cripple wall framing, and damage to connections between the cripple wall and the wall or floor framing above. If the in-plane cripple wall drift in one direction becomes large, the cripple walls in the other direction will lean out of plane and be prone to collapse (Figure 2-4). In addition to structural damage, large cripple wall drift or collapse can damage mechanical, electrical, and plumbing (MEP) components commonly located in the crawlspace. As discussed in references cited in Appendix B, adding plywood or oriented strand board (OSB) along the interior faces of cripple walls is a common retrofit measure to improve the earthquake performance of houses with respect to this earthquake vulnerability.

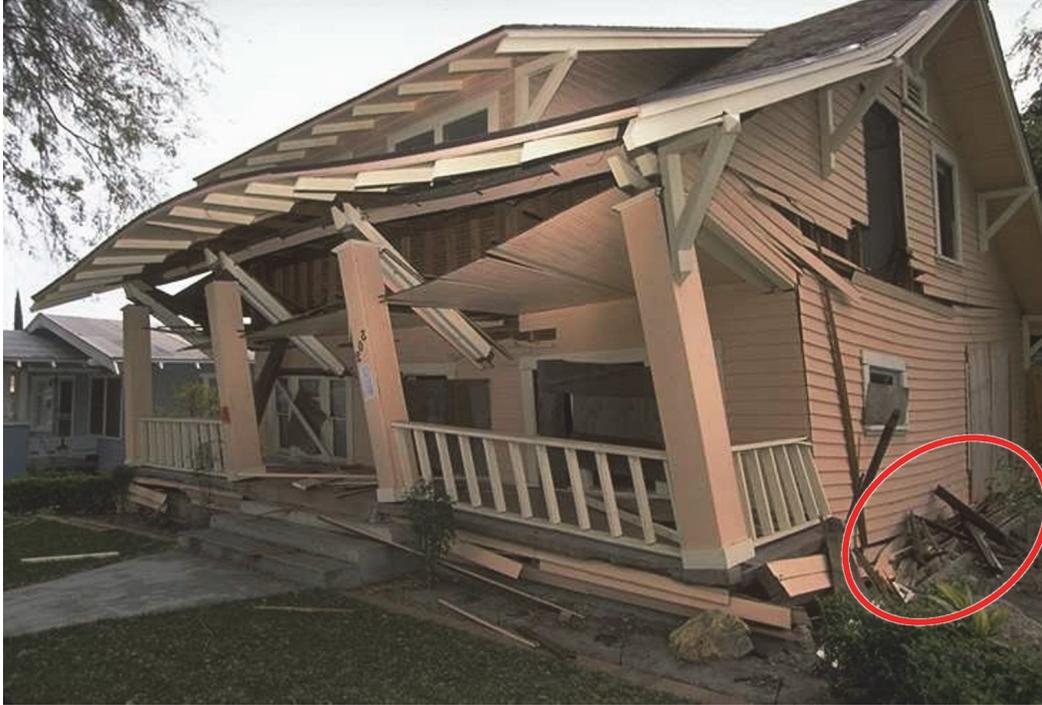
Figure 2-4 Cripple wall collapse caused by the 1994 Northridge, California earthquake resulting in widespread related damage in upper-story framing and relative movement between the main house and the covered porch (photo credit: Federal Emergency Management Agency, or FEMA).

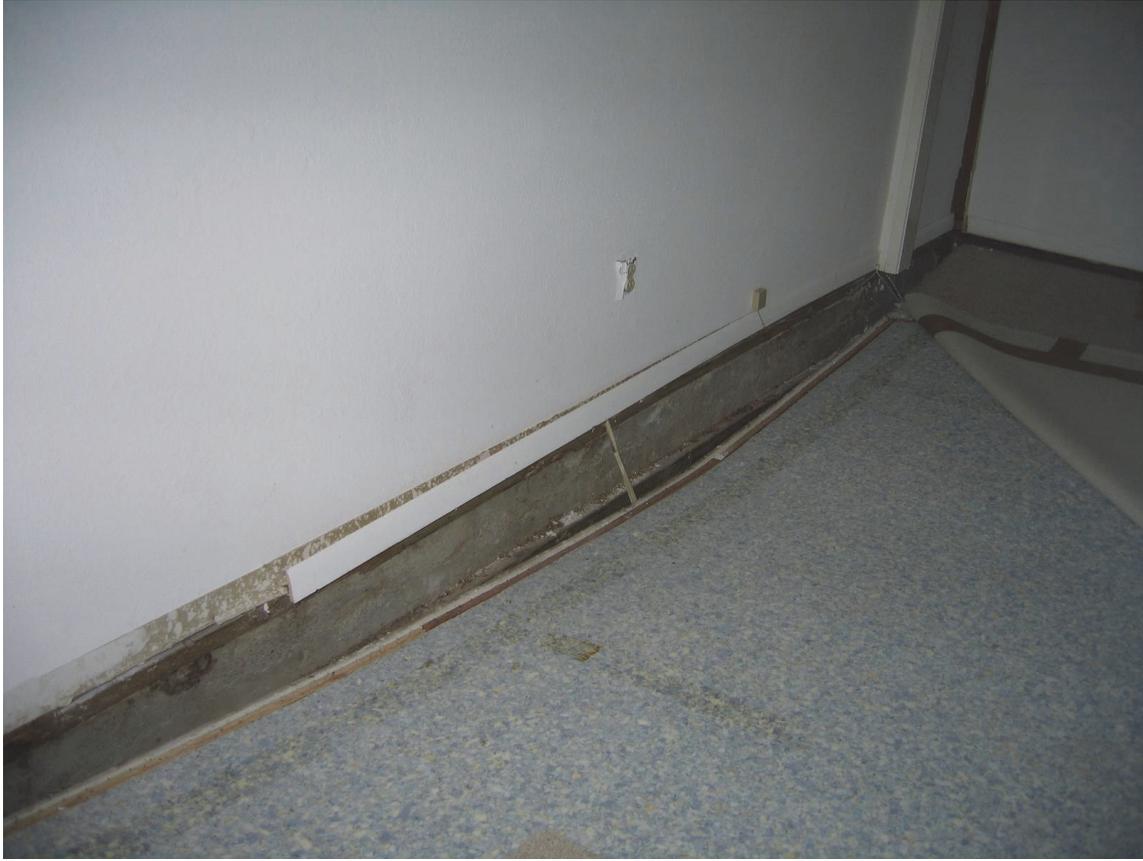
Figure 2-6 Damage at uphill end of a hillside house caused by the 2003 San Simeon, California earthquake. The floor framing detached and pulled away from the uphill foundation, causing the floor to sag (photo credit: Exponent).

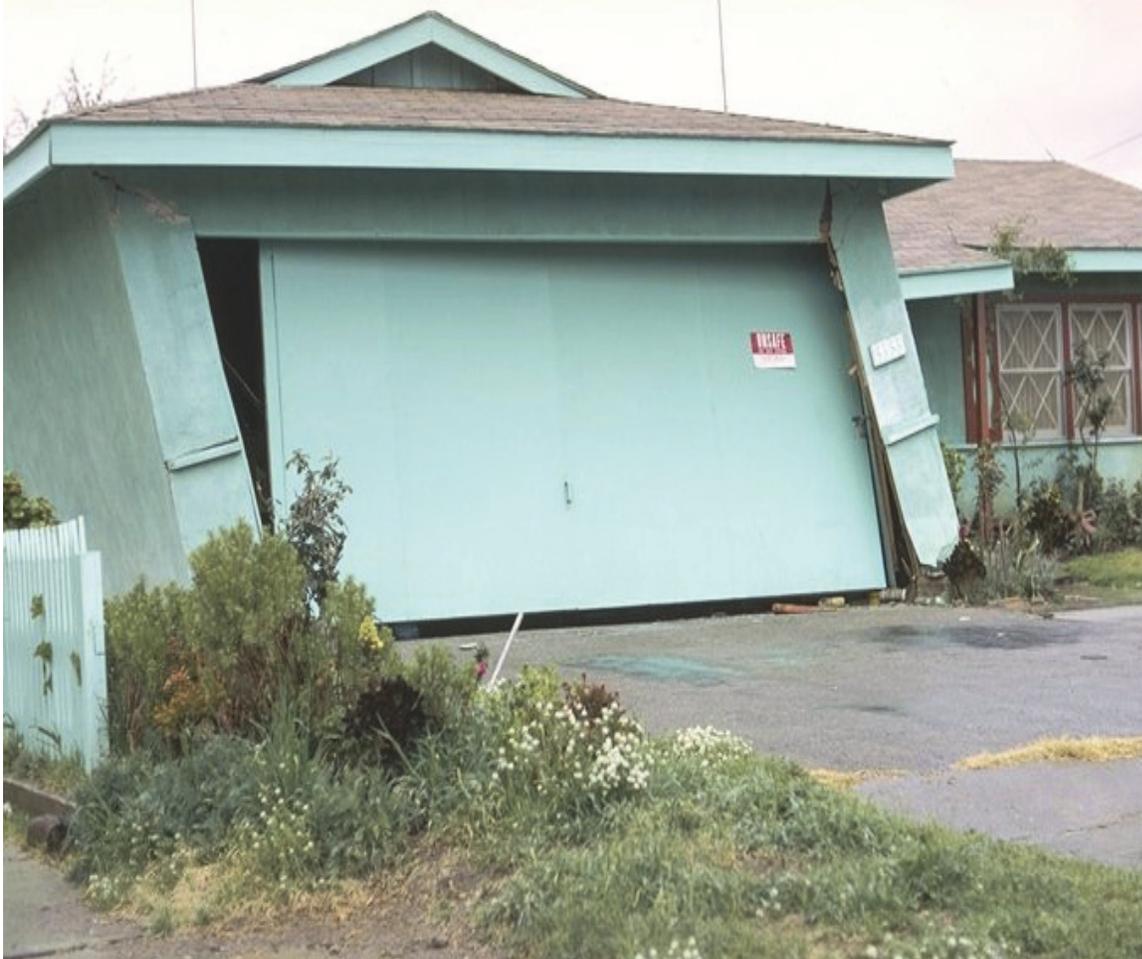
Figure 2-7 Large in-plane drift of narrow wall piers at garage door opening caused by the 1971 San Fernando, California earthquake (photo credit: National Information Service for Earthquake Engineering, or NISEE).

Where window and door openings leave only narrow wall segments to resist earthquake forces, wall lines can be prone to excessive in-plane drift (Figure 2-7) and possibly collapse. Where wider wall segments are not possible, newer houses avoid this vulnerability by using portal frame systems, proprietary engineered wall piers, or even structural steel elements. This mechanism can result in damage to wall pier finishes and sheathing, damage to wall pier framing, damage to connections at the tops and bottoms of wall piers, and inoperability of doors and windows within racked wall lines.

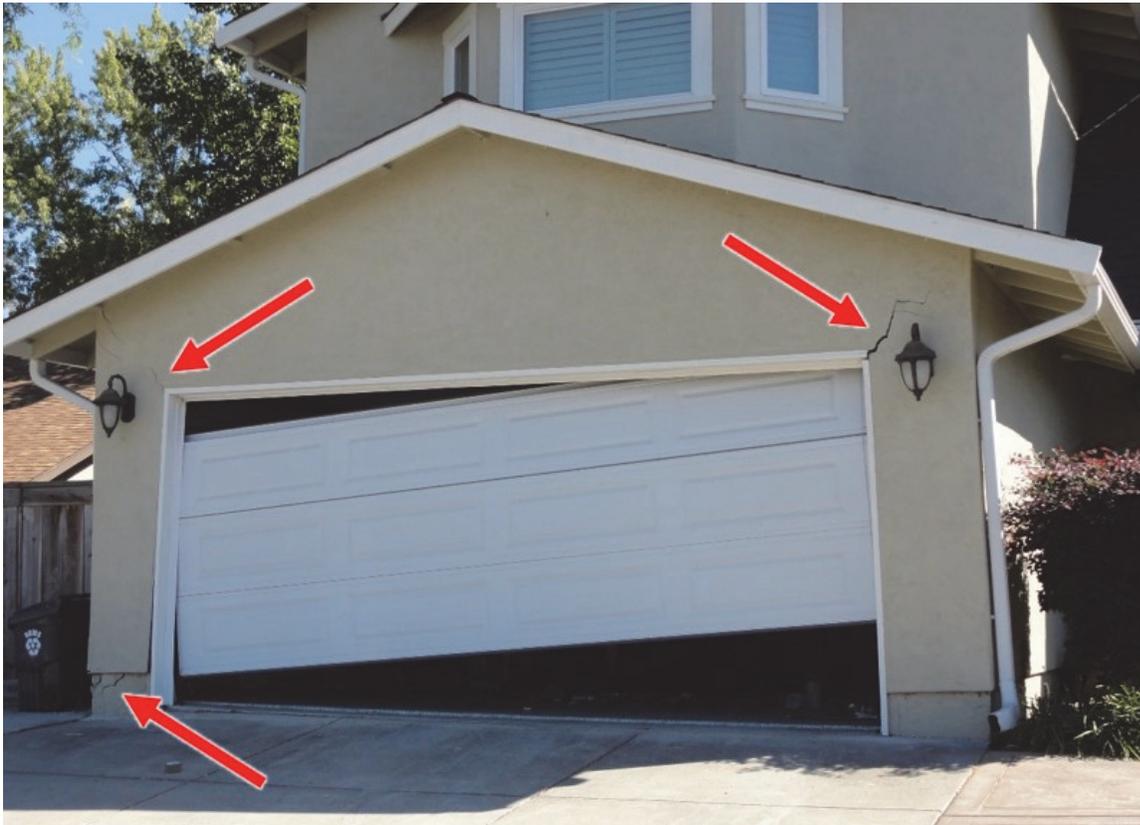
Figure 2-8 Damage related to living space over garage caused by the 2014 South Napa, California earthquake. In-plane racking of the front wall line of the garage caused cracking and possible framing damage in the narrow wall segments on either side of the garage door (photo credit: Exponent).

Multi-story houses with attached garages often have living spaces directly over relatively open garage areas. Where only narrow wall segments are provided on either side of a wide garage door, the additional weight of the upper story can make an already weak condition even more prone to excessive drift (Figure 2-8) and possibly collapse.

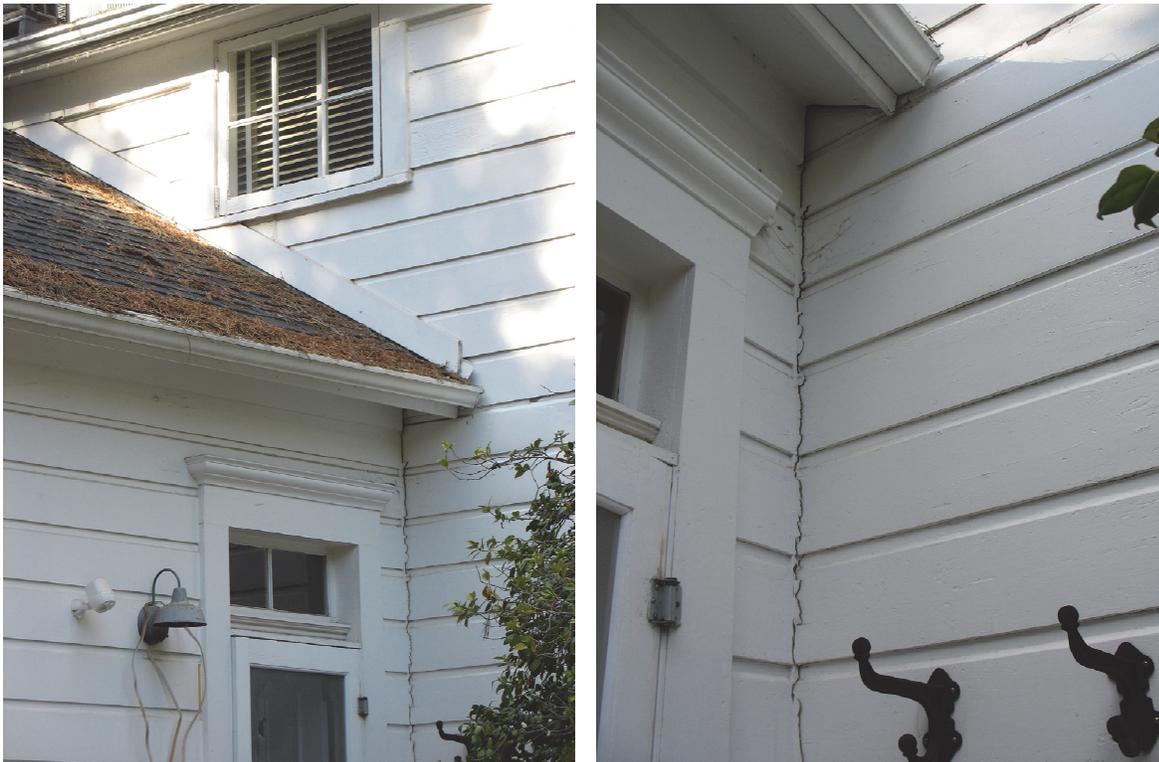
Figure 2-9 Left: Adjoining wings of a house create a framing discontinuity. Right: Separation of wood siding at intersection of adjoining wings caused by the 2014 South Napa, California earthquake. The separation was not structurally significant because there was no continuous framing or structural connection between the wings (photo credit: D. Bonowitz).

Earthquake damage is often concentrated where structural framing is discontinuous from one story to the next or between wings of a house in plan. Earthquake damage associated with these framing discontinuities includes concentrated damage to finishes, residual separations, and framing damage. In split-level houses, where the floor or roof framing is discontinuous between the one-story and two-story portions, differential movement and lack of effective connection between the portions can lead to damage. Where the common wall between the portions provides support for the lower-story floor or roof, the separation can result in local collapse. Where two wings of a house join, relative movement between the wings can lead to damage along the intersection (Figure 2-9).

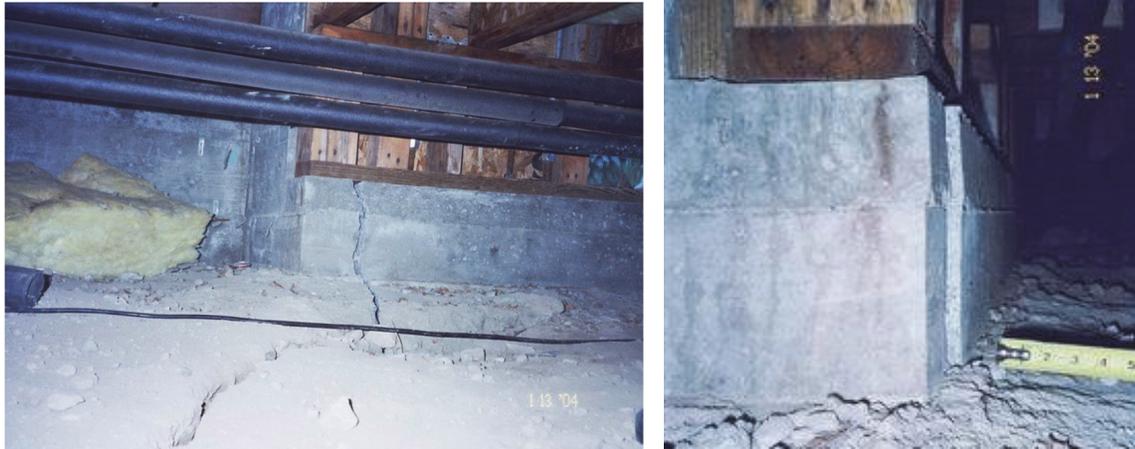
Figure 2-11 Cracking of concrete stemwall in-line with ground crack resulting from the 2003 San Simeon, California earthquake (left). The offset across the crack is revealed in the photograph on the right (photo credit: Exponent).

Earthquake damage to concrete footings and stemwalls is almost always caused by permanent ground deformation due to one or more of the mechanisms discussed in Chapter 5. This damage typically takes the form of fresh-appearing cracks with offsets (vertical or horizontal) (see Figure 2-11) or sloping across cracks and joints. In cases of significant ground deformation, a concrete stemwall may tilt or slope.

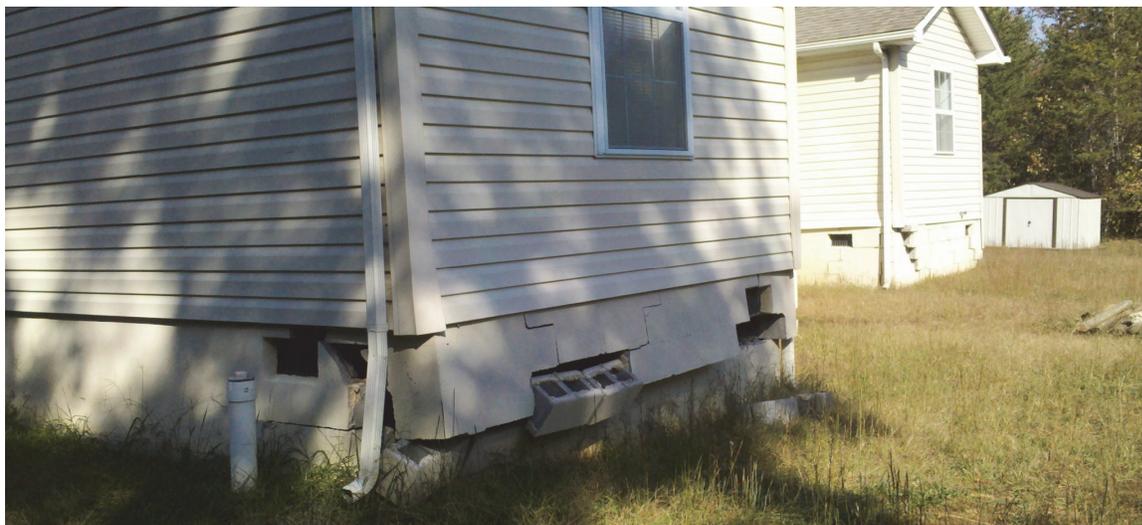
Figure 2-12 Damage of unreinforced, ungrouted masonry stemwalls caused by the 2011 Virginia earthquake (photo credit: M. Mahoney).

Continuous brick strip footings or brick stemwalls were used in older houses, and these foundations are almost never reinforced. Stemwalls constructed of concrete masonry units and supported by concrete footings are used in some newer houses and may or may not have grouted cells or steel reinforcing. Earthquake damage patterns for these foundation elements are similar to those of concrete footings and stemwalls, except that offsets between masonry units can occur, particularly in the case of unreinforced foundations (see Figure 2-12).

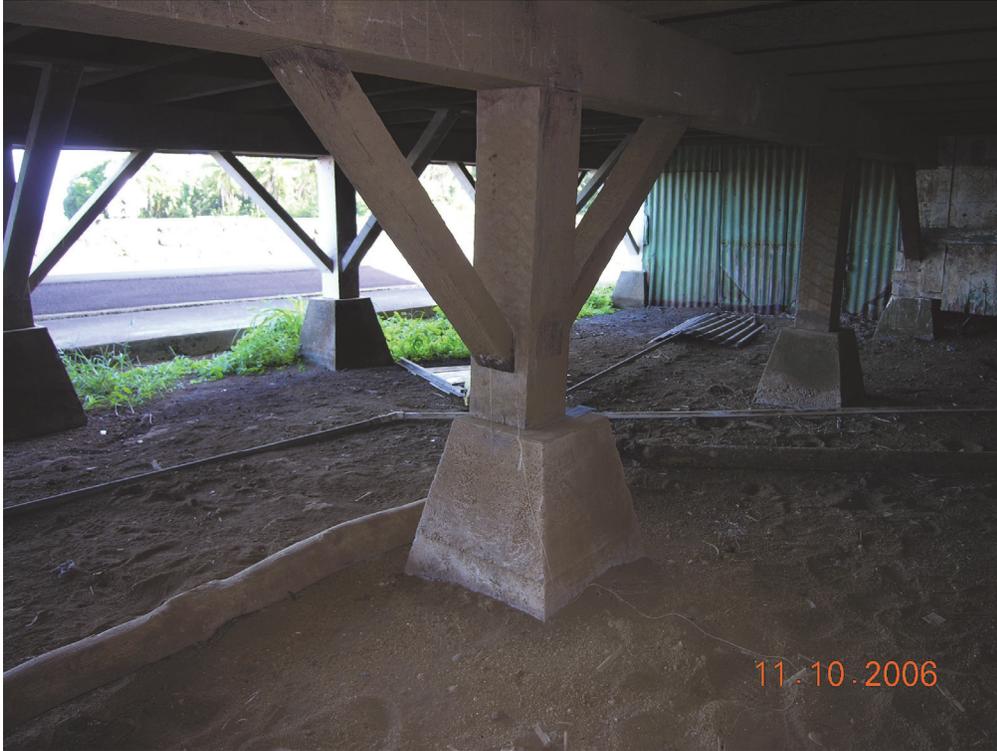
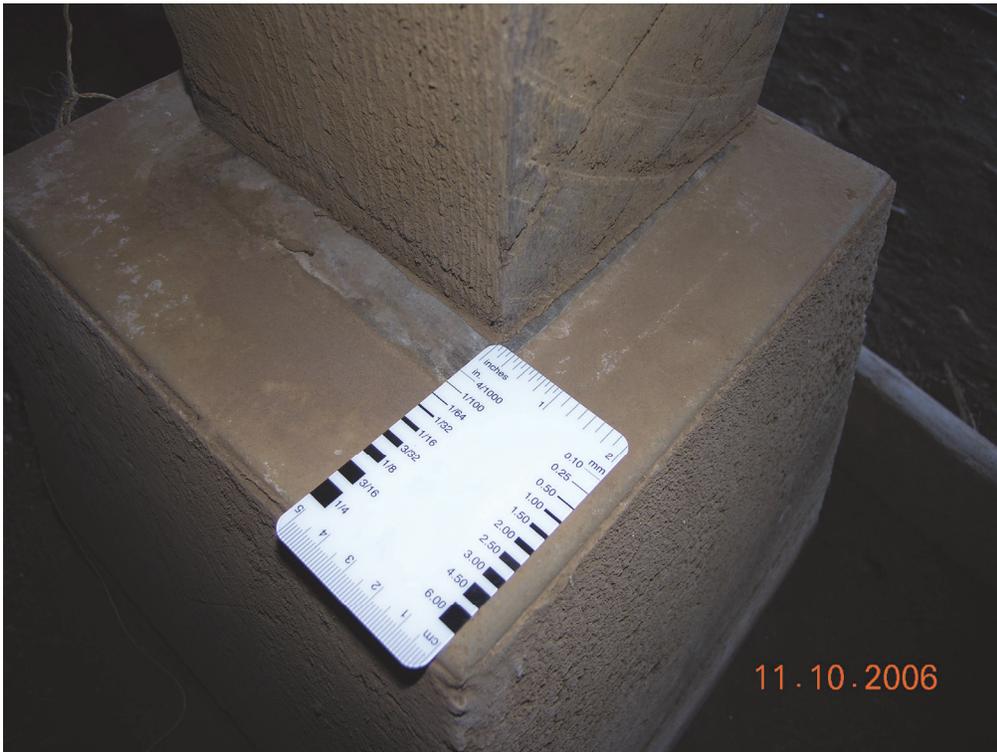
Figure 2-13 Shifting of an unattached wood post along the top of the concrete pier due to the 2006 Kiholo Bay, Hawaii earthquake. There was no continuous perimeter foundation around the building (photo credit: Exponent).

Earthquake damage to concrete piers is almost always caused by permanent ground deformation due to one or more of the mechanisms discussed in Chapter 5. This damage can take the form of cracking or rotation of piers due to movement of the ground. Unattached wood posts can move relative to the floor beams or piers (Figure 2-13) or become dislodged and fall as a result of earthquakes. If posts are attached to both the floor beams and piers, the wood posts or connections can become damaged (Figure 2-14).

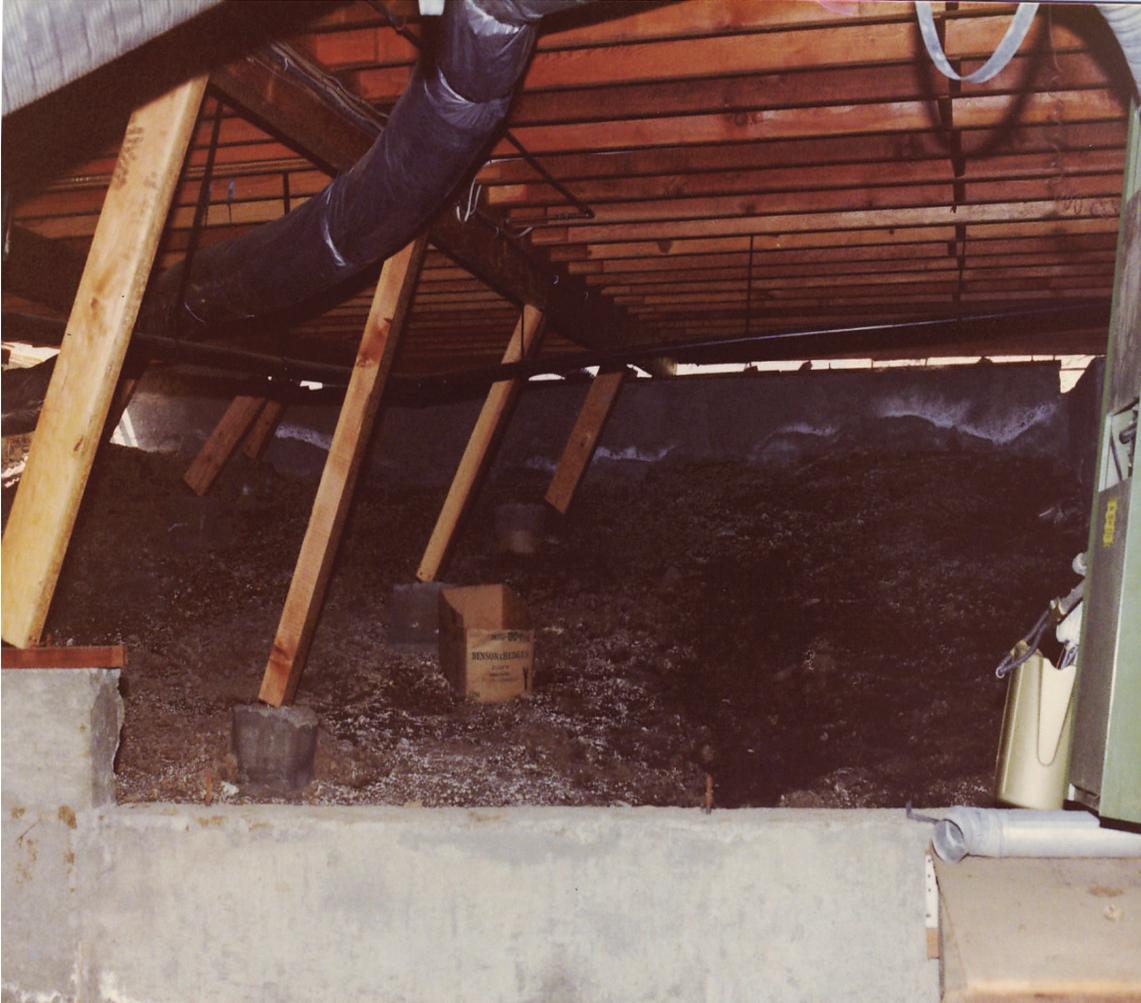
Figure 2-14 Leaning posts within the interior of the house plan. The house had a perimeter foundation with inadequate anchorage between the superstructure and the foundation (photo credit: R. Gallagher).

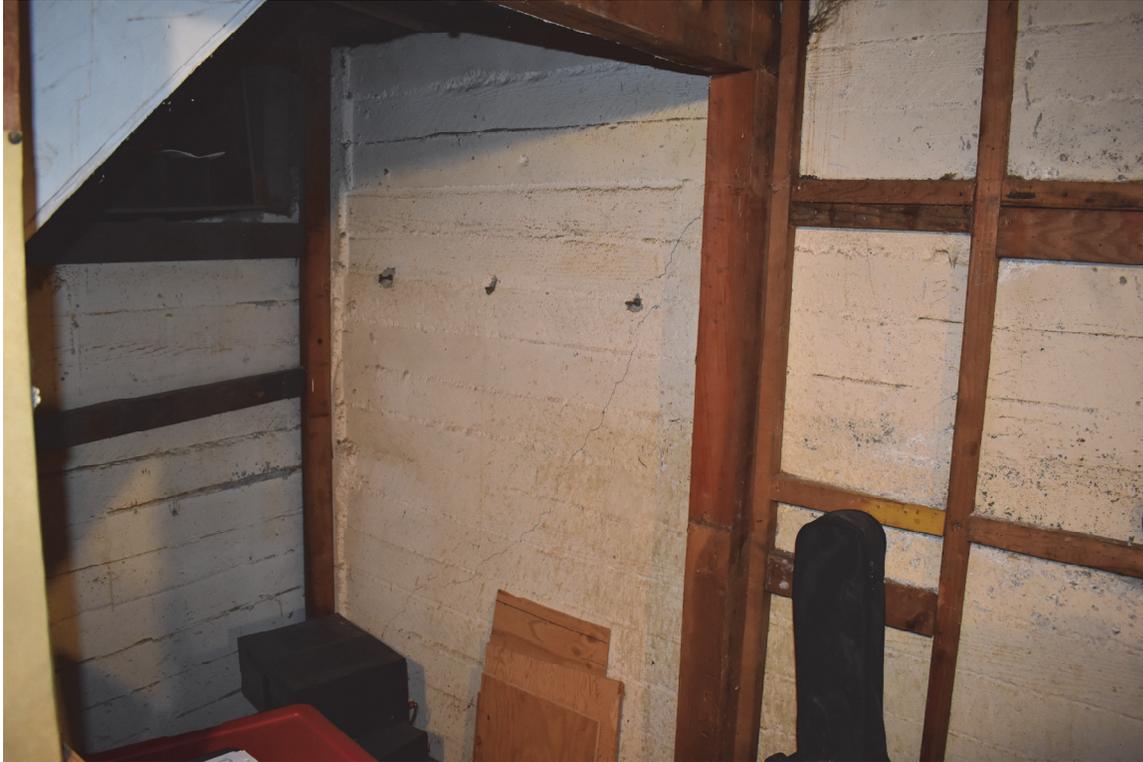
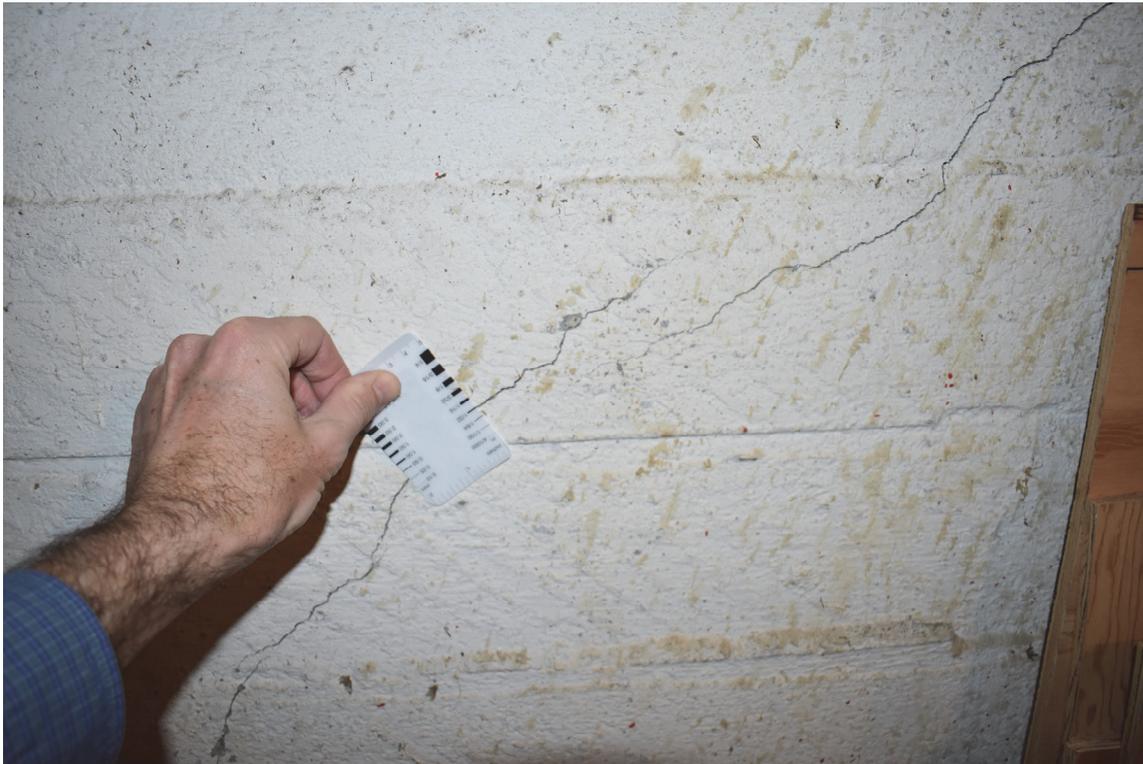
Figure 2-15 Typical non-earthquake-related cracking of concrete California basement wall (photo credit: Exponent).

Full basements are rare in warm locales where the frost line depth is only a few inches from the ground surface. In these cases, the most common basements are effectively below-grade closets just large enough to house a boiler or water heater (the so-called California basement) or are built into a sloping site so that the basement walls also retain several feet of soil at the uphill end. In the latter case, the basement “room” is actually a below-grade garage accessed by a sloped driveway. In most cases, concrete basement walls have minimal reinforcing steel and no construction joints, so they are prone to cracking (Figure 2-15).

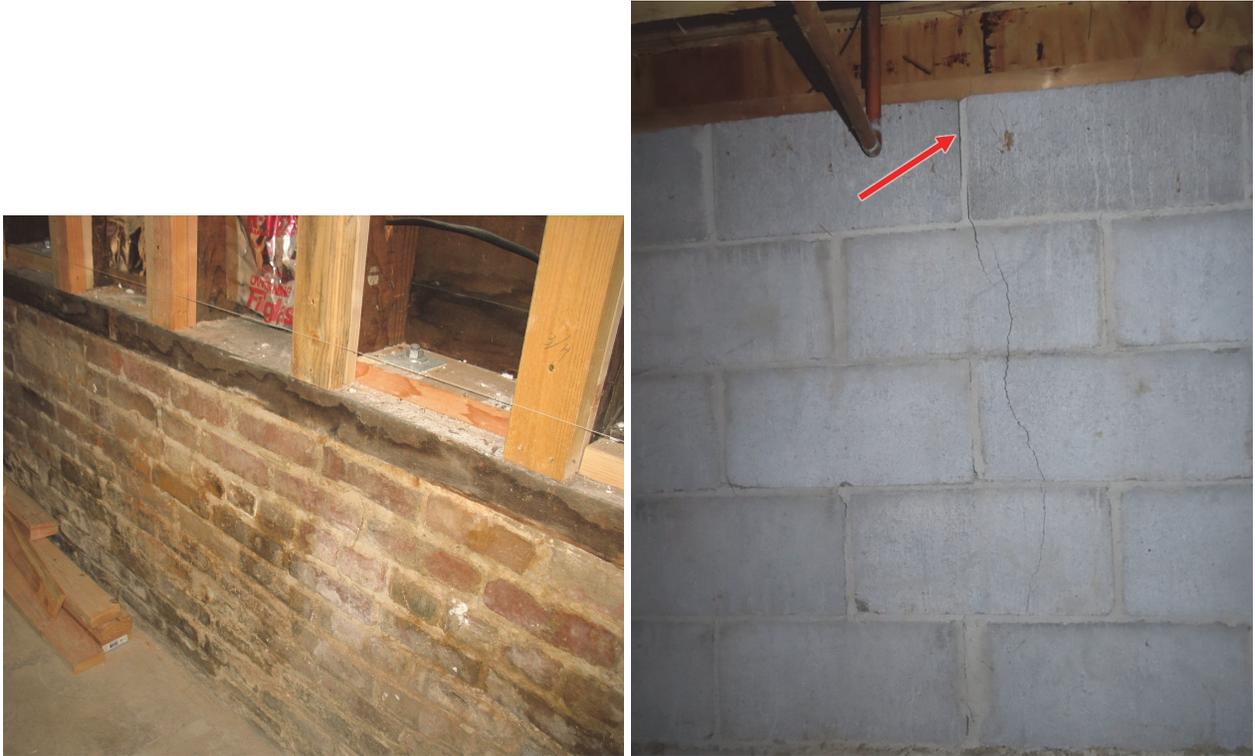
Figure 2-16 Typical brick masonry (left) and CMU (right) basement wall configurations, where cracking in the right photo was caused by the 2018 Anchorage, Alaska earthquake (photo credits: D. Bonowitz, left, and Z. Stutts, right).

See the discussion of concrete basement walls above. Earthquake damage to masonry basement walls can be similar to that associated with masonry stemwalls (discussed above) or retaining walls (see Chapter 5). Typical brick masonry and concrete masonry unit (CMU) basement wall configurations are depicted in Figure 2-16.

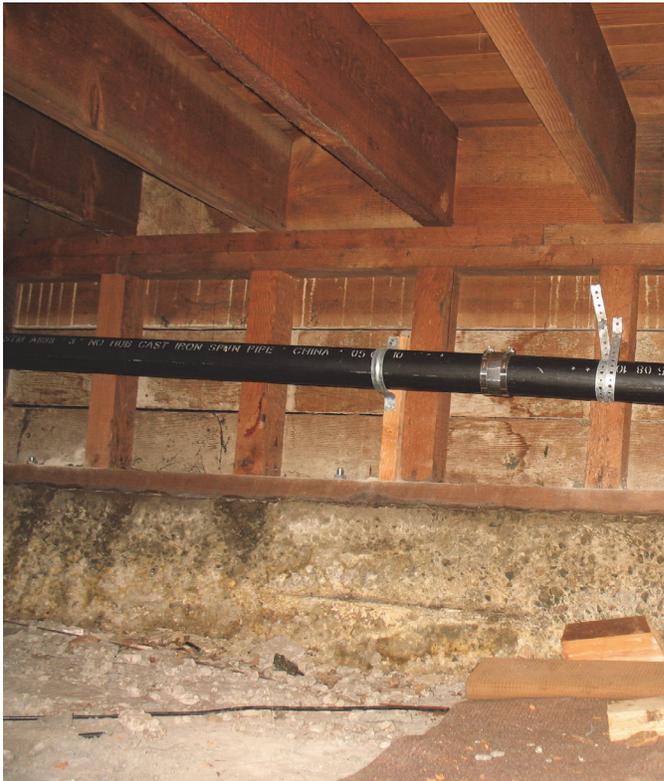
Figure 2-17 Sill plate below cripple wall framing of older house with steel post-installed anchor bolts attaching the sill plate to the foundation (photo credit: D. Bonowitz).

Wood-frame houses with continuous concrete or masonry foundations have wood sill plates (sometimes referred to as foundation sill plates or mudsills) that bear on the foundations and provide bases for wood wall studs or floor joists (see Figure 2-17). Sill plates in newer houses, particularly along perimeter wall lines, are almost always attached to the foundations with steel anchor bolts embedded into the concrete or masonry. Sill plates in older houses may not have steel anchors but may have been set into the wet concrete to provide some nominal attachment. In urban areas of California, it is rare to find a sill plate lying directly on a concrete footing with no attachment at all.

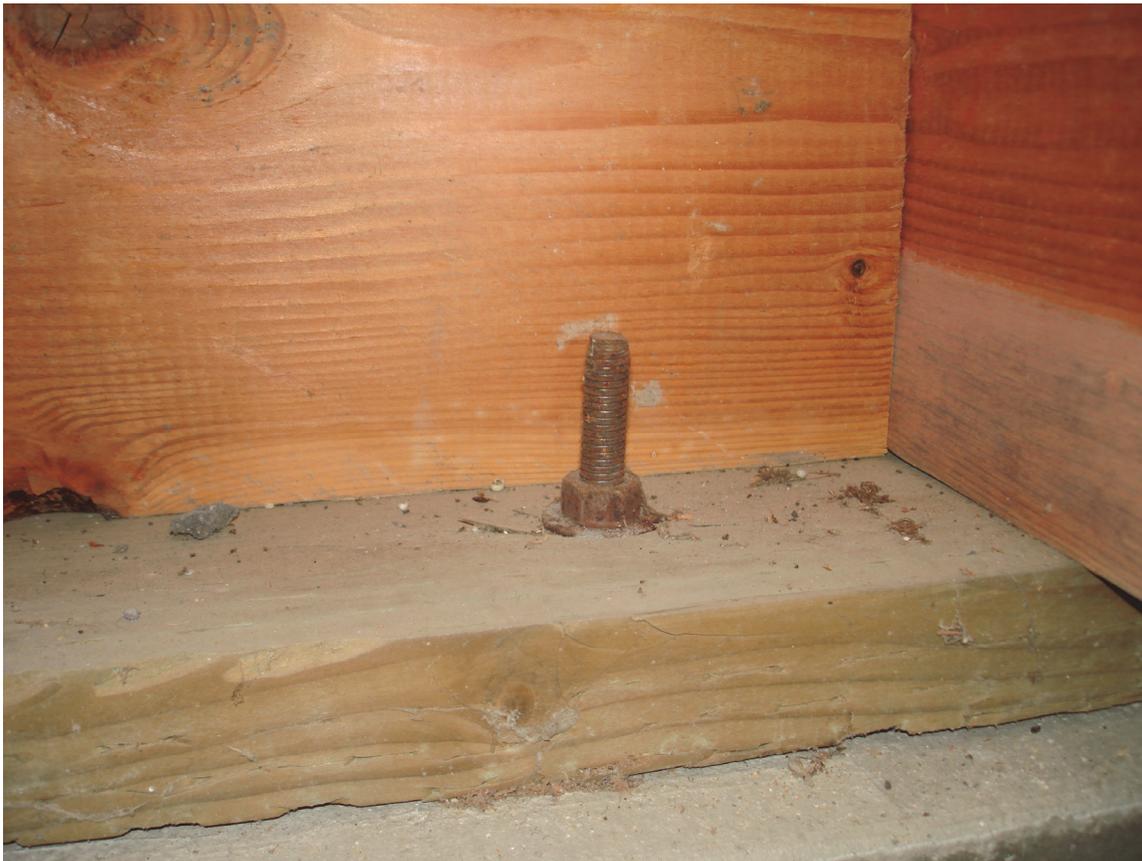
Figure 2-18 Typical steel cast-in-place anchor bolt attaching sill plate to concrete foundation (photo credit: E. Mikailian).

As discussed above, wood sill plates in all but the oldest houses are typically attached to foundations with embedded, or cast-in-place, steel anchor bolts (see Figure 2-18). Earthquake damage associated with steel cast-in-place anchor bolts can include splitting of the wood sill plates, deformation or fracture of the steel anchors, or damage to the concrete or grout surrounding the anchors (localized crushing of a sill plate around a washer can be caused by over-tightening of a nut or an under-sized washer). Fracture of steel anchors is rare and would typically be accompanied by damage patterns associated with sliding of the sill plates, as discussed in Section 2.2.1. Damage to the concrete or grout is typically in the form of fresh cracking or spalling of the concrete or grout around the anchor bolts and is most often associated with anchors installed with inadequate end or edge distances.

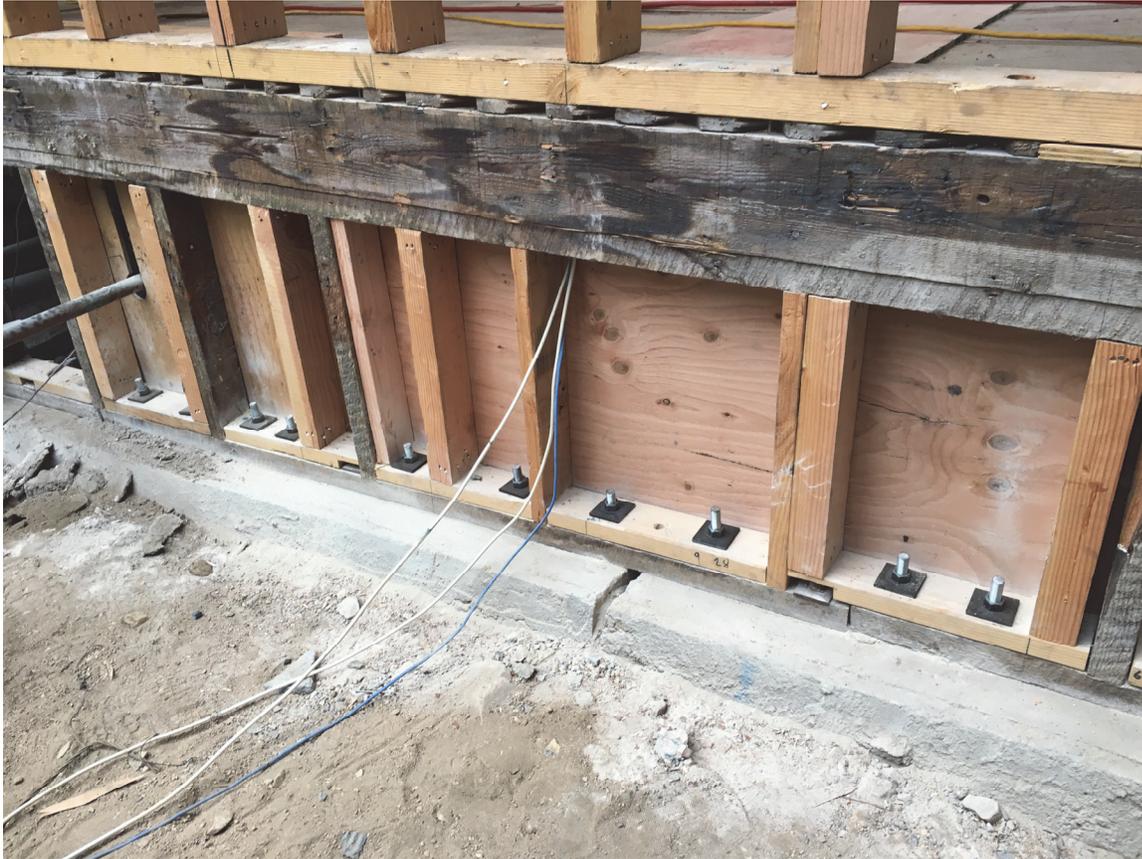
Figure 2-19 Steel post-installed anchor bolts associated with modifications to a house. These are adhesive anchors attached to an existing concrete foundation (photo credit: E. Mikailian).

Steel anchor bolts may be installed into hardened concrete or grout. Usually, such an installation is part of a seismic retrofit or other alteration made after original construction (Figure 2-19). The bolts can be expansion-type anchors or adhesive anchors. Earthquake damage patterns associated with steel anchor bolts installed into hardened concrete or grout are similar to those for steel cast-in-place anchors. These anchors can be more prone to pull-out failure if not adequately attached to the concrete or masonry.

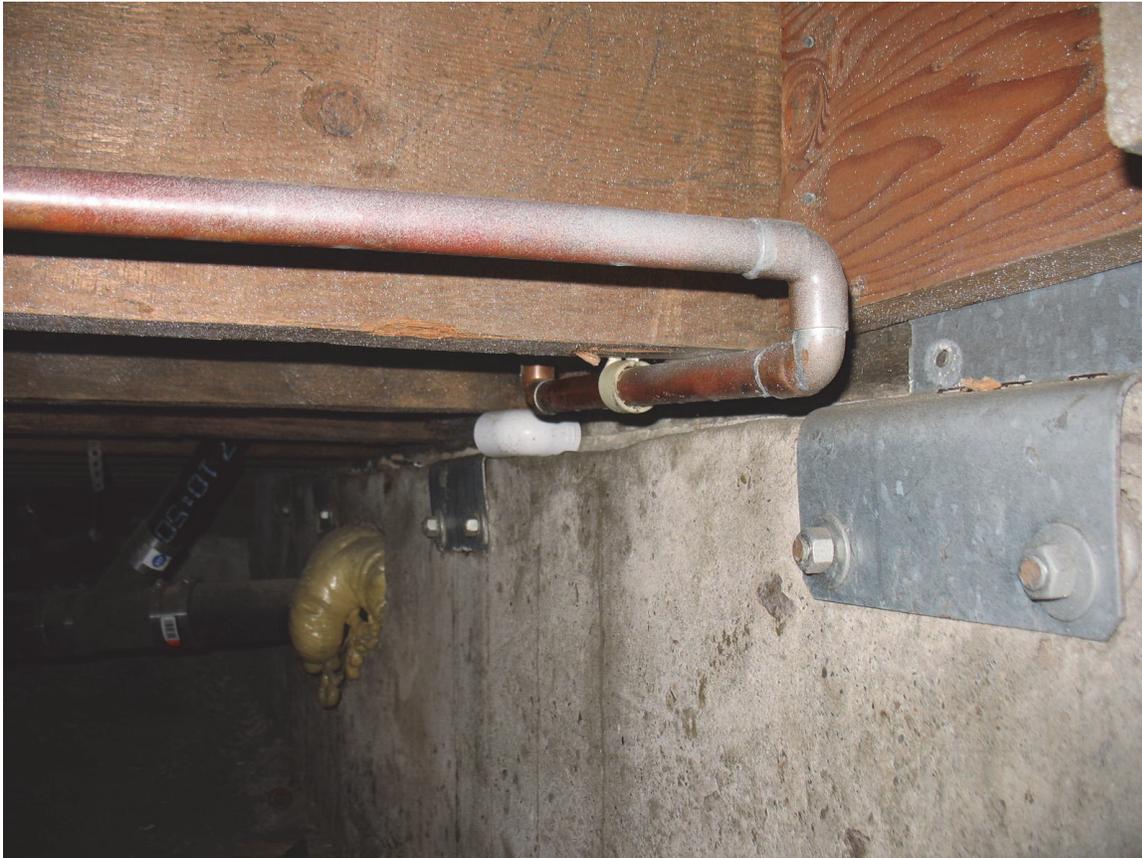
Figure 2-20 Steel post-installed plate connectors attaching a wood sill plate to a concrete stemwall. The connectors were installed as part of a seismic retrofit (photo credit: D. Bonowitz).

Steel plate connectors (sometimes referred to as retrofit plates) serve the same purpose as post-installed bolt anchors but are used where installation of bolt anchors is difficult. The steel plates are attached to the sides of sill plates with wood screws and attached to the concrete or masonry stemwalls with steel post-installed bolt anchors (Figure 2-20); the plates typically contain pre-drilled holes for inserting these fasteners into the sill plates and foundations. Earthquake damage associated with steel post-installed plate connectors is most likely to include splitting of the wood sill plates, deformation or fracture of the wood screws, or damage to the steel post-installed bolt anchors (see discussion above). Although unlikely, damage can also include deformation or fracture of the steel plates.

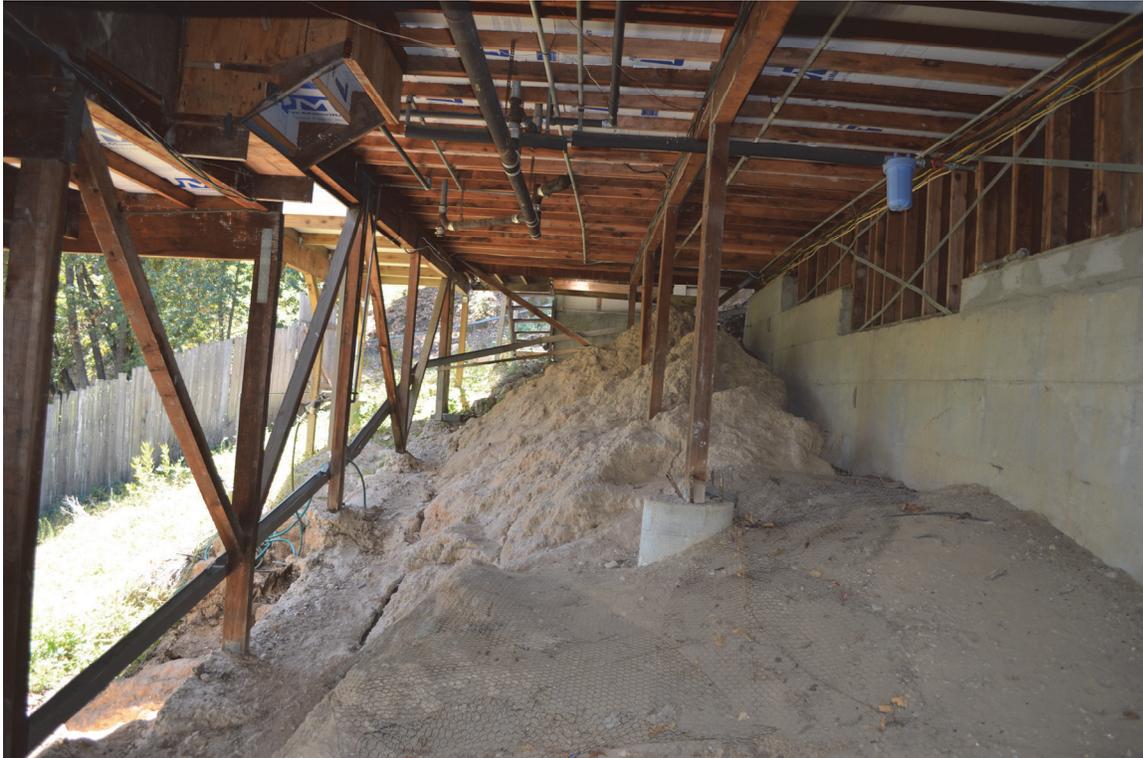
Figure 2-21 View of the framing connections to the uphill foundation (at right side of the photograph) at a hillside house (photo credit: Exponent).

The framing-to-foundation connections at the uphill end of a hillside house (Figure 2-21) can be prone to earthquake damage. These connection details can vary significantly, so earthquake damage can involve wood ledgers, wood sill plates, steel anchors, or other connection assemblies. If the connection is severed completely, the damage can manifest as loss of bearing for the floor joists, with associated damage to floor finishes and adjacent wall finishes.

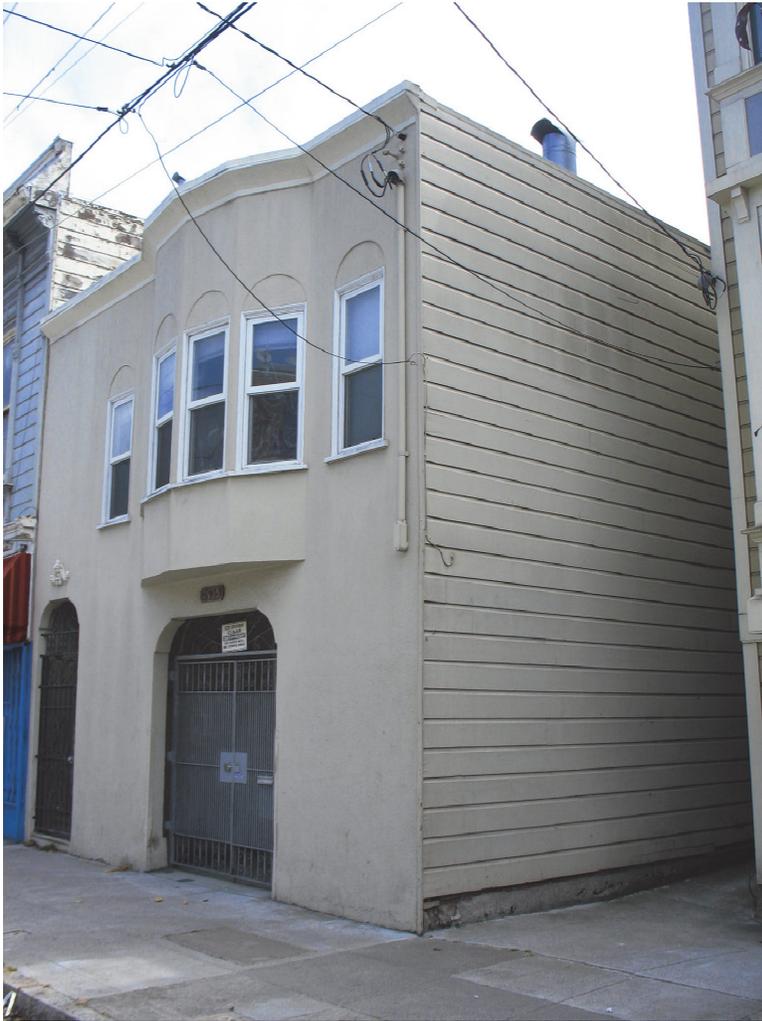
Figure 2-22 Horizontal wood siding (shiplap) on the side wall and stucco on the front face of a house with a living-space-over-garage condition (photo credit: D. Bonowitz).

Earthquake damage associated with horizontal wood siding, in order of increasing severity, includes localized splitting of the siding around nails, withdrawal of the nail heads from the siding, detachment of the siding from the wall framing, localized crushing of siding, elongation of nail holes at the back faces of the siding boards, and occasionally splitting of the wall framing at the nails. Walls braced by horizontal wood siding alone (such as at garages and cripple walls where the opposite faces are unfinished) are prone to large residual drift.
