Earthquake Damage Assessment and Repair Guidelines for Residential Wood-Frame Buildings

Volume 2 | ENGINEERING GUIDELINES

CEA-EDA-02 2020

Earthquake Damage Assessment and Repair Guidelines for Residential Wood-Frame Buildings, Volume 2 – Engineering Guidelines

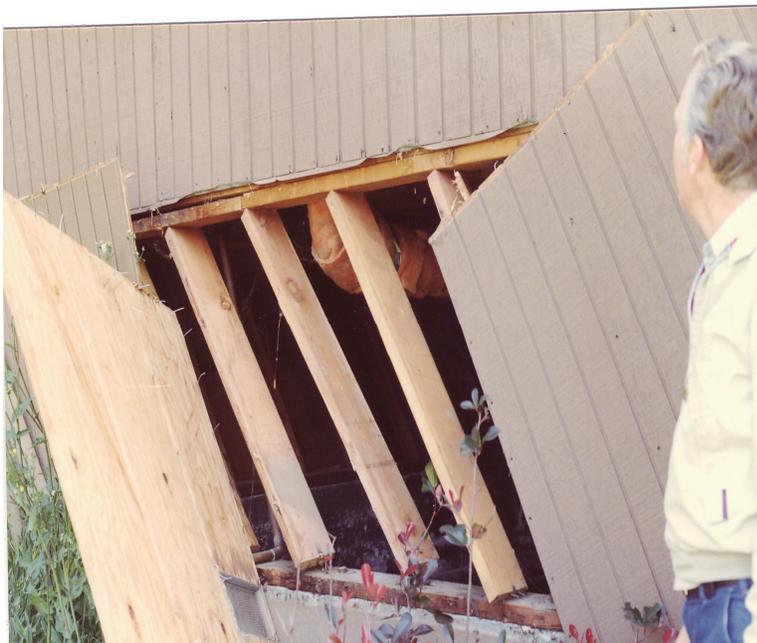
Figure 2-23 Plywood panel siding detached from cripple wall framing at a hillside house (photo credit: R. Gallagher).

Plywood is commonly used as an exterior wall finish material in houses, typically in the form of panels with decorative vertical grooves. Although these panels may not be considered structural sheathing, their earthquake damage patterns are similar to those of wood structural panels described below (Figure 2-23). Plywood panel siding that is edge nailed at all edges of each panel can effectively function as a shear wall. It is more common, however, to find edge nailing along only one of the two vertical panel edges. When installed in this manner, plywood panel siding retains some bracing capacity but much less than if the edges were fully nailed, and additional panel and framing deformation, as well as more frequent nail tear-out at panel edges, can occur with this installation.

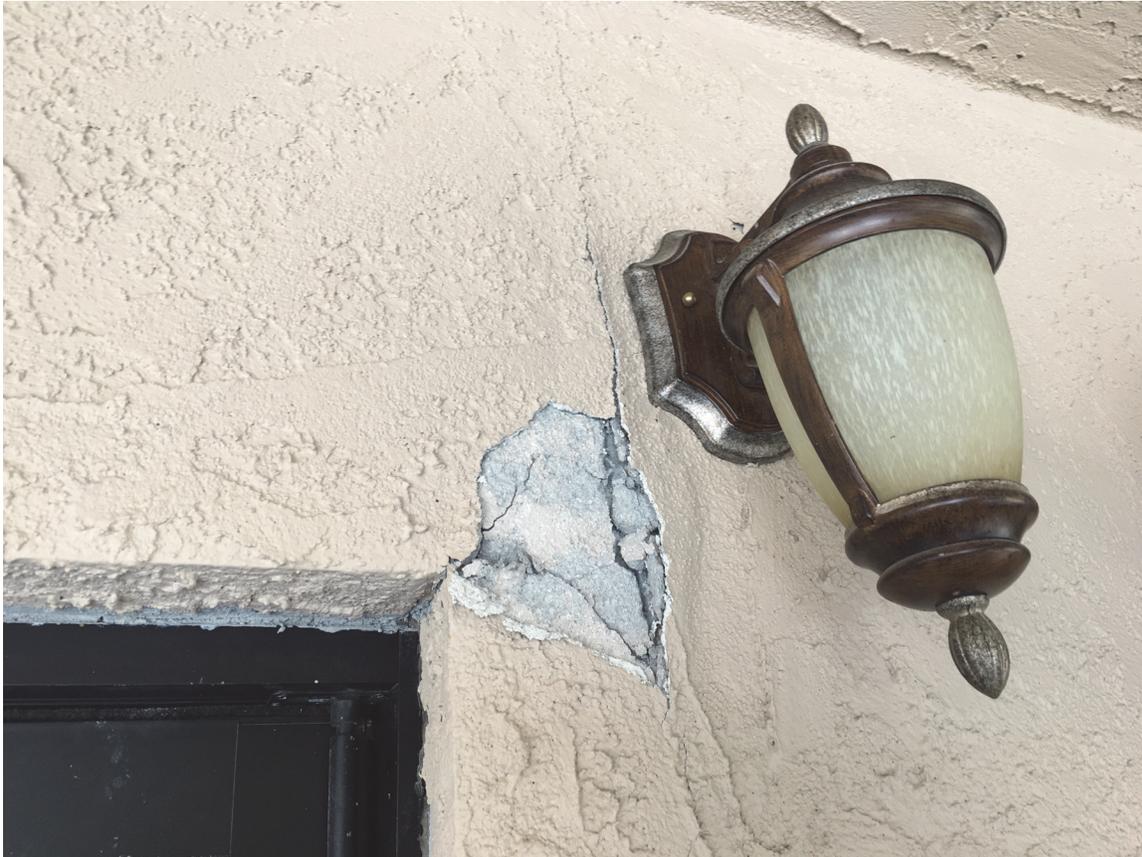
Figure 2-24 Stucco cracking and spalling at a door opening due to the 2019 Ridgecrest, California earthquake (photo credit: M. Ziemer).

The most common earthquake damage to stucco finishes includes diagonal cracking emanating from corners of door and window openings (Figure 2-24). As strong shaking continues, the cracks can extend from these openings, transitioning to longer horizontal cracks, and “X” cracks can form across a pier between openings. Spalling of the stucco along cracks can also occur. In more extreme cases, particularly where the lath connection is inadequate, large areas of stucco can detach from the wall framing. Earthquake damage to stucco can also manifest as a horizontal crack at the interface between the sill plate and foundation, associated either with in-plane sliding of the sill plate or out-of-plane deformation of the wall.

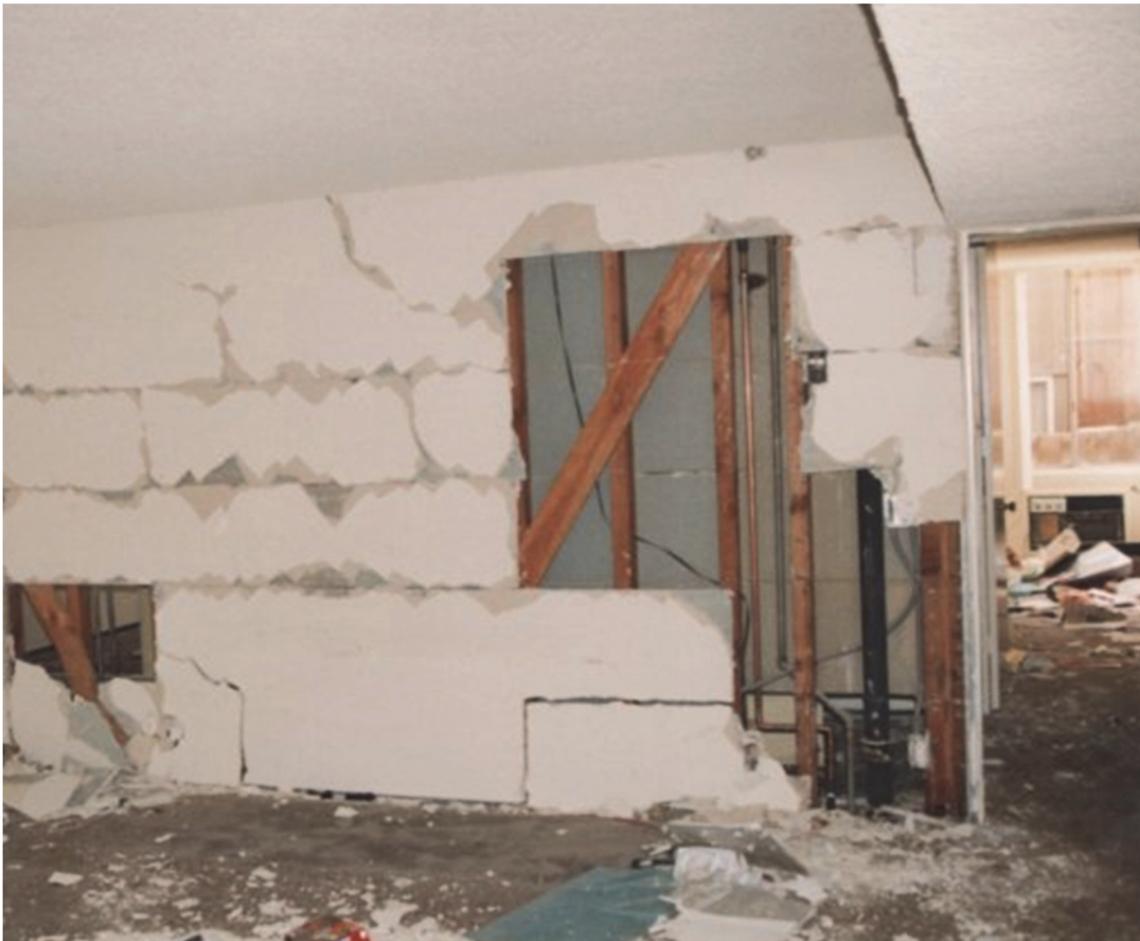
Figure 2-26 Earthquake-induced cracking and delamination of plaster on gypsum lath (photo credit: Exponent).

From the mid-1930s to the 1950s, interior wall finishes in houses transitioned from plaster on wood lath to gypsum wallboard. During that transition, many houses were built with plaster applied over gypsum lath panels. This wall finish system is sometimes called button board for the way the plaster is keyed to the gypsum panels with spaced round holes. Earthquake behavior at low displacement levels is similar to that of plaster on wood lath, including cracking. At higher displacement levels, behavior is more similar to that of gypsum wallboard (Figure 2-26).

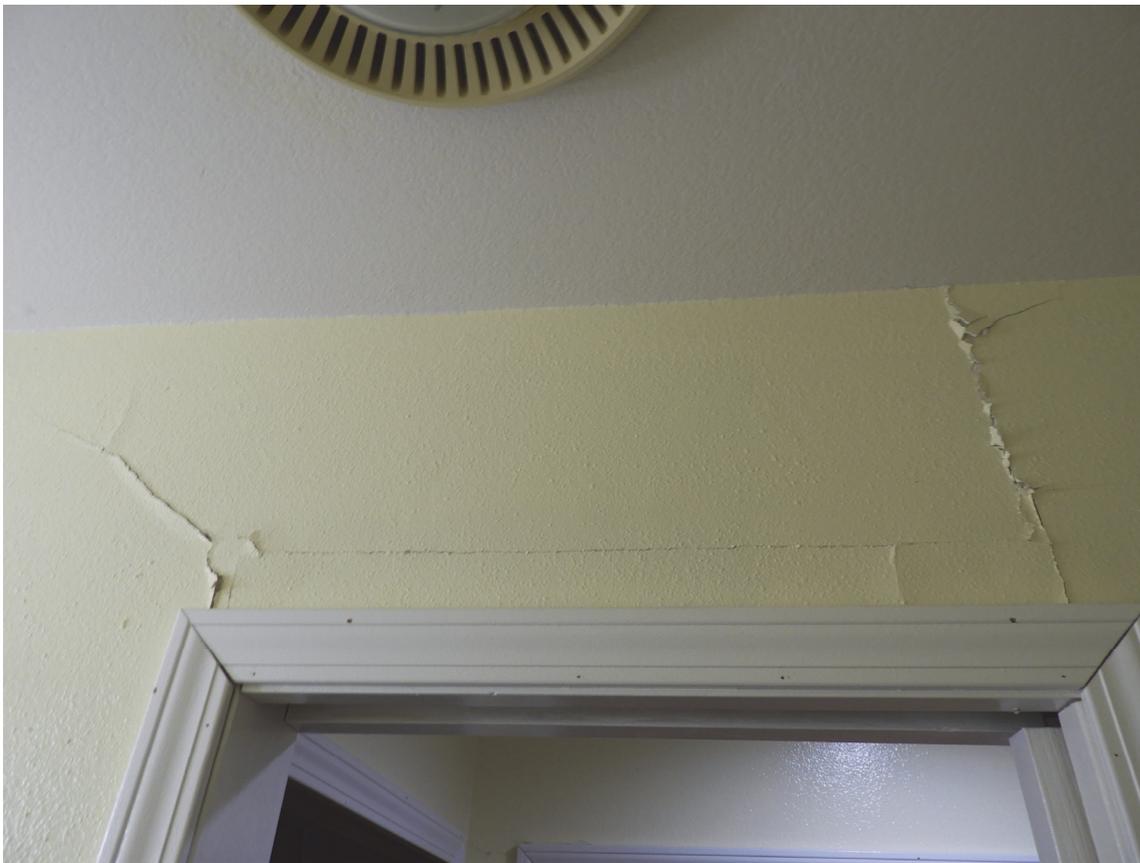
Figure 2-27 Cracking of gypsum wallboard at corners of door opening caused by the 2018 Anchorage, Alaska earthquake (photo credit: Z. Stutts).

Gypsum wallboard, also called drywall, is the most common interior wall finish material in houses built after the 1940s. Cracking of gypsum wallboard at corners of door and window openings is common in moderate-to-strong earthquakes, and cracking can also occur along taped joints between wallboard panels (Figure 2-27) and corner beads. Gypsum wallboard nails can work loose or pull out under earthquake shaking (or from other causes), leaving a pattern of raised nail heads discernible through the paint or taped finish. Where attached with screws, pullout is less likely, but with enough in-plane racking of the panel, the screws can gouge a slot in the drywall sheet not easily observed from the finished side. This “slotting” along the back sides of the panels reduces their stiffness in subsequent cycles of earthquake shaking. In more severe earthquakes, the panels may detach from the wall framing.

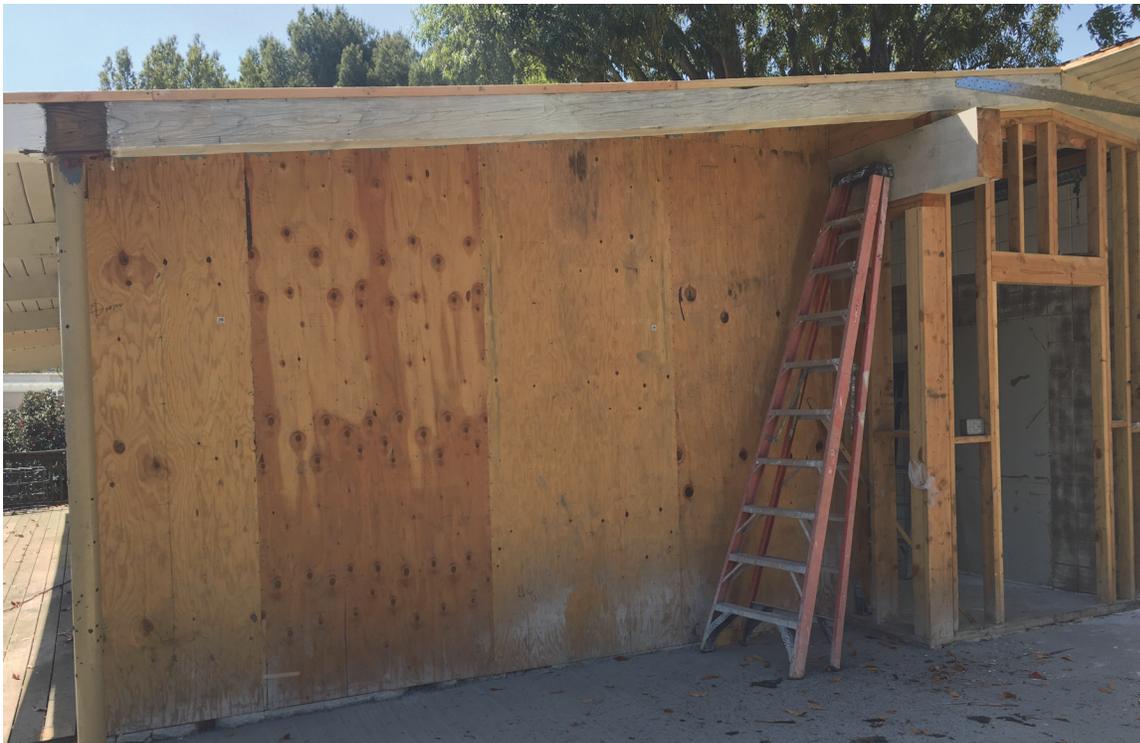
Figure 2-28 Wood structural panel (plywood) sheathing revealed by the removal of exterior finishes (photo credit: E. Mikailian).

Wood structural panel (WSP) sheathing is a general category that includes plywood (Figure 2-28) and oriented strand board. Particleboard and fiberboard sheathing, although less common in California, are grouped with WSP sheathing in these *Engineering Guidelines* because their use in seismic-force-resisting systems and their earthquake damage patterns are similar. A California house (or addition) built after about 1990 is likely to have a seismic-force-resisting system consisting of WSP-sheathed shear walls, although houses are still constructed without it. WSP sheathing is also found in retrofitted older houses, especially applied to the inside face of cripple wall studs.

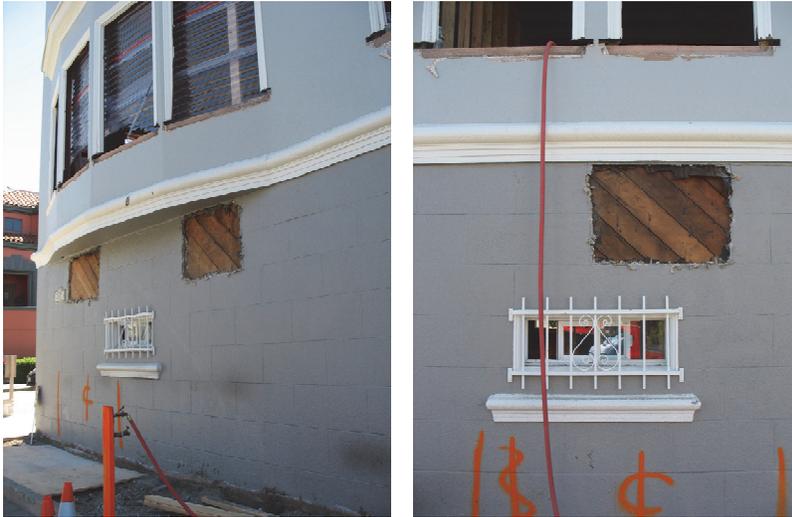
Figure 2-29 Diagonal lumber sheathing revealed by the removal of exterior finishes (photo credit: D. Bonowitz).

Prior to the mid-20th century, diagonal lumber sheathing (Figure 2-29) was used as a wall bracing system in many houses. Diagonal lumber sheathing typically consists of 1-inch thick boards laid diagonally across the wall framing and nailed to the studs and plates. Diagonal lumber sheathing is stiffer and stronger than horizontal lumber sheathing (discussed below). Earthquake damage to diagonal lumber sheathing includes splitting of the boards around nailed connections and, at higher shaking intensities, splitting of the wall framing to which the boards are attached.

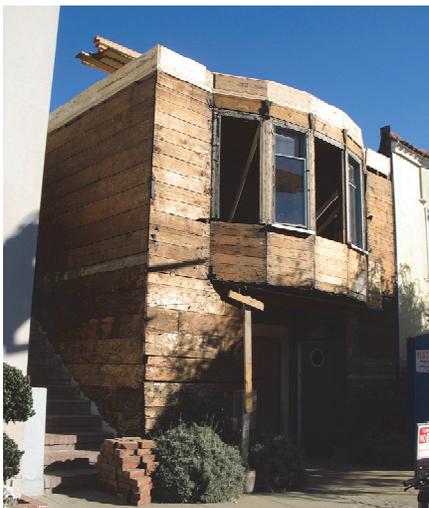
Figure 2-30 Horizontal lumber sheathing revealed by the removal of exterior finishes (photo credit: D. Bonowitz).

Horizontal lumber sheathing, particularly underlying the exterior wall finishes, is common in houses built before the mid-20th century (Figure 2-30). Behavior of horizontal lumber sheathing during earthquakes is similar to that of horizontal wood siding.

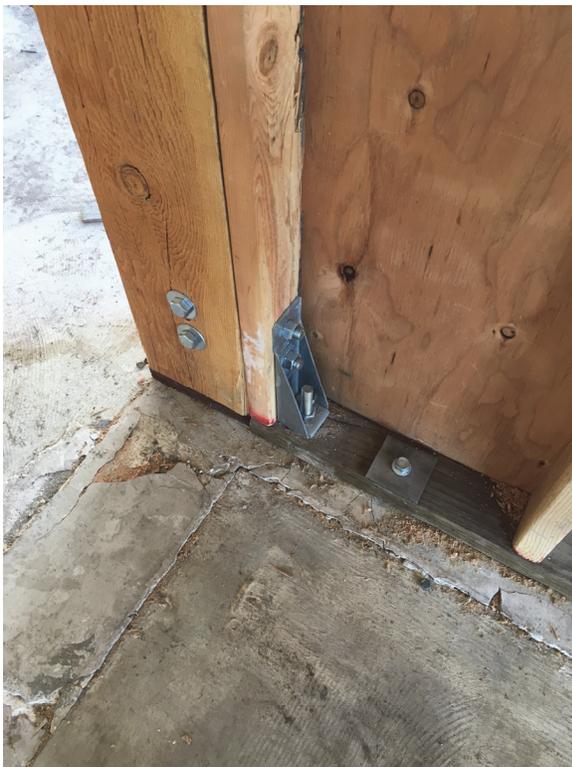
Figure 2-31 Tie-down at end of wood structural panel shear wall (photo credit: E. Mikailian).

Tie-down hardware is sometimes found in newer houses with an engineered design, particularly at the ends of narrow shear walls (Figure 2-31). Similar hardware is used in combination with posts to provide load paths for overturning effects between shear walls in successive stories. Common anchorage systems include proprietary bracket-type tie-down devices, light-gauge metal straps, and threaded rods used in stacked shear wall systems. All these devices are intended to resist tension forces associated with uplift of the shear walls.

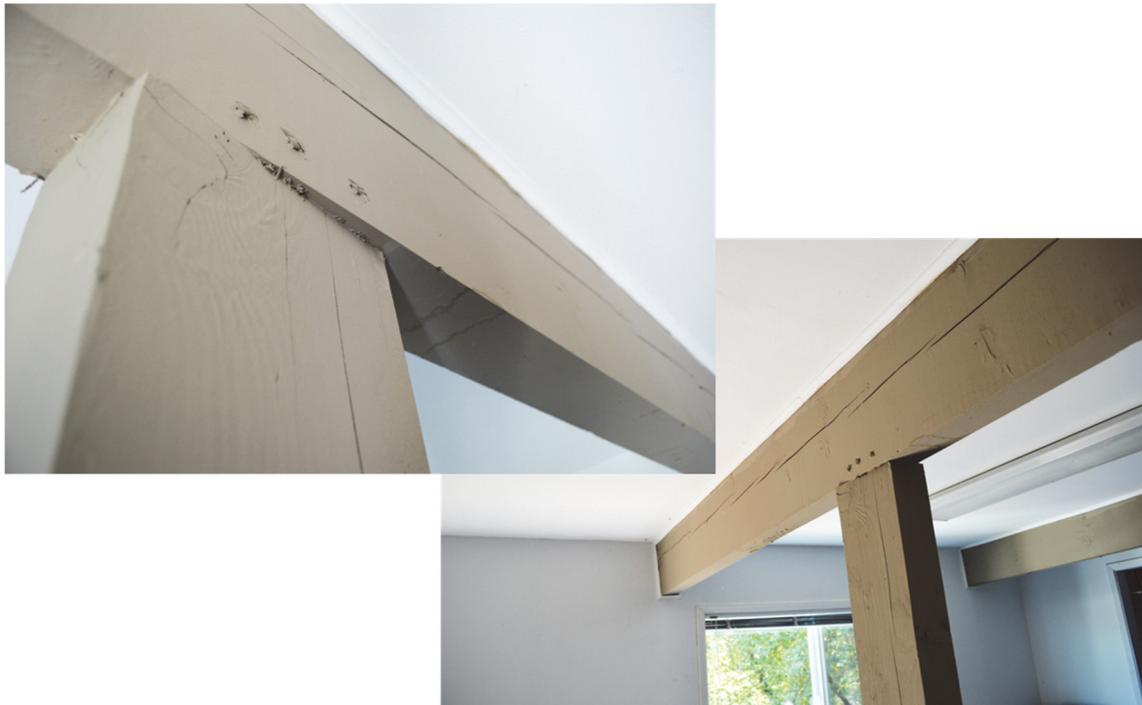
Figure 2-32 Gravity-load-carrying post supporting a beam. The two members, which are toe-nailed together, are misaligned, but lack of an unpainted surface indicates no recent relative movement (photo credit: Exponent).

Although generally not a part of seismic-force-resisting systems, gravity-load-carrying elements such as posts (Figure 2-32) can experience residual drift or shifting due to earthquakes. Posts with inadequate connections at the tops or bottoms are more susceptible to these damage mechanisms. Recent shifting at post connections is typically accompanied by freshly exposed wood surfaces along the connections and distress to connection fasteners, if present.

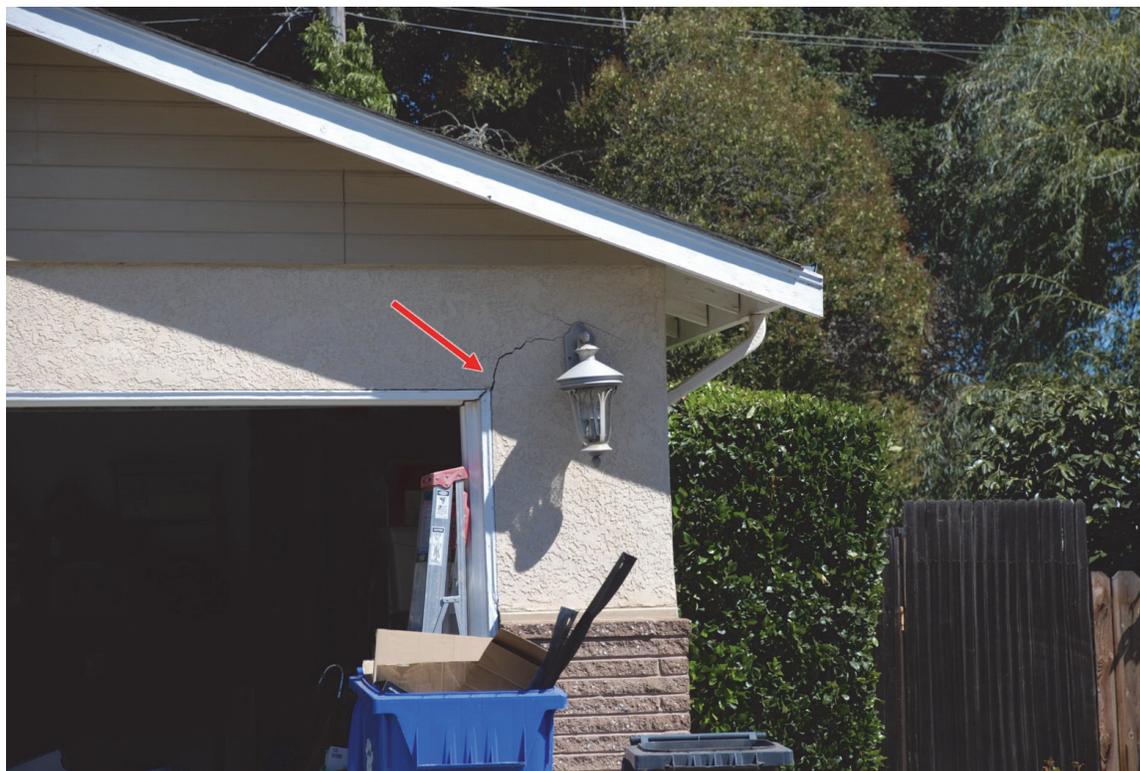
Figure 2-33 Concentrated earthquake damage to stucco at the top of a narrow wall segment adjacent to a garage door (photo credit: K. Cobeen).

Earthquake damage to portal frames can include concentrated damage to the sheathing or straps at the connections between the narrow wall piers and the beams (Figure 2-33). Concentrated damage to the sheathing and anchors may also occur at the bases of narrow wall piers, associated with rocking of the piers.

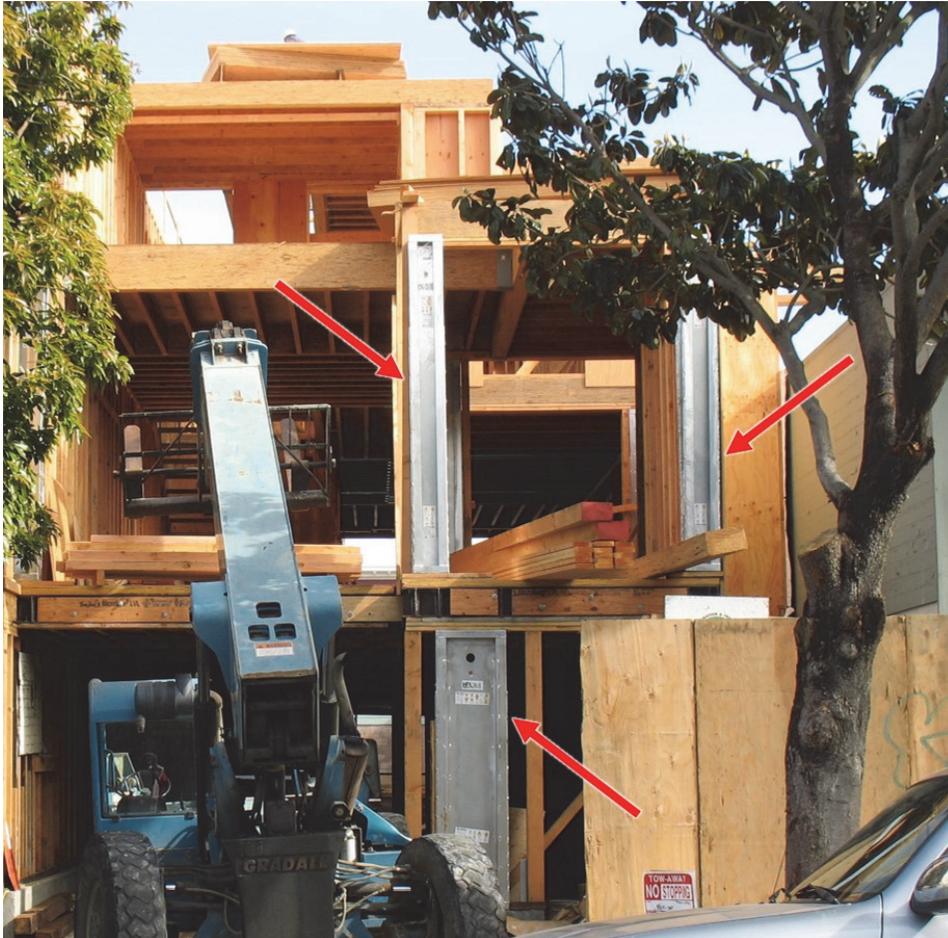
Figure 2-34 Proprietary shear walls at narrow wall piers between large window and door openings (photo credit: D. Bonowitz).

Pre-engineered, manufactured wall panels may be used on new houses or be used for retrofitting existing houses (Figure 2-34). These proprietary systems are typically used where the available wall length is narrow, for example on either side of a wide garage door. With typically high shear capacity and high aspect ratios, proprietary wall panels require careful detailing of boundary elements and base attachments. Earthquake damage to these panels includes separation of the panels from the surrounding wood framing and damage to the tie-downs.

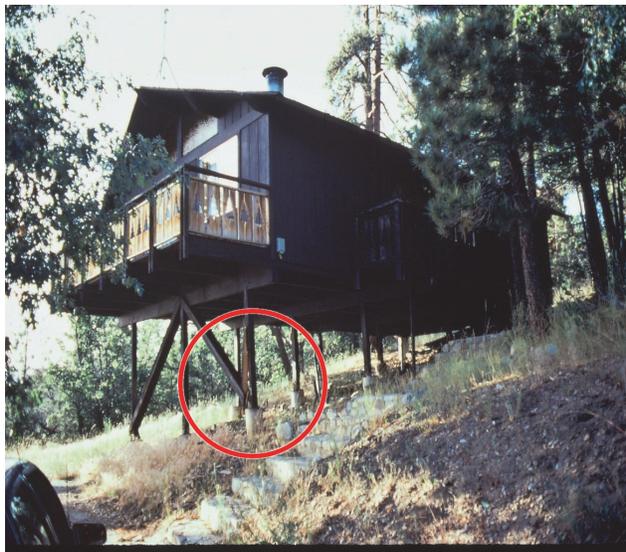
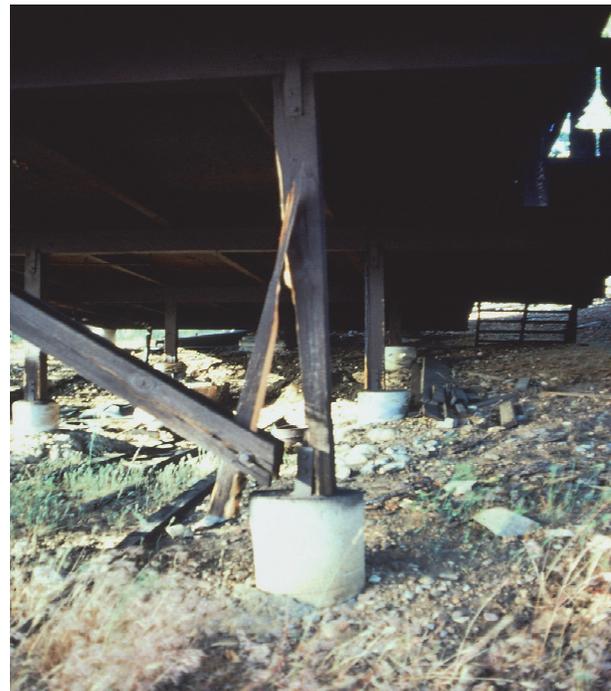
Figure 2-35 Damage at bolted connection of diagonal lumber bracing to post at hillside house. Damage at the connection includes splitting of the diagonal lumber brace and fracture of the post (photo credit: R. Gallagher).

Diagonal lumber bracing is found in some older hillside houses between the floor framing and foundations. (This is lumber specifically installed to provide bracing, as opposed to the let-in bracing that is sometimes used to square-up walls before sheathing is installed.) The bracing may be nailed or bolted to the tops and bottoms of posts, which support the gravity loads of the superstructures. The bracing is often ineffective in compression, so it is typically used in an X-pattern. Typical earthquake damage to diagonal lumber bracing includes splitting of the bracing at connections (Figure 2-35), or in the case of nailed connections, withdrawal of the fasteners from the framing to which the bracing is attached.

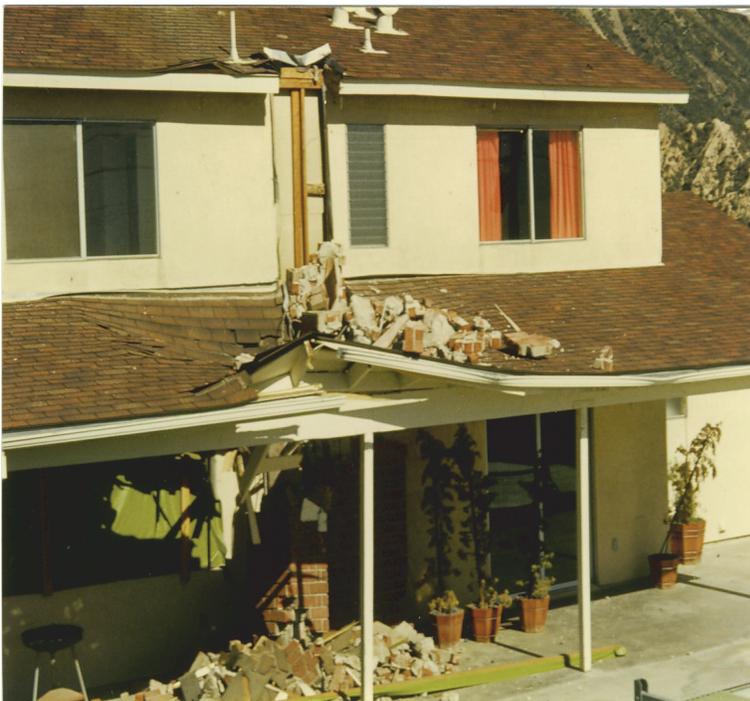
Figure 2-36 Damage to porch roof framing caused by chimney collapse (photo credit: R. Gallagher).

Damage to floor, ceiling, or roof framing in earthquakes is rare and is typically associated with forces imparted by adjacent chimneys (Figure 2-36) or other heavy elements attached to walls, separations at framing discontinuities, or loss of vertical supports due to damaged foundations, posts, or wall framing. Significant damage to floor, ceiling, or roof framing will typically be accompanied by conspicuous damage to their finishes.

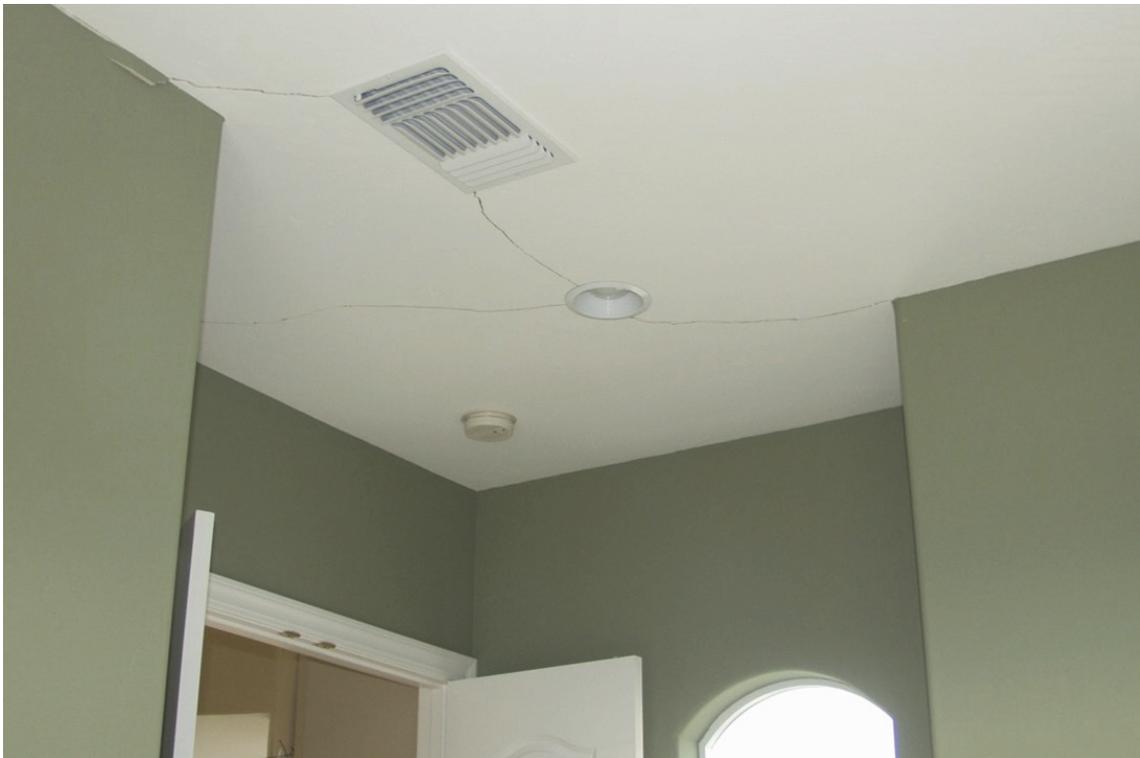
Figure 2-37 Cracking of ceiling finishes caused by the 2003 San Simeon, California earthquake (photo credit: Exponent).

Like floor diaphragms, structurally significant earthquake damage to ceiling diaphragms is rare. Cracking of brittle ceiling finishes, such as gypsum wallboard and plaster, can occur at relatively low intensity shaking but is usually not structurally significant (Figure 2-37). Damage patterns to these finishes are similar to those of similar materials used as wall finishes. Damage to ceiling diaphragms may also occur where the ceiling finishes are continuous across discontinuous framing, such as at split levels, stairwells, or where the joist directions change. In one-story houses or in the uppermost story of multi-story houses, ceiling finishes typically serve as the diaphragm sheathing for ceilings, except in cases of attics with floor systems.

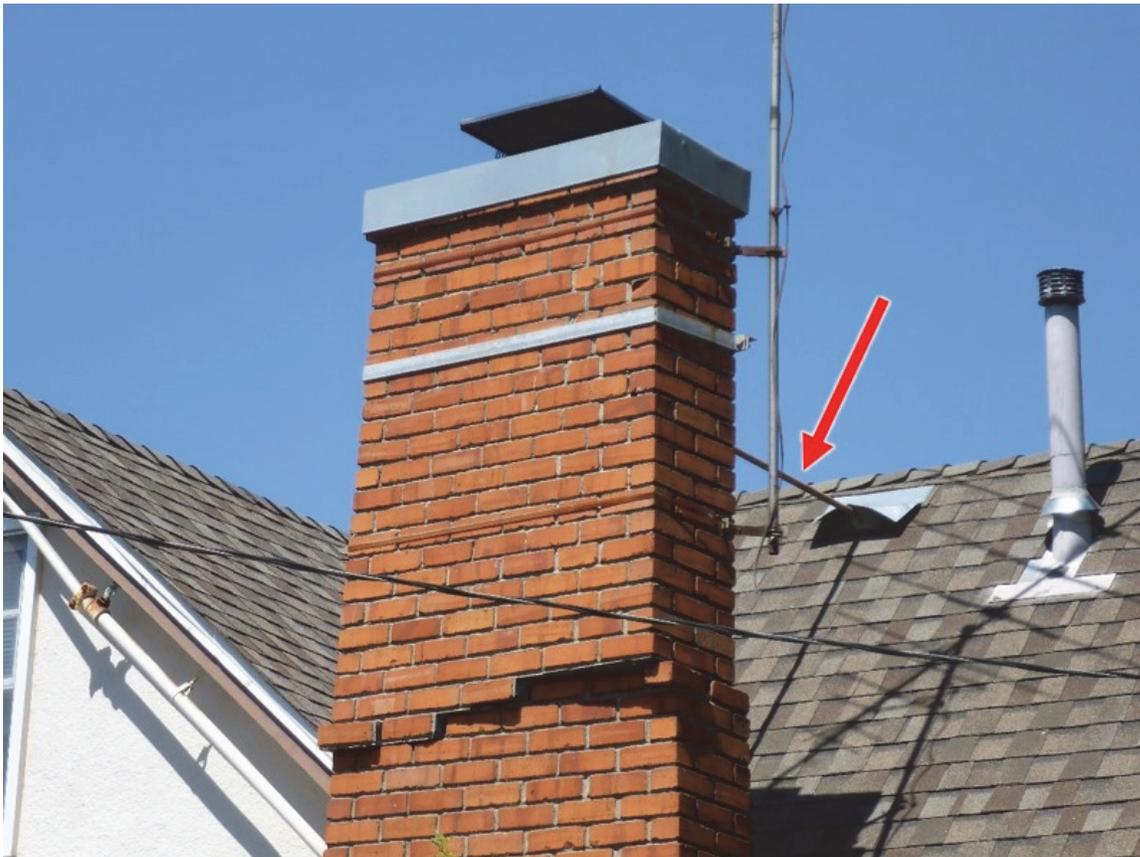
Figure 2-38 Earthquake-induced fractured chimney near the roof line. The brace between the chimney and roof, visible behind the chimney, was not adequate to prevent the damage (photo credit: Exponent).

Masonry chimneys are among the most vulnerable elements of houses. Unreinforced chimneys are vulnerable to cracking near rooflines (Figure 2-38), sometimes breaking away and falling. If the top portion of a chimney falls onto the roof, it can cause damage to the roofing and roof framing. Reinforced chimneys can separate from adjacent walls (Figure 2-39) and exhibit residual outward leaning following earthquakes. Many chimneys were built with steel straps embedded in the masonry and attached to floor or roof framing. Where inadequately connected, the straps can pull out, damaging the framing members or roof sheathing.

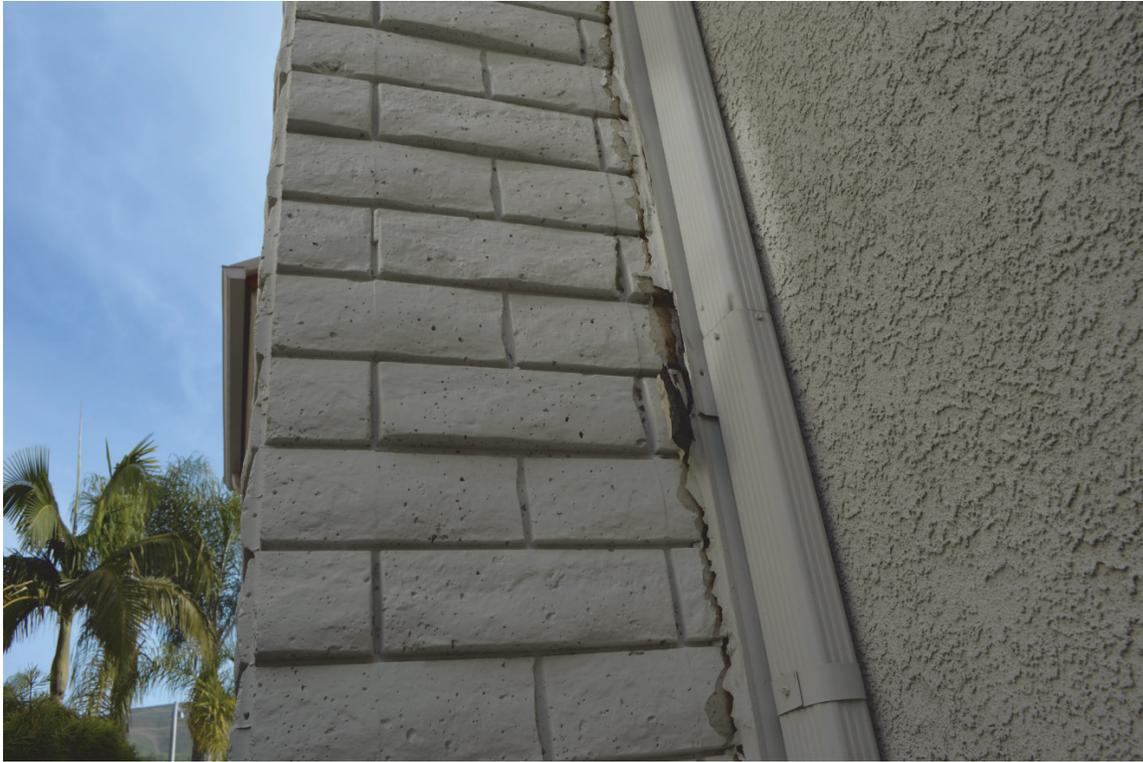
Figure 2-39 Separation of chimney from house caused by the 2014 La Habra, California earthquake. The separation was relatively minor, and the chimney remained attached to the house (photo credit: Exponent).

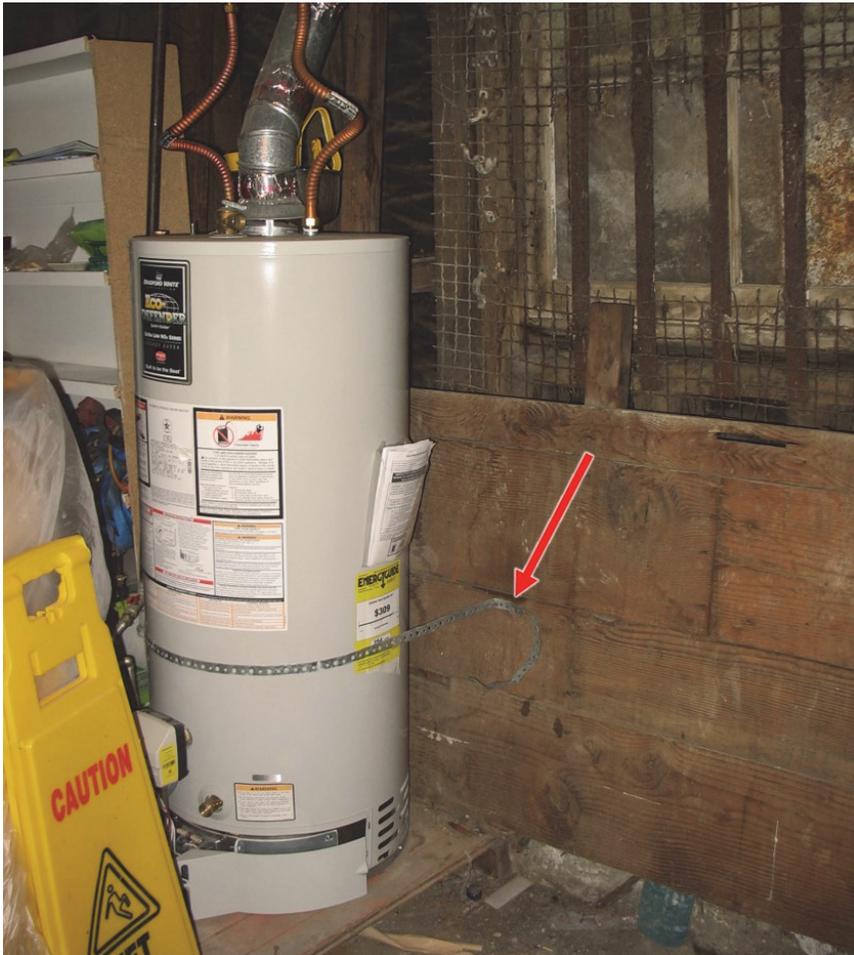
Figure 2-40 Inadequately strapped water heater (photo credit: D. Bonowitz).

Common MEP components of houses include water heaters, furnaces, air conditioning units, and pool or spa equipment, as well as their associated piping. Many of these MEP components in modern houses are anchored or braced; similar components in older houses are frequently unanchored and unbraced. Water heaters in older houses are likely to have been strapped to the adjacent wall if the water heaters have been recently replaced or if the properties have been recently purchased; however, poorly installed or anchored water heater straps are common (Figure 2-40).

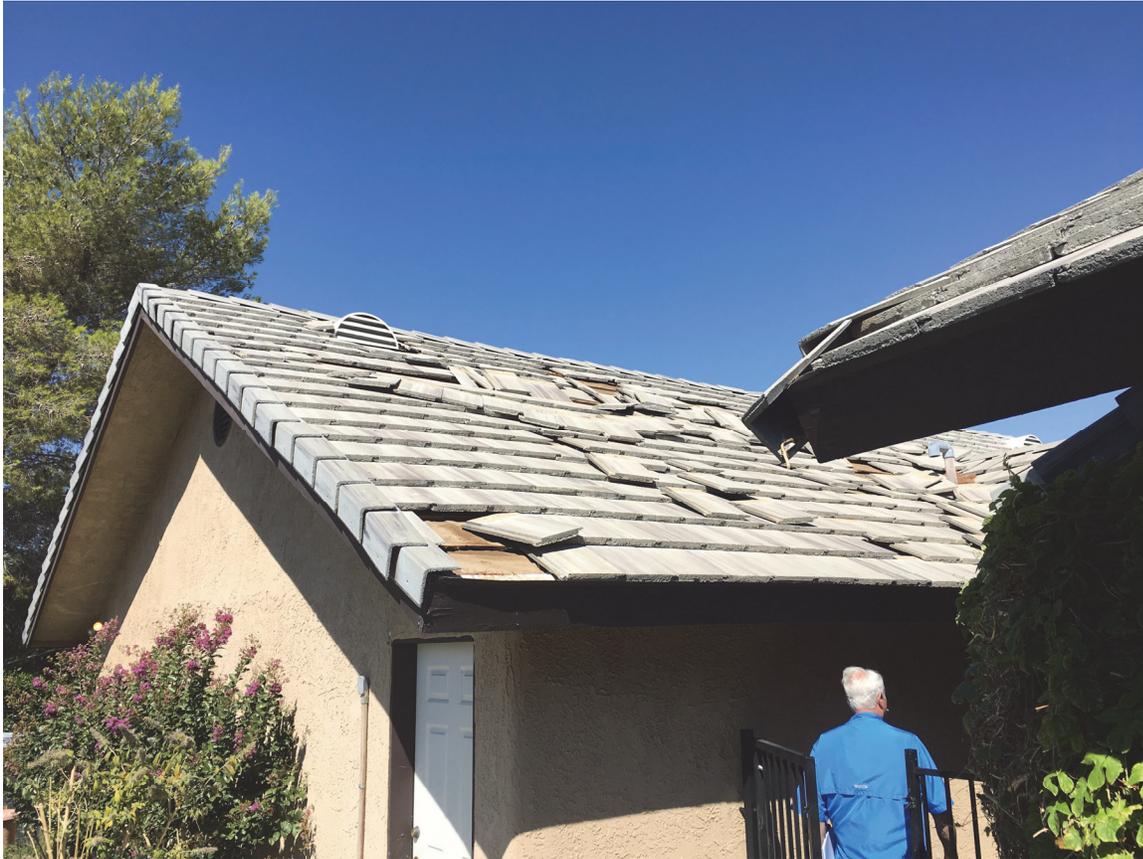
Figure 2-41 Displaced roof tiles caused by the 2019 Ridgecrest, California earthquake (photo credit: M. Ziemer).

Houses typically contain a wide variety of architectural components that can become damaged or dislodged during earthquakes. Common components include clay or concrete roof tiles and brick or stone veneer. Roof tiles can become loose and present falling hazards in the event of aftershocks (Figure 2-41). Brick or stone veneer that is inadequately anchored to walls may separate from the walls or collapse.

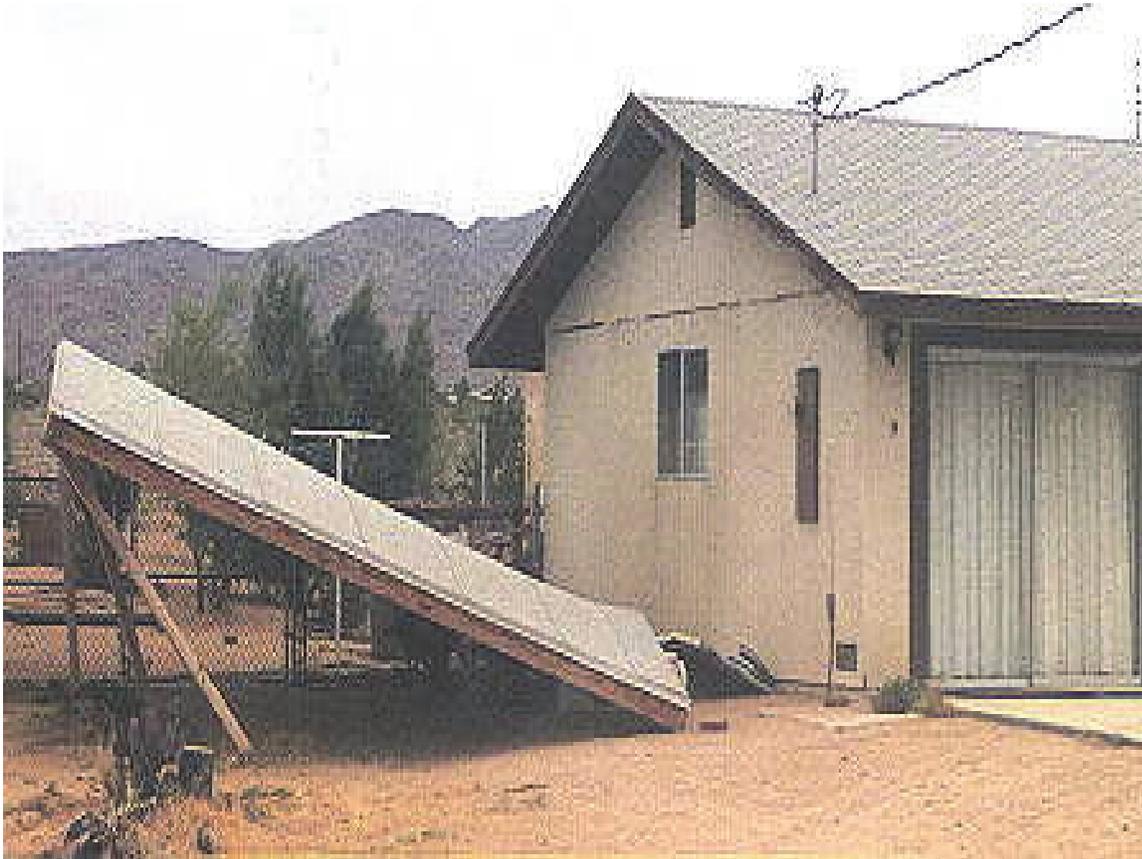
Figure 2-42 Earthquake-caused detachment of the carport from the house wall, resulting in collapse (photo credit: California Office of Emergency Services).

Earthquake damage tends to concentrate where parts of a house with different construction abut or attach to each other. This often occurs at appurtenances, such as exterior decks, porch roofs, carports, or patio covers, where the damage is likely to include cracked finishes, damage to ledgers or fasteners, and residual separations. An appurtenance with no seismic-force-resisting system of its own may be vulnerable to collapse if its attachment to the main structure is damaged (Figure 2-42). Damage to an appurtenance, such as a deck at an entry door, can block ingress and egress to a house

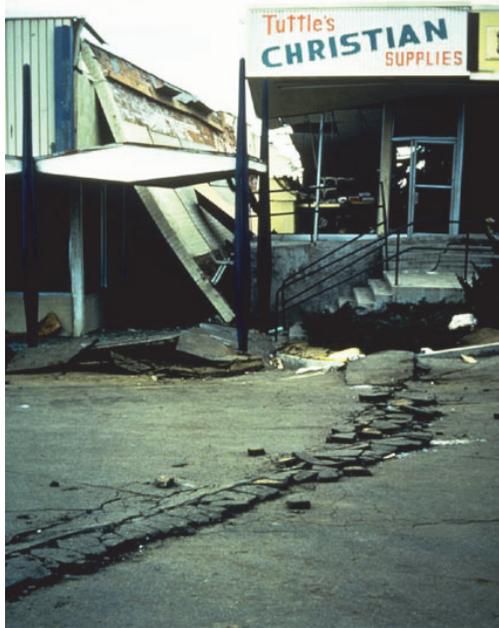
Figure 5-1 Surface fault rupture from the 1971 San Fernando, California earthquake and associated damage to pavement and structures in the Sylmar area (photo credit: National Information Service for Earthquake Engineering, or NISEE).

When fault slip extends to the ground surface, the resulting ground displacements are termed “surface fault rupture” (Figure 5-1). Examples from California with surface fault rupture include the 1906 San Francisco, 1971 San Fernando, 1992 Landers, and 1999 Hector Mine earthquakes.

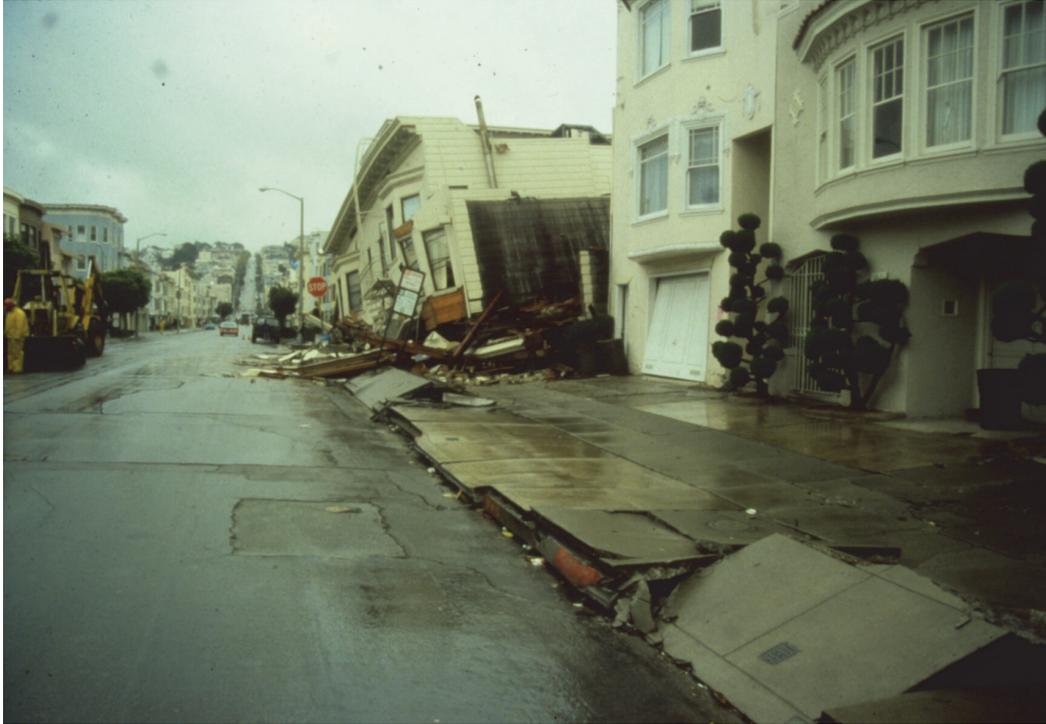
Figure 5-7 Buckled pavement from liquefaction-induced ground oscillations, San Francisco Marina District, 1989 Loma Prieta, California earthquake (Seed et al., 1990).

When liquefaction effects are manifest at the ground surface, such effects may take the form of sand boils and ejecta, settlement, ground fissures, lateral spreads, and landslides (e.g., flow failures). In the absence of driving static shear stresses, liquefaction can result in large transient ground oscillations that can lead to buckled or cracked pavements and curbs and broken pipelines (Figure 5-7). Such damage will typically not have a consistent pattern of lateral displacements.

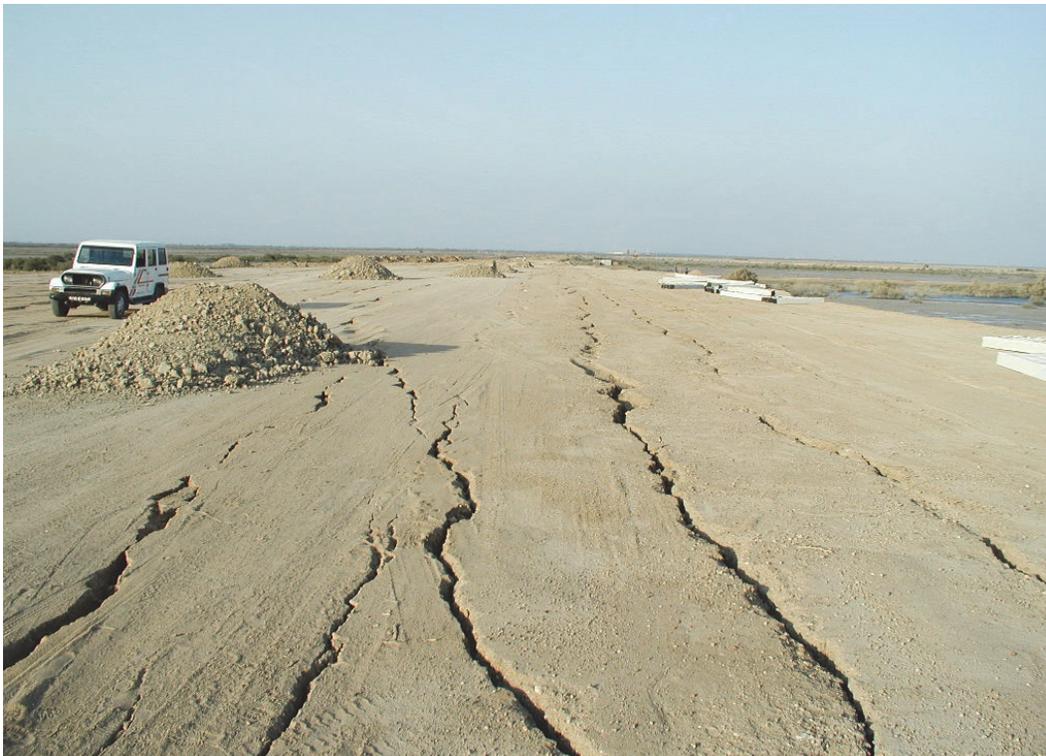
Figure 5-8 Ground cracking of fill from liquefaction-induced cyclic mobility of foundation soils during 2001 Gujarat, India earthquake (photo credit: J. P. Stewart).

When driving static shear stresses are present, liquefaction can lead to lateral spreading from cyclic mobility or a flow slide (Figure 5-8 and Figure 5-9). Surface effects generated by lateral spreads will involve a consistent pattern of lateral ground movement and surface cracking (Youd and Garris, 1995). Post-liquefaction re-consolidation will occur regardless of the static shear stress condition and can result in relatively uniform settlement (Figure 5-10) or can produce differential settlements (Figure 5-11). Liquefaction at shallow depths can cause sand boils to form (Figure 5-12), which occurs when excess pore pressures in a liquefiable strata vent through cracks or openings in overlying non-liquefied layers.

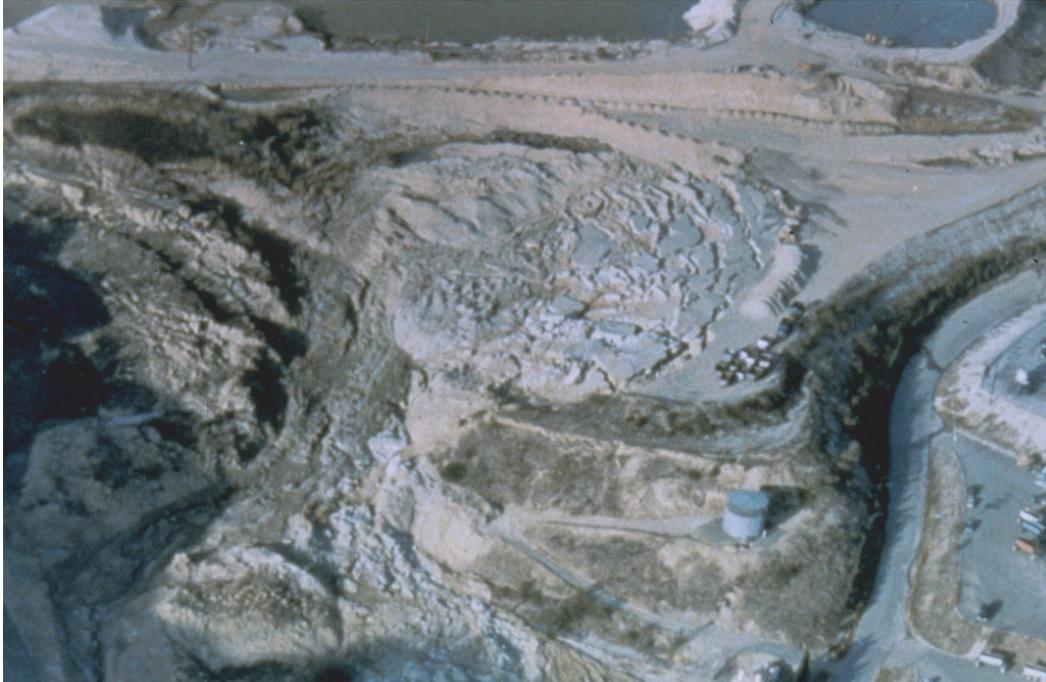
Figure 5-9 Flow slide at Tapo Canyon Tailings Dam, California, 1994 Northridge earthquake (photo credit: Y. Moriwaki).

Lateral spreads and flows can occur in soil on very mild slopes or behind a free-face if the soil is geologically young, has a granular texture, and the groundwater table occurs at shallow depths. The principal technical issues associated with these types of slides are related to the triggering of liquefaction and the estimation of post-liquefaction residual strengths. Both of these issues are addressed in Chapter 7. If these post-liquefaction strengths exceed static shear stresses, the problem is one of cyclic mobility, which in a slope stability context is analogous to lateral spreads. If the post-liquefaction strengths are less than static shear stresses, flow slides will occur that can involve very large displacements, such as shown in Figure 5-9.

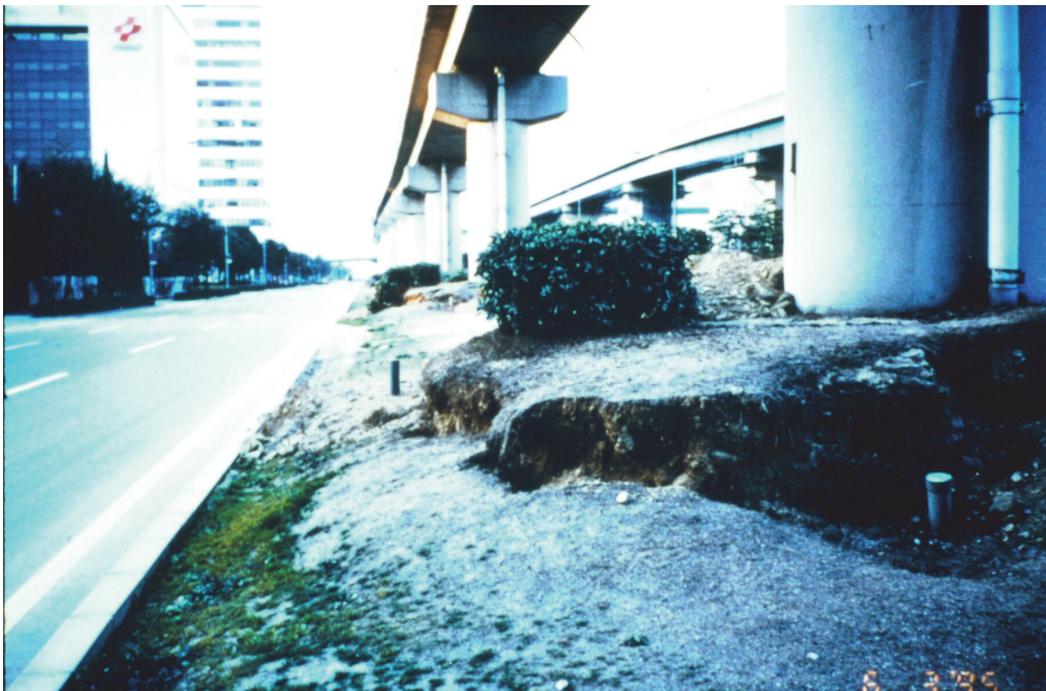
Figure 5-10 Uniform settlement of liquefied fill soils, 1995 Kobe, Japan earthquake. The amount of settlement is shown by the difference between the unsettled pile-supported bridge bent and the surrounding ground. The uniformity of the settlement is shown by the lack of cracking in the pavement (Sitar et al., 1995).
