Earthquake Damage Assessment and Repair Guidelines for Residential Wood-Frame Buildings

Volume 2 | ENGINEERING GUIDELINES

CEA-EDA-02 2020

Earthquake Damage Assessment and Repair Guidelines for Residential Wood-Frame Buildings, Volume 2 – Engineering Guidelines

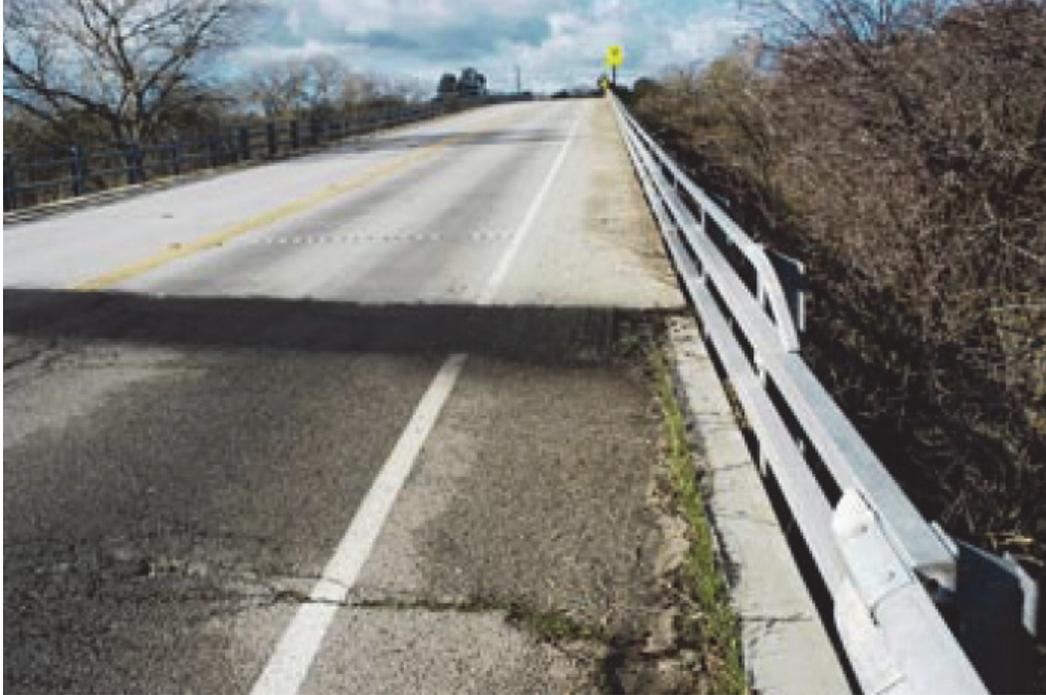
Figure 5-11 Templeton Road Bridge settlement following the 2003 San Simeon, California earthquake. The settlement of approximately 5 inches was a result of liquefaction beneath the bridge abutment foundation (EERI, 2004).

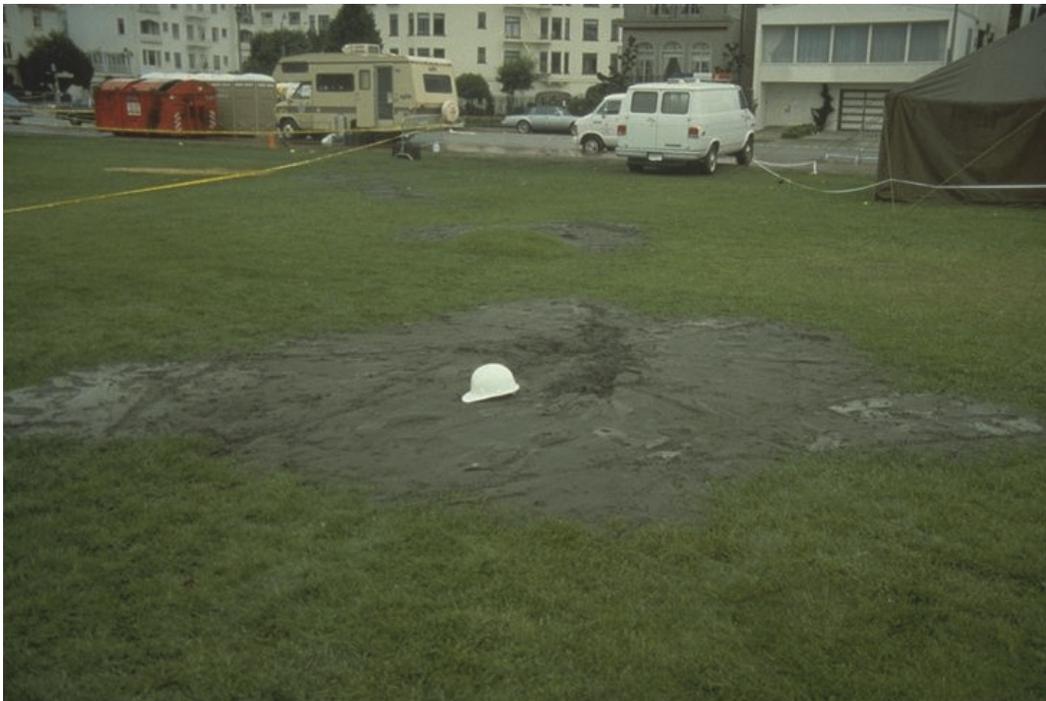
Figure 5-12 Sand ejecta after liquefaction of hydraulic fill from the 1989 Loma Prieta, California earthquake (photo credit: NISEE).

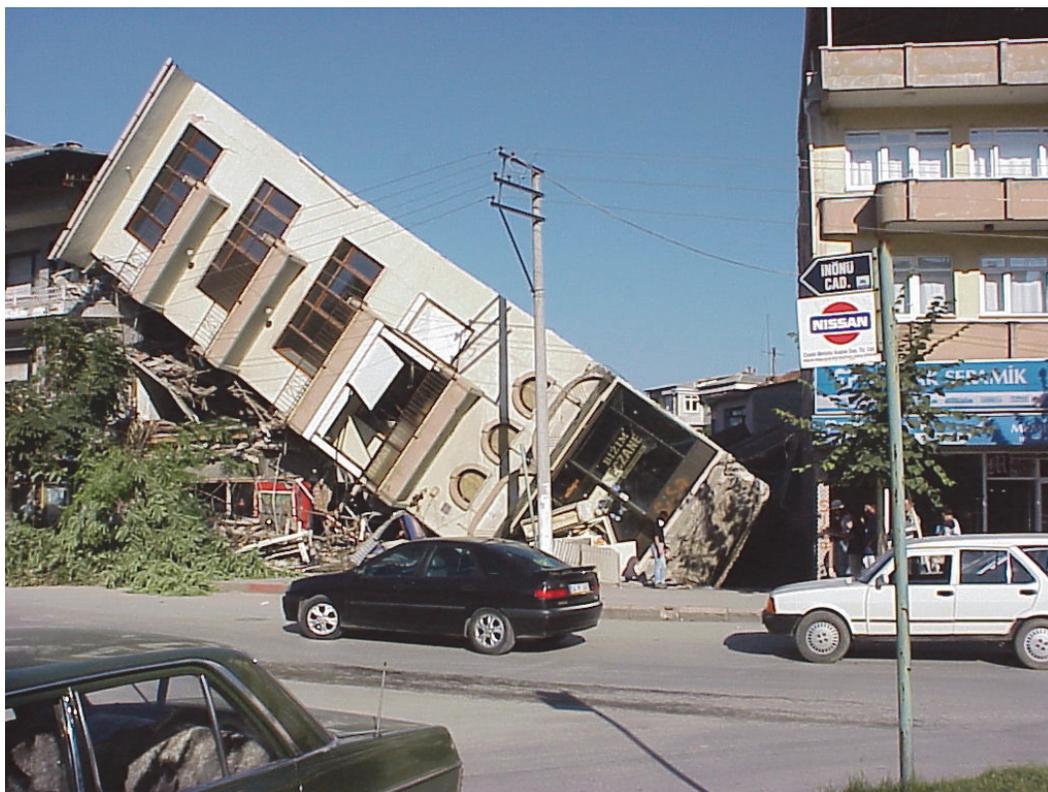
Figure 5-13 Foundation bearing failure of shallow foundation in Adapazari from the 1999 Kocaeli, Turkey earthquake (photo credit: J. P. Stewart).

For structures supported on shallow foundations, liquefaction effects can include foundation bearing failures (Figure 5-13), foundation settlement or tilting or both (Figure 5-14), and lateral translations of foundations (Figure 5-15). Depending on their stiffness and strength and the magnitude of deformations, the foundation elements themselves may or may not be structurally damaged as these deformations occur.

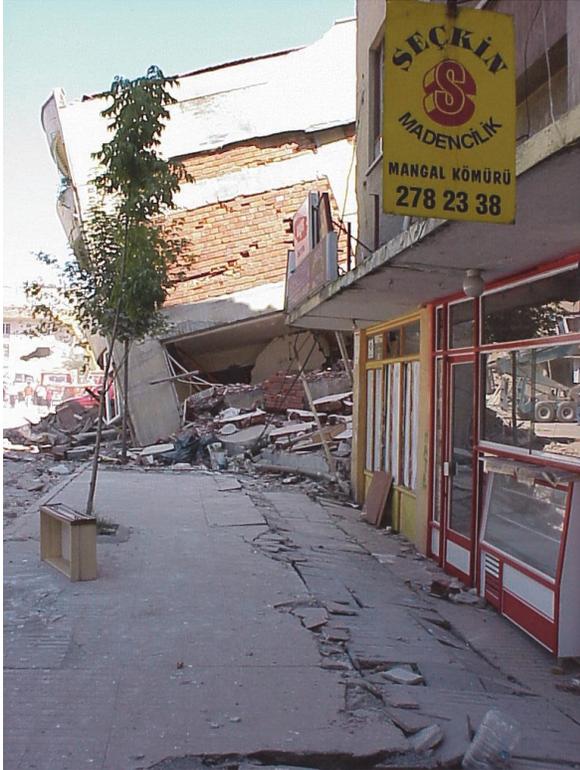
Figure 5-14 Settlement relative to surrounding ground (foreground) of mat foundation in Adapazari from the 1999 Kocaeli, Turkey earthquake (photo credit: J. P. Stewart).

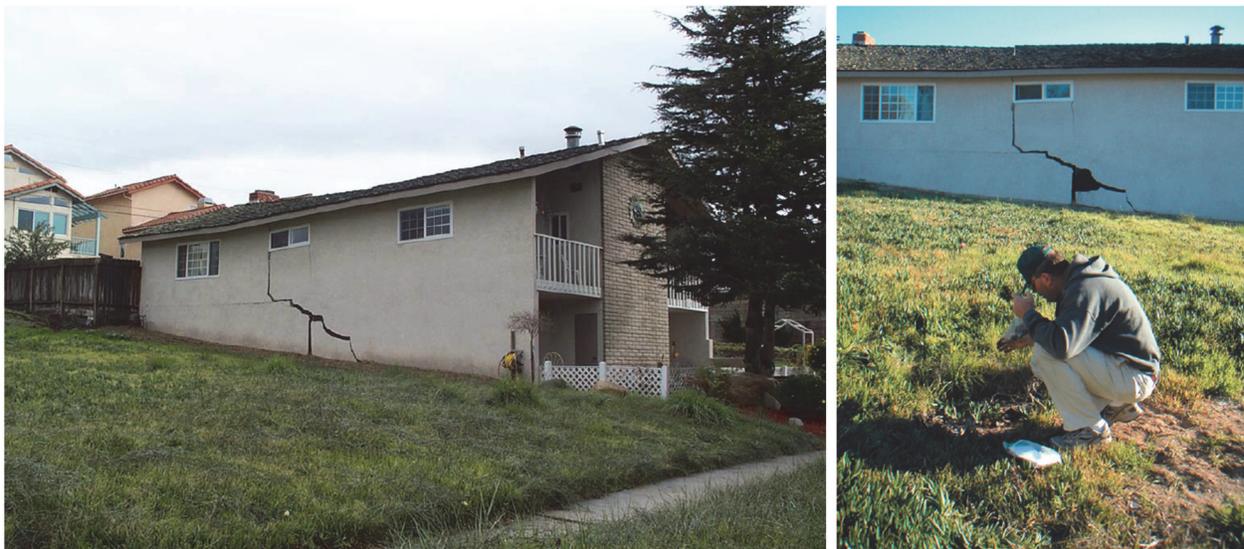
Figure 5-15 Damage to a residence in Oceano, California from lateral spreading following the 2003 San Simeon earthquake. Photo (right) taken along head scarp offset and its intersection with residence foundation (photo credits: San Luis Obispo County Department of Planning & Building, left; Holzer et al., 2004, right).

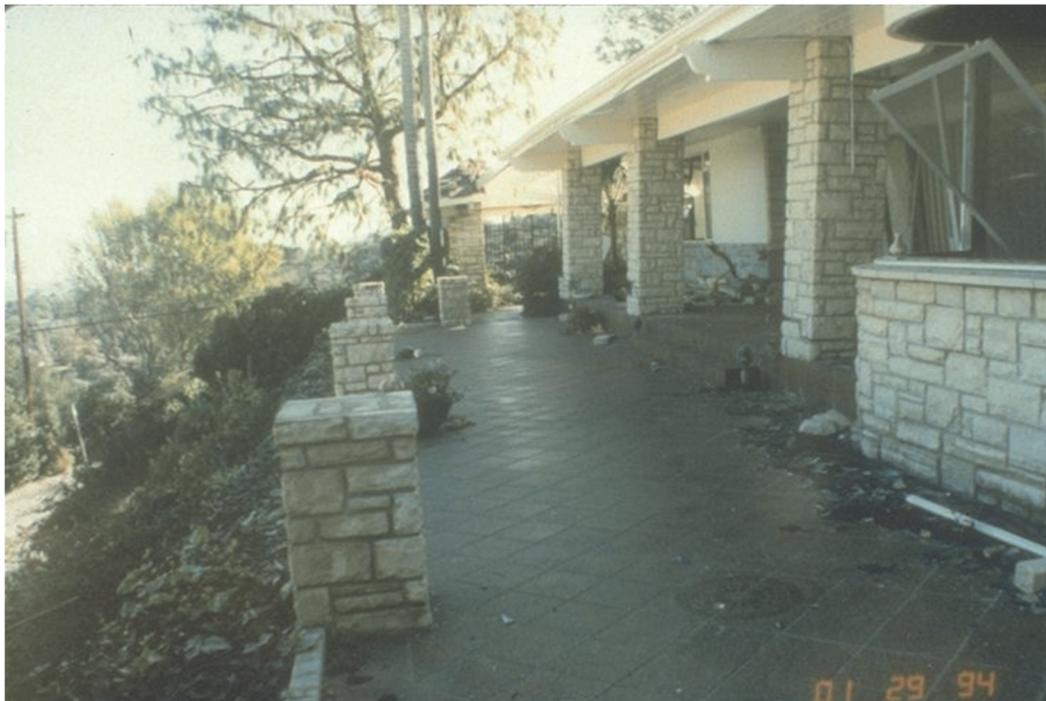
Figure 5-16 Structure damaged by movements in wedge fill from the 1994 Northridge, California earthquake (photo credit: NISEE).

Seismic compression is defined as the accrual of contractive volumetric strains in unsaturated soil during strong shaking from earthquakes. Such strains may result in ground surface settlements and potential lateral movements near slopes (Figure 5-16). This process has been observed to be especially prevalent in artificial fill soils. Ground deformations in compacted fill slopes from seismic compression are well documented in the literature (Pyke et al., 1975; Stewart et al., 2001; Stewart et al., 2004a) and are recognized as representing a significant hazard with respect to collateral loss during earthquakes (SSC, 1995).

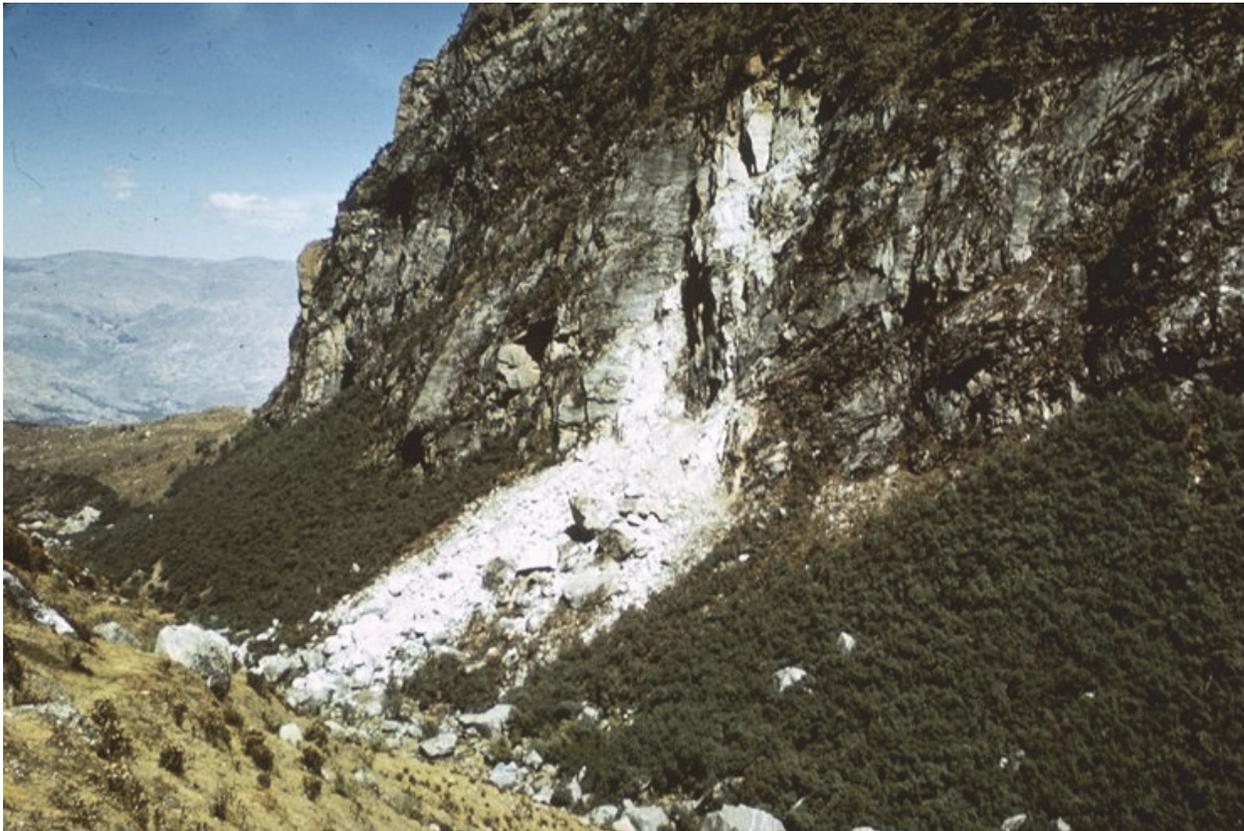
Figure 5-18 Rockfall from the 1970 Peru earthquake (photo credit: NISEE).

- masses of disrupted slide material, such as rock falls or avalanches (Figure 5-18)
- relatively coherent slide masses whose displacement is accommodated along well-defined slip surfaces or across relatively broad, distributed shear zones
- lateral spreads and flows associated with soil strength loss due to pore pressure increase

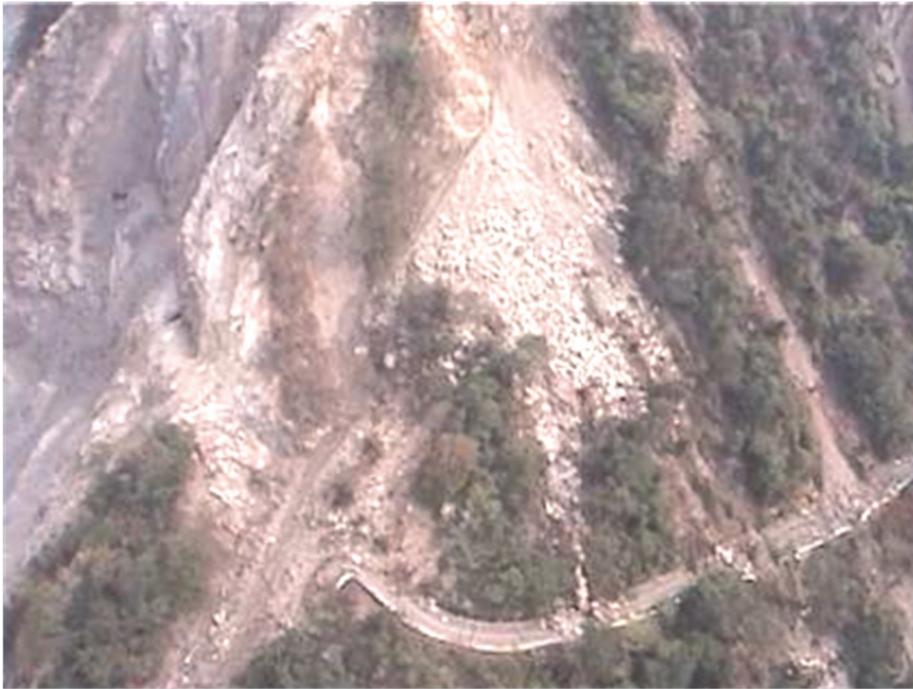
Figure 5-19 Example of disrupted landslide—rockfall in central Taiwan from 1999 Chi Chi, Taiwan earthquake (photo credit: J. P. Bardet).

Disrupted slides and falls, as described by Keefer (1984), occur in areas of high topographic relief (slopes steeper than 35 degrees to 40 degrees) and tend to involve closely jointed or weakly cemented materials (Figure 5-19). Rock avalanches are a particularly damaging type of disrupted slide, involving slide masses that originate in steep terrain and disintegrate into streams of rock that can travel large

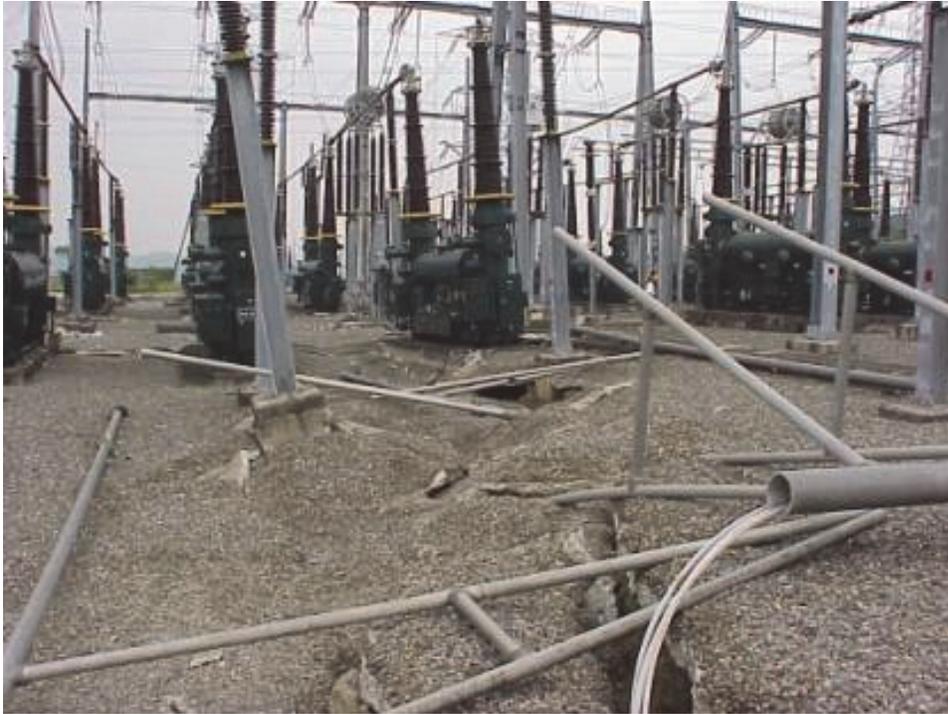
Figure 5-20 Head scarp of coherent landslide at Junliu Switching Station, Taiwan, induced by 1999 Chi Chi, Taiwan earthquake. Slide movements of approximately 3 feet to 4 feet occurred along a bedding plane in rock (photo credit: J. P. Stewart).

Coherent slides can occur in rock or soil materials and at slope angles much lower than those for disrupted slides and falls (Figure 5-20). Coherent slides in rock typically involve slip along basal surfaces weakened by weathering, jointing, or prior shearing, or along bedding planes and other discontinuities that dip out of slope. Keefer (1984) reports that coherent slides in rock masses have occurred on slopes as shallow as 15 degrees. Coherent slides in soil can occur along basal slip surfaces or relatively distributed shear zones. These slides most commonly involve fill embankments (i.e., sliding occurring within the embankment materials or in relatively soft foundation soils) (Rogers, 1992; Bardet et al., 2002) but have also been widely documented in natural alluvial soils (Keefer, 1984).

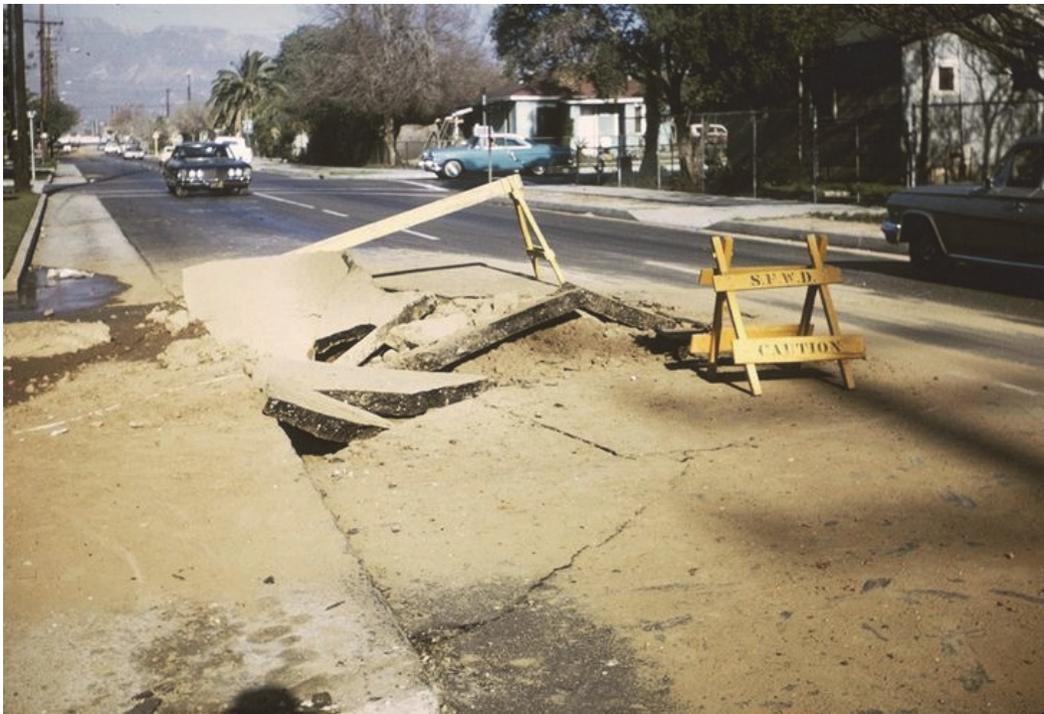
Figure 6-2 Pipe failures and resulting pavement distress and settlement from the 1971 San Fernando, California earthquake (photo credit: NISEE).

- **Utility lines.** Utility lines can be sensitive to ground deformations and breaks in these lines can be a good indicator of permanent ground deformation. Examples of these utilities include water service pipes, water mains, sanitary sewer pipes, and gas pipes (Figure 6-2). If possible, modes of pipe failure should be noted (e.g., extension, shear, compression). When the reconnaissance is performed after an earthquake, repairs of underground utilities by municipalities may have already occurred; hence, recently patched areas of streets may be evidence of underground utility repair (i.e., water or sewer pipe breaks).

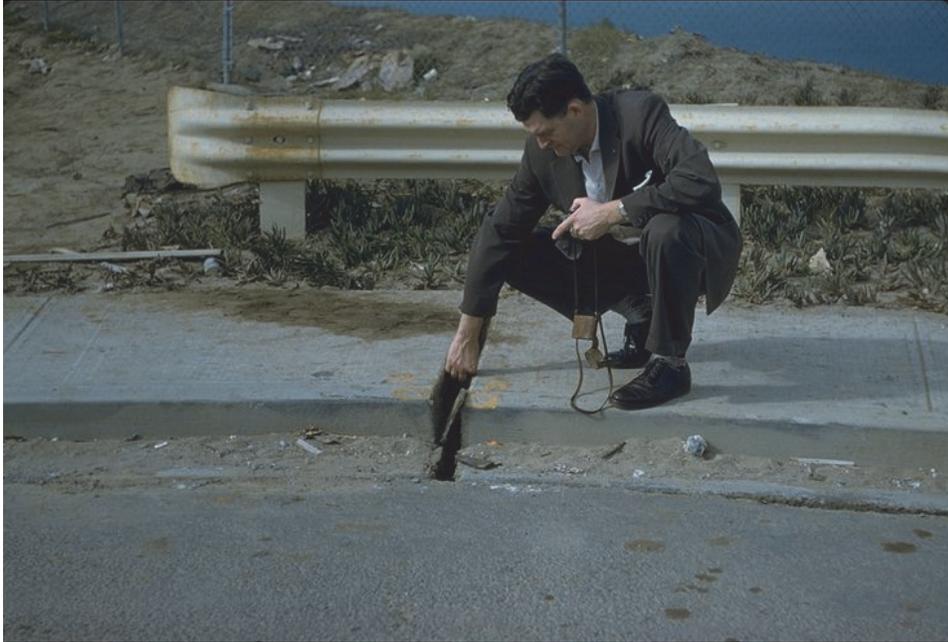
Figure 6-3 Separation in sidewalk from 1957 Daly City, California earthquake (photo credit: NISEE).

- **Nearby houses.** Damages to nearby properties are good indicators of the intensity of shaking experienced at a house. The condition of improvements with different vulnerabilities to earthquake damage should be noted. For example, damage to utility lines, flatwork (Figure 6-3), or foundations (Figure 6-4) at nearby houses are indicators of permanent ground deformation that warrant consideration at the subject site. However, block wall damage is common even at low intensity of earthquake shaking and is not a good indicator of earthquake-induced permanent ground deformation if the crack pattern in the wall is inconsistent with a prevailing pattern of ground deformation.

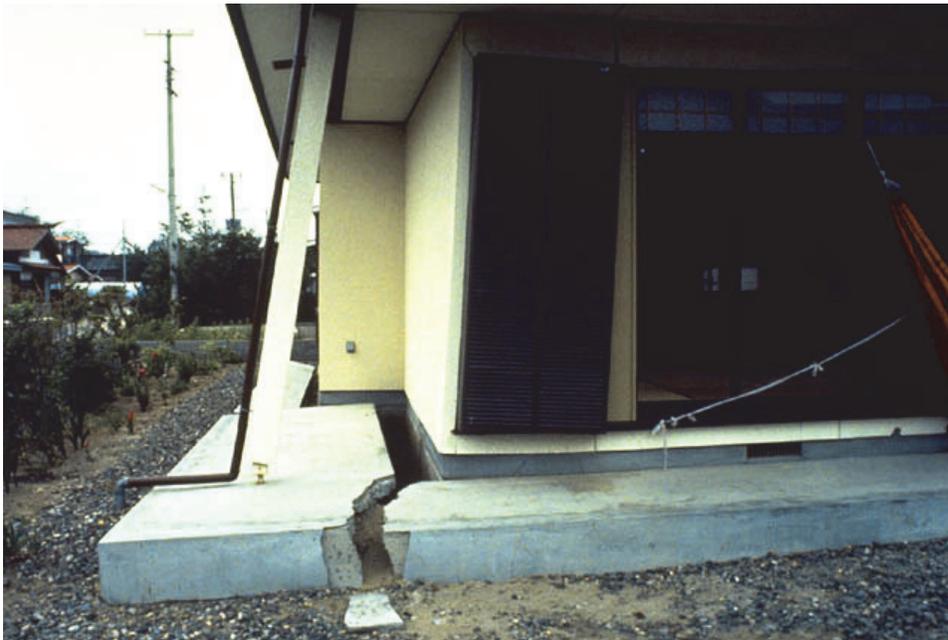
Figure 6-4 Damage to house foundation in Wakami, Japan, caused by lateral spreading following the 1983 Nihonkai-Chubu, Japan earthquake (photo credit: NISEE).

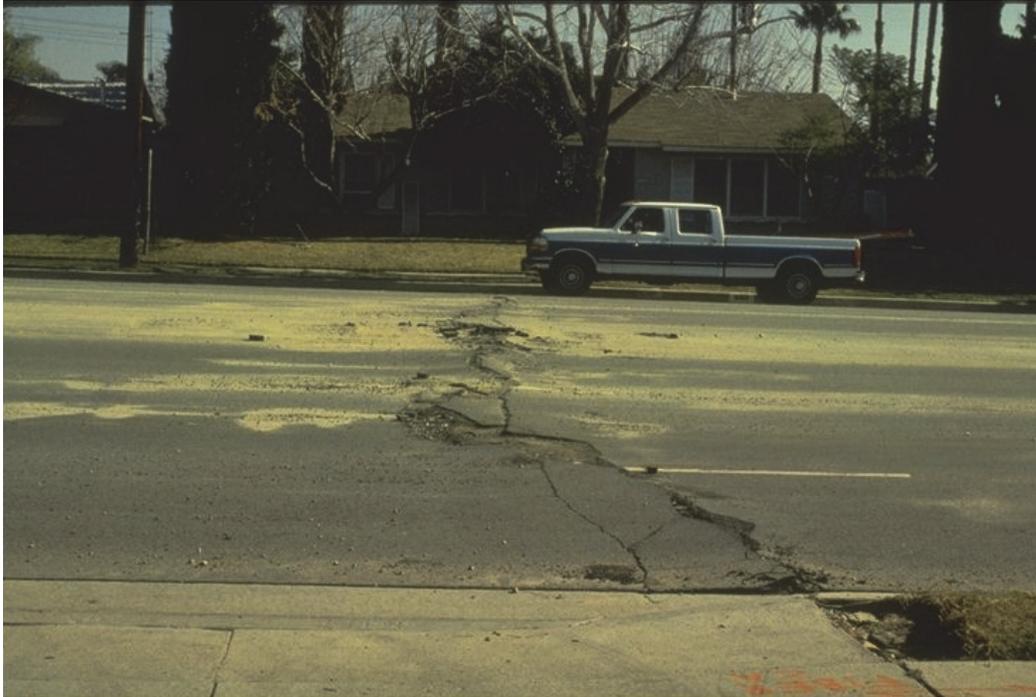
Figure 6-6 Localized compression feature and pavement damage from the 1994 Northridge, California earthquake (photo credit: NISEE).

- **Hardscape and flatwork.** Fresh cracks in hardscape or flatwork (e.g., driveways, patios, sidewalks) or the opening of construction joints are good indicators of earthquake-induced permanent ground deformation, especially if the cracking pattern is consistent with a prevailing pattern of ground deformation. Also, fresh-appearing out-of-levelness in patios, decks, or other hardscape or flatwork inconsistent with normal construction practices (e.g., patios adjacent to structures are sloped away from the building for drainage) are indicators of potential earthquake-induced permanent ground deformation. However, fresh cracks that form a random pattern may represent pre-earthquake damage that was worsened by the earthquake shaking. Indicators such as paint or debris within cracks, previous patching of cracks, and previous releveling are good indicators of pre-earthquake damage possibly associated with static ground deformation (see Figure 6-6, Figure 6-7, Figure 6-8, and Figure 6-9).

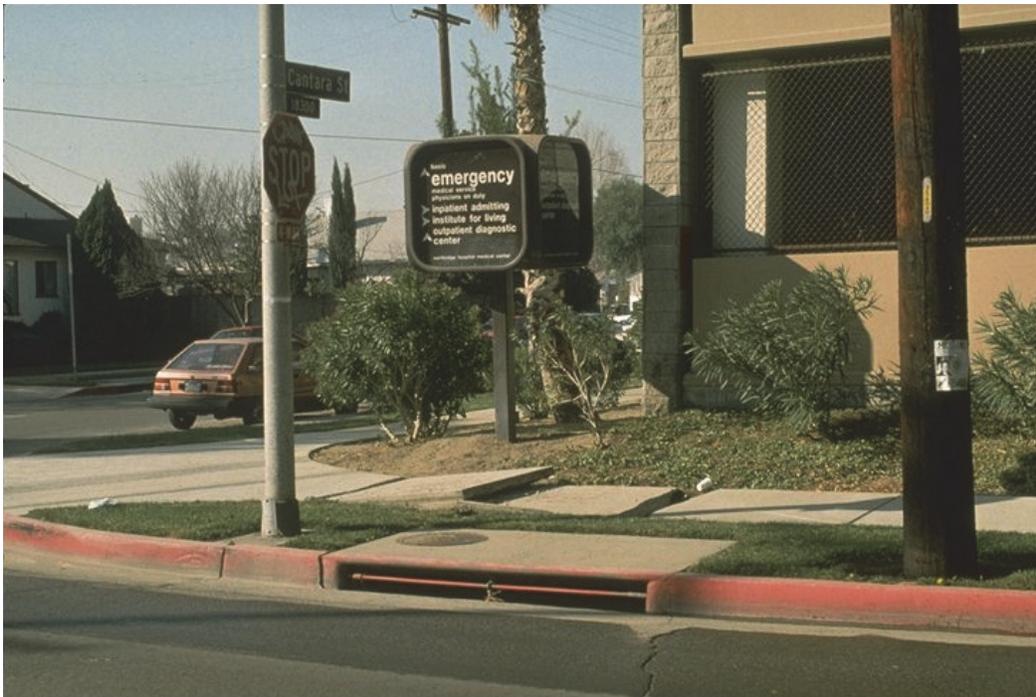
Figure 6-7 Sidewalk buckled from lateral compression by the Northridge Hospital Medical Center from the 1994 Northridge, California earthquake (photo credit: NISEE).

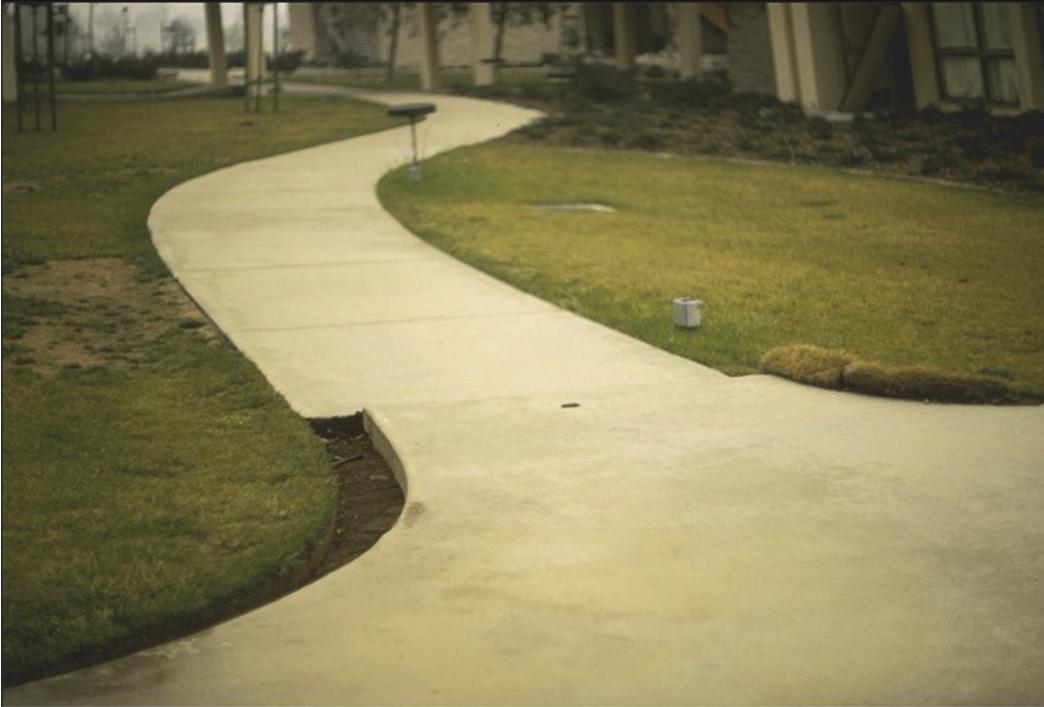
Figure 6-8 Offset sidewalk from the 1971 San Fernando, California earthquake (photo credit: NISEE).

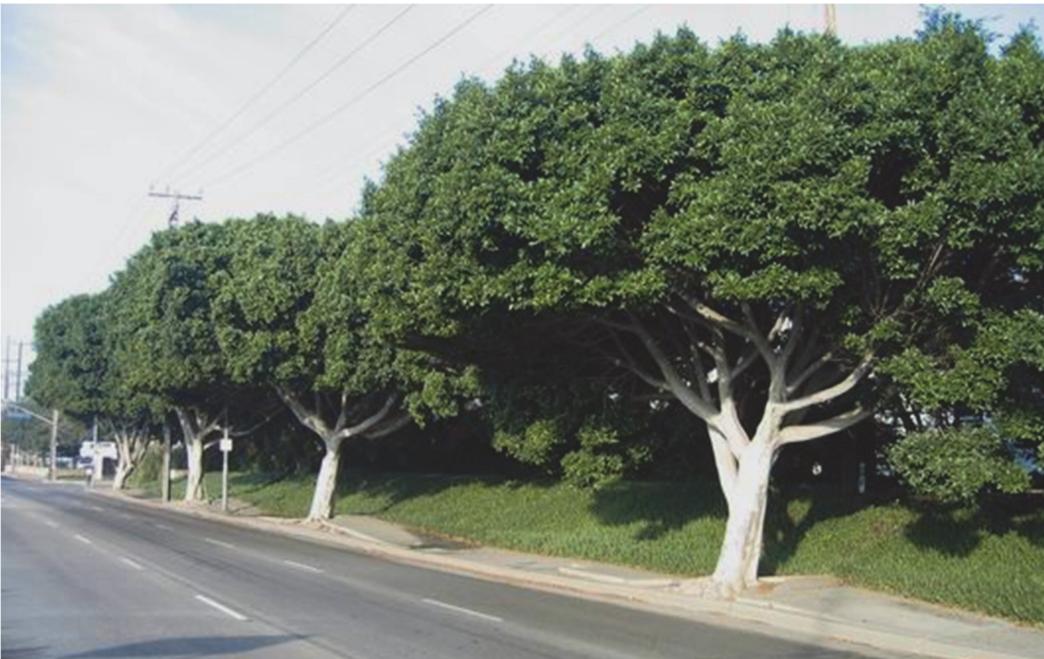
Figure 6-9 Tree root damage to sidewalks and other surface improvements is common and not associated with earthquake damage (photo credit: Exponent).

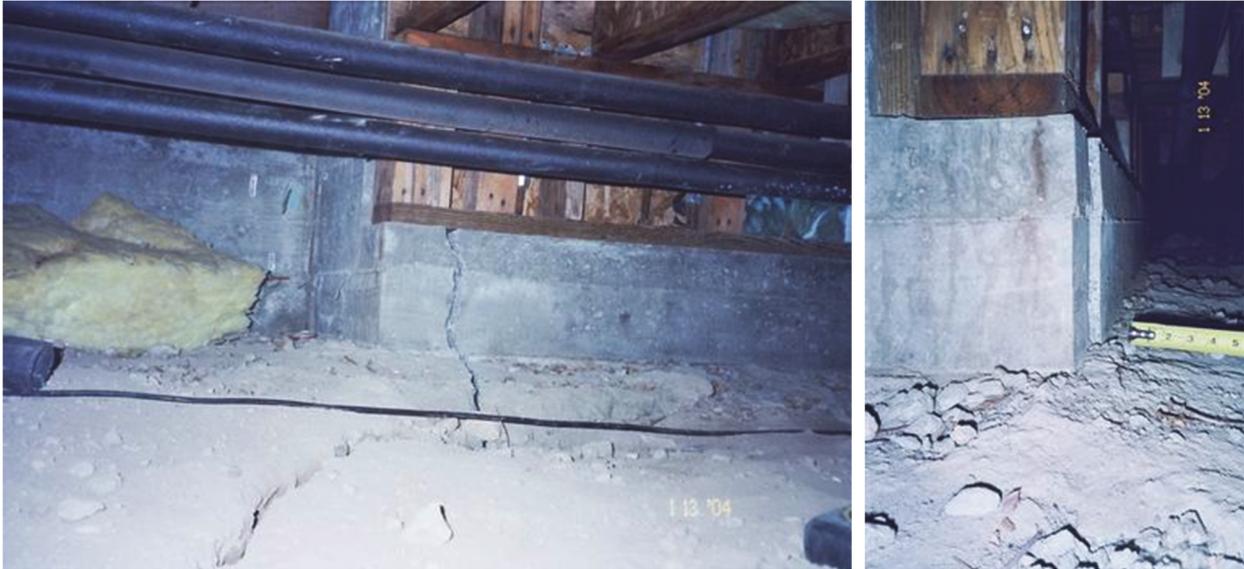
Figure 6-11 Foundation and ground cracking following the 2003 San Simeon, California earthquake, where the photo on the right shows the offset present across foundation crack (photo credits: Exponent).

- Foundations.** Indicators of earthquake-induced permanent ground deformation related to foundation performance include: (a) fresh cracking in concrete foundation elements; (b) soil deformations adjacent to foundations (e.g., bulging or tension cracks); and (c) out-of-levelness consistent with conspicuous earthquake damage to adjacent house walls (Figure 6-11).

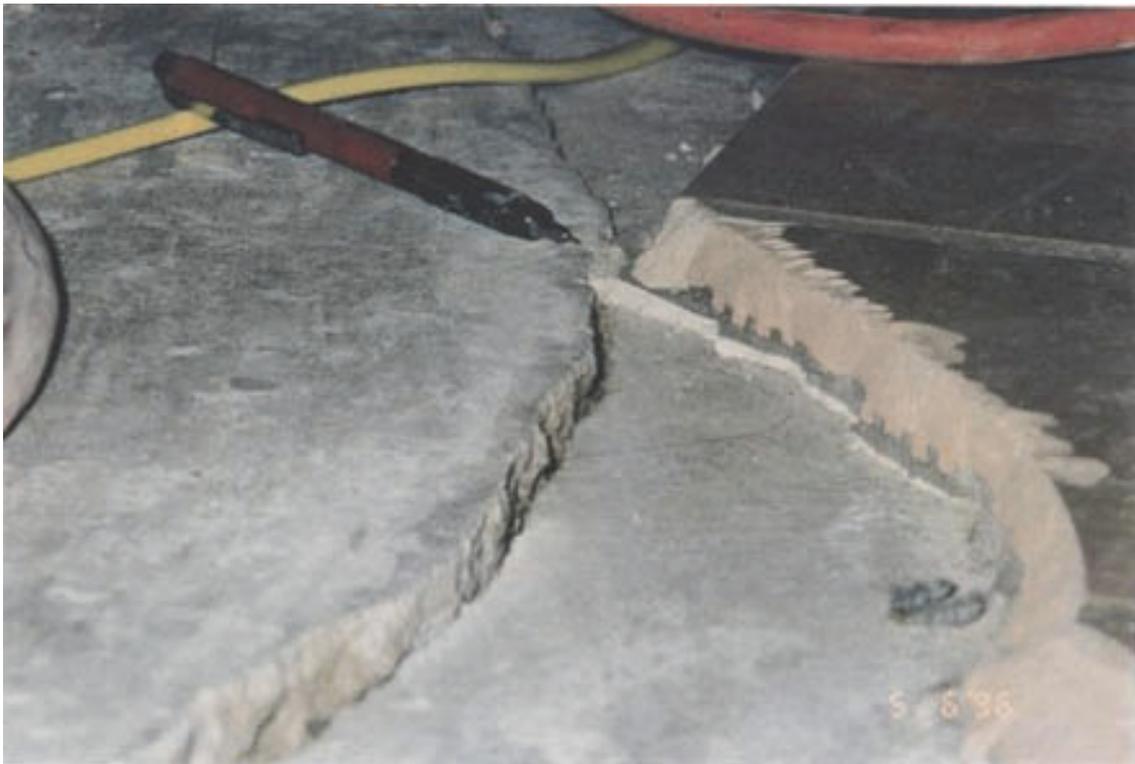
Figure 6-12 Grout completely filling the slab-on-grade crack (indicated by pencil) indicates that slab crack was present at the time of the tile installation and has not experienced movement since tile installation (photo credit: Exponent).

- Fresh cracking in concrete foundation elements** requires direct inspection of the foundation elements. This inspection can be performed along the sides of a structure, from direct inspection of interior floor slabs (which may require rolling back carpet), or from crawlspace inspections. If foundation concrete is not directly visible, geotechnical consultants can look for fresh cracks in tiles applied to slab-on-grade surfaces or in wall finishes (e.g., stucco) above the foundation elements. Fresh cracking in any of these elements indicates potential earthquake-induced permanent ground deformation. Conversely, patching of cracks, debris within cracks, or evidence of previous releveling are indicators of long-term, re-occurring ground movement unrelated to earthquake shaking (Figure 6-12, Figure 6-13, and Figure 6-14).

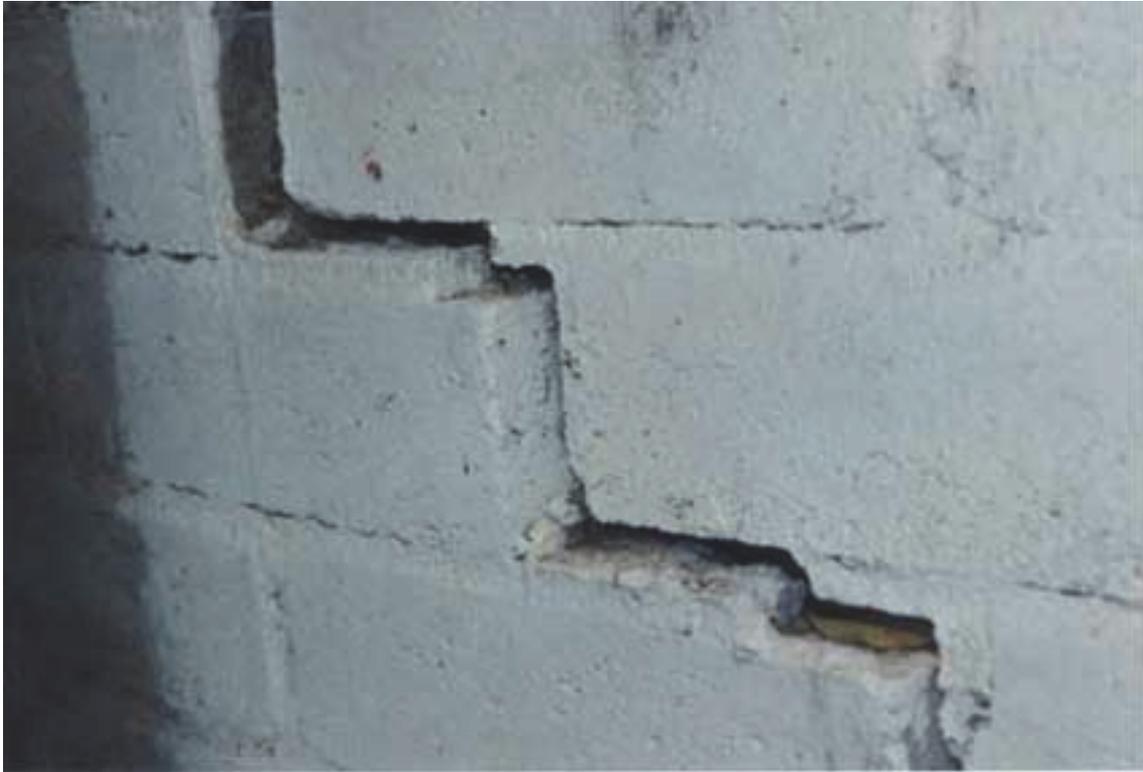
Figure 6-13 Paint within concrete block wall crack indicates that the crack was present at the time of last painting (photo credit: Exponent).

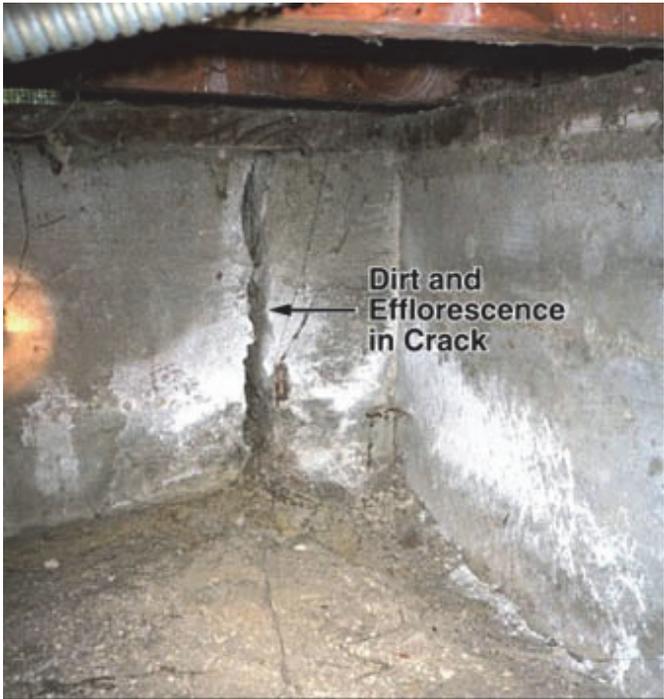
Figure 6-14 Dirt and efflorescence indicates age of foundation wall crack is not recent (photo credit: Exponent).

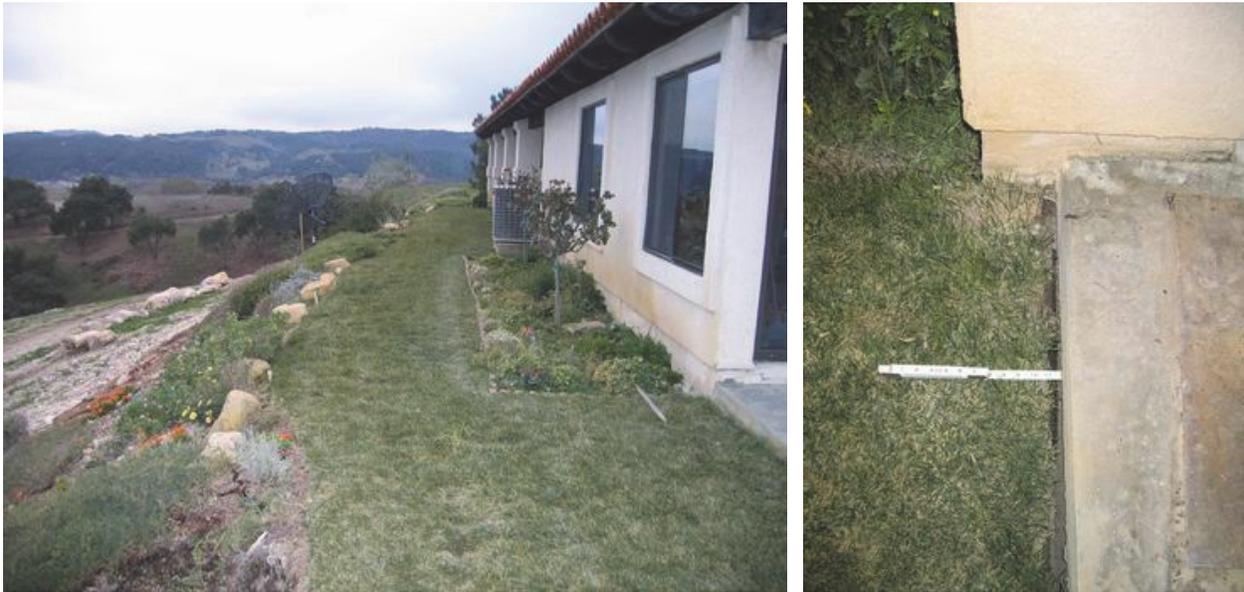
Figure 6-15 Ground separation from residence along slope side of structure following the 2003 San Simeon, California earthquake (image credit: Exponent).

- **Soil deformation near the foundation** involves permanent ground deformation that is localized around foundations, indicating full or partial bearing failure or foundation sliding (Figure 6-15). This mode of permanent ground deformation usually results from seismic pore-pressure induced strength loss in foundation soils (i.e., liquefaction), and in past earthquakes has generally only been observed in structures with significant bearing loads (typically 3 stories or more in height).

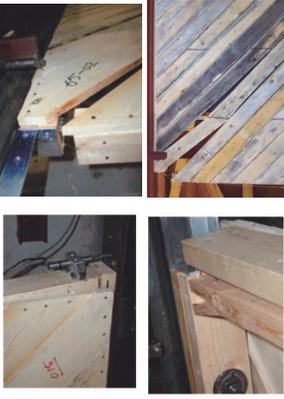
Wall behavior at failure was generally characterized by two types of failure modes: failure of perimeter nails or failure of walls at corners before perimeter nail capacity could be developed

<p>Failure modes of tested shear walls</p>	> 3%

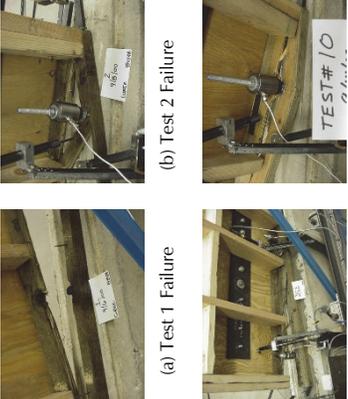
Specimen	Damage Description	Damage Appearance	Sill Horizontal Displacement at Anchor Bolt (test group average)	Hysteresis Curve (load vs. sill horiz. disp. at anchor bolt)
Sill plate-to-foundation anchorage with steel threaded rod anchor bolts and 2x sill plates (horizontal loading applied 1 foot above base of wall)	Sill plate-to-foundation anchorage behavior for loads approaching ultimate capacity was typically characterized by yielding of the anchor bolts in bending and elongation of the bolt holes at the sill plate	Not Provided	Not Provided	Not Provided
Sill plate-to-foundation anchorage behavior at failure was typically characterized by splitting of the sill plate. This occurred as net uplift forces on the test specimens increased and the sill plate bent and twisted due to uplift forces in the plywood and the inherent eccentricity between the plywood and the anchor bolts	Sill plate-to-foundation anchorage behavior at failure was typically characterized by splitting of the sill plate. This occurred as net uplift forces on the test specimens increased and the sill plate bent and twisted due to uplift forces in the plywood and the inherent eccentricity between the plywood and the anchor bolts

<p>(a) Test 1 Failure (b) Test 2 Failure (c) Test 6 Failure (d) Test 10 Failure</p>	0.25 inches to 0.50 inches
