Background Document

FEMA P-58/BD-3.9.24

Fragility of Transformers

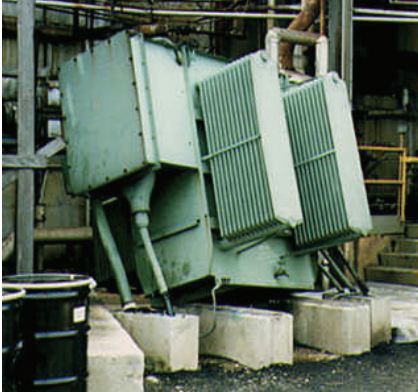
Fragility, damage measures, and consequences for	
Component category:	D5011.010 Transformer, unknown installation D5011.011 Transformer, well anchored, cabinets within ½ inch are bolted together, strong load path to floor, no large nearby items that could fall on generator, internal coils firmly restrained D5011.012 Transformer unanchored but restrained by adjacent equipment D5011.013 Transformer, 1 deficiency (typ unanchored)
Basic composition:	Varies; see Figure 1
Units:	ea
Number of damage states:	1
If multiple damage states:	<input type="checkbox"/> ordered; <input type="checkbox"/> mutually exclusive; <input type="checkbox"/> simultaneous
Author and date:	K Porter 05 Oct 2009
Damage states, fragilities, and consequences for D5011.010, average or unknown installation conditions. For other conditions see Table 7.	
	DS1
Description:	Inoperative
Illustration:

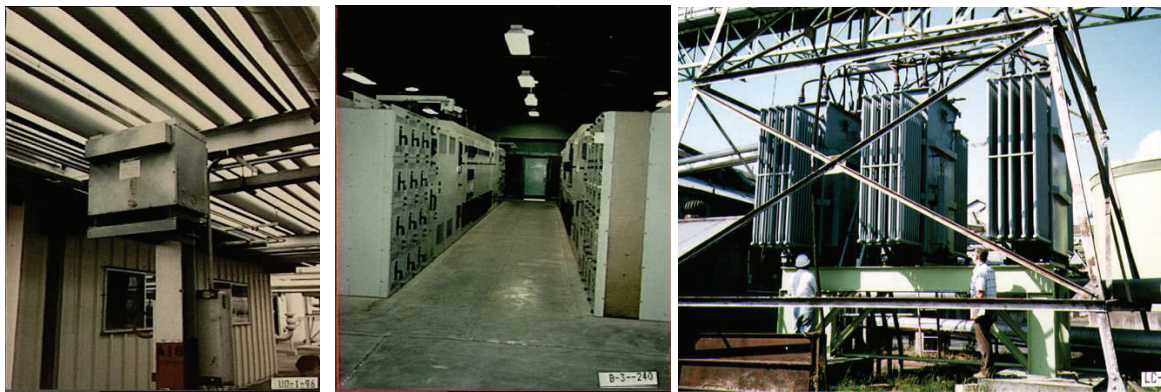
Figure 1. Some varieties of transformer: (a) 100 lb, 480/120V column-mounted, (b) 2400/480V transformers and attached switchgear
