# Background Document

## FEMA P-58/BD-3.8.1

# Fragility Curves for Wood Light-Frame Structural Systems

Charles Ekiert and Andre Filiatrault  
Department of Civil, Structural and Environmental Engineering  
University at Buffalo, State University of New York  
Buffalo, New York 14260

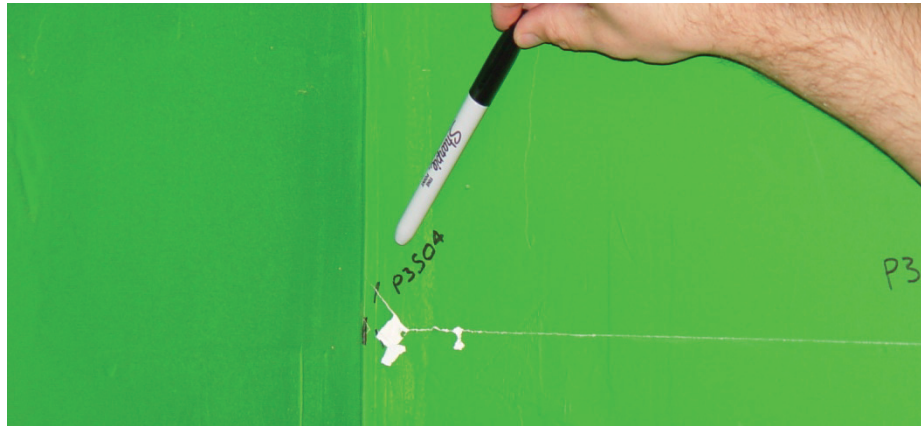
**Figure 1 - Damage State 1 for Partition Walls with Gypsum Wallboard: Dimpling of Wallboard over Nail/Screws, Cracking at Vertical or Horizontal Seams (from Christovasilis et al. 2007).**

could easily be repaired by replacing the tape along the seam of two adjacent panels, applying new joint compound, sanding and re-painting. For the complete replacement damage state  $DS_2$ , the entire panel would need to be replaced along with the application of new tape and joint compound, sanding and re-painting. Experimental results have shown that studs are typically not damaged by the failure of gypsum wallboard and, therefore, replacement of the studs is not considered in the damage states. These two damage states for gypsum wallboard partitions are listed in Table 1 and illustrated by photographs in Figs. 1 and 2.

Damage States ( $DS_i$ )	Description of Damage State
$DS_1$	Cracking of paint over fasteners or joints (Fig. 1)
$DS_2$	Local and global buckling out-of-plane and crushing of gypsum wallboard (Fig. 2)

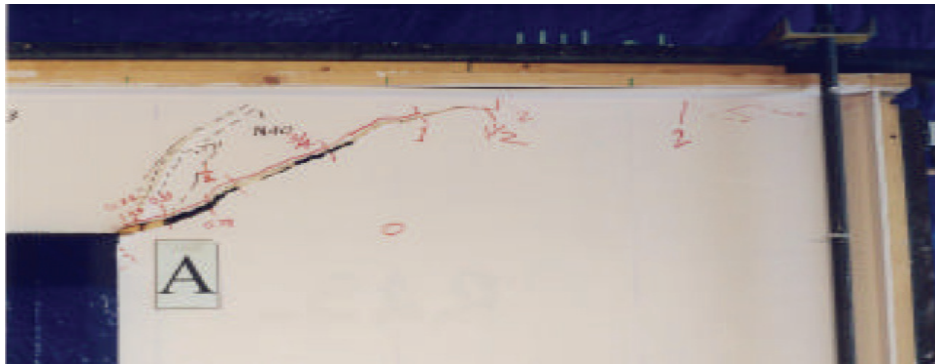
**Figure 2 - Damage State 2 for Partition Walls with Gypsum Wallboard: Global/or Local Buckling and Crushing of Wallboard (from McMullin et al. 2001).**

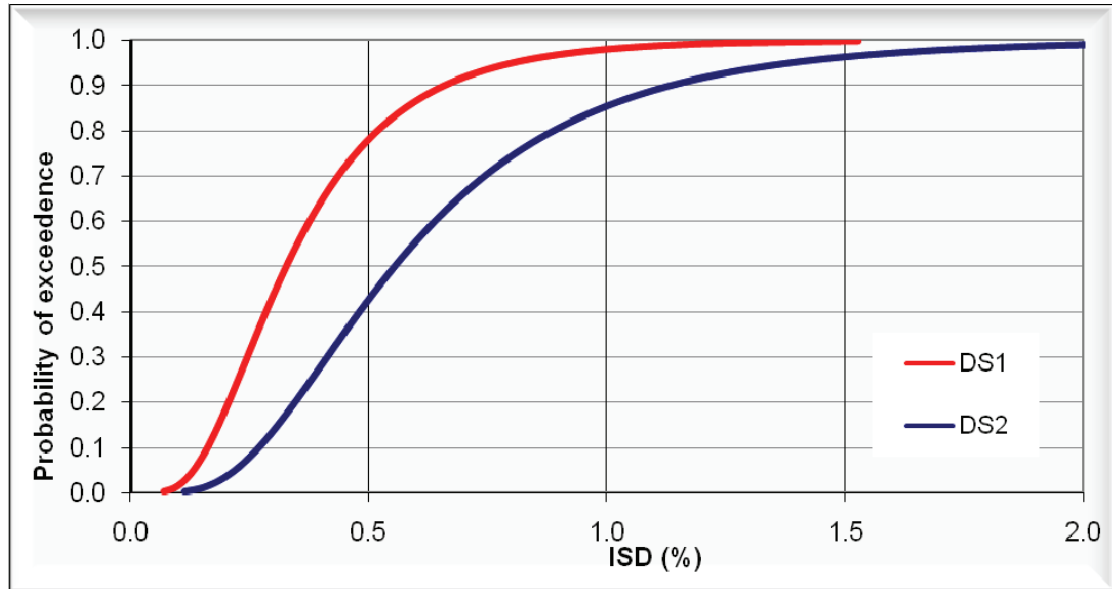
**Figure 3 - Fragility Curves for Partition Walls with Gypsum Wallboard.**

The fragility curves for the two damage states of gypsum wallboard partitions are shown in Fig. 3. The median and dispersion for each fragility curves are listed in Table 2.

Damage States	Demand Parameter (DP)	Median ( $\theta$ ) <sup>*</sup>	Dispersion ( $\beta$ )
DS <sub>1</sub>	Inter-Story Drift ISD (%)	0.33	0.55
DS <sub>2</sub>		0.56	0.56

For walls incorporating OSB/Plywood sheathing, three damage states were defined based on the type of repairs that would need to be conducted besides that to the gypsum wallboard. For damage to gypsum wallboard, the fragility curves developed in Section 2 and shown in Fig. 3 should be used independently. The three types of repairs considered are 1) DS<sub>1</sub>, re-nailing of wood sheathing, 2) DS<sub>2</sub>, replacement of wood sheathing and 3) DS<sub>3</sub>, replacement of the entire wall. For the re-nailing damage state DS<sub>1</sub>, a contractor would need to remove the exterior siding, replace the nails that came loose in the wood sheathing and reapply the siding. The DS<sub>2</sub> repairs would consist of removing the siding and wood sheathing, then replace with new sheathing and reapply the siding. For the complete DS<sub>3</sub> replacement, the entire wall, including studs, top plate and sill, would need to be taken out and all new members installed. The damage states are listed in Table 3 and illustrated by photographs in Figs. 4 to 6.

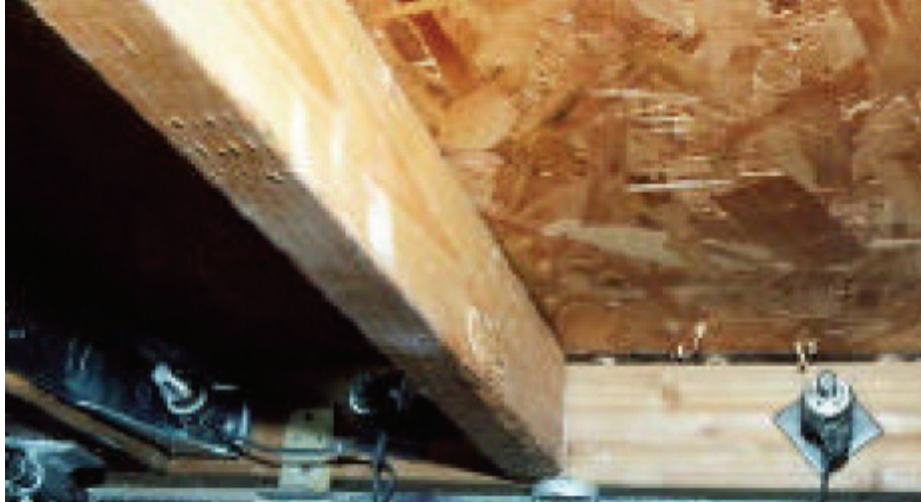
**Figure 4 - Damage State 1 for Walls with OSB/Plywood Sheathing (System #50): Slight Separation of OSB/Plywood from Framing (from Pardoen et al. 2002).**

Damage States (DS <sub>i</sub> )*	Description of Damage State
DS <sub>1</sub>	Slight separation of sheathing or nails come loose (Fig. 4)
DS <sub>2</sub>	Permanent rotation of sheathing, tear out of nails or sheathing tear out (Fig. 5)
DS <sub>3</sub>	Fracture of studs, major sill plate cracking (Fig. 6)

Damage States (DS <sub>i</sub> ) <sup>*</sup>	Description of Damage State
DS <sub>1</sub>	Slight separation of sheathing or nails which come loose (Fig. 4)
DS <sub>2</sub>	Permanent rotation of sheathing, tear out of nails or sheathing (Fig. 5)
DS <sub>3</sub>	Fracture of studs, major sill plate cracking (Fig. 6)

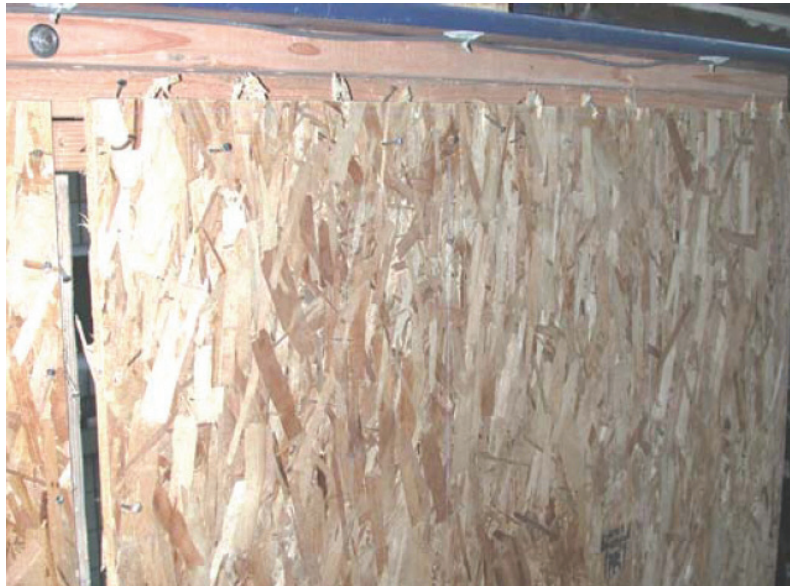
**Figure 5 - Damage State 2 for Walls with OSB/Plywood Sheathing (System #50): Replacement of OSB/Plywood (from Gatto and Uang 2002).**

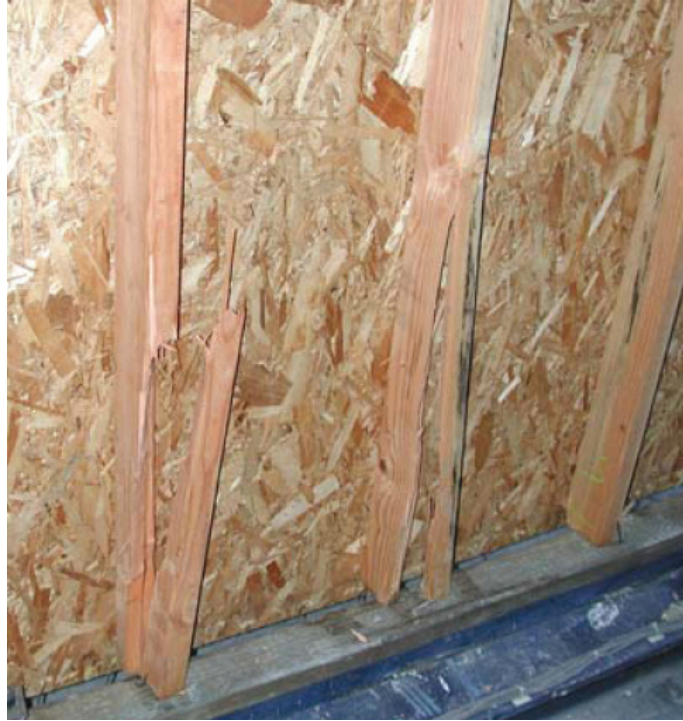
**Figure 6 - Damage State 3 for Walls with OSB/Plywood Sheathing (System #50):  
Replacement of Entire Wall (from Gatto and Uang 2002).**

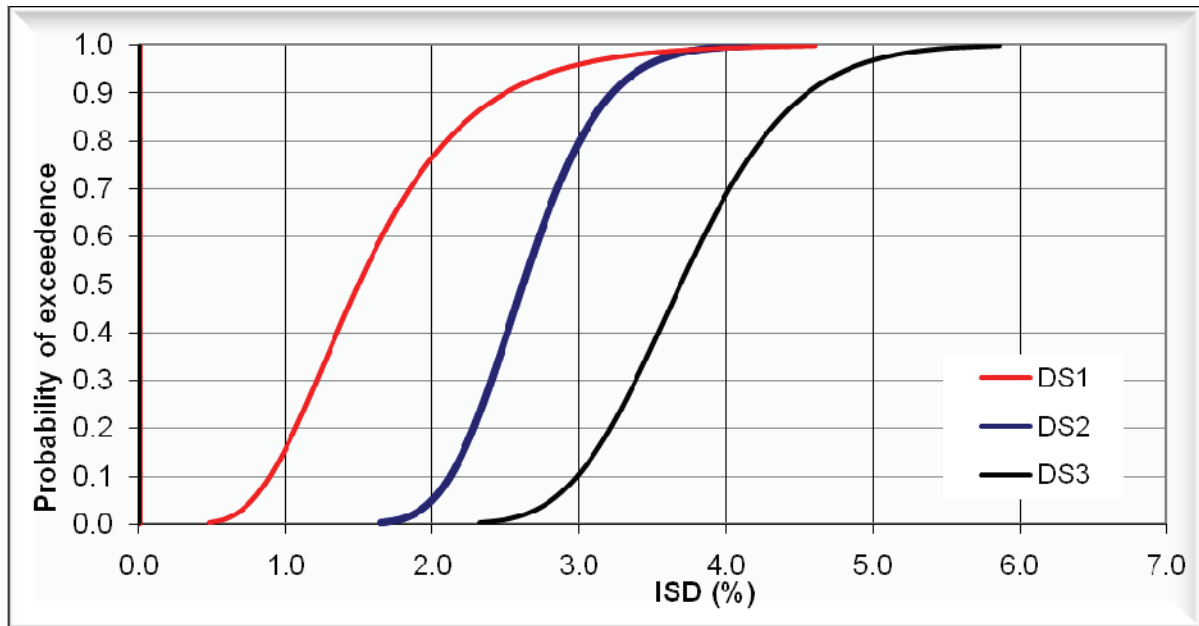
**Figure 7 - Fragility Curves for Walls with OSB/Plywood Sheathing (System #50).**

The fragility curves shown in Fig. 7 were developed based on both the judgment of the authors (Method E) and laboratory test data (Method A). The fragility curves for damage states  $DS_2$  and  $DS_3$  are from test data, while the fragility curve for damage state one ( $DS_1$ ) was determined using the judgment of the authors, because of the limited reported experimental data at which nails loosen. The dispersion parameter ( $\beta$ ) is arbitrarily set to a higher value of 0.40 for damage state  $DS_1$  to reflect the higher uncertainties with this damage state. The median and dispersion values for these fragility curves are listed in Table 4.

Damage States*	Demand Parameter (DP)	Median ( $\theta$ )**	Dispersion ( $\beta$ )
$DS_1$	Inter-Story Drift ISD (%)	1.50	0.40
$DS_2$		2.62	0.16
$DS_3$		3.69	0.17

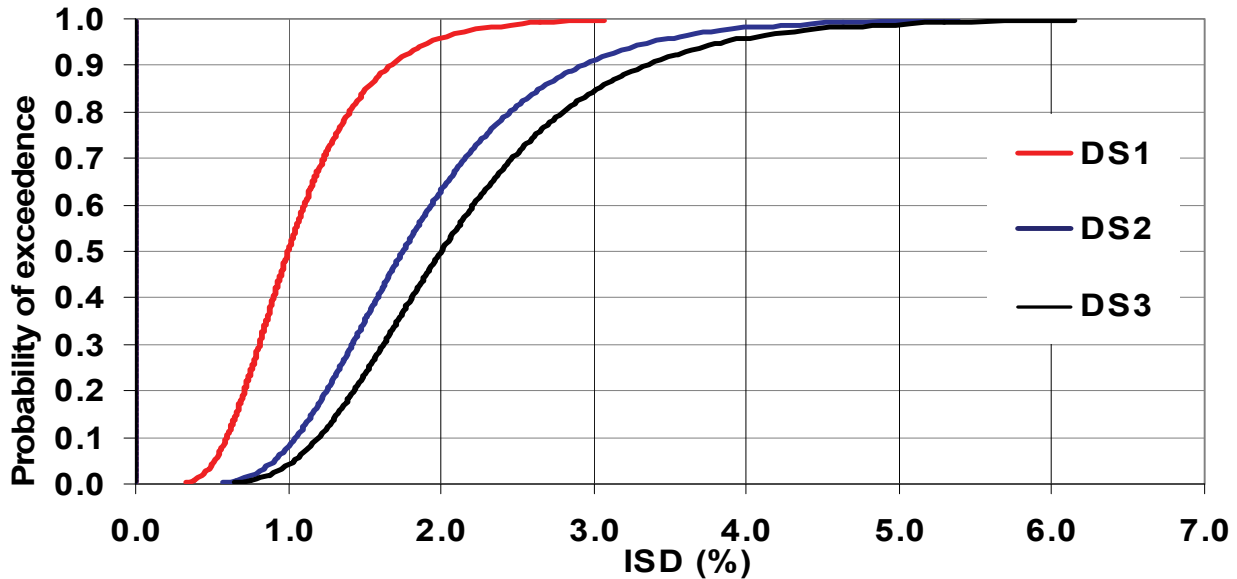
**Figure 8 - Fragility Curves for Walls with OSB/Plywood Sheathing, Basic Strength Design (System #47).**

The fragility curves based on the judgment of the authors are shown in Fig. 8. The median and dispersion values for these fragility curves are listed in Table 6.

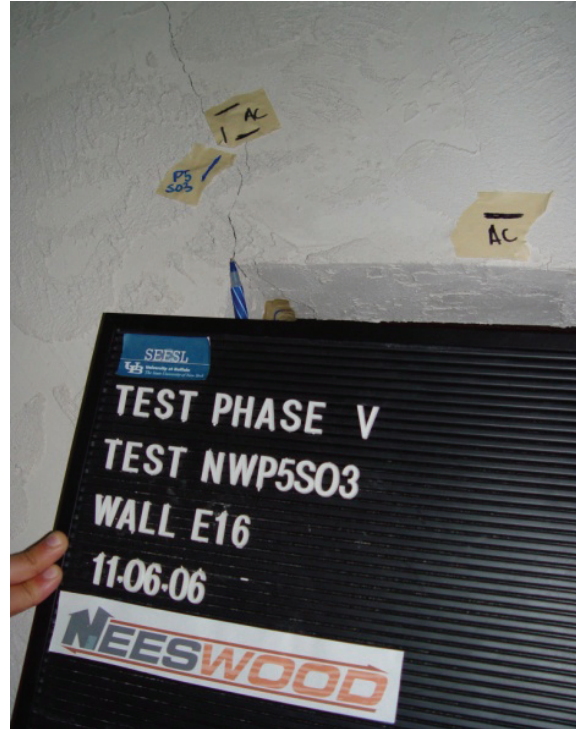
**Figure 9 - Damage State 1 for Walls Incorporating Stucco as Exterior Finish: Small Cracking of Stucco (from Christovasilis et al. 2007).**

Damage States (DS <sub>i</sub> )*	Description of Damage State
DS <sub>1</sub>	Cracking of Stucco (Fig. 9)
DS <sub>2</sub>	Spalling of stucco, separation of stucco and sheathing from studs (Fig. 10)
DS <sub>3</sub>	Fracture of studs, major sill plate cracking (Fig. 11)

Damage States (DS <sub>i</sub> )	Description of Damage State
DS <sub>1</sub>	Cracking of Stucco (Fig. 9)
DS <sub>2</sub>	Spalling of stucco, separation of stucco and sheathing from studs (Fig. 10)
DS <sub>3</sub>	Fracture of studs, major sill plate cracking (Fig. 11)

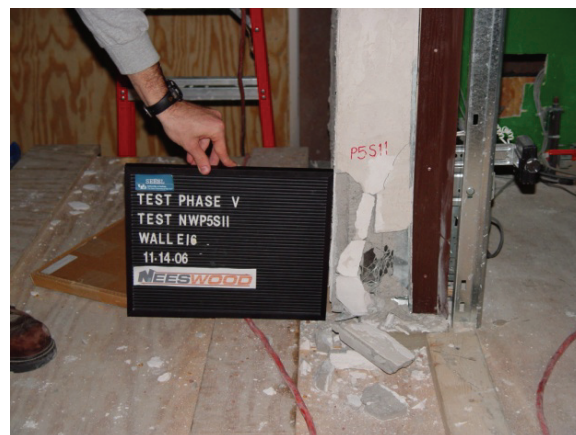
**Figure 10 - Damage State 2 for Walls Incorporating Stucco as Exterior Finish: Replacement of Spalled Stucco (from Christovasilis et al. 2007).**

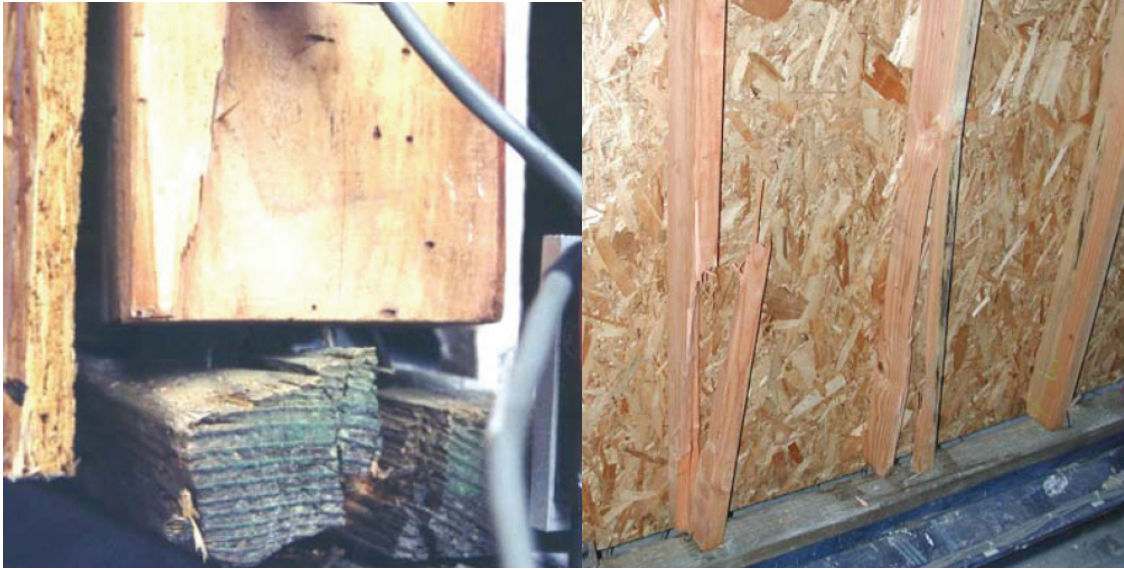
**Figure 11 - Damage State 3 for Walls Incorporating Stucco as Exterior Finish: Replacement of Entire Wall (from Gatto and Uang 2002).**

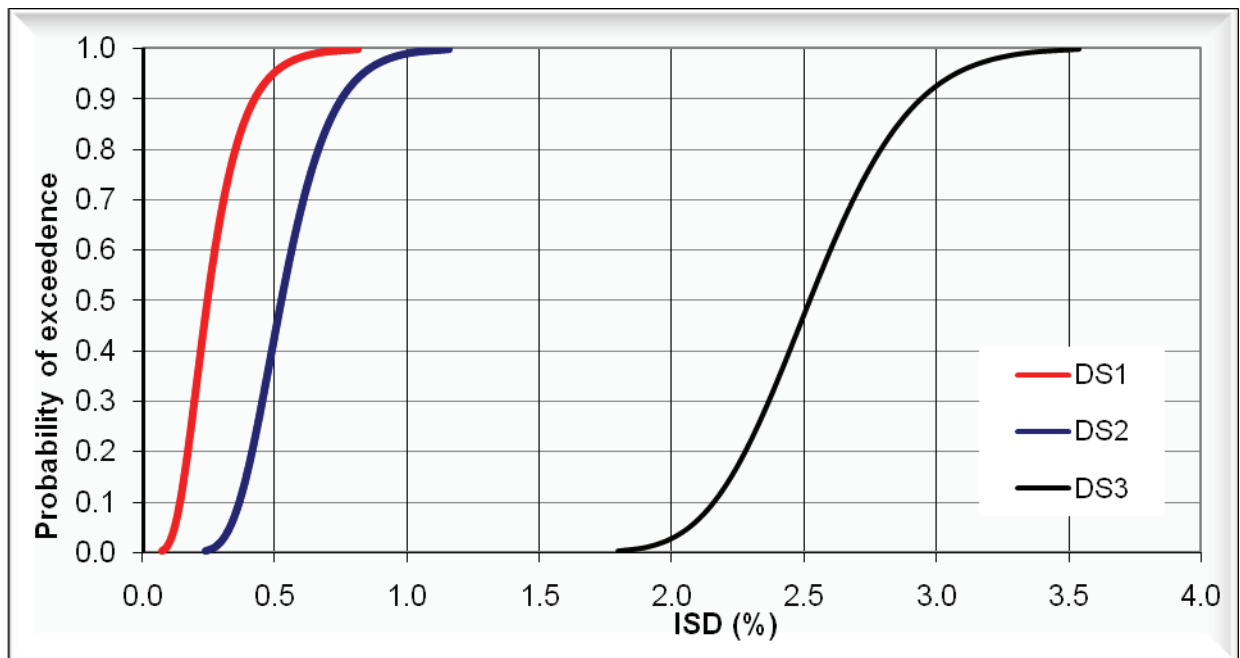
**Figure 12 - Fragility Curves for Walls with OSB/Plywood Sheathing and Stucco Exterior Finish (System #51).**

The fragility curves for shear walls with Oriented Strand Board/Plywood sheathing with exterior stucco finish are shown in Fig. 12. The median and dispersion values for these fragility curves are listed in Table 8.

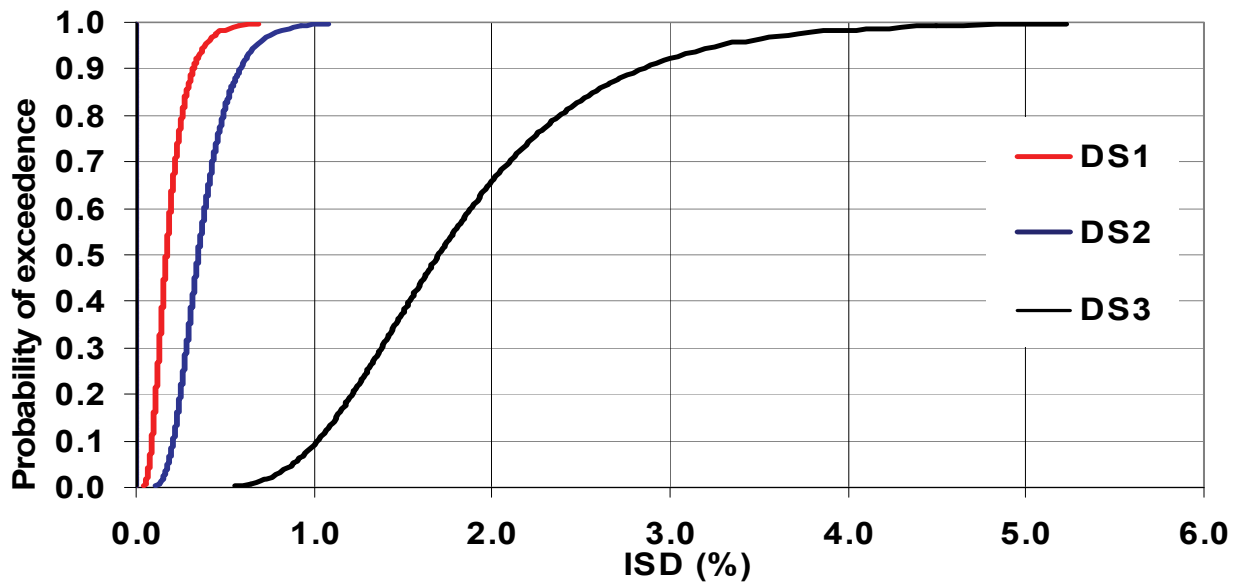
**Figure 13 - Fragility Curves for Walls with OSB/Plywood Sheathing and Stucco Exterior Finish, Basic Strength Design (System #48).**

The fragility curves based on the judgment of the authors are shown in Fig. 13. The median and dispersion values for these fragility curves are listed in Table 10.

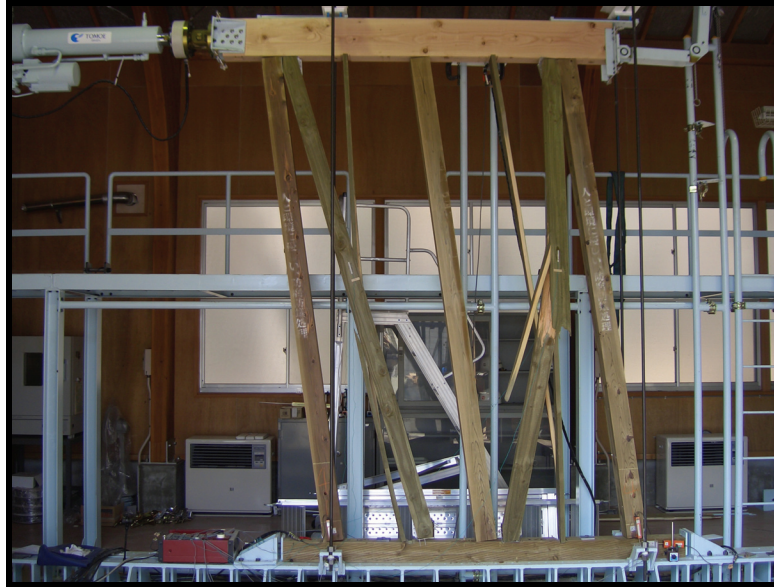
**Figure 14 - Damage State 1 for Wood Stud Framing Braced by Diagonal Bracing: Failure of Diagonal Bracing (from Isoda 2007).**

For wood stud framing braced by wood diagonal bracing, a single damage state, DS<sub>1</sub>, failure of the diagonal bracing member, is considered. After failure of the diagonal bracing, it is assumed that the strength and stiffness of the wall is reduced essentially to zero and the entire wall will need to be replaced. This damage state is listed in Table 11 and illustrated in Fig. 14.

Damage States (DS <sub>i</sub> )*	Description of Damage State
DS <sub>1</sub>	Failure of Diagonal Bracing (Fig. 14)

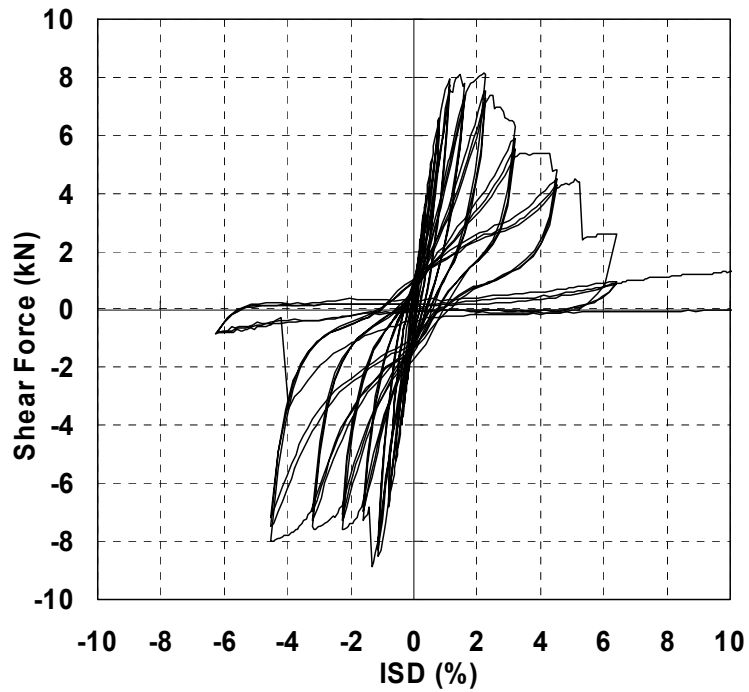
Figure 15 – Experimental Load-Displacement Curve for Wood Stud Framing Braced by Diagonal Bracing (from Isoda 2007).

The fragility for wood stud framing braced by diagonal bracing was established from the judgment of the authors based on a limited number of subassembly cyclic test data performed in Japan on 6 ft long by 10 ft high wall assemblies incorporating diagonal bracing. Figure 15 shows the experimental lateral load-displacement obtained from one of these wall assemblies. The peak lateral load in each loading direction is reached for an Inter-Story Drift, ISD, between 1% and 2%. After this peak load is reached, the stiffness and strength of the wall assembly degrades very quickly. Based on these experimental results, the authors recommend basing the fragility curve for this system #52 on a median ISD value of 1% with a moderate dispersion value of 0.3. This fragility curve is shown in Fig. 16. The median and dispersion values for this fragility curve are listed in Table 12.

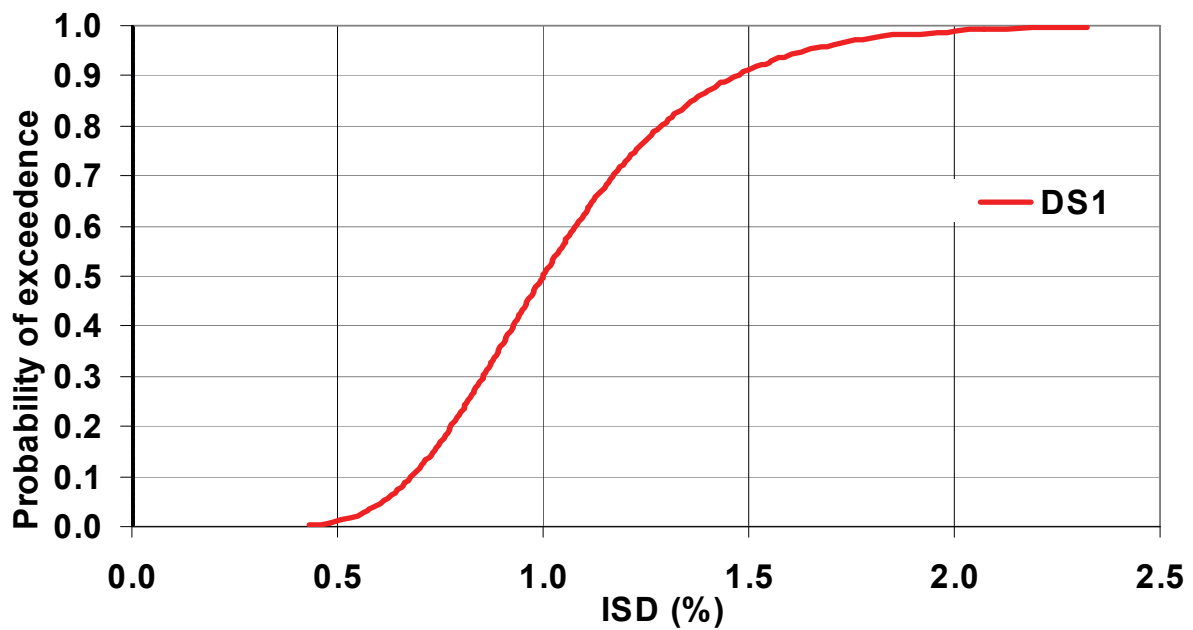
Figure 16 - Fragility Curve for Light Wood Frame, Diagonal Strut Bracing (System #52).

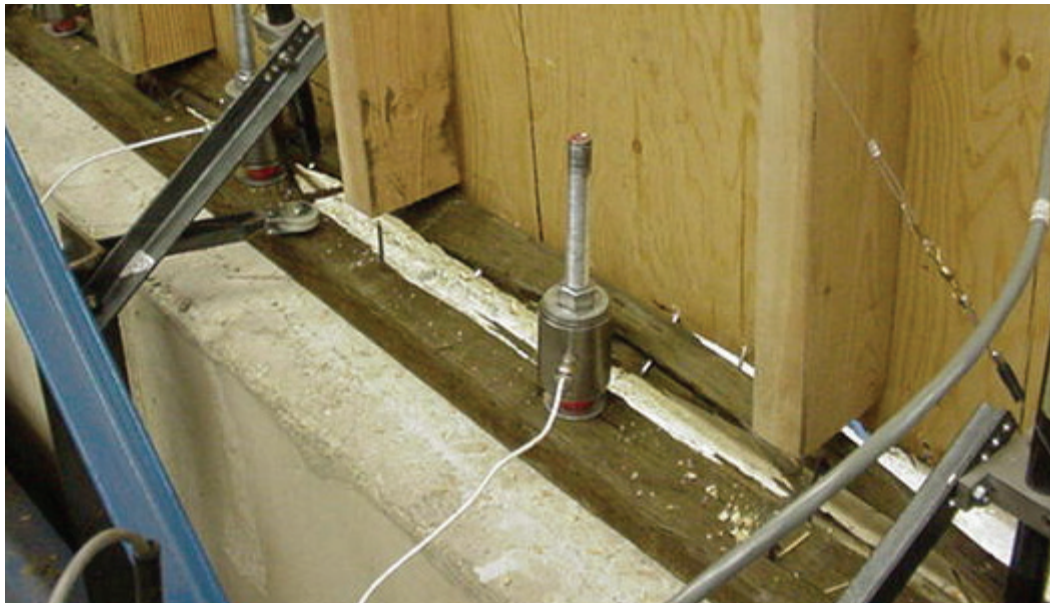
**Figure 17 - Damage State 1 for Sill Plates without Holdowns: Replacement of Entire Wall (from Mahaney and Kehoe 2002).**

For the development of the fragility curves for sill plates without holdowns, only one damage state,  $DS_1$ , failure of the sill plates, is considered. This singled damage state is associated with complete splitting of the sill plates, as shown in Fig. 17. The repair for the sill plate splitting would be to replace the entire wall. In most cases the sill plates failed due to the overturning moment, which causes the sill plate to uplift, bend and split due to tension perpendicular to grain.

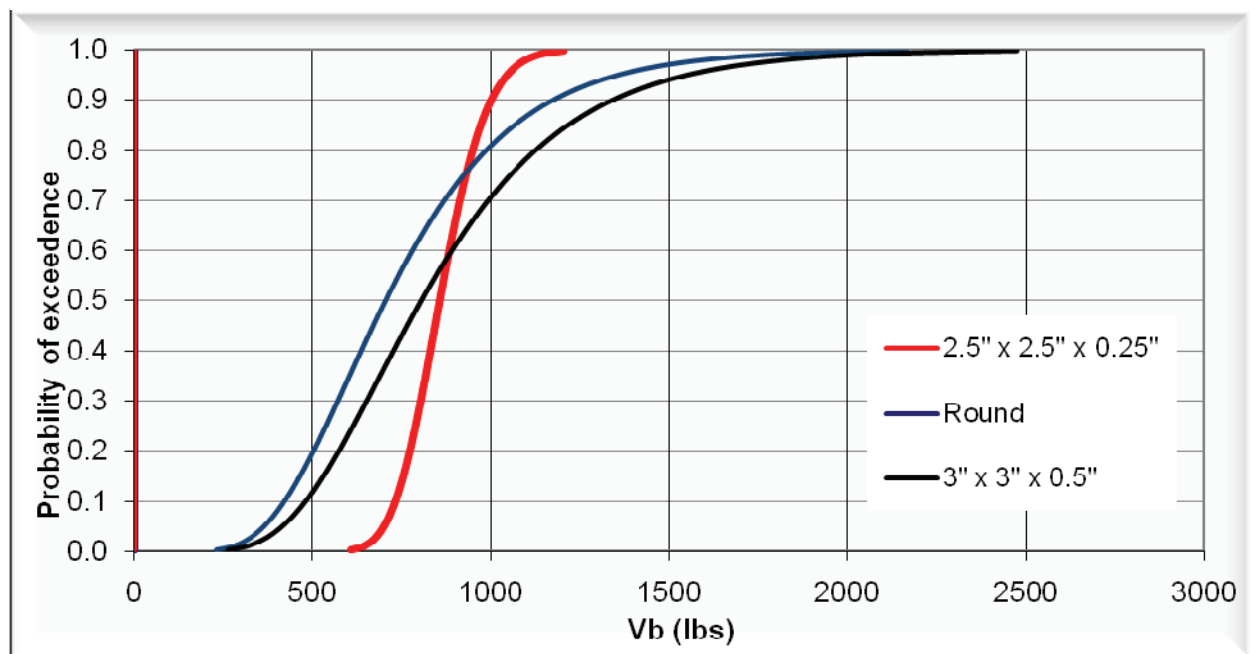
**Figure 18 - Fragility curves for 2x Sill Plates without Holdowns and with Various Types of Bolt Washers.**

The fragility curves shown in Fig. 18 for 2x sill plates without holdowns contain three different types of bolt washers (2.5" square by 0.25" thick washer, standard 1.5" round washer and 3" square by 0.5" thick washer). The fragility curve for the 2.5" square washer by 0.25" thick washer was based on experimental data. While the median for both the standard round and 3" square washer are from experimental data, the dispersion factor ( $\beta$ ) was increased to 0.40 based

on the judgment of the authors to reflect the limited experimental data available. These median and dispersion values are shown in Table 13.

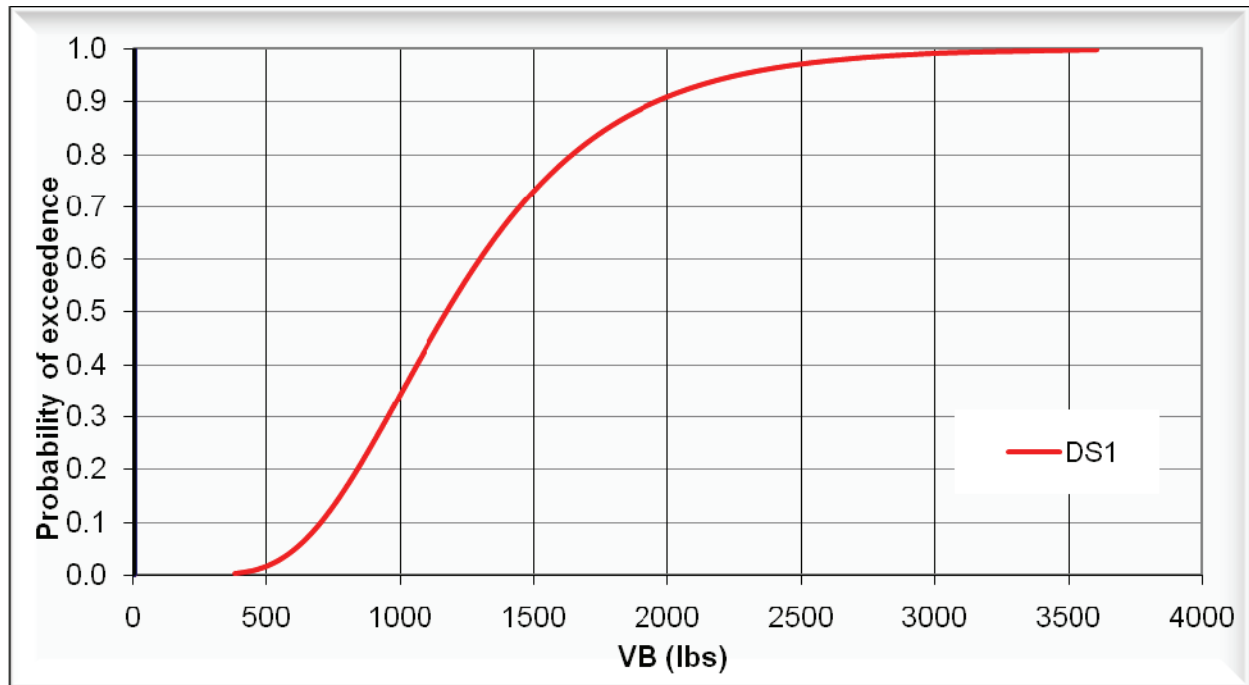
**Figure 19 - Fragility Function for 3x Sill Plates without Holdowns.**

The fragility curve shown in Fig. 19 is for 3x sill plates, without holdowns, and connected to a concrete foundation with 5/8" diameter anchor bolts incorporating 2.5"square x 0.25" thick washers. Because of the limited experimental data available (i.e two tests), the dispersion parameter ( $\beta$ ) was increased to 0.4. The median and dispersion for this fragility curve is shown in Table 14. Note that the median value for 3x sill plates is 37% higher than the median for 2x sill plates (1174 lbs vs 855 lbs) indicating the beneficial effect of using 3x sill plates when holdowns are not incorporated.

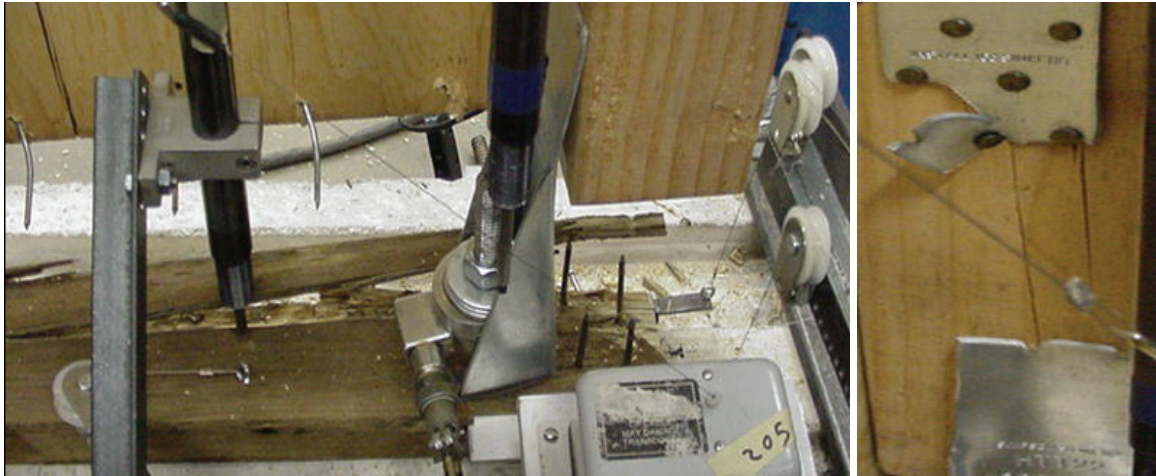
**Figure 20 - Damage State 1 for Sill Plates with Holdowns:  
Replacement of Entire Wall (from Mahaney and Kehoe 2002).**

For the development of the fragility curves for sill plates incorporating holdowns at the end of the wall piers, only one damage state, DS<sub>1</sub>, complete failure of the sill plates and/or of the holdowns. This damage state is illustrated by a photograph in Fig. 20. Both types of failures (sill plates and holdowns) are grouped together since it is the opinion of the author that failure of the holdown controls the behavior and when the holdown fails the sill plate will fail soon after. This could be shown by comparing the median values of the fragility curves for sill plates with and without holdowns; the sill plates with holdowns can withstand a force about three times that without holdowns.

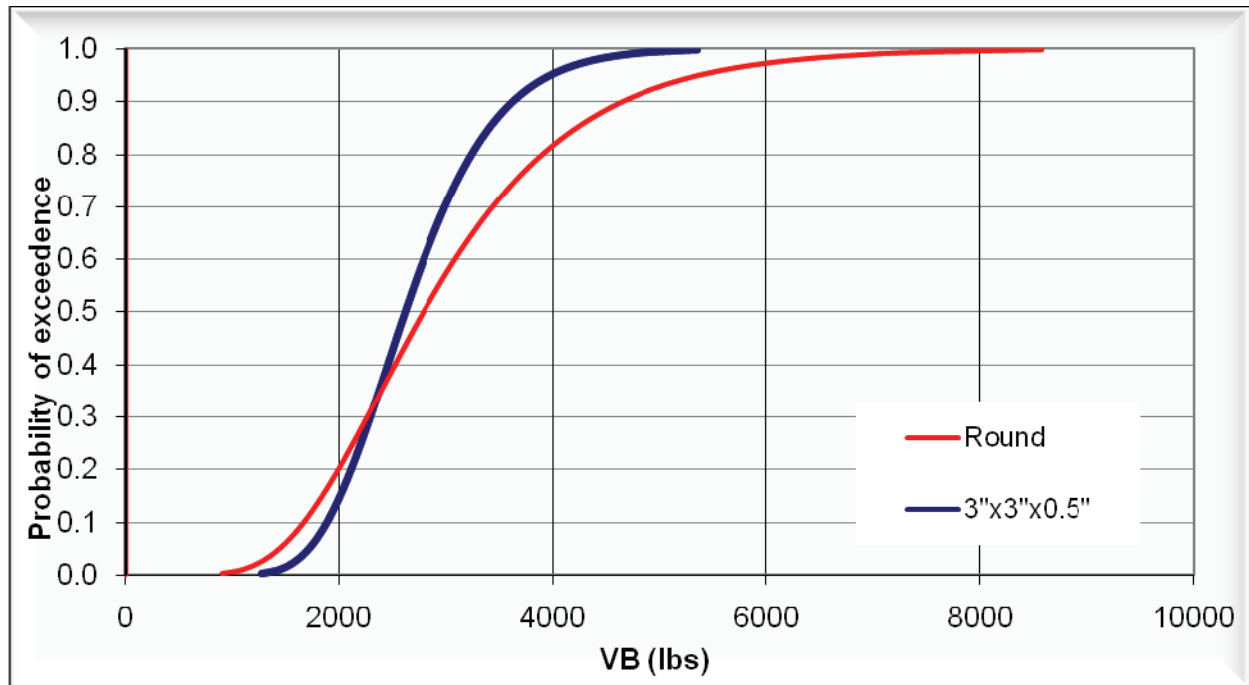
**Figure 21 - Fragility Curves for 2x Sill Plates with Holdowns and with Various Types of Bolt Washers.**

The fragility curves shown in Fig. 21 for 2x sill plates with holdowns contain two different types of bolt washers (standard 1.5" round washer and 3" square by 0.5" thick washer). The fragility curve for the 3" square washer by 0.5" thick washer was based on experimental data. While the median for the standard round are from experimental data, the dispersion factor ( $\beta$ ) was increased to 0.40 based on the judgment of the authors to reflect the limited experimental data available. These median and dispersion values are shown in Table 15. Note that the median values are similar for both types of washers indicating that the types and sizes of washers are not important parameter governing the failure capacity of sill plates with holddown.

Washer Type	Demand Parameter (DP)	Median ( $\theta$ )	Dispersion ( $\beta$ )
Standard Round 1.5" dia.	Shear Force per Anchor Bolt VB (lbs)	2790	0.40
3"x3"x0.5"		2620	0.26

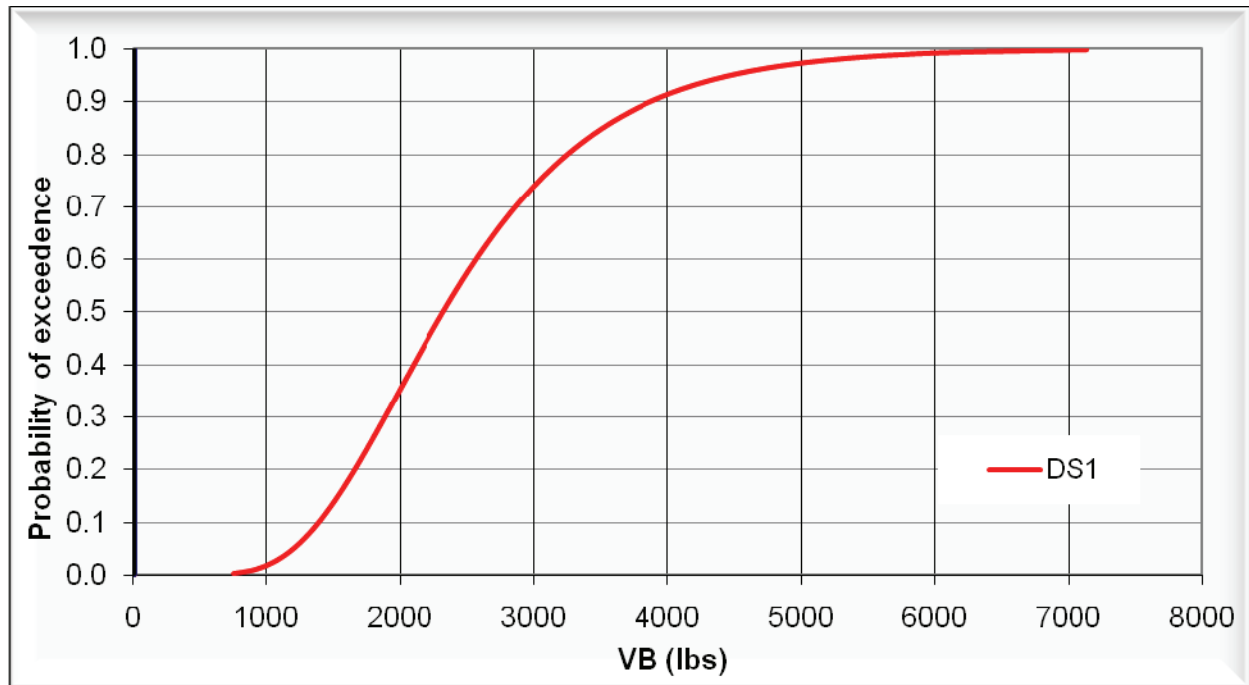
**Figure 22 - Fragility Function for 3x Sill Plates with Holdowns.**

The fragility curve shown in Fig. 22 is for 3x sill plates, with holdowns, and connected to a concrete foundation with 5/8" diameter anchor bolts incorporating 2.5"square"x 0.25" thick washers. Because of the limited experimental data available (i.e two tests), the dispersion parameter ( $\beta$ ) was increased to 0.4. The median and dispersion for this fragility curve is shown in Table 16. Note that the median value for 3x sill plates is similar (actually slightly lower) than the median values for 2x sill plates indicating that the size of the sill plate is not an important parameter governing the failure capacity of sill plates with holdowns.

Damage State	Demand Parameter (DP)	Median ( $\theta$ )	Dispersion ( $\beta$ )
DS <sub>1</sub>	Shear Force per Anchor Bolt VB (lbs)	2324	0.40

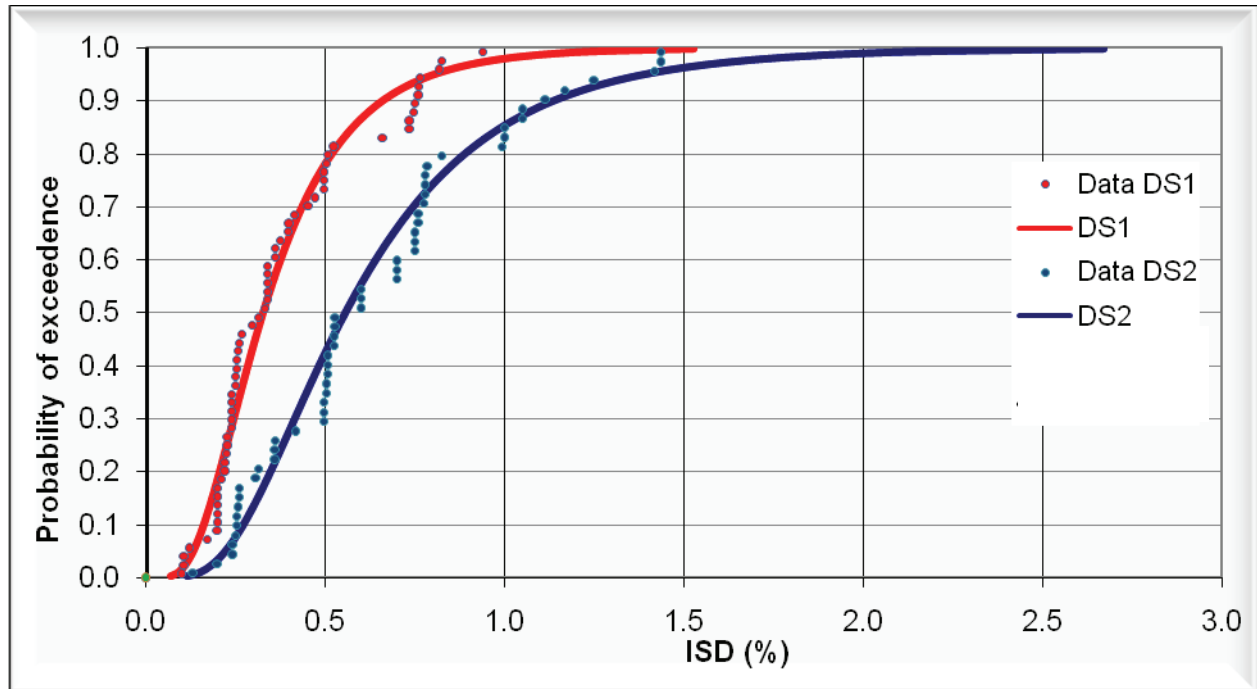
**Figure A1 - Fragility Function for Walls with Gypsum Wallboard.**

Median $\theta$	Dispersion $\beta$	Number of Samples	Lilliefors Test
<b>DS1</b>	<b>0.33</b>	<b>0.55</b>	<b>62</b>	<b>Fails</b>
<b>DS2</b>	<b>0.56</b>	<b>0.56</b>	<b>56</b>	<b>Passes</b>

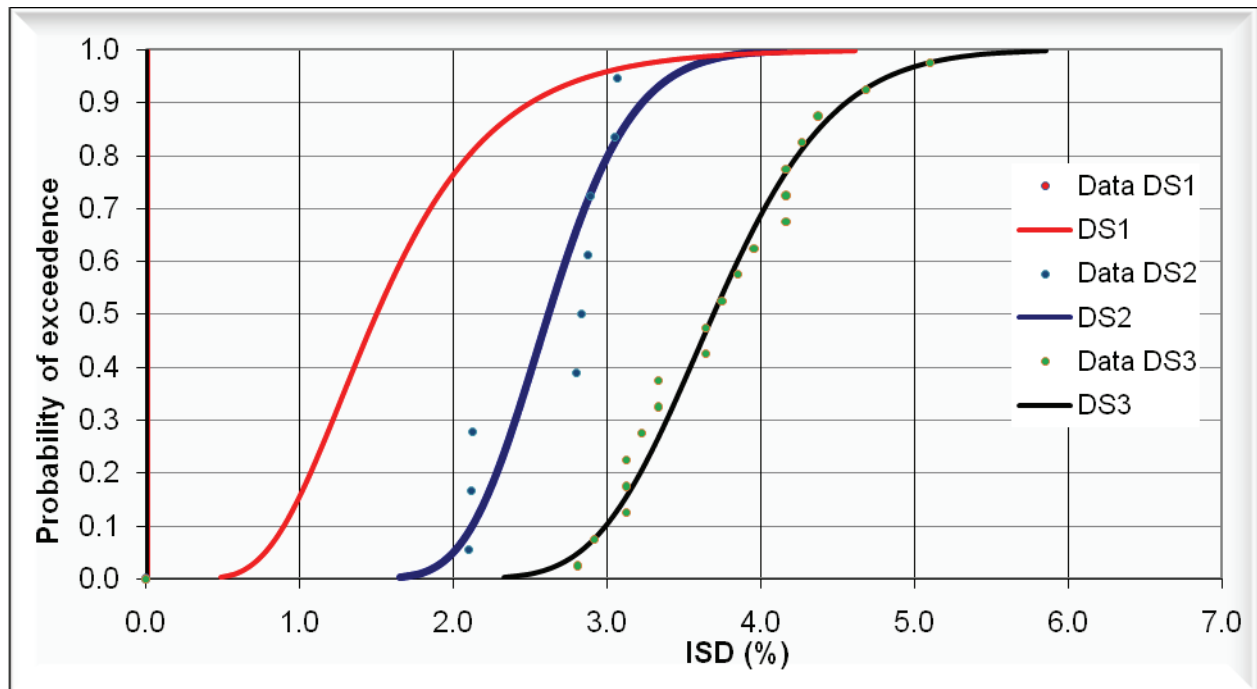
**Figure A2 - Fragility Function for Walls with OSB/Plywood Sheathing (System #50).**

Median $\theta$	Dispersion $\beta$	Number of Samples	Lilliefors Test
<b>DS1</b>	<b>1.50</b>	<b>0.40</b>	<b>N/A</b>	<b>N/A</b>
<b>DS2</b>	<b>2.62</b>	<b>0.16</b>	<b>9</b>	<b>Passes</b>
<b>DS3</b>	<b>3.69</b>	<b>0.17</b>	<b>20</b>	<b>Passes</b>

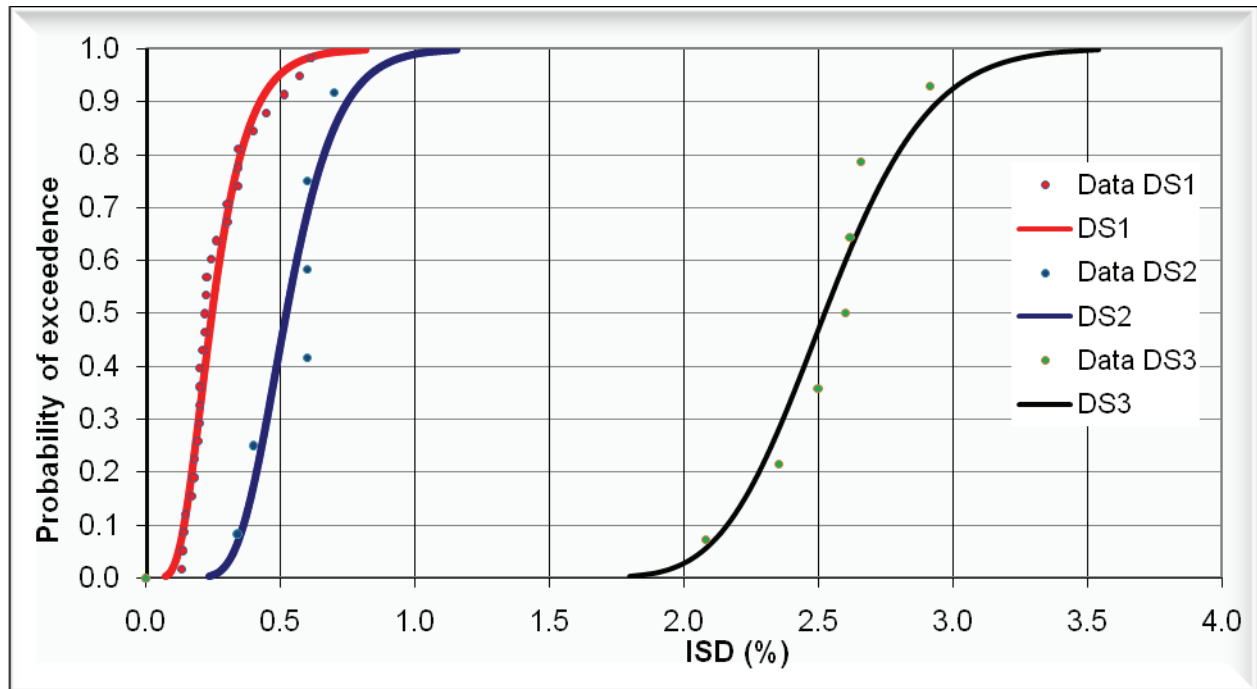
**Figure A3 - Fragility Function for Walls with OSB/Plywood Sheathing and Stucco Exterior Finish (System #51).**

Median $\theta$	Dispersion $\beta$	Number of Samples	Lilliefors Test
DS1	0.246	0.427	29	Fails
DS2	0.523	0.282	6	Passes
DS3	2.522	0.121	7	Passes

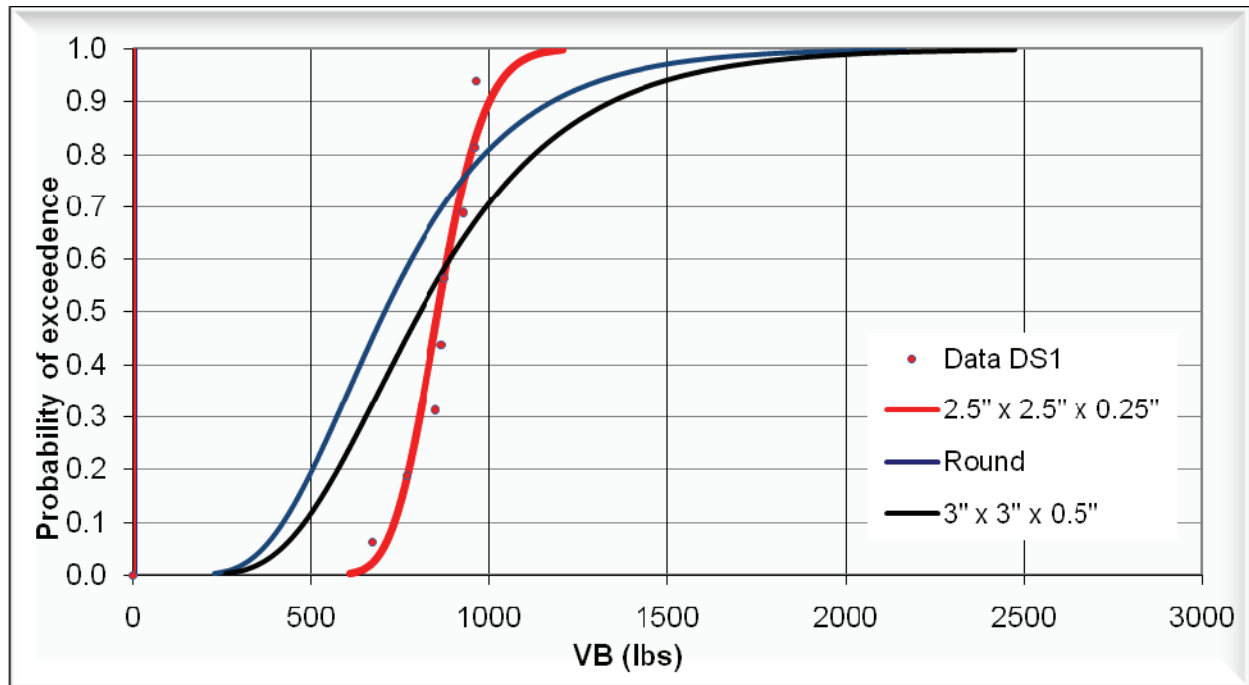
**Figure A4 - Fragility Function for 2x Sill Plates without Holdowns.**

Washer Type	Median $\theta$	Dispersion $\beta$	Number of Samples	Lilliefors Test
2.5"x2.5"x0.25"	855.05	0.12	8	Passes
Standard Round 1.5" diameter	704.25	0.40	N/A	N/A
3"x3"x0.5"	805.25	0.40	N/A	N/A

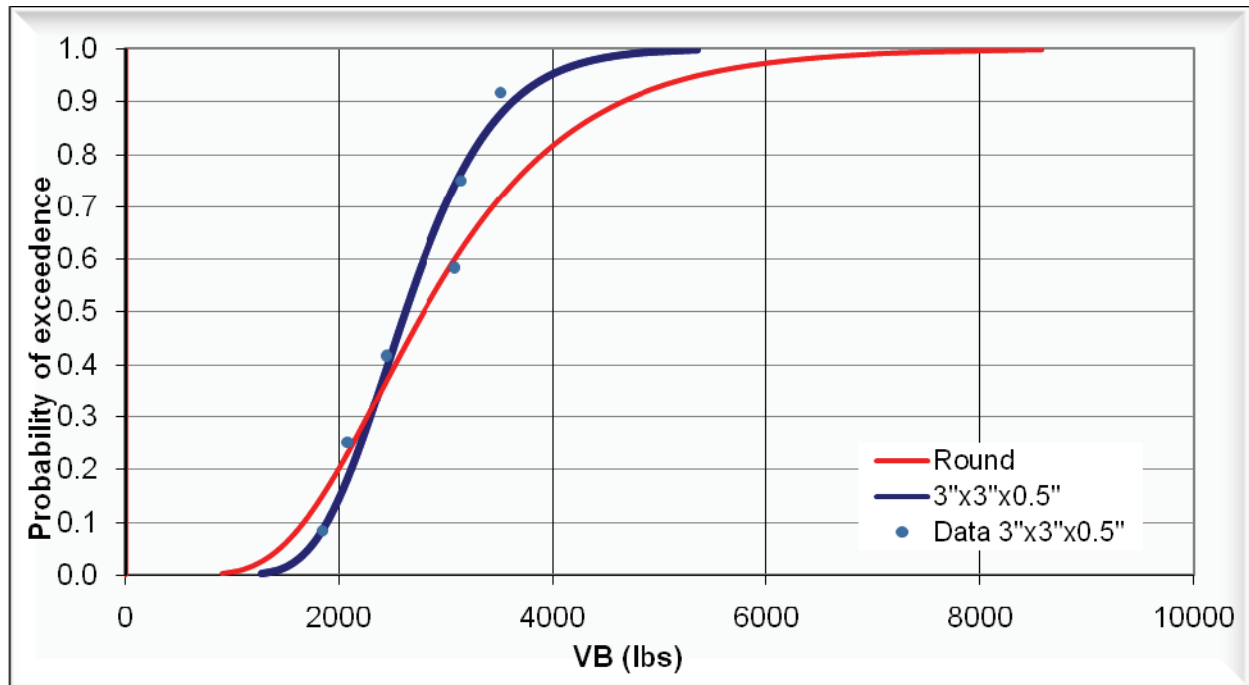
**Figure A5 - Fragility Function for 2x Sill Plates with Holdowns.**
