FEMA P-58/BD-3.9.22

Fragility of Fans

Keith Porter

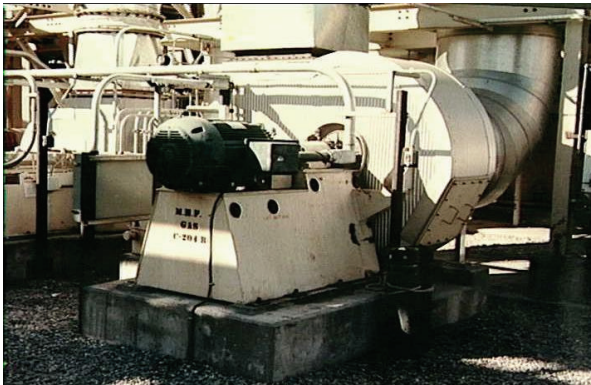
Figure 1. Fan (background) and drive motor (foreground, EPRI)
