Tenth U.S. National Conference on Earthquake Engineering
Frontiers of Earthquake Engineering
July 21-25, 2014
Anchorage, Alaska

POSTEARTHQUAKE SAFETY EVALUATION PROCEDURES FOR BHUTAN BUILDINGS

J. E. Rodgers¹, B. J. Lizundia², S. Yangdhen³, Y. Lotay⁴, A. Hortaçsu⁵
and K. D. Tshering⁶

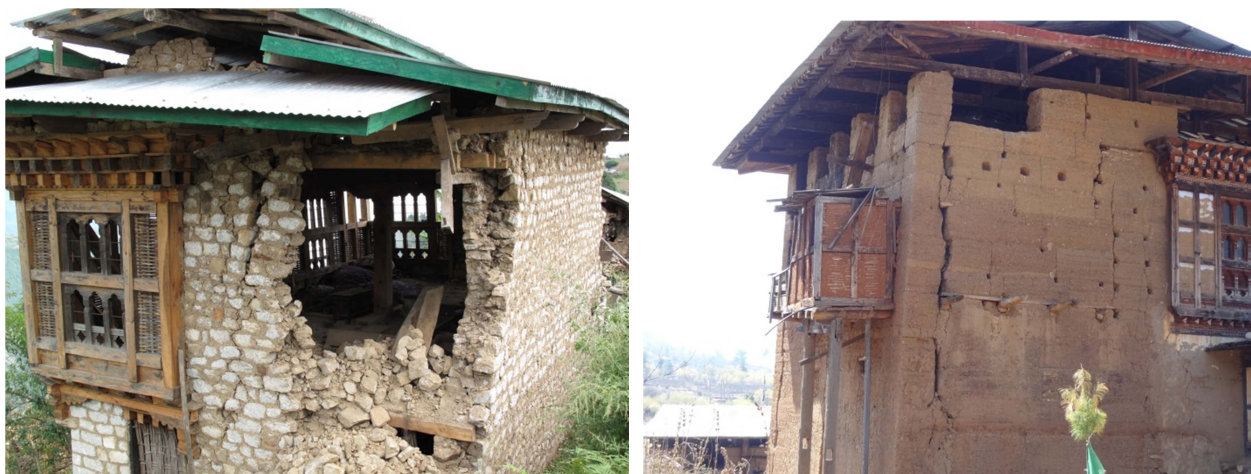
Figure 2. Vernacular stone masonry (left) and rammed earth (right) buildings showing types of damage many such buildings suffered in the 2009 and 2011 earthquakes, respectively. (Photo credits Department of Disaster Management, GeoHazards International)

Bhutan's vernacular architecture is considered a national cultural treasure. Vernacular building types include rammed earth, rubble and semi-dressed stone masonry, ekra (also known as ikra or Assam-type, a lightweight timber frame construction with plastered woven bamboo and reed wall panels), timber and bamboo. Though beautiful, many building types have seismic vulnerabilities caused by tall walls, elevated roofs and large windows. Other key deficiencies in vernacular buildings include a lack of positive diaphragm-to-wall ties and inadequate wall continuity at corners. Rammed earth, adobe and vernacular stone masonry walls (the latter often built with mud mortar) are generally unreinforced and have low shear strength. Based on damage observed following the 2009 and 2011 earthquakes, significant damage is expected in strong shaking, especially in rammed earth and rubble stone buildings. Figure 2 shows damaged vernacular buildings.

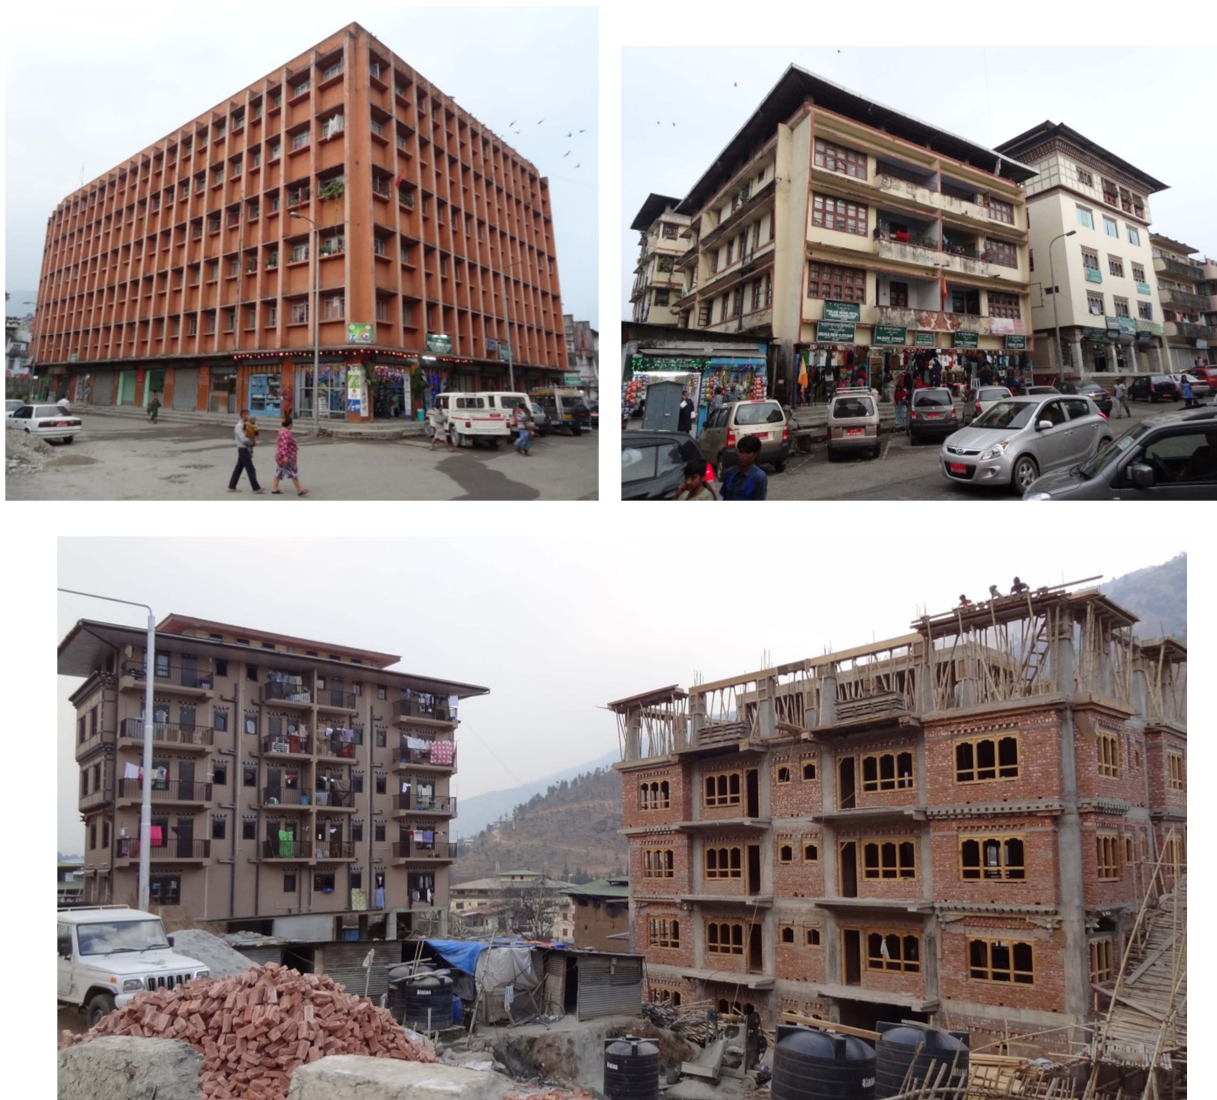
Figure 3. Older reinforced concrete buildings in Phuentsholing (top); new reinforced concrete frame buildings in Thimphu (bottom); (Photo credits Janise Rodgers, GeoHazards International).

in the upper stories to mimic traditional architectural elements. While most concrete buildings are constructed to India's seismic design codes (which Bhutan's building code incorporates by reference), damage to columns is expected in open ground stories and other locations where stairs or infill walls adversely affect their response. Brick infill walls and façade elements are likely to cause significant falling hazards during and after a strong earthquake. Larger cities such as Thimphu and Phuentsholing, the main border city with India, have a number of older reinforced concrete buildings constructed before Bhutan adopted earthquake-resistant design codes in 1997. While some of these buildings may have been built to Indian seismic design standards, those constructed prior to 1993, when India introduced special seismic detailing requirements for reinforced concrete frames, are expected to experience earthquake damage similar to that observed in non-ductile concrete frame buildings elsewhere. Figure 3 shows examples of both older and newer concrete buildings.

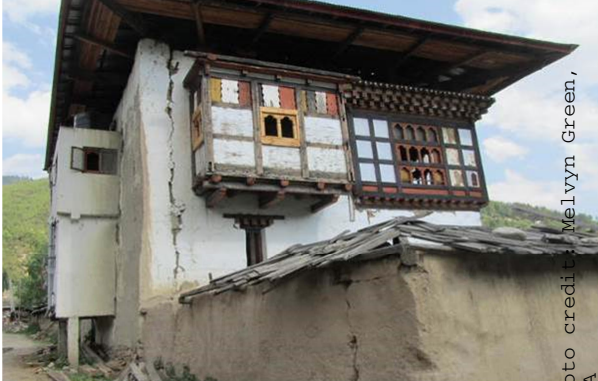
Condition and Posting	Illustration
Rammed Earth Walls	
<p>Nominally Vertical Cracks at Corners</p> <p>Post UNSAFE when cracks go through the wall.</p>

Table 1. Excerpt of part of wall damage section of rammed earth condition table showing new, more graphical format for detailed evaluations

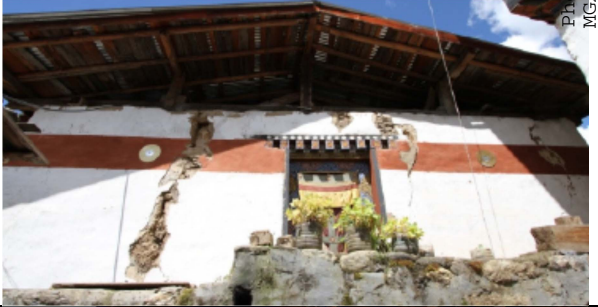
<p>Photo credit: Melvyn Green, MGA</p>
<p>Vertical Cracks in Other Locations</p> <p>Post UNSAFE when there are a several cracks along the wall line and there is significant spalling associated with the crack.</p>

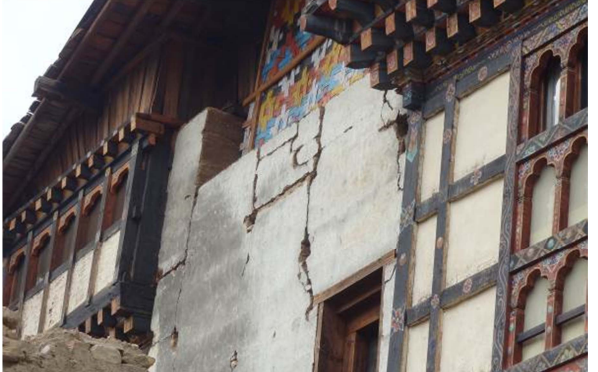
<p>Post RESTRICTED USE when cracks go through the spandrel, but the pier or wall remains largely intact.</p>

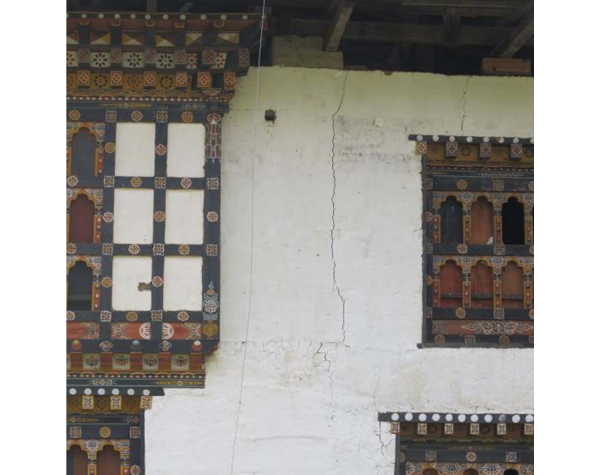
<p>Post INSPECTED if cracks do not go completely through a wall and do not have out-of-plane offsets along the crack.</p>
