Repair of Earthquake-Damaged Masonry Fireplace Chimneys

SOUTH NAPA EARTHQUAKE RECOVERY ADVISORY

FEMA DR-4193-RA1

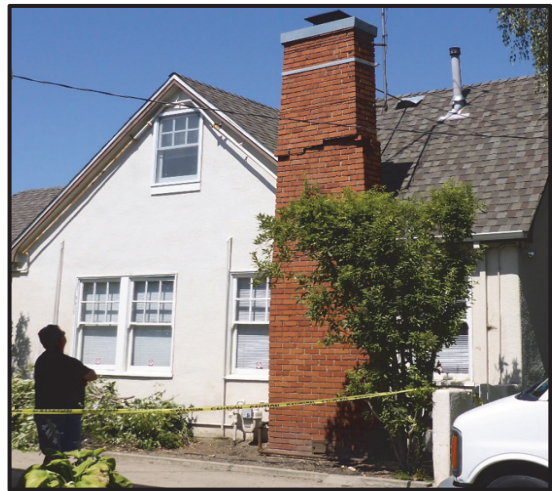
Figure 1: Chimney damaged in the South Napa Earthquake. Photo Credit: Exponent.

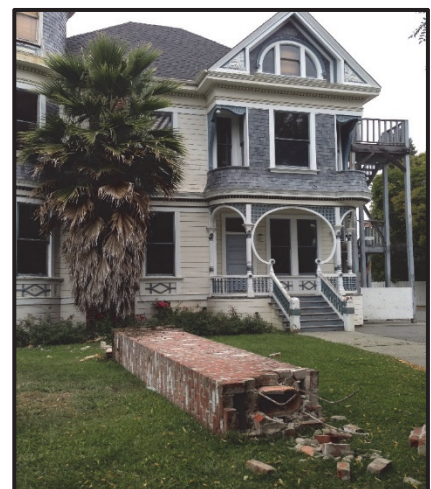
Figure 2: Chimney damaged in the South Napa Earthquake. Photo Credit: Janiele Maffei, CEA
