State of California

Safety Assessment Program Evaluator Student Manual

May 2020

Version 16

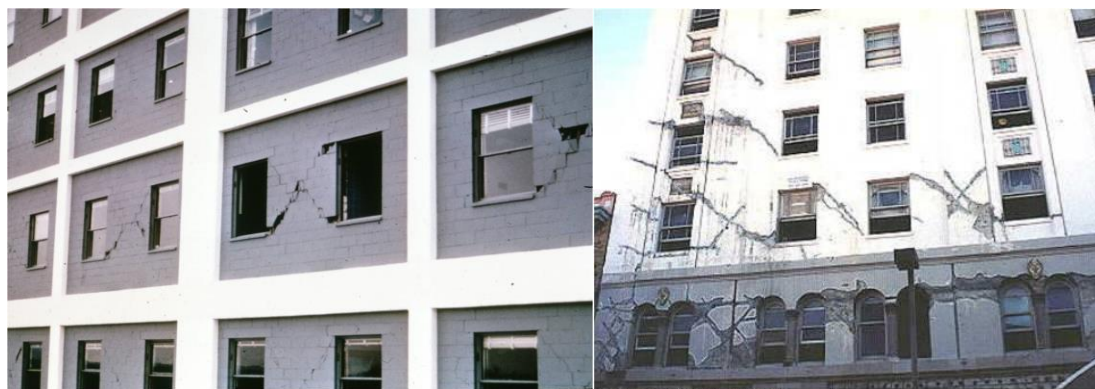
Figure 2-2 – Shear cracking

The above photos illustrate classic X-shaped shear cracking that occurs in response to lateral seismic forces.

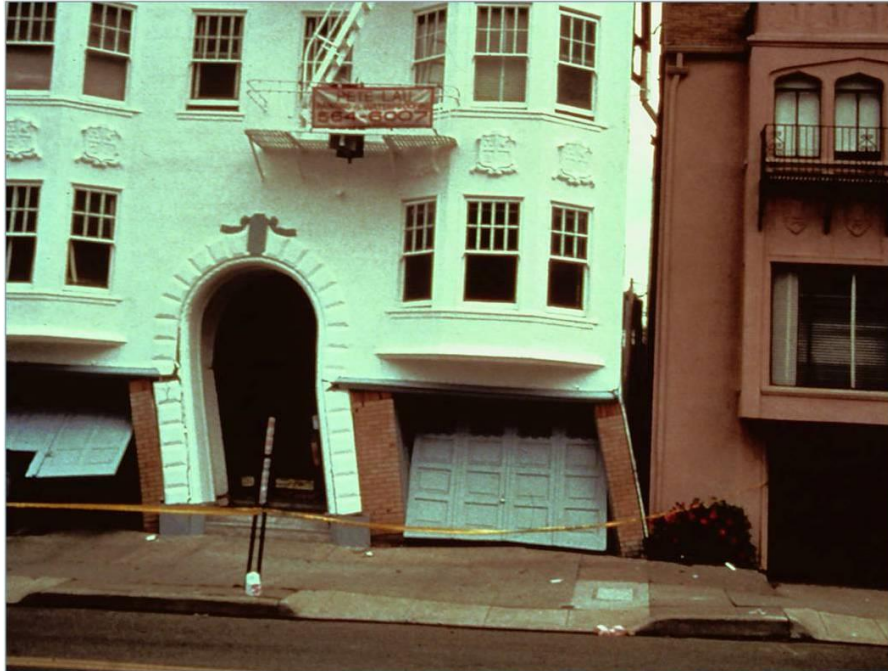
Figure 2-3 – Soft story failure, San Francisco, 1989 Loma Prieta Earthquake

This building did not have sufficient lateral force resistance in its lowest floor, resulting in this dangerous “soft story” failure.

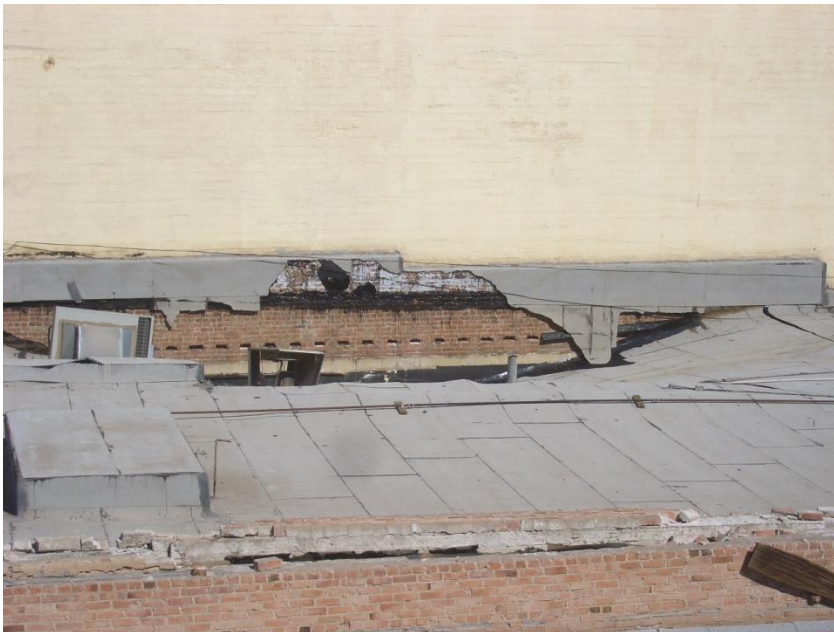
Figure 2-6 – Roof-wall connection failure, 2010 Baja Earthquake

Roof diaphragm has failed, so building has lost its lateral load resistance capacity.

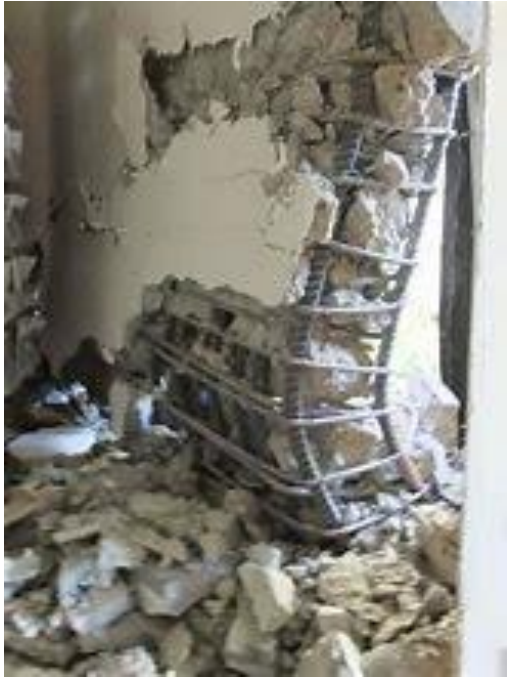
Figure 2-7 – Non-ductile concrete wall failure

Insufficient steel reinforcing led to non-ductile failure in this concrete wall.

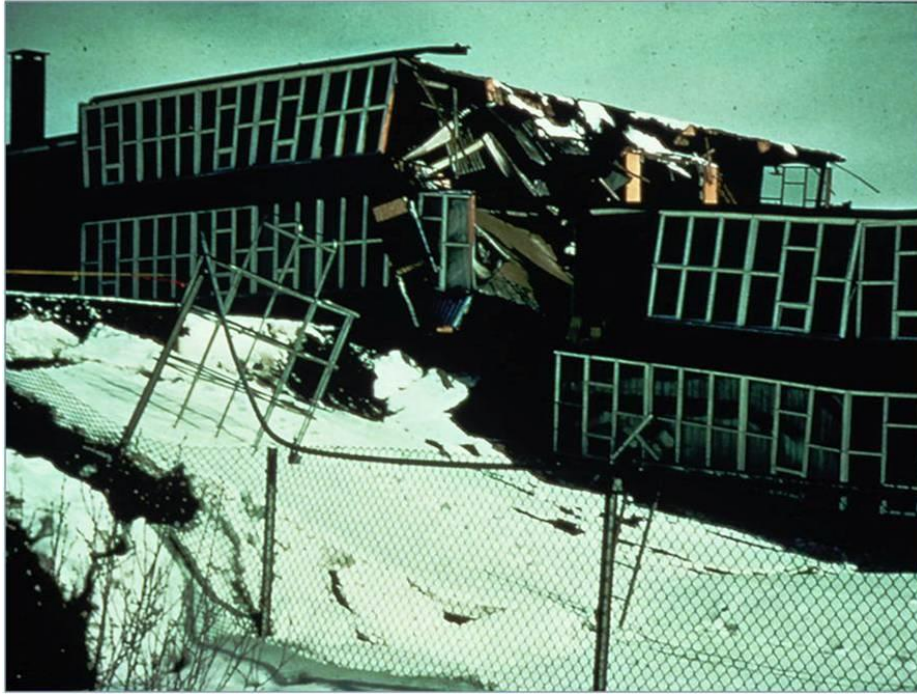
Tilt-up walls may not have been anchored correctly to roof, leading to this failure.

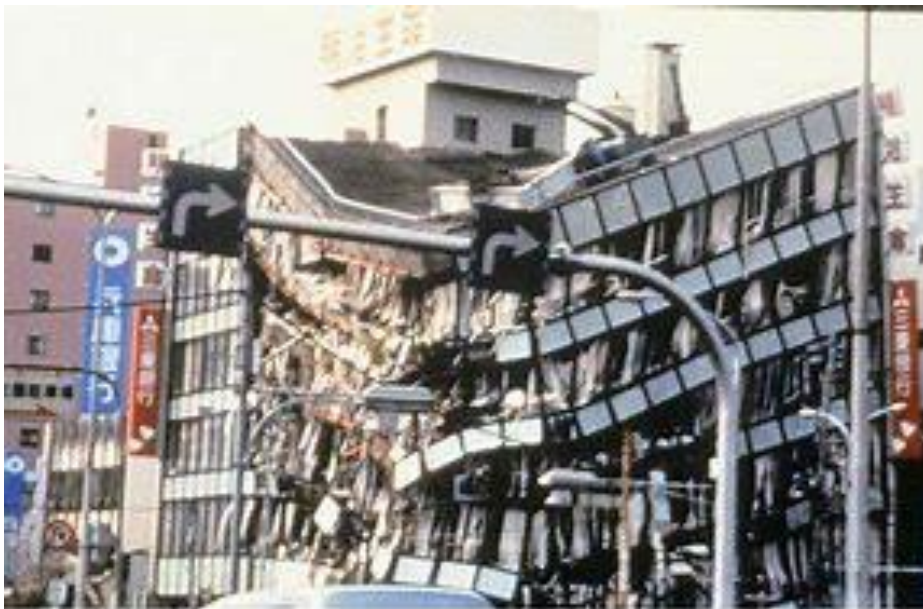
Figure 2-10 – Partial collapse of structure.

This structure in Japan suffered partial structural collapse.

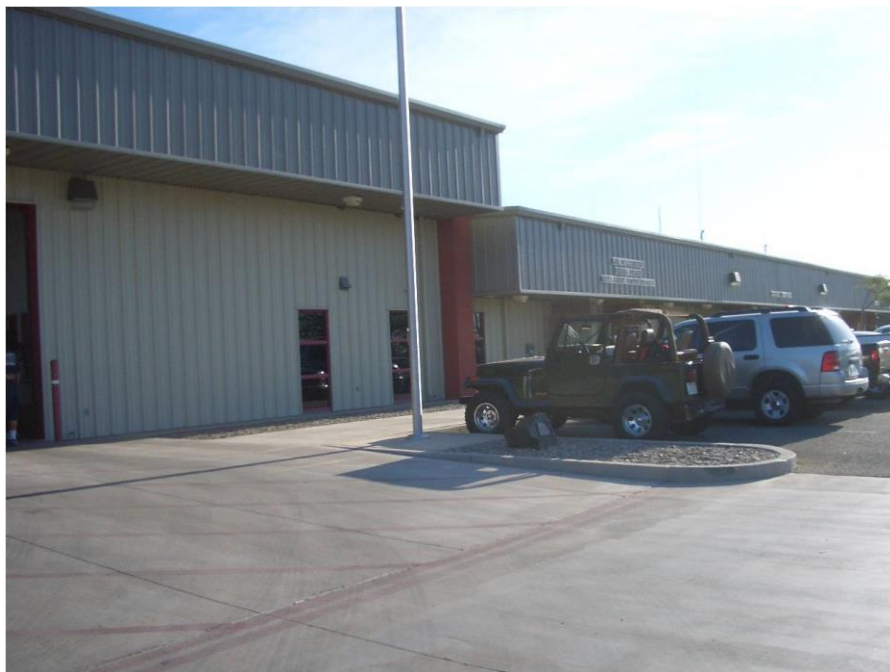
Figure 2-13 – Imperial County EOC, 2010 Baja Earthquake

Figure 2-21 shows the Imperial County Emergency Operations Center, which was in the affected area of the M7.2 Baja Earthquake, which occurred on April 4, 2010. (This earthquake has technically been called the El Major – Cucupah Earthquake, but for the sake of brevity will be termed the 'Baja Earthquake' in this manual.) The Emergency Operations Center is a relatively new building with a structural design that anticipated strong ground motion. It was also properly designed as an 'essential facility.' The building had no serious damage, and remained in use as the Emergency Operations Center. It was appropriately tagged INSPECTED.

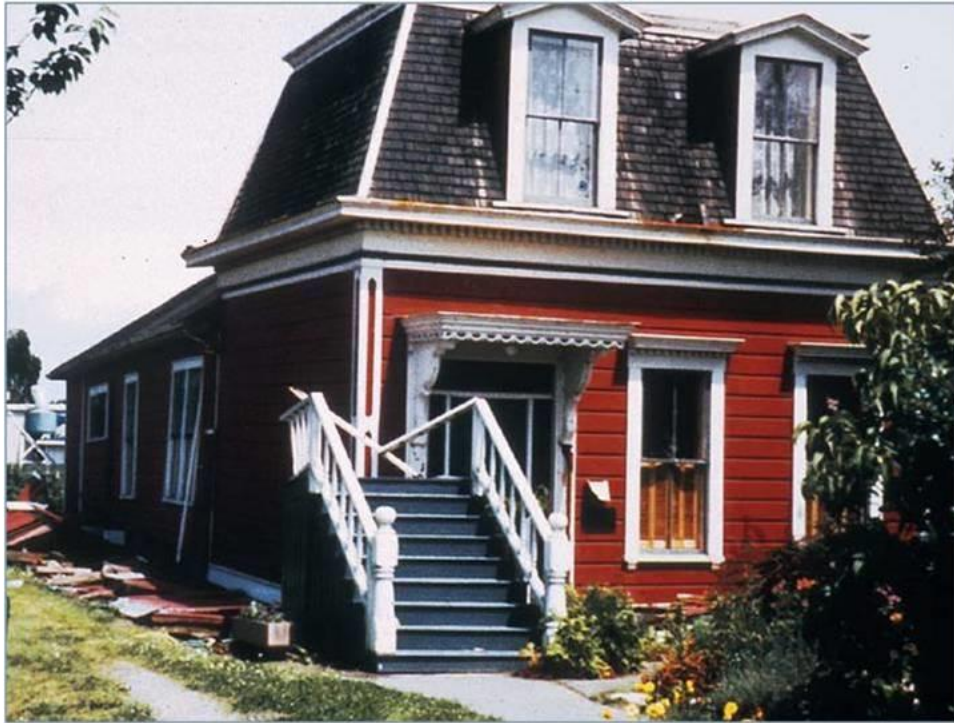
Figure 2-14 – Home collapsed on cripple walls, 1992 Humboldt Earthquake

Figure 2-14 shows an older home that collapsed on its cripple walls in the M7.2 Humboldt Earthquake of 1992, with its epicenter near Petrolia, CA. The home was no longer viable for occupancy, as the cripple wall collapse broke the water and sewer piping. The California Health and Safety Code requires that a building have working water and sewer plumbing and be enclosed from the weather in order to be occupied, and this building's condition violates two of those requirements. However, the house fell as a single unit, and is not racked or otherwise indicating any threat of collapse, so it would be possible for the occupant to go in to retrieve important possessions. A RESTRICTED USE placard would be appropriate here.

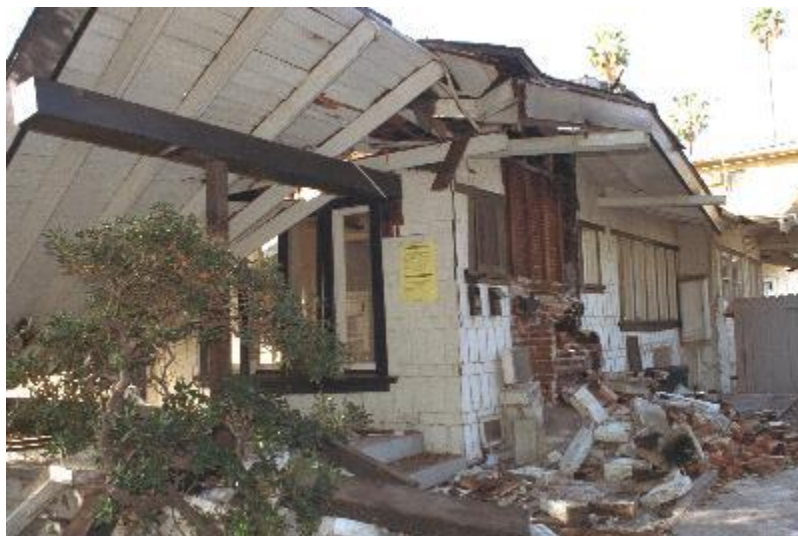
Figure 2-15 – Yellow tagged home, 1994 Northridge Earthquake

Figure 2-15 shows a home with a collapsed porch awning and chimney. Other damages to the home are not discernable from this photo. The house was yellow-tagged with a dual language placard.

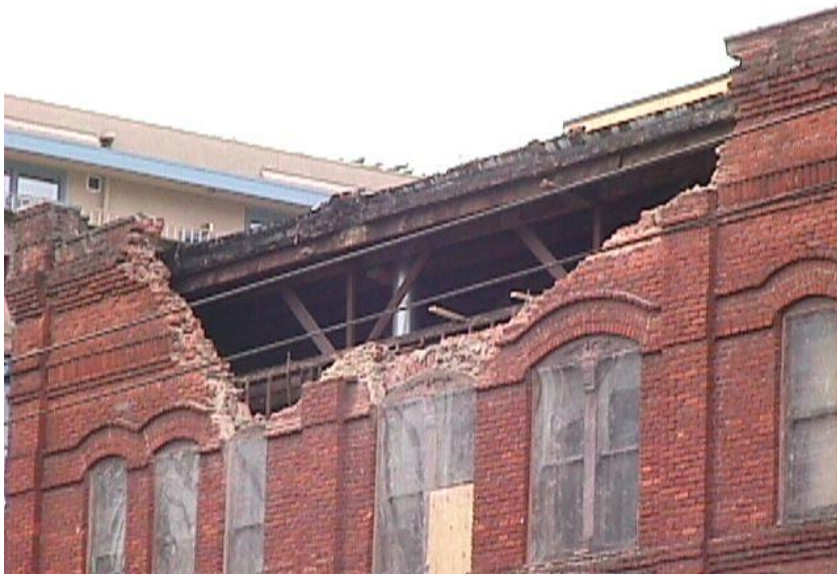
Figure 2-16 – Unreinforced masonry wall failure, 2001 Nisqually Earthquake.

Figure 2-16 shows the collapse of an exterior unreinforced masonry wall. Other damage is not readily visible in the photo. Unreinforced masonry buildings are very fragile in earthquakes, having no credible tensile resistance; the building likely has been tagged UNSAFE.

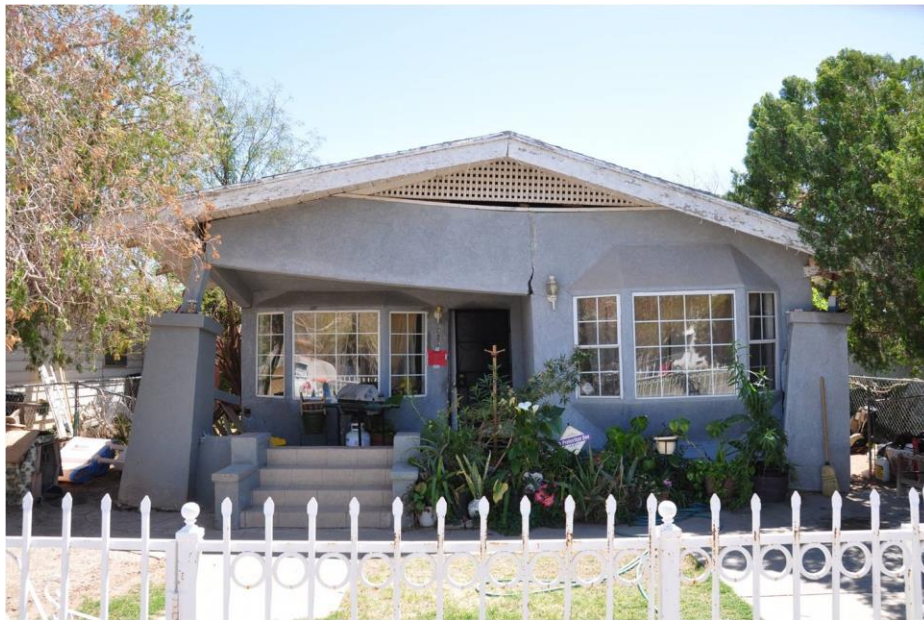
Figure 2-17 – Heavily damaged house, 2010 Baja Earthquake

Figure 2-17 shows a house that has a porch with severe damage, and the entire house is racked, as evidenced by the leaning columns on either corner of the house. It does not take much racking for a structure to be pushed into failure mode; this house was correctly tagged UNSAFE.

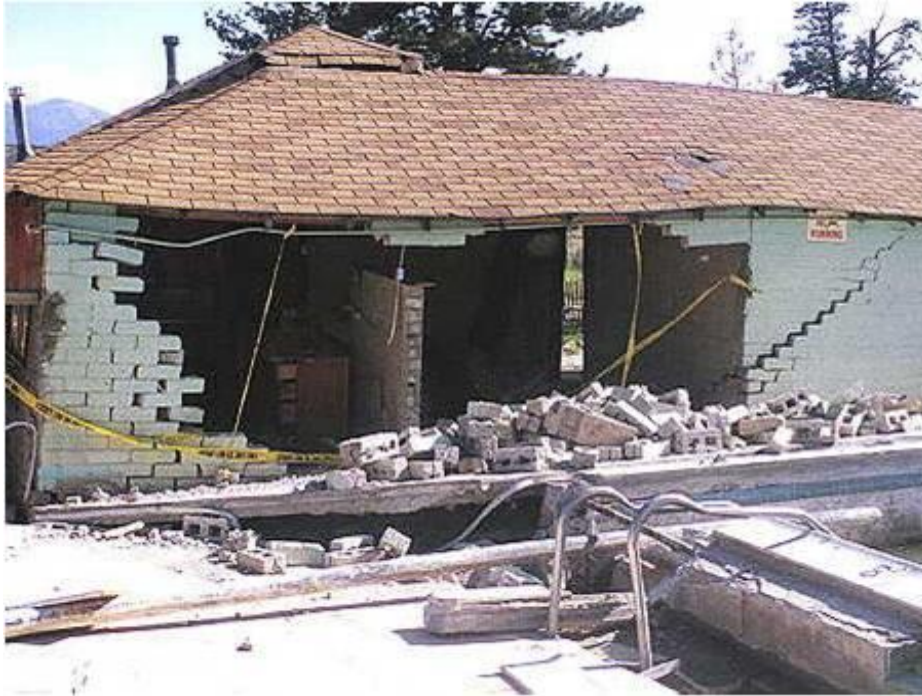
Figure 2-18 – Uplifted pool and damaged URM building, 1992 Big Bear Earthquake

Figure 2-18 shows an unreinforced masonry building with extensive damage. The question here is, why did the pool come up out of the ground? There could be several reasons; if the pool is sited in sandy soil with a high water table, liquefaction may have caused the pool to simply become buoyant and rise up out of the ground. Another cause may have been a scarp that pushed the pool up. If the latter, it needs to be identified, by a geologist or geotechnical engineer if necessary, and the information supplied to the building department via the assessment form for this building.

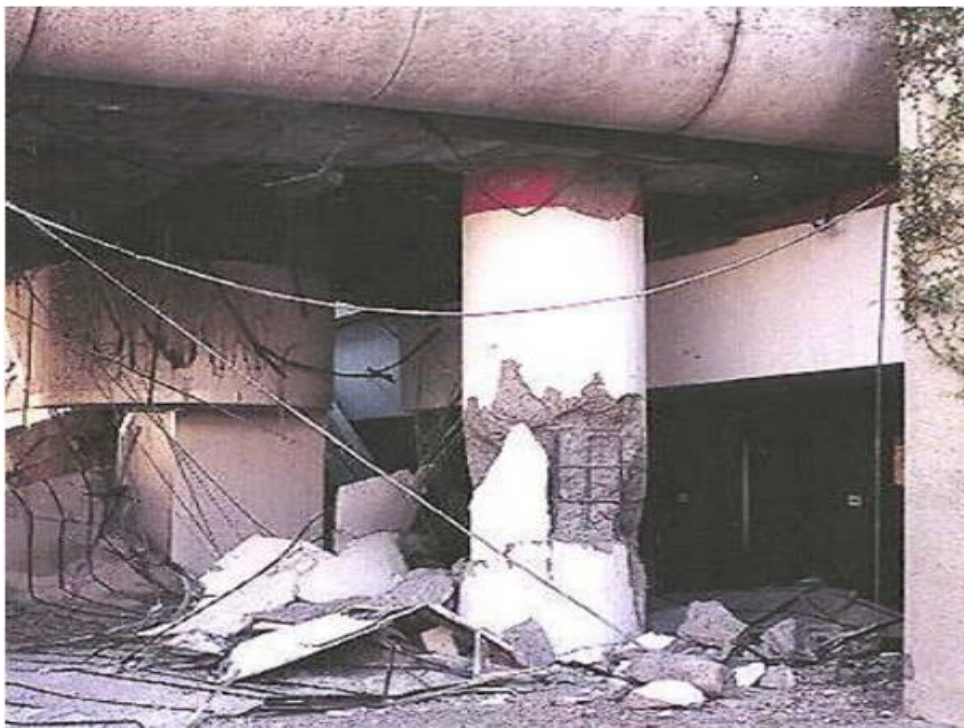
Figure 2-19 – Damaged column at department store, 1994 Northridge Earthquake

Figure 2-19 shows a reinforced concrete column supporting a pedestrian overcrossing that spalled away the concrete cover protecting the rebar. Upon closer examination in Figure 2-20, it is clear that the column is now in a type of failure mode. The rebar is bent, and there is a diagonal crack through the center of the column. These conditions indicate that a P-delta effect is at work that is translating vertical load into lateral movement. The entire area should be barricaded off, and tagged “AREA UNSAFE,” using a felt pen to insert the word AREA in front of the word UNSAFE on the placard. The pedestrian overcrossing should also be barricaded at both ends and placarded UNSAFE as well.

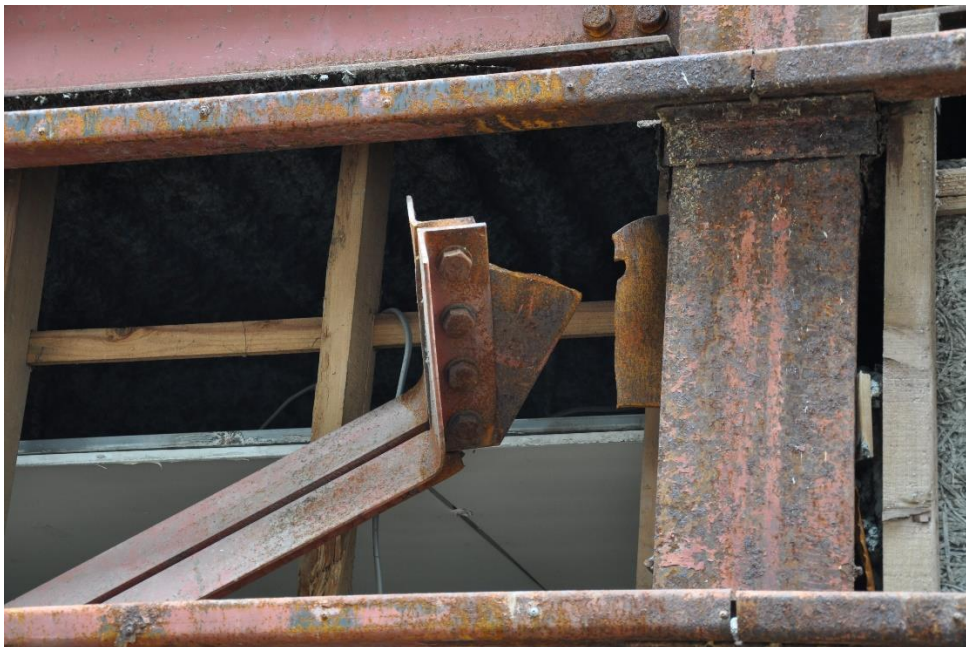
Figure 2-21 – Failure of steel gusset plate.

Figure 2-21 shows a failed steel gusset plate on a lateral brace.

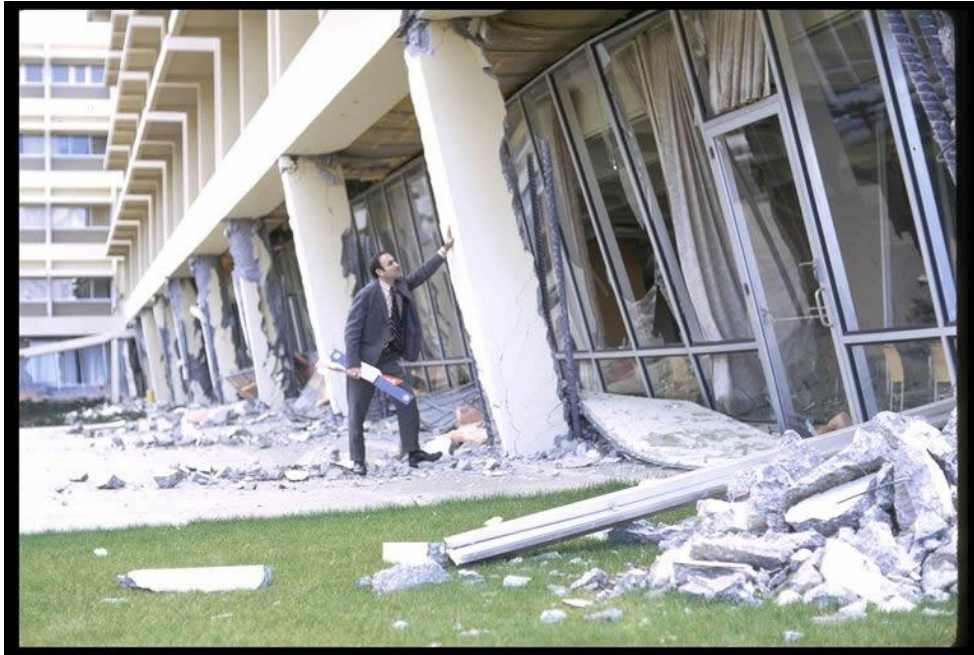
Figure 2-22 – Failure of concrete moment frame.

Figure 2-22 shows first floor racking of a multistory concrete moment frame structure.

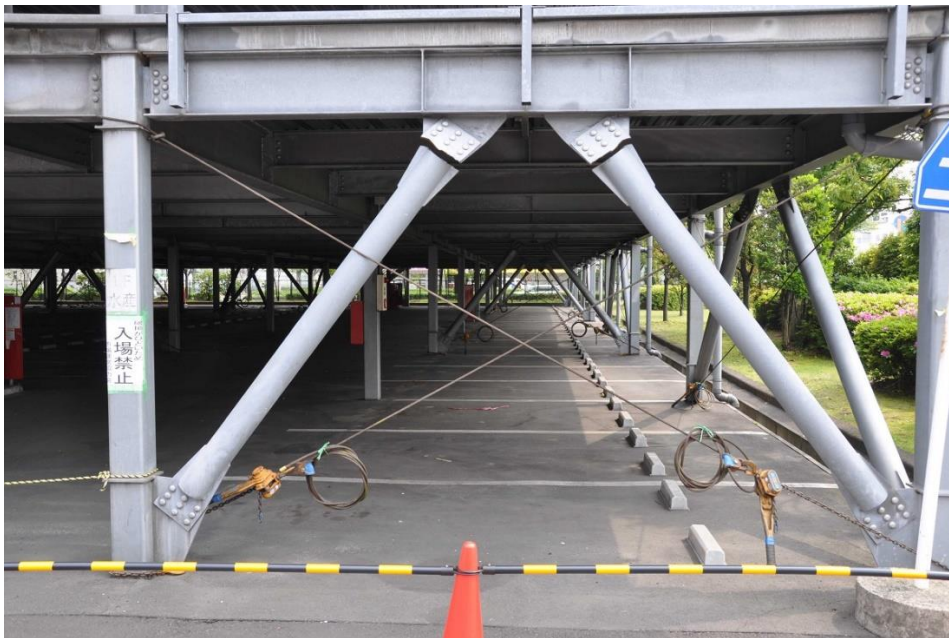
Figure 2-23 – Failed gusset plates on lateral bracing

Figure 2-23 shows two gusset plates that pulled apart at the top of steel lateral bracing.

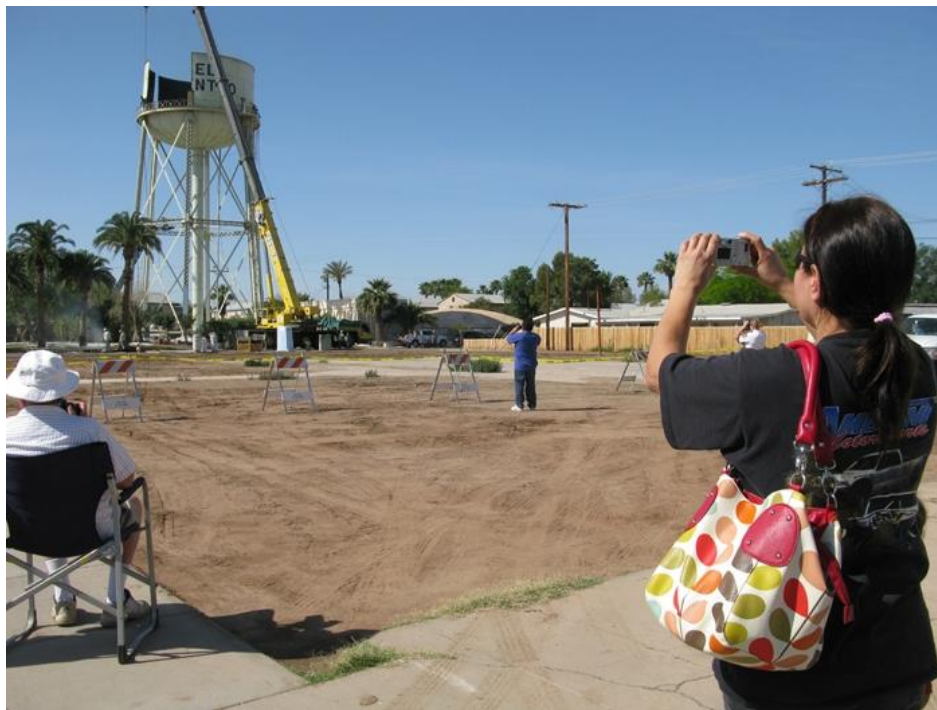
Figure 2-28 – Water tower undergoing demolition to abate collapse hazard

Within the collapse zone of the water tower were two residences and an 8-unit apartment building. These were all tagged UNSAFE and evacuated due to the clear and present danger from the potential collapse of the neighboring water tower. Within a very short time, the City of El Centro acted to demolish the water tower and remove the hazard (Figure 2-28). Then the UNSAFE tagging of the neighboring residences in the collapse zone could be reassessed and reversed. (Note that, if the neighboring residences had their own safety issues beyond the one posed by the collapse hazard, the new assessments would reflect that in the posting of those residences.)

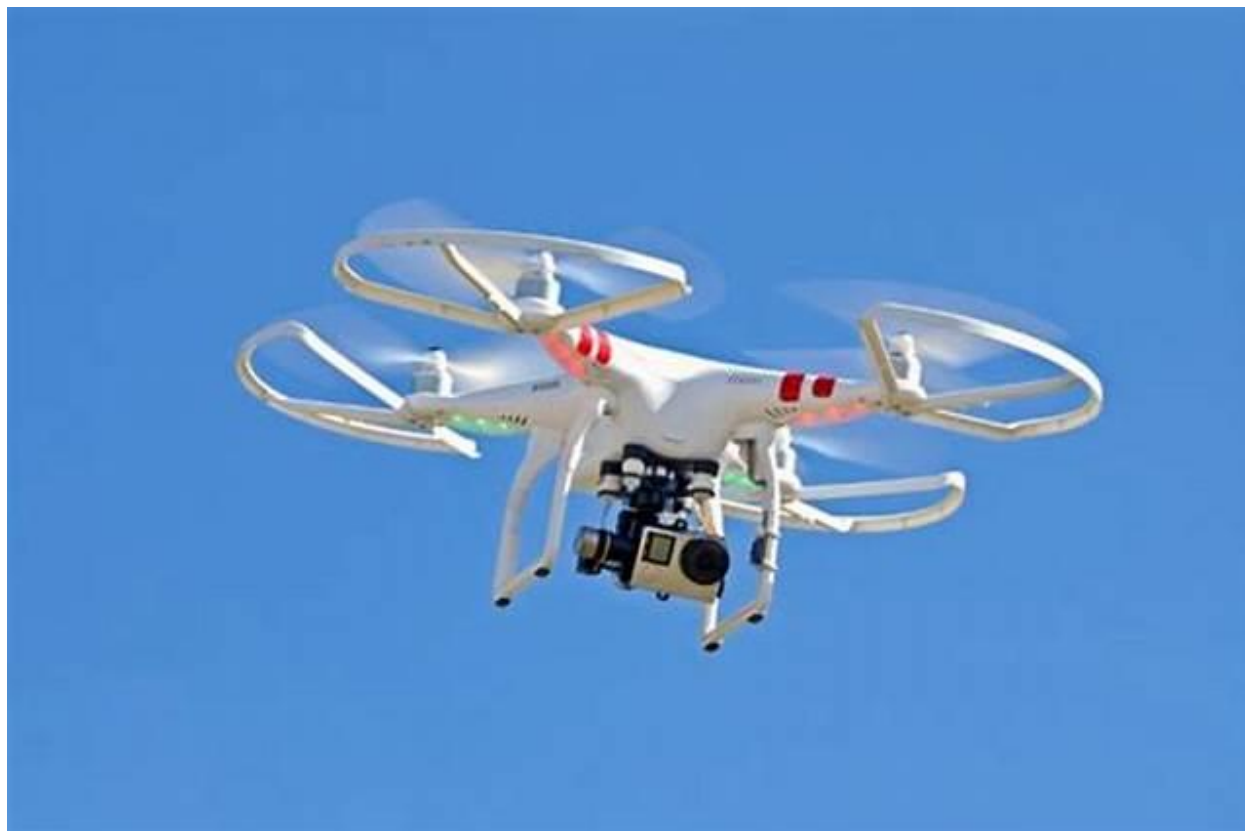
Figure 2-33 – Example of a drone with camera

If a government entity chooses to use drones as part of their post-disaster operations, care must be taken to avoid drone interaction with other types of aircraft. It may be necessary to get clearance from authorities to operate drones for this purpose, and to coordinate drone use with other post-disaster air operations. Privacy laws should also be considered, as well as the safety of personnel on the ground. Operators should be certified to operate drones. It is also best if the model of drone chosen has an “auto-return-home” feature.

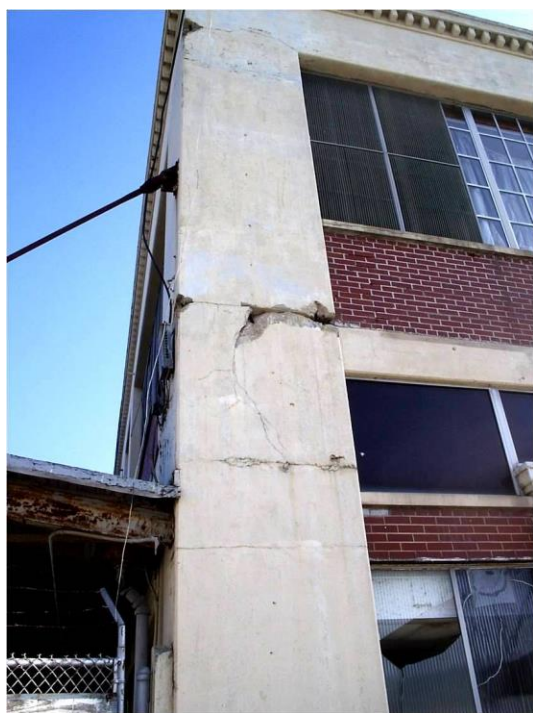
Figure 3-1 - Damaged concrete column, 2005 Hurricane Katrina

Figure 3-1 shows a reinforced concrete column that suffered some flexure damage due to the high winds of Hurricane Katrina. It is easy to see from this photo that taller buildings without sufficient steel reinforcing could be severely damaged in such storms.

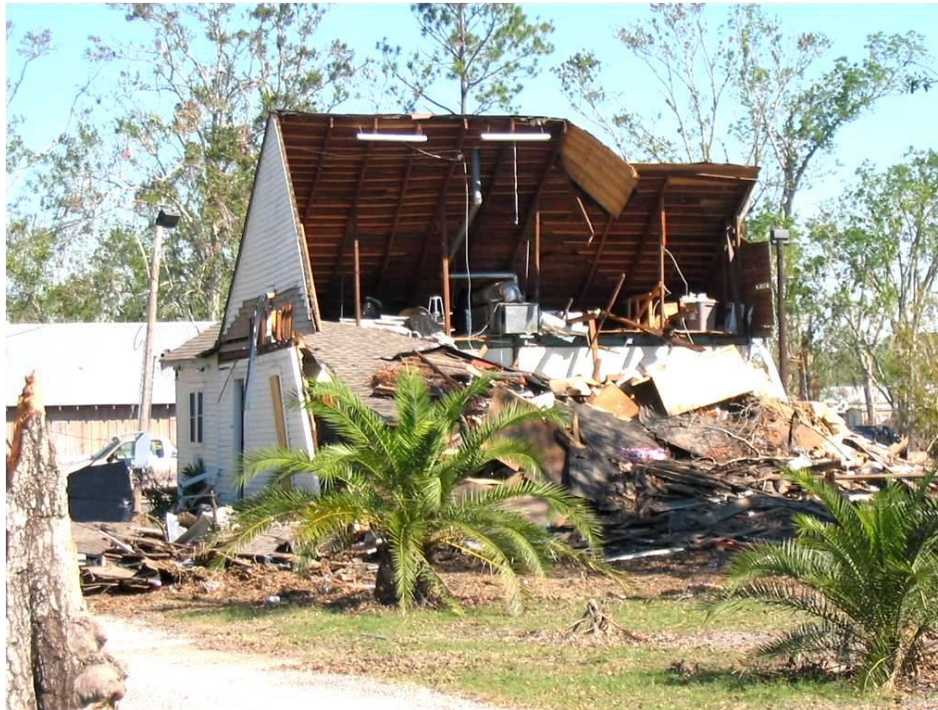
Figure 3-3 – Damaged house, 2005 Hurricane Katrina

Figure 3-3 shows a wood frame house where the back end and part of the roof was torn off by Hurricane Katrina. The wall of the house is noticeably leaning, indicating that the house is no longer stable.

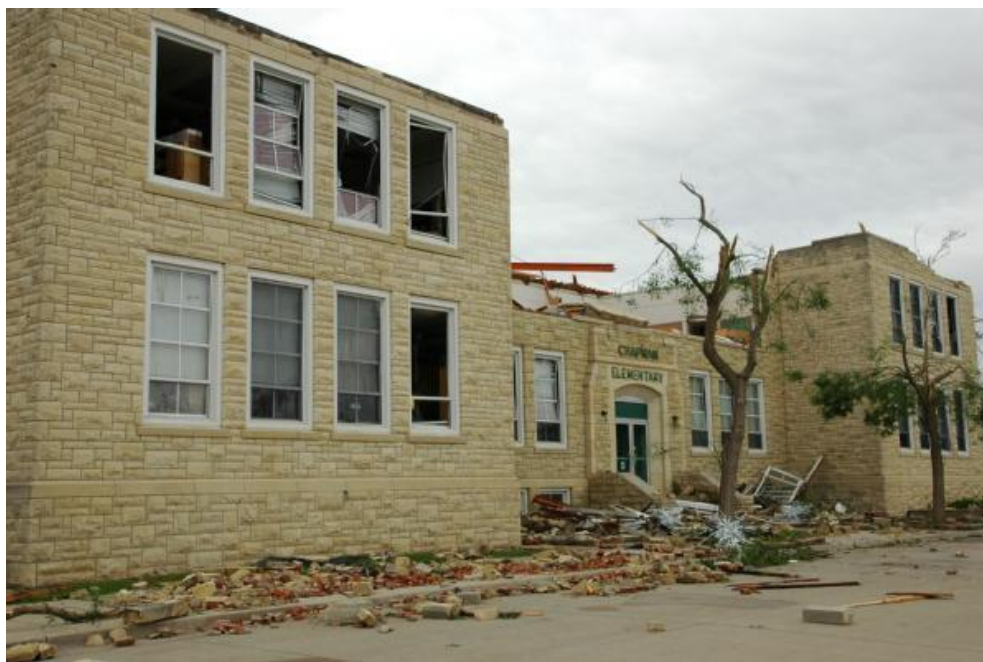
Figure 3-6 – Roof torn off elementary school, Chapman, KS tornado, 2008

That same tornado caused the damage seen in Figure 3-6. The roof of the Chapman Elementary School was torn off, and the windows were blown out. In the same event, the school administration building, the high school, and the middle school were all destroyed.

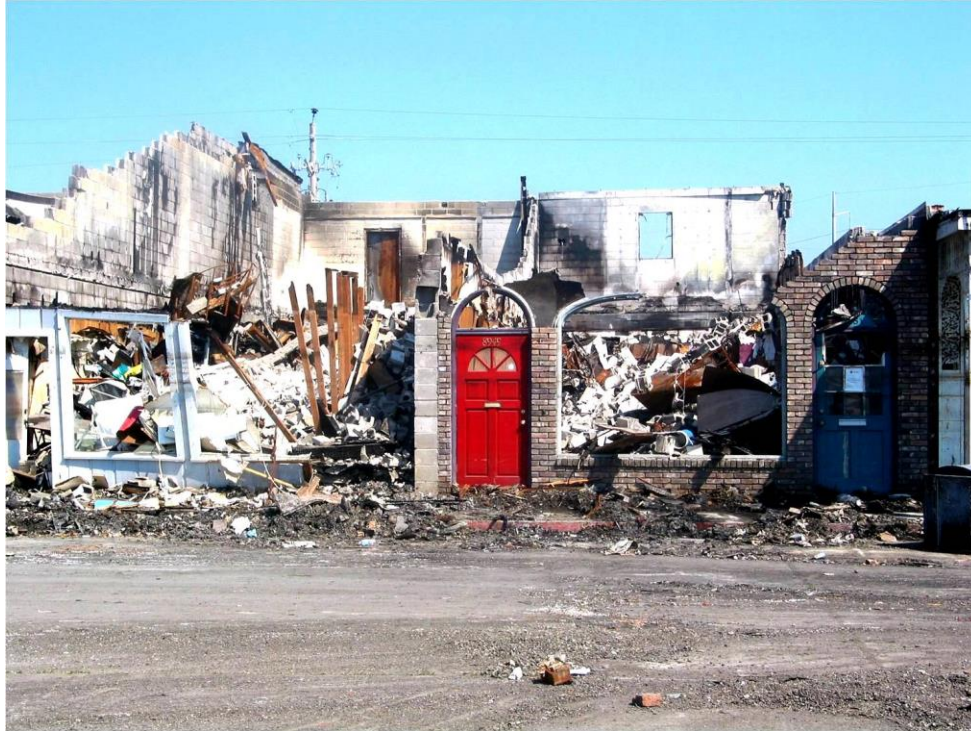
Figure 3-7 – Destroyed commercial building, 2005 Hurricane Katrina

Strong winds have been known to damage or destroy unreinforced masonry buildings. Note the building in Figure 3-7; this unreinforced masonry commercial building was practically demolished by Hurricane Katrina. Many of the walls have been debilitated, and the roof is gone. Water from the hurricane reached about seven feet high, and the structure at some point caught fire, burning everything above the water line. It is interesting to note that the door appears to be unscathed through all of this, and likely still works!

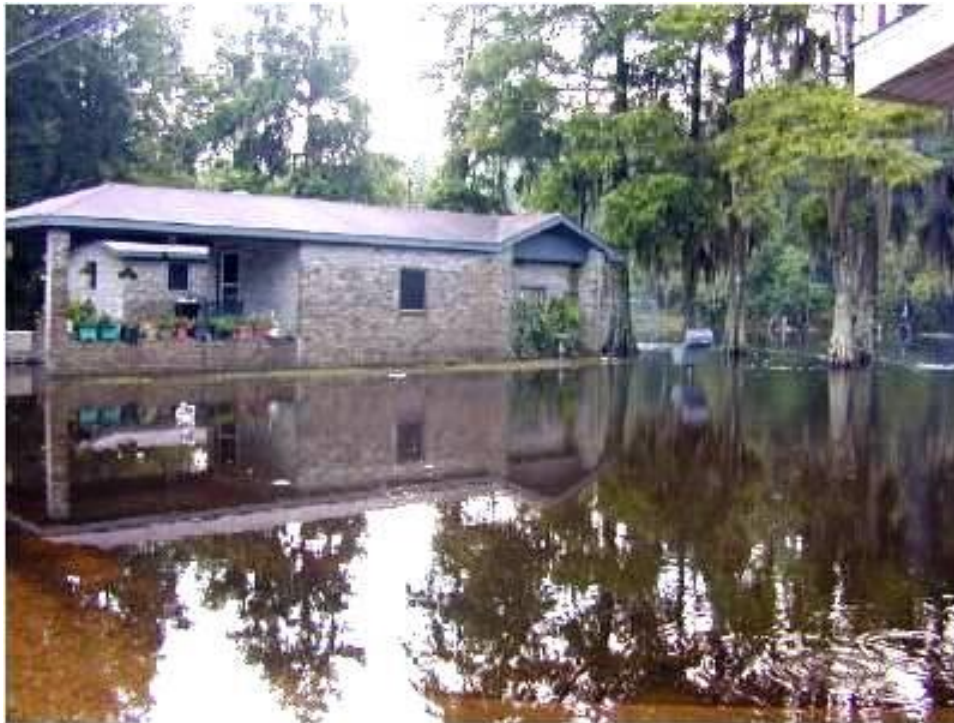
Figure 3-8 – Inundation flooding, Louisiana, 2001 Hurricane Allison

As seen in Figure 3-8, the water line from flooding can be seen on the exterior of a building, which will indicate how much of the interior was inundated. In this case, the water line is at the top of the windows. The walls, floors, and contents will be soaked with flood water, and there will be a great deal of work to be done before the building can be inhabited again. However, if there is no other risk such as a hazardous material spill or structural damage, the building can be posted RESTRICTED USE so content removal and repair can begin. If the ceilings have been soaked, the placard should have a caution that the ceilings were soaked and might fall.

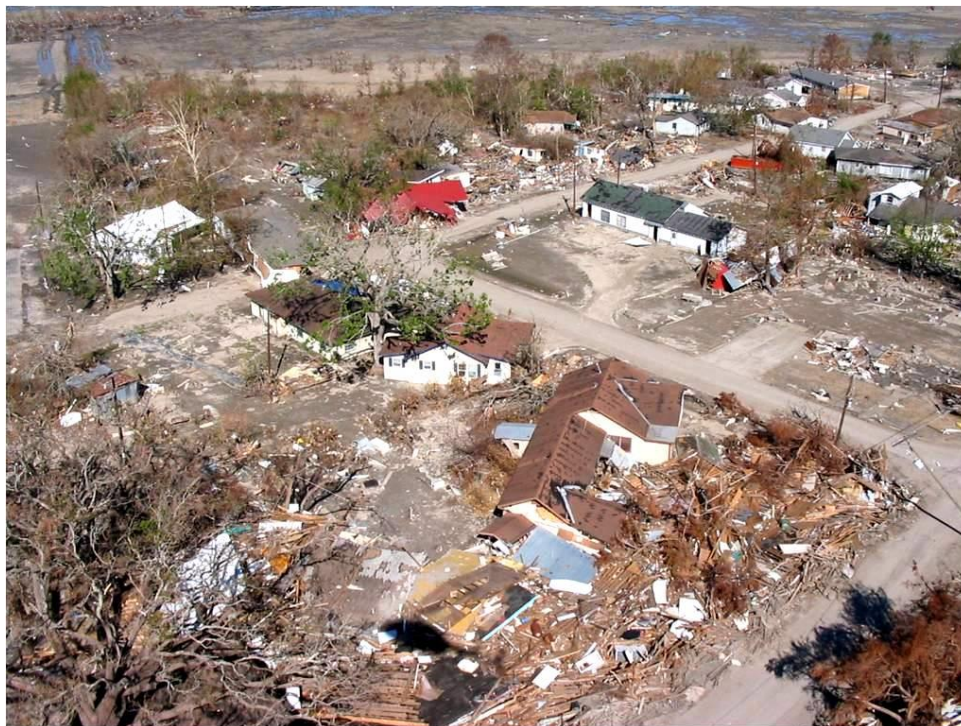
Figure 3-9 – Damaged neighborhood, 2005 Hurricane Katrina

Figure 3-9 shows the widespread damage that often results from flooding. The storm surge from a hurricane scatters buildings and debris in its wake. In this case, homes are left sitting in the road, pushed against trees, and half-buried in debris. This photo was taken after the roads were cleared, except for the occasional house still in the road.

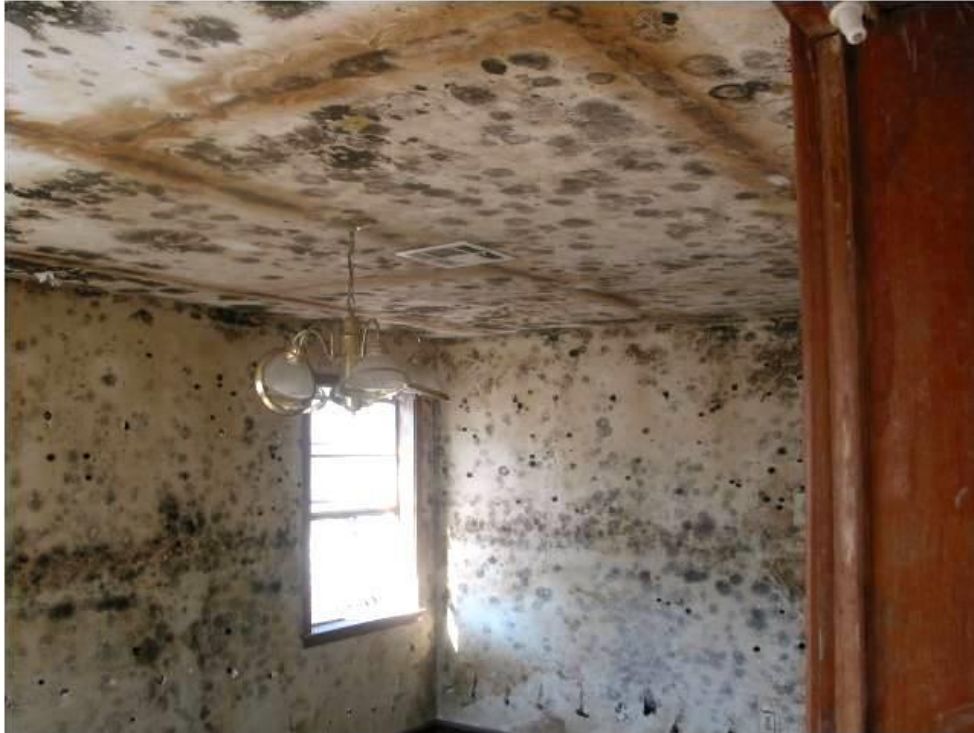
Figure 3-10 – Mold growth, 2005 Hurricane Katrina

As stated before, mold should be treated as risky or hazardous, and protection must be worn before entering a mold spore laden environment. Figure 3-10 shows a relatively mild case of mold in an inundated home. (It can be worse!) Naturally, if a person is allergic to mold, entering a house like this one is not an option!

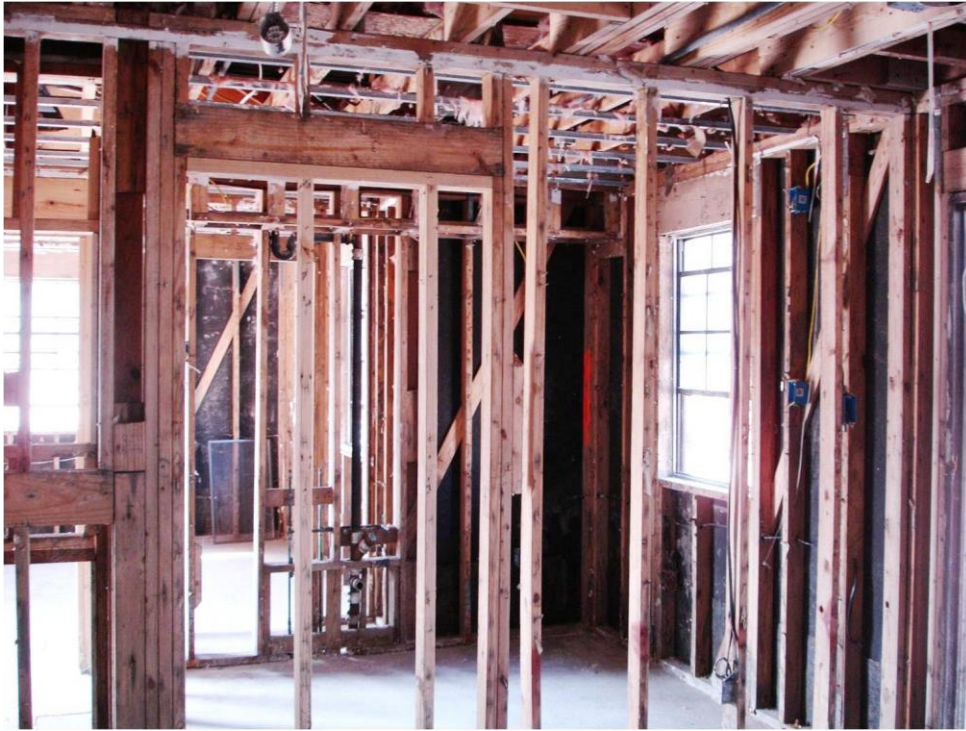
Figure 3-11 – Wood frame structure under cleanup, 2005 Hurricane Katrina

Figure 3-11 shows what needs to be done as part of the repairs: the wallboard, insulation, and electrical must be stripped out, and even the studs may have to be treated with bleach or fungicide before rebuilding can start.

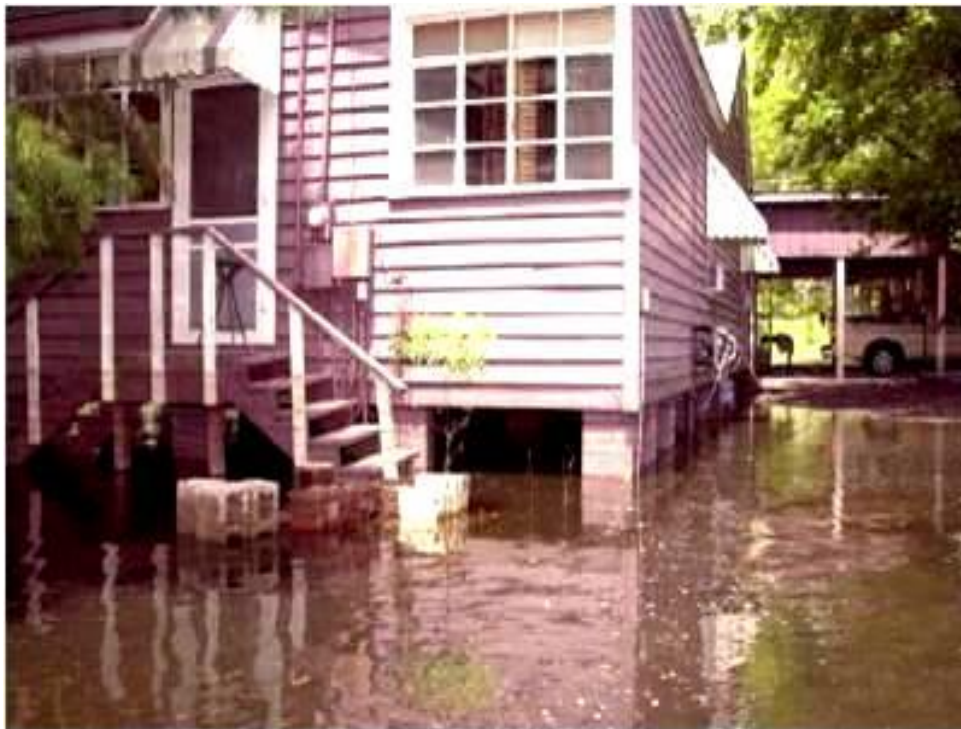
Figure 3-12 – Raised house, Louisiana, 2001 Tropical Storm Alison

The house in Figure 3-12 was built on pillars, which allows for good air flow in normal conditions, and allows flood water to flow under the house in a flood. The water line on this home is a few inches below the first floor level, so the flood water never entered the house or affected the utilities. So, safety evaluation of this structure would include examining the foundation pillars to make sure that they were sound, and that there has been no scouring or settlement at the foundation pillars. Of course, this evaluation would be done only after all the water drained away and the ground was dry. The water line indicates that the first floor framing became wet. If warping is not evident at the time of the safety assessment, the house could be posted **INSPECTED**. A note could be made about potential warping to be watched for on the placard and the evaluation form.

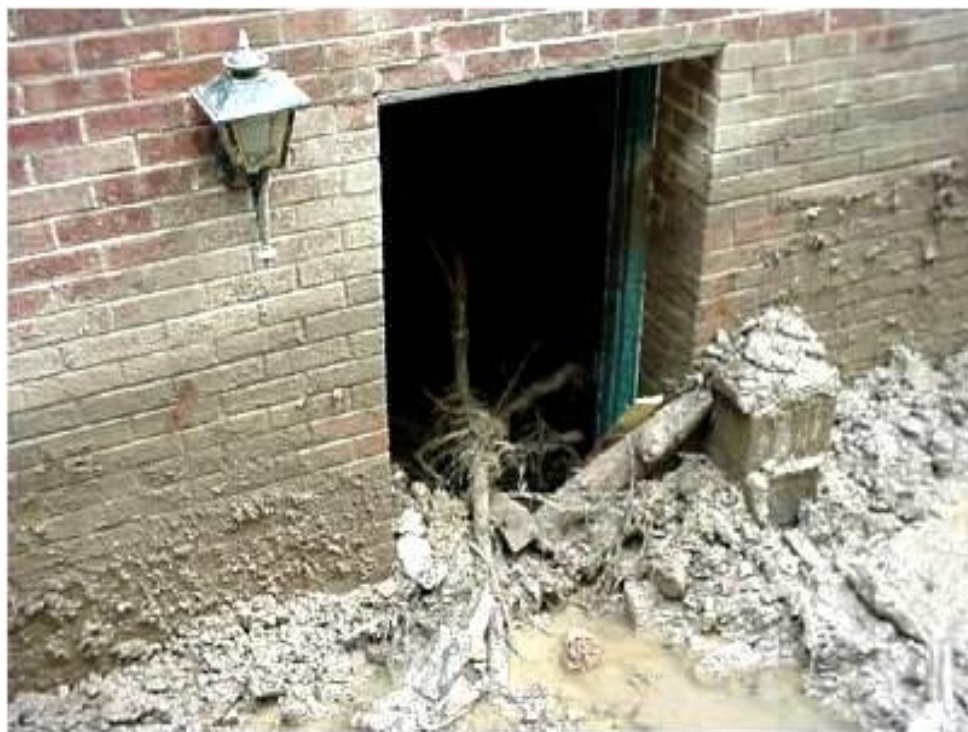
Figure 3-13 – Flash flood debris, 2001 West Virginia flood

Mud and other debris must be considered in safety assessments due to blocked doorways that deny access to buildings. In Figure 3-13, the mud and debris covers about half the door height. Access is not fully available until the debris is removed. If an evaluation was done before the debris was removed, the most likely posting would be **RESTRICTED USE**, with no access until the debris was removed.

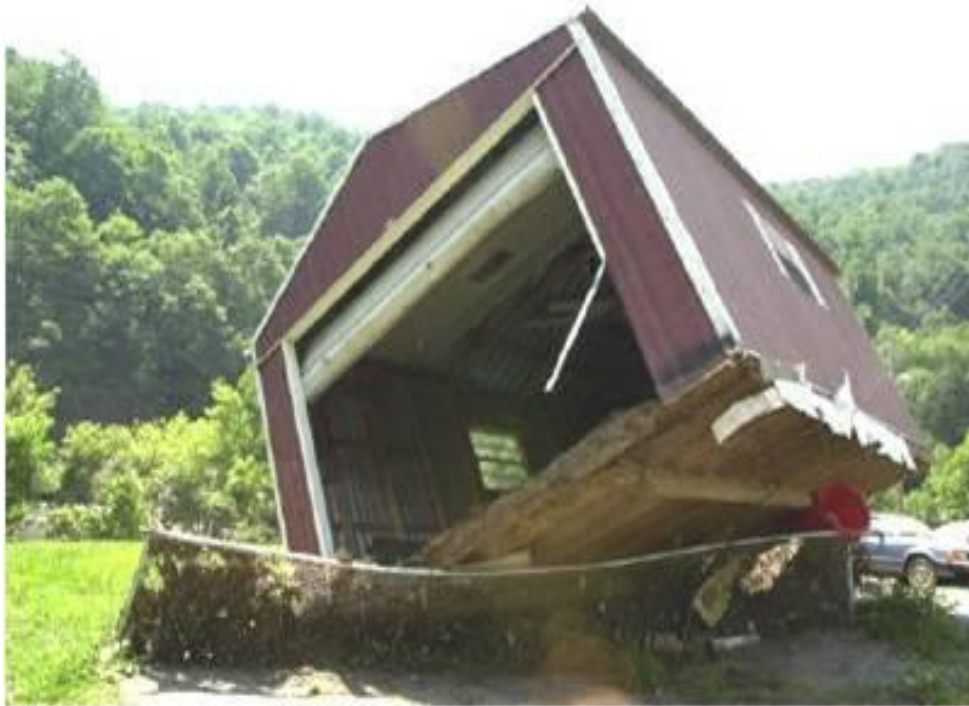
Figure 3-14 – Garage shed swept away, 2001 West Virginia Flood

In Figure 3-14, a garage shed was swept away and found left resting on a fence downstream somewhere. This building likely was just sitting on sleepers and was never attached to a foundation, so when the flood came, the shed did not stand a chance. The building is a collapse hazard in its present situation, so it should be posted UNSAFE.

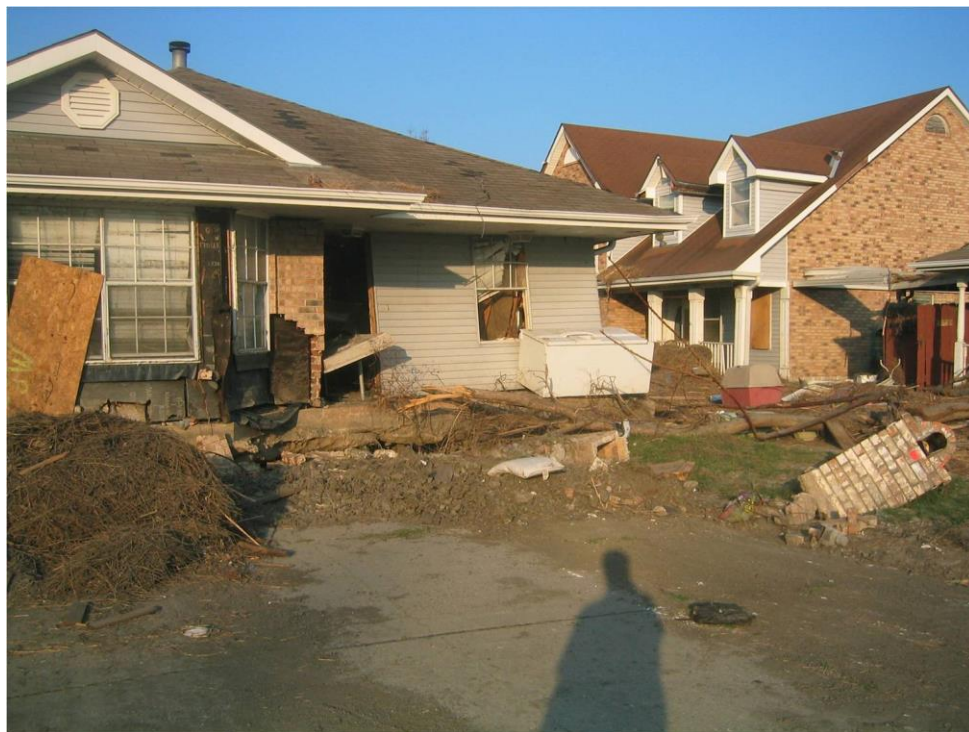
Figure 3-15 – Floated home with post-tensioned concrete slab, 2005 Hurricane Katrina

Swift water, such as that found in hurricane storm surges, can also remove well-built homes with their attached concrete foundations and move them downstream. There were more than a few cases of this observed due to Hurricane Katrina in Louisiana and Mississippi. Figure 3-15 shows a modern, well-built home that was solidly attached to its post-tensioned concrete foundation in St. Bernard Parish, Louisiana. The storm surge in this area was well over 20 feet high. This home was not the only one in this subdivision that was floated out of the ground and driven against other structures in the neighborhood. This house would likely be posted RESTRICTED USE for possession retrieval; it is not a collapse hazard, but cannot be lived in.

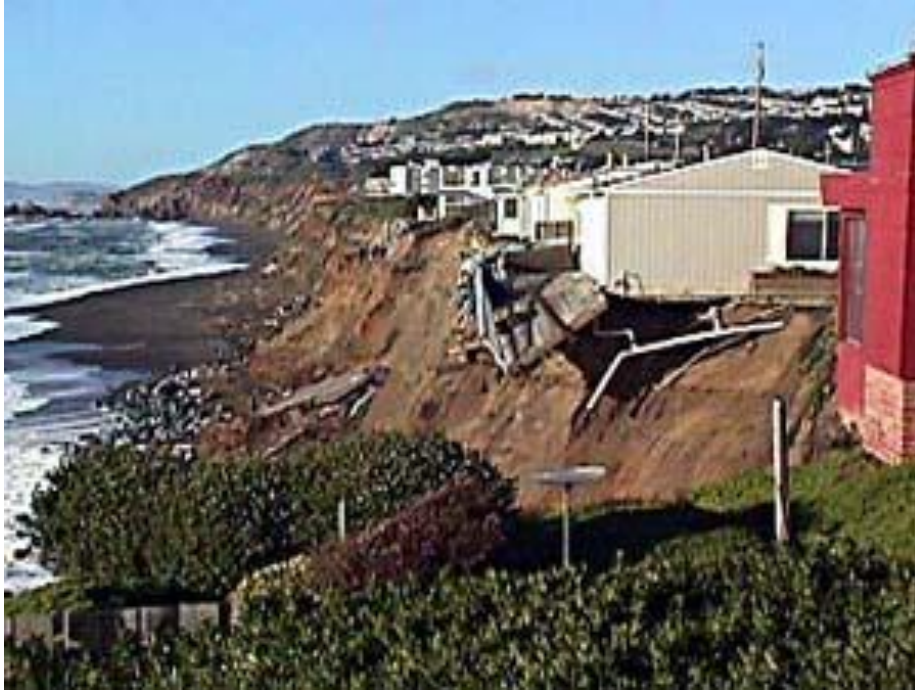
Figure 3-16 – Unsafe house due to cliff erosion, Pacifica, CA, 1998 El Nino Storms

Coastal flooding and wave action during storms will also lead to hazardous conditions for buildings on coastal cliffs. Figure 3-16 shows a house in Pacifica, California that is cantilevered over the cliff's edge due to erosion of the cliff from storm-driven wave action. This building must receive an UNSAFE posting, and there is absolutely no need for a SAP evaluator to enter this building!
