State of California

Safety Assessment Program Evaluator Student Manual

May 2020

Version 16

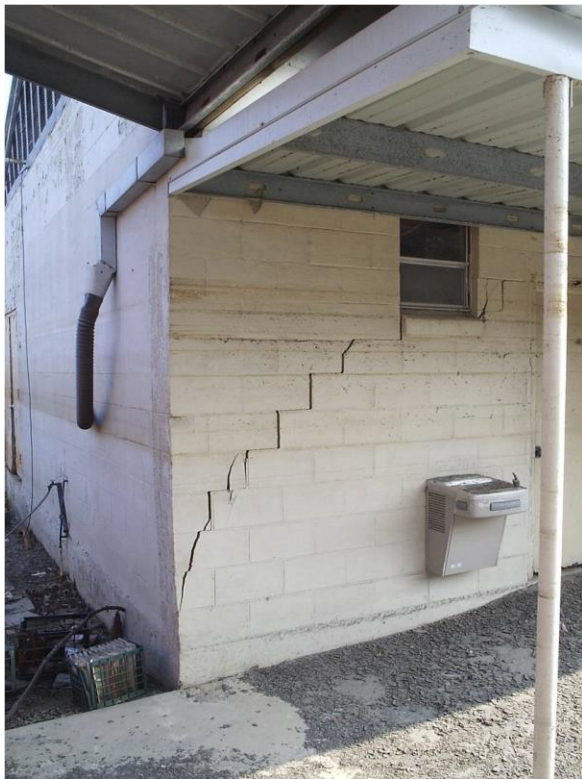
Figure 3-17 – Flooded URM building, 2005 Hurricane Katrina

In Figure 3-17, this building has suffered some structural damage due to flood forces, but will also have an extensive cleanup effort required in order to become usable again. Flood water carries bacteria and chemicals obtained in its journeys through the community, so occupancy of this building at present is not safe without proper cleanup and repairs. A RESTRICTED USE placard would be appropriate for this structure.

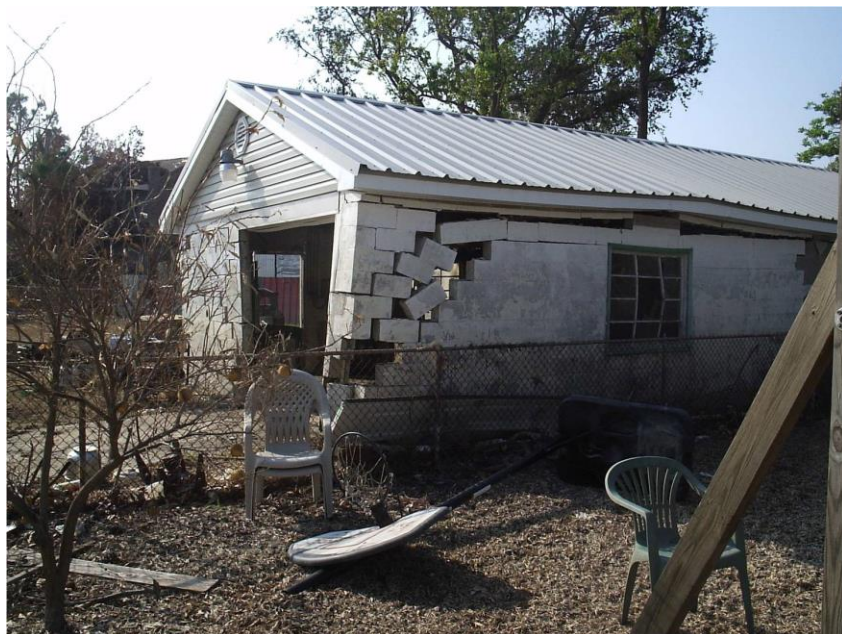
Figure 3-18 – Unreinforced masonry building failure due to storm surge, 2005 Hurricane Katrina

Figure 3-18 shows an unreinforced masonry garage in the process of failure. Note the water line just below the top of the windows; the force of the water caused the damage shown.

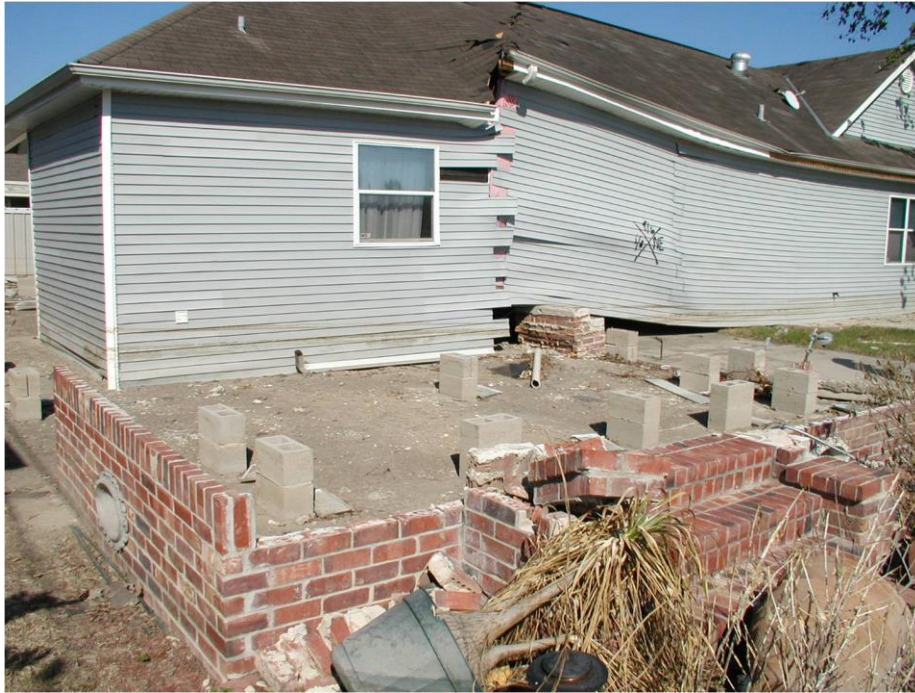
Figure 3-19 – Wood frame home floated off its foundation, 2005 Hurricane Katrina

In Figure 3-19, the house floated in the floodwaters of Hurricane Katrina off its foundation and settled unceremoniously into its present position. Note the stairs in the foundation wall in the foreground; there is no corresponding door on the house in the wall closest to the stairs. This house actually does not belong to the foundation it is resting on, but floated there from another place! The house was not attached to its foundation, which is common in some parts of the country.

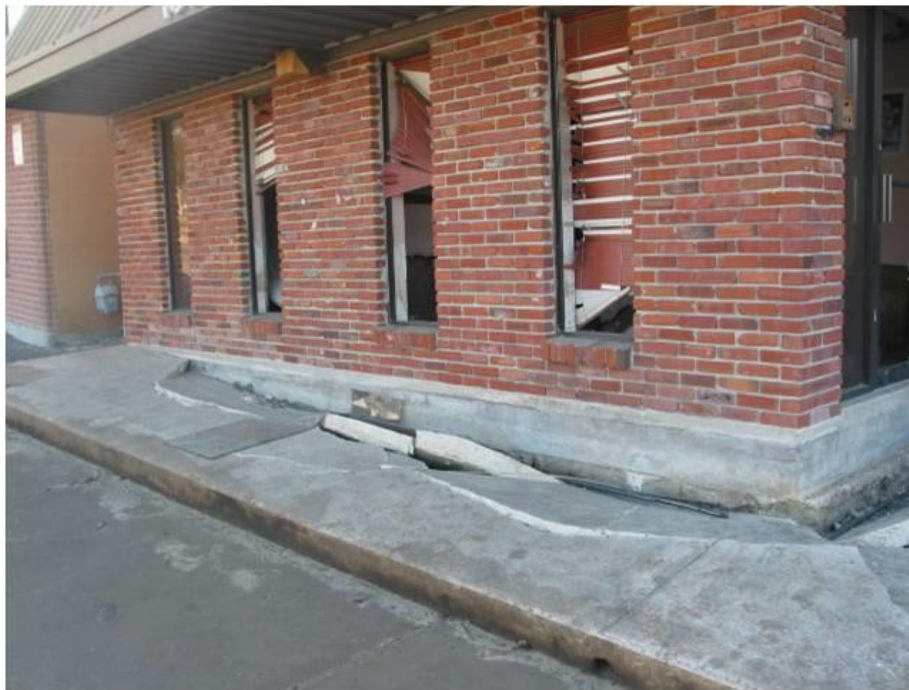
Figure 3-20 – Scouring under sidewalk, 2005 Hurricane Katrina

Figure 3-20 shows how scouring causes damage. Floodwaters managed to work their way under the sidewalk, which ended up unsupported and thereby failed. If this had been a building, the structure would be seriously compromised.

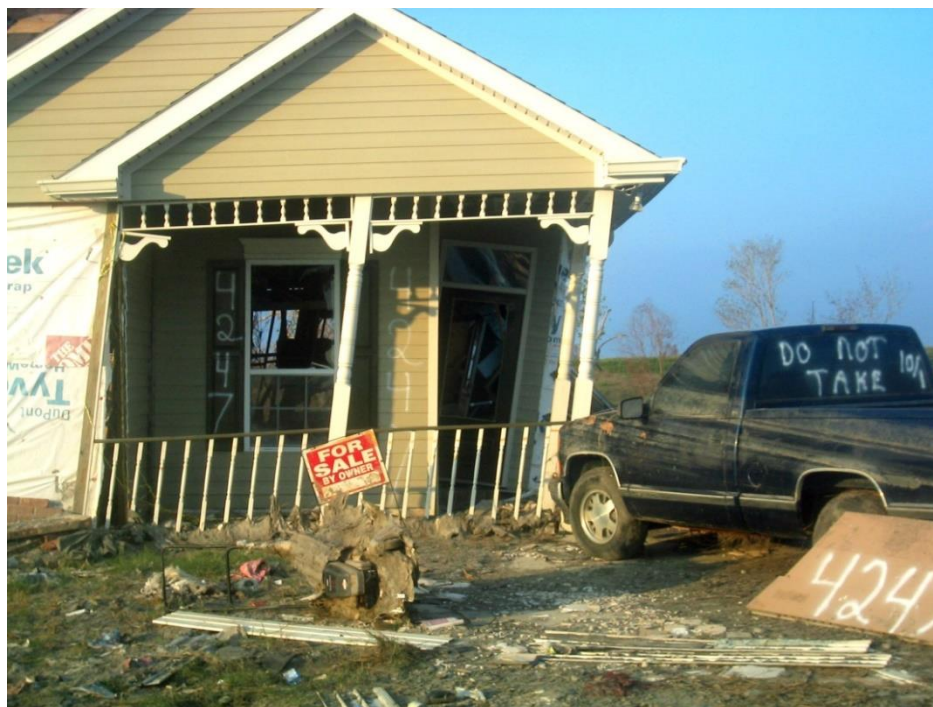
Figure 3-21 – Racking damage to wood frame building, 2005 Hurricane Katrina

Figure 3-21 shows a wood frame building that suffered racking damage during Hurricane Katrina.

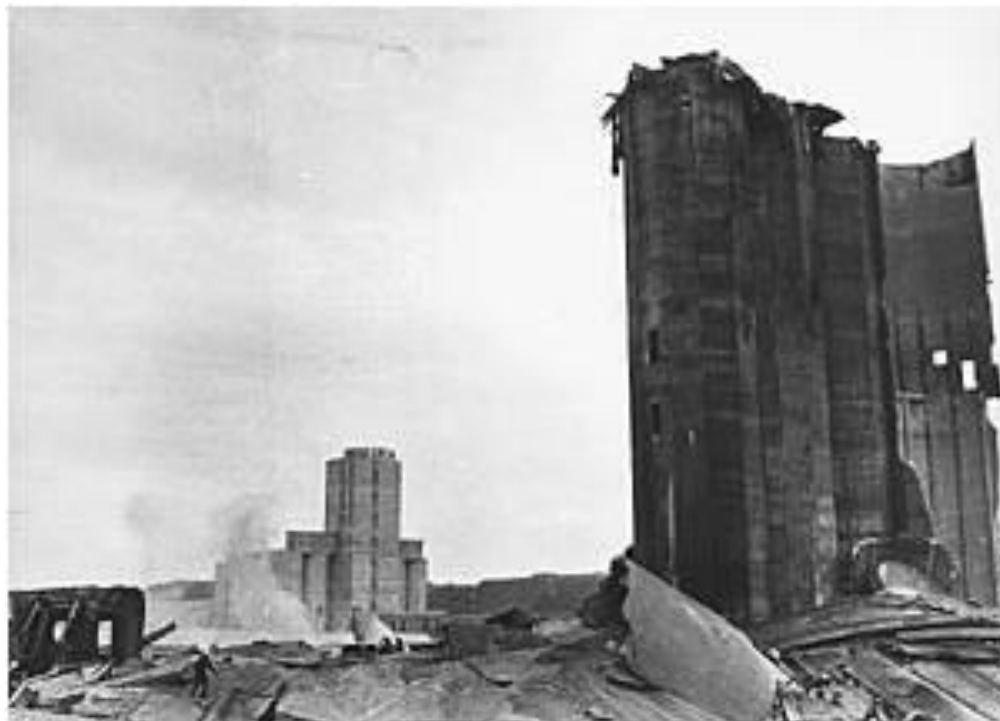
Figure 3-25 – Explosion – damaged granary

Figure 3-25 shows a granary built of reinforced concrete that was blown apart in a dust explosion. Flammable dusts present an explosion hazard when in the right fuel-to-air ratio and in the presence of a spark or flame. Flammable dusts can include flour, paper or wood dust, or even the dusts of certain metals.

Granary explosions are historically rather common, and are the chief reason why granaries are built of concrete or masonry instead of wood.

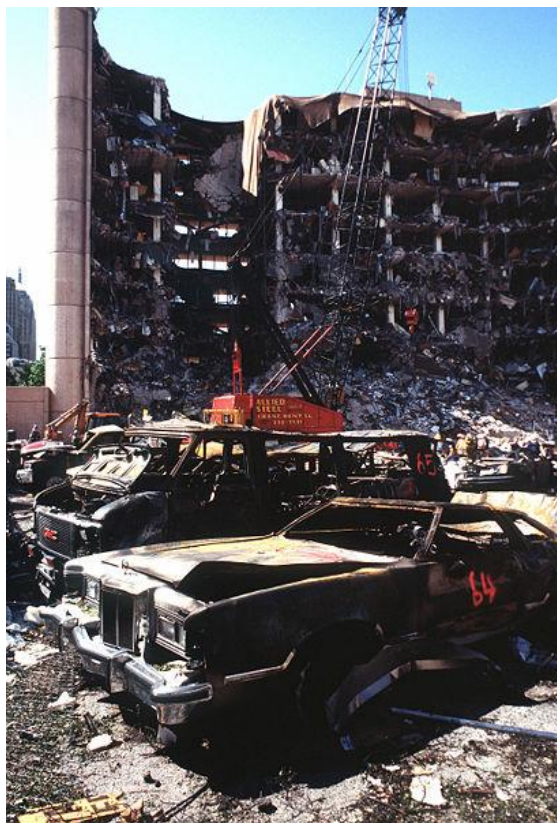
**Figure 3-28 – Terrorist bombing, 1995
Oklahoma City, OK**

Figure 3-28 shows the damage to the Murrah Federal Building in Oklahoma City after a 1.5 ton bomb was set off by terrorists. The building itself suffered extensive damage, and due to loss of lateral load capacity became extremely hazardous to survivors and rescuers alike. At one point, the wind speed increased to the extent that rescuers had to evacuate the building until the winds reduced, due to the building remnants being so fragile. Neighboring buildings suffered racking damage, and one had its concrete roof deck disconnected from the rest of the structure, where it threatened to fail and to pancake the rest of the floors in the building. The destroyed cars in the foreground have been marked with orange paint for tracking purposes.

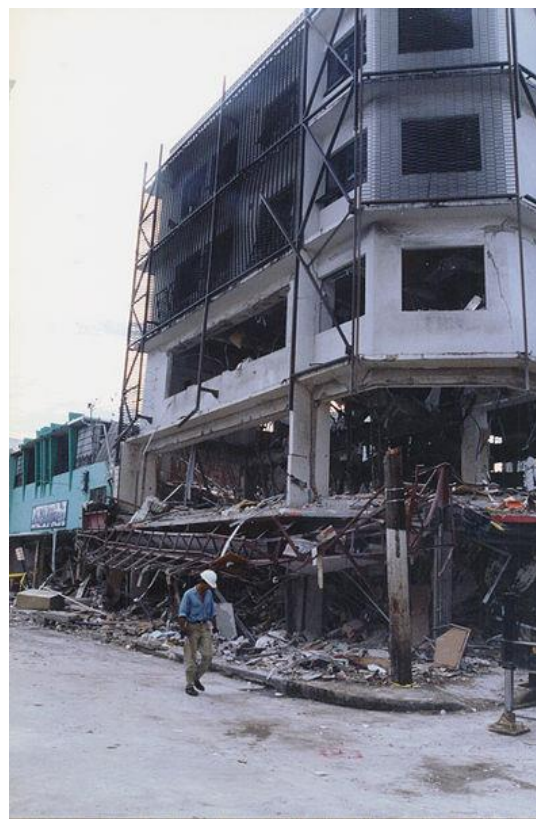
Figure 3-29 – Explosion, 2002 Puerto Rico

Figure 3-29 shows the damage from an explosion at the Humberto Vidal building in Puerto Rico. The explosion caused the collapse of one of the building's lower stories. Natural gas may have been involved in the blast

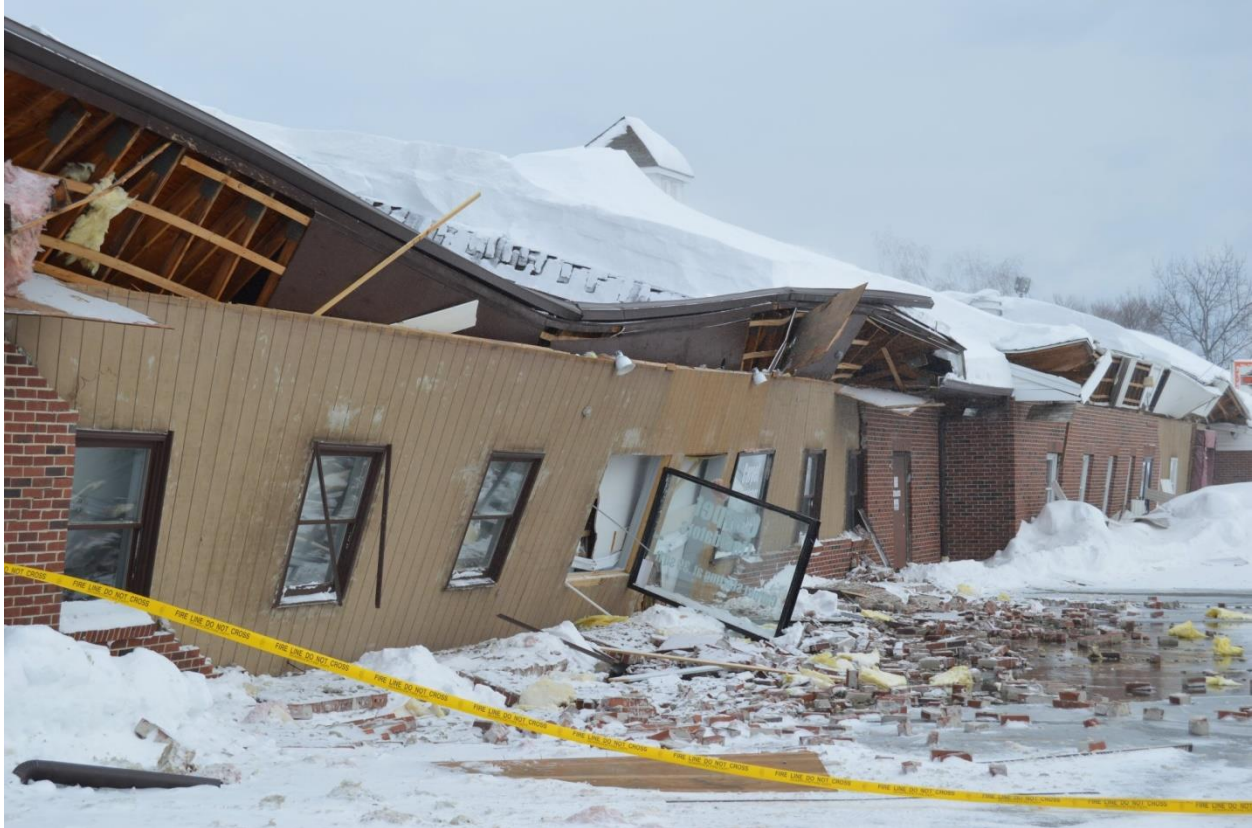
Figure 3-36 - Snow-caused roof and structure collapse in Massachusetts.

Heavy, wet snow is dangerous even for modern, well-built structures. Snow density in excess of 20 lbs/cf can occur in warmer storms, and the structural load capacity of roof structures can be exceeded. In addition, snow shedding off of roofs can damage or destroy features below, such as gas meters.

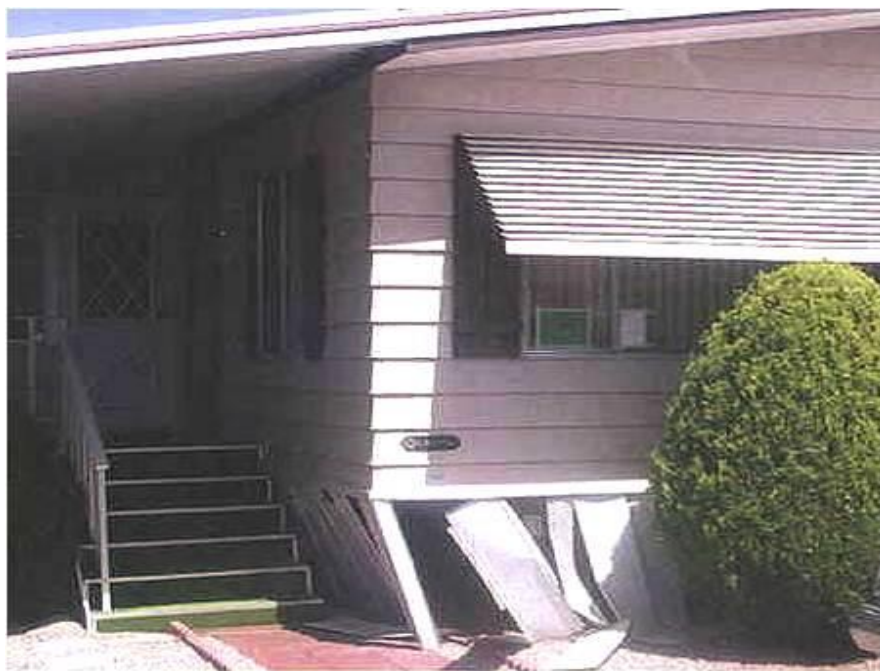
Figure 4-2 – Mobile home shifted on supports, 1992 Landers/Big Bear Earthquakes

Figure 4-2 shows a mobile home that has shifted on its supports. The home has been tagged INSPECTED. Although it has moved, the evaluation must have confirmed that the utilities are still operational, and the supports are still upright. There are no falling hazards from the porch awning, and the access is not impaired.

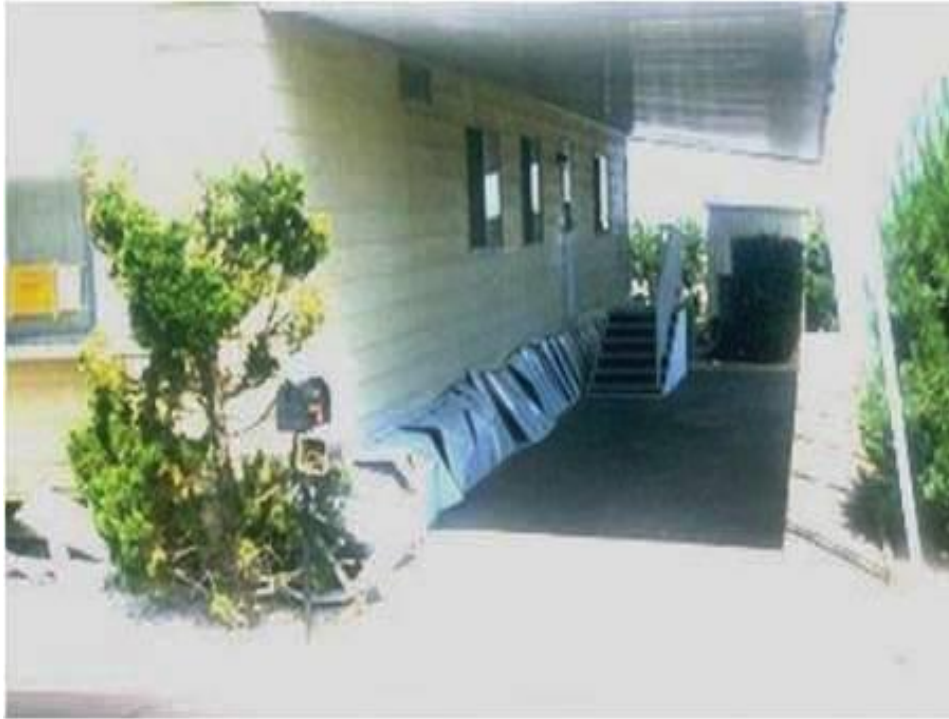
Figure 4-3 – Mobile home partially fallen, 1992 Landers/Big Bear Earthquakes

Figure 4-3 shows a mobile home that has moved off its jack stands and is resting on the ground. Looking at the buckled skirt, the level of the door with respect to the landing, and the separation between the landing and the unit, one has an idea of how far the unit moved. The unit will not fall further and is therefore stable.

The unit likely has damaged utilities, and the awning is now a falling hazard. Once the utilities are turned off, the unit could be accessed for possession retrieval. This unit could be posted RESTRICTED USE.

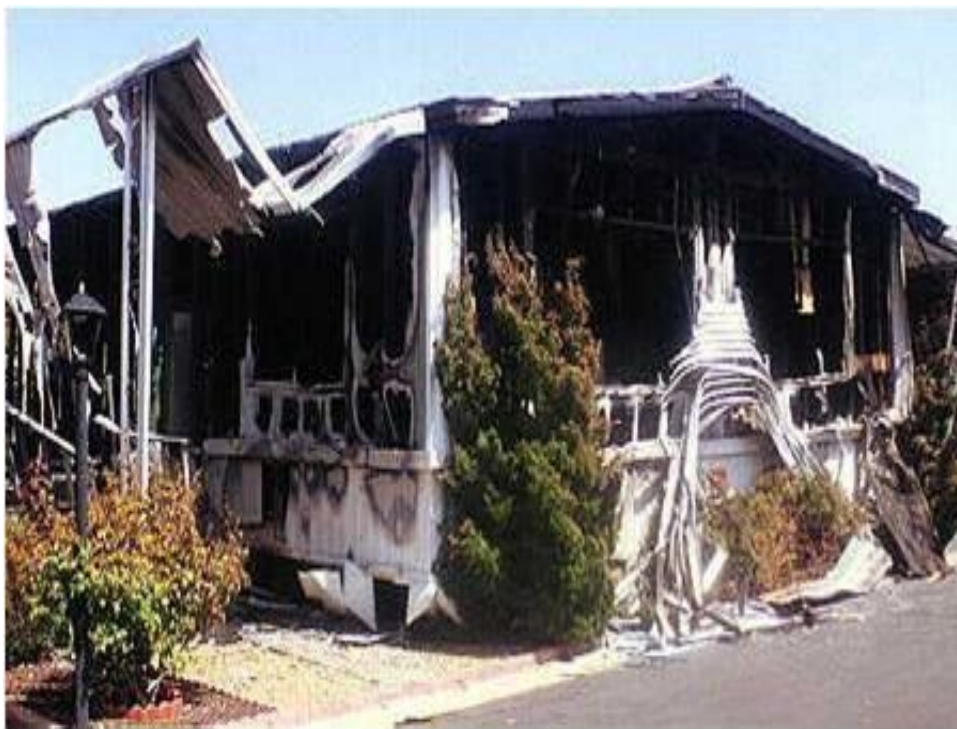
Figure 4-4 – Mobile home burned up, 1992 Landers/Big Bear Earthquakes

The mobile home in Figure 4-4 has been obviously destroyed by fire and has been posed UNSAFE. This is an example of what can happen when a unit falls off its supports and breaches the gas line. With the fire out, and the gas and electricity turned off, this unit is no longer a threat to adjacent units. Entry, of course, is dangerous.

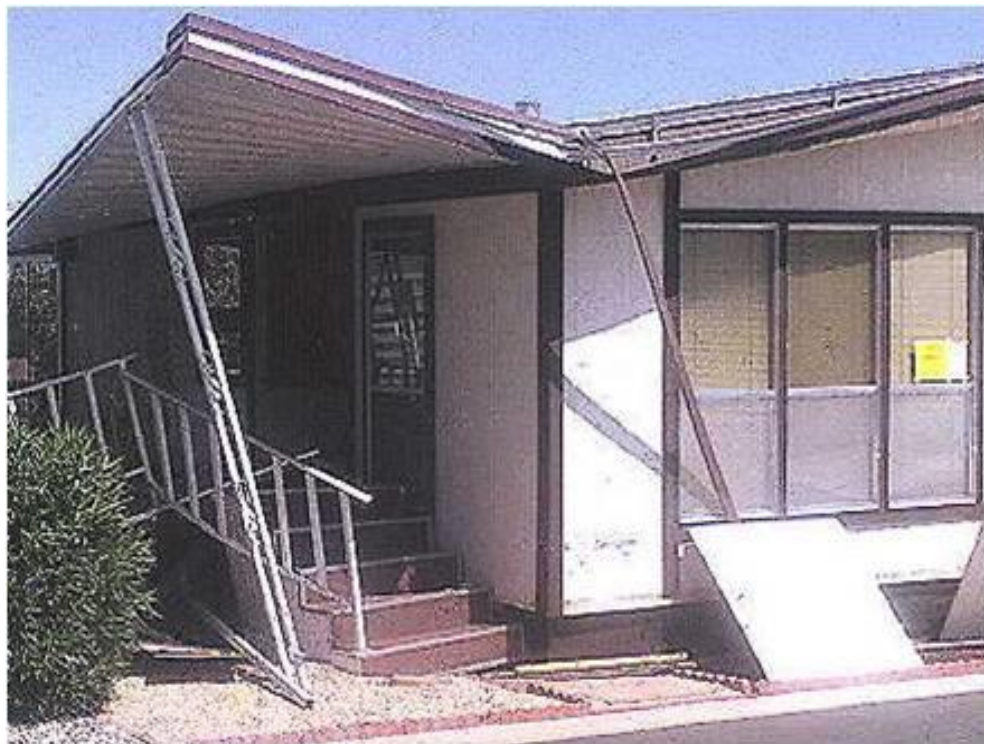
Figure 4-5 – Mobile home collapsed on supports, 1992 Landers/Big Bear Earthquakes

In Figure 4-5, the unit is off of its supports and is stable on the ground, unable to fall any further. However, the canopy over the side stairs is unstable and a falling hazard. This represents a safety threat from an aftershock or strong wind.

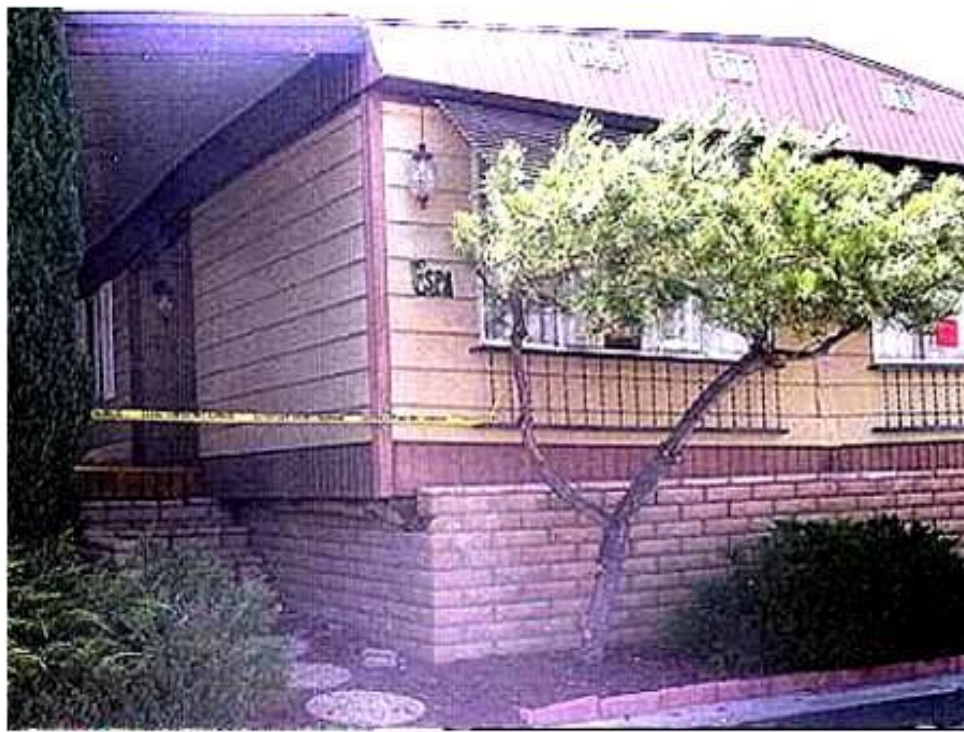
Figure 4-6 – Mobile home rendered unstable, 1992 Landers/Big Bear Earthquakes

This mobile home (Fig. 4-6) is dangerous in a deceptive manner. It appears at first glance to be in fine form, but close examination shows that the steel frame of the unit is resting on the nonstructural, unreinforced, one-brick-thick masonry skirting, which could give way at any time. Further, the marriage line on this double-wide unit is pulling apart at the bottom. This unit is a dangerous collapse hazard, and no one should enter it until it has been made safe. The UNSAFE placard is the right call in this case. Note that barricade tape has been run across the entryway to emphasize the denial of access.

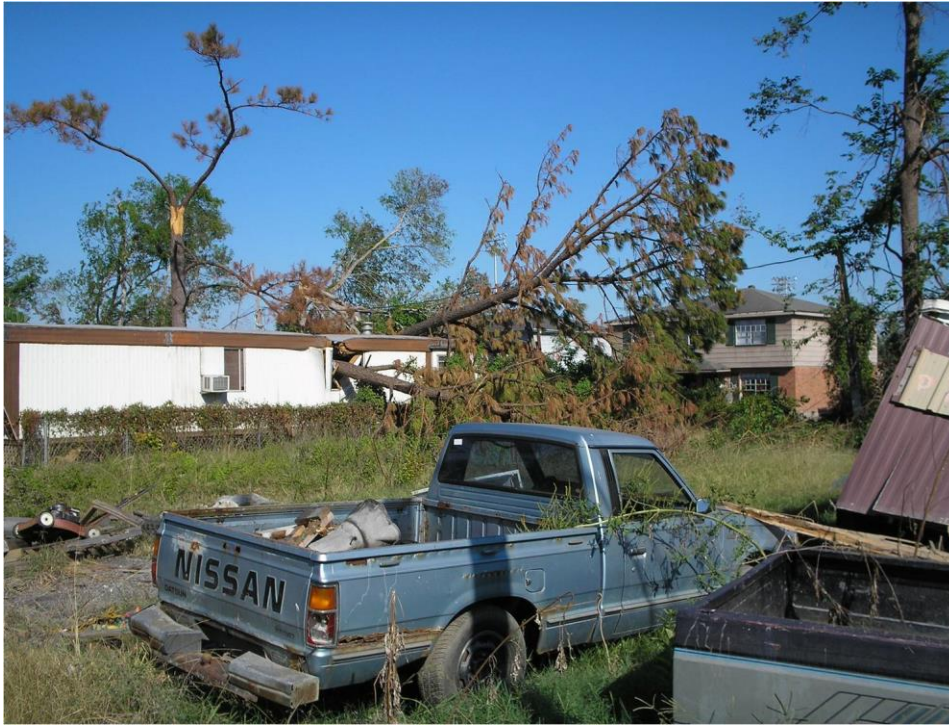
Figure 4-8 shows a heavily damaged mobile home that would be posted RESTRICTED USE for possession retrieval only. Again, the home is now open to the elements and not a suitable shelter, and with this level of damage, may have other issues as well.

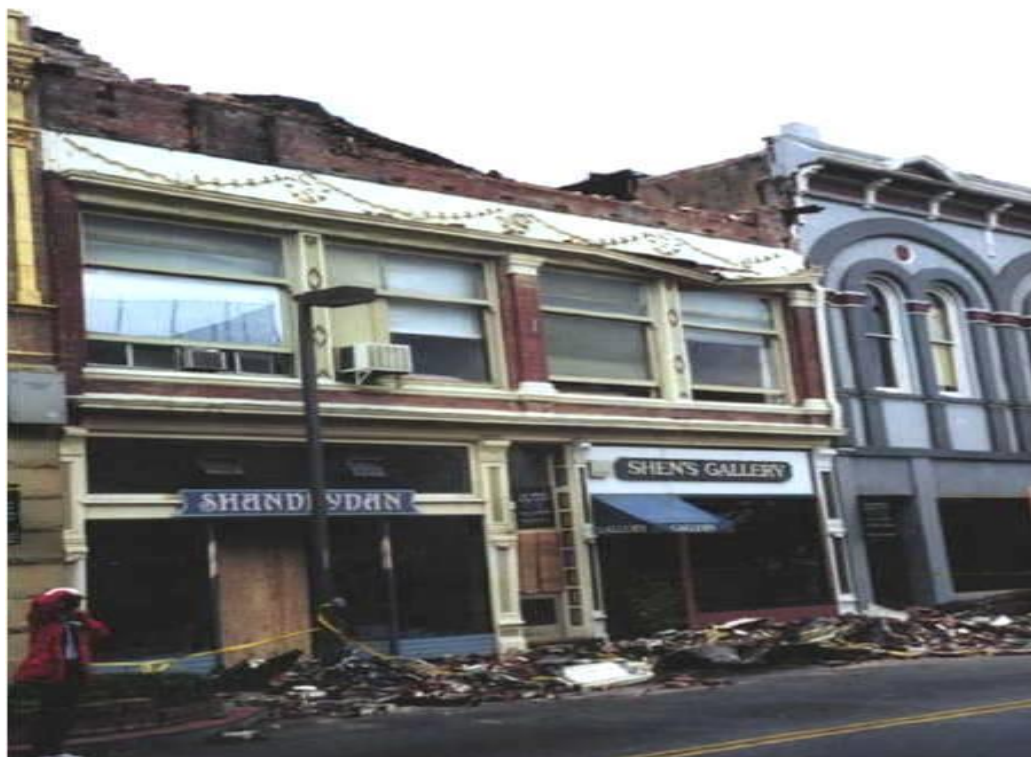
Figure 4-9 – Santa Cruz Commercial District, 1989 Loma Prieta Earthquake

In Figure 4-9, the parapets have fallen from the older, historic district buildings. This is a common hazard in such areas. Unreinforced masonry parapets that have not been anchored or braced are a major falling hazard. In this case, the parapet has mostly fallen into the street, but loose bricks still remain, constituting a hazard to the public right-of-way. Stabilization in this case may be as simple as removing the loose bricks and providing a temporary tieback system to contain the remaining bricks above the opening. The tieback system could consist of sheets of plywood on the exterior, with cables anchored to the roof framing, and pulled tight with “come-alongs.” This temporary measure would allow the sidewalk to reopen, and potentially allow the store owner back into the building to retrieve possessions. This also has the ability of protecting the wall from aftershocks. Consequently, it could help minimize the cost to complete repairs.

Another workable measure would be to build a canopy across the sidewalk, similar to a construction canopy that would protect pedestrians from falling debris as they walk past the building. This approach would protect pedestrians, but would not do much to protect the building from additional damage.

In both cases, the measures could be instituted in a very short period of time. Once stabilized, the pressure for rapid repair or even demolition is reduced or eliminated. This allows for a more thoughtful repair program that can incorporate the requirements of the Secretary of the Interior’s standards and the State Historic Building Code.

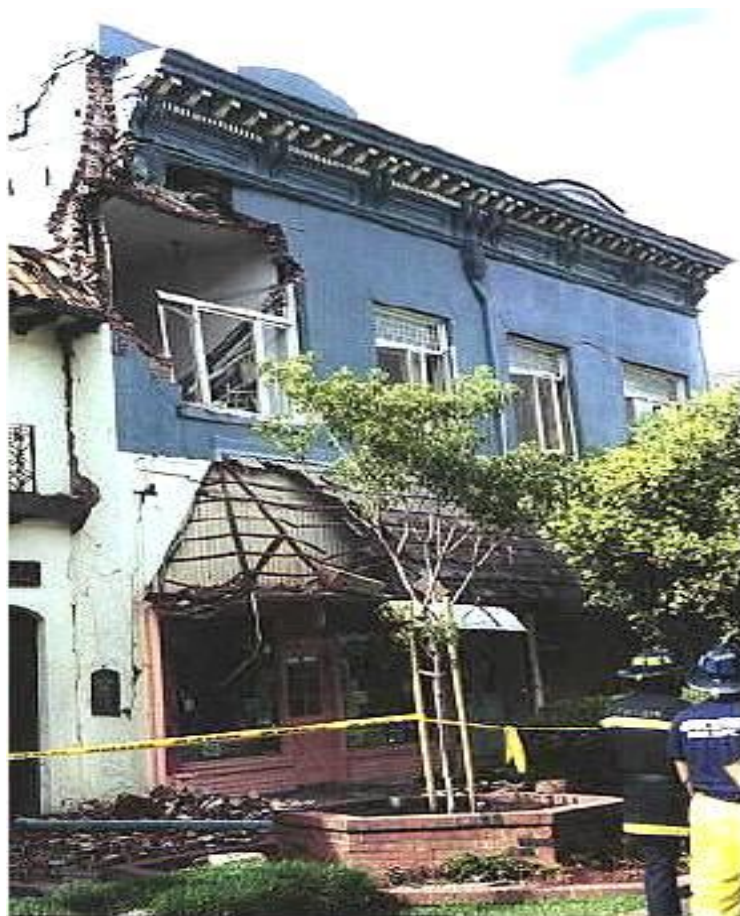
Figure 4-10 – Santa Cruz Commercial District, 1989 Loma Prieta Earthquake

In Figure 4-10, there is a falling hazard to the public right-of-way because of the loose bricks near the window. These loose bricks can fall at any time, whether there are aftershocks or not. The front of the building can be easily stabilized through the use of a tie back system as described in the last building. In this case, the cable connections would be easier than in the previous example. Using plywood with strong backs, the cables are then passed through the opening and connected to the floor diaphragm. The tie back can be either cable or rods with turnbuckles. This allows the system to be periodically tightened to provide the most protection. Again, once stabilized, the building could be reopened for possession retrieval. As with the previous example, such stabilizations can provide the owner more time to fully develop a repair program that addresses historic restorations well.

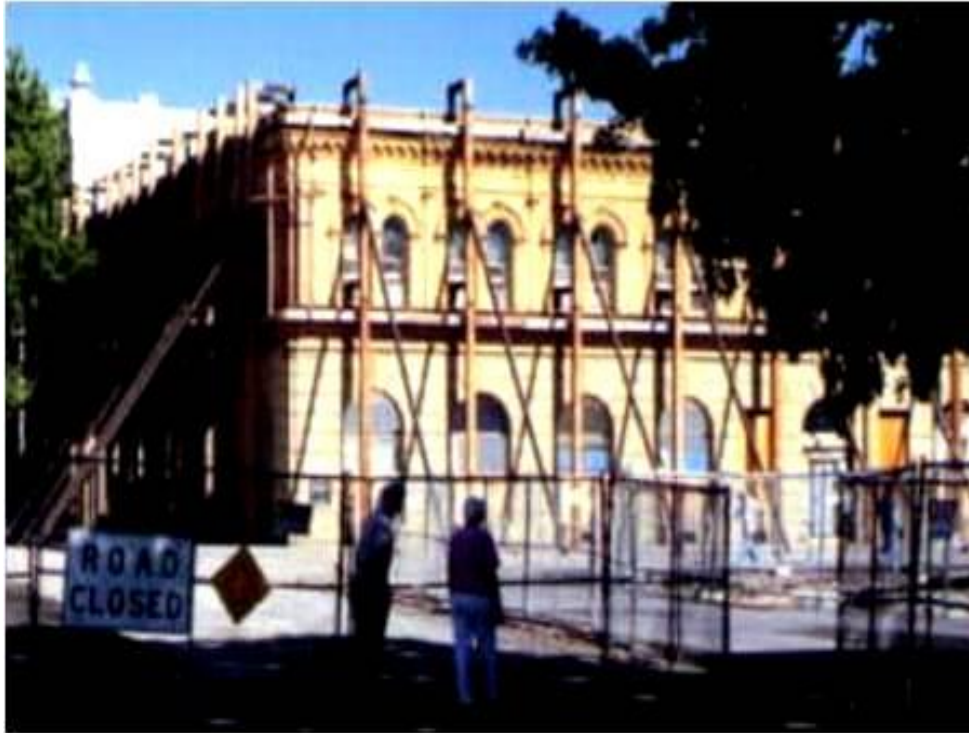
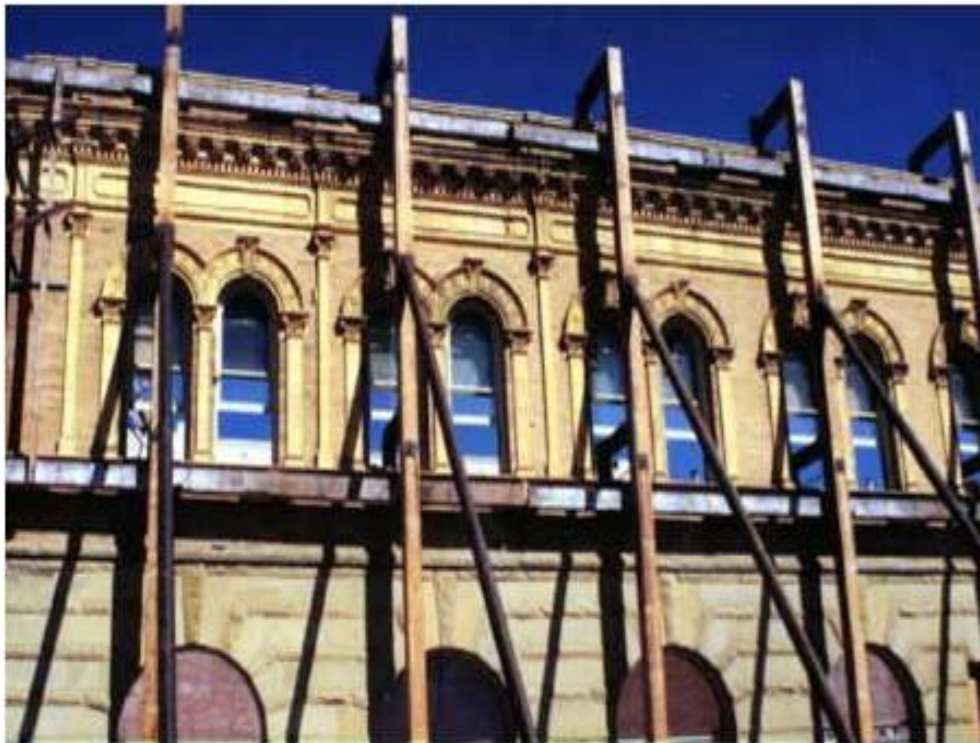
Figure 4-11 – Historic building, Santa Cruz, 1989 Loma Prieta Earthquake

Figures 4-11 and 4-12 show a building that was badly damaged by the Loma Prieta earthquake. The floor and roof systems separated from the walls, and were a distinct collapse hazard. After considerable evaluation and discussion, a system was developed to save the historic character of

this building. This is an example of a longer term, more complex stabilization procedure that is part of the repair process.

The City of Santa Cruz deemed this building an imminent hazard. The potential for collapse was great in even a moderate aftershock. Additionally, the building posed a significant threat to the public right-of-way. In this case, the roof and floors were removed, and the walls were stabilized with a system of “raker” shores. These are diagonal members connected together with steel beams at the floor and the roofline. They are intended to replace the diaphragms and provide out-of-plane load support for the walls. The walls were damaged, but were still able to support themselves for in-plane loads. Each of these frames is in an “A” configuration to provide maximum support for the walls. During the repair process, these braces can remain in place until such time as the new diaphragms are reconnected to the walls and can provide the lateral support needed for building stability. The raker shore frames are then removed and the final pieces of the diaphragm are installed. In this case, a building that was on the National Register of Historic Places was saved, and the building was reopened for operation with an extended useful life.

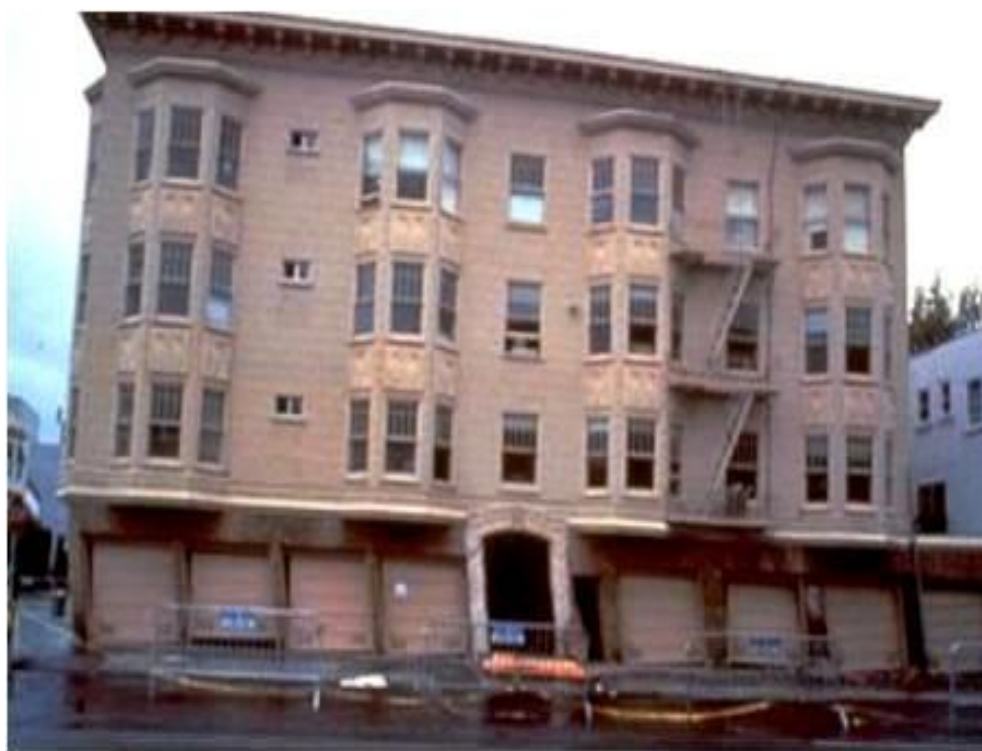
Figure 4-13 – Marina District, San Francisco, 1989 Loma Prieta Earthquake

The example in Figure 4-13 is definitely a potential collapse hazard, yet it was stabilized in a rather simple manner. Large timbers were installed diagonally across the garage openings. The braces were attached to the header across the top of all the openings. The diagonal braces were

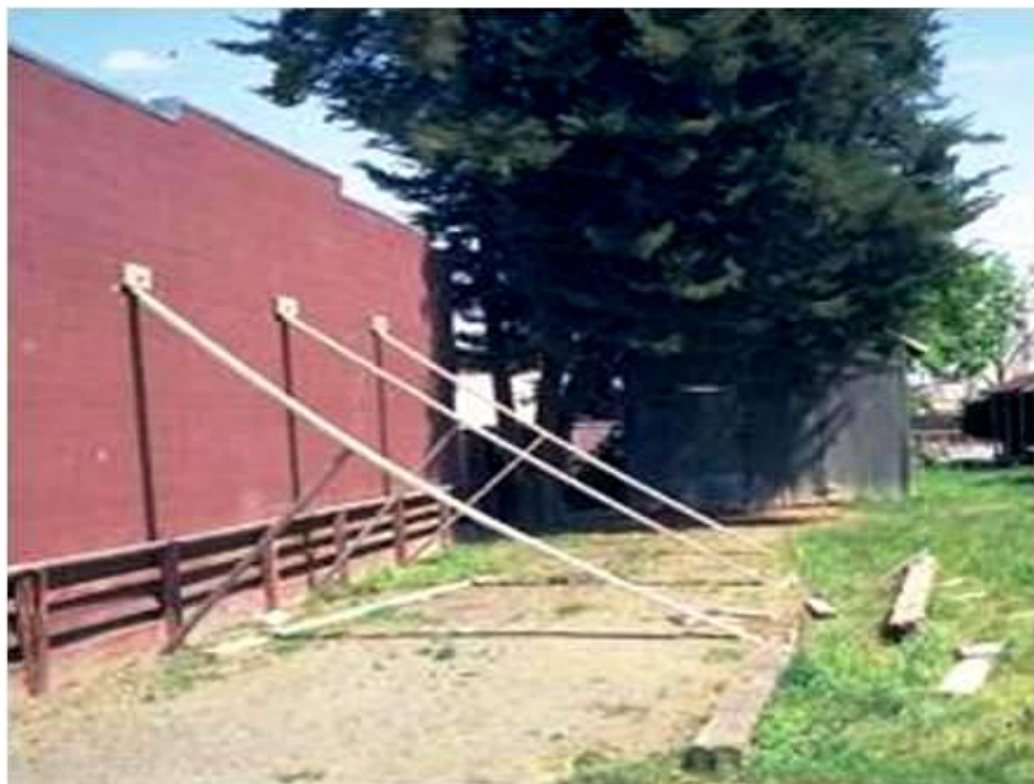
Figure 4-14 – Tilt-up Concrete Wall, 1983 Coalinga Earthquake

As stated before in Chapter 2, older concrete tilt-up wall construction has a problem with failure of the roof-wall connection. The older designs allowed the ledger to which the roof was attached to be split down their length at the through-bolt to the wall in response to lateral forces, resulting in a failed lateral load system. The simplest way to brace these walls temporarily is with steel tilt-up wall braces, similar to those used in the construction of tilt-up walls. If the stabilization needs to be done at once, and such braces are not readily available, wood braces can be used temporarily, provided that they have the capacity to support the walls.

In Figure 4-14, the braces are too slender to support the wall. They were installed tight as well, indicated by the bowing in the braces. Even a moderate aftershock or wind would have the capacity to load these braces to the failure point. If a SAP evaluator finds a situation like this in the field, the collapse zone should be barricaded with barricade tape, tagged AREA UNSAFE, and the building department alerted about this hazard.

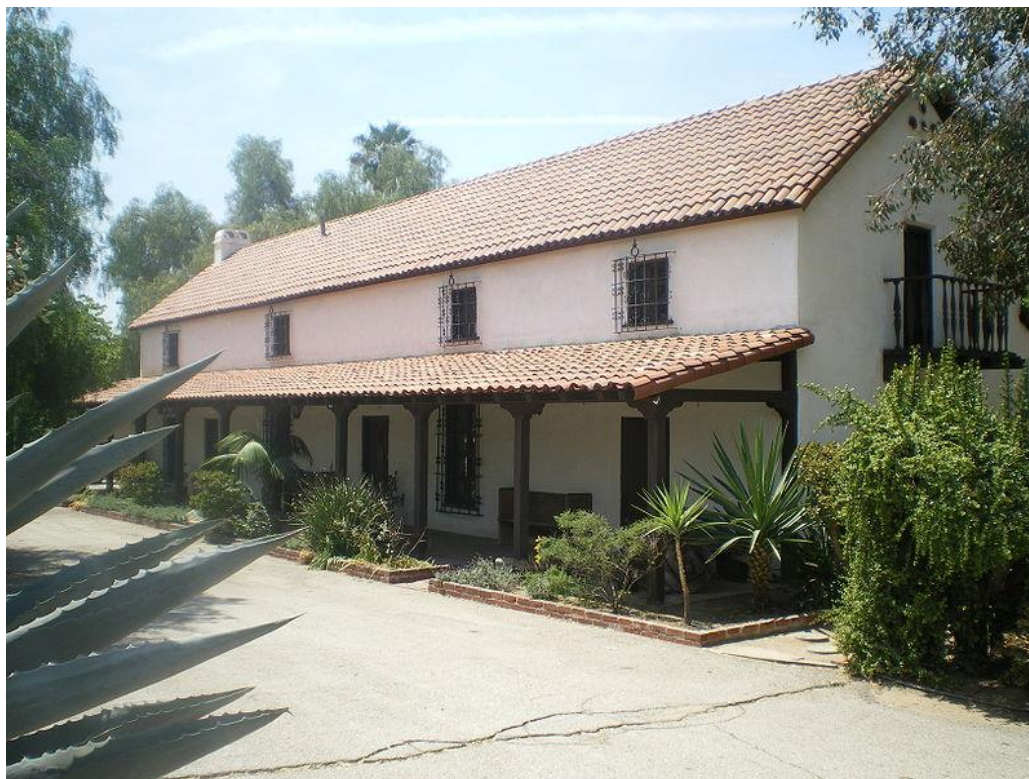
Figure 4-16 – Romulo Pico Adobe, Mission Hills, CA

Figure 4-16 shows the historic Romulo Pico Adobe building in Mission Hills, CA. Construction began in 1834, and additions were made to the structure up to about 1874. Privately restored and expanded in the early 1930s, it was purchased by the City of Los Angeles in 1965. It was listed on the National Register of Historic Places in 1966. The building was damaged in the 1971 Sylmar Earthquake and afterward repaired.

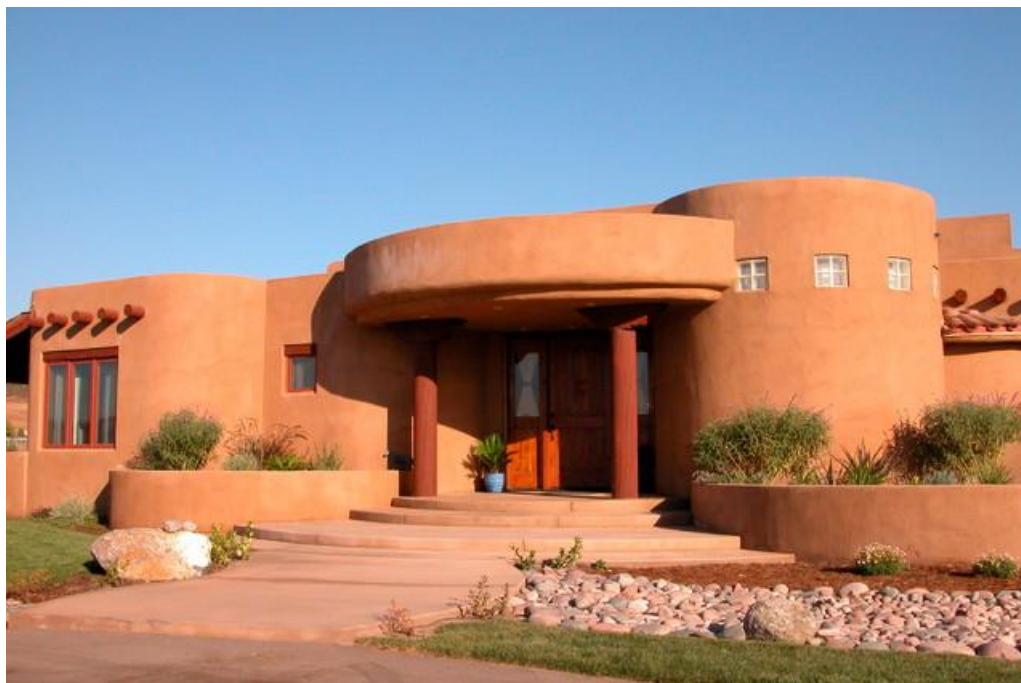
Figure 4-17 – Example of a modern adobe structure

Figure 4-17 is an example of a modern adobe residence. Figure 4-18 shows adobe brick being dried in the sun.

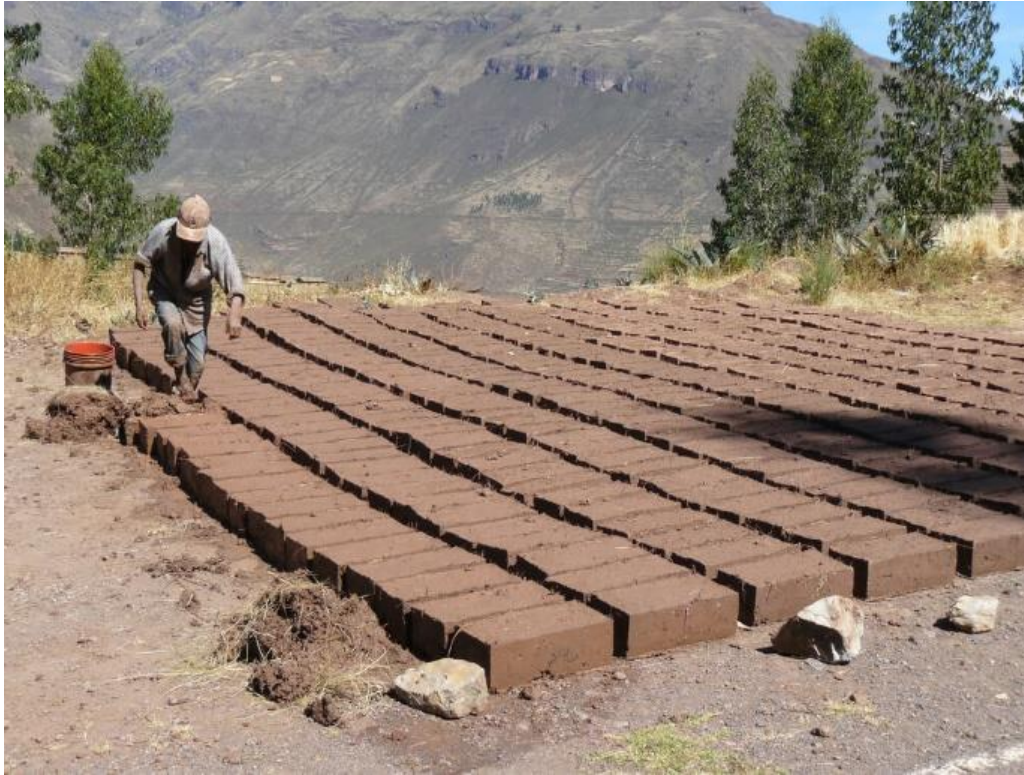
Figure 4-18 – Adobe bricks being dried in the sun.

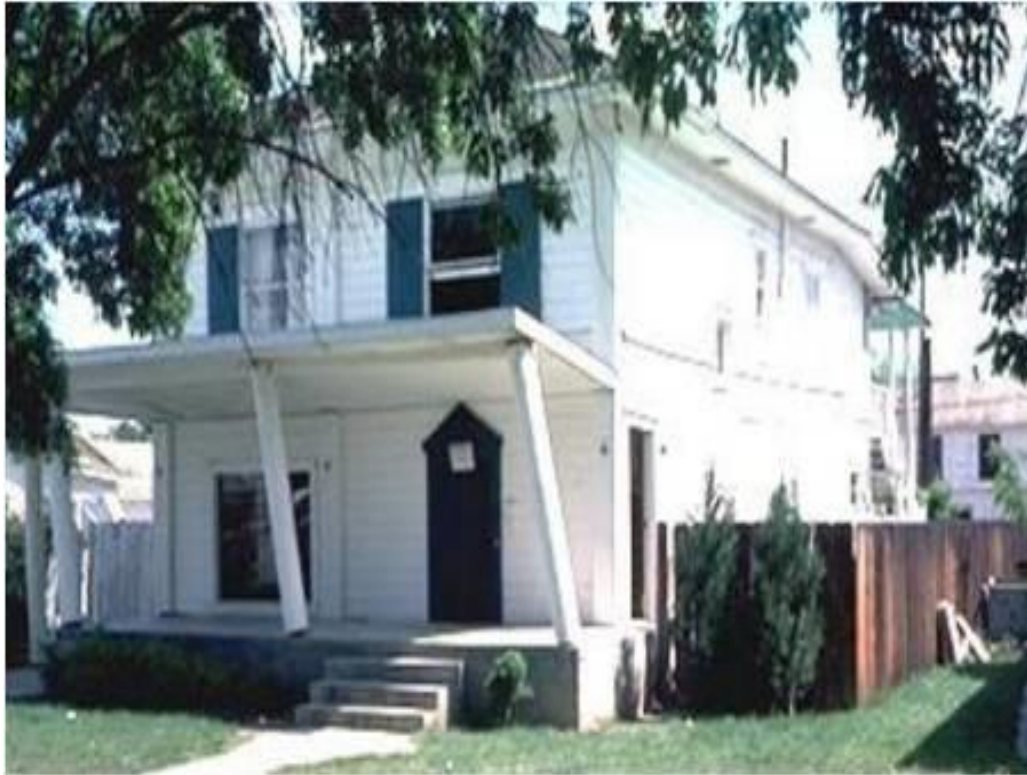
Figure 4-19 – House with cripple wall damage, 1983 Coalinga Earthquake

The two-story house in Figure 4-19 has suffered failure of its cripple wall. This failure resulted in damage to the roof over the porch, which has pulled down on one side with the house. The main structure will not collapse further, as the walls and second floor framing are in good shape. Therefore, the structure is stable, with the porch roof remaining a falling hazard. The home could be accessed successfully by using the rear entrance. We know that all utility connections were damaged except the electrical connections. Damaged utilities have been shut off.

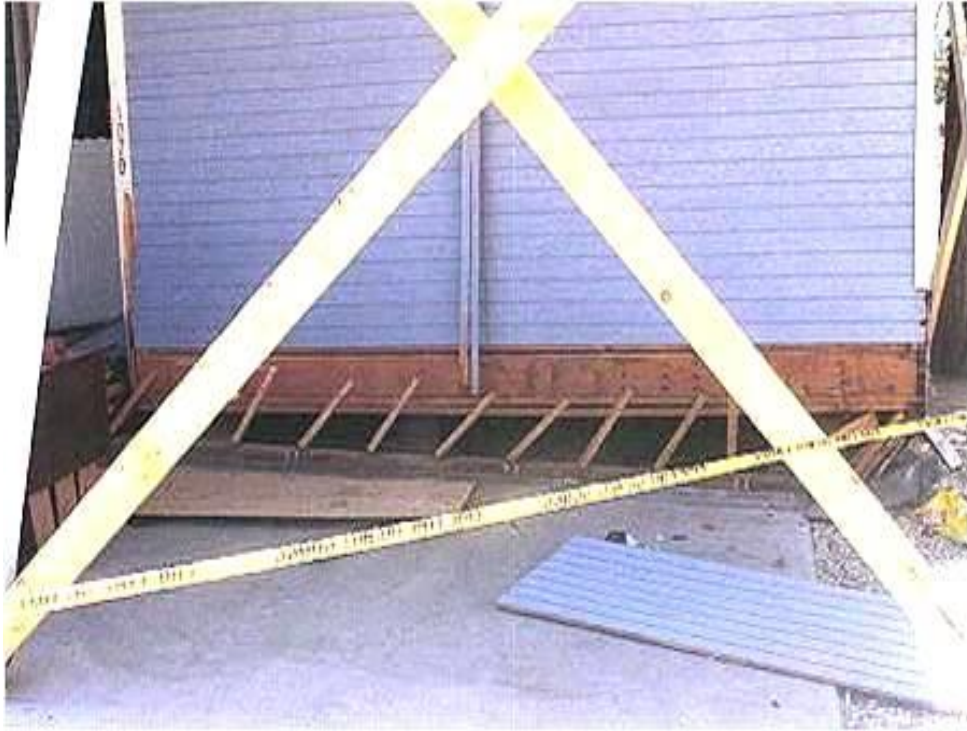
Figure 4-20 – House with cripple wall failure, 1992 Big Bear Earthquake

The 1992 Big Bear Earthquake caused the cripple wall failure of this newer home, which illustrates that not all cripple wall failures occur in older homes. The home is a two story structure, with a part of the second story supported by wood posts. The failure of the cripple studs caused the structure to shift to the right, moving off the foundation. The upper room above the carport has been shifted down by the cripple wall failure and is in danger of collapsing.

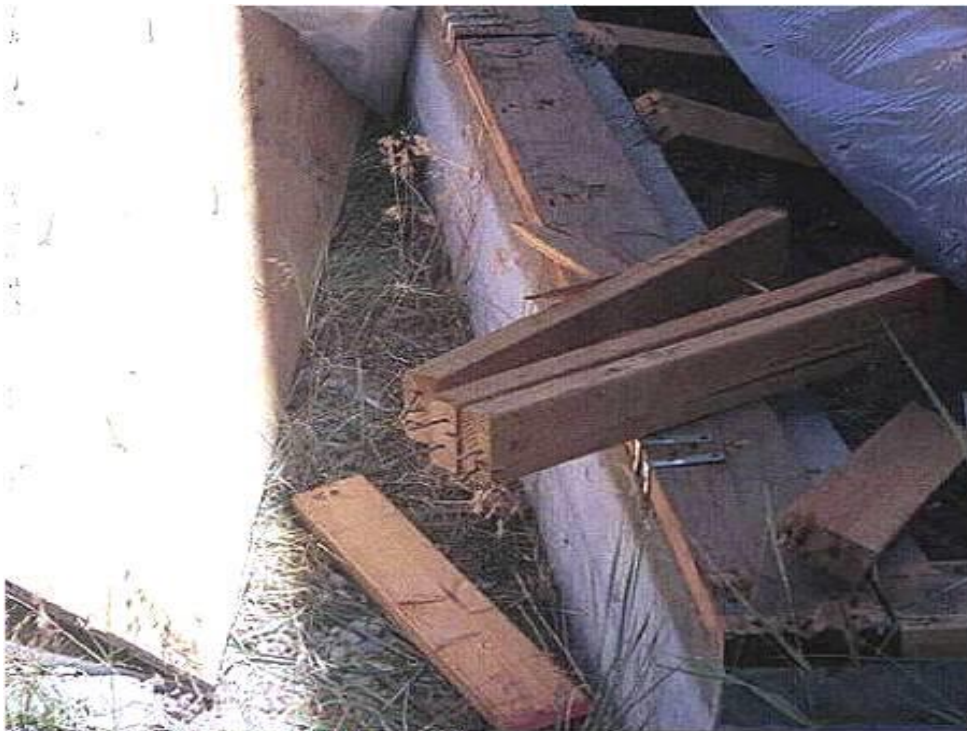
Figure 4-21 – Detail of failed cripple wall, 1992 Big Bear Earthquake

In Figure 4-21, it is clear why the cripple wall failed. The T111 siding that was nailed to the cripple wall studs was not nailed properly, using nails closely spaced at the siding edges. This would have allowed proper transfer of lateral forces from the structure to the sill plate at the foundation. Instead, it simply pulled out. Also, the metal straps that were used to anchor the sill plate were not properly installed. Instead of coming up both sides of the sill plate and nailing across the top, these straps as installed do not prevent the sill plate from tipping.
