State of California

Safety Assessment Program Evaluator Student Manual

May 2020

Version 16

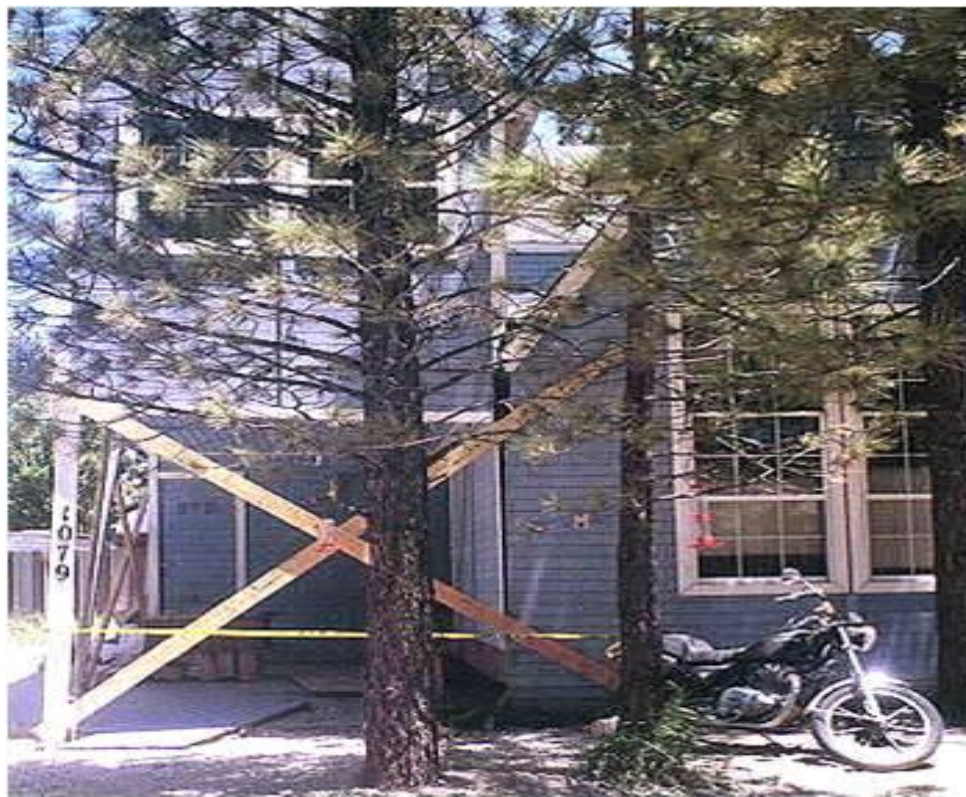
Figure 4-22 – Collapsed house with failing upper room, 1992 Big Bear Earthquake

Figure 4-22 shows the room over the carport leaning against the rest of the house. The bracing was installed in a hopeful manner by either a contractor or the owner. It may help somewhat with keeping the support posts from kicking out due to gravity loads, but does not help much with lateral loads from aftershocks or wind. The brace on the lower left is attached to a vertical support that is not designed for lateral loads, which the brace on the lower right is attached to the house, which now is not attached to the foundation.

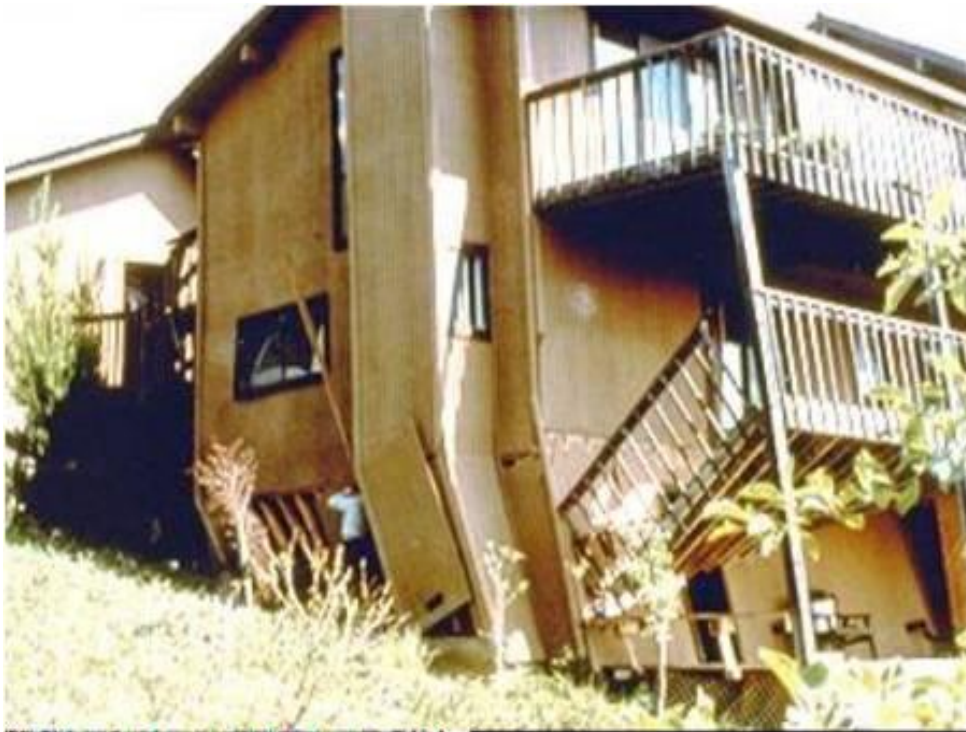
Figure 4-23 – Damaged apartment building, 1984 Morgan Hill Earthquake

Some safety notes on Figure 4-23 – never do what the person is doing on the side of this building! This building can be easily assessed for safety without entering it and risking one's life! Also, note the failed porch on the lower story. Is the upper story porch still attached? One should not risk life and limb by walking onto such structures!

As with many hillside homes, the lowest level on this hillside home has the least strength due to the lack of sheathed wall length. This damage likely occurred due to inadequate nailing of the sheathing along with the fact that there is a difference in the structural stiffness between the uphill end and the downhill end. The lateral forces tend to be drawn into the stiffer end of the wall panels, thereby overstressing the connections. This can be seen by the loss of sheathing at the uphill end of the wall.

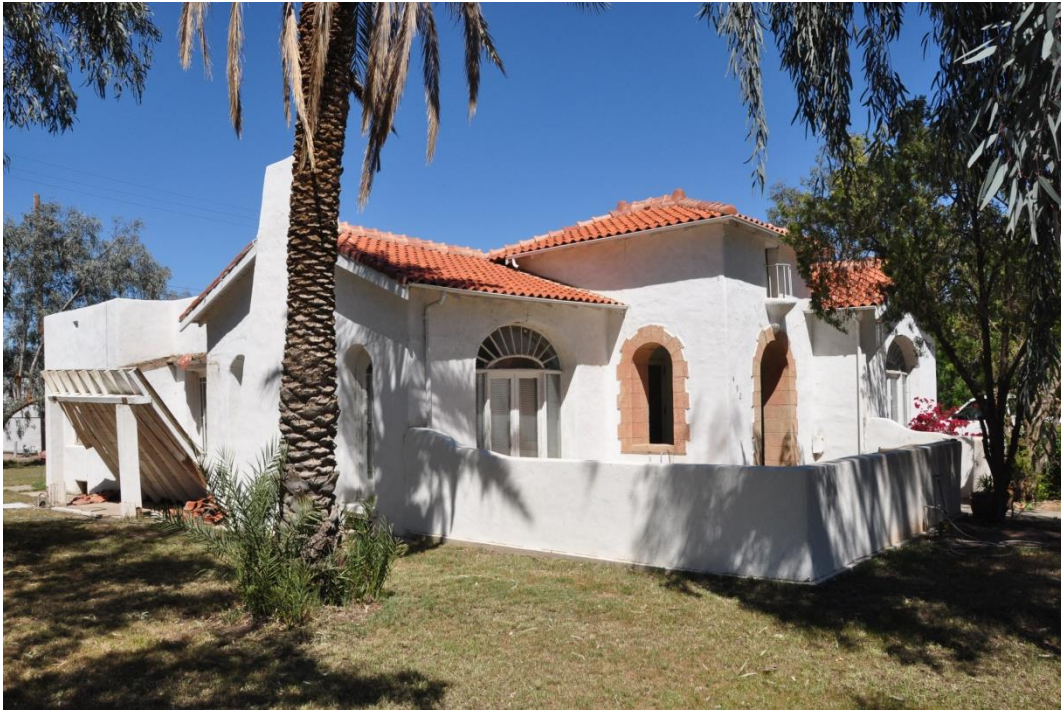
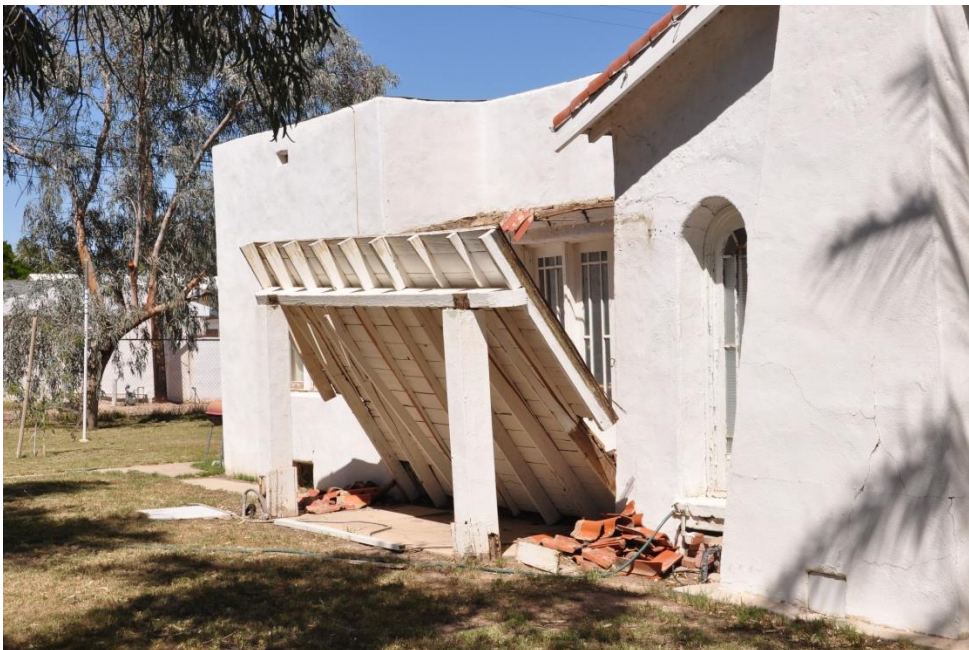
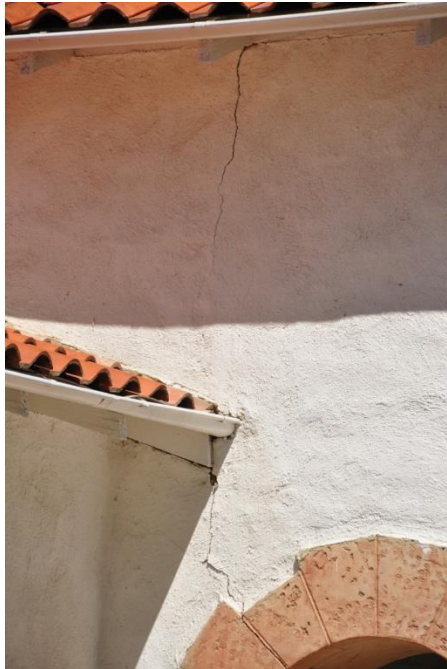
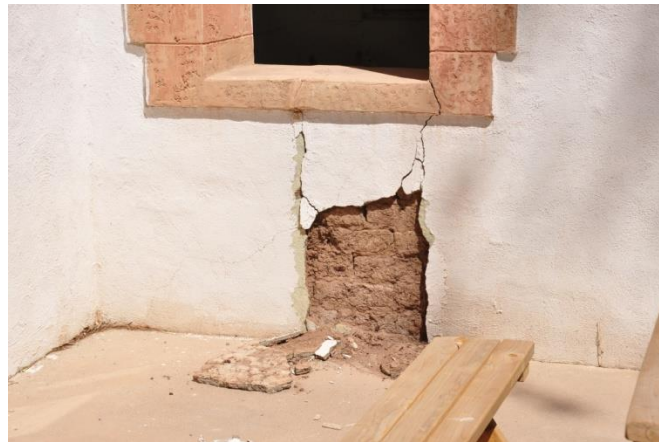
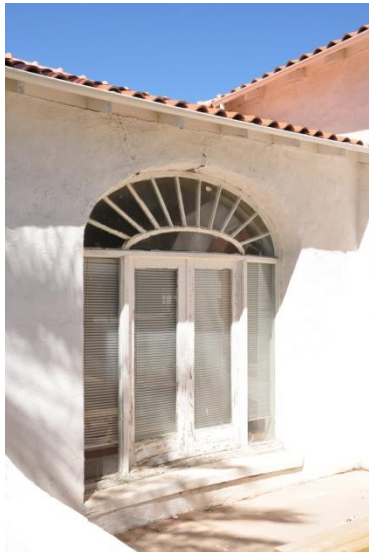
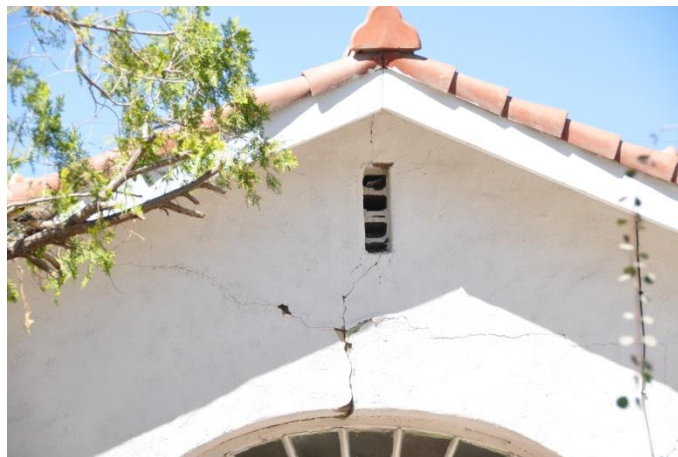
1. This is a 1300 square foot adobe unreinforced masonry house at 492 Cypress Street in Doverton, CA.
2. Earthquake damage includes cracking above three of the arches, spalling that reveals the adobe wall, and a wood porch awning that collapsed. The exterior lights are flickering intermittently, and water is also flooding the back yard from a broken pipe.
3. Perform a Rapid Evaluation and post the building accordingly.

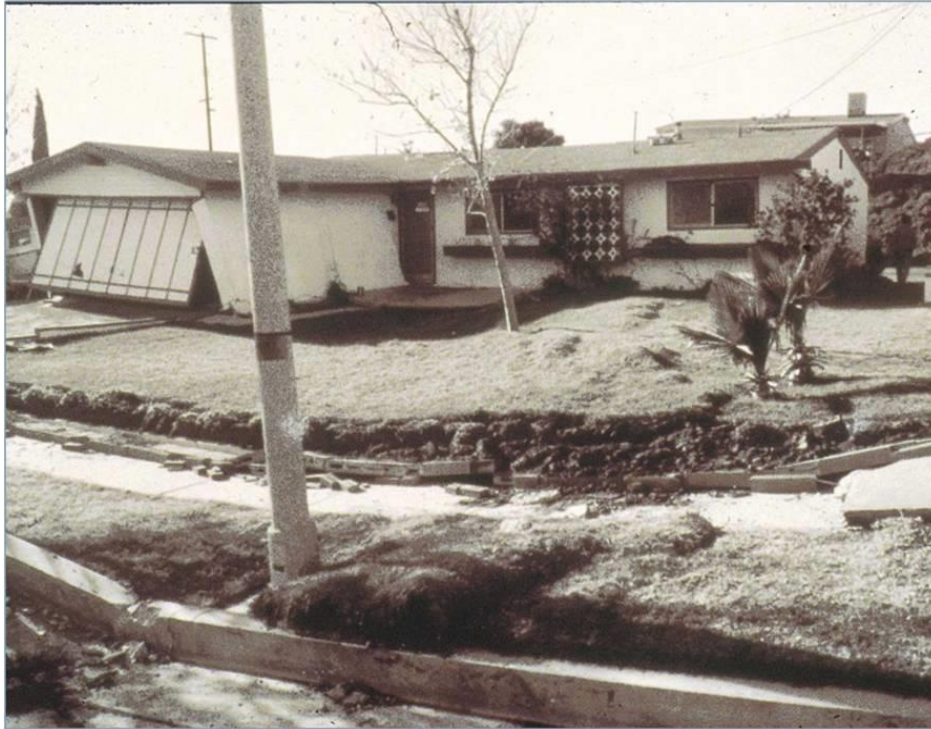
Figure 6-2 – Surface rupture, 1971 Sylmar Earthquake

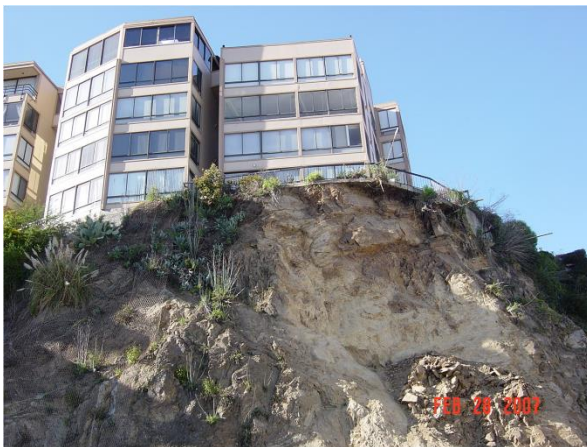
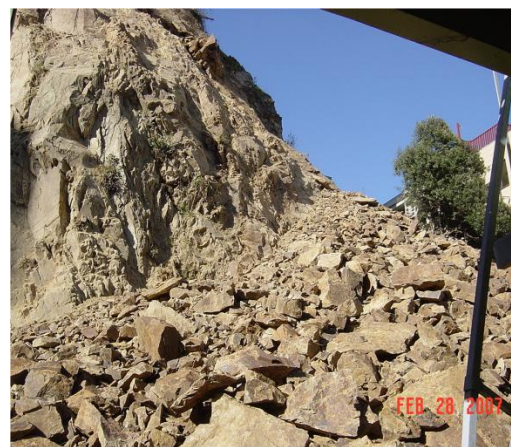
Figure 6-3 – Hillside slide, San Francisco

Figure 6-4 – Toe of slide, San Francisco

Figures 6-3 and 6-4 show a landslide that occurred in San Francisco. The rock debris at the toe of the slide damaged a building there.

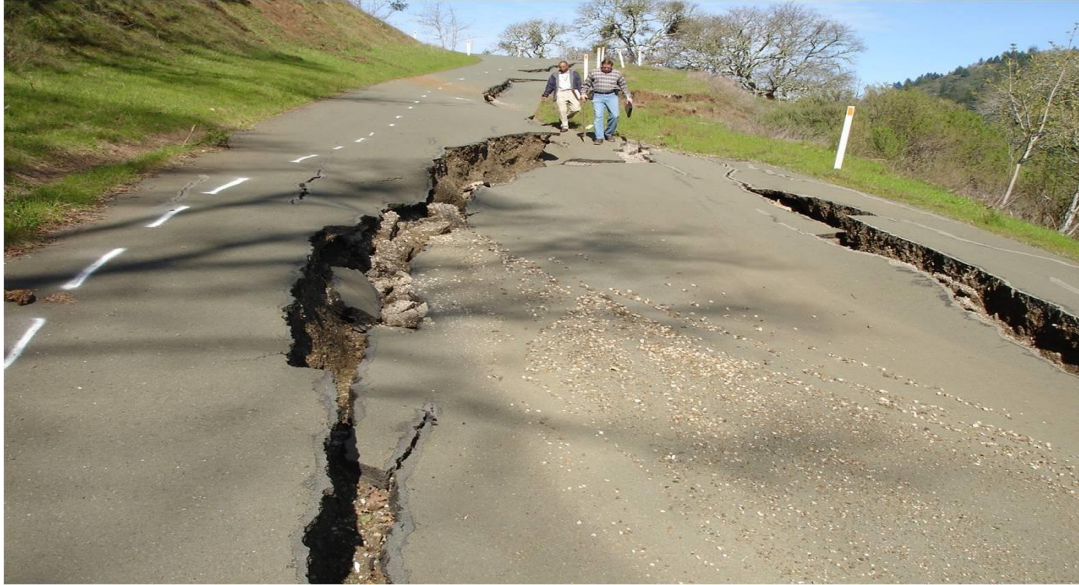
Figure 6-5 – Block failure of road subsurface, 2005-06 Winter Storms

Figure 6-5 shows a condition called “block failure.” Oversaturation of soils on hillsides can lead to the hillside moving in large sections, or “blocks,” in this case, taking the roadway with them.

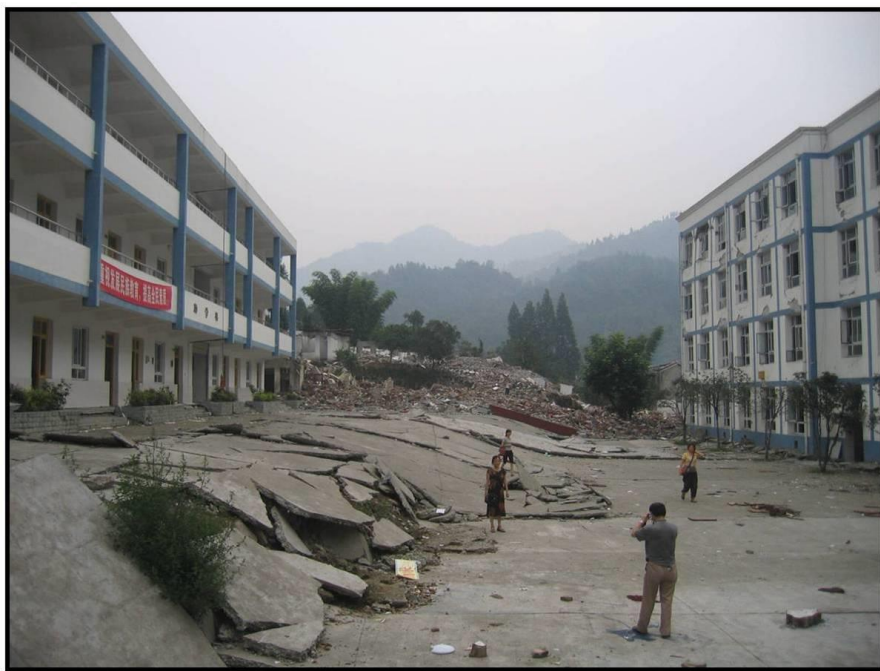
Figure 6-6 – Scarp through community in China

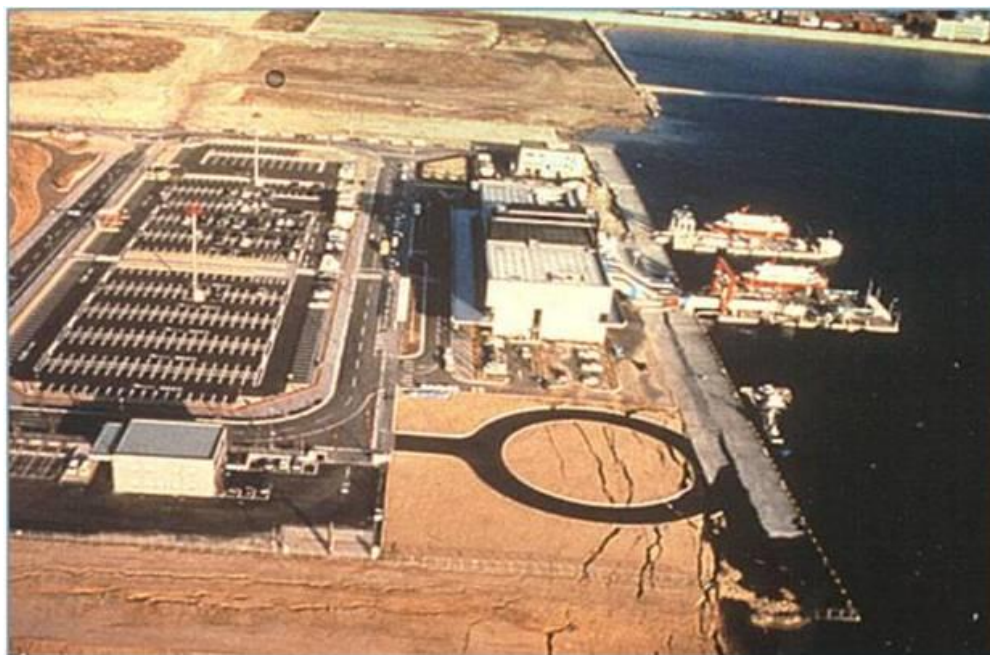
Figure 6-7 – Lateral spreading

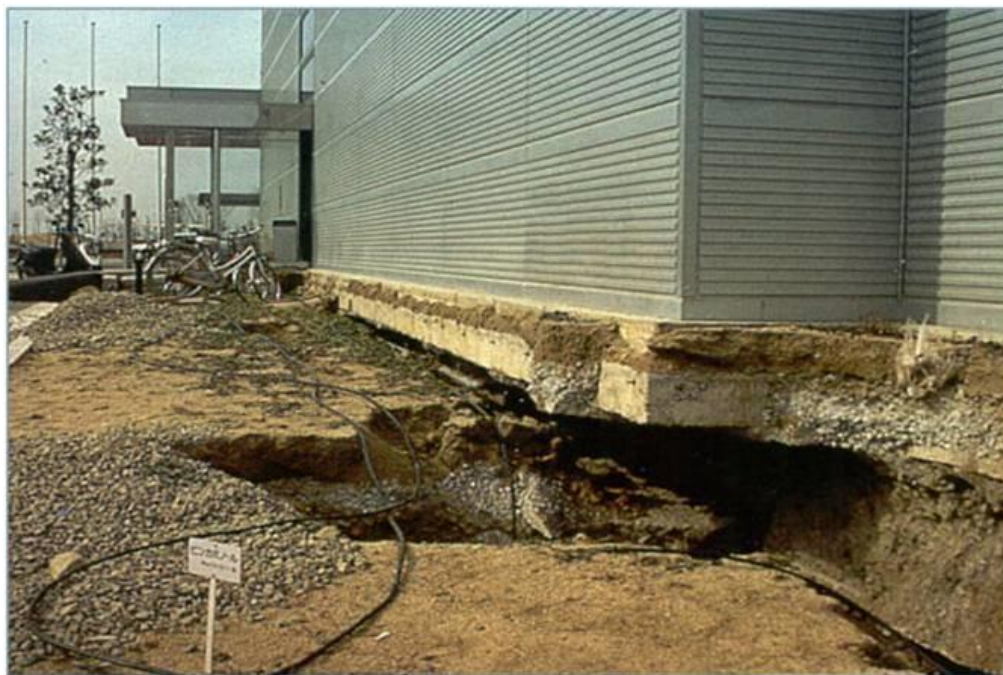
Figure 6-8 – Earthquake-induced settlement (Japan)

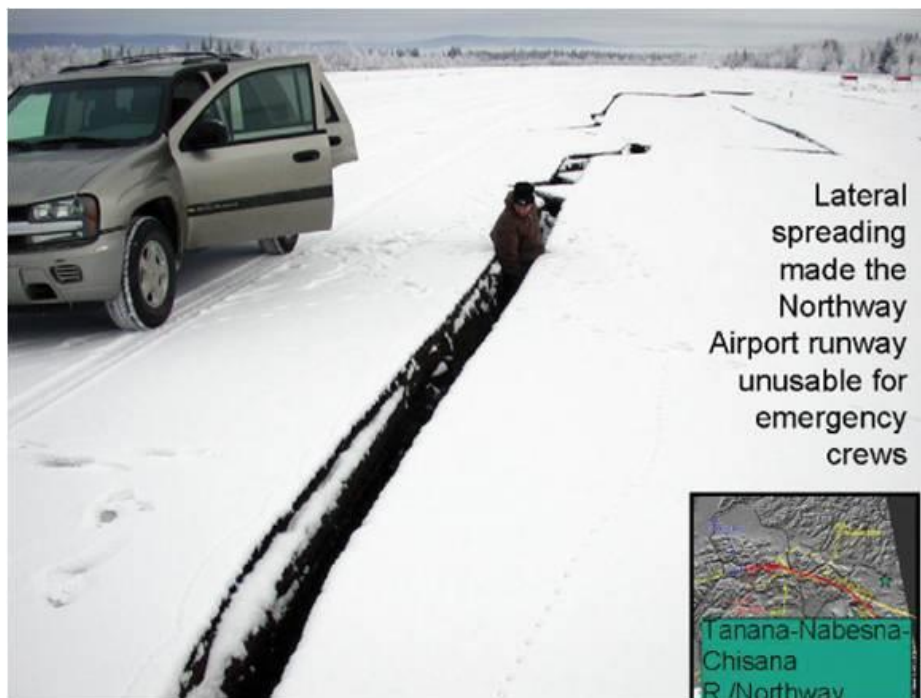
Figure 6-9 – Airport runway with lateral spreading, 2008 Denali Earthquake, Alaska

Please note in Figure 6-9 the man standing in the large crack. This is another unsafe activity that no SAP evaluator should ever do!

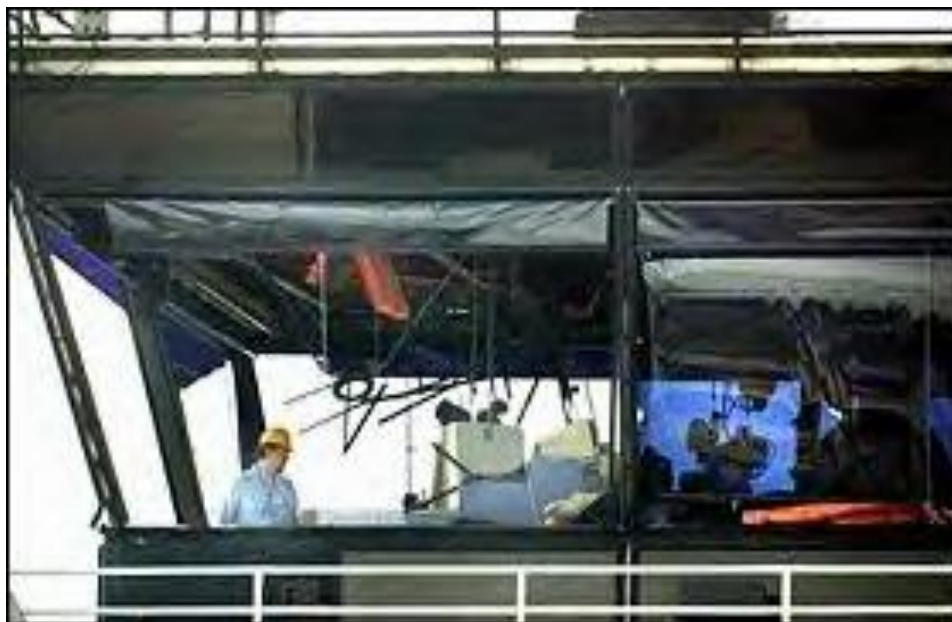
Figure 6-10 – Damaged airport control tower

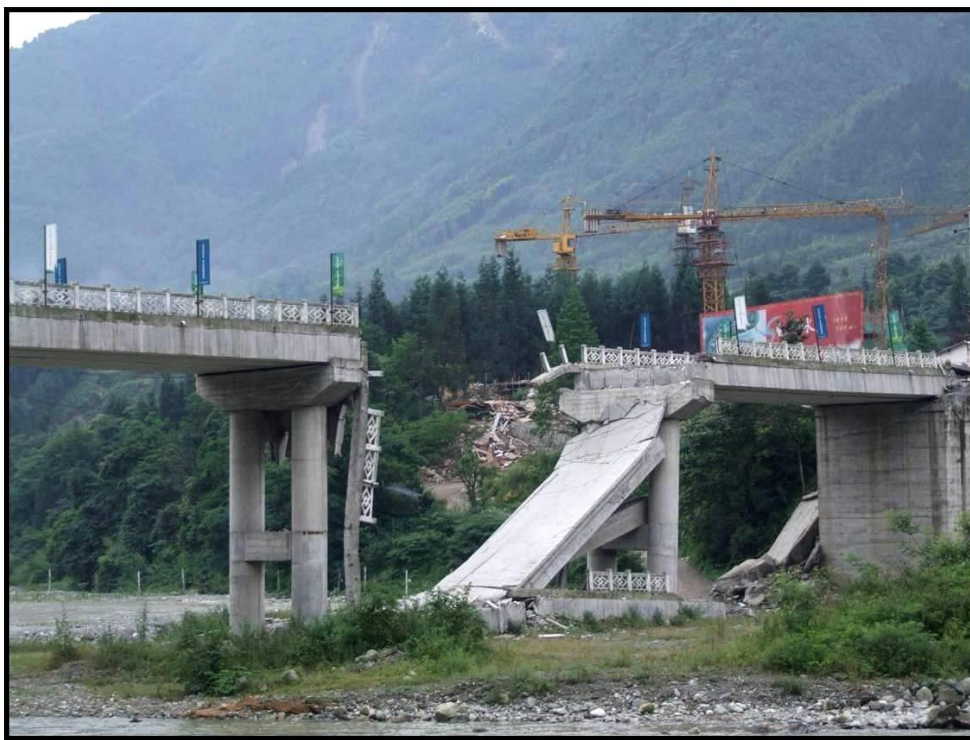
Figure 6-11 – Bridge with fallen span (China)

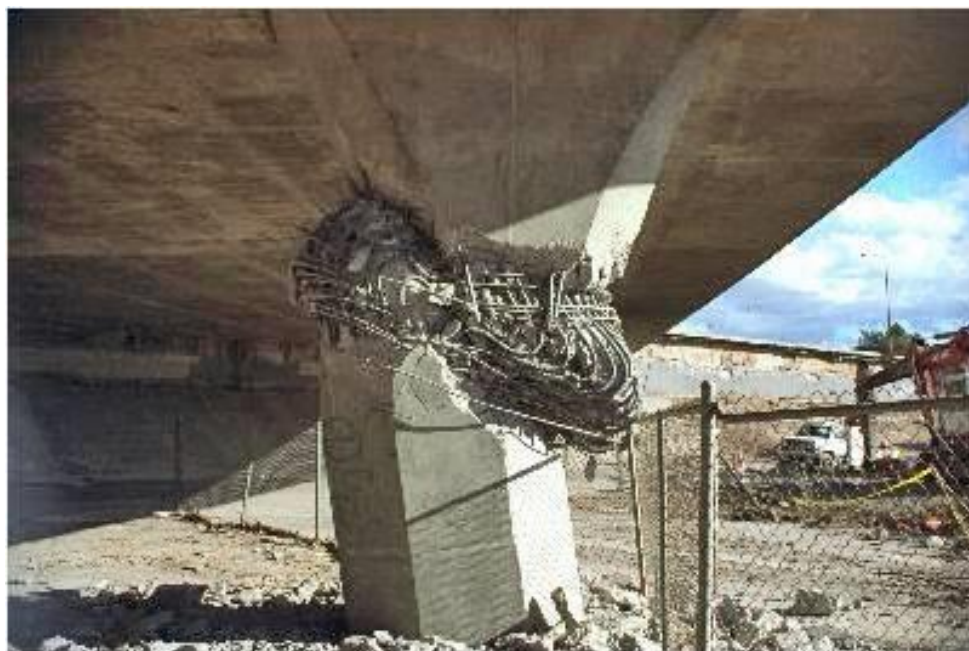
Figure 6-12 – Freeway overpass column collapse, 1994 Northridge Earthquake

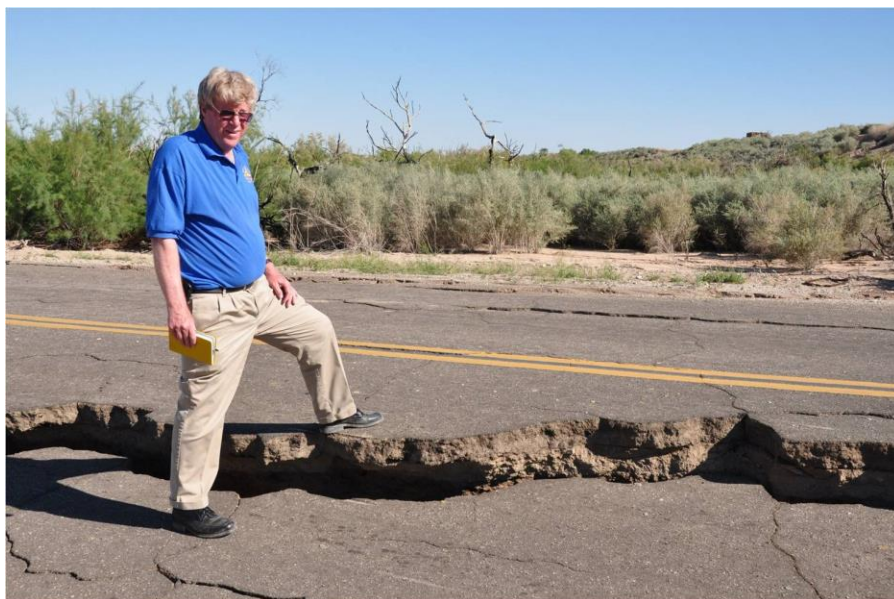
Figure 6-13 – Road damage, 2010 Baja Earthquake

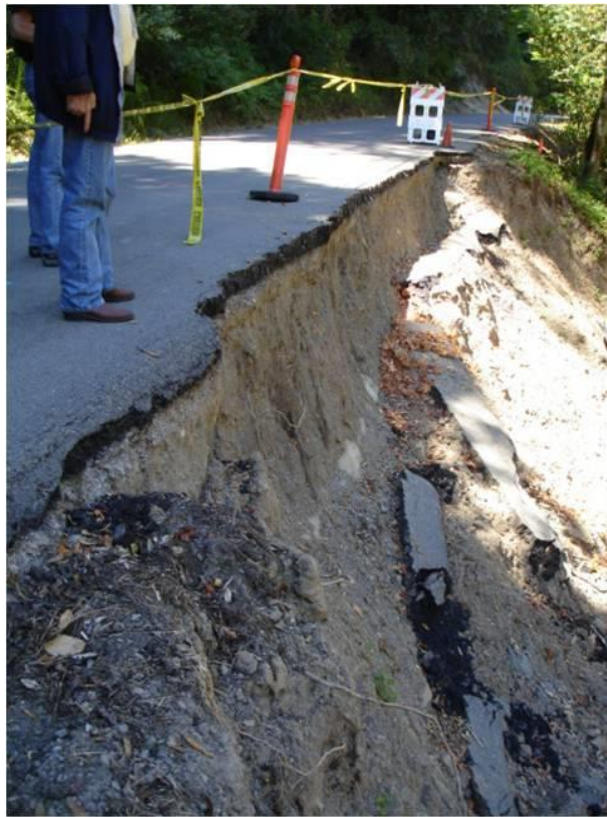
Figure 6-14 – Road slipout

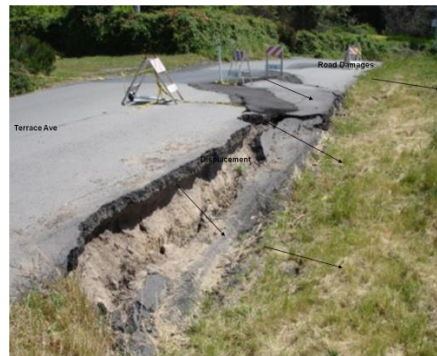
Figure 6-15 – Scarp damage

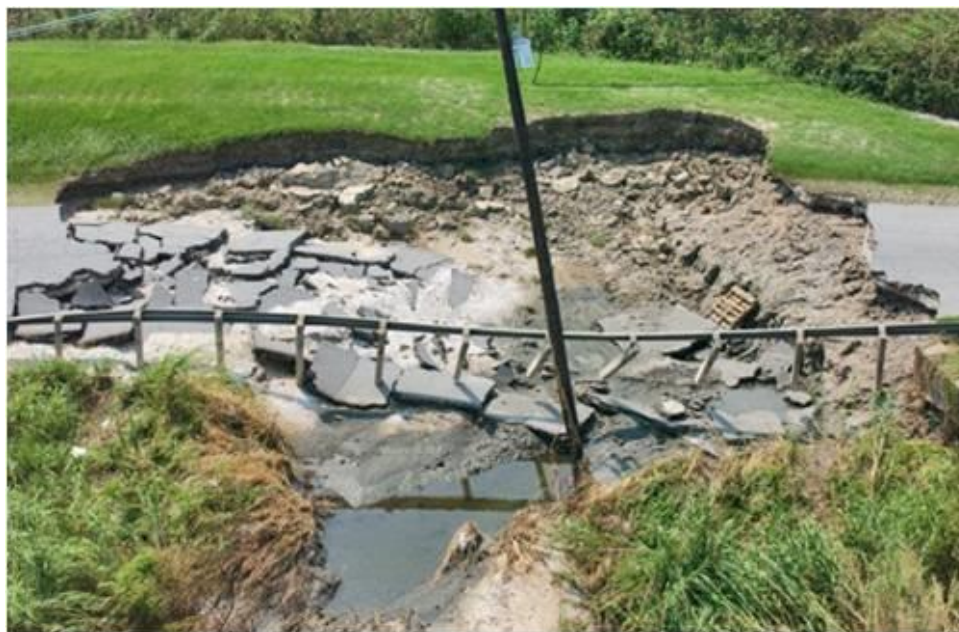
Figure 6-16 – Road washout, 2005 Hurricane Katrina

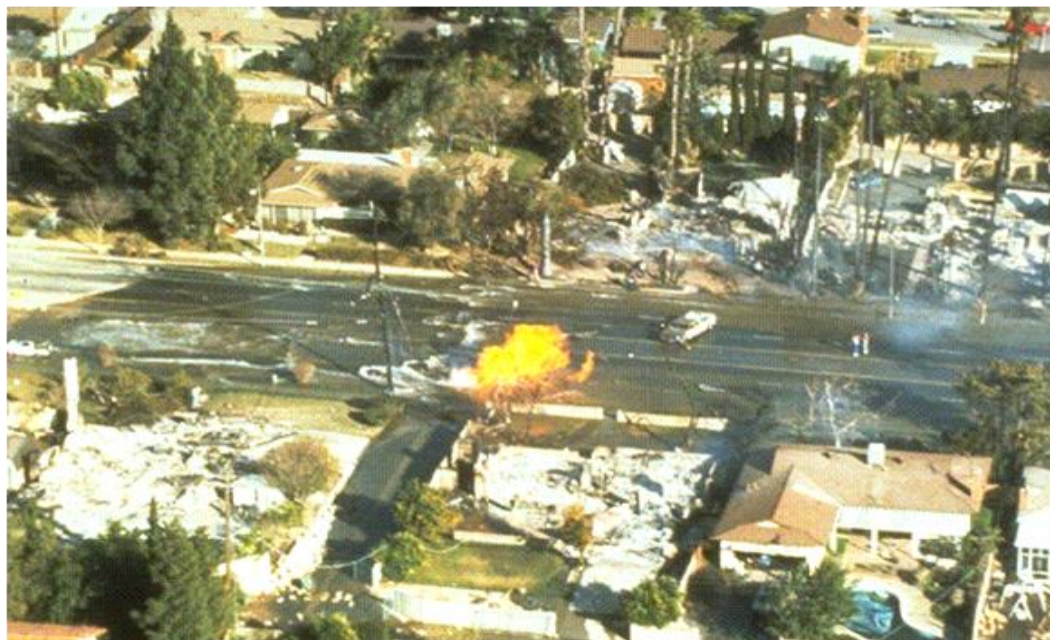
Figure 6-17 – Water and gas main breaks, 1994 Northridge Earthquake

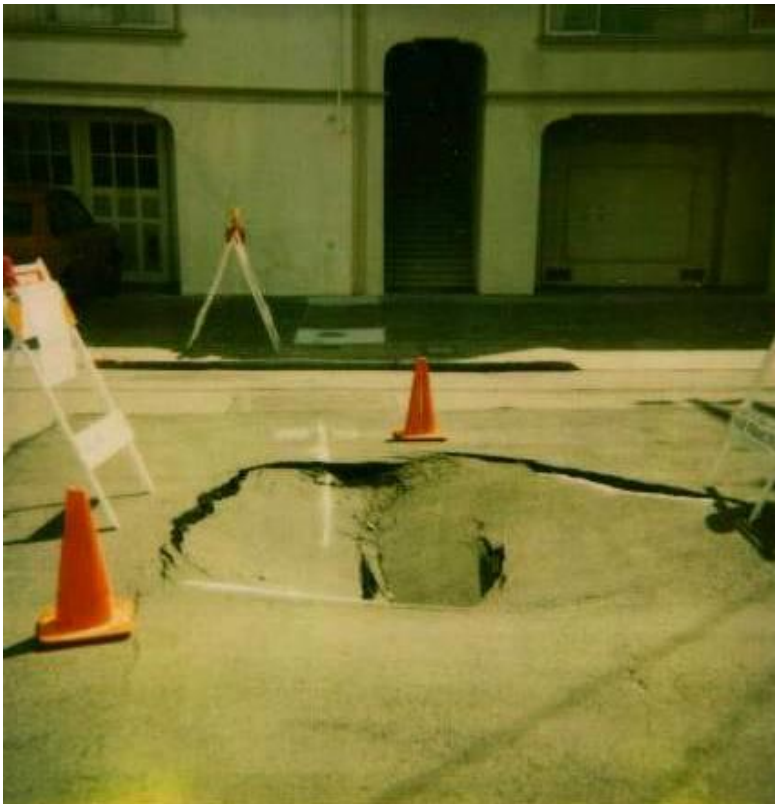
Figure 6-19 – Sink hole at storm main break

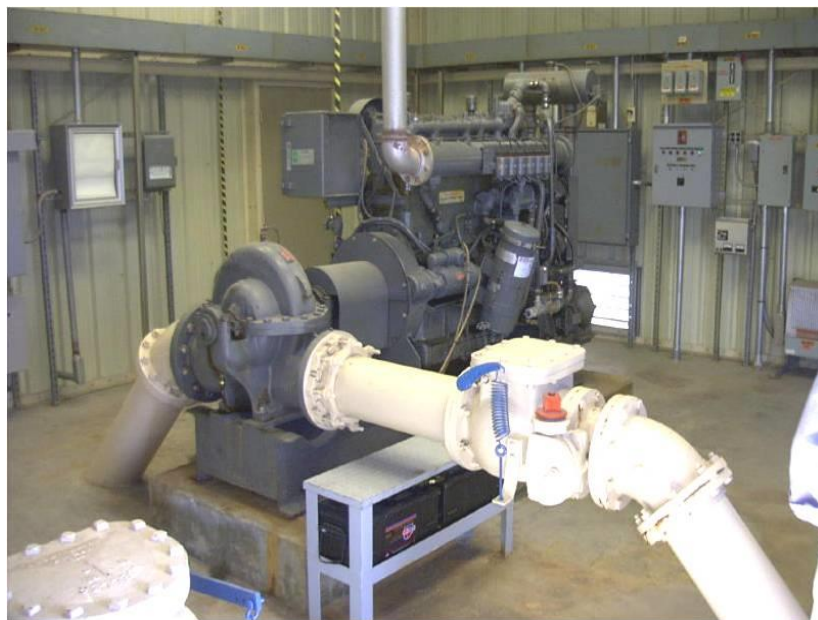
Figure 6-20 – Pump station

Pump stations are part of water, wastewater, natural gas, and liquid fuel systems. All but wastewater pump stations are usually at grade, and may have components as deep as 10 feet below grade. The most common types of damage will include damage to the electrical power and control systems, fallen electrical cabinets, and damage to piping. Building damage is less likely unless the structure is unreinforced masonry.

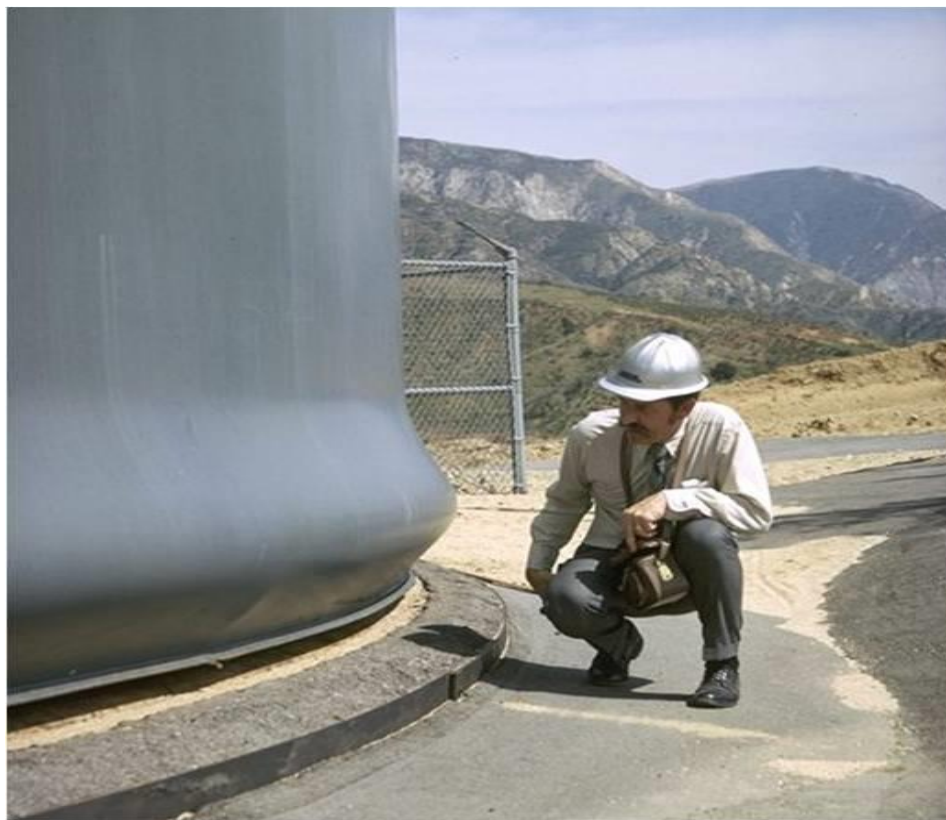
Figure 6-21 – Steel water tank with ‘elephant’s foot’ buckling

Some of the types of damage that may occur to unanchored steel tanks include uplift of the entire tank, leading to the connecting piping being damaged or broken. When ground motions become strong and the tank walls are forced into resisting overturning and bending forces, the tank wall will buckle at the base, leading to the condition called ‘elephant’s foot.’ In severe cases, the floor to roof seam will burst open. Sloshing water can also damage the roof of the tank.

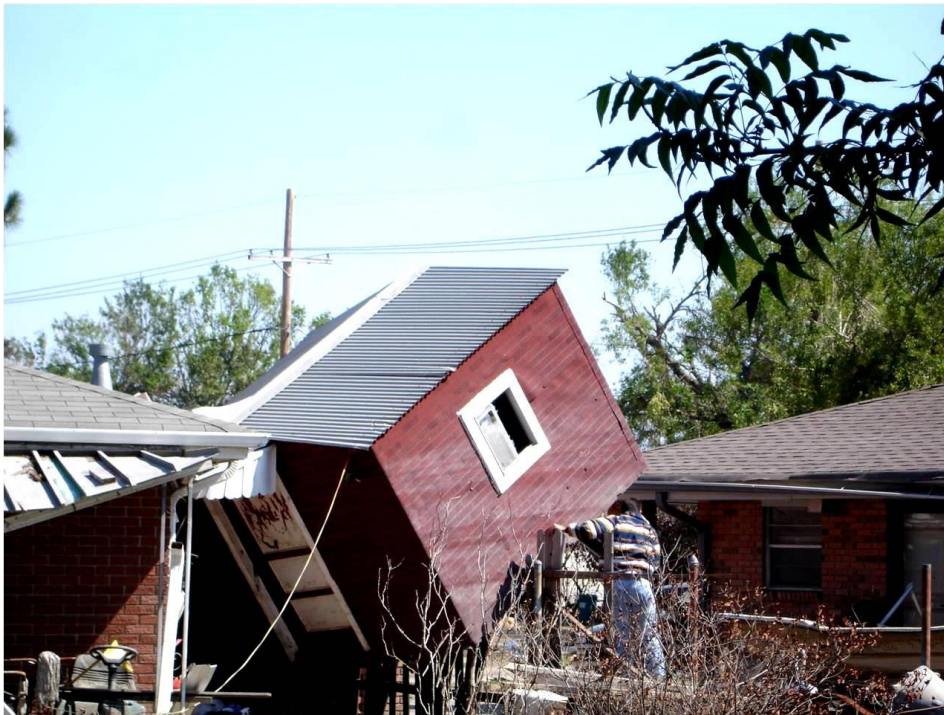
Figure 7-2 – Shed on fence, 2005 Hurricane Katrina

Figure 7-2 shows a shed that floated onto a fence; the SAP evaluator is getting a little too close to this! SAP evaluators are encouraged to be careful when evaluating unstable structures not to get too close.

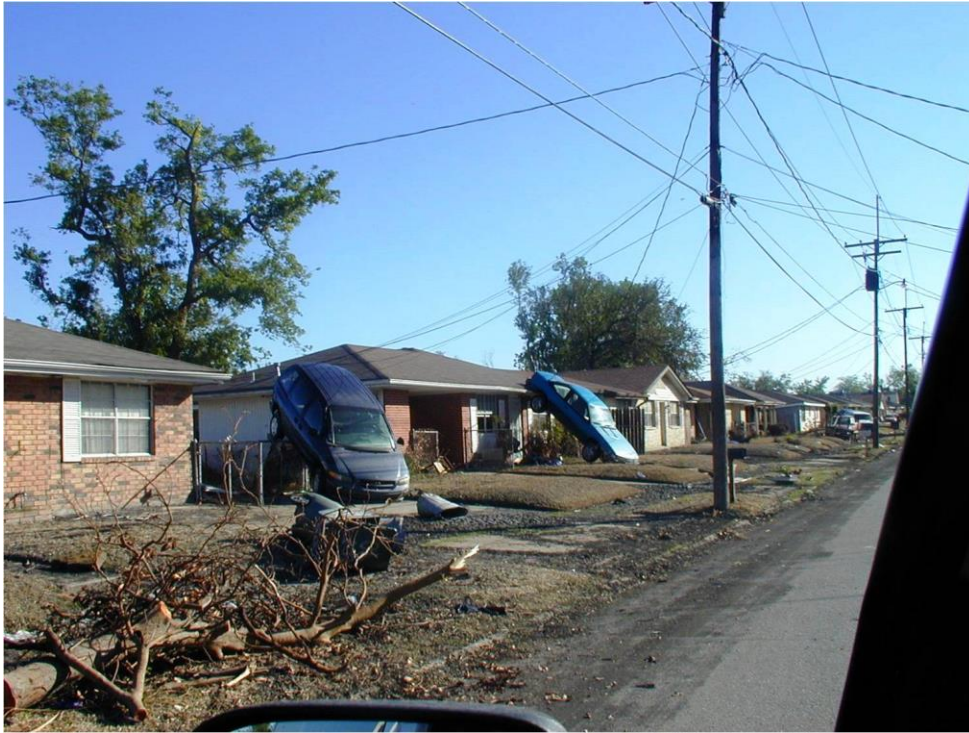
Figure 7-3 – Stranded cars, 2005 Hurricane Katrina

Figures 7-3 and 7-4 show some vehicles stranded onto buildings. SAP evaluators must avoid walking under these sorts of things! The roofs are not designed for these types of loads!

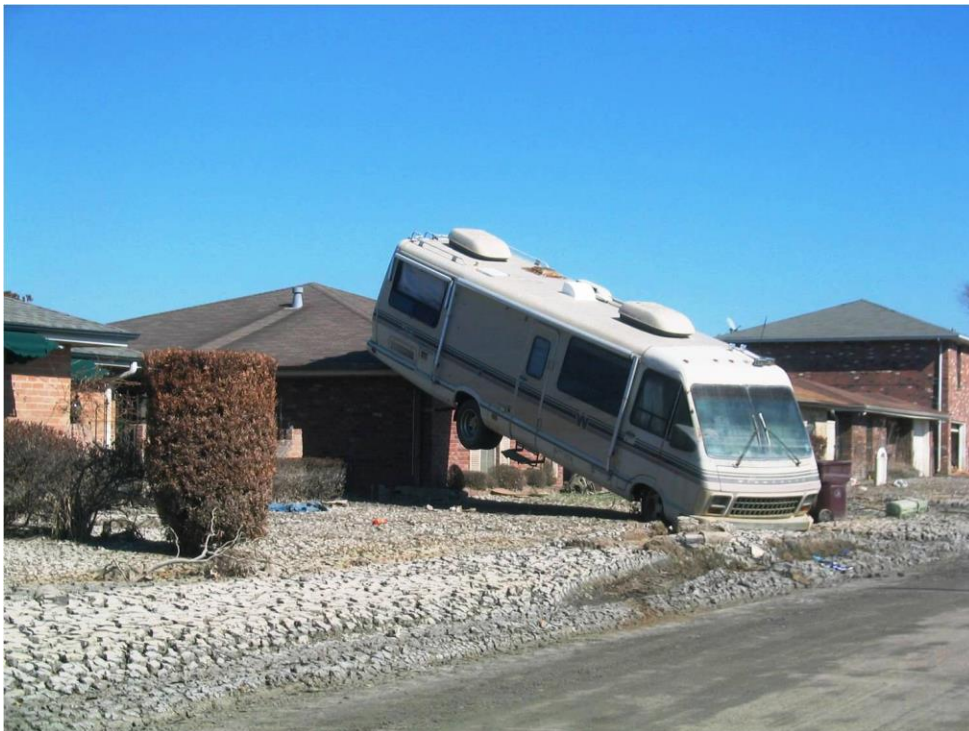
Figure 7-4 – Stranded motor home, 2005 Hurricane Katrina

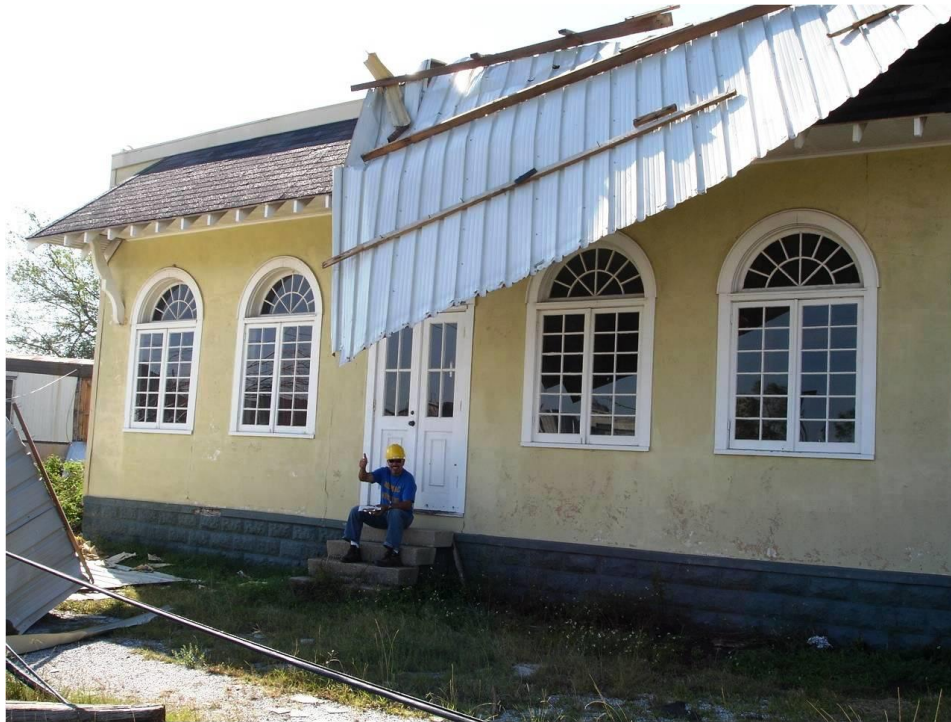
Figure 7-5 – Roof fragment falling hazard, 2005 Hurricane Katrina

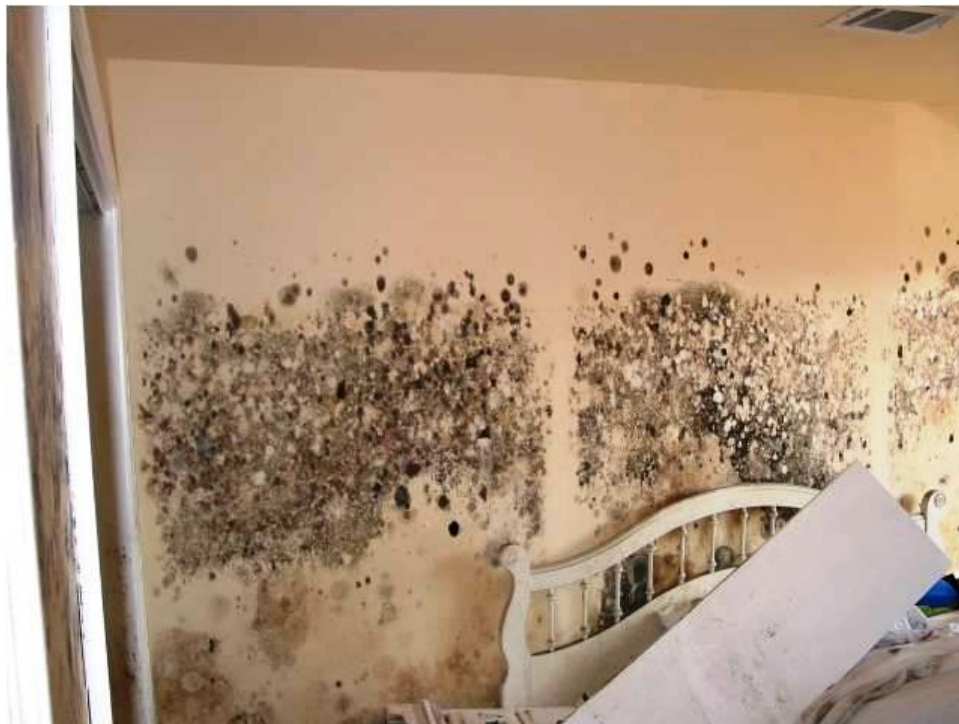
Figure 7-6 – Mold growth, 2005 Hurricane Katrina

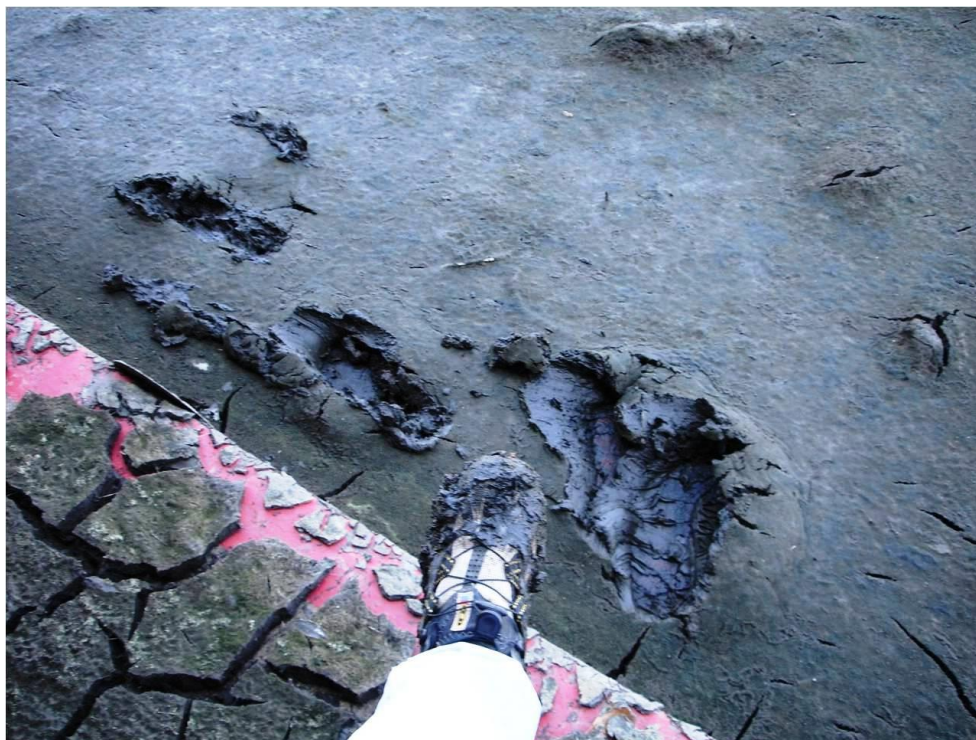
Figure 7-7 – Mud slipping hazard, 2005 Hurricane Katrina

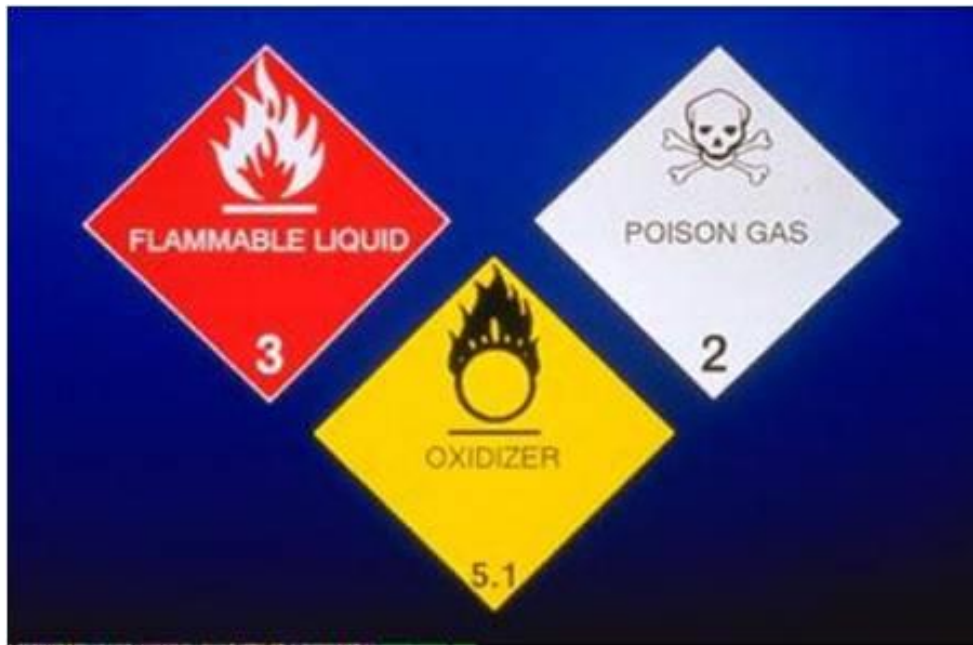
Figure 7-11 – Examples of DOT Placards

Figure 7-11 shows some examples of the DOT placards. In addition to these, containers with materials that have multiple classifications will have a placard for each classification. As with the building placards, remember that these placards indicate what is supposed to be in the container, not what may actually be in it. A placard showing a benign chemical could be inaccurate!
