# SEISMIC VULNERABILITY EVALUATION GUIDELINE FOR PRIVATE AND PUBLIC BUILDINGS

Part II: Post Disaster Damage Assessment

## Submitted by: National Society for Earthquake Technology-Nepal (NSET)

November 2009

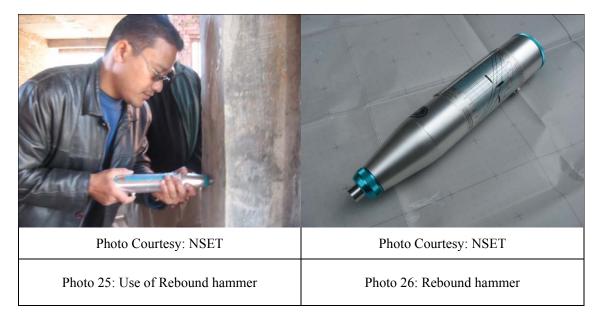
The person operating the equipment places the impact plunger of the hammer against the concrete and then presses the hammer until the hammer releases. The operator then records the value on the scale of the hammer. Typically three or more tests are conducted at a location. If the values from the tests are consistent, record the average value. If the values vary significantly, additional readings should be taken until a consistent pattern of results is obtained.

Since the test is relatively rapid, a number of test locations can be chosen for each wall. The values from the tests are converted into compressive strength using tables prepared by the manufacturer of the rebound hammer.

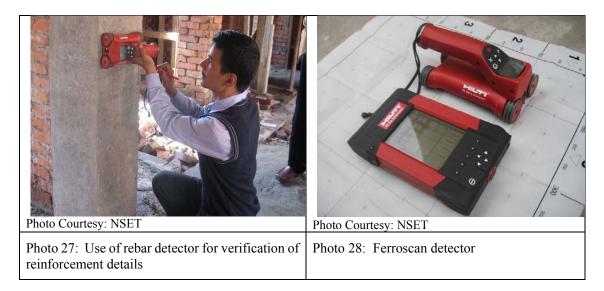
If size of the bar is known, the covermeter readout can be used to determine the depth of the reinforcing bar. If the depth of the bar is known, the readout can be used to determine the size of the bar. If neither quantity is known, most rebar detectors can be used to determine both the size and the depth using a spacer technique.

The process involves recording the peak reading at a bar and then introducing a spacer of known thickness between the probe and the surface of the wall. A second reading is then taken. The two readings are compared to estimate the bar size and depth. Intrusive testing can be used to help interpret the data from the detector readings. Selective removal of portions of the wall can be performed to expose the reinforcing bars. The rebar detector can be used adjacent to the area of removal to verify the accuracy of the readings.

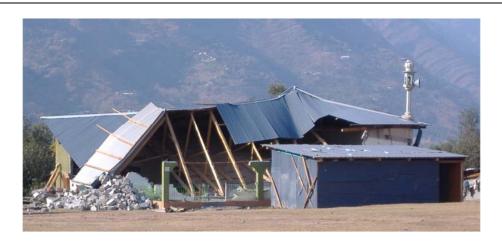
# Damage Grade 4

Gaps occur in walls, walls collapse, partial structural failure of floor/ roof, Building takes a dangers state.

Vacate the building, demolish and construct or extensive restoration and strengthening

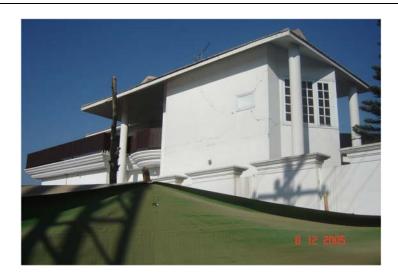
# Damage Grade 1

Thin cracks in plaster, falling of plaster bits in limited parts, fall of loose stone from upper part of building in rare cases Building need not be vacated, only architectural repairs needed, Seismic strengthening advised

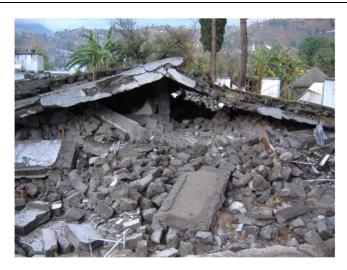
Total or near total collapse

Clear the site and reconstruction
