**16th US-Japan-NZ Workshop on the Improvement of
Structural Engineering and Resiliency
Nara, Japan, 27-29 June 2016**

2015 Gorkha (Nepal) Earthquake: An Overview

Professor Rajesh Dhakal, PhD, FIPENZ
Professor of Structural and Earthquake Engineering
Department of Civil and Natural Resources Engineering
University of Canterbury
Christchurch, New Zealand

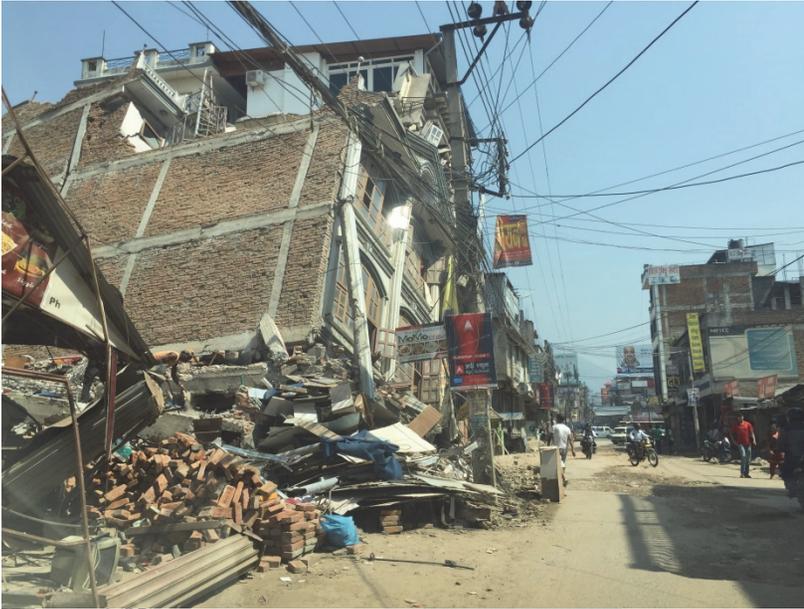
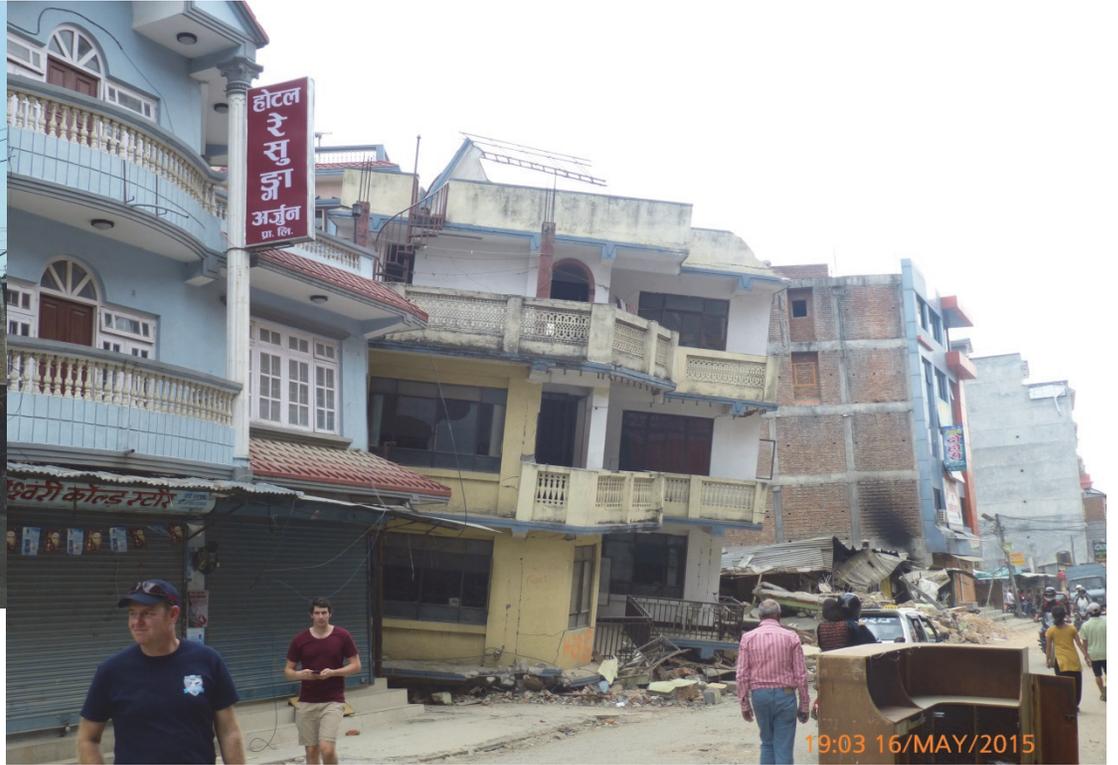
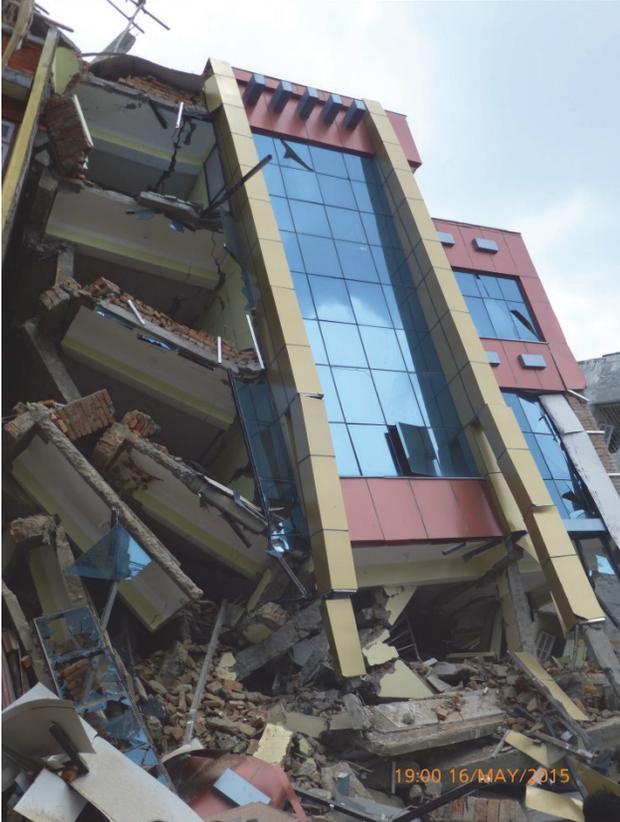
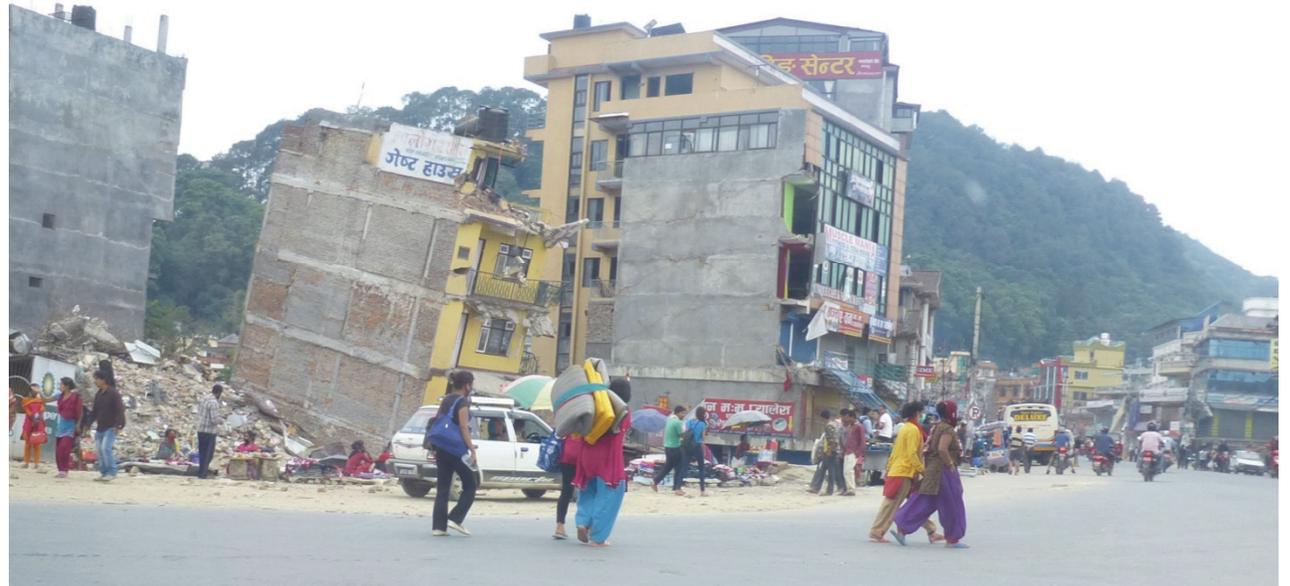
Most Non-Engineered Houses Collapsed

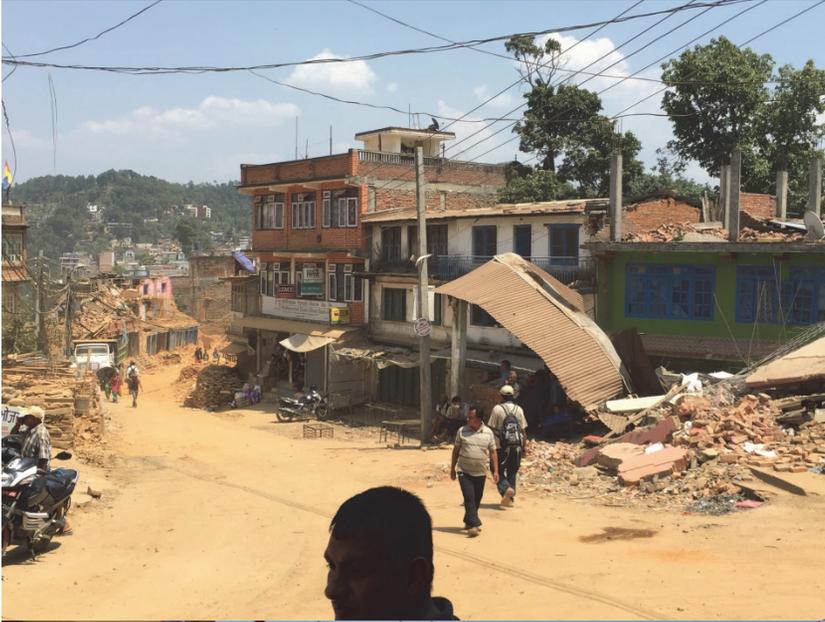
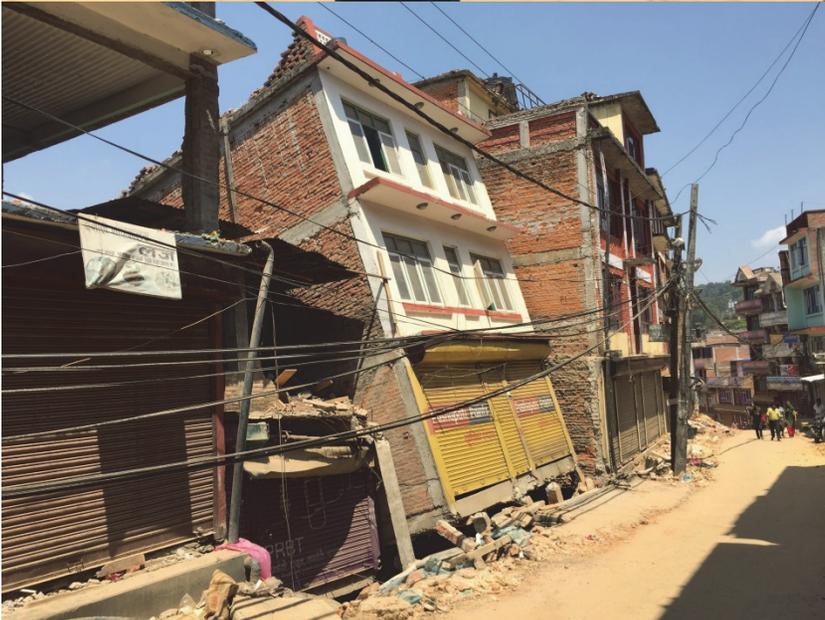
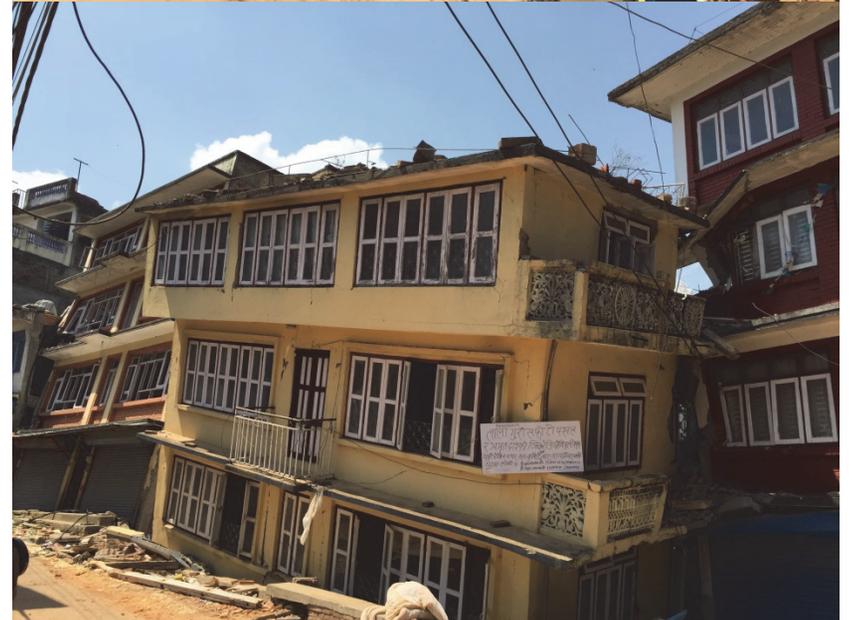
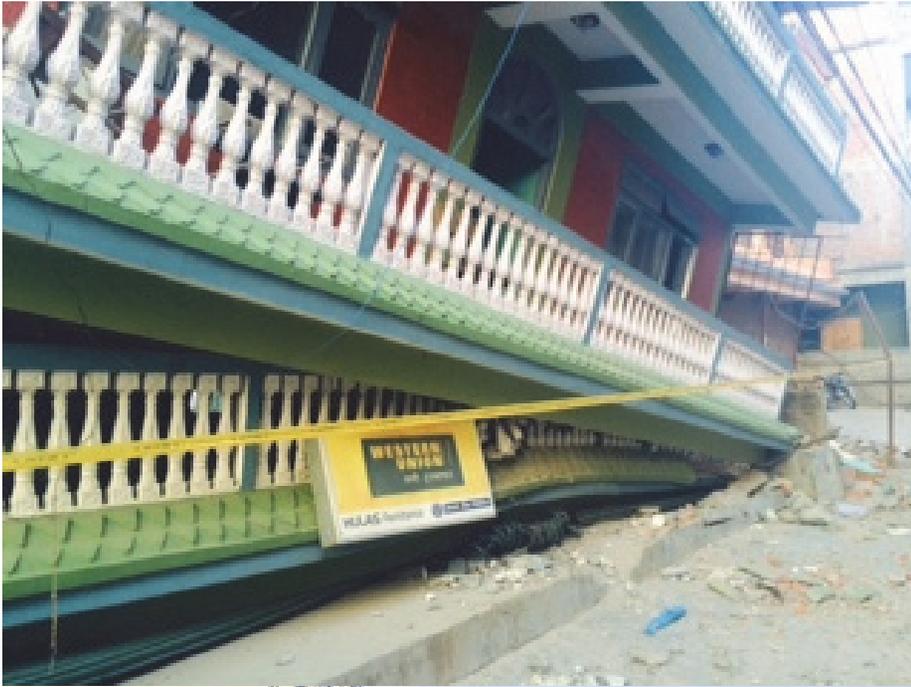
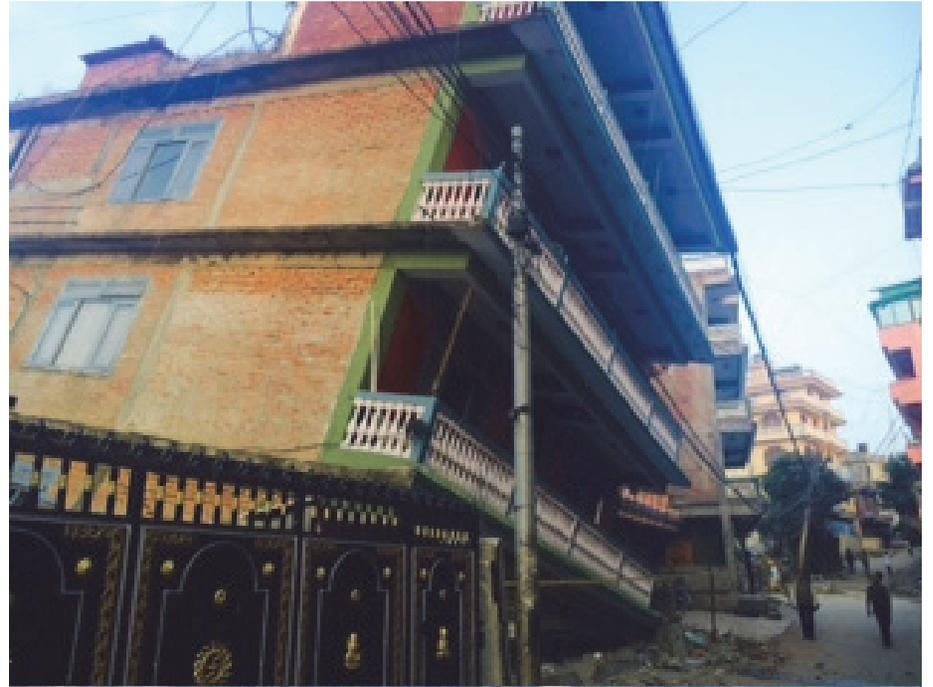
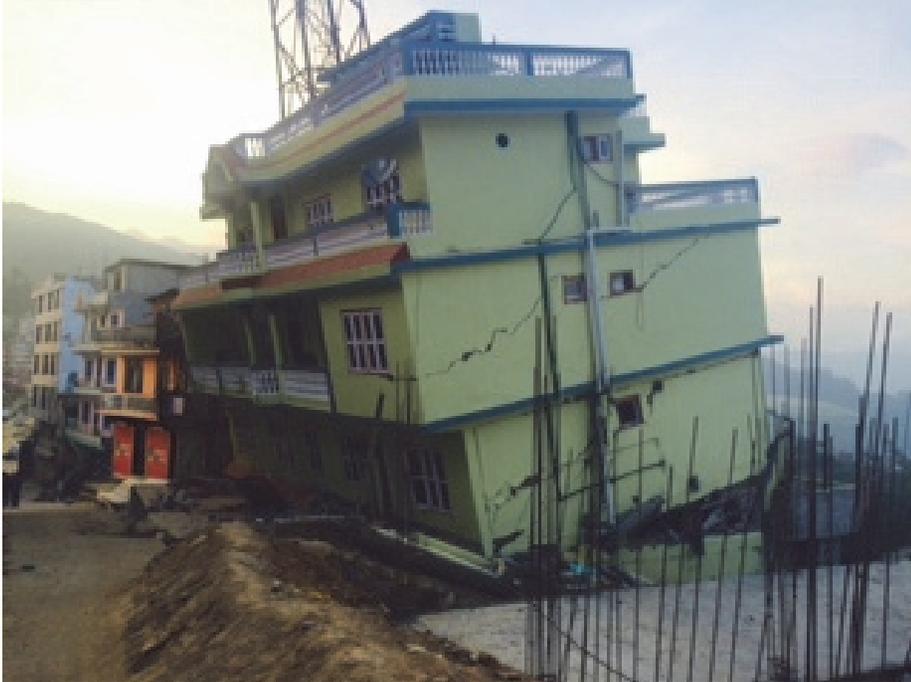
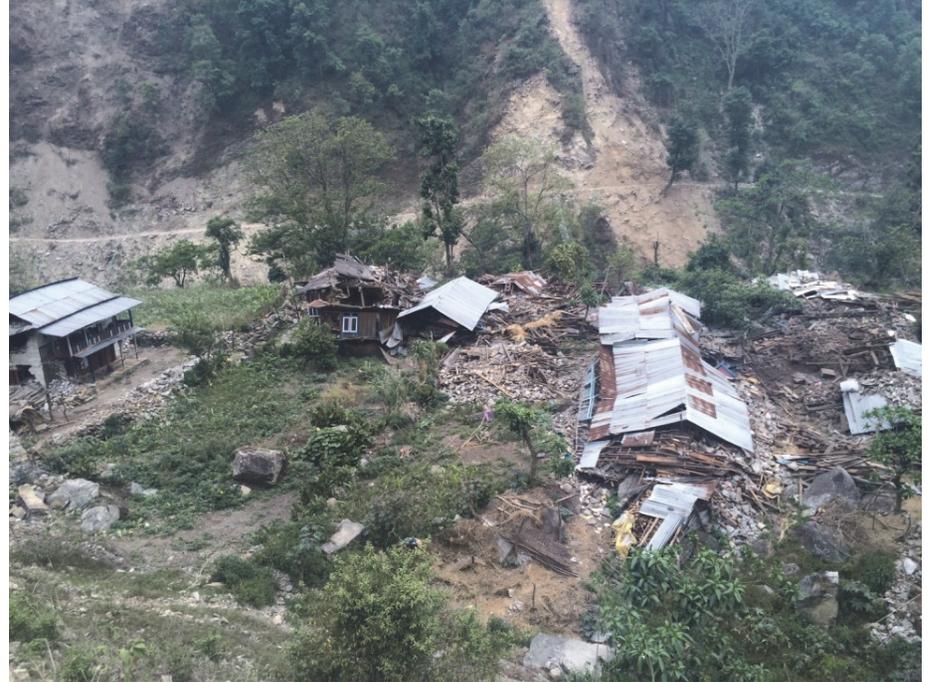
Hilly settlements were hit harder: Ridge effect

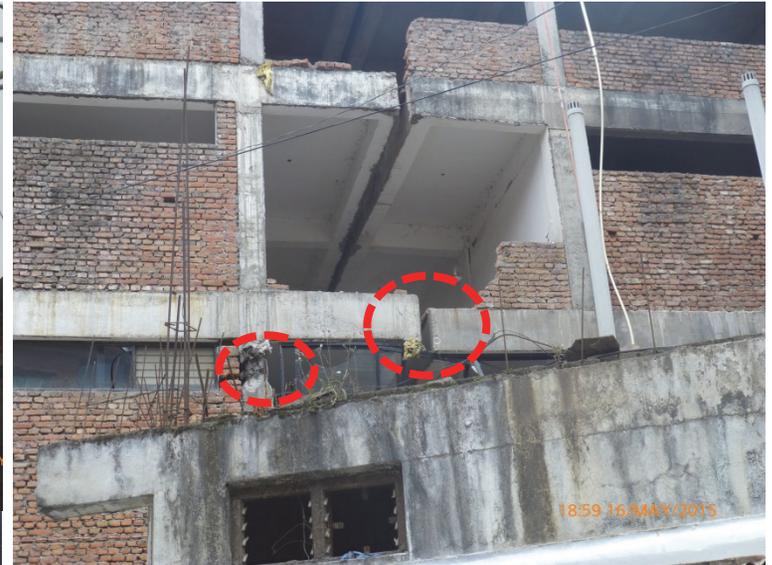
Buildings under construction: Bad Examples

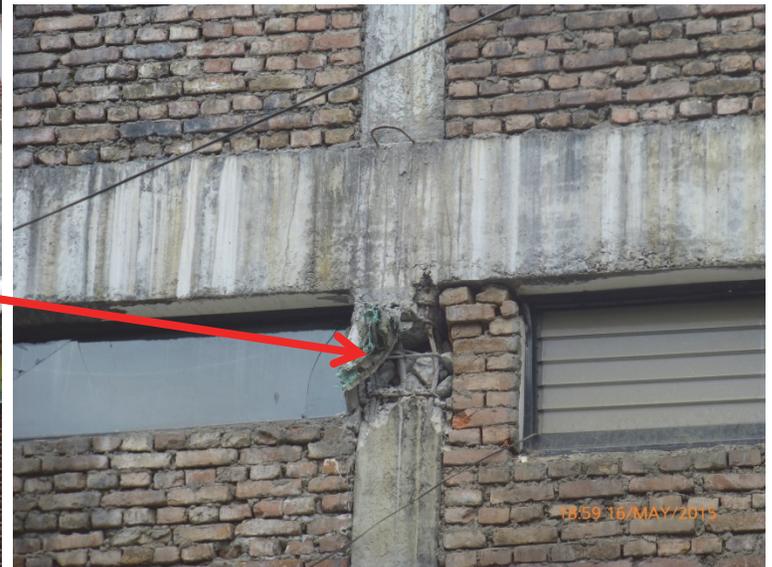
Incorrect strength hierarchy
